# PROPERTY INSPECTION REPORT

203 Saint Nicholas Cir. Sandy Springs, GA. 30327

Mar 10, 2021

1599

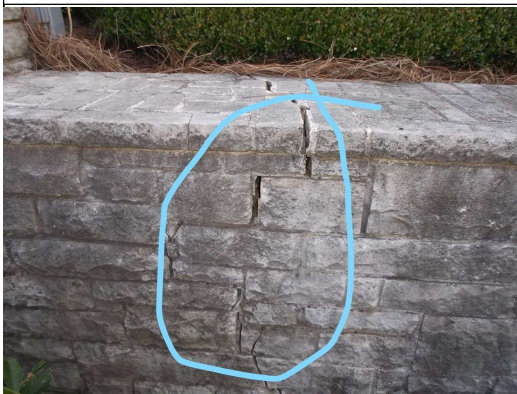
Movement cracks at the front yard wall

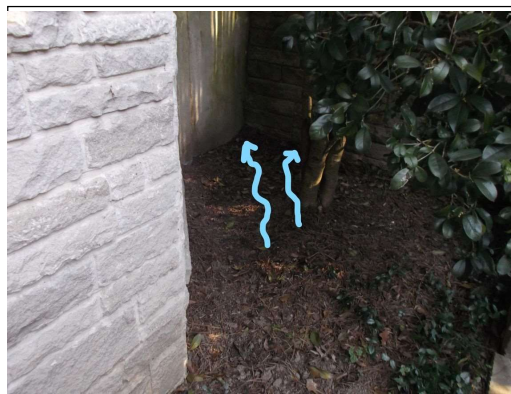
Soil slopes to foundation right side of house

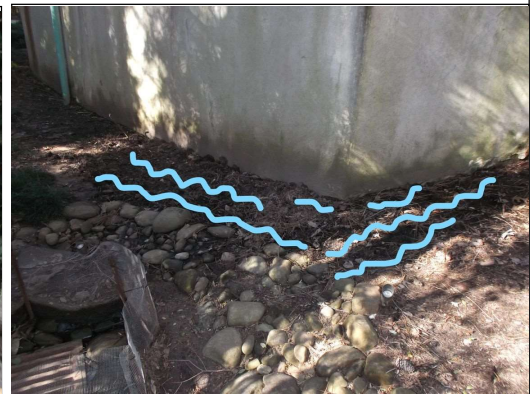
Water seeping out ground below pool wall

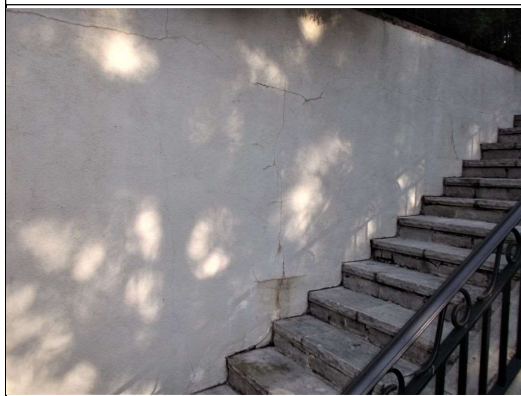
Movement crack and loose stucco

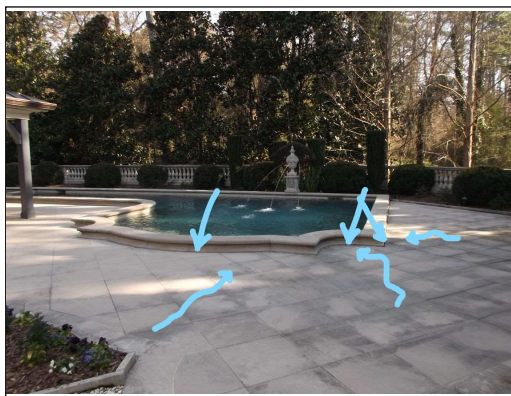
Deck slopes to pool, missing gaskets, mortar

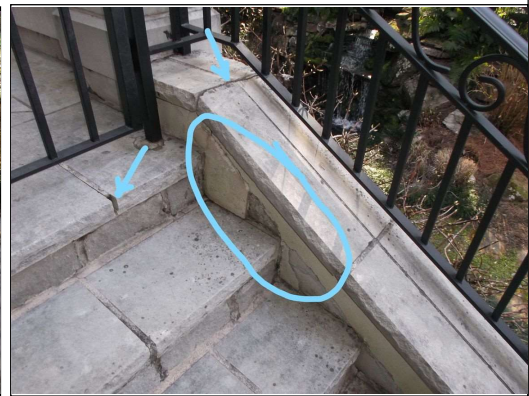
Movement cracks at basement stairs

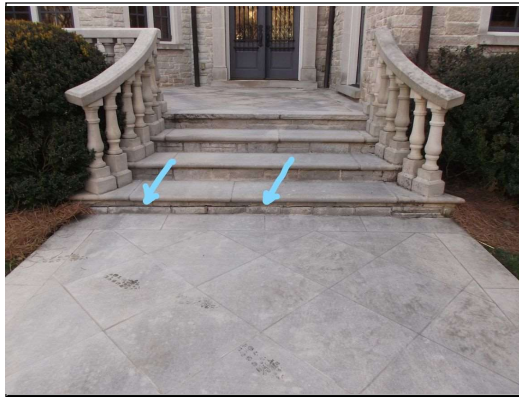
Settling crack across the bottom step joint

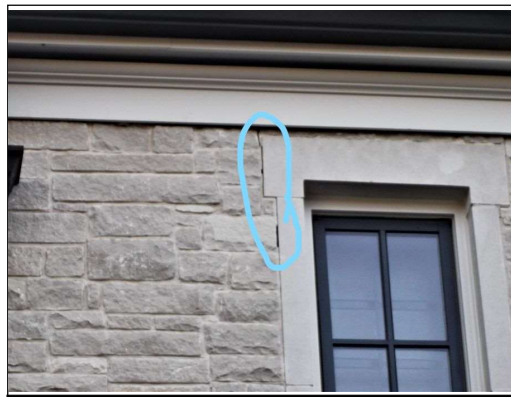
Settling crack at front left window

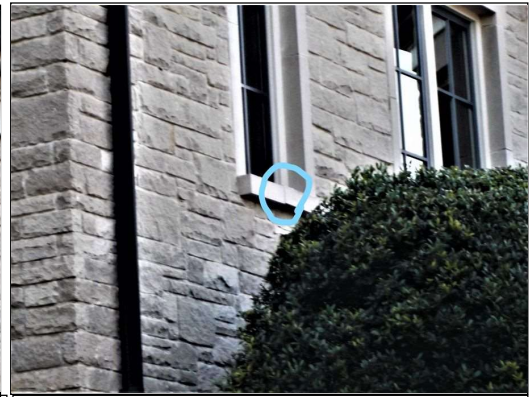
Settling crack at window masonry seal

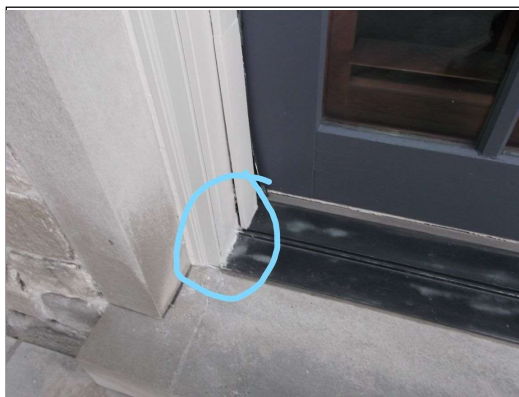
Water damage painted at front doors

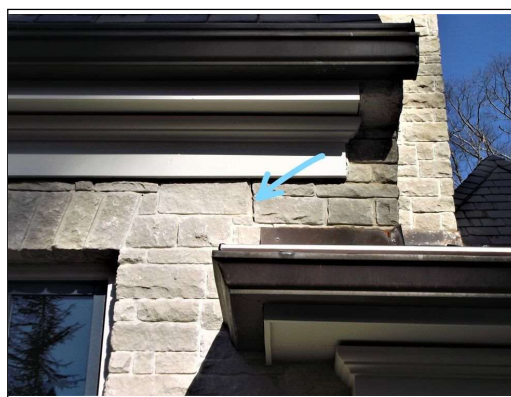
Settling crack at corner of house at cook out

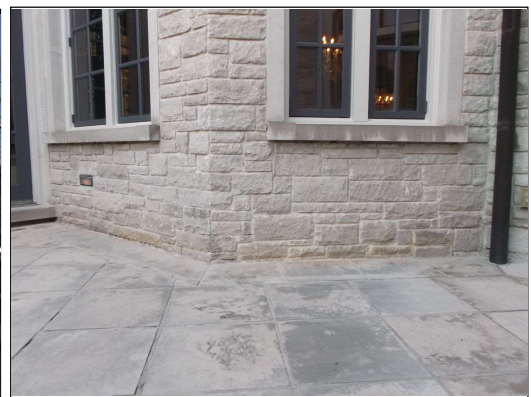
Missing weep holes in veneer several areas

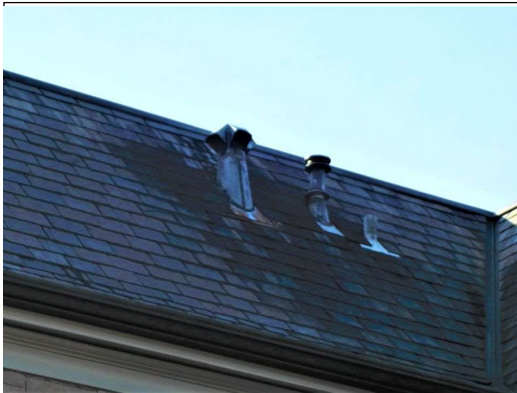
Shingles need wash, vent pipes need paint

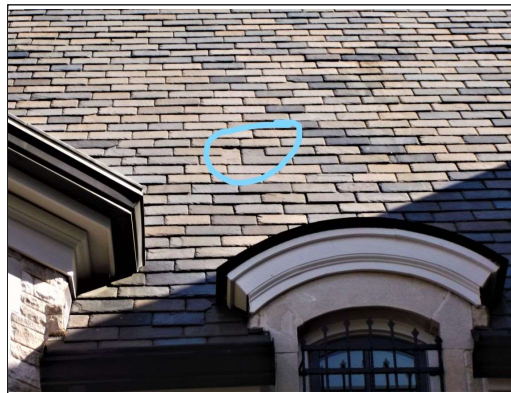
Missing shingle at front roof

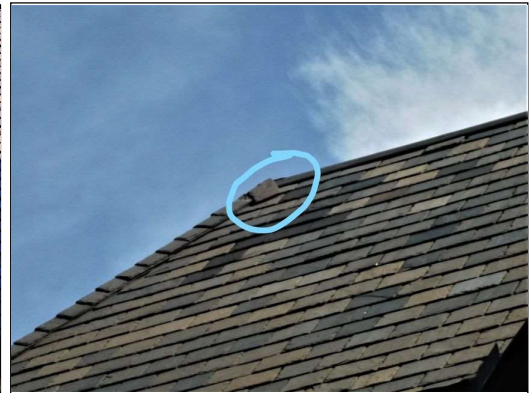
Detaching or loose shingle at front ridge

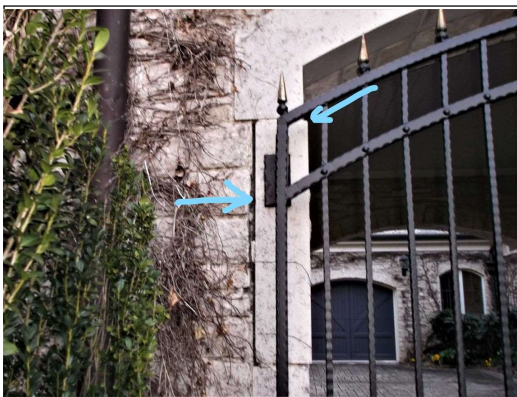
Masonry detaching at left side of vehicle gate

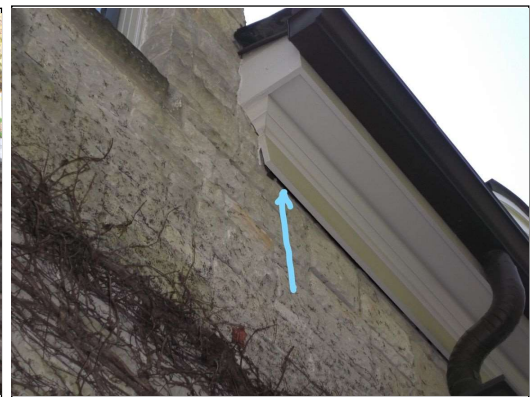
Freeze board gap at brick needs filler

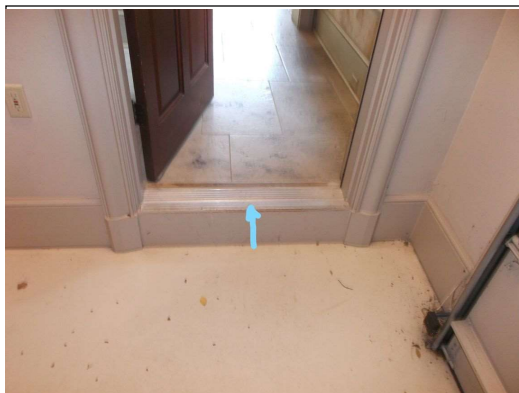
Step up from garage is a trip hazard (high)

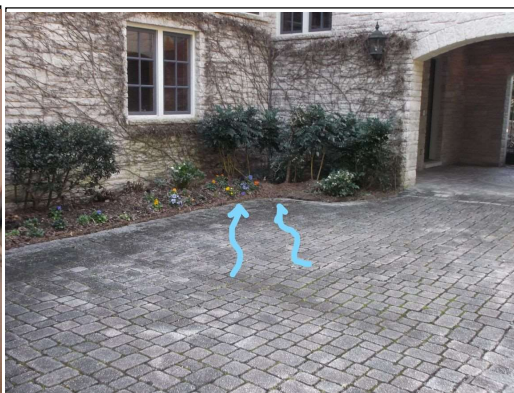
Courtyard driveway slopes to the house

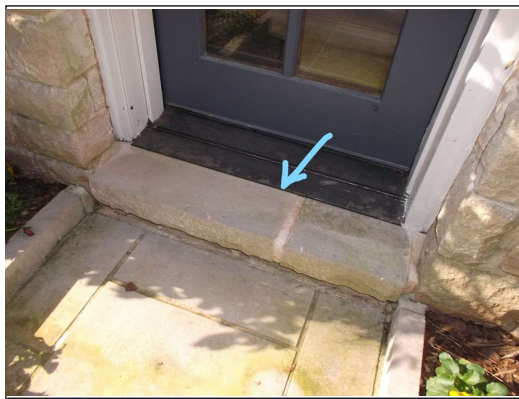
Missing caulk at threshold on masonry

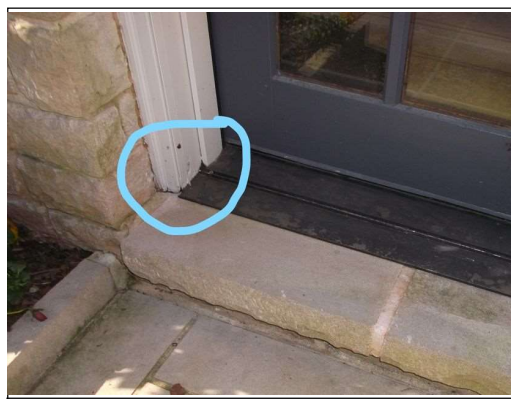
Water damage at rear door frames

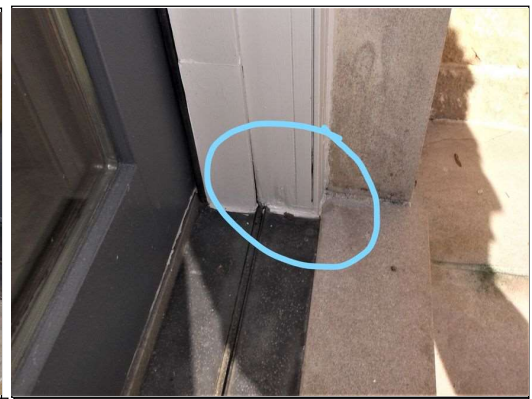
Water damage at rear door frames

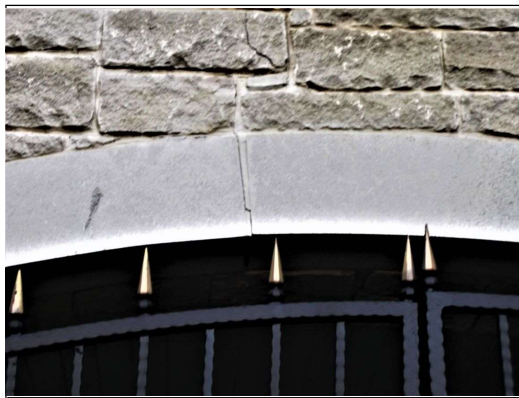
Settling crack at masonry header

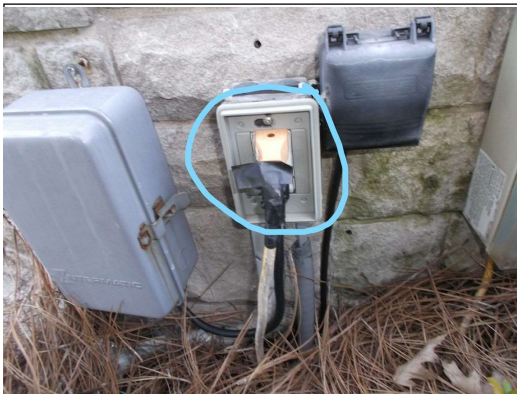
Missing box cover & conduit detached below

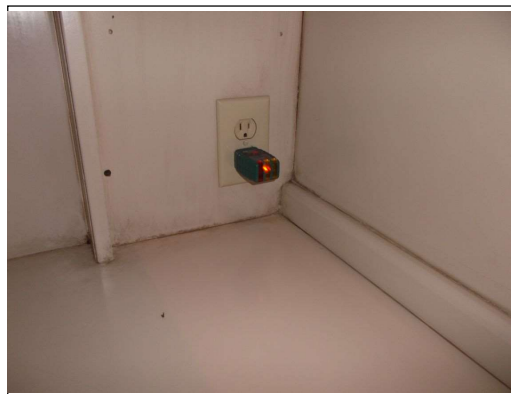
Outlets tested open ground master bed

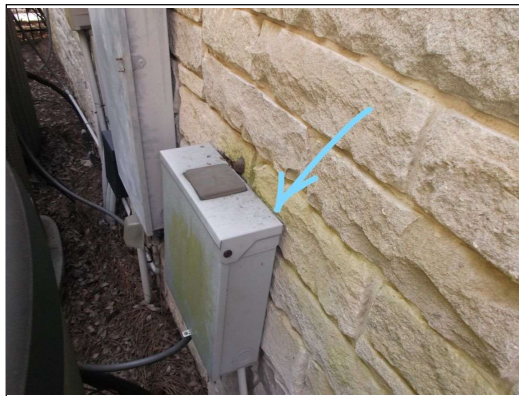
Missing bead of caulk across top of boxes

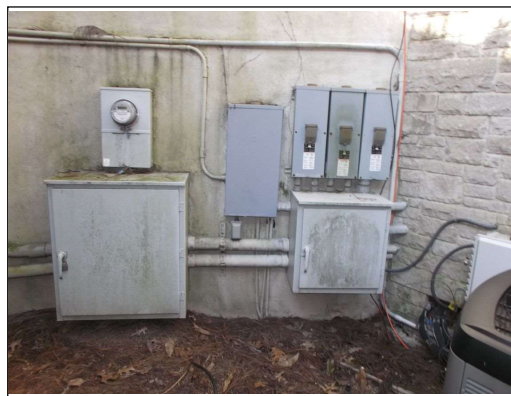
Outlet not energized below panel box

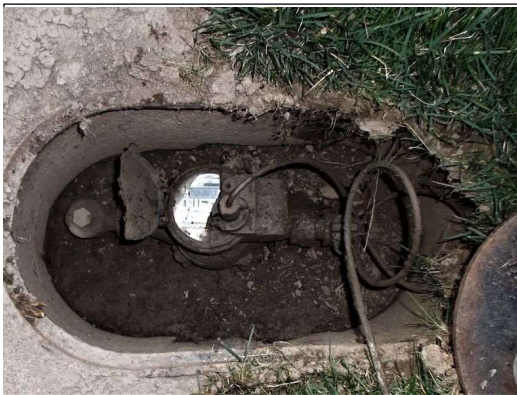
Meter had a slow turn when checked

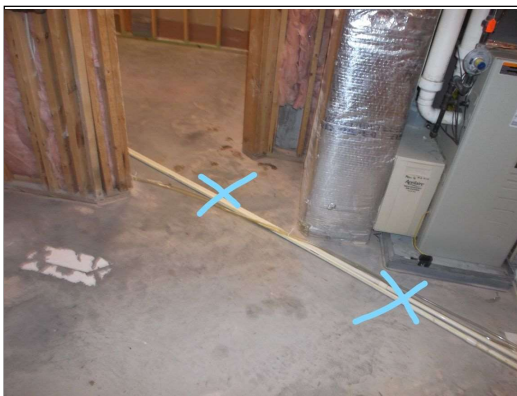
Drain pipes on floor can be damaged

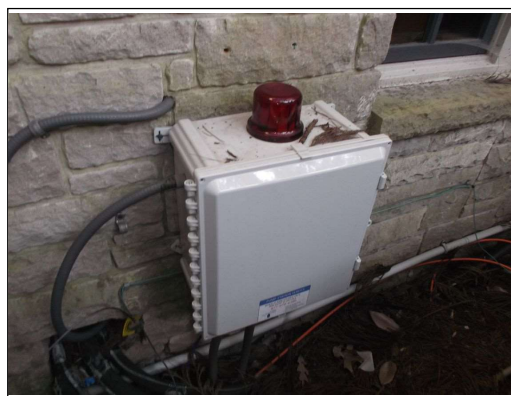
Ejection/septic controls at basement ground?

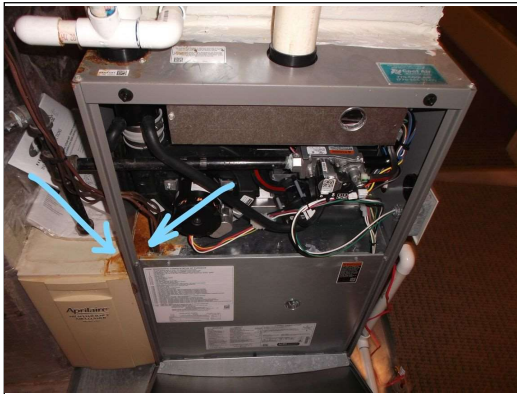
Rust in furnace at basement

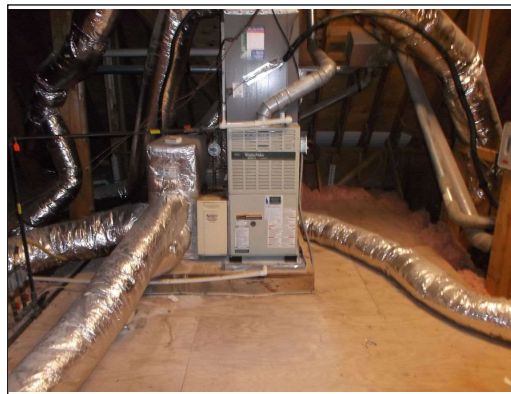
One older furnace in attic

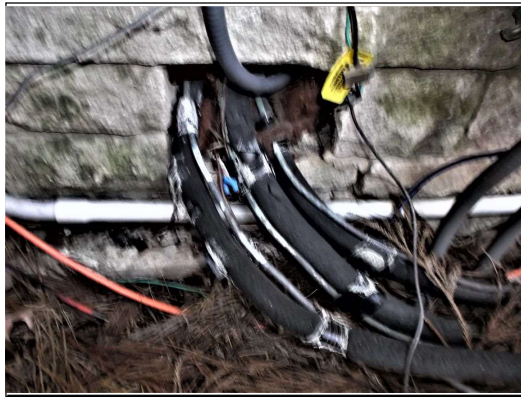
Missing, deteriorated refrigerant line insulatio

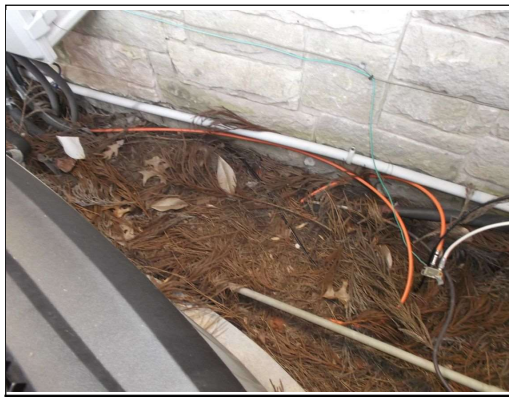
Refrigerant lines under the debris

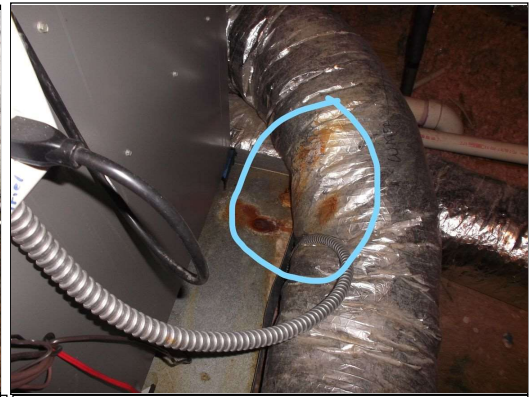
Rust stains in furnace pan at attic

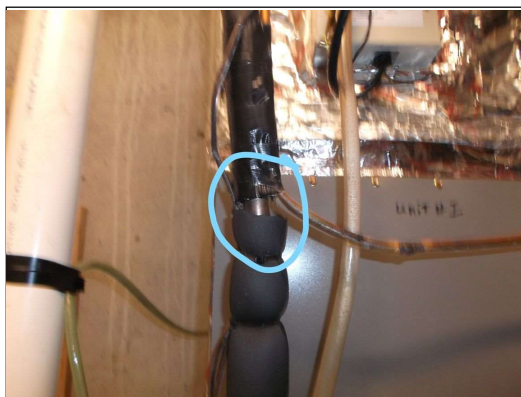
Missing refrigerant line insulation

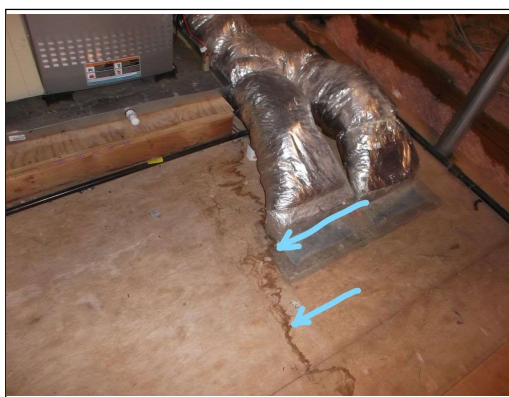
Dry water stains on attic floor at left furnace

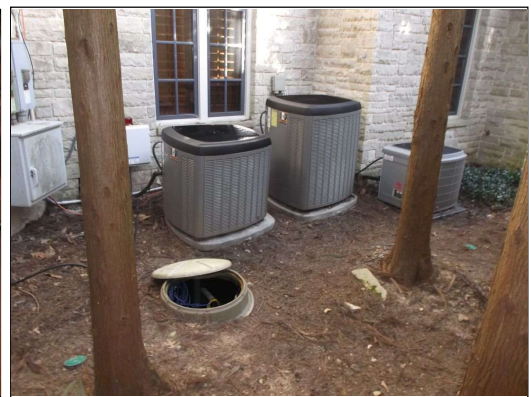
The right small AC unit is older Carrier unit

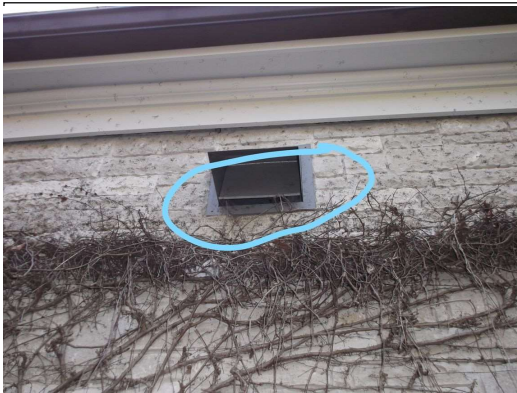
Kitchen exhaust fan terminal door open

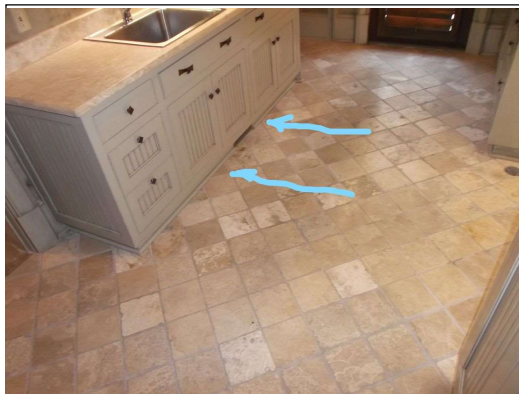
Laundry floor sinks at wash sink cabinet

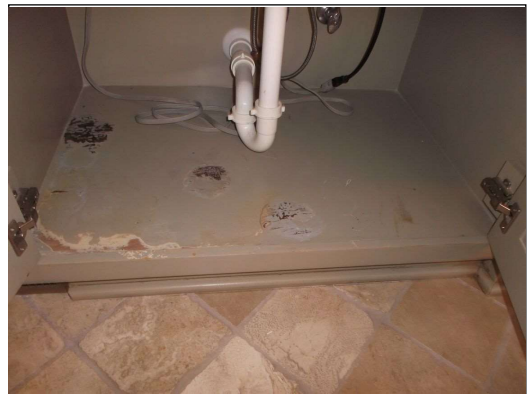
Water damage in sink cabinet

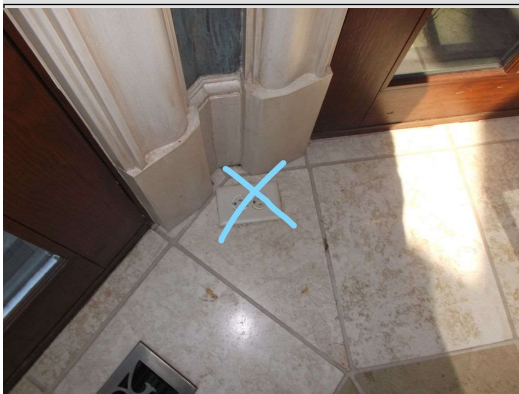
Outlets not water proof at sunroom

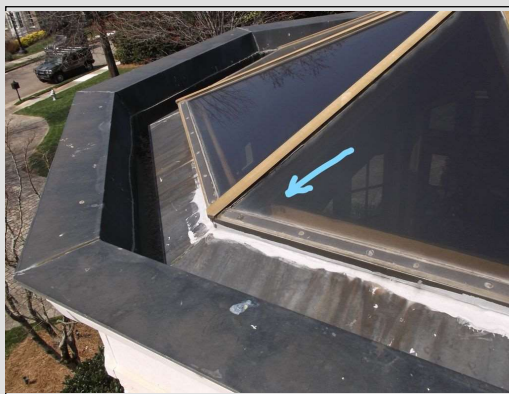
Cracked glass at skylight in sunroom

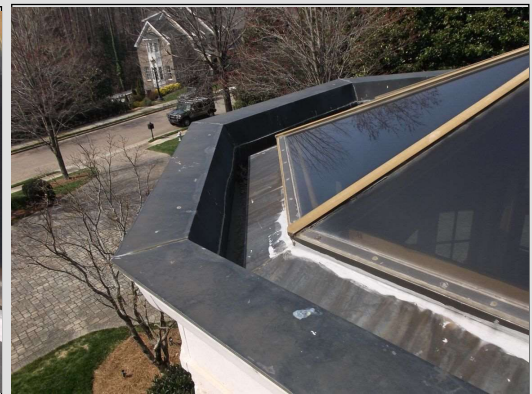
Sunroom copper roof needs cleaning

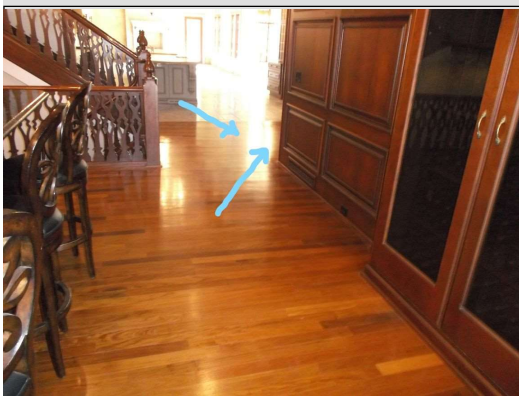
Kitchen, bar room, dining floor slope to hall

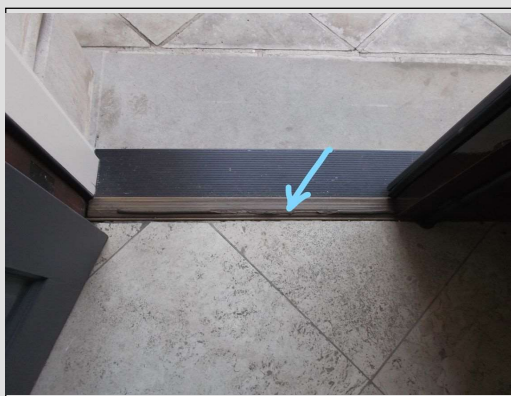
Front door weather strip damaged

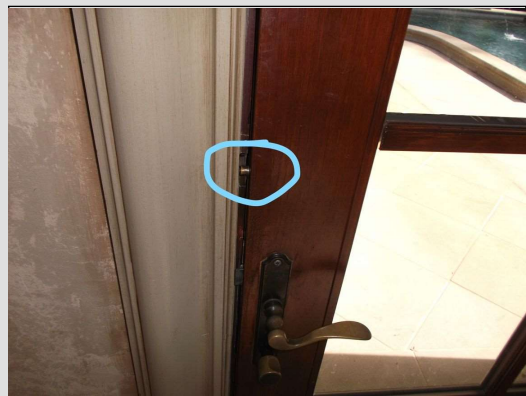
Door lock to cook out area bump door frame

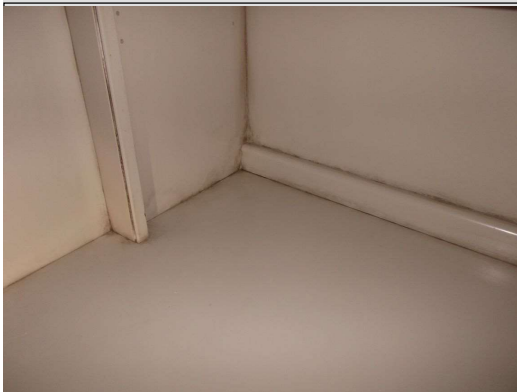
Verify stains are faux paint or not

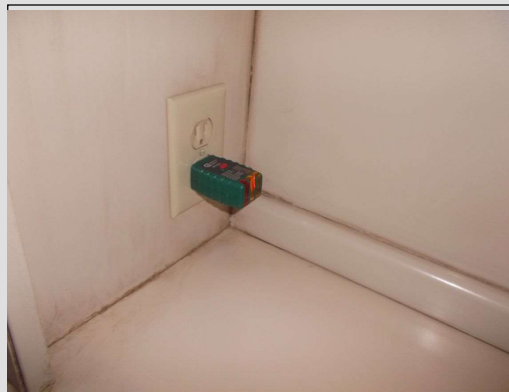
Outlets tested open ground at wall cabinets

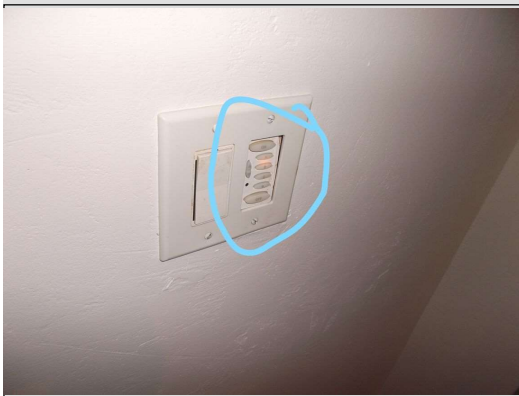
Light switch loose in the outlet box

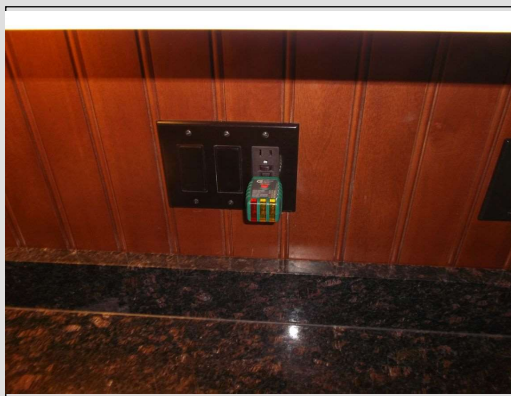
Bar counter outlet could not be reset

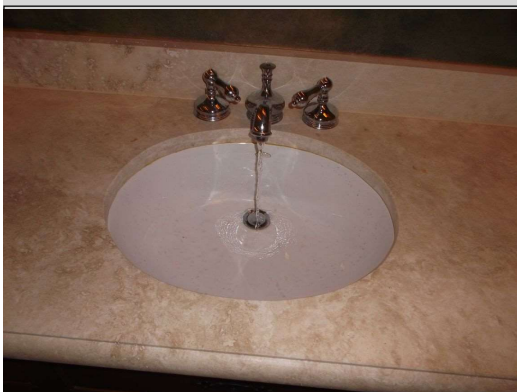
Low water flow at front bed bath sink

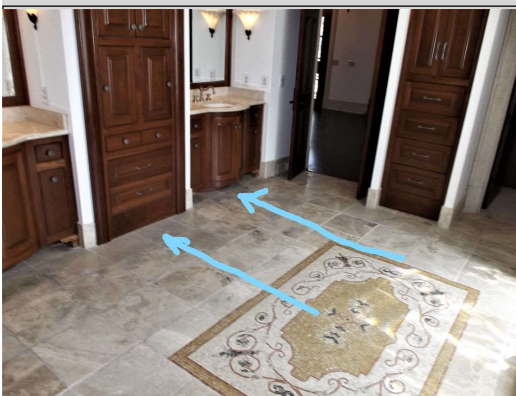
Master floor slopes to sink wall

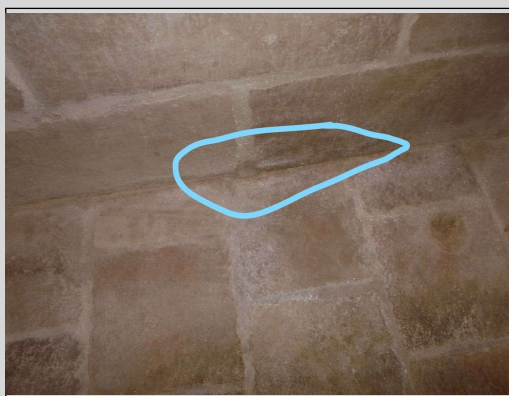
Cracks in shower tile grout

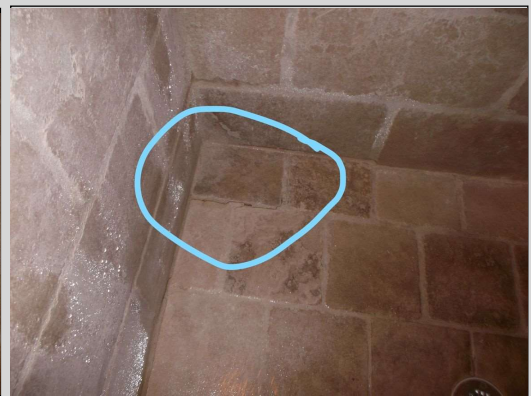
Loose tile in shower and defective grout

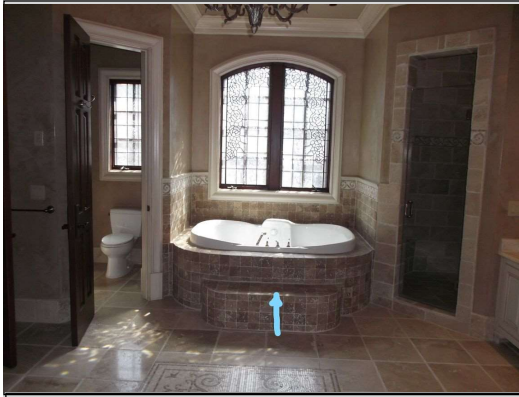
Step up to tub too high

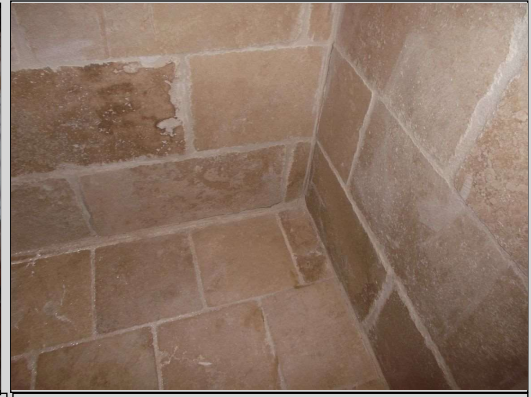
Cracks in tile grout

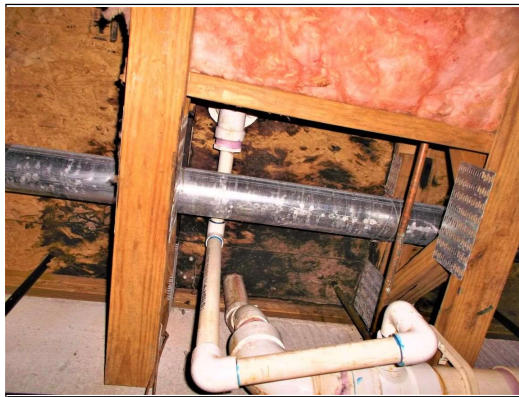
Water damage to floor seen in crawlspace

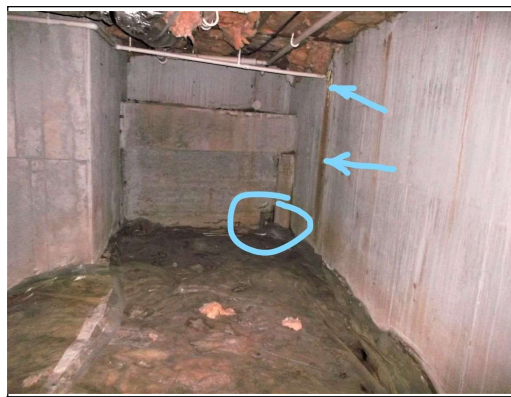
Damp foundation wall and water stains

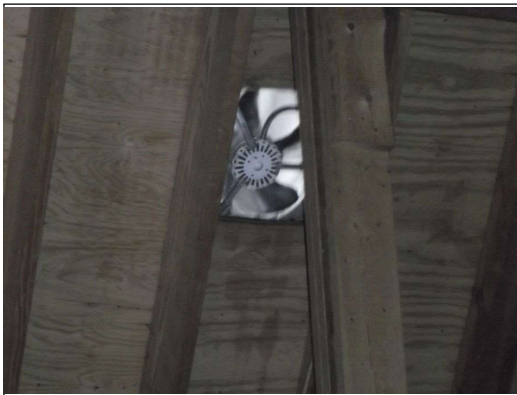
One exhaust fan in attic roof

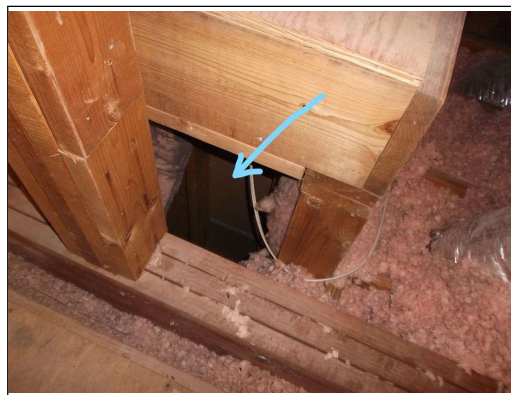
Missing insulation at keeping room wall (attic

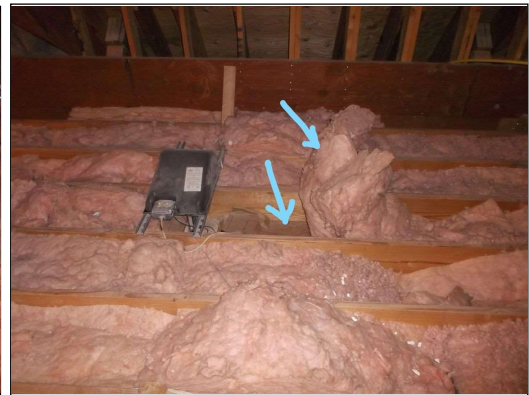
Ceiling insulation detached

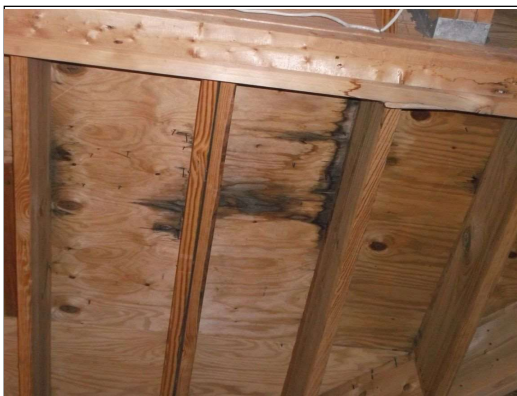
Dry water stains seen from the stairwell

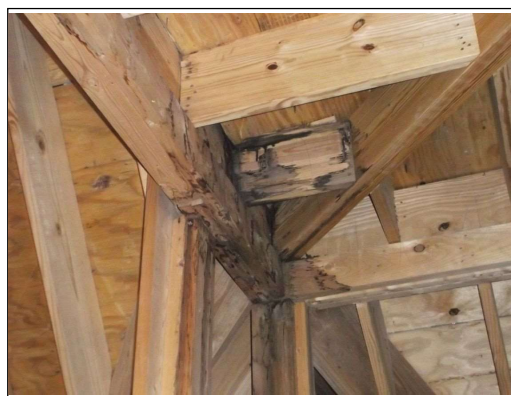
Dry stains on roof rafter framing

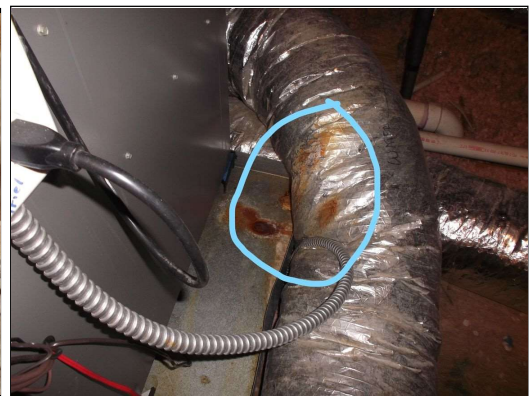
Dry water stains right side of furnace

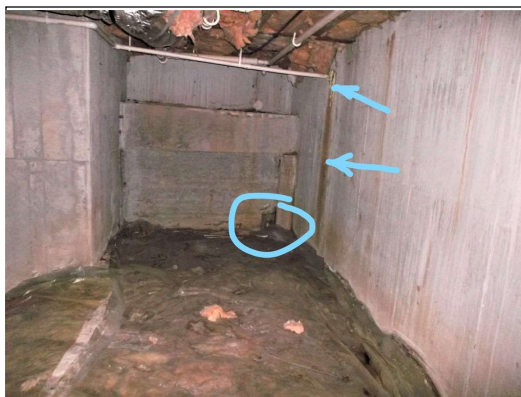
Water stains and dampness at wall

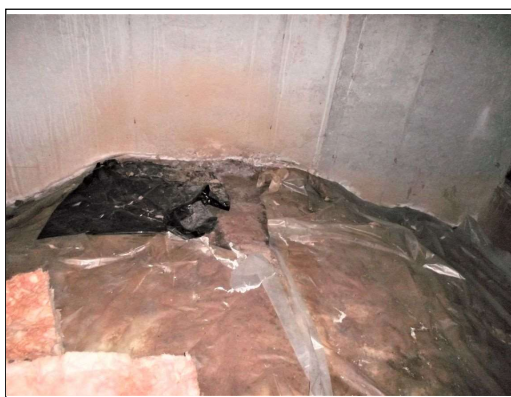
Exposed soil several areas
