PROPERTY INSPECTION REPORT

6584 Aria Village Dr. Sandy Springs, GA.

Jul 31, 2021

This inspection is for water damage information, water intrusion, repairs needed after water intrusion, construction defects and builder's defects.

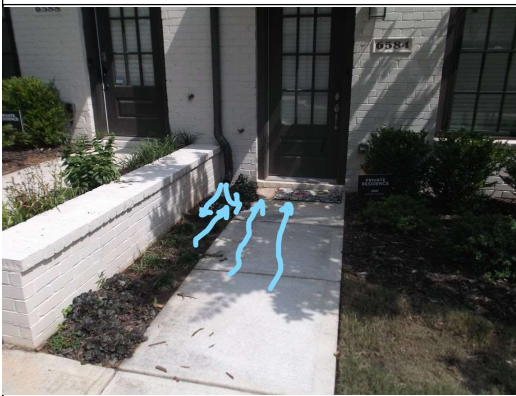
The front walkway to the townhouse door entry slopes toward the front door and can cause rain water to drain to the front of the building and into the soils. Over time, soil saturation can cause erosion at and under the building foundation and differential settling can take place under certain conditions (builder check the code).

Walkway slopes to doorway/poor grading

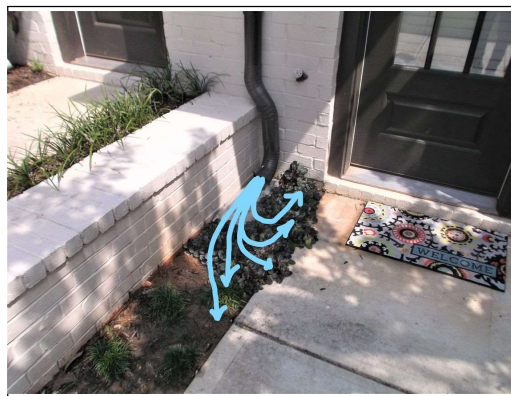
Soil has poor slope holds roof water

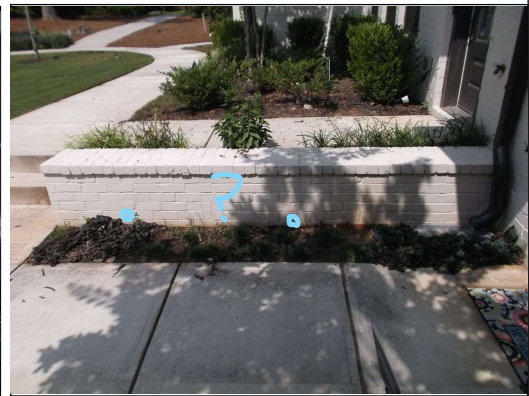
Could not verify there are drainage openings in the retaining wall at the front of the townhouse at the left side of the front door. Ground water can build up in the soils, create hydrostatic pressure that can cause water to seep into the building under certain conditions.

No drainage holes

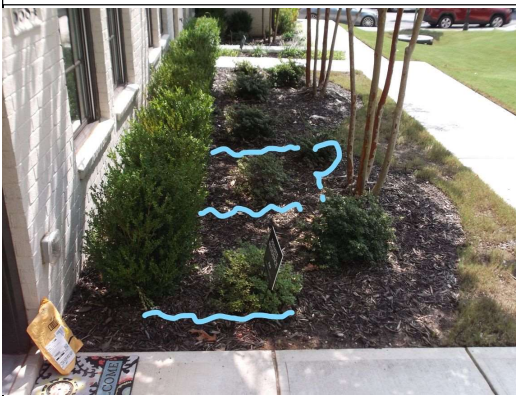
The front plant bed does not have the proper grading and slope away from foundation can cause differential settling due to soil saturation from rain over time (soil slope should be 6 inches for the first 10 feet away from the foundation)(builder check the code).

Poor soil grade and slope front plant bed

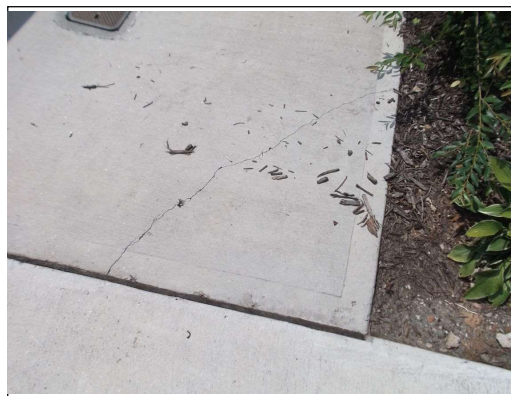
The driveway to the garage has a broken corner section at the street (can cause additional damage if not repaired or continued driving onto).

Driveway has broken corner at the street

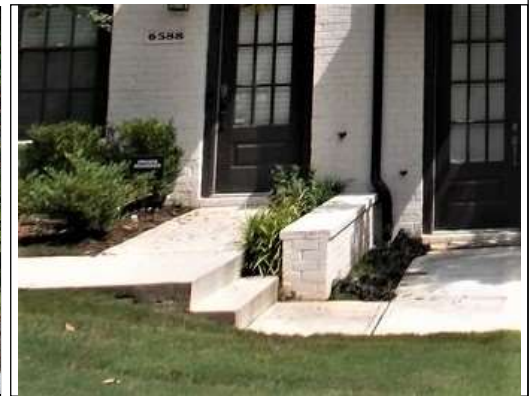
Bottom step blocks drainage from soil

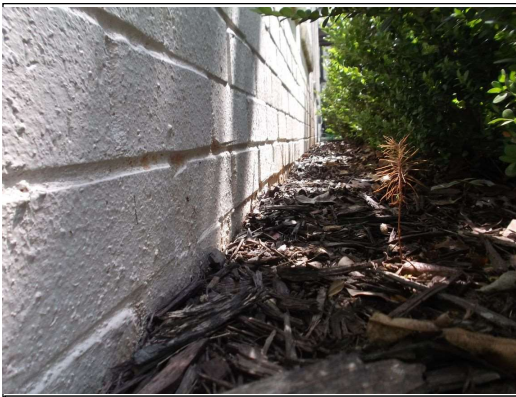
Could not verify there are proper weep holes and plastic or rubber flashing located or installed in the brick veneer near the bottom course at various areas (lets in air and moisture to drain out (builder verify).

Cannot verify proper weep holes in veneer

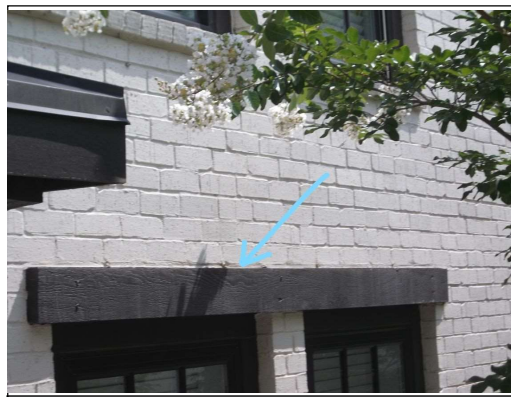
Cannot see flashing above beam

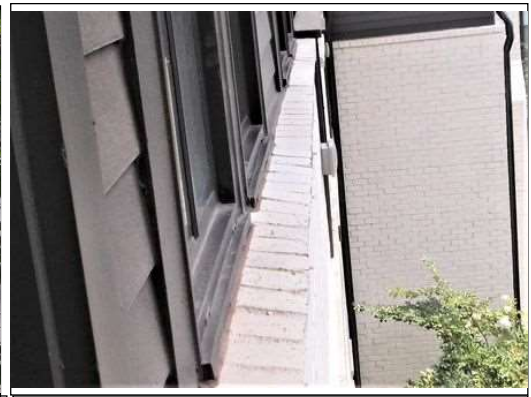
Window screens not installed. There is defective caulk at the bottoms of the window seals resting on the brick at the upper level can let water under window seal. Verify the metal cladding wrapped around the bottom window seals do not have open ends and allowing water intrusion into the openings and into the wall space at all windows. Cannot verify there is flashing installed where the wood beams traveling over windows in the brick veneer. Defective paint on windows at the roof tops.

Gaps @ window seal caulk & openings @ ends

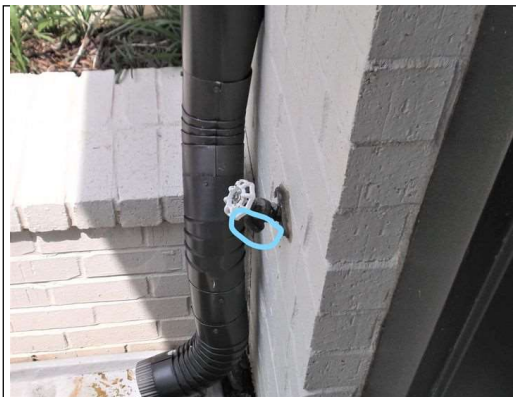
There are missing anti siphon devices at exterior hose bibs (can let contaminated water back into the drinking water under certain conditions).

No anti siphon device on hose faucet

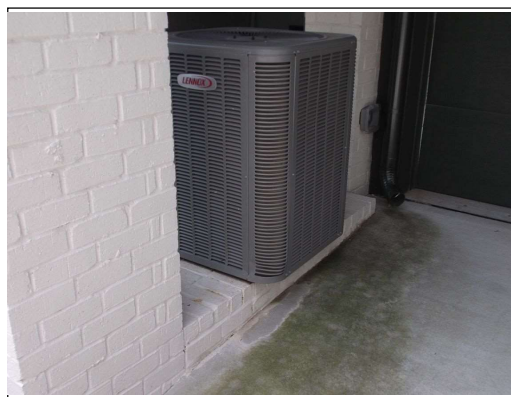
The AC unit at the rear of the townhouse was placed more to the right neighbors driveway path (shall not encroach into the path or over the property line).

The AC unit is placed in neighbors path

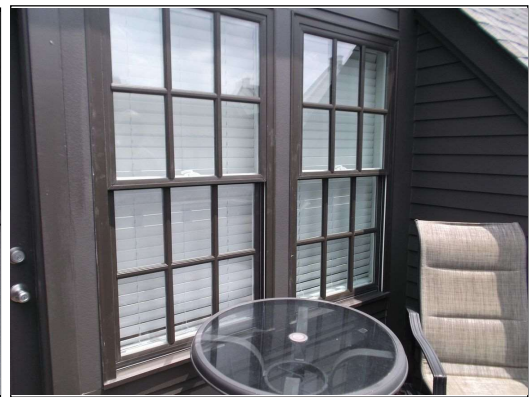
Defective paint on windows

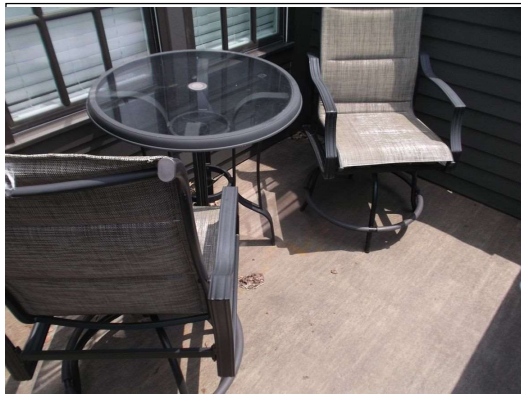
The roof patio floor slopes to the building and not to the drains near the exterior parapet. Can cause water buildup in the corner and at the wall (can cause water intrusion at the wall and floor under certain conditions).

Floor slopes to the interior corner

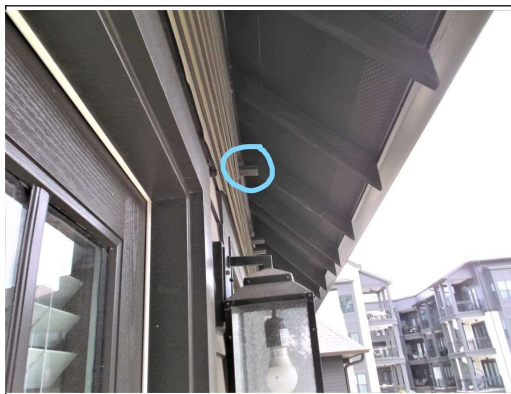
Drain pipe not turned down can drain back.

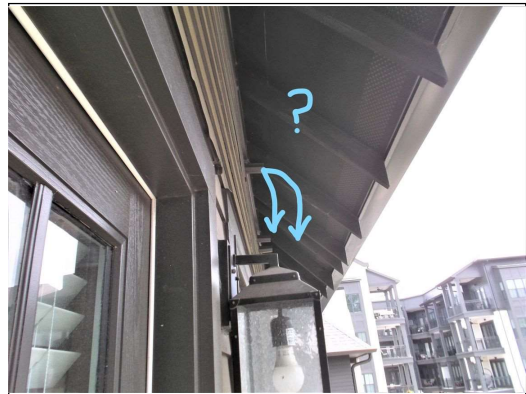
Pipes should have a elbow.

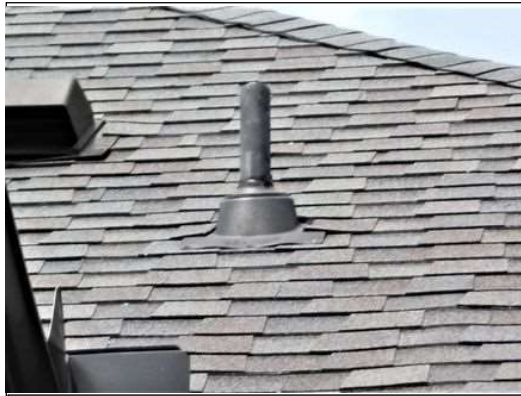
Based on a inspection of the roofs on this building, the plumbing pipe flashing may be installed on tiop of the shingles and face nailed (nails can extract over time and cause leaks and water can get under the sides of the flashing and penetrate nail holes. There should no nails in the bottom flange of the flashing exposed and where they are placed on the side flange shall be covered with shingles.

Flashing on top shingles face nailed can leak

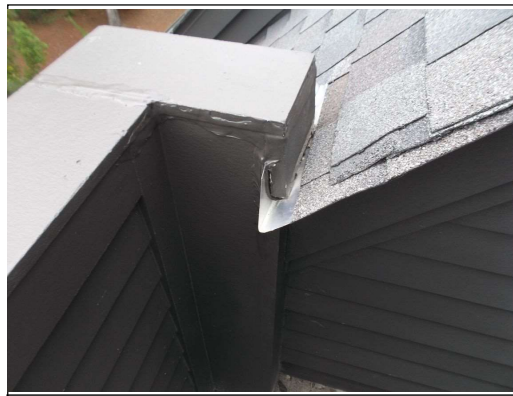
Builder verify the roof top patio parapet walls flashing does not have sharp metal corners that are a safety hazard. Verify the flashing where the parapet walls end at the roof shingles are pouring water back under the flashing and into the walls and under the roof.

Sharp metal flashing at parapet wall and roof

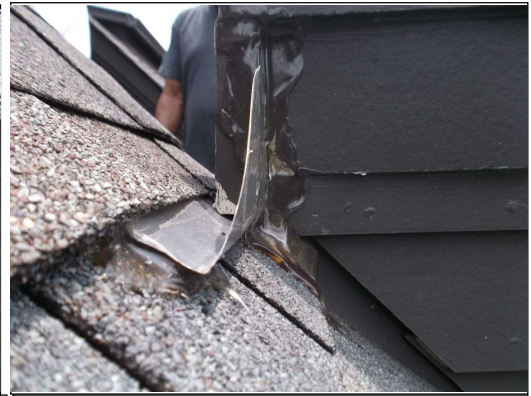
Flashing turned slightly up can drain back

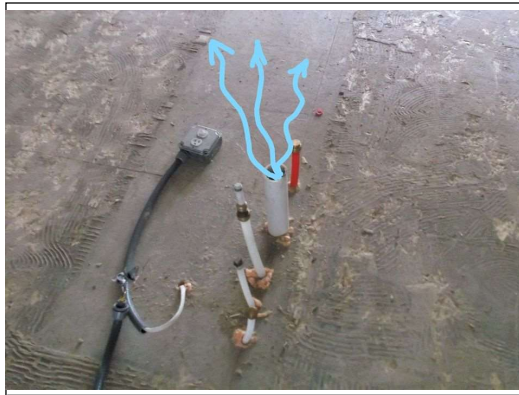
There is an open waste pipe rising out of the kitchen floor that has not been capped off (can let sewer gas, methane gas and radon gas into the living space under certain conditions).

Open waste pipe in kitchen

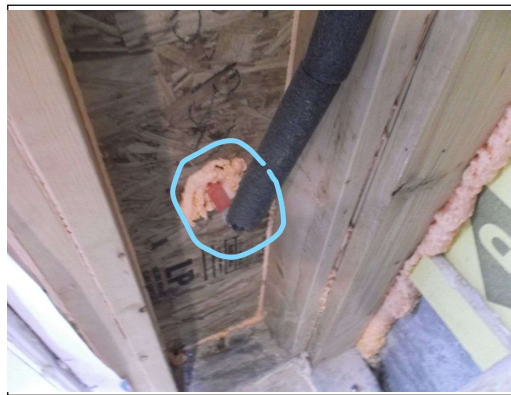
Missing insulation

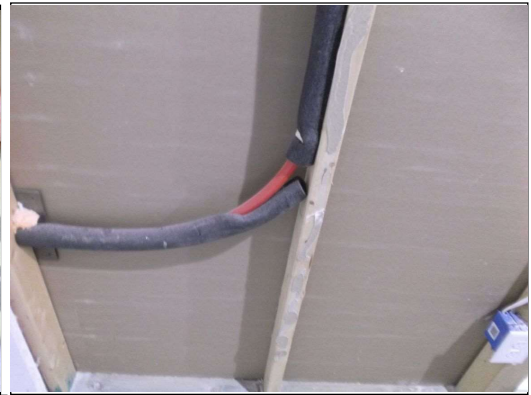
Detached pipe insulation

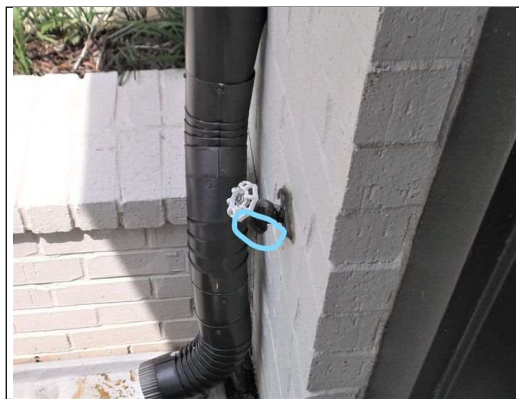
Missing anti siphon devices at hose faucets

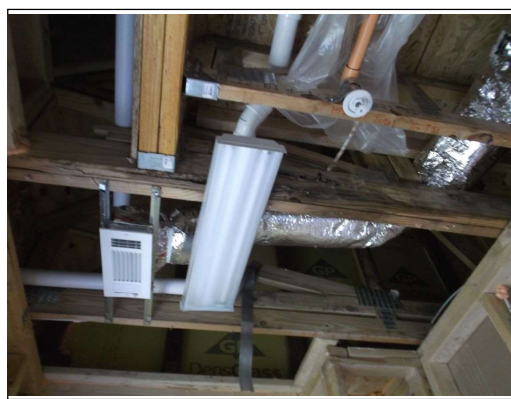
Builder verify all PVC drain pipe in the 3rd floor ceiling has been properly glued together and no leaks. There are missing pieces of pipe insulation at the 1st floor front exterior wall where the front hose faucet is located and exterior wall (verify pipe insulation is installed before insulation is installed and sheetrock installed).

Verify no pipes are leaking

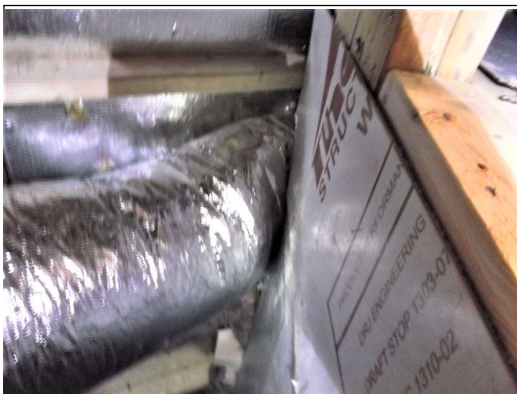
There are crushed air ducts above the attic traveling through a opening above a interior wall that are crushed (can reduce airflow, restrict airflow to rooms served). Builder verify and correct). Several air return and air send vent covers are bent and damaged.

Air ducts appear crushed in attic ceiling

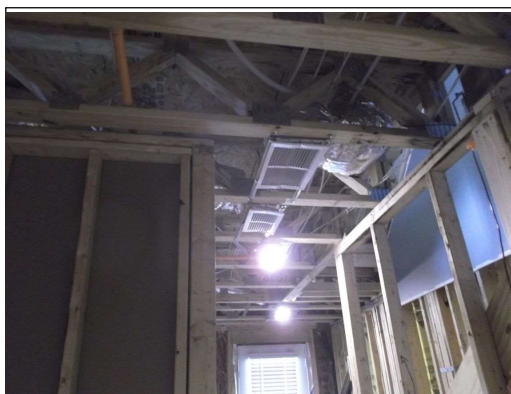
Air vent covers damaged at several areas

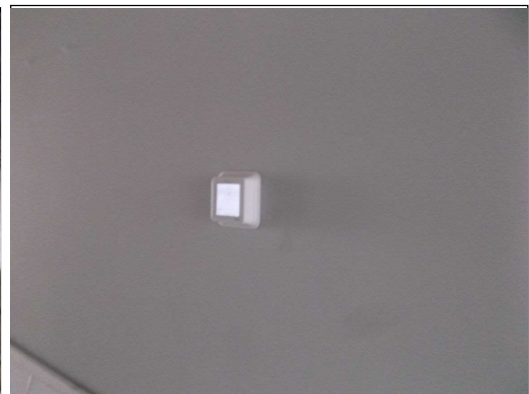
HVAC wall thermostat controls may have had water intrusion at the floors receiving water damage (it is advised to replace any controls where water penetration suspected).

Verify thermostats have no water damage

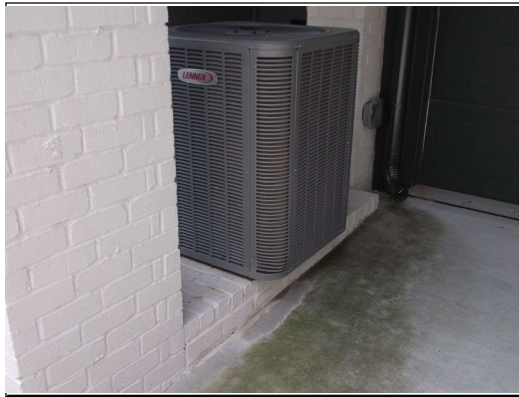
The AC unit at the rear of the building was installed encroaching the right neighbor's driveway path shall be in line with the wall and no further.

AC unit over property line/dent at bottom

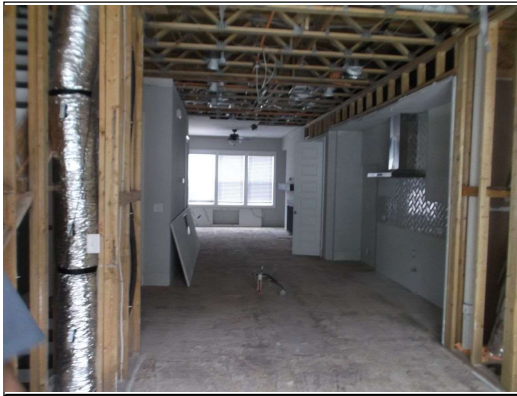
The kitchen cabinets, counter tops and components have been removed. The sub floor has been damaged from floor covering removal. Verify no water got into the exhaust fan controls area.

Sub floor damage

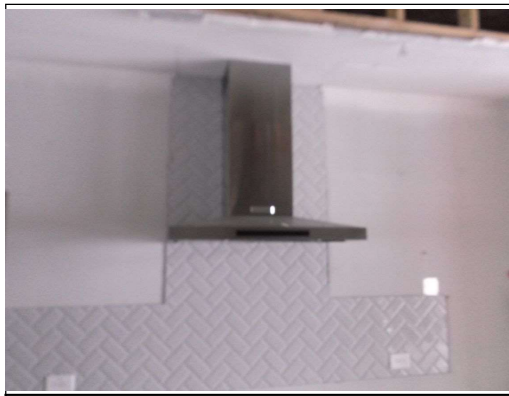
Verify no water got into exhaust fan controls

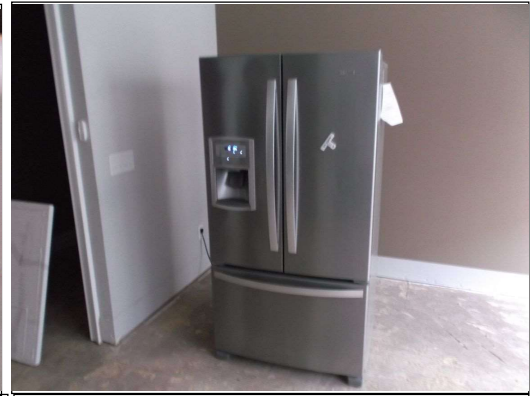
Verify no water got into refrigerator controls

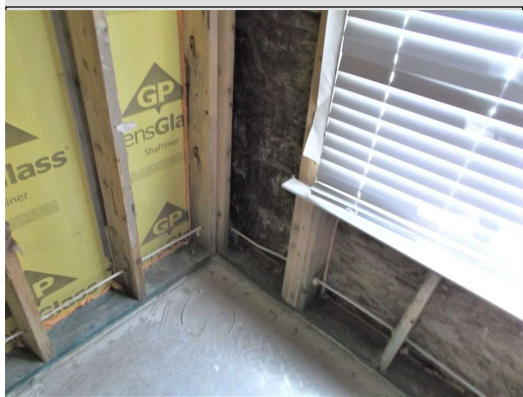
1st floor: There are dry water stains at the front exterior sheathing at the left side of the front room (builder verify cause of stains and correct). Builder check brick veneer, all windows, flashing and roof system above these areas. There is wood sub floor engineered structural board surrounded by the concrete floor in the 1st floor closet (can attract termites if not treated). Verify why plywood was placed in the closet when the townhouse was built. 1st floor is supposed to be concrete (is there something needing access under the floor requiring a removable floor utilities under the floor, pipes?).

Dry water stains on sheathing

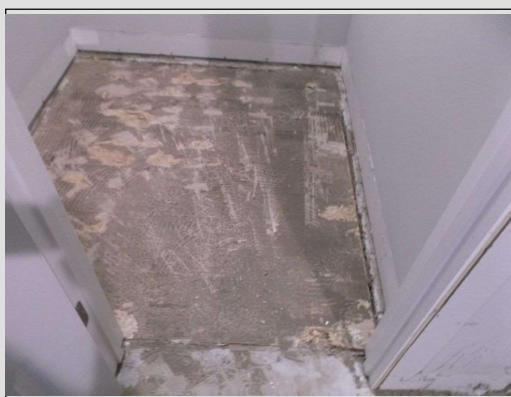
Wood sub floor in concrete floor 1st level

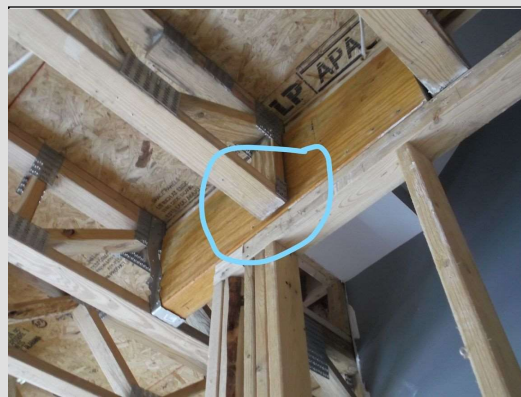
There is a floor truss (under the main level) that is missing a joist hanger above the stairs at the 1st level beam at the stair opening.

Truss supported @ top cord only/need hange

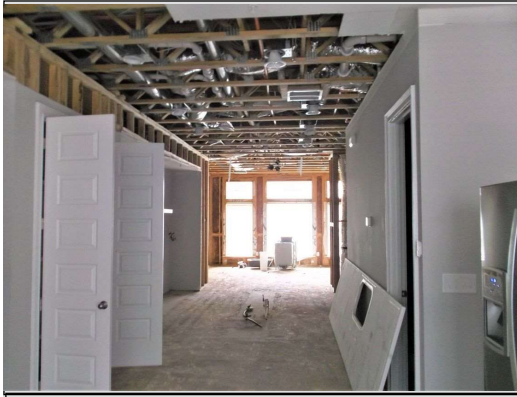
Verify no water intrusion to light fixtures

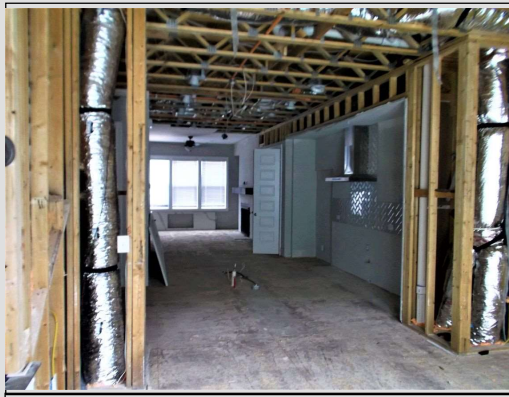
2nd Level: The main level sub floor has been damaged from floor covering removal. There are squeaks and pops noted in the sub floor at some areas (builder advised to check floor for squeaks and re-screw). Where water flowed from the upper level into the ceiling of the main level there may be water damage to light fixtures, ceiling fans and other electronic control devices (thermostats, low voltage panels, doorbell box...).

Sub floor damaged from flooring removal

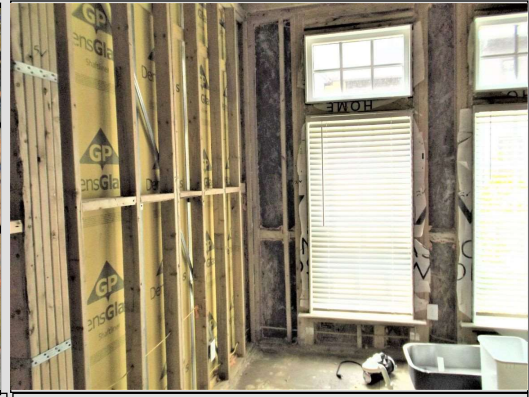
2nd Level: Dry water stains at exterior wall sheathing at the left corner area of the great room south wall (builder verify any water intrusion and or leaks have been found and repaired before closing wall and finishing).

Dry water stains at exterior wall sheathing

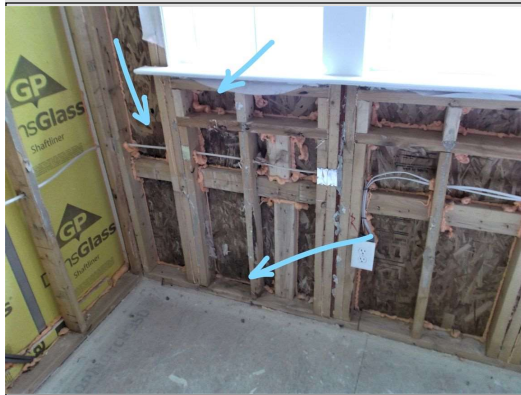
There are dry water stains on the exterior wall sheathing below the windows at the south side of the building (builder verify window seal metal cladding is water tight, closed on ends and solid caulk bead. The metal window cladding appears to be open at the ends of the window seals where there are stains on the sheathing seen from inside the room. There is openings in the caulk bead at the window seals at the 3rd level.

Dry water stains at exterior sheathing

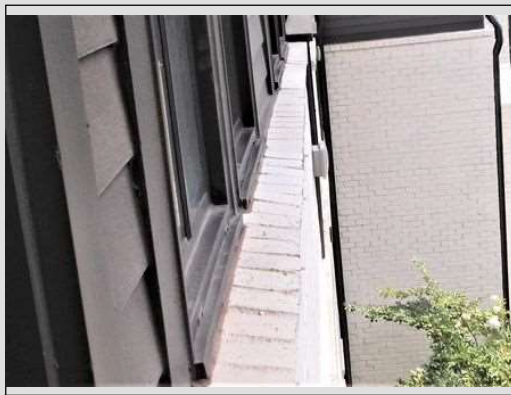
Gaps in caulk, cladding open at ends

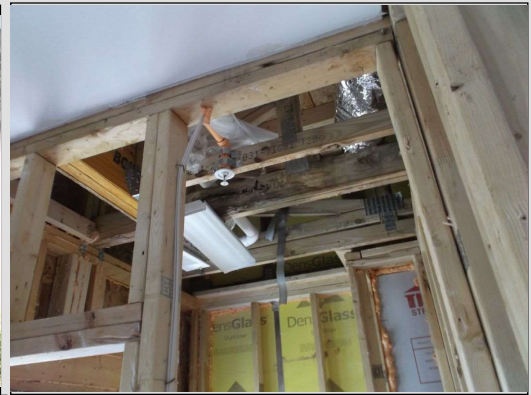
There are some dry water stains on the ceiling trusses where drain pipes pass over and under roof deck floor. Builder verify there are no pipes leaking and no roof leaks above.

Dry water stains on ceiling framing

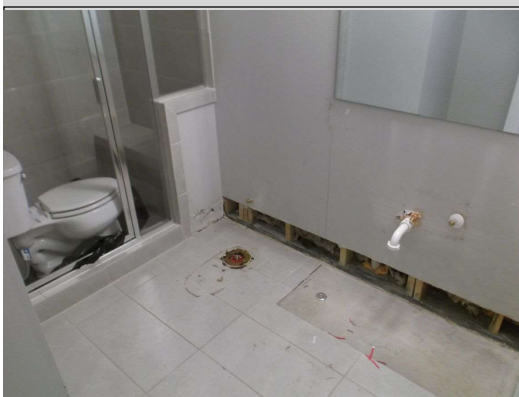
1st floor bath: Toilet and vanity have been removed. Builder verify no water got into the exhaust fan and light fixture (water can cause damage).

Toilet and vanity removed

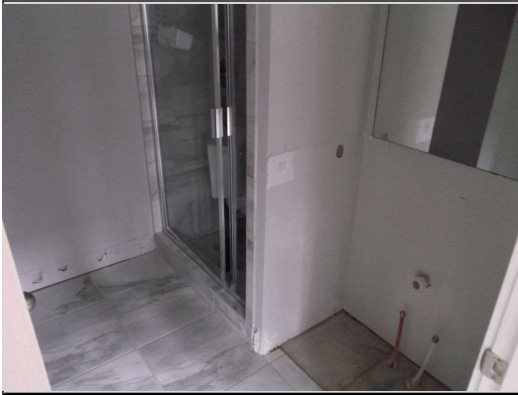
3/4 bath fixtures removed. Builder verify all repairs and installations are done by certified contractors and plumbers. There are two exhaust fan air ducts join to one air duct in attic (can restrict airflow to the outside where both fans are operating and one fan can blow back into other bath under certain conditions).

3/4 bath fixtures removed/waste pipe no cap

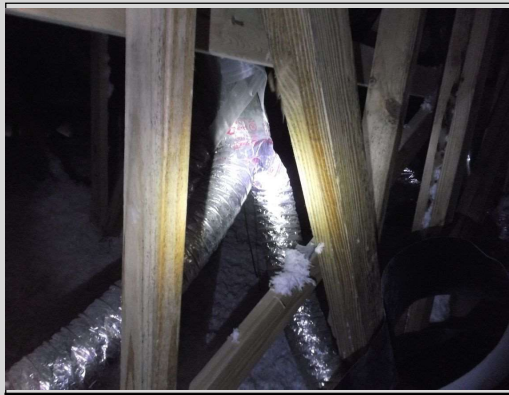
Two exhaust fan ducts join to one at attic

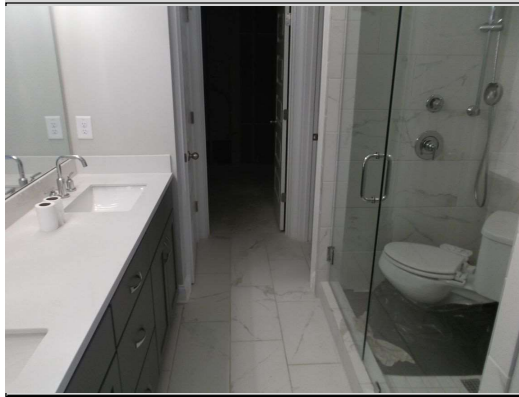
Toilet removed at master bath

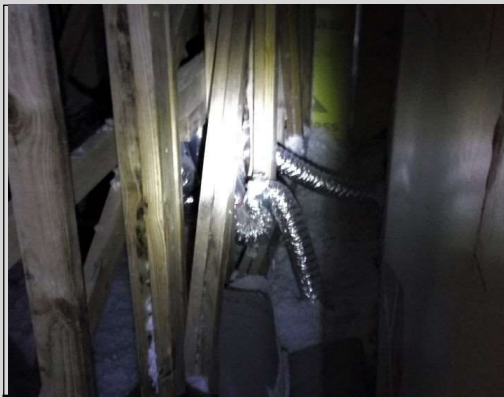
Master bath: Exhaust fan duct has too many turns in the attic (exhaust ducts should have the straightest runs as possible to get maximum air exhaust to the outside). Fixtures removed at the master.

Exhaust fan duct has too many turns

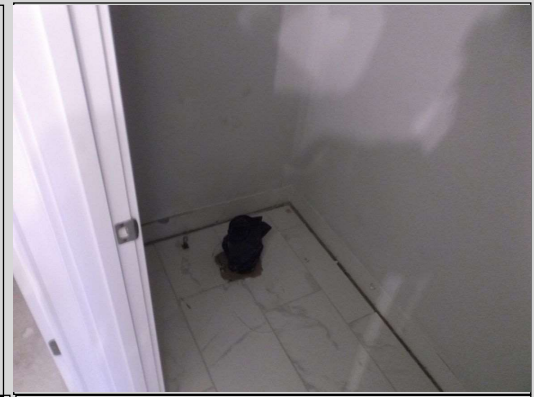
Toilet drain not properly capped
