# PROPERTY INSPECTION REPORT

25 Rosemont Parkway, Covington, GA.

**Inspection Date:**

Oct 26, 2021

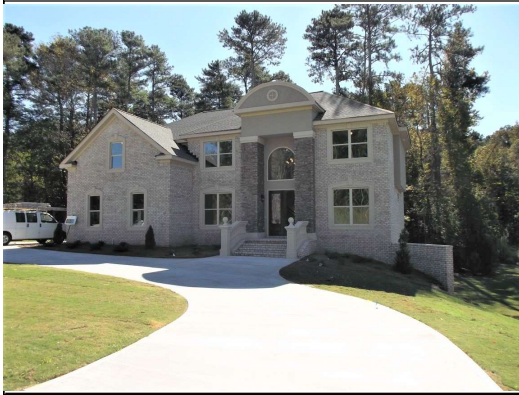
The driveway should be pressure washed after all work is completed. The driveway has excessive slope to the right at the right side entry. There is a broken section in the driveway at the street. The driveway has a small broken corner near the right side of the double car garage.

Driveway has excessive slope, dip to the right

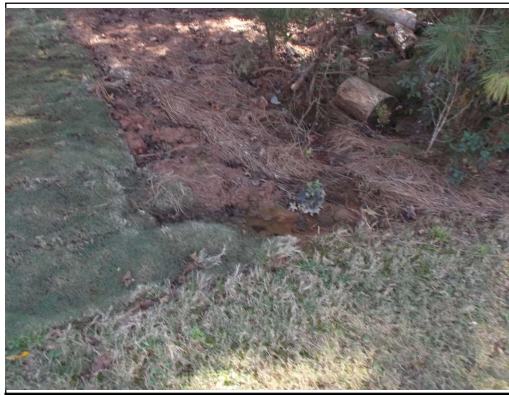
The soil at the front yard near the street is water logged and soggy, water on top of the ground (verify no water leaks, underground water, or seepage underground). The right side yard and rear yard is very water logged and water ponds in the yard. If this home is on a septic tank system a water logged ground can cause the septic tank to malfunction under certain conditions.

Water in the ground at the rear yard

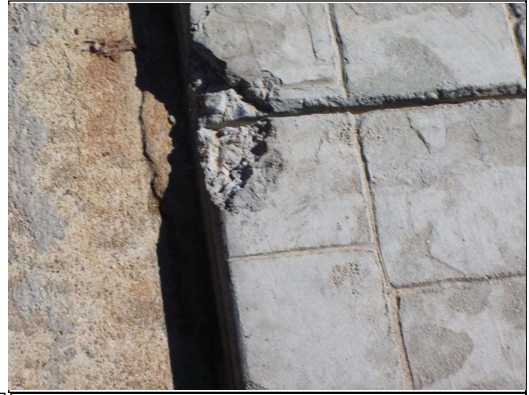
Broken section in driveway at the street

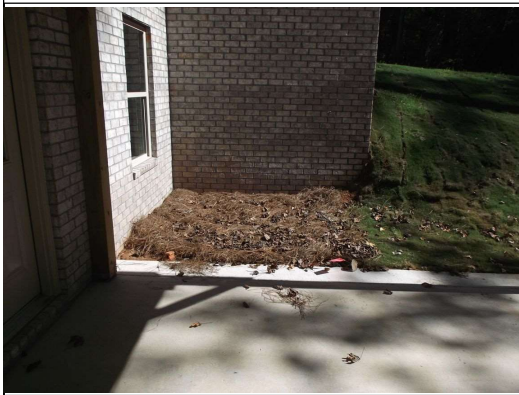
Poor soil slope away from the foundation at the rear of the house at the inside corner of the retaining wall. Cannot verify there is a perimeter drain pipe at the right retaining wall coming to daylight not drain holes in that wall.

Poor soil slope out of inside corner

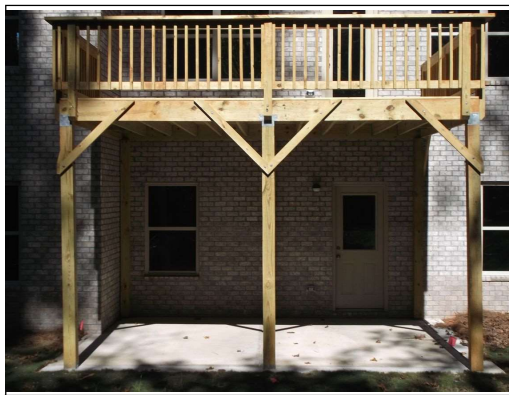
Deck and posts lean to the left

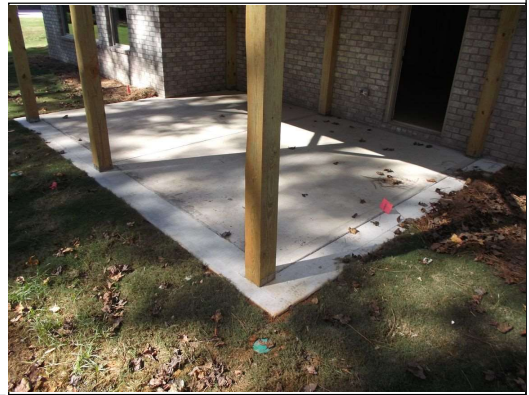
Patio appears to have been added onto

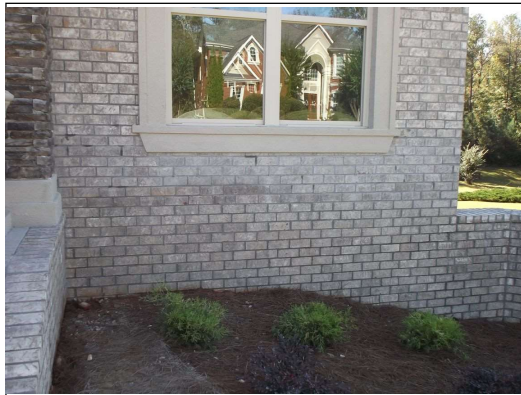
Verify the brick color and mortar will match at the front on the right of the front porch and at the retaining wall backside on the right of the house. Brick Mortar in contact with the soil at the front and other areas can be damaged from excessive moisture,

Verify brick color and mortar color

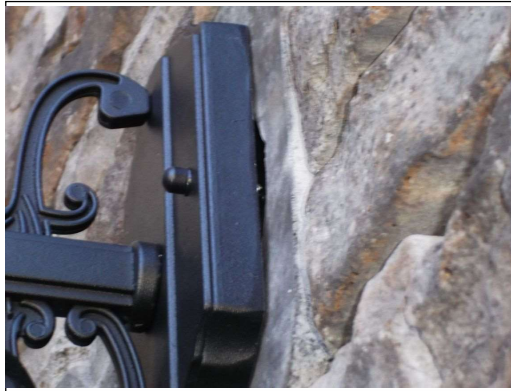
Missing caulk around light fixtures at the front porch attached to the stone veneer. Window screens not installed.

Missing caulk at light on stone wall

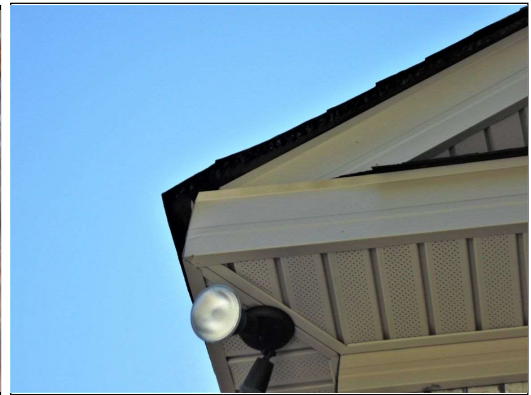
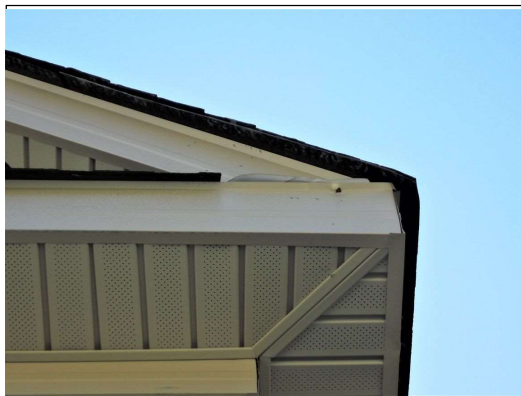
Verify fascia metal sheds water away

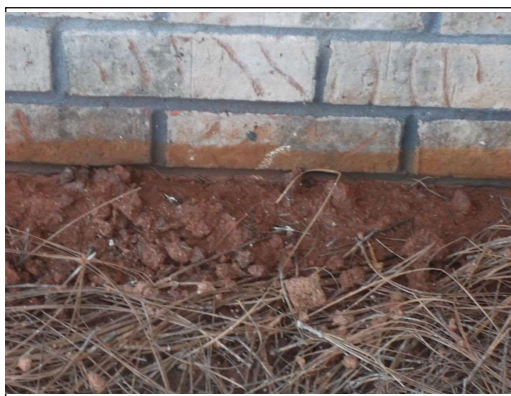
Soil contact mortar and brick

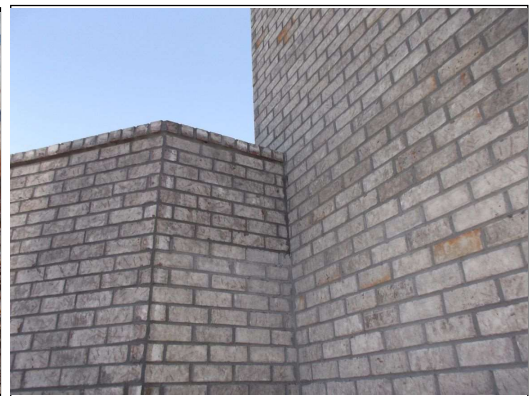
Verify mortar will dry same color

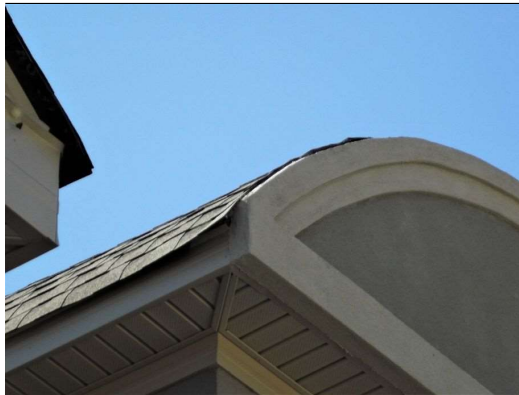
Shingles not covering top of stucco

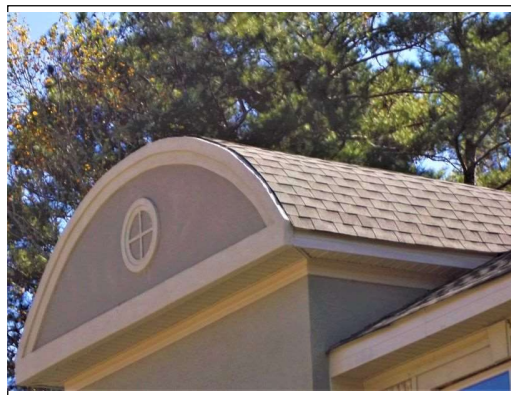
Shingles not covering stucco

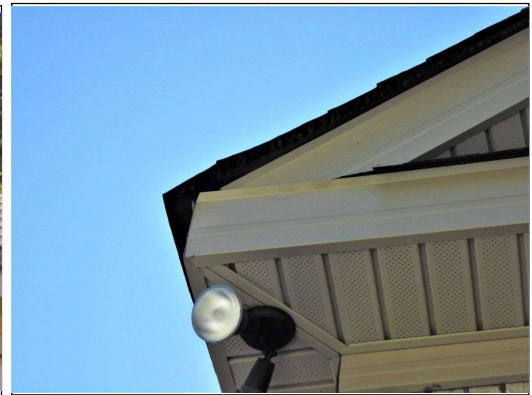
Metal fascia upper appears behind lower piece

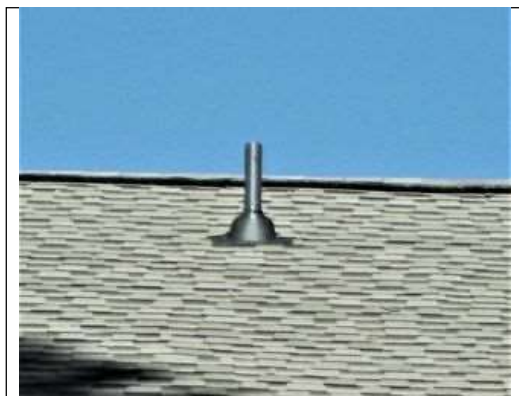
Pipe flashing appears to have been installed on top of the shingles and face nailed (can cause water intrusion over time, nails can extract and roof water can get under flashing and into nail holes). The metal fascia sections at the front garage roof gable appears to not be properly flashed over the bottom fascia piece (if not proper water can get into seam and into soffit).

Pipe flashing on top of shingles face nailed

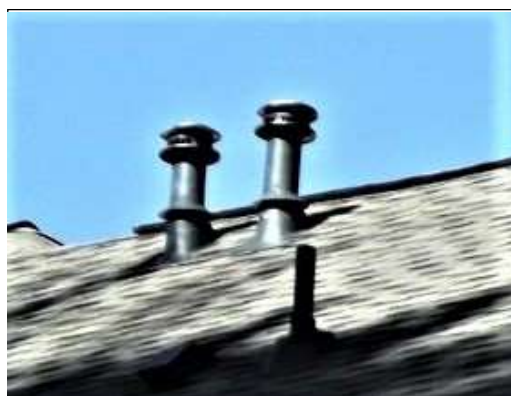
Flashing on top shingles face nailed

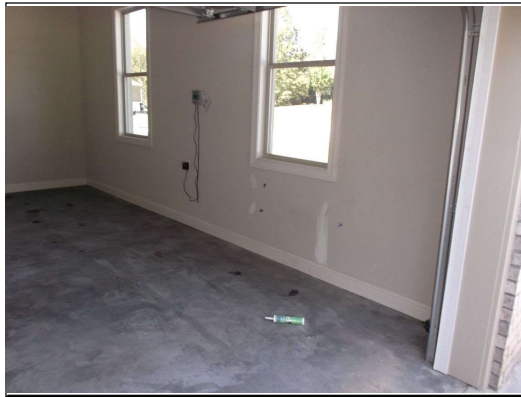
Still finishing and painting

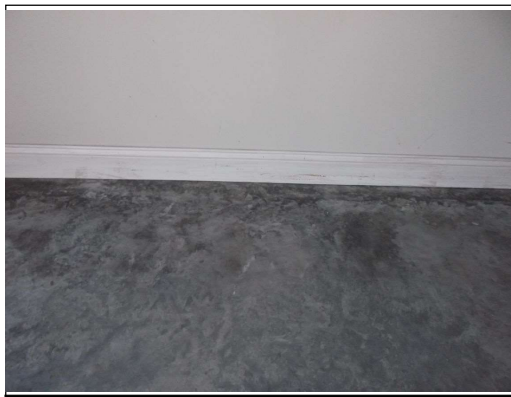
Contractor still doing drywall repairs and painting in both garages. The baseboards have been installed close to or on the concrete floor (can attract termites under certain conditions, should be at least a 1/4 inch air gap under most conditions).

Baseboard rest on the garage floor

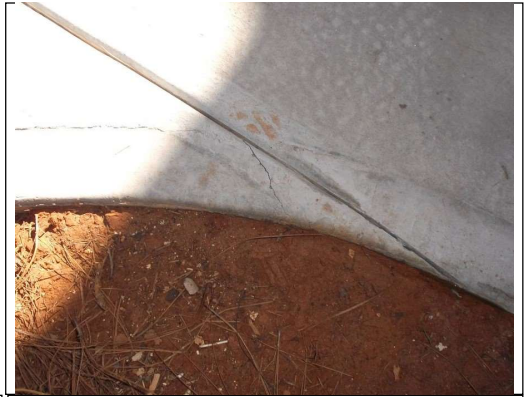
Crack in driveway near the entry of the double car garage at the right side.

Crack in driveway corner right side of entry

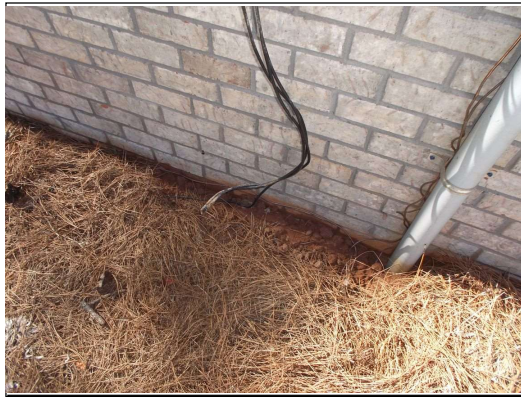
Cannot see the electrical system ground rod

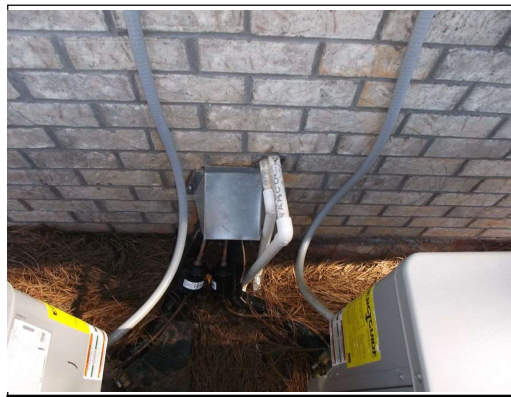
AC conduit not clamped to brick at lower area

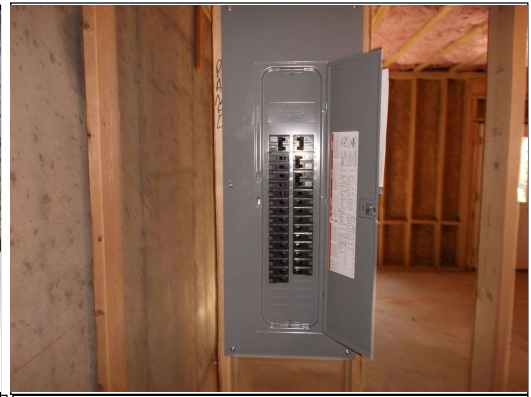
Screws too tight in distribution panel cover

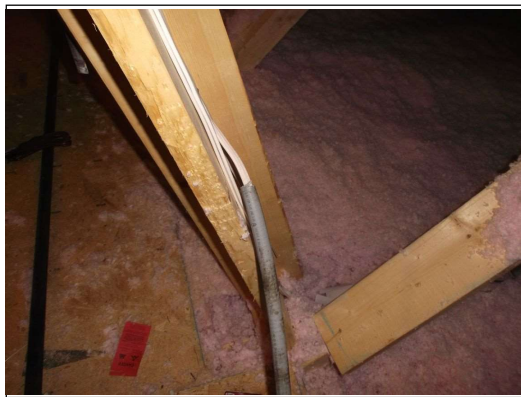
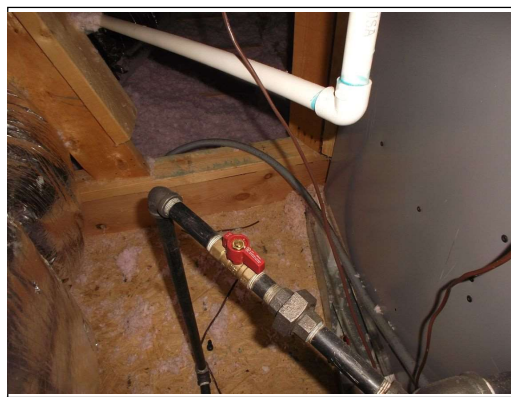
Electrical conduit not clamped to wood @ atti

Conduit not clamped to wood in attic

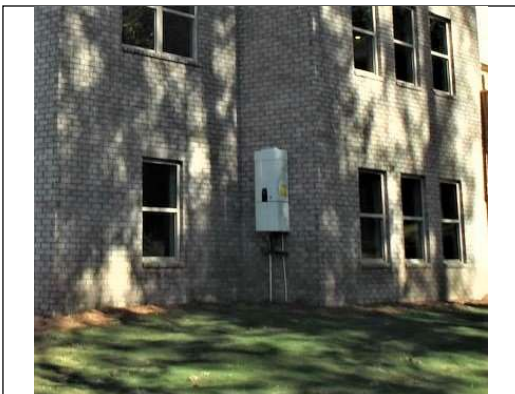
Water heater installed on the outside

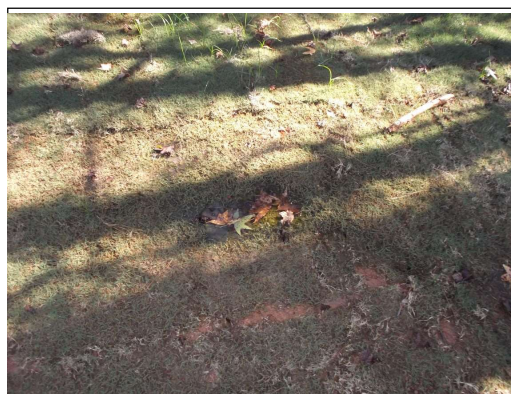
Excessive water in the soil at the rear yard. If there is a septic tank in the back yard soggy soil can cause the septic system to not function as intended. Excessive water in the ground at the front yard at the left side of the property line near the curb (verify no water leaks).

Ground water logged at the rear yard

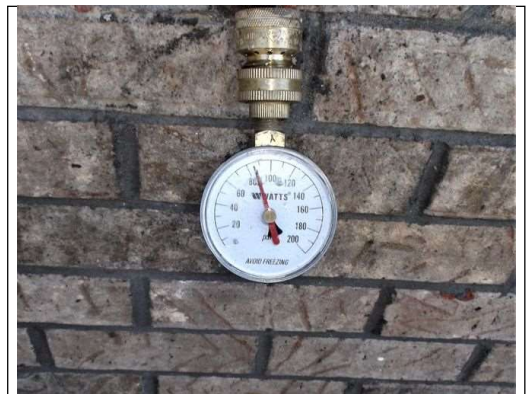
Water pressure tested 83 psi which would be too high (anything over 80 can cause damage to pipes, appliances and cause faucets to seep).

Water pressure over 80 psi

Water pressure over 80 psi  Recommend plumber evaluate  Recommend pressure regulator box

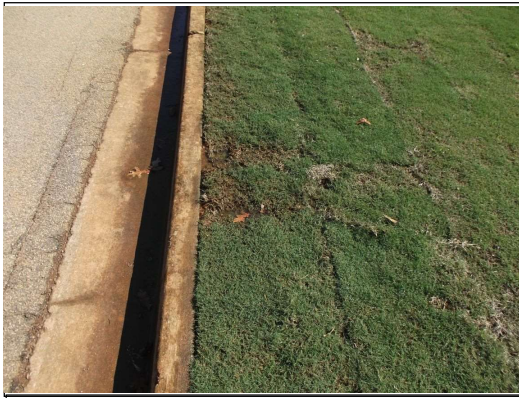
Excessive water in the ground at front yard

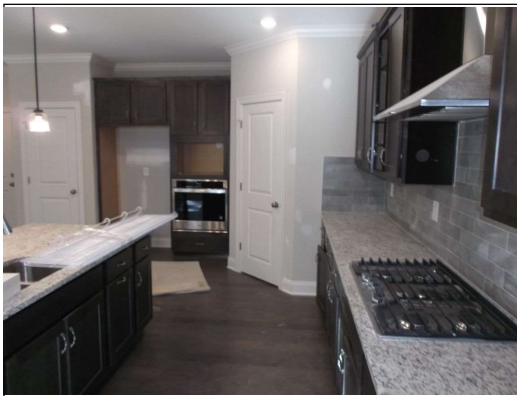
Refrigerator and ovens location causes excessive walking to prepare meals.

Refrigerator located away from stove & sink

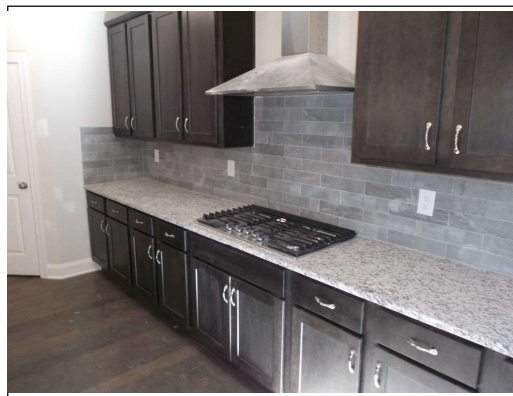
Workers residue on cabinets, appliances

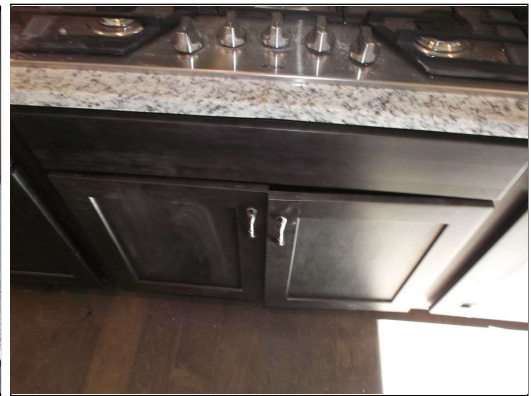
Doors soiled and bump

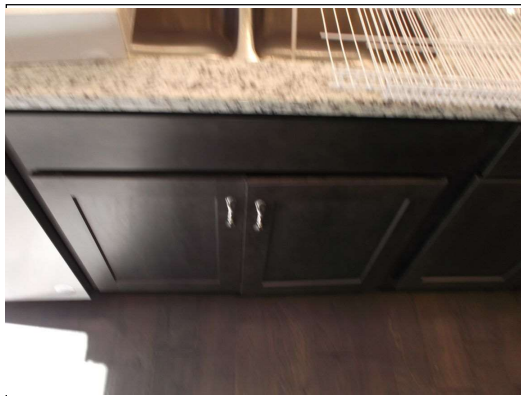
Doors bump

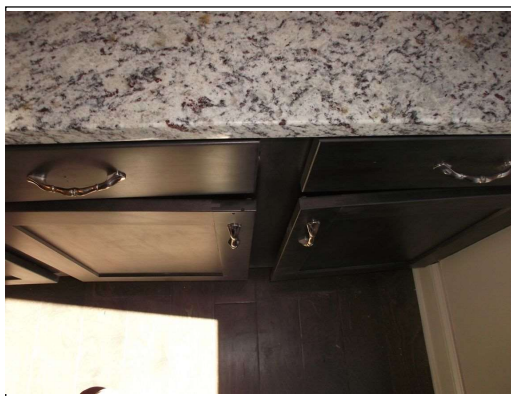
Doors not fully closing

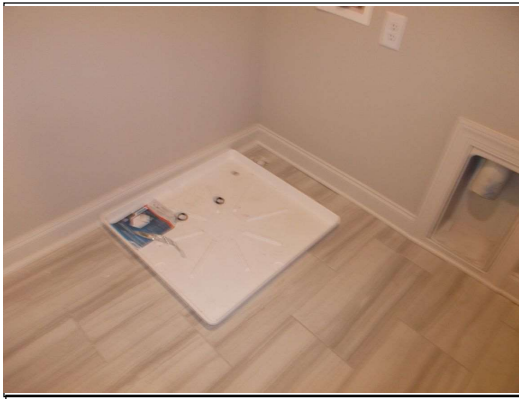
Washer drain pan not fully installed at the time of the inspection.

Drain pan installation not completed

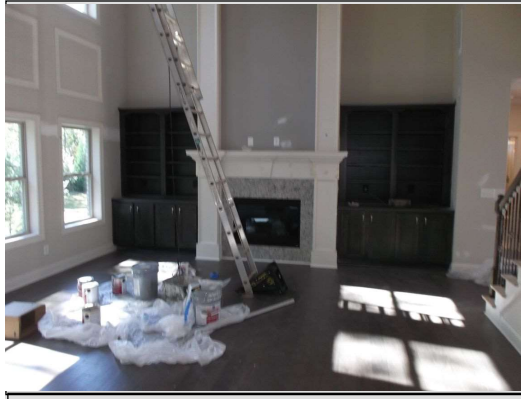
Still finishing and painting

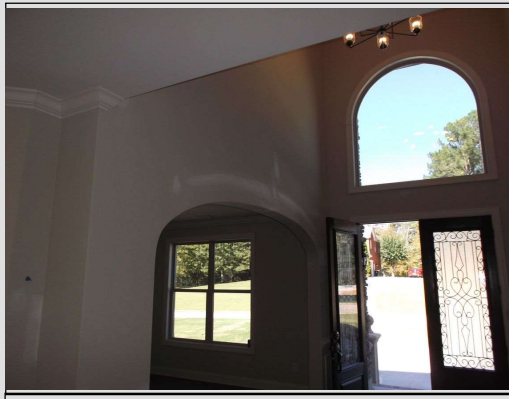
Contractors still finishing and painting

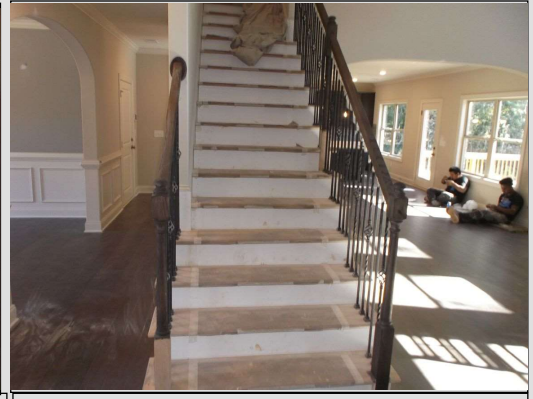
Verify fireplace is operational. Contractors still finishing stairs.

Stairs not finished/dust on floors

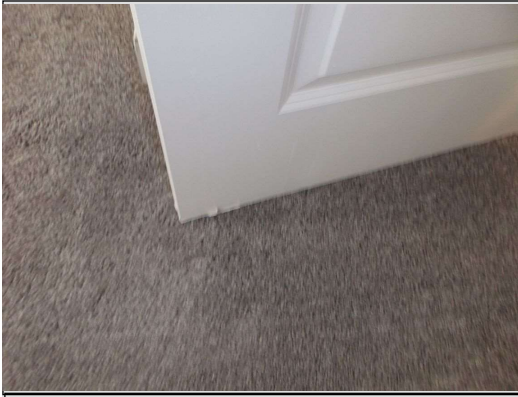
1st floor bedroom door veneer peeling at the bottom.

1st floor bedroom door veneer peals

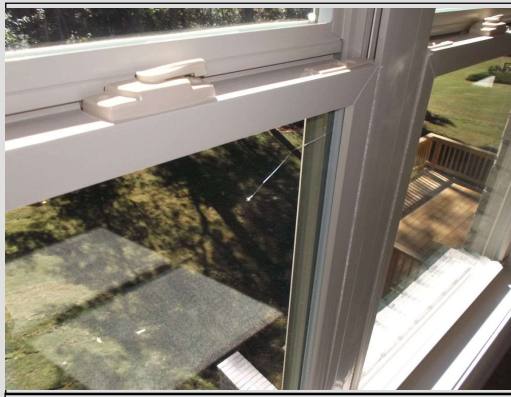
Cracked glass at master bed rear window

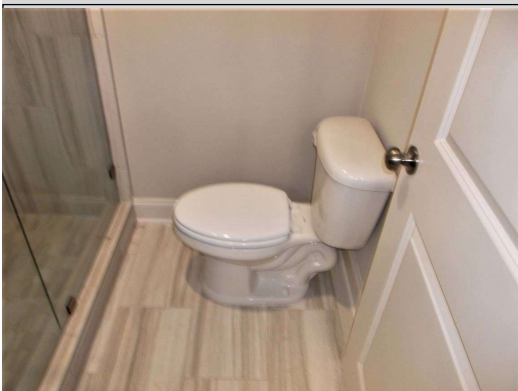
Jack and Jill bath toilet installed to wrong way or too close to the shower glass. The shower door drags too much on the shower curb.

Toilet too close to shower glass

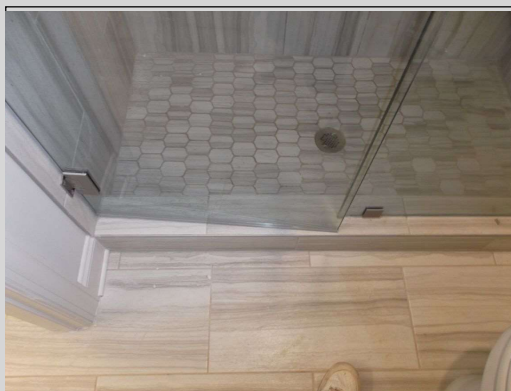
Shower door drags too much on curb

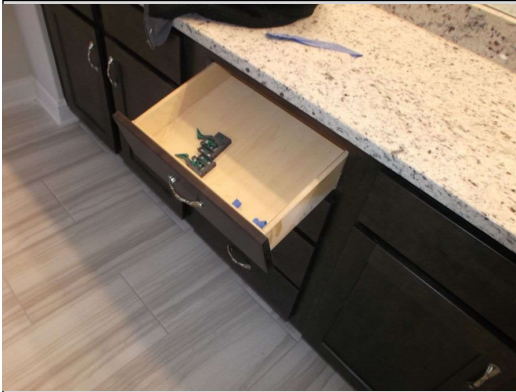
Defective drawer hardware at master

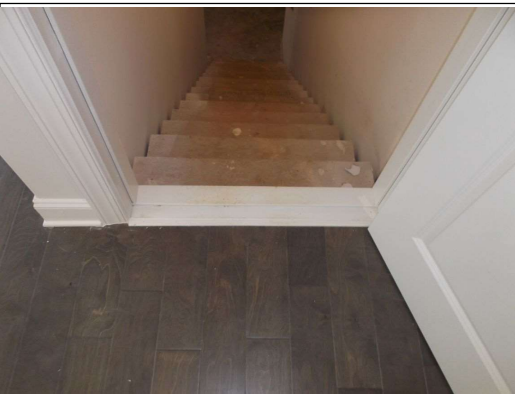
Threshold can be a trip hazard.

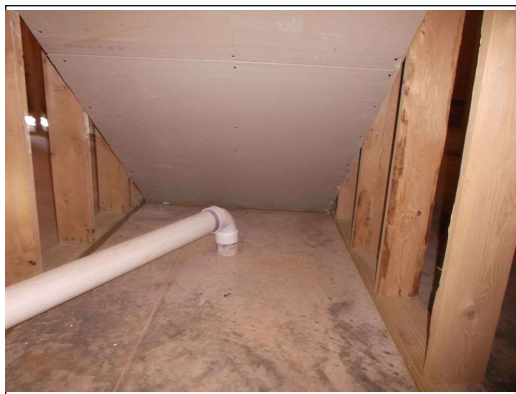
Verify termite shield in place

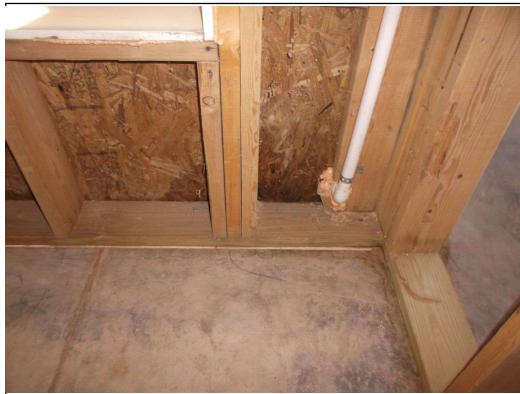
Water stains on exterior sheathing

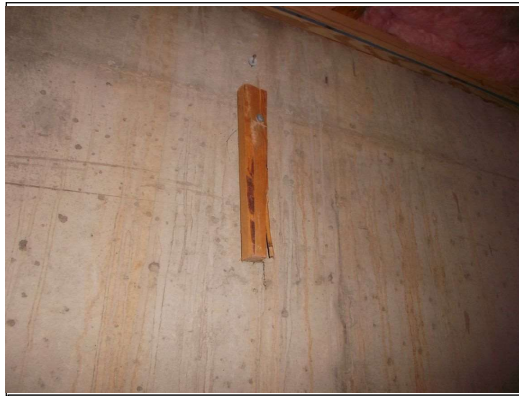
Wood nailed to foundation wall

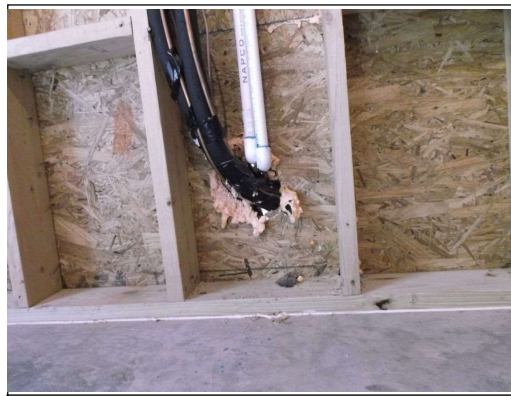
Hole in exterior wall

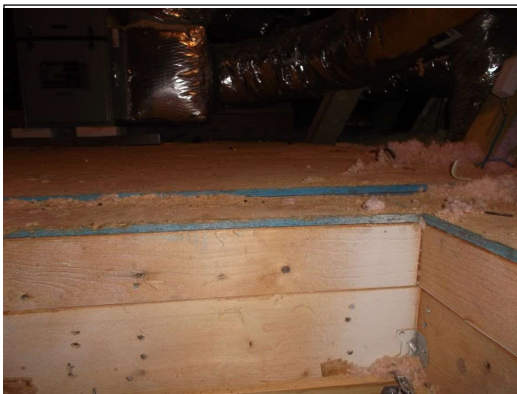
The attic flooring has one sheet installed on top of the other near the stairs entry (can be a trip hazard).

Attic floor layers are a trip hazard
