# PROPERTY INSPECTION REPORT

6155 Redwine St. Norcross, GA.

Dec 30, 2020

1599

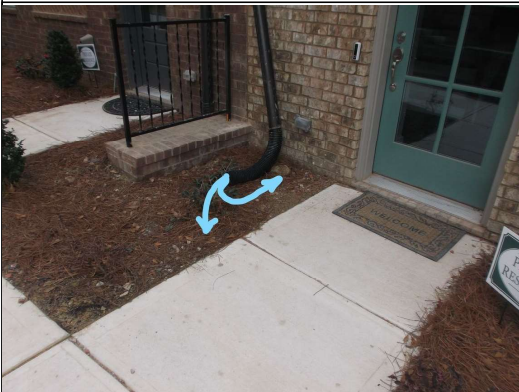
Soil slopes to the front of the building

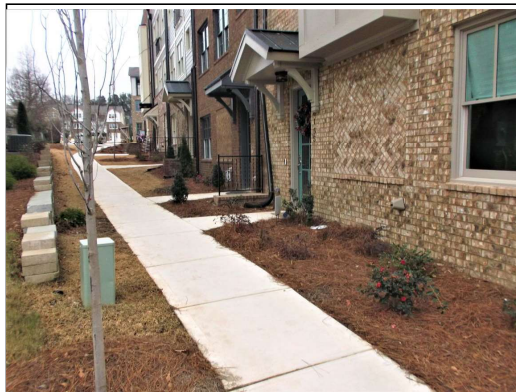
**Material**  Concrete  Flagstone  Gravel  Brick  Other  
**Condition**  Satisfactory  Marginal  Poor  Trip hazard  Typical cracks  Settling cracks  
**Comments** Front walkway has been installed higher than soil grade causing poor soil slope away from front of the homes foundation;

Walkway & soil grading has poor slope away

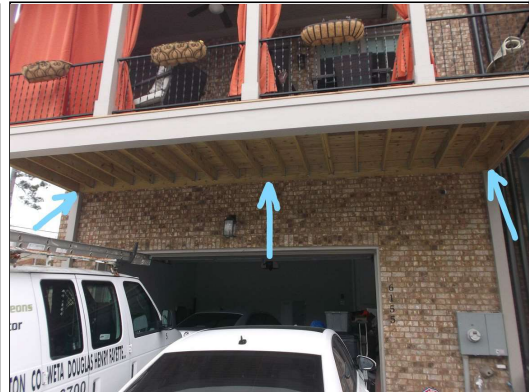
Wood deck bolted to the house through the brick veneer can cause damage to veneer, poorly bearing on the support posts at the brick wall and not enough posts for support at the brick veneer (extra posts would block garage vehicle entry; weak guard railing at the rear wood deck on left; builder verify wood deck railing is 42 inches high at all sides;

Deck bolted through brick/improper posts

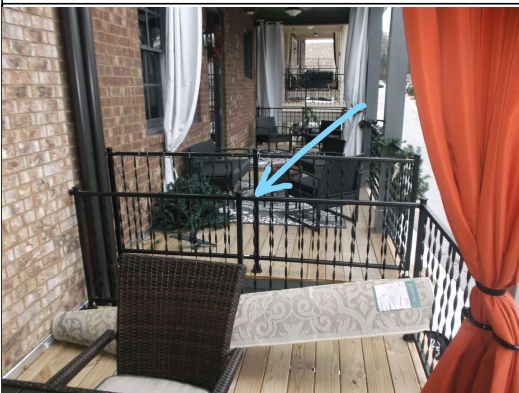
Weak railing at deck (safety hazard)

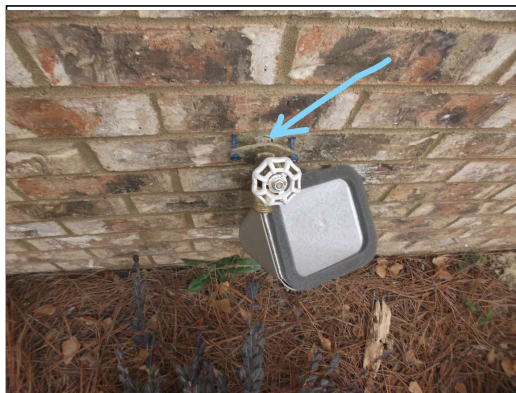
**Comments** Front hose faucet water pipe extends too far out from brick can freeze under certain conditions or if not protected;

Hose faucet pipe exposed can freeze;

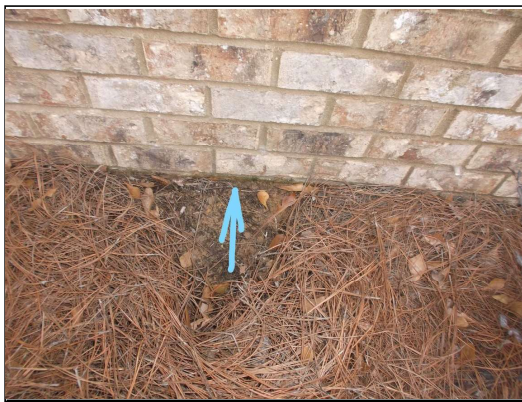
Soil contact brick and mortar at several areas

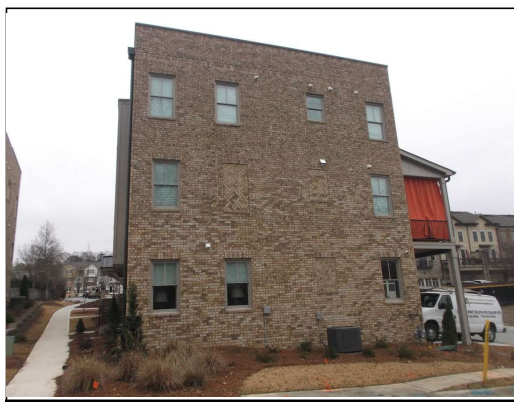
Cannot verify control joints in veneer @ side

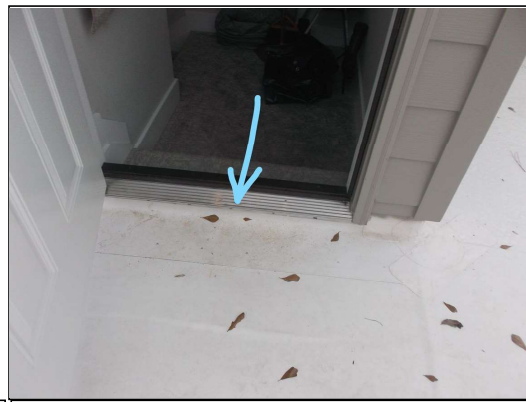
Roof door threshold not fully supported

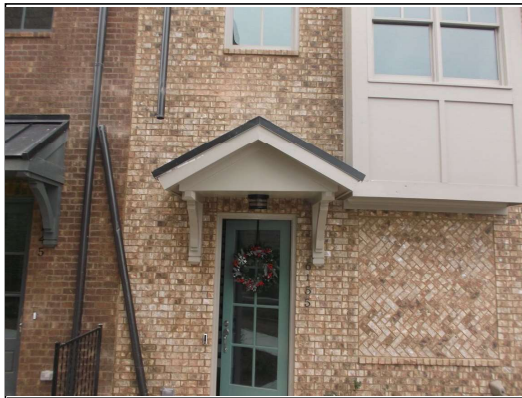
**Comments** Missing paint at the front door roof fascia;

Defective paint at the door roof fascia

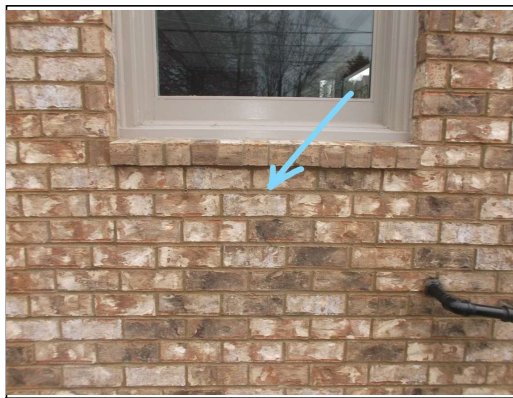
Cannot see plastic flashing in mortar

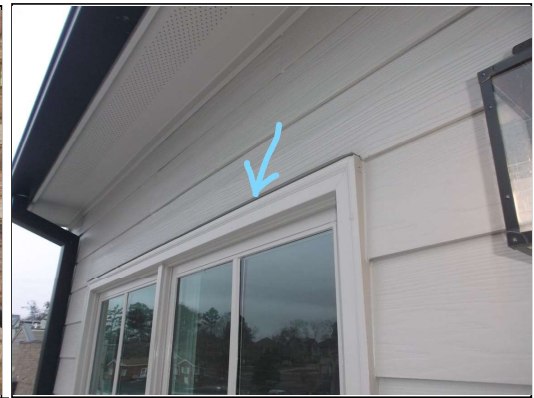
Gap at drip flashing over window, poor slope

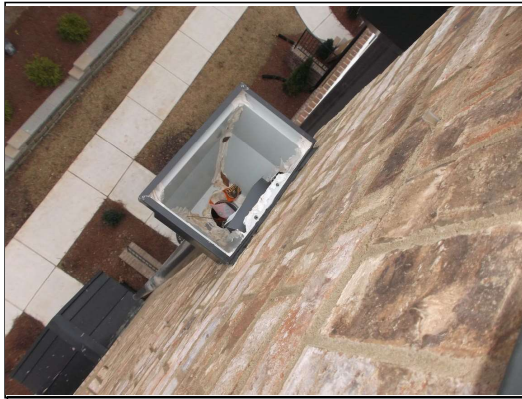
Verify scupper are water tight

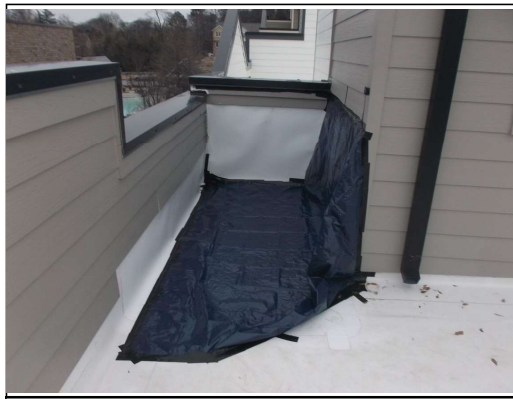
Water leak somewhere at west side of roof

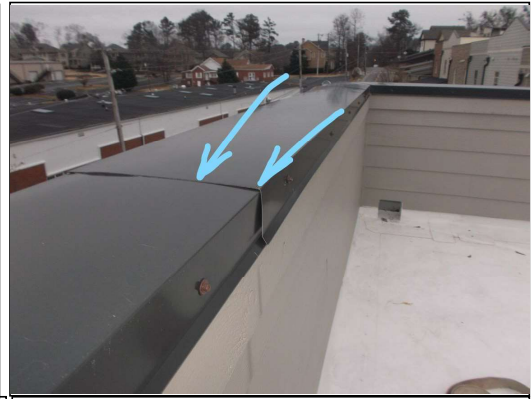
Poor sealing at parapet cap flashing

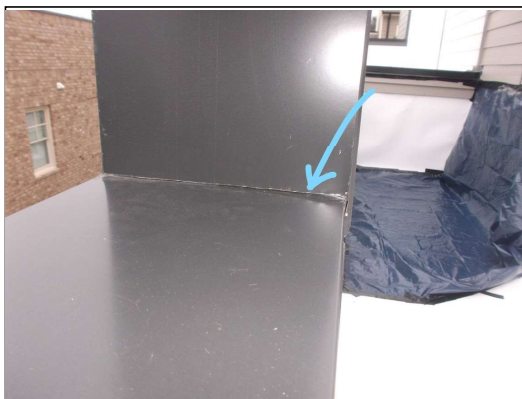
Poor caulk at parapet joints

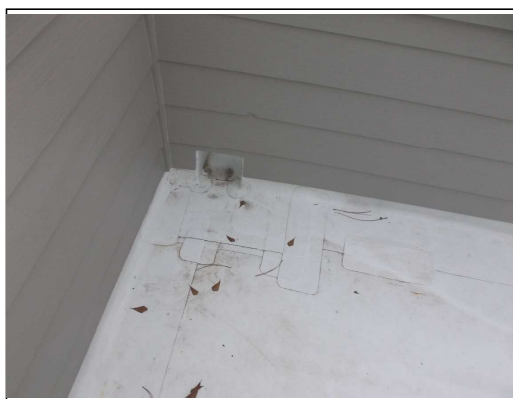
Numerous patches at scupper openings

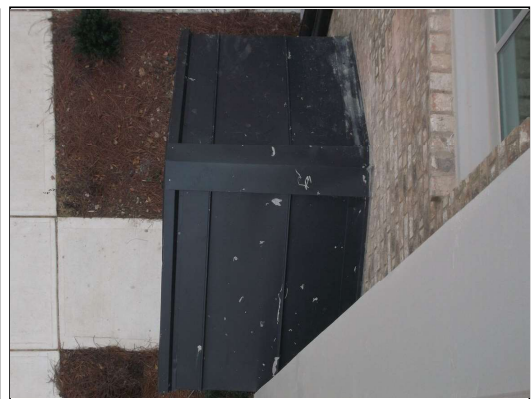
Workers debris on metal roof coverings;

Workers debris on metal roofs

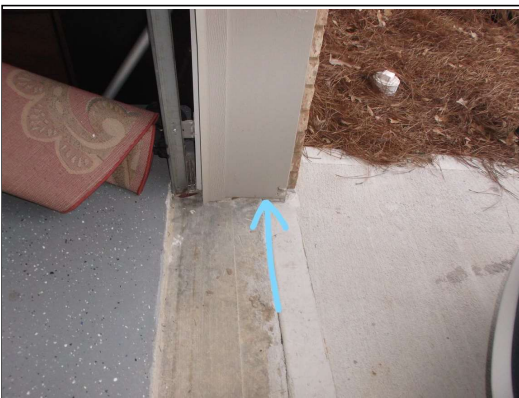
Vehicle door frame contact concrete

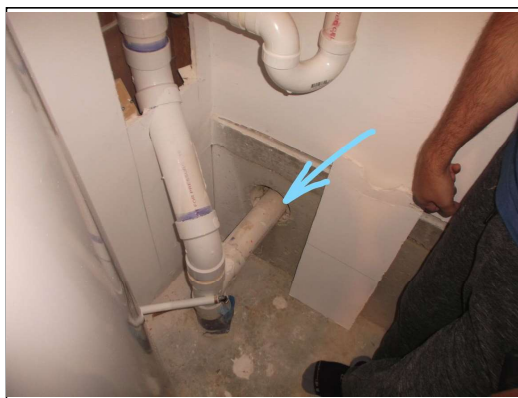
Opening in wall where waste pipe enter

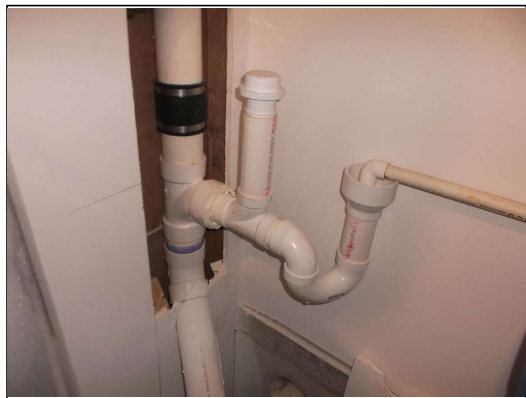
Hole water heater wall too wide @ waste pipe

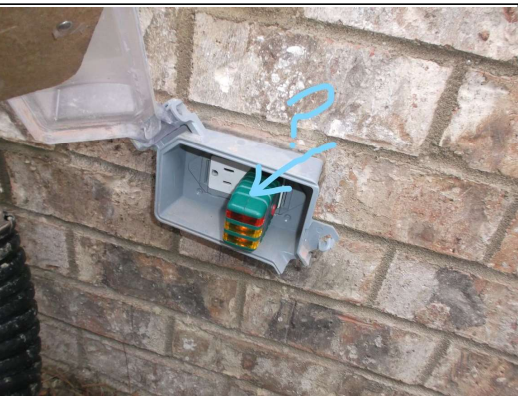
Front exterior outlet did not trip

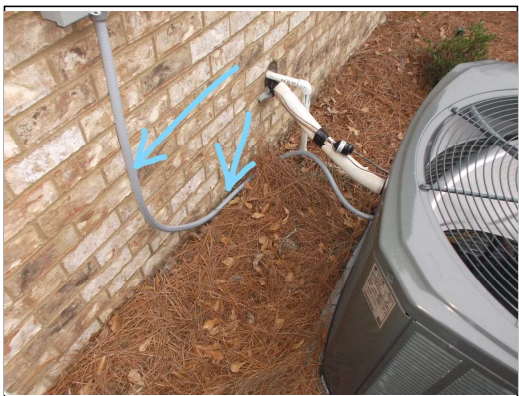
AC conduit is not clamped to the exterior wall can be damaged; distribution panel box door not latching properly;

AC conduit not clamped to brick

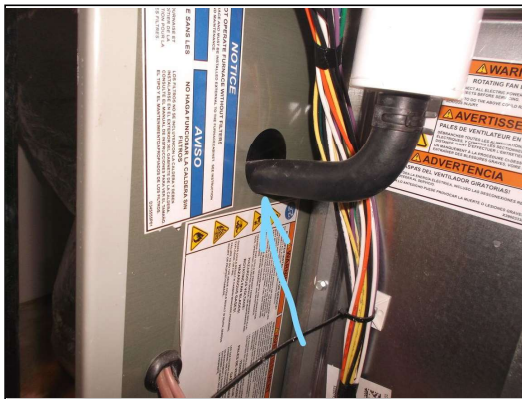
Rubber condensate pipe touch sharp metal

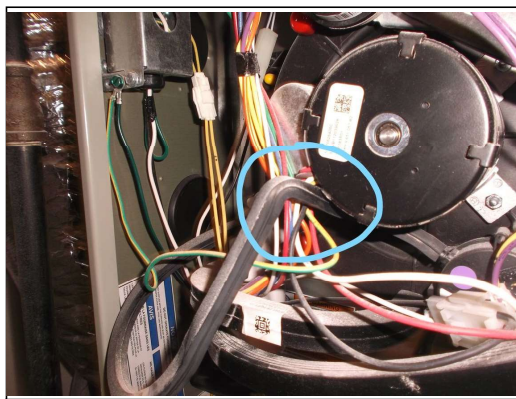
Exhaust fan vacuum tube sharp turn

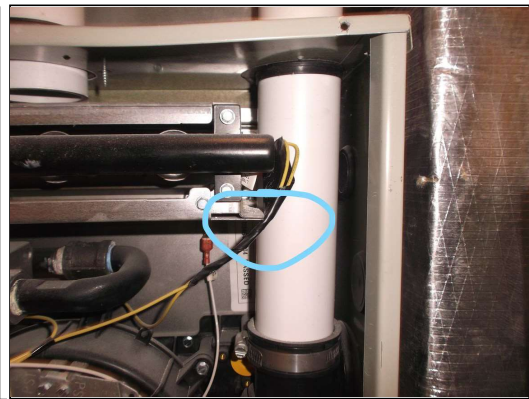
electrical wires contact burner flame shield

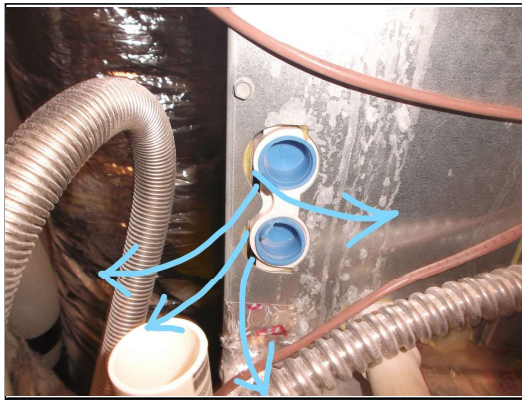
House air blowing out of holes in air handler

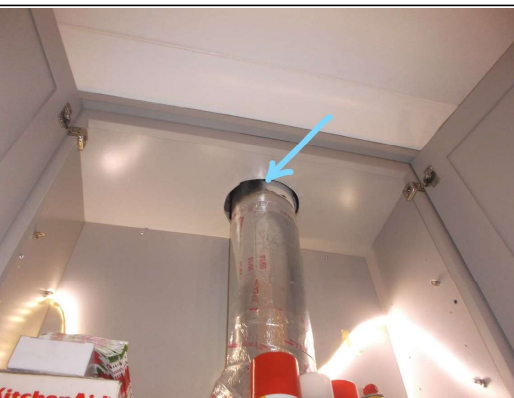
Opening where vent pipe pass through ceiling

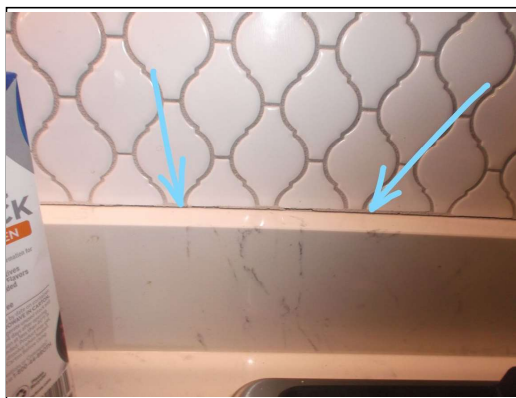
**Comments** Cracks in the grout where wall tiles rest on the counter back splash;

Cracks at grout at back splash and wall tiles

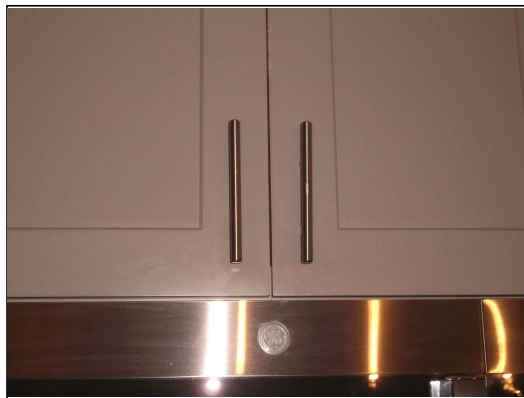
Door handles not level or plumb

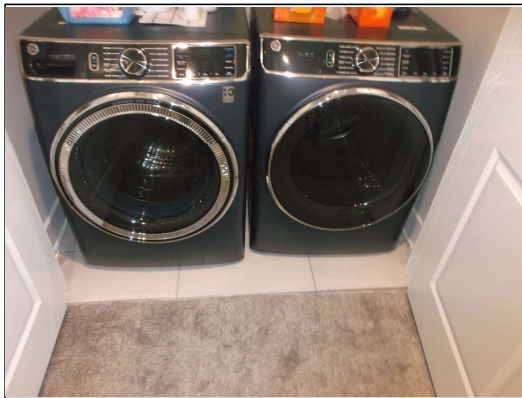
**Maintenance:**  
No washer drain pan in place;

No washer drain pan in place

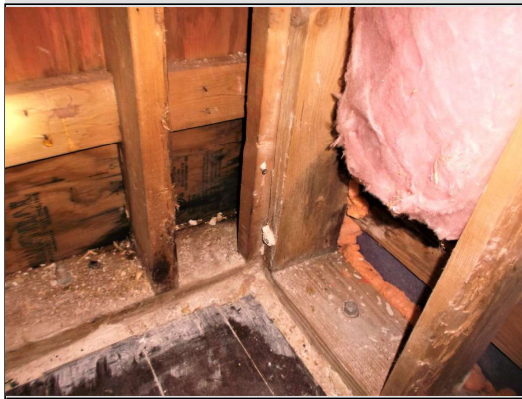
Water intrusion at lower coat closet walls

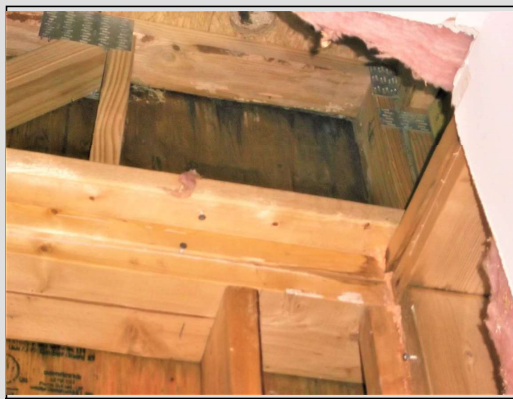
water intrusion at coat closet upper wall

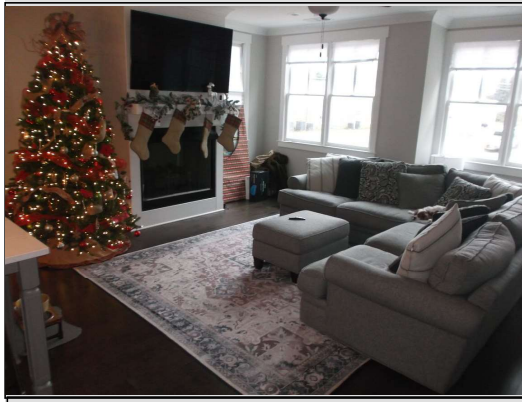
Floor slopes to the exterior and corner

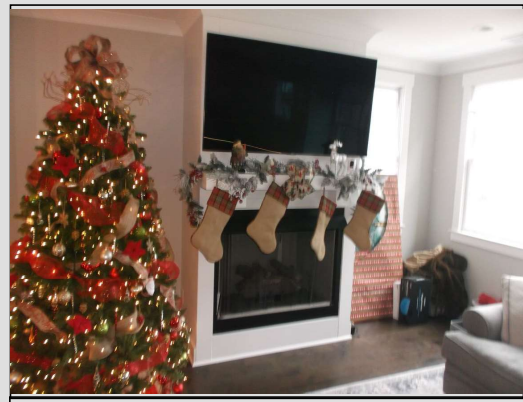
Mantel projection too shallow

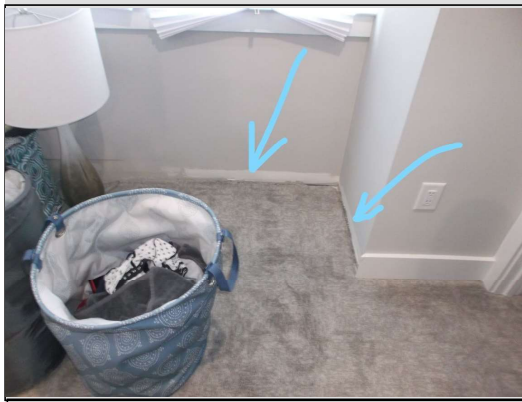
Missing baseboards in master bedroom

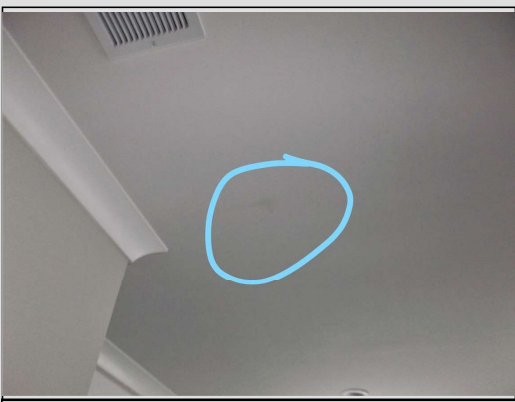
Dry water stain in master ceiling

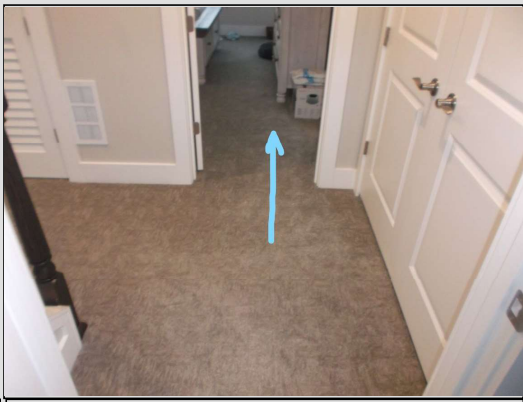
3rd floor hall slopes towards the rear bed

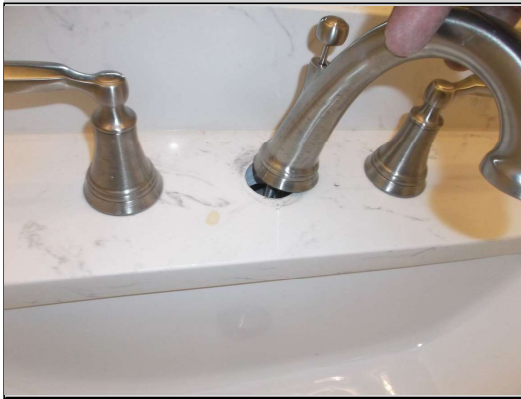
1st floor sink faucet detaching from the counter at the base;

1st floor bath sink faucet detaching at base

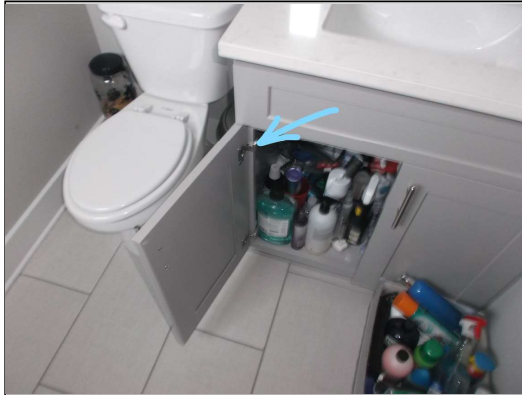
Rear bed bath cabinet door hinges loose

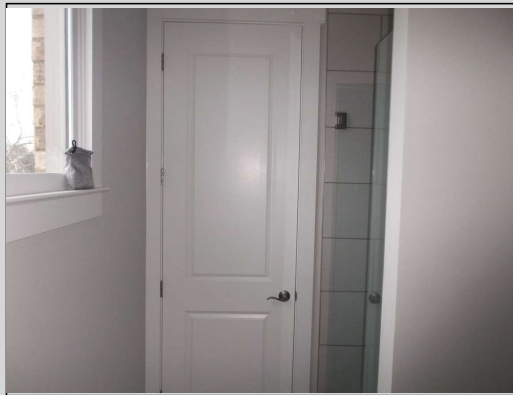
Rear bed bath closet door rub frame

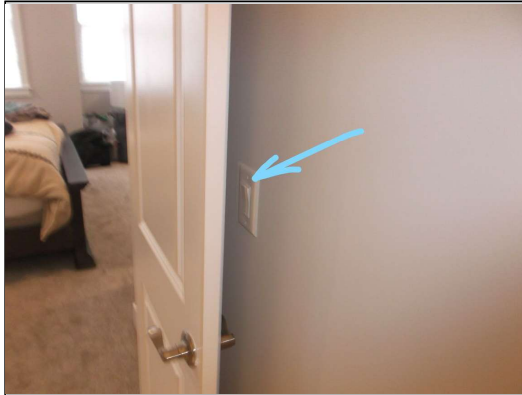
Master bath light switch located behind door

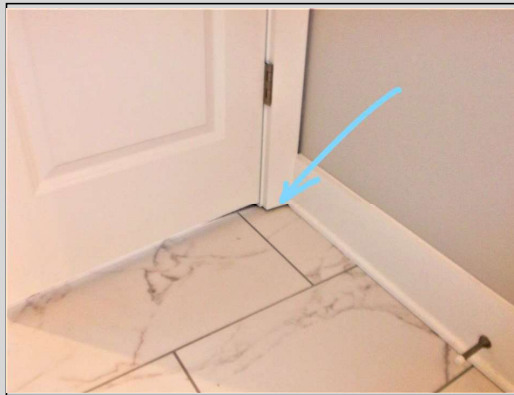
Missing caulk where door frames end at tiles

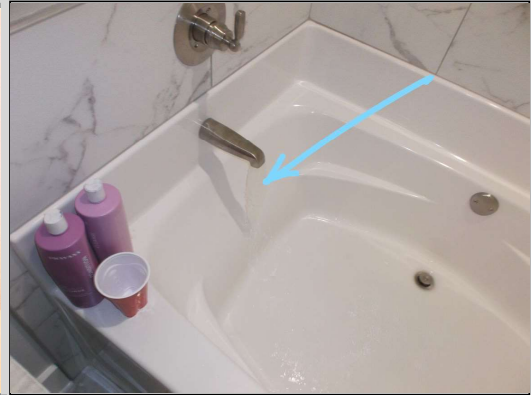
Poor water flow at master tub fspout
