# PROPERTY INSPECTION REPORT

2618 Baker Ridge Dr. NW Atlanta, GA. 30318

Oct 4, 2026

**Report Number:**

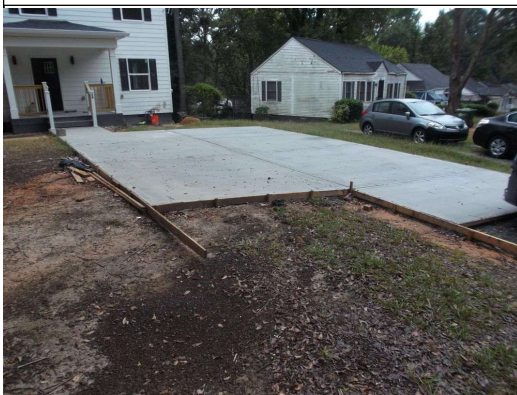
The driveway has been poured on top of the ground and is not complete (soil can erode from under the driveway over time and if there is placed soil on the sides of the existing driveway it must be extremely compacted to help prevent settling and movement). Be aware if soil is added at the house side of the driveway this may increase the slope to the foundation if not graded properly. The driveway is not angled properly to access both slabs when entering from the street.

Driveway on ground, not angled, not finished

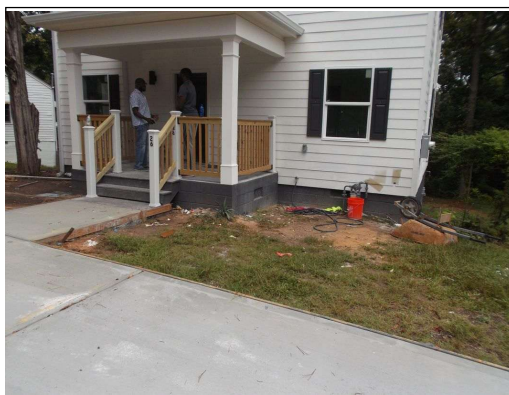
The soil is sloping to the foundation at the front of the house. Soil shall have a slope of 6 inches for the first 10 feet away from the foundation to cause water to drain from the foundation and away from the property.

Soil slopes to foundation, debris in front yard

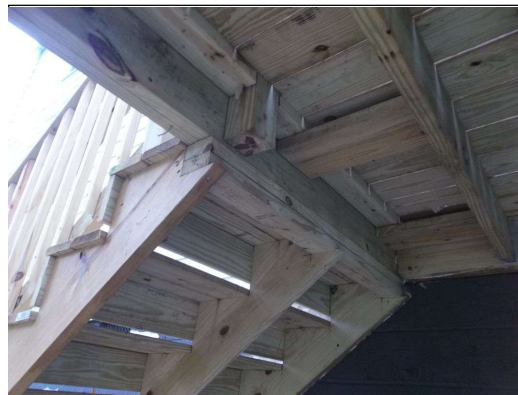
The deck stair stringers are not bearing on the floor rim joist properly. Missing handrail at the deck stairs. Support posts are not notched and bolted to the rim joists. Rail posts are not bolted to the rim joists.

Deck stairs improperly bearing on rim

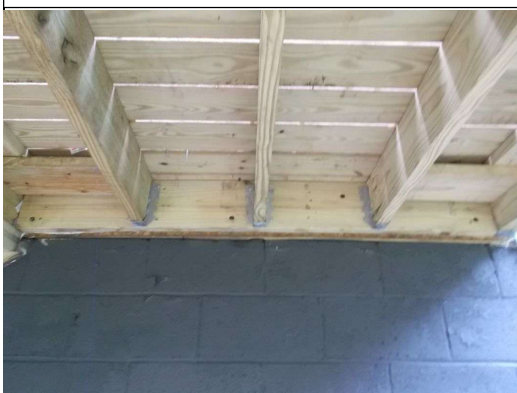
The rear wood deck is missing 1/2 inch bolts, washer and nuts fastening the deck ledger to the house rim joist. The deck stairs has a 2 by 4 for a handrail that is improper. (should be a 2 inch square or round handrail). Cannot see deck-to-house flashing at the joining. The deck stairs stringers are not bearing on the floor ledger properly and are missing metal strong ties.

Missing bolts, missing flashing

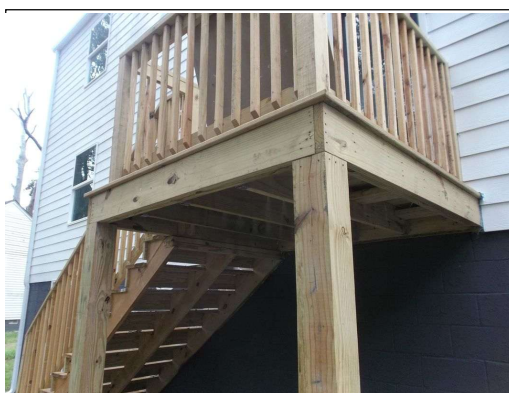
Posts not notched and bolted

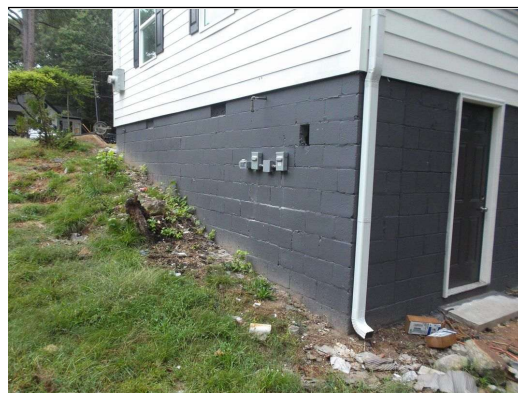
Debris scattered in yard around the house

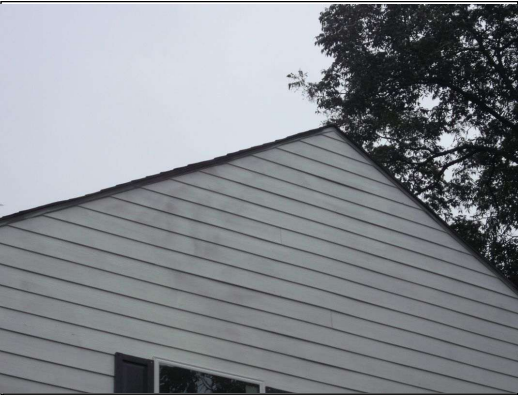
The siding paint is incomplete around the house (can see missed areas, not enough coats and blemishes). Shutters are improperly fastened to the house with screws (verify screws will not rust). The siding does have a minimum air gap of at least 1 inch from the deck floor. The front porch roof beam appears to slope slightly to the left.

Defective paint many areas around the house

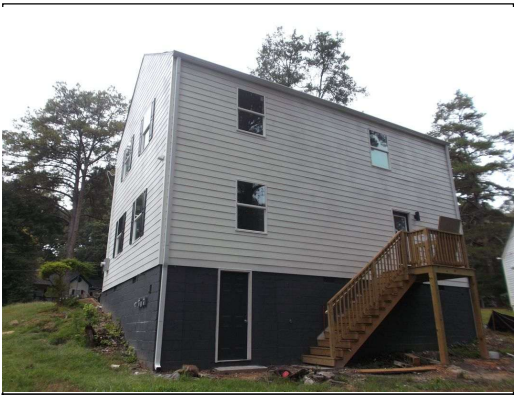
The front upper gutter slopes away from the downspout on the left side of the house (should be a downspout on both ends of the main gutter at the front and rear of the house). Verify all gutters are level or have a very slight slope to downspouts. Where long runs of gutters have only one downspout at one end, they can overflow during heavy downpours. Downspouts pouring at the foundation shall be routed away properly so that water will drain away from the foundation.

Defective paint, spouts pour at foundation

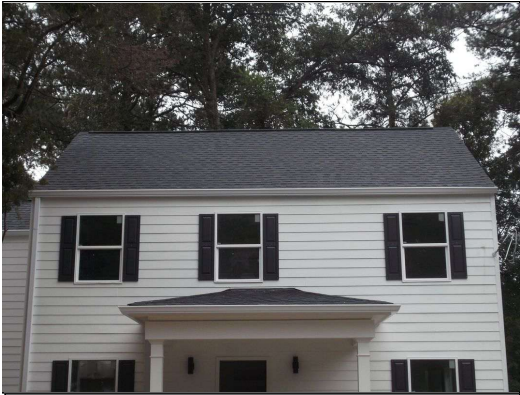
Missing spout right side, porch roof slope left

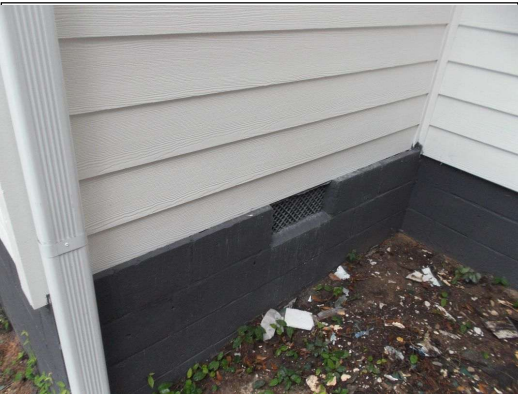
Missing bead of caulk across the top of and electric meter box, around light fixtures on the siding and at vent terminal boxes attached to the siding. Missing piece of the flashing at the front of the house on the left where the siding sits back from the front of the foundation wall (water can get into the wall and basement).

Siding set back from foundation, debris

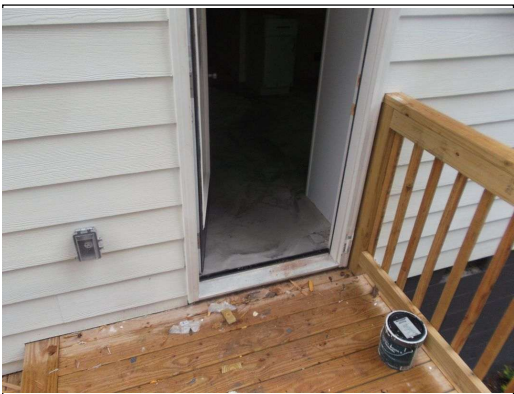
Window screens not installed. Missing wood supports under exterior door's thresholds. Missing flashing over the rear exterior door under the siding. Missing lock hardware at the exterior doors.

Siding close to deck, missing support at door

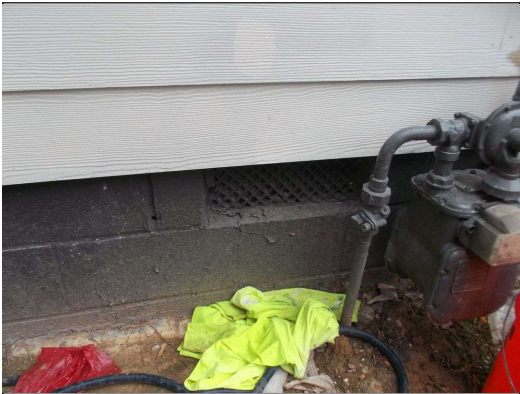
Paint peeling at the foundation blocks at areas around the house. Foundation vents defective, missing doors and screens at areas around the house.

Defective foundation vents several areas

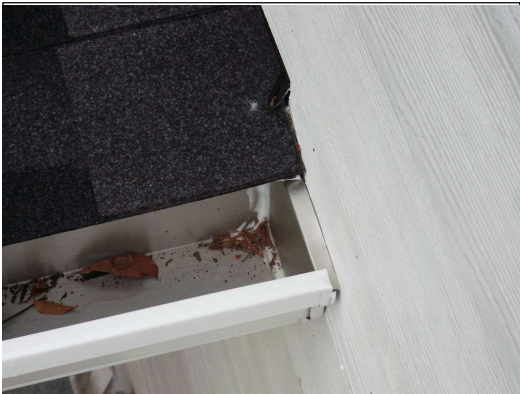
Pipe and or vent flashing appears to be installed on top of the shingles at the bottom flange and face nailed. Can see what appears to be tar no the flashing at the bottom of the flange (can dam up water that gets under the flashing. Also can see a tar or mastic placed around the plumbing pipe at the boot collar. Nails can extract, water can get under flashing and into holes in the roof covering and cause leaks over time. There should be no face nails in the flashing and where there are nails on the side flanges they should be covered with the shingles. It is advised that the roofer review the findings and make corrections where needed.  
Roof-to-wall flashing is not kicked out properly or far enough at areas around the house.

Flashing not kicked out properly

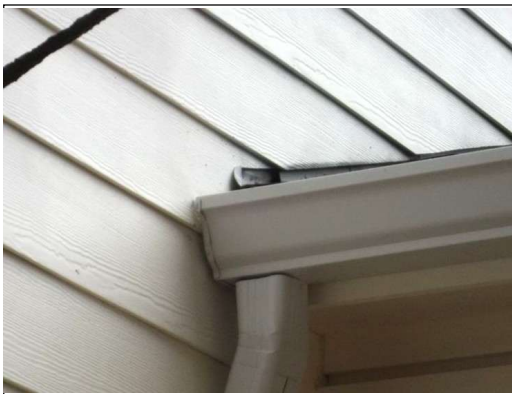
Flashing not extended, kicked out far enough

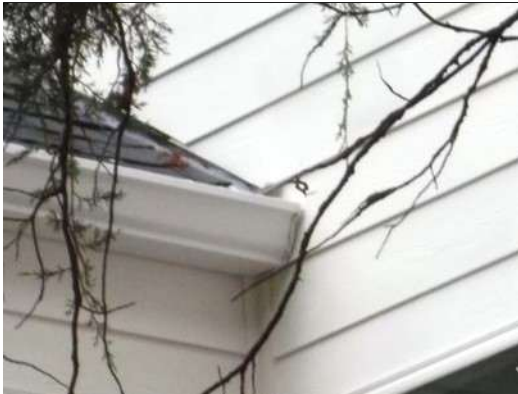
Flashing improperly kicked out

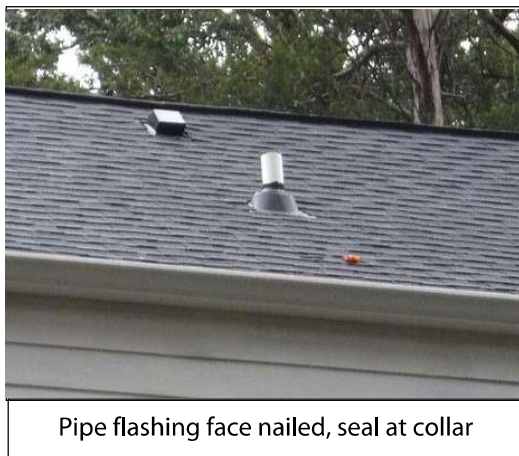
Pipe flashing face nailed, seal at collar

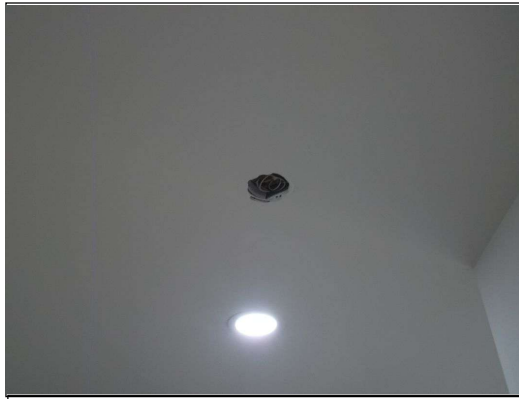
Could not access the basement due to door locked. Cannot verify the condition of the electrical wiring. There is a missing smoke alarm or light fixture at the main level near the hall. Missing bead of caulk where the exterior lights are attached to the siding and over the top of the electrical meter box.

Missing fixture at hall ceiling

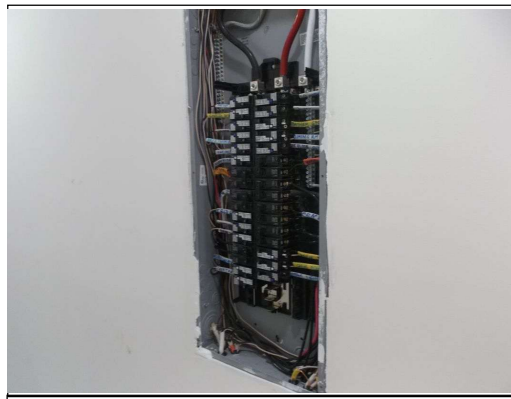
Panel wiring appears OK

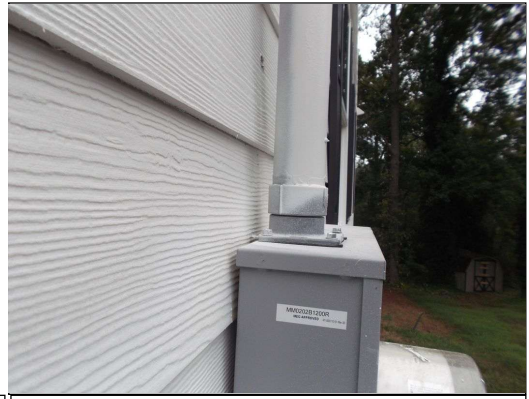
Missing bead of caulk over meter at siding

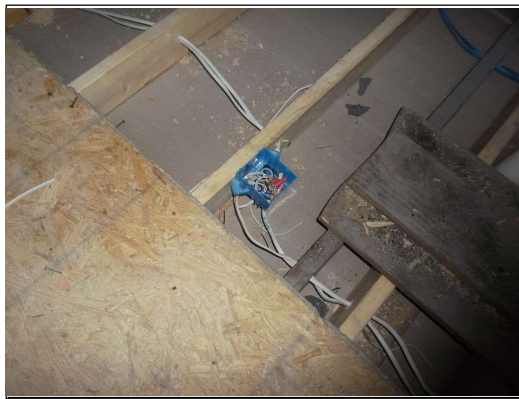
Open junction box in the attic, check all

The electrician is advised to check the complete electrical system in the house, the attic and basement for complete and safe installation.

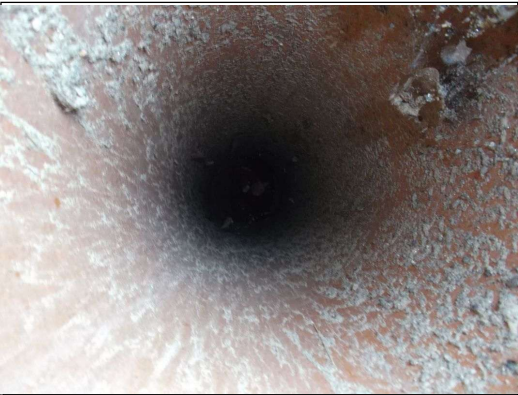
The main waste pipe riser at the front yard is broken at the collar and the cap was off (debris can get into the line and clog). The original clay waste pipe appears to be under the front yard at areas (it is advised to have a sewer scope to inspect the line). Cannot verify what type of waste pipe passes through the foundation front wall at the basement and cannot inspect the plumbing in the basement because the door was locked. The water heater pressure-temperature relief pipe terminates at the deck stairs should not discharge on or near any walking surface. The water meter lid is broken. The rear hose faucet has a defective valve, the handle hard to turn on and off and leaks. PVC waste pipes supported with metal straps in the basement should be PVC straps or plastic.

Open waste pipe riser front yard

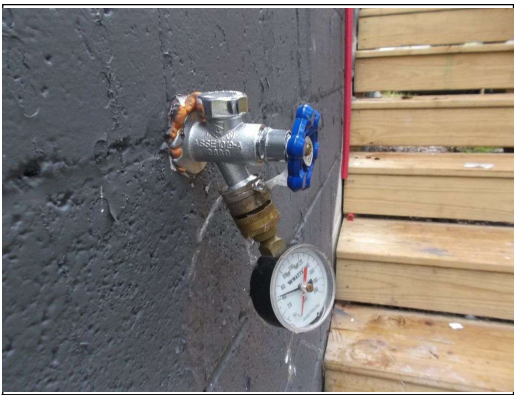
Defective valve rear hose faucet, leaks

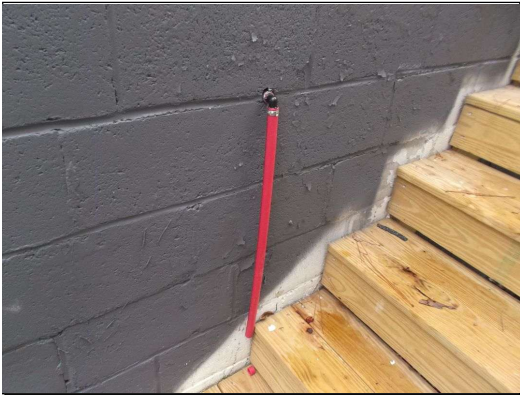
Water heater PTR pipe discharges at steps

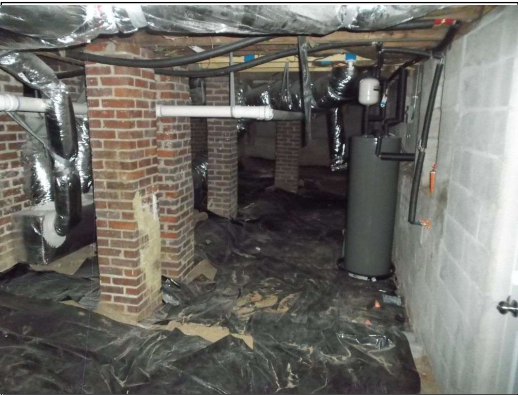
Cannot inspect water heater, door locked

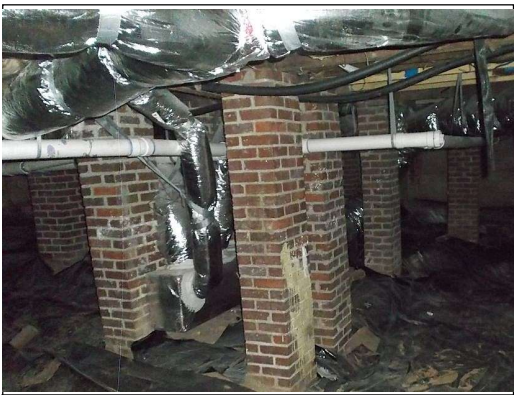
Waste pipes supported with metal straps

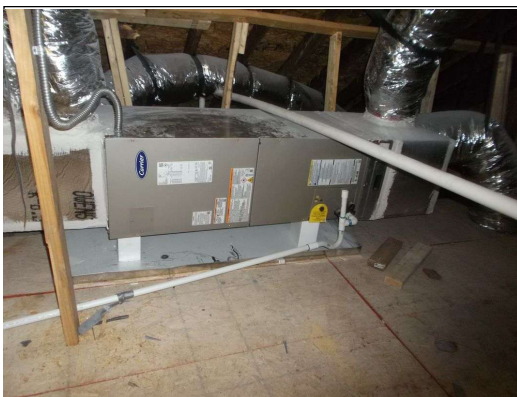
No drain pipe connected to drain pan

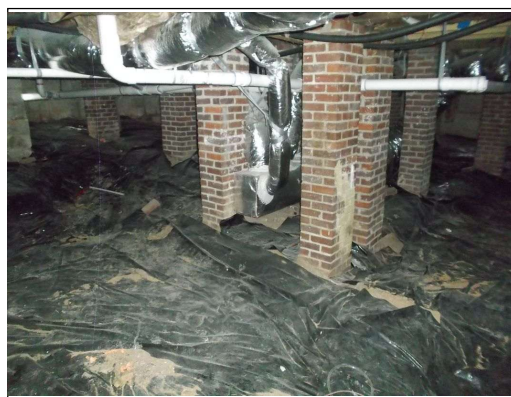
Cannot fully access furnace in basement

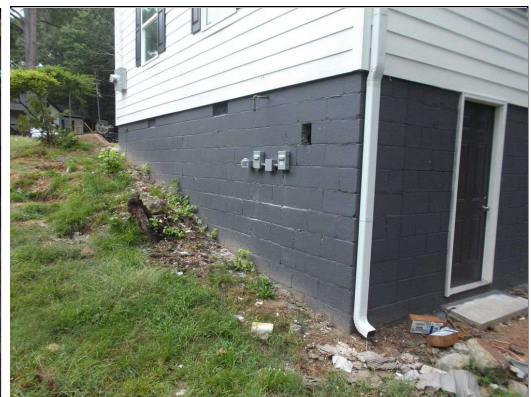
The HVAC system is no completed at the time of the inspection. The refrigerant lines are not complete, there are no AC units outside at the right side of the home, thermostats are not installed. The attic furnace drain pan is not connected to the drain pipe. There are debris and dust in ducts in the floors. Cannot see the furnace in the basement as the door is locked.

AC units not installed right side of house

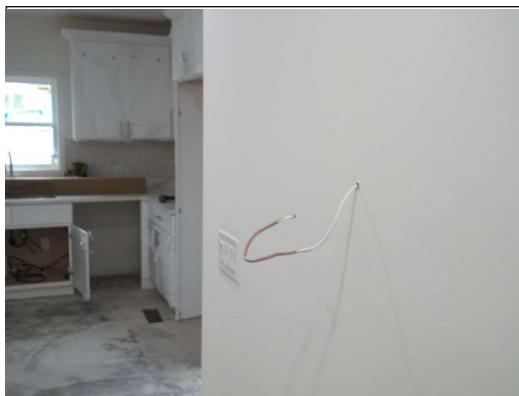
Thermostats not installed

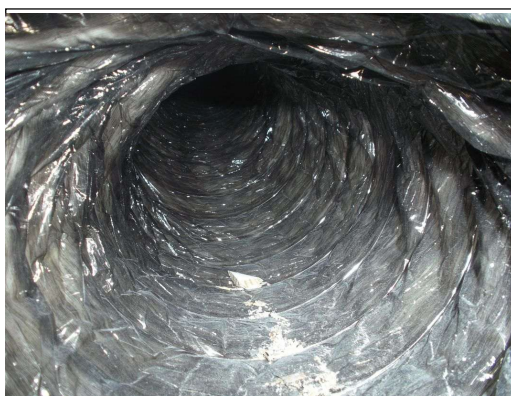
Dust and debris in floor ducts

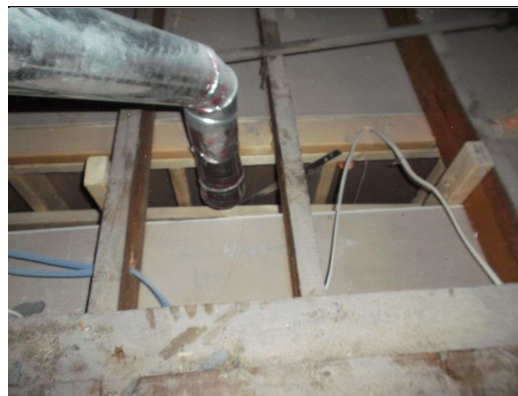
Gas vent pipe touch combustibles

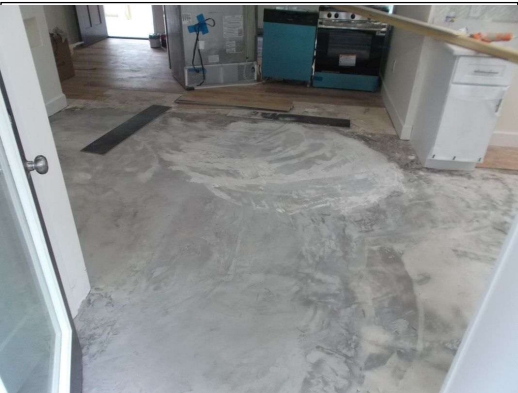
The kitchen is not complete. Plumbing not finished in the sink cabinet. Trims and moldings not completed and flooring not installed. Verify the sink counter does not slope left and right from the center of the sink. Appliances not installed and connected.

Kitchen floor and trim not finished

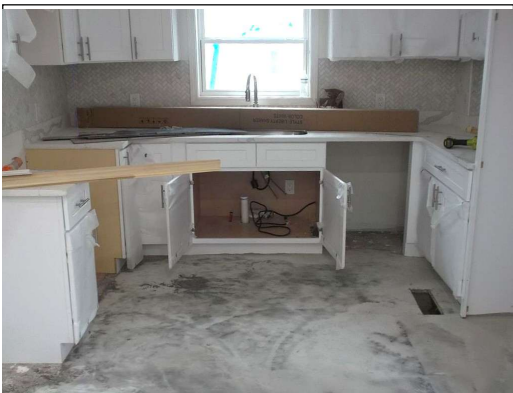
Verify counter not sloping left and right

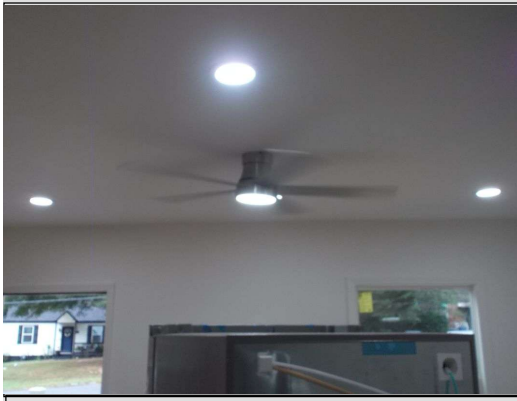
Ceiling fan not plumb

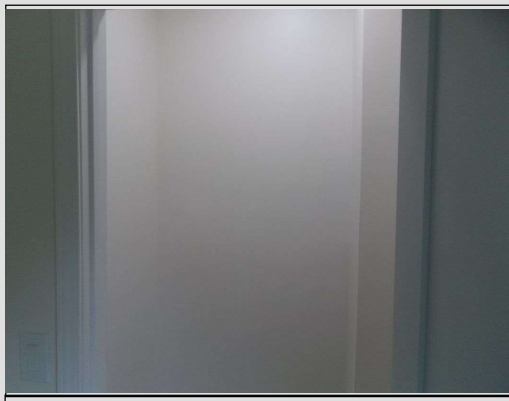
Missing closet shelves

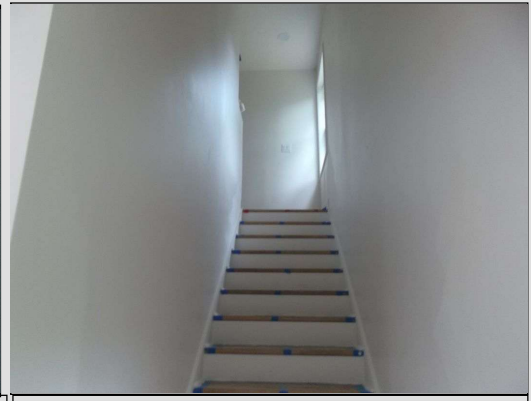
Missing handrail, defective finish and painting

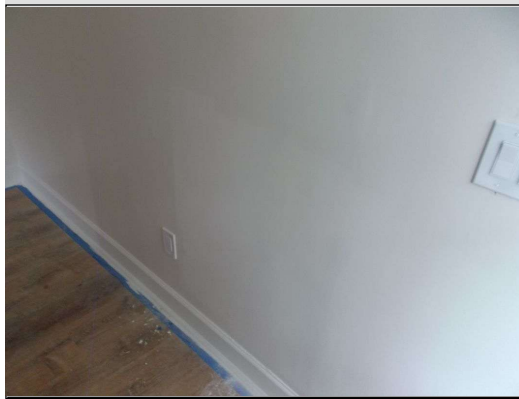
Defective finishing and painting at areas

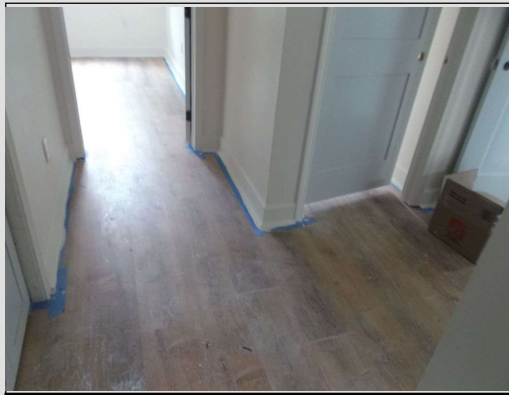
Hump in floor hall to bedrooms

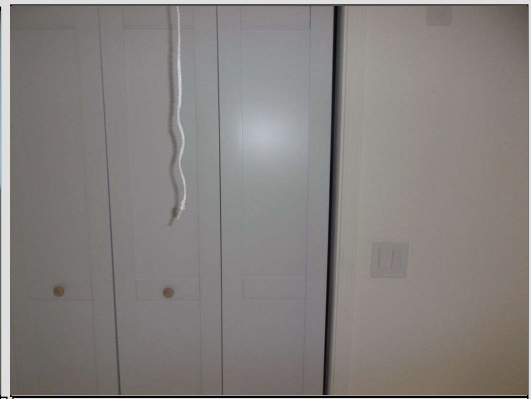
Bi-fold doors off center gap at wall

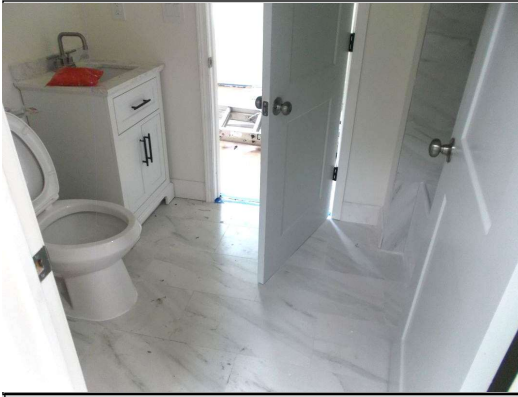
Hall bath incomplete

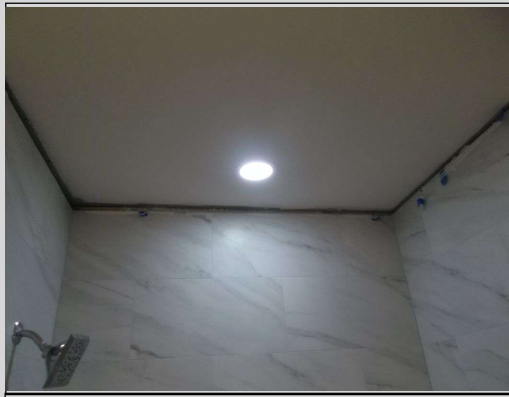
Incomplete finishing at shower wall tiles

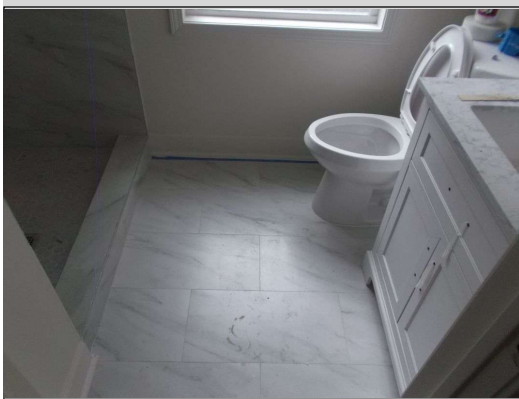
Main Bath: The main bath is in the final stage of completion. Mirror missing. Cabinet not finished, mirror not installed...

Main bath in final stage of completion

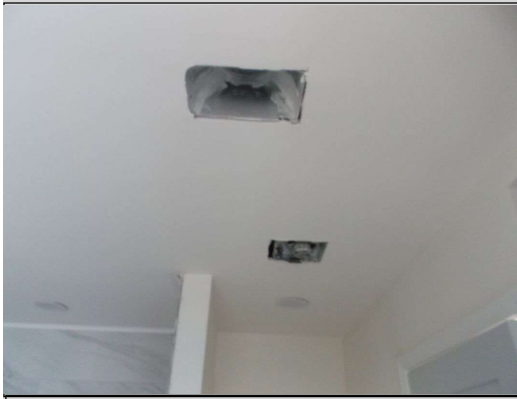
Vent covers not installed

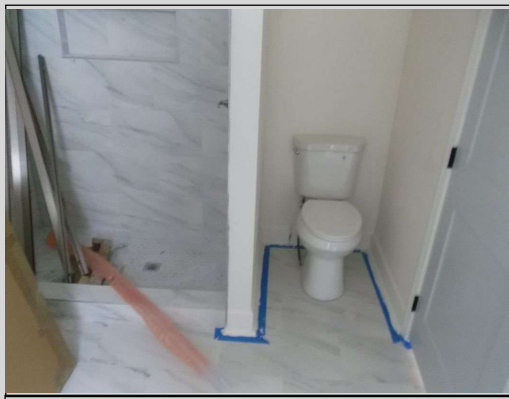
Master Bath: Toilet not hooked up to water supply, mirrors and hardware not installed, missing caulk at areas. Exhaust fan and air vent cover not installed.  
Master bath in final stage of finishing.

Toilet not hooked up

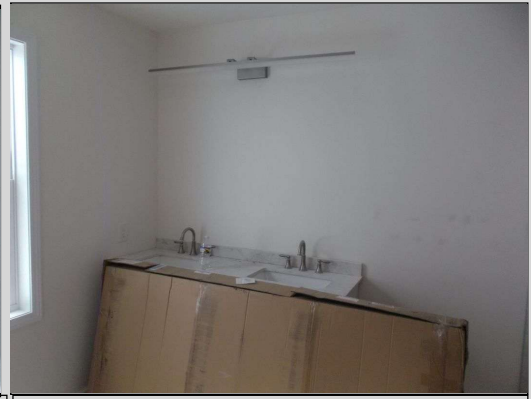
Mirror and hardware not installed

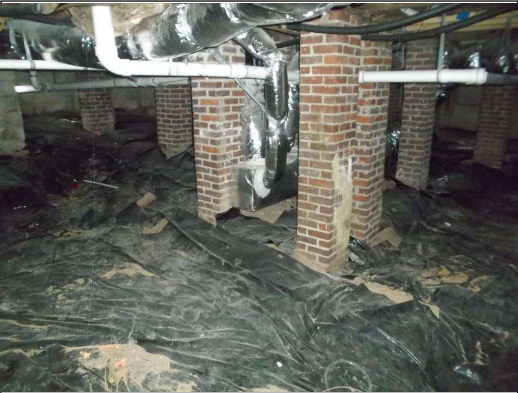
Could not see all areas of the basement

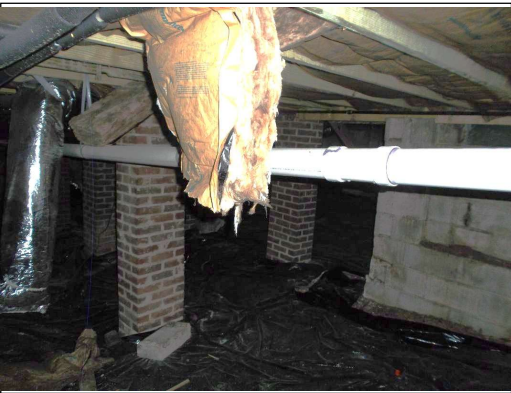
Could not access the basement due to the door being locked. Floor insulation installed backwards under the floor system (paper should face the heated space). Insulation falling down at some areas. vapor barrier on the ground is loose and can see soil at some areas. Cannot verify the condition of the floor framing, beams and supports in the basement. It is advised to get the basement door unlocked to get access and verify conditions. Foundation vents missing screens and doors at areas. Paint peeling at the foundation blocks at areas.

Insulation backwards

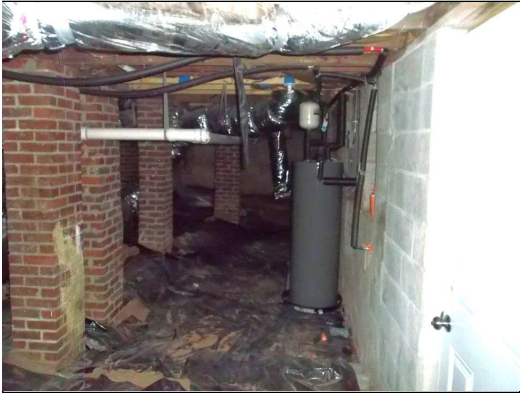
Basement rear area, insulation backwards

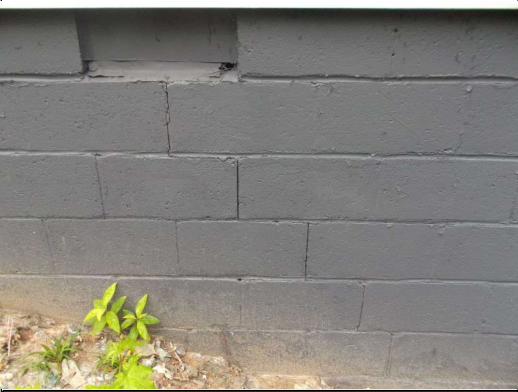
Common crack at blocks right side

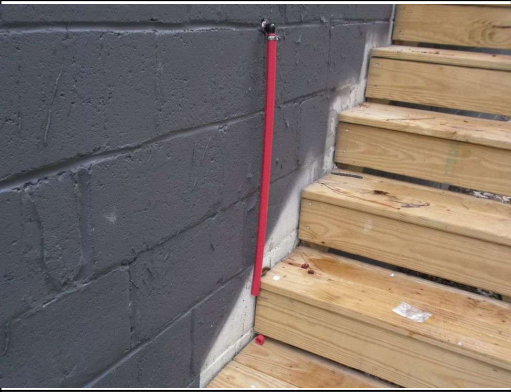
Paint peeling at blocks

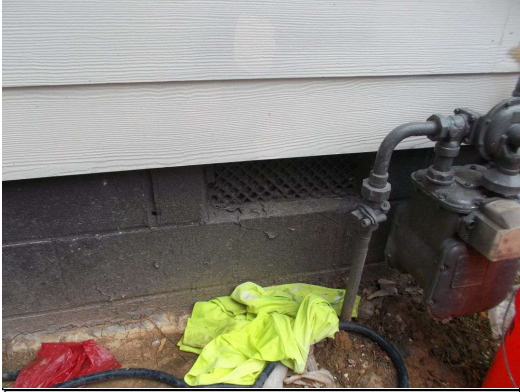
Defective foundation vents at areas

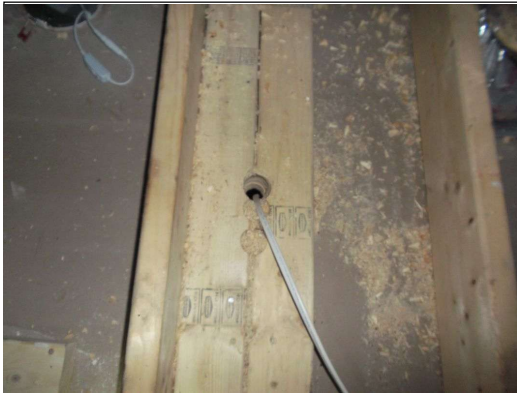
There is an open chase seen in the attic leading to the 2nd floor and down through the house where the gas vent pipe travels that shall be closed. Missing fire caulk in wall top plate holes seen from the attic.

Missing fire foam or fire caulk at holes

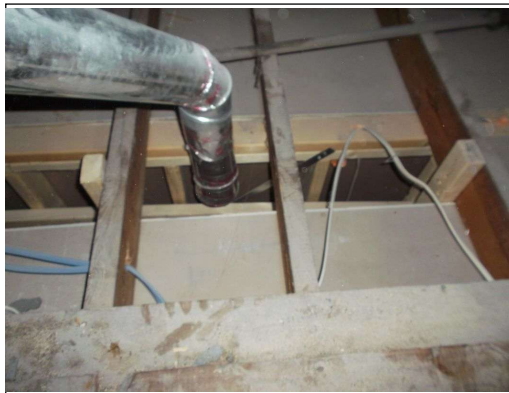
Open chase, vent pipe touch wood

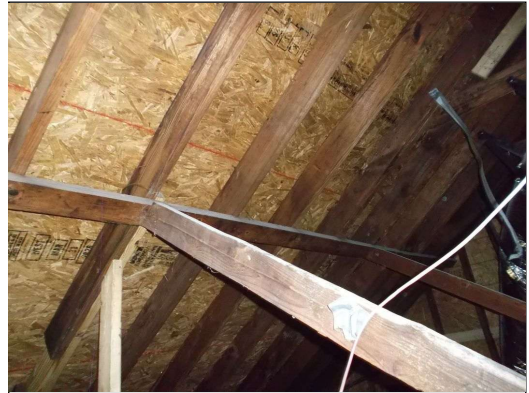
There is no insulation in the attic. Missing spacer clips between roof deck wood OSB panels used for expansion in panels.

Missing spacer clips between roof panels

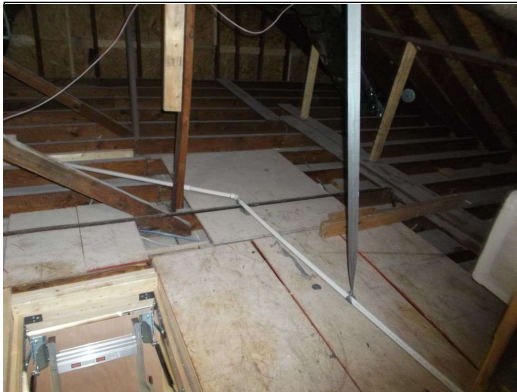
Single stud purlins, missing insulation

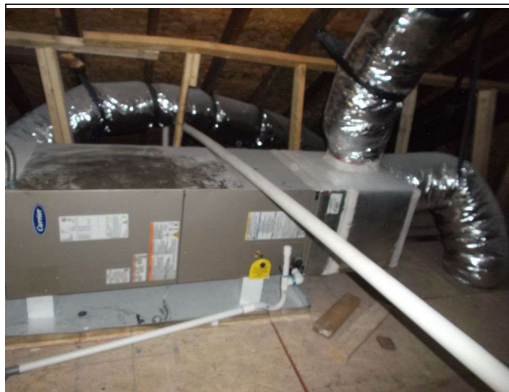
Single stud purlins should be double studs

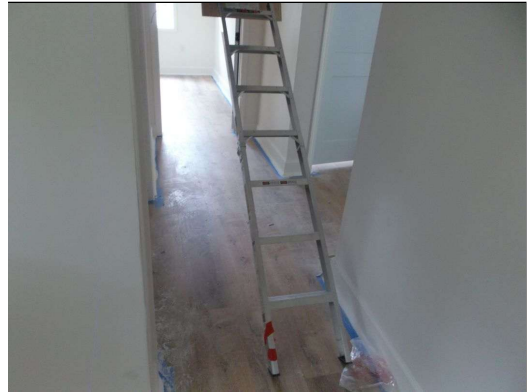
The attic floor is not supported or improperly supported at areas. The attic ladder is too long.

Ladder too long
