PROPERTY INSPECTION REPORT

1065 Peachtree Street NE. #3704, Atlanta, GA. 30309

Nov 30, 2021

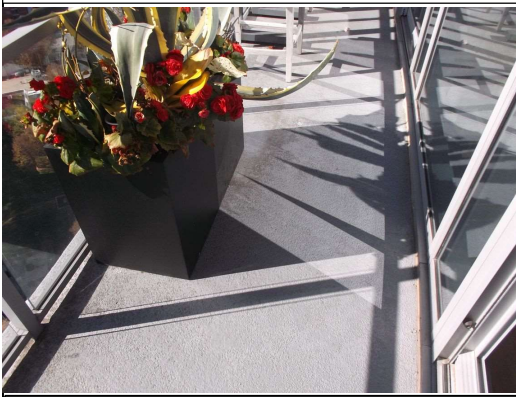
The balcony floor needs pressure wash and or painting.

Stains in the balcony floor paint finish

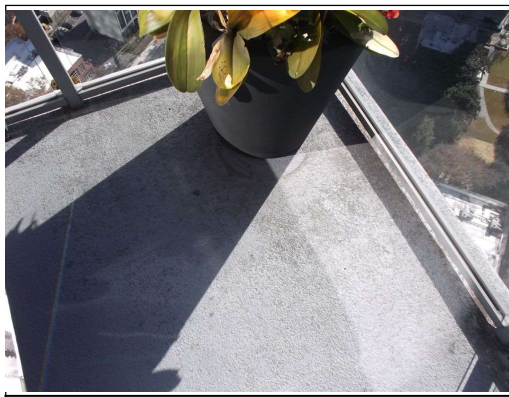
Stains in the balcony floor paint finish

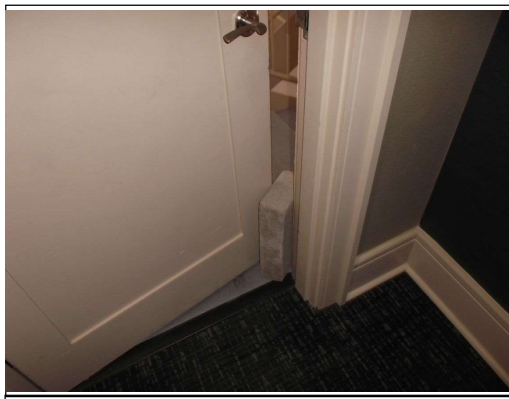
The stairwell door was propped open with a cinder block is a fire and safety hazard.

Stairwell door propped open with a block

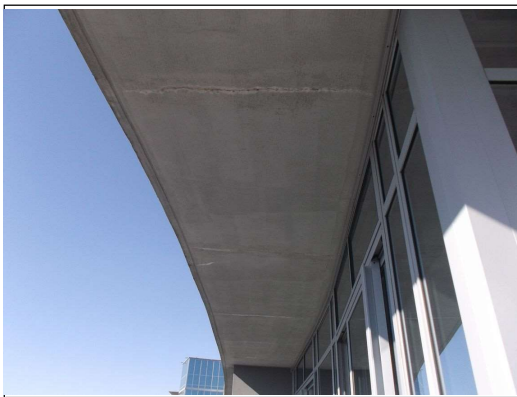
There are settling cracks noted in the concrete ceiling over the balcony.

Movement cracks across balcony ceiling

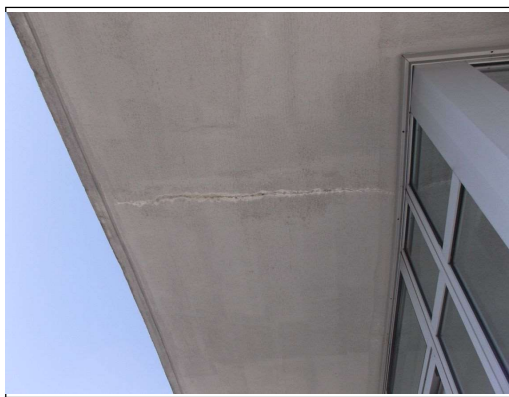
Crack in balcony ceiling

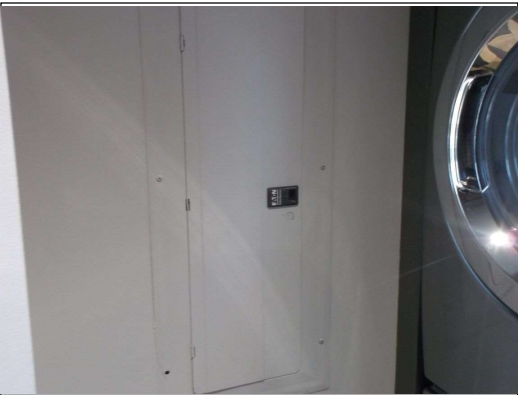
Panel cover sealed to the wall (paint, mud)

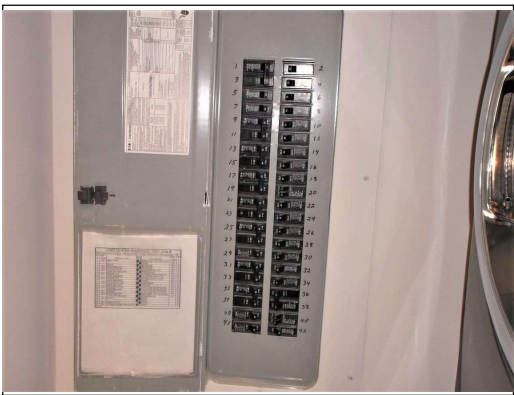
More than 6 breakers in panel no main switch

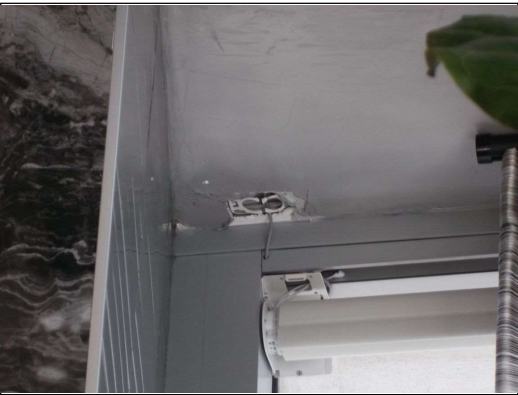
Open outlet box in Living room ceiling

There is a missing cover plate or fixture in the greatroom ceiling at the right side of the fireplace. There is a slight bend in the balcony door bottom track at the left side.

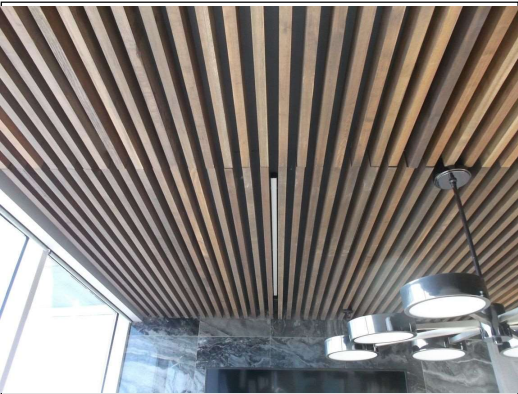
One light did not illuminate in the office when lights switched on.

One light fixture no operating in office

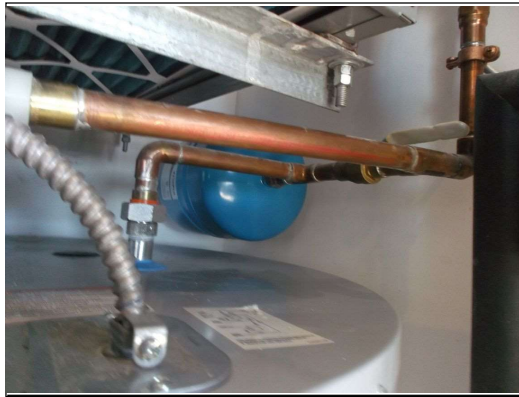
The expansion tank above the water heater is supported with the water pipe which can cause damage. The expansion tank should have independent supports.

Expansion tank resting on the water pipe

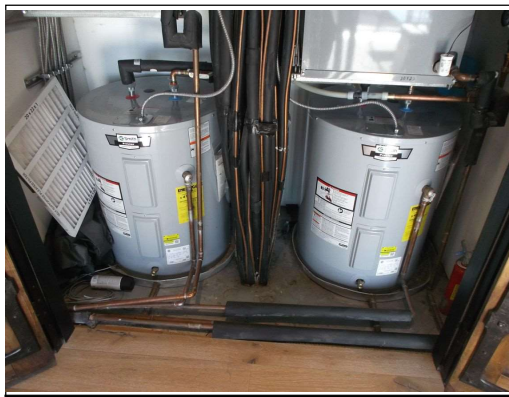
Water pipes traveling across the utility closet floor at the doorway were poorly placed to prevent movement and damage. Pipes should have been installed close to the floor on thin wood, and covered with a box, chase or on a running board.

There are water pipes passing across the utility room doorway entry and are not supported on blocks nor braced to prevent movement can be damaged if disturbed. have a certified plumber support and secure these pipes.

Pipes not protected nor properly supported

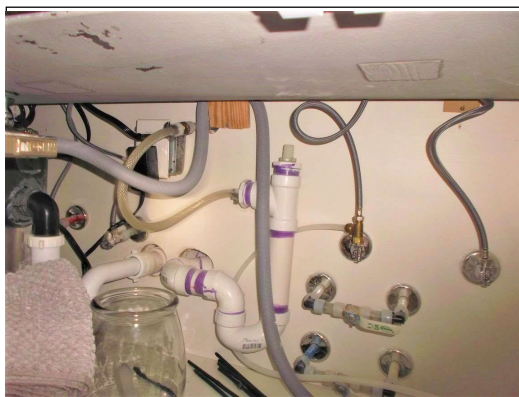
The kitch. sink drain pipe has opening

There appears to be a opening in the sink drain pipe riser in the cabinet. Verify there is no mechanical vent missing at this location. If the waste pipe system has a vent in the pipe's system somewhere else, then the hole can be simply closed and no mechanical vent needed.

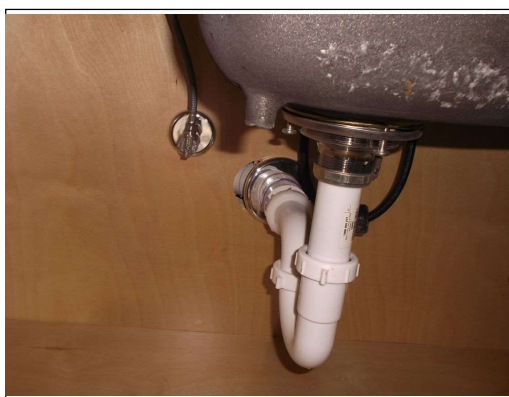
Close all holes in walls at at sink pipes

Close all holes in walls below sink cabinets where sink drain pipes enter to prevent drafts and air infiltration.

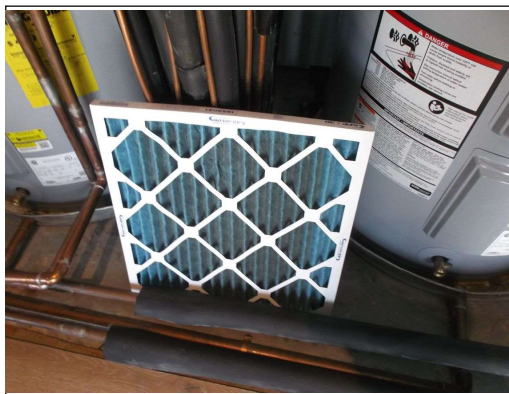
Air filters dirty advised to replace. It is advised to have the air ducts, furnaces, plenums and air handlers professionally cleaned.

Air filter dirty

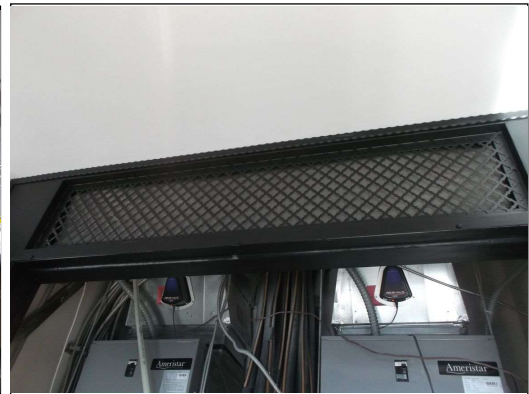
Verify return air screen has been cleaned

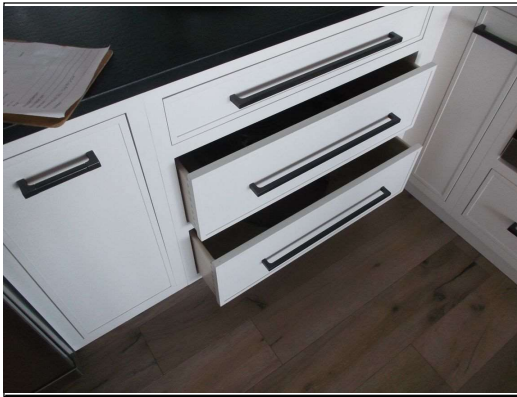
Drawers bump

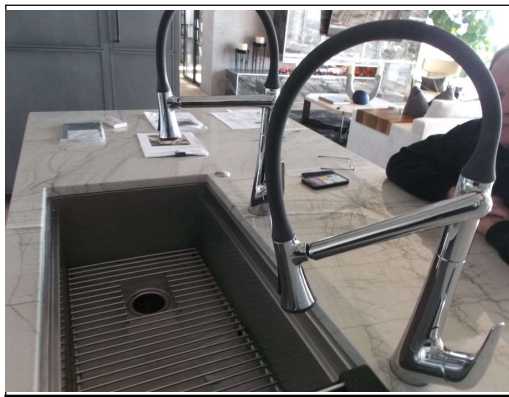
The sink faucet's extended spouts or goose necks are loose at the bodies and faucets pour back to the sink rim.

Faucets loose at the body

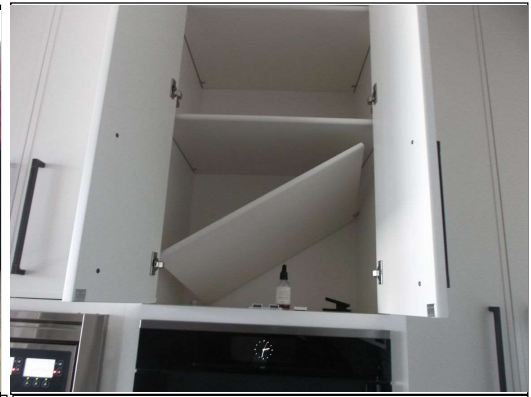
Cabinet shelf detached over coffee bay

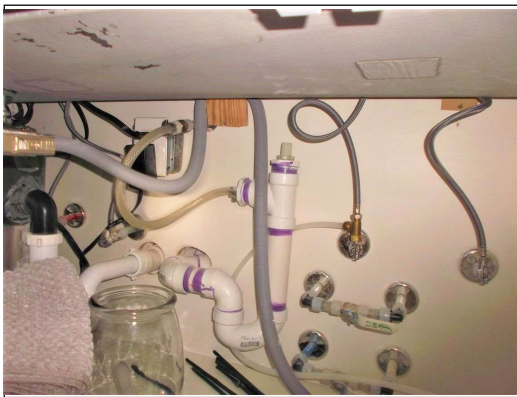
Opening at the top of the sink drain pipe

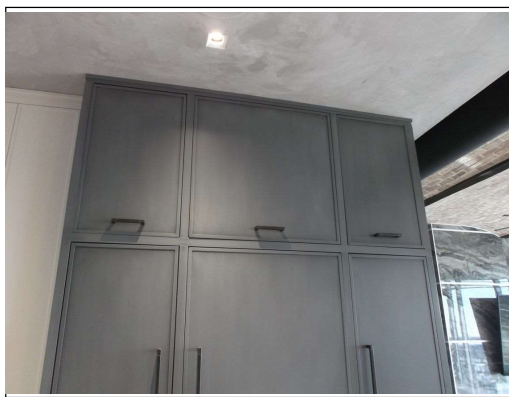
Cabinet door has loose hinges on the right above the refrigerator.

Loose hinges at right wall cabinet door

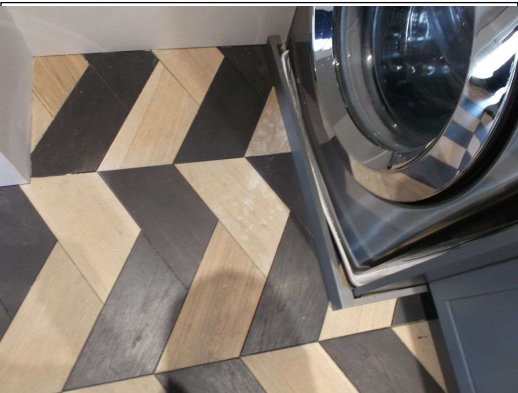
There appears to be stains in the floor tile in front of the washer. There appears to be a separation in the floor tiles (hump) where entering the laundry room.

stains in the floor tile at the washer

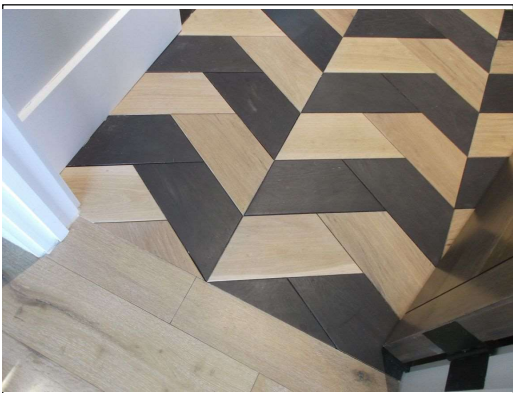
Hump in the floor tile at seam

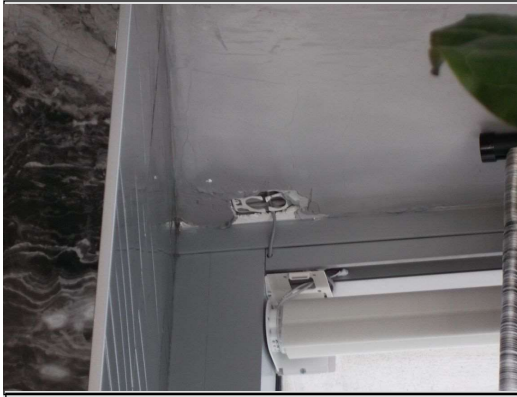
Missing fixture or cover to right of fireplace.

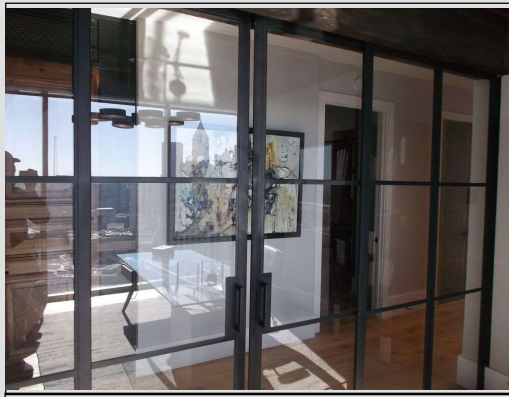
There is one ceiling light not illuminating at the office. The office door closes after opening. Missing door stops at the utility closet doors. Couple of missing door stops.

Office door closes after opening

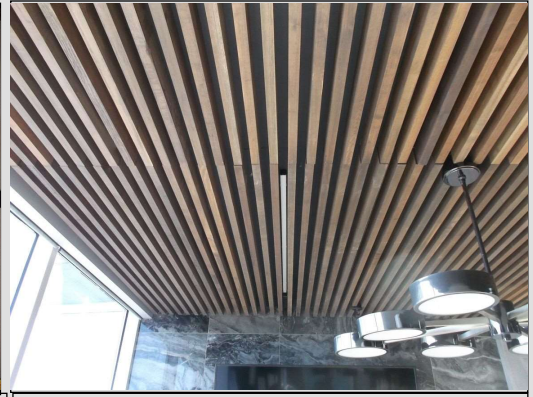
Office light not illuminate when switched on.

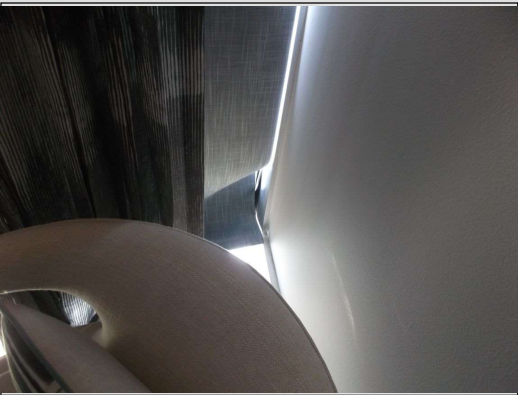
The right bedroom right window shade is not balanced or plumb causing the blind to strike the baseboard and kink when closing. The right bedroom window glass gasket appears to be detaching from the wall frame at the right side at the bottom of the wall. The right bedroom left window glass appears to be slightly fogged (verify).

Window shade kinks at baseboard

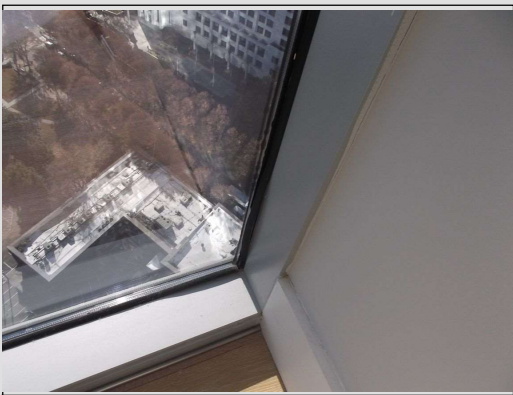
Gasket slightly detaching at right window

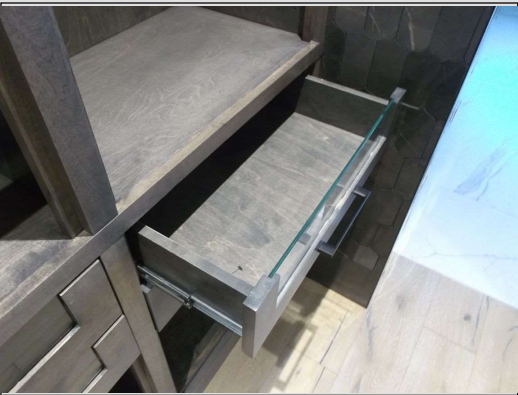
In the master closet there is a top drawer door that bumps at the right side. Missing roller blind at the master bath.

Top drawer bumps

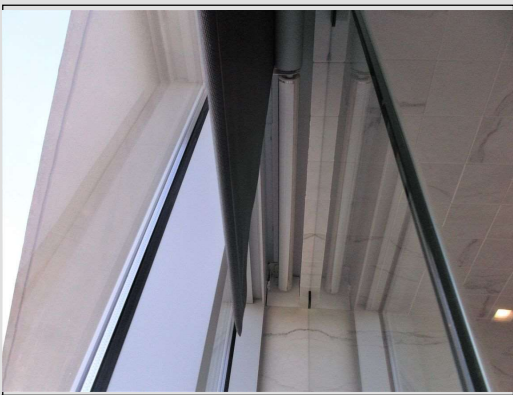
Blind missing at master bath

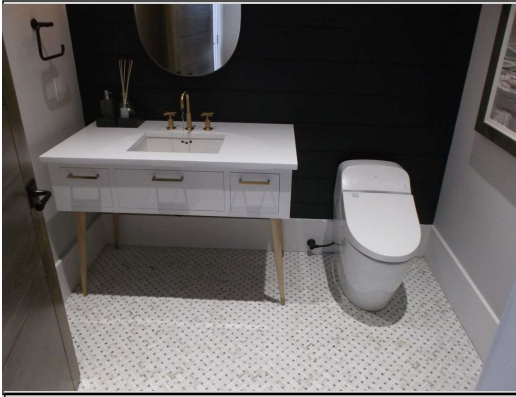
1/2 Bath

1/2 bath water did not get hot at the sink. Verify exhaust fan draft.

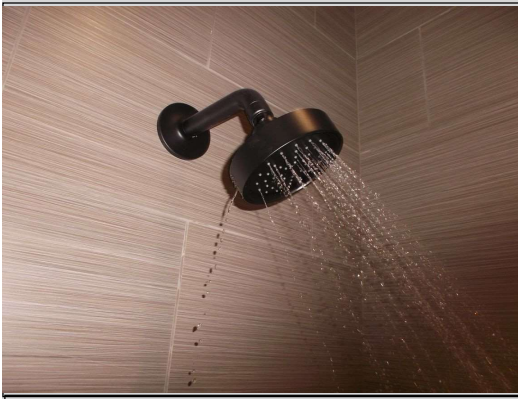
1st bedroom bath shower head leaks at the fitting. Water did not get fully hot. Verify exhaust fan operational or natural draft by building.

Shower head leaks at the fitting

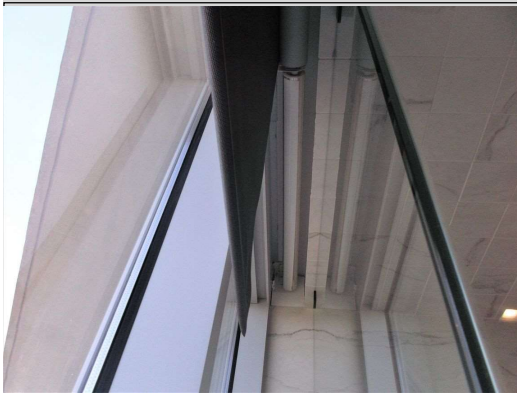
Master bath window shade missing at the right window roller. Toilet closet light did not illuminate when light switches were operated. The mirror has a crack at the left bottom corner. The lights did not illuminate around the mirror glass.

Shade missing

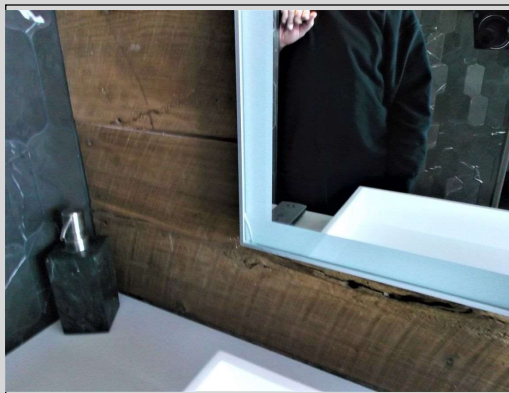
Mirror cracked/lights not illuminating

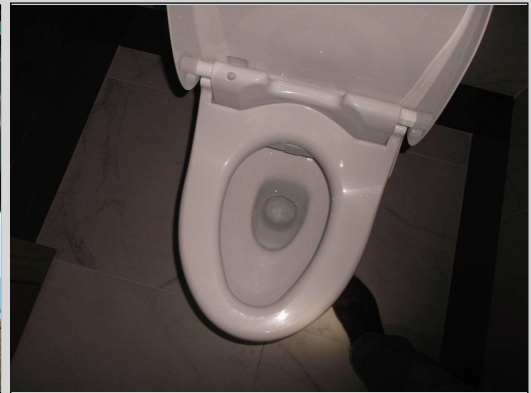
Verify the toilet flush is not defective. Water was weak and slow to drain out.

Toilet slow flush?
