PROPERTY INSPECTION REPORT

500 Semira St. SW. Atlanta, GA.

Sep 27, 2021

1599

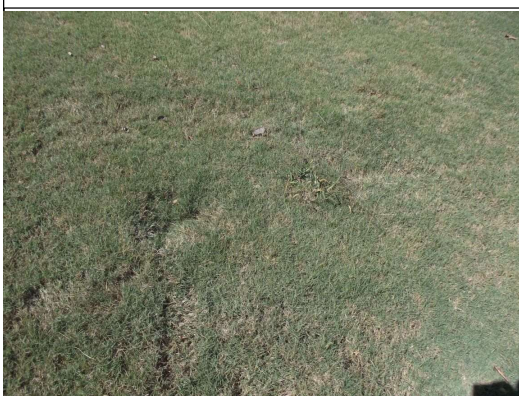
Sink holes in yard

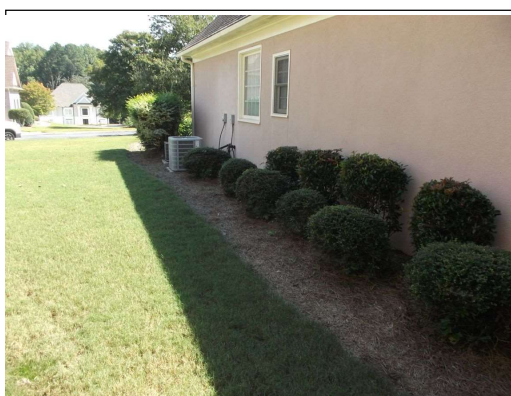
Poor soil slope away from foundation

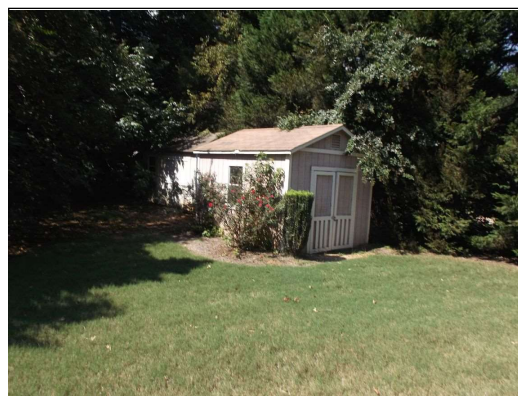
The storage buildings at the rear yard have wood and siding contacting the soil and there is wood rot. The front storage building floor has rot. The storage buildings electrical outlets did not trip when tested (verify outlets are GFCI protected).

Water damage at storage buildings

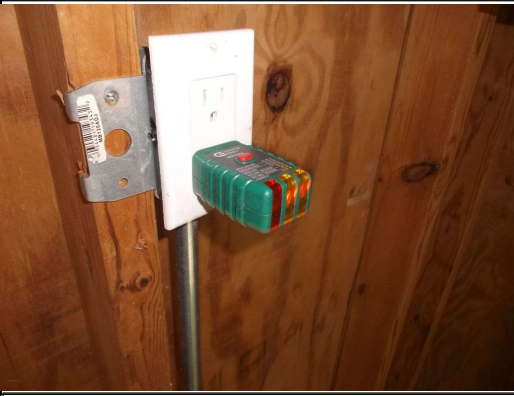
Outlets not GFCI protected at storage bldgs.

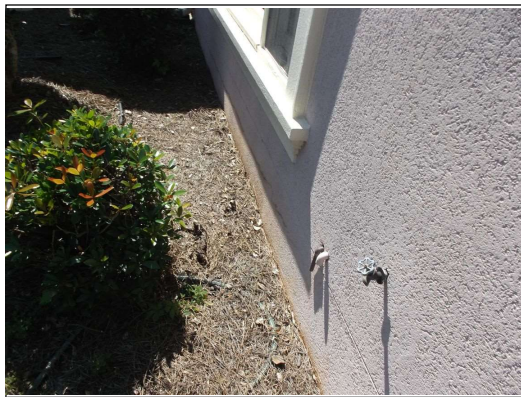
The stucco is in contact with the soil. Where stucco contact soil there can be termite intrusion, moisture intrusion and rot under certain conditions. There are major cracks in the stucco at the front and various other areas.

Stucco in soil/no anti siphon device on faucet

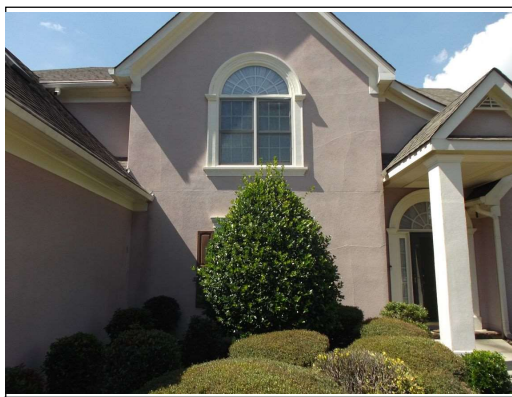
Stucco cracks, trim rot, missing gutter at porch

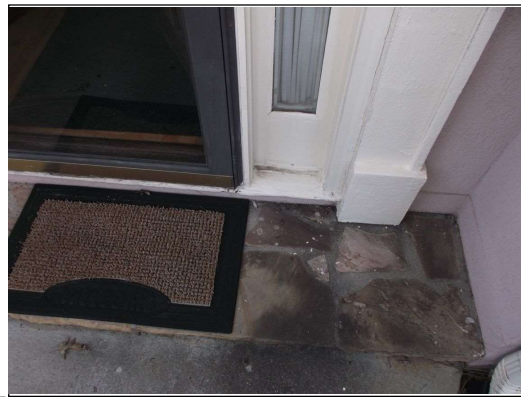
Water damage at front door and in wall

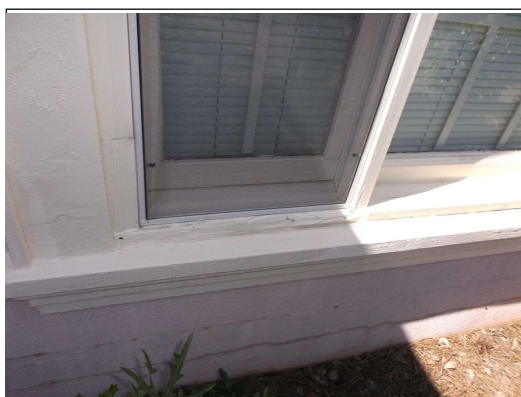
Water damage front and rear windows

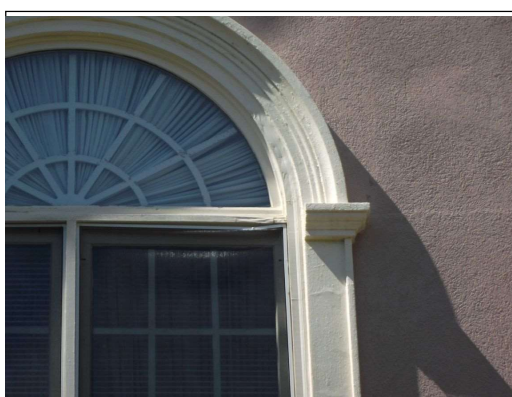
Water damage at several windows/cracks

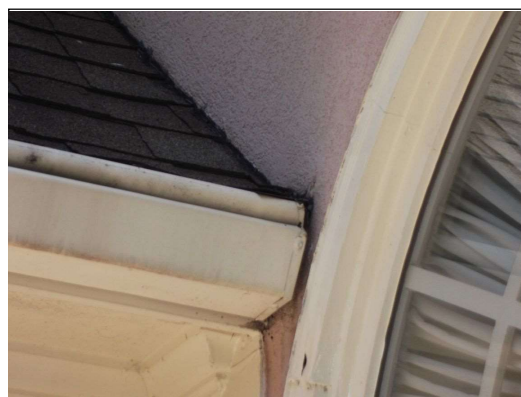
There is defective roof-to-wall flashing at some stucco areas causing water to get into the walls (garage, front porch, great room...)

Defective roof-to-wall flashing several areas

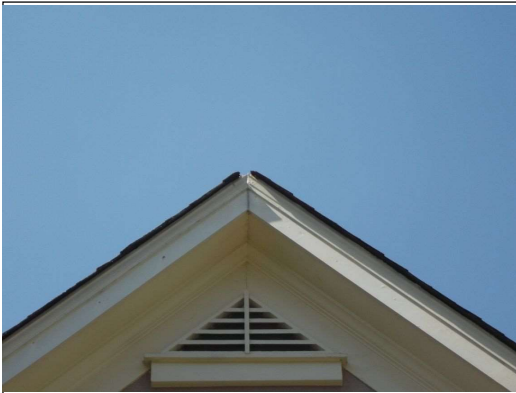
Broken ridge shingles at the front gables

It is advised to have a professional roofer check and service the roof shingles to extend the life of the roof covering. Chimney cap needs painting.

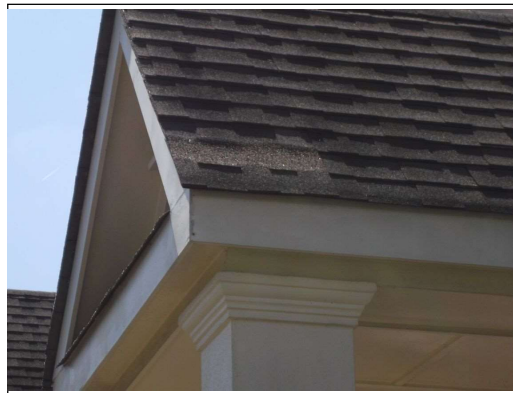
Missing shingle

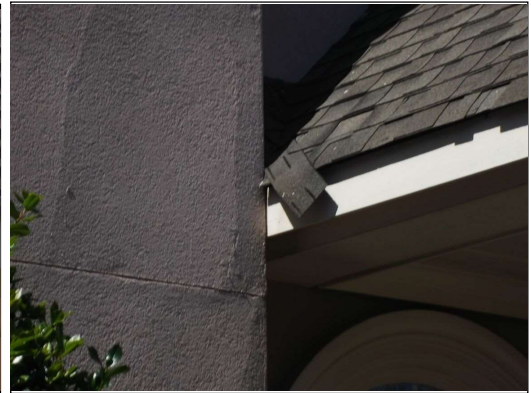
Cracks in stucco and detaching shingles

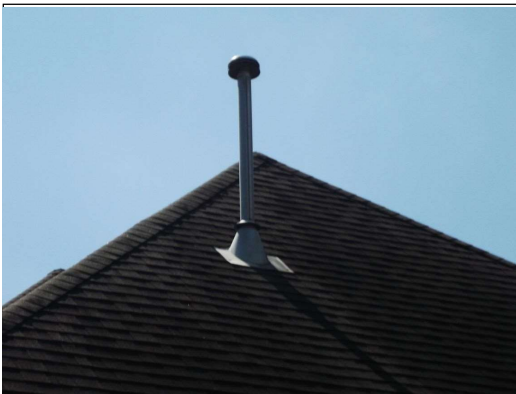
Gas vent pipe rises up too high above roof

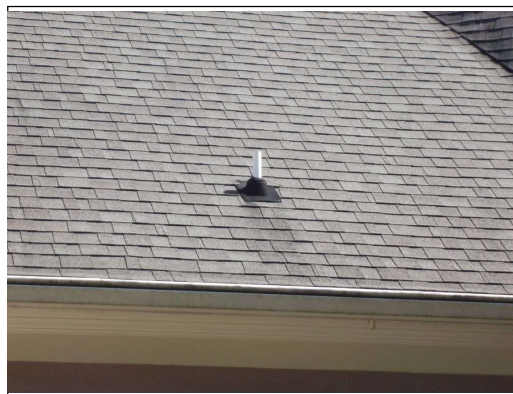
Flashing on top shingles face nailed

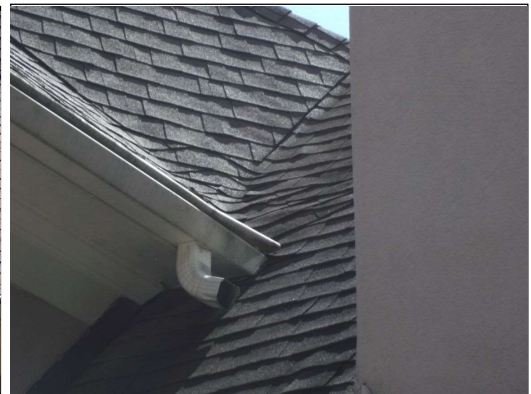
Defective or loose shingles at rear valley

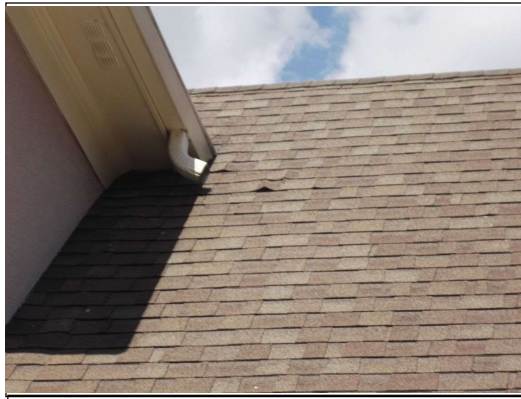
Defective shingles

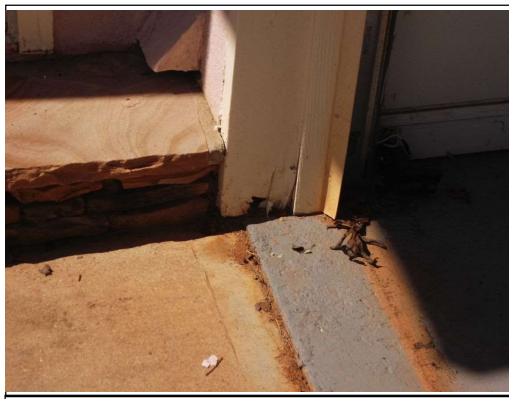
Rot at vehicle door frames at the bottoms

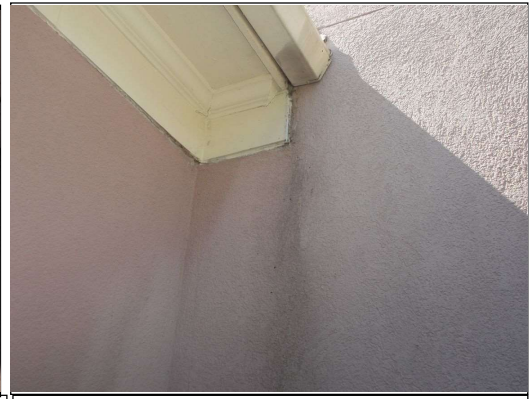
Water enter wall at back of garage

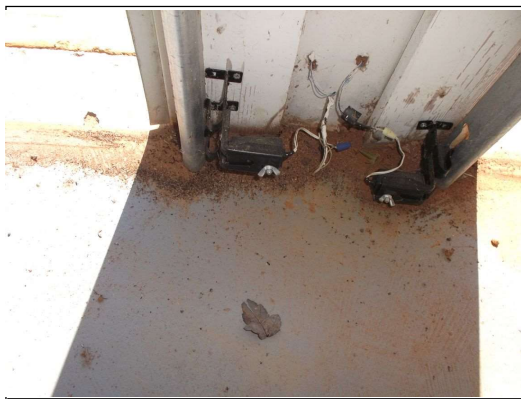
Ants on the floor

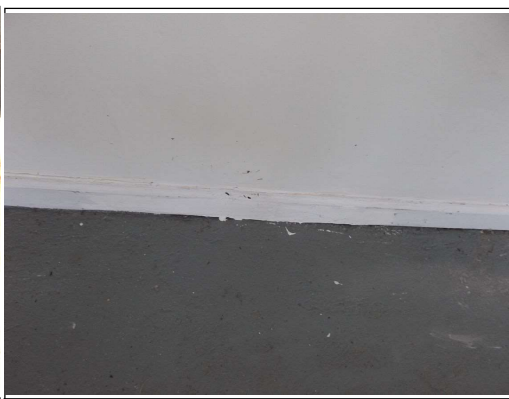
Water damage in garage back wall

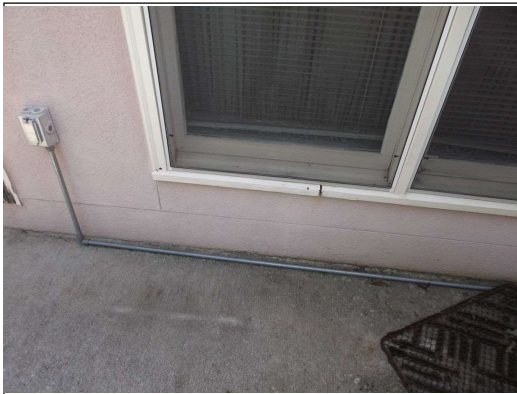
Conduit not fastened to patio or wall

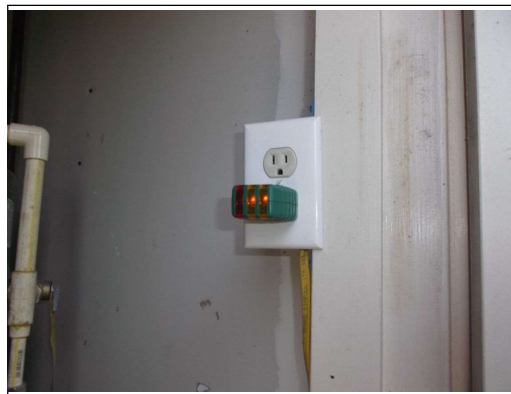
Outlet at water heater closet not GFCI

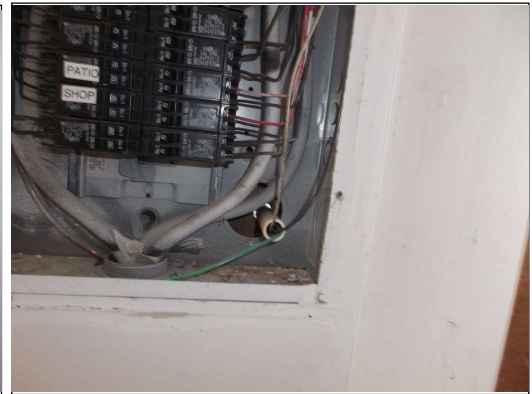
There is a hole in the back of the distribution panel that can let sparks escape (should be closed). There is electrical conduit traveling around the wall at the patio that is not clamped to the patio or wall (movement can cause damage to electrical cables). Electrical outlets at water heaters are not GFCI protected. There are two neutral wires connected to one breaker in the panel (verify OK). The distribution panel box was installed too close to the right wall to have easy access.

Hole in panel box wall is fire safety issue

It is advised to have a professional electrician check, service and repair electrical system for safety. There is a hole in the back of the distribution panel that can let sparks escape into the storage room wall.

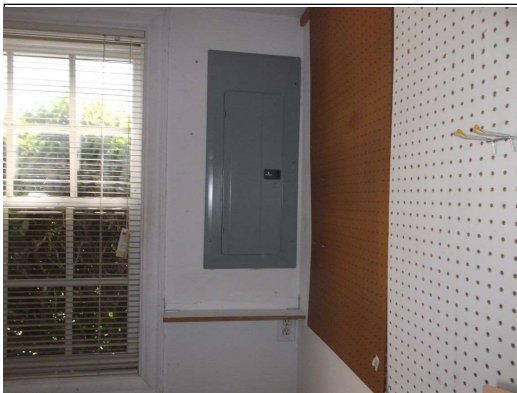
Side wall too close to panel door

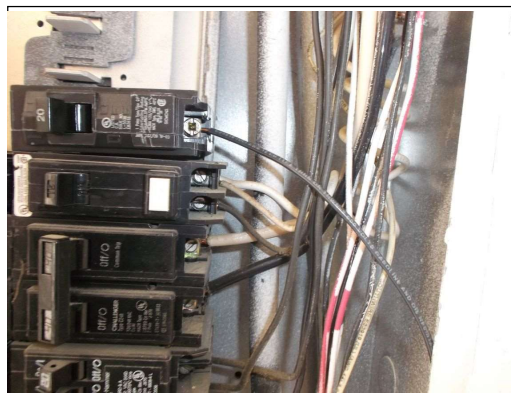
Two neutrals connected to a breaker

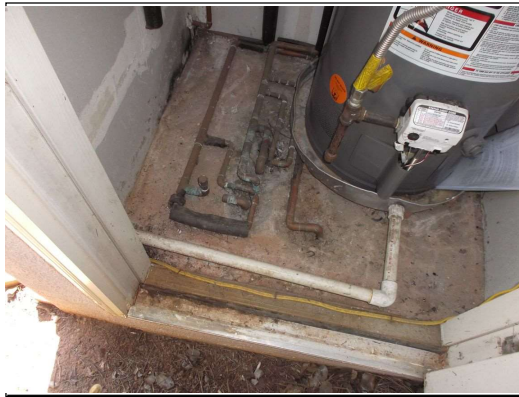
Pipes not wrapped in insulation

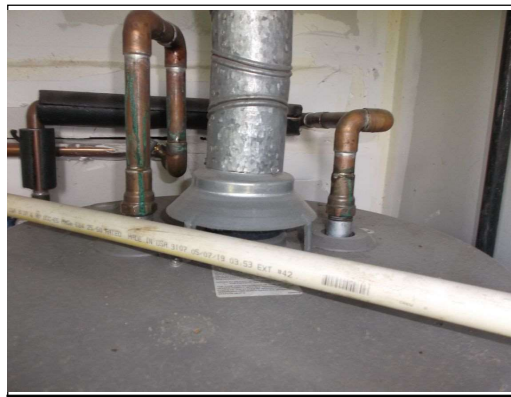
Copper and steel join w/o dielectric fittings

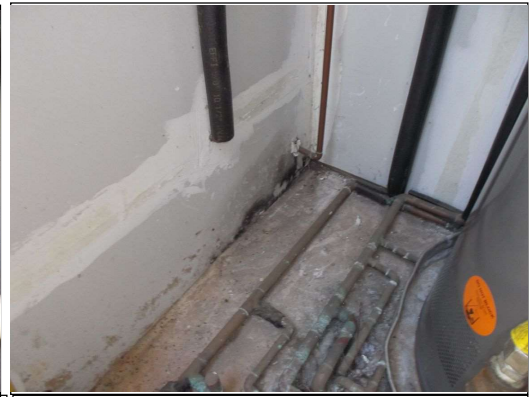
Water damage at front utility room

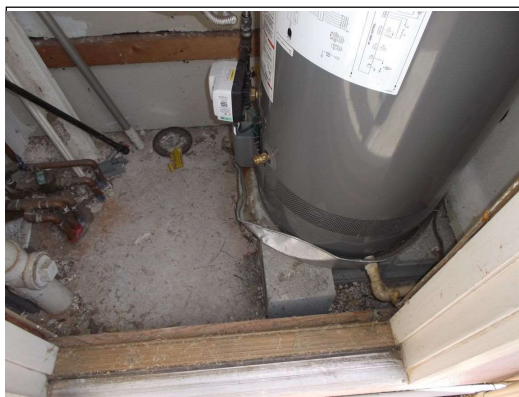
Drain pan crushed

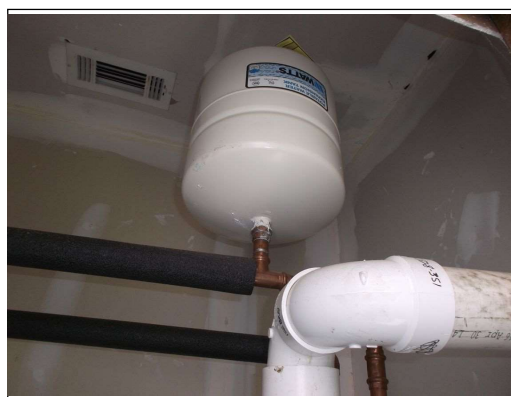
Expansion tank rest on water pipe

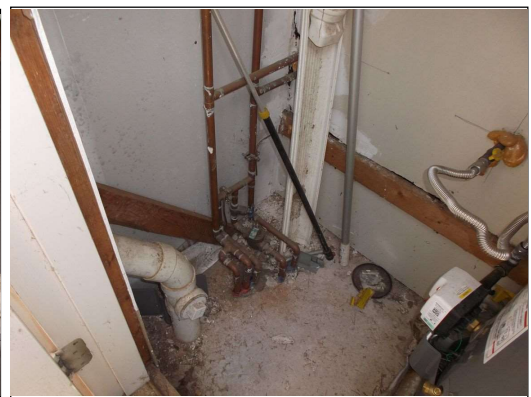
Pipes not wrapped in insulation

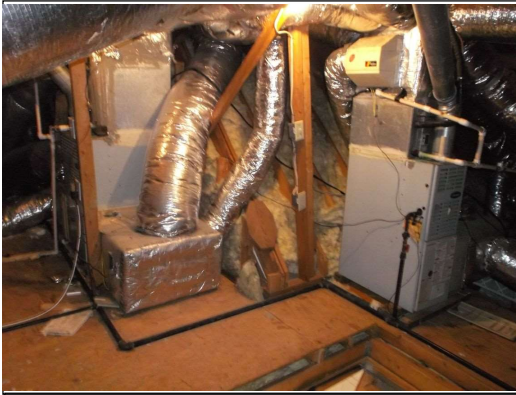
Furnaces appear to be aging

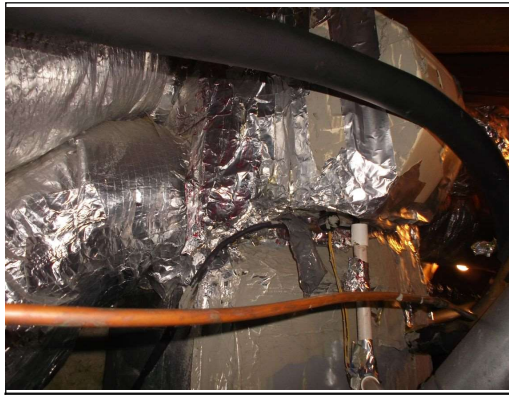
Defective attached dehumidifier

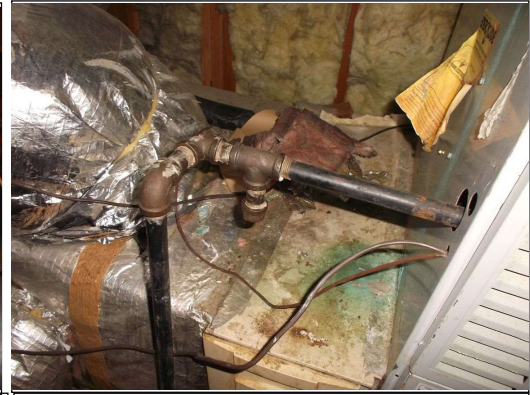
Improper sediment trap in gas pipe

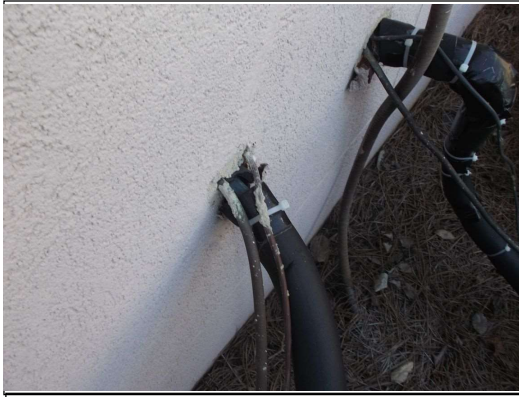
Refrigerant line insulation missing in wall

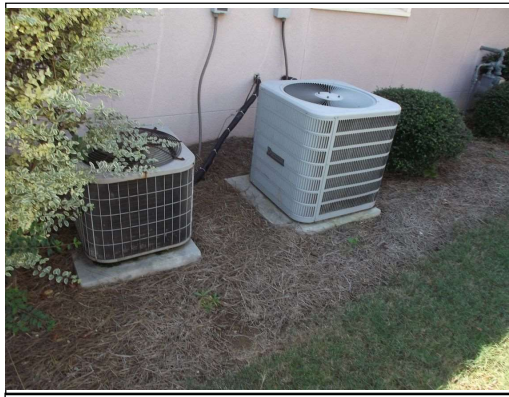
The AC units may be nearing the end of use or will need ongoing repairs to maintain operation.

AC units appear original to house

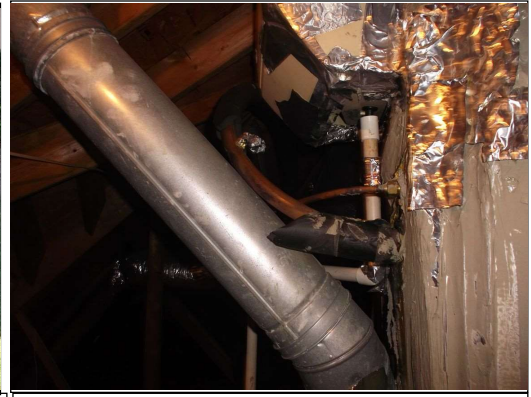
Missing refrigerant line insulation

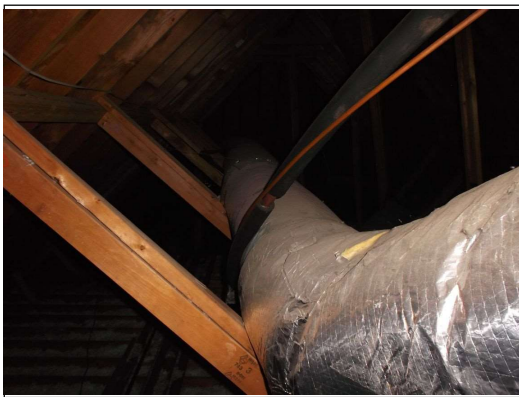
Missing refrigerant line insulation

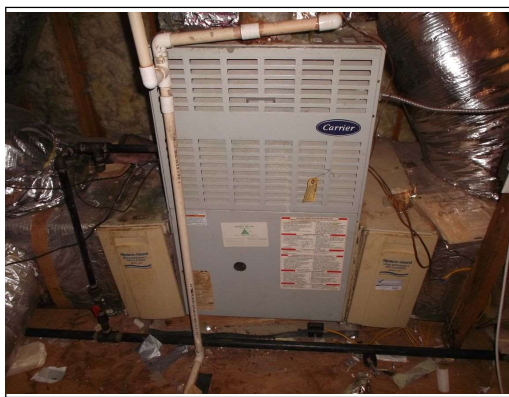
AC units appear original to house

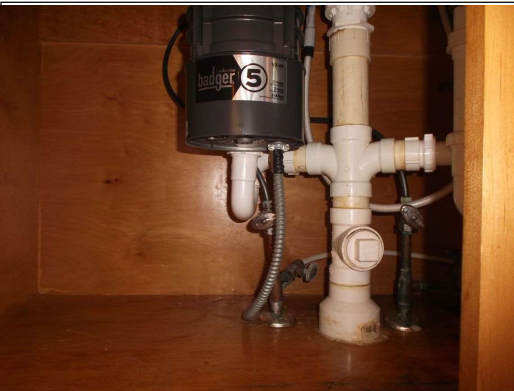
Conduit detached from disposal disposal wor

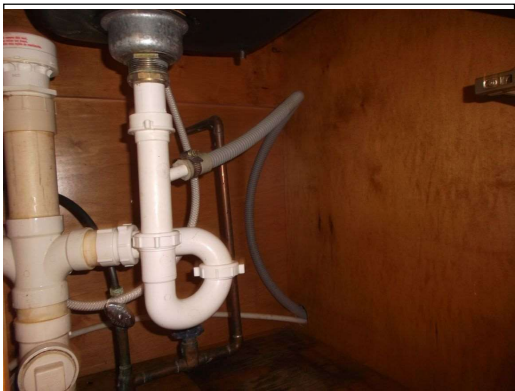
Dishwasher drain pipe not high looped

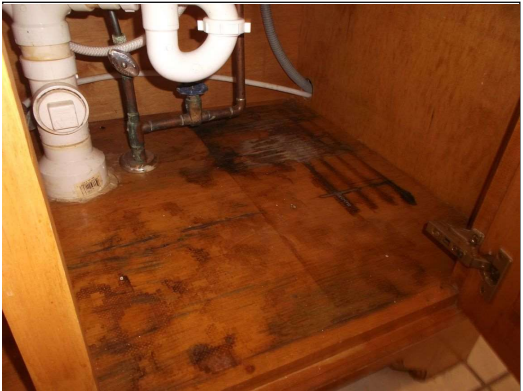
Sink cabinet floor stained

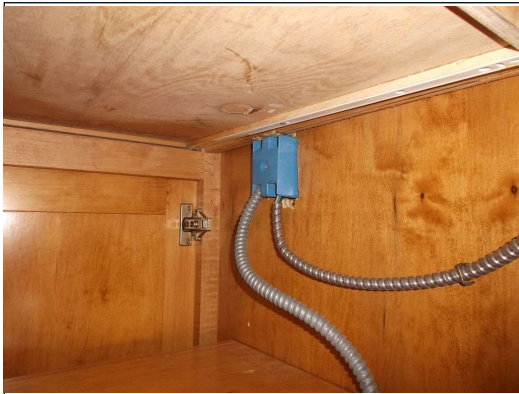
Conduit detaching from electrical box

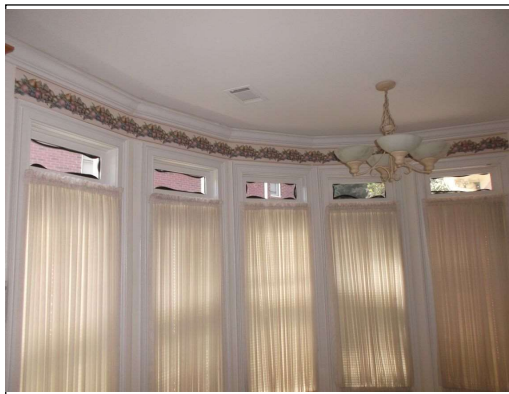
Breakfast room window glass seals broken

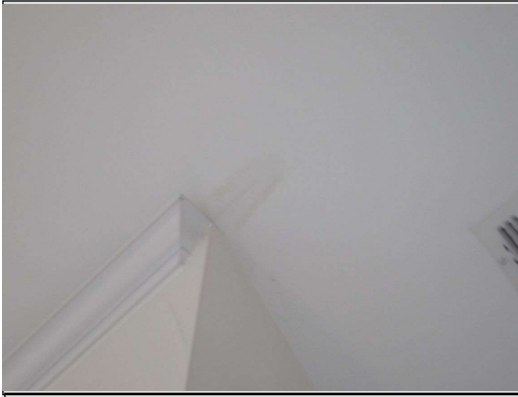
Stains on great room ceiling

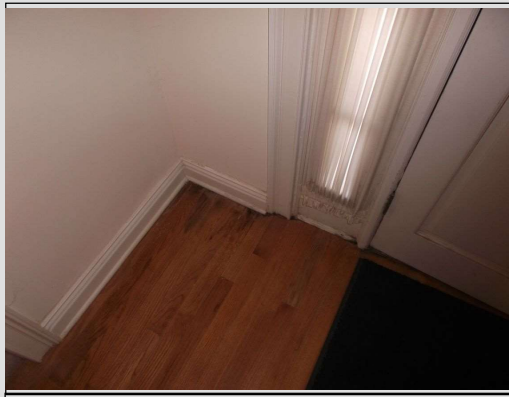
Water damage at foyer floor and wall

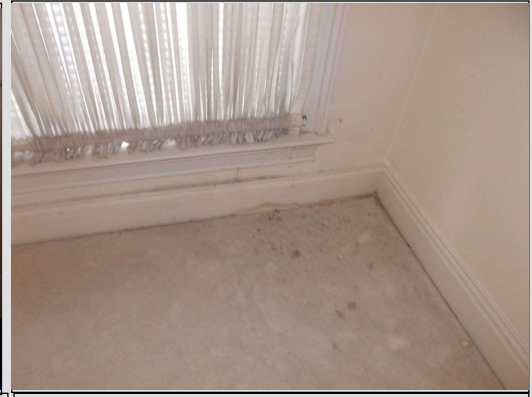
Water damage at great room wall

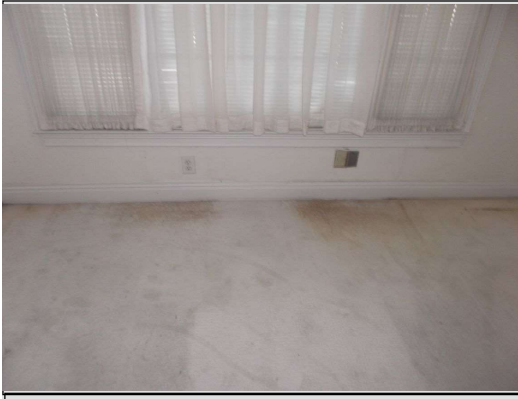
May be water intrusion at front room wall

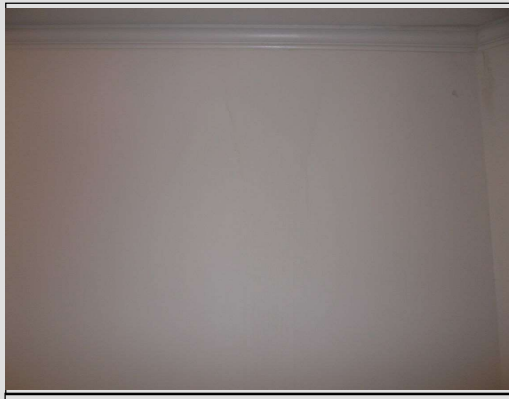
Dry water stains on the master bedroom wall behind the fireplace.

Dry stains on master bed wall

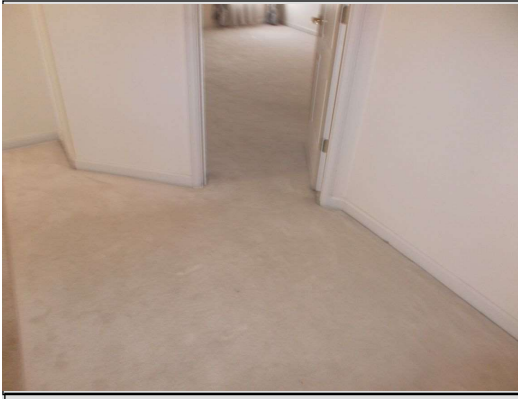
Hall floor slopes to left bed doorway

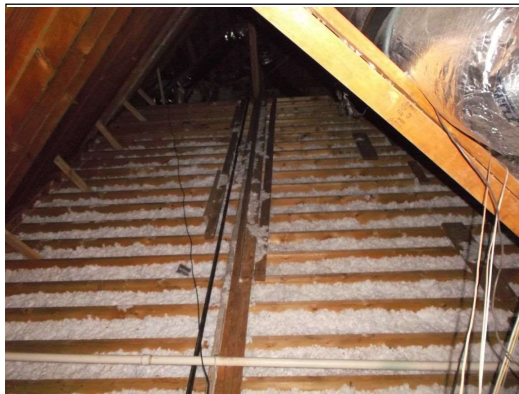
Poor insulation coverage

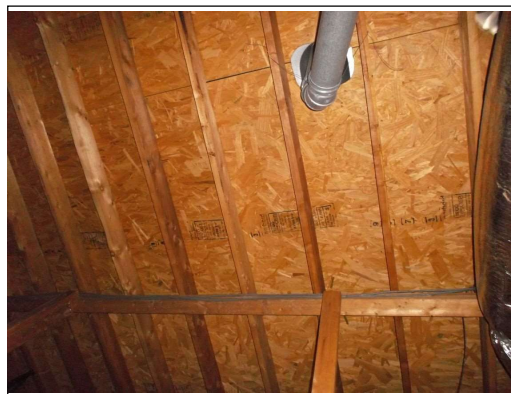
Missing spacer clips between panels

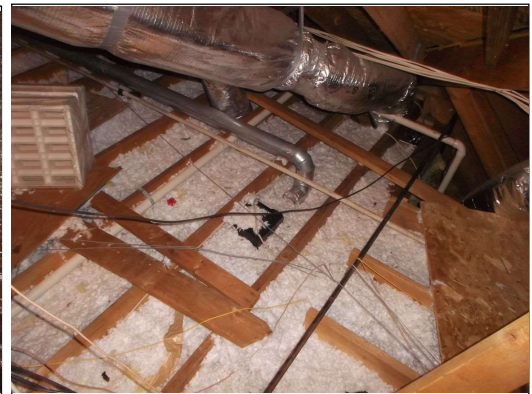
Pipe detached from exhaust fan

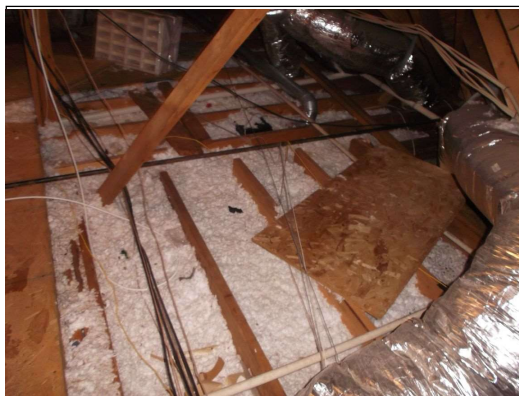
Poor insulation thickness

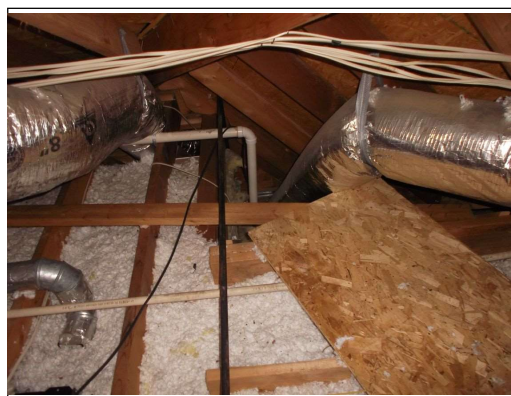
Open chase from the 1st floor
