PROPERTY INSPECTION REPORT

683 River Valley Dr. Jonesboro, GA.

Jun 12, 2021

Maurice Sharpe

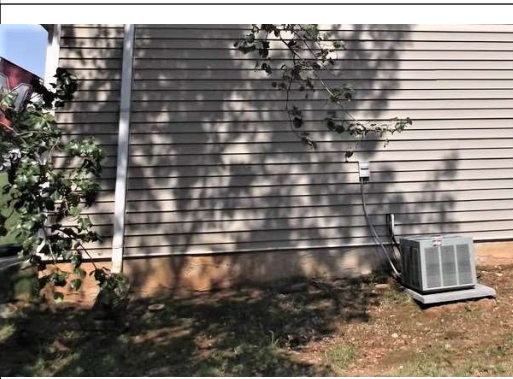
Soil erosion at the right side of the house

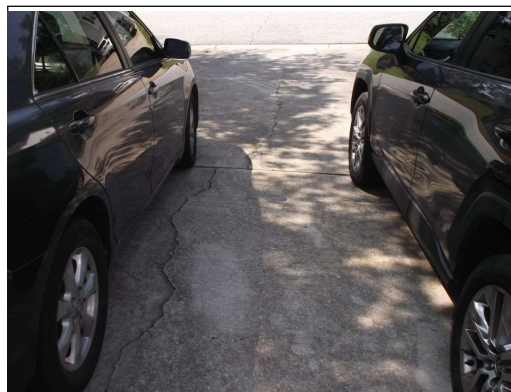
Moderate cracks in driveway

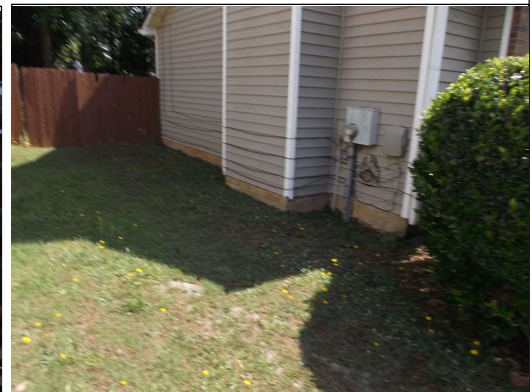
Soil slopes to the foundation left side

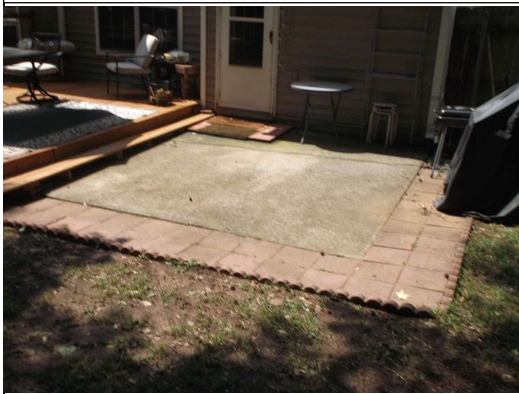
Patio crack and settling away

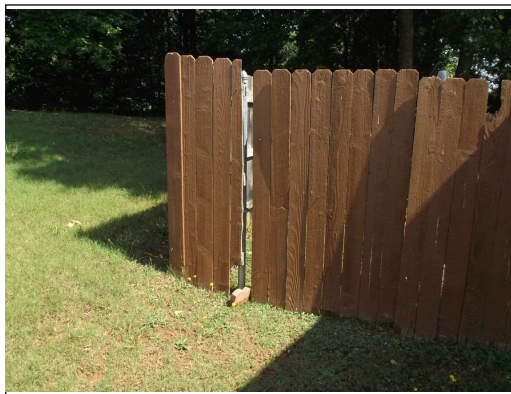
Fence wood damaged

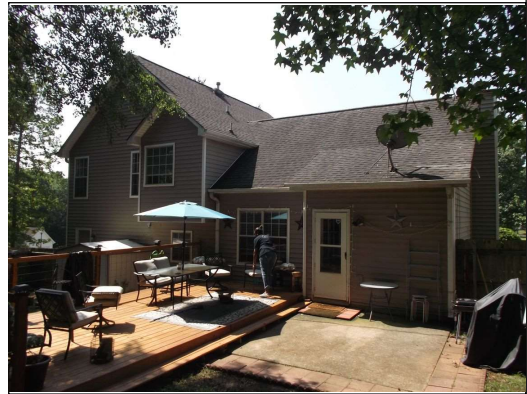
Wood deck do-it-yourself

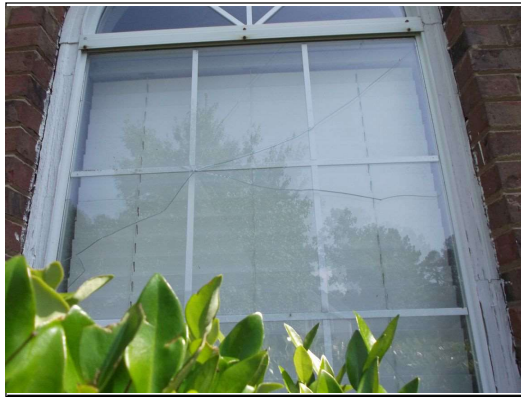
Window glass broken

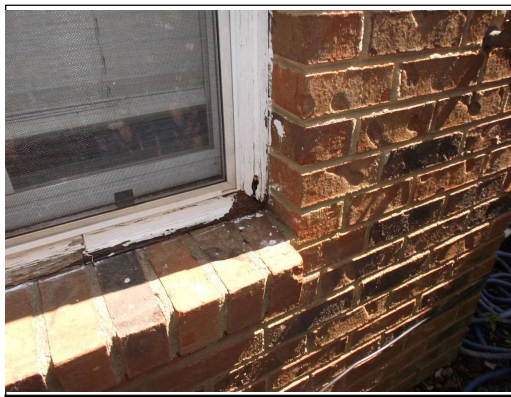
Rot at front window frame

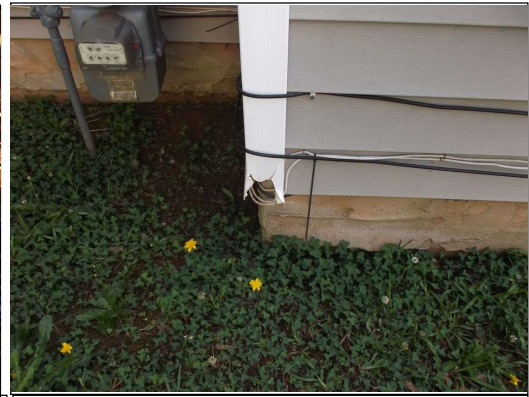
Siding damage some areas

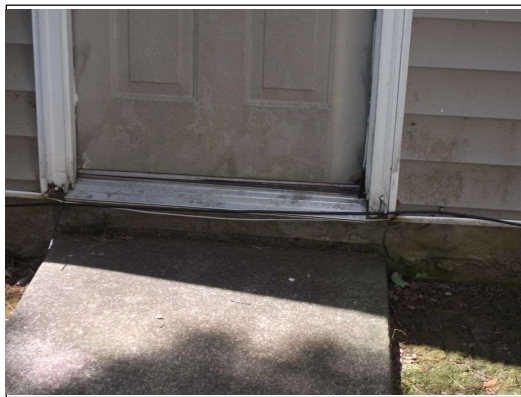
Rear doors rot and water damage

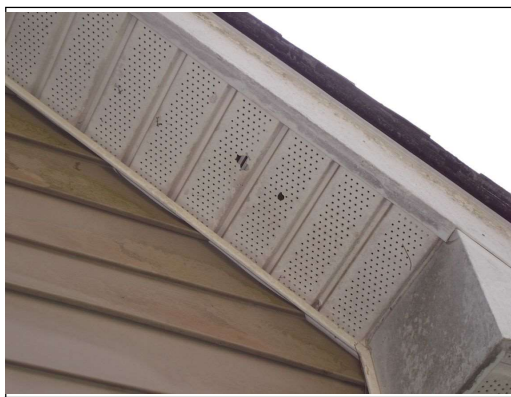
Holes in vinyl soffit left side

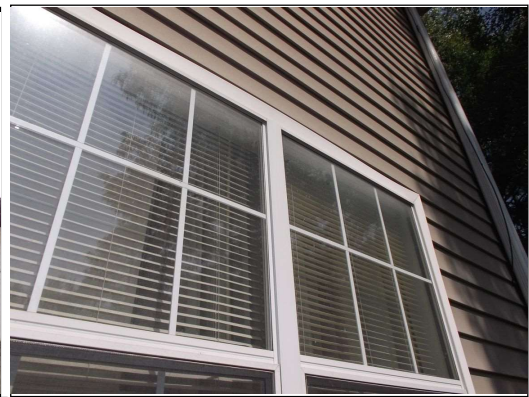
Window glass fogged at front of the house

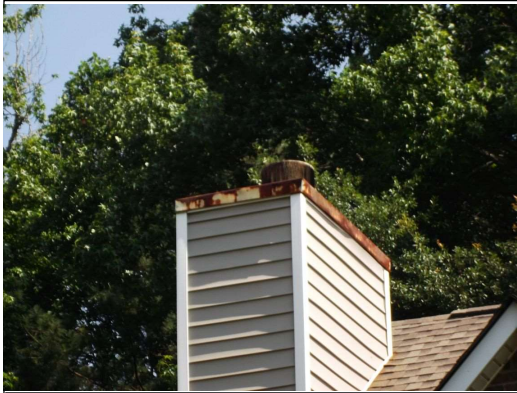
Chimney cap rusting and needs painting

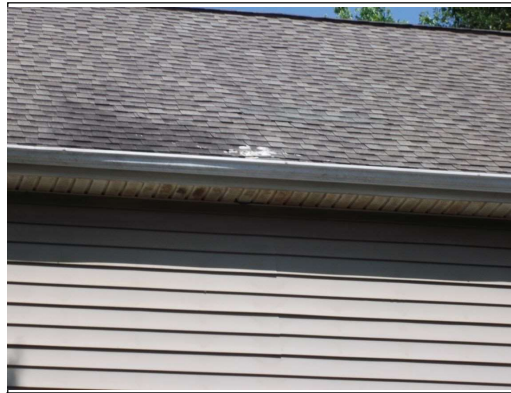
Shingle appears patched at the right side

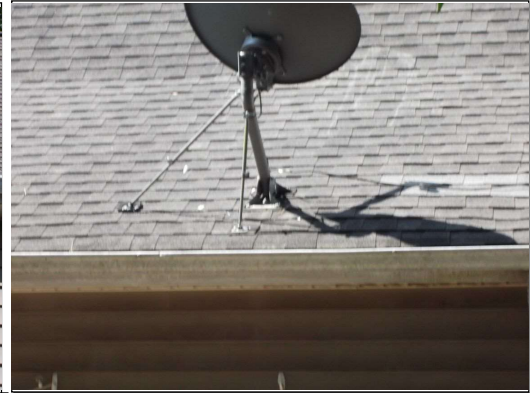
TV dish bolted to the roof can cause leaks

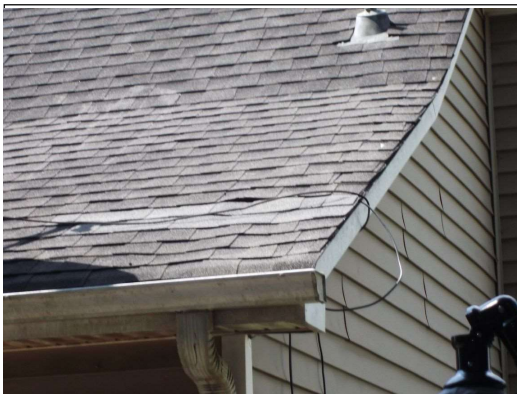
Shingle repair/waves in roof decking

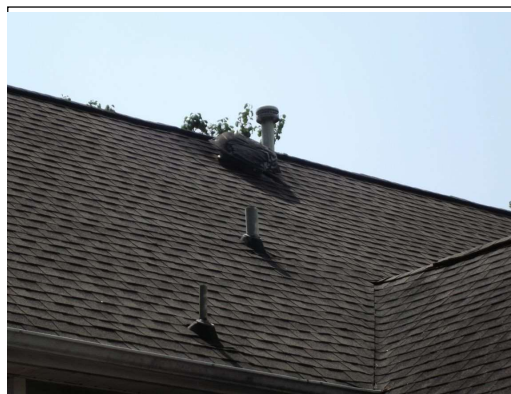
Pipe flashing on top shingles face nailed

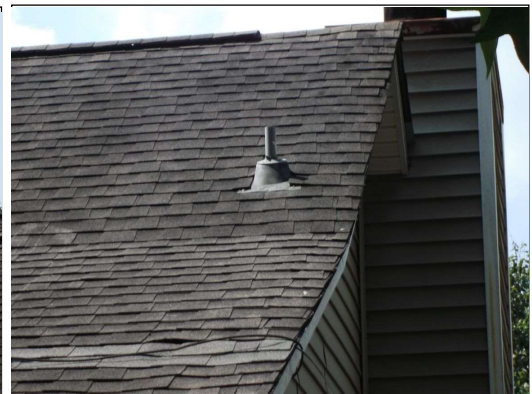
Flashing on top shingles face nail at bottom

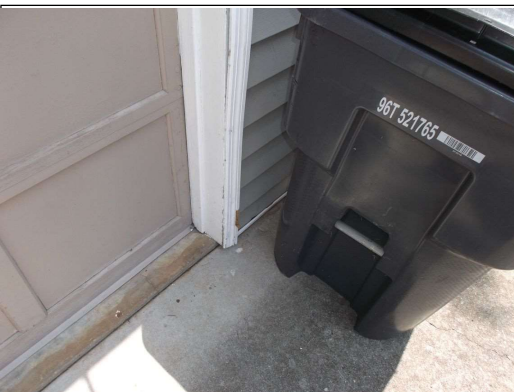
Vehicle door trim damaged wrong type

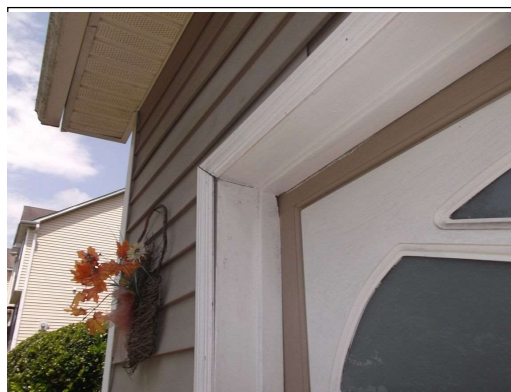
Door trim detaching

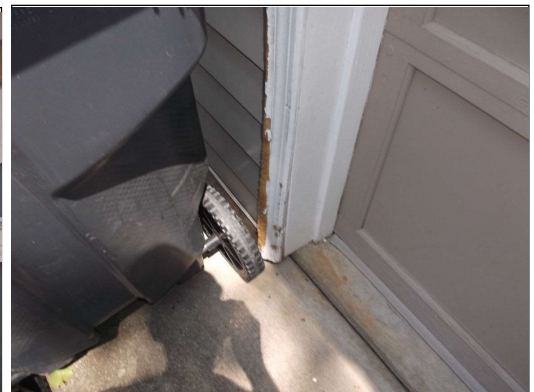
Water damage to door trim

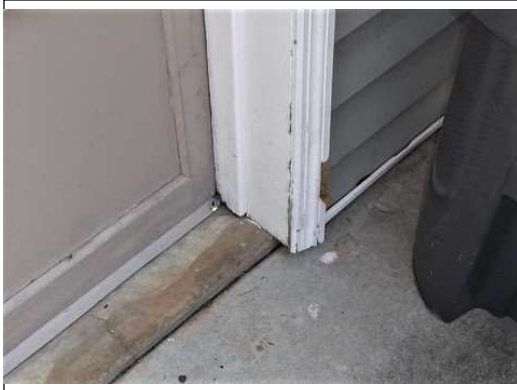
Door frame contact the concrete floor

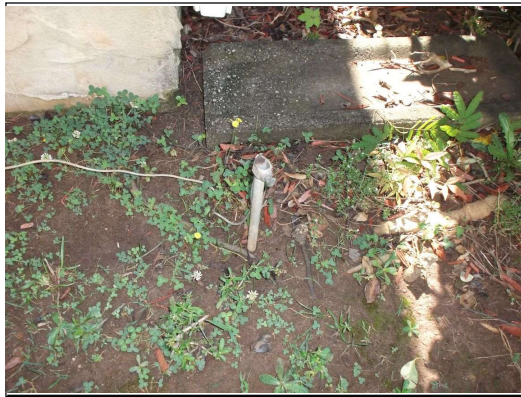
Ground rod not driven all the way in ground

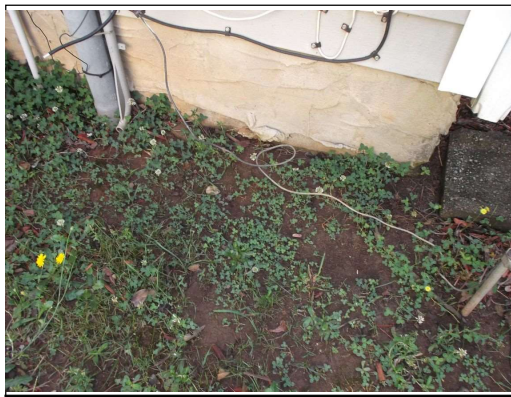
Ground wire not strapped to wall

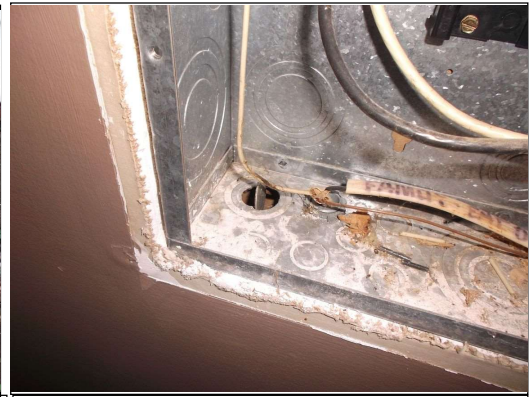
Hole in bottom of panel box can let sparks out

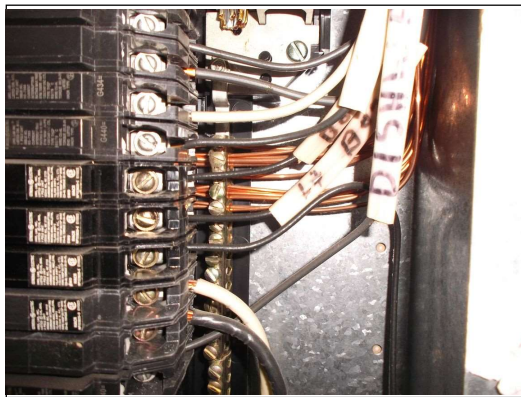
Ground wires bunched under 1 screw

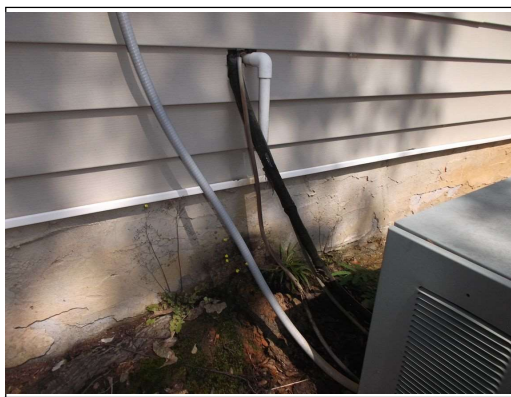
AC electrical conduit not strapped to wall

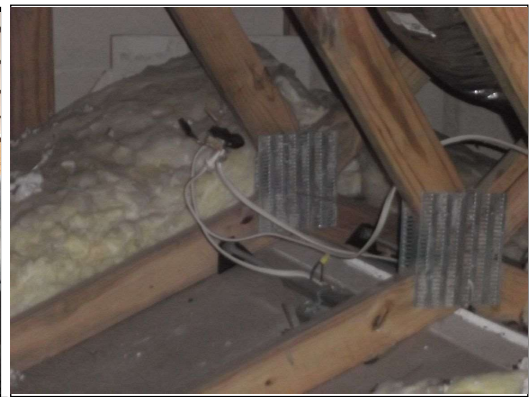
Exposed wire connections in attic

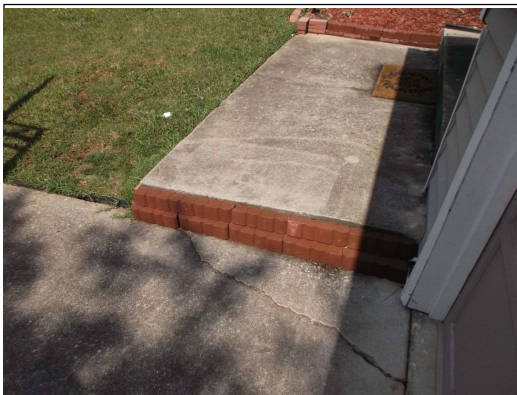
Water pipe under stacked bricks at walkway

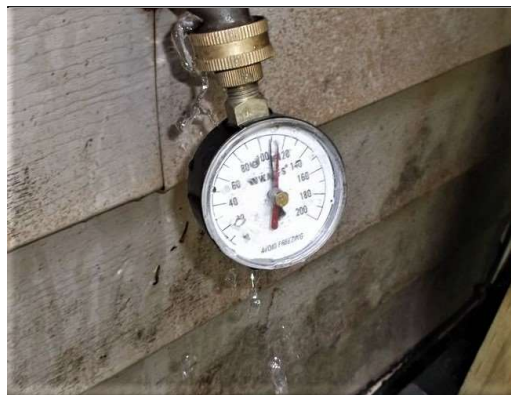
Water pressure 109 psi is too high

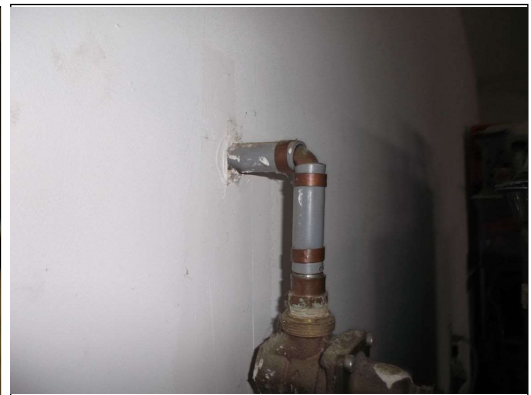
Gray plastic Polybutylene water pipe

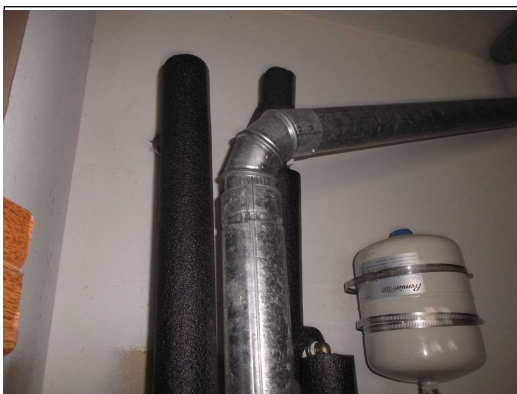
Water heater gas vent pipe wrong way

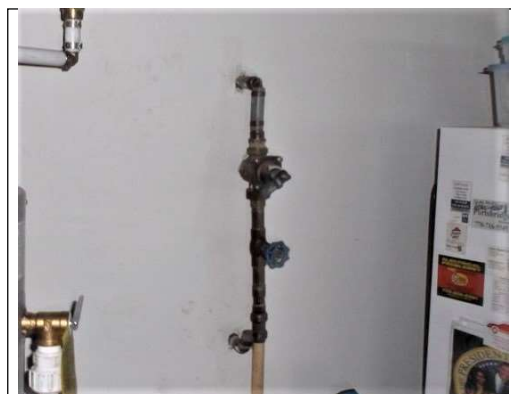
Verify pressure regulator valve not defective

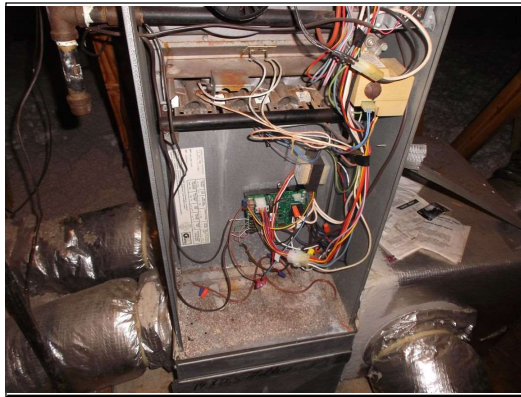
Slight rust and debris in furnace

It is advised to have a certified HVAC company check, service and repair conditions and maintenance;

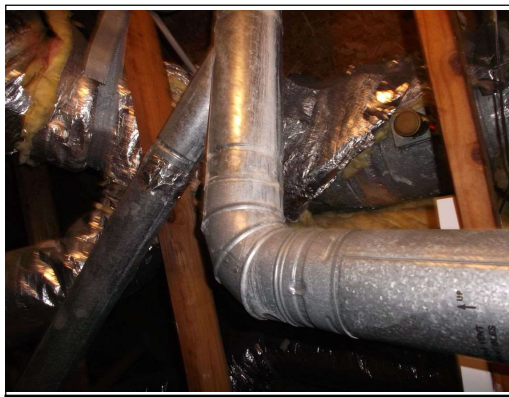
Corrosion on gas vent pipe

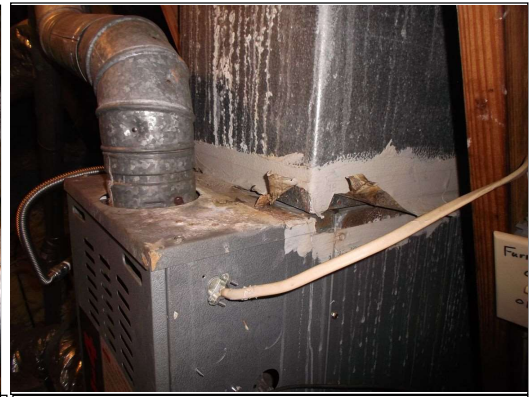
Sealant and duct tape detaching

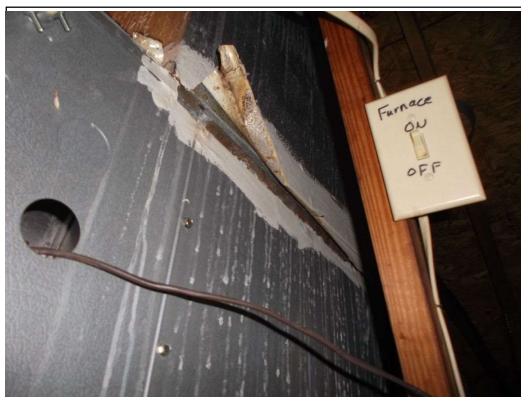
Duct tape & sealant detaching at air handler

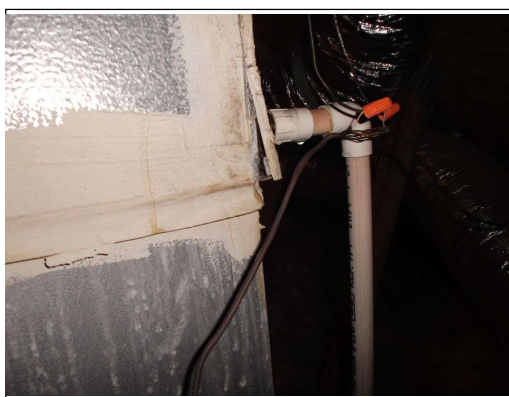
Duct tape detaching at air handler

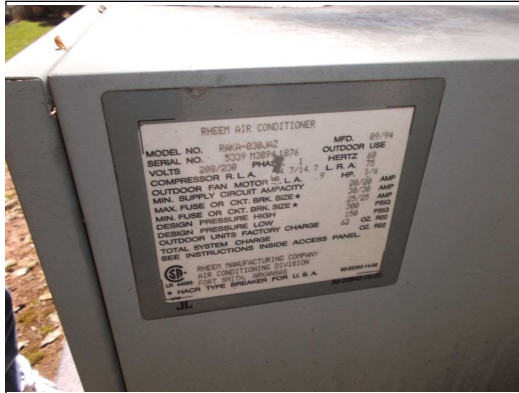
AC date 1994

It is advised to have a certified HVAC company check, service and repair system as needed for maintenance before closing (AC systems last about 19 years)

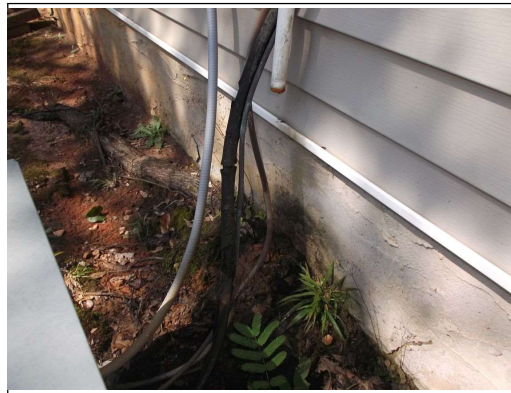
Condensate dripping at the foundation

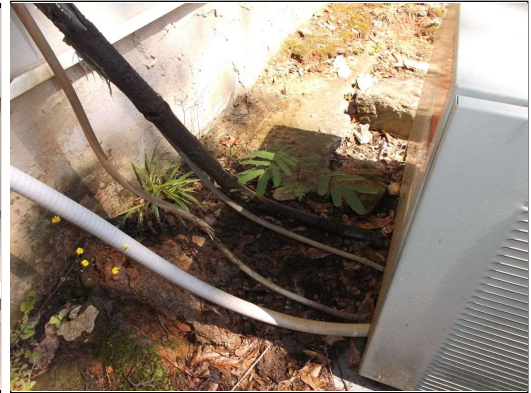
Refrigerant line insulation deteriorated

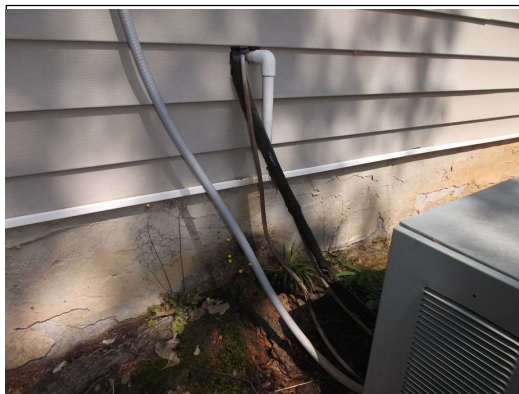
Electrical conduit not fastened to wall

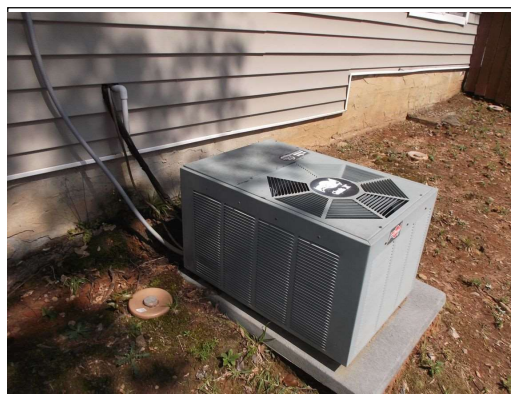
AC unit buzzing while operating

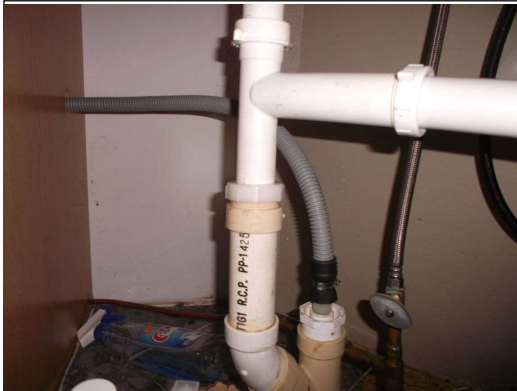
No trap nor vent in sink drain pipe

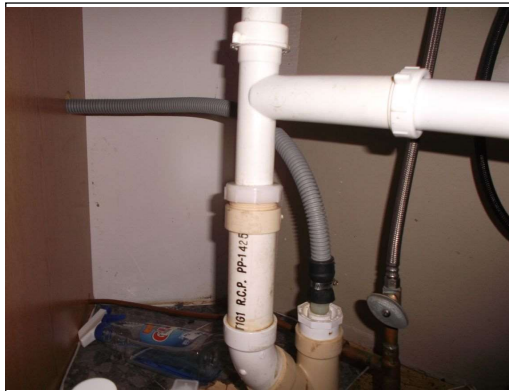
Dishwasher pipe not hi looped up to counter

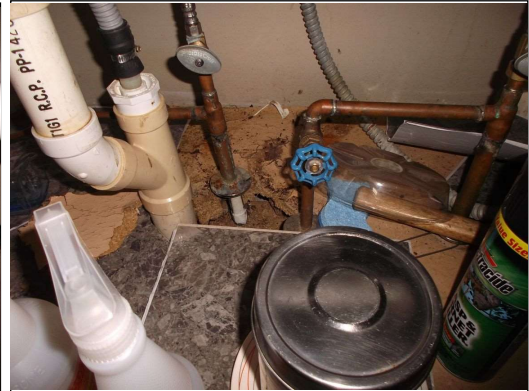
Sink cabinet floor rotted

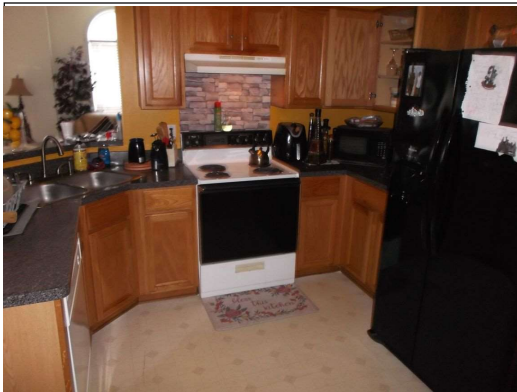
Some cabinet doors not fully self closing

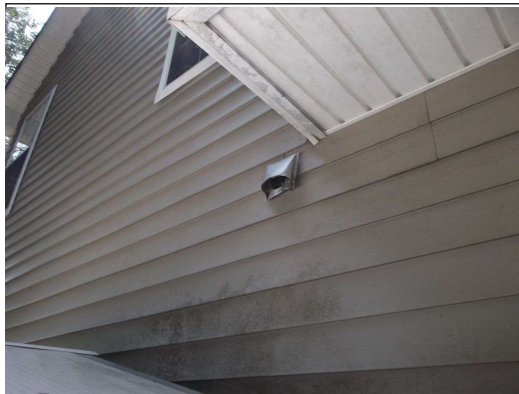
Dryer vent terminal missing door flap

Dryer exterior wall vent terminal missing door flap (replace)

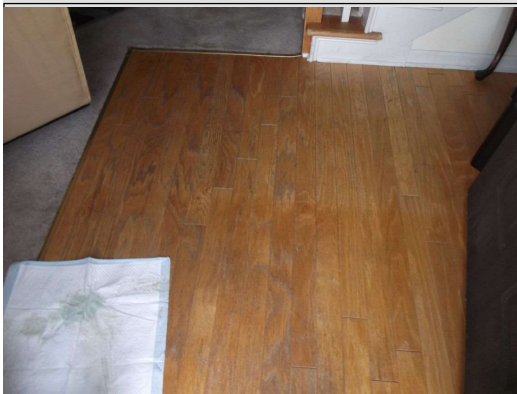
Wood flooring finish worn at front door

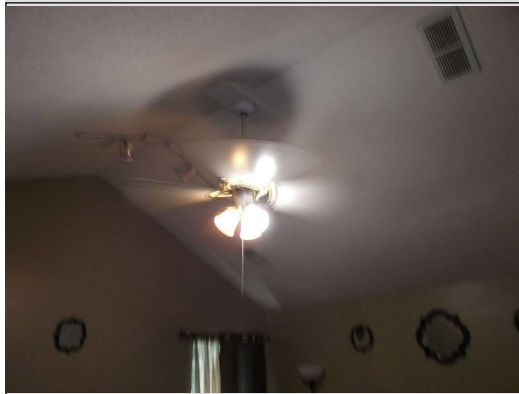
Master ceiling fan wobbles

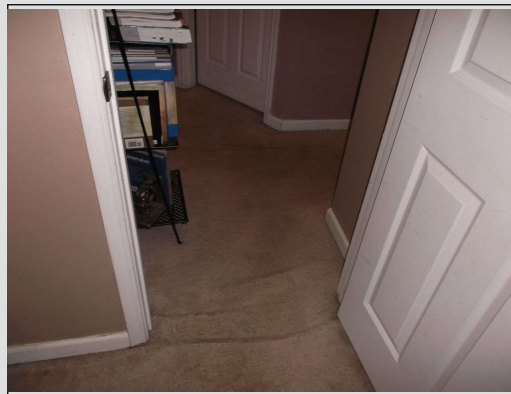
Master floor squeaks and hall carpet soiled

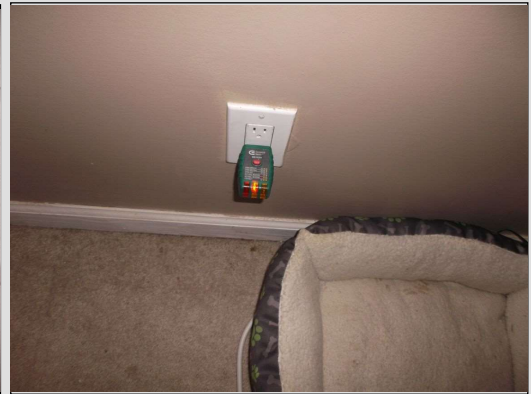
Outlet tested open ground

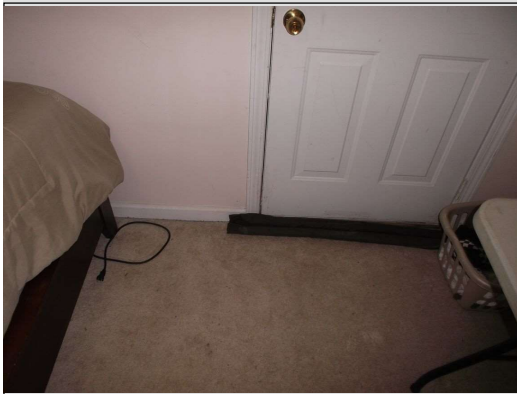
Daylight at the rear exterior door

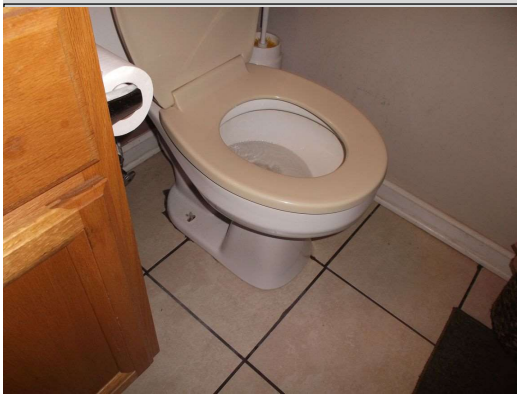
Toilet loose at the floor/no caulk

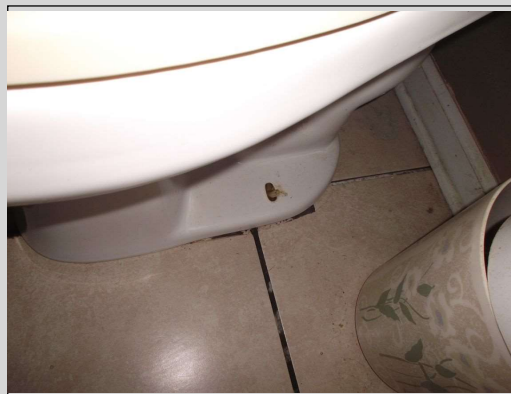
Missing bolts at screws

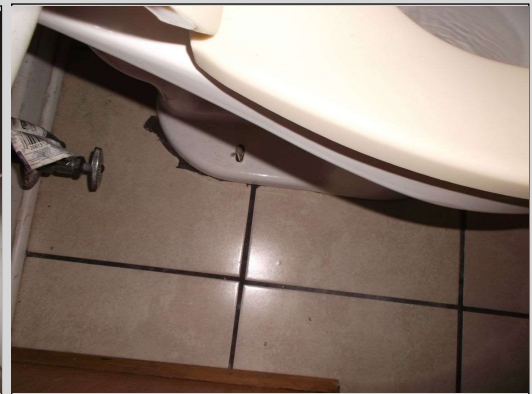
Missing bolts at screws

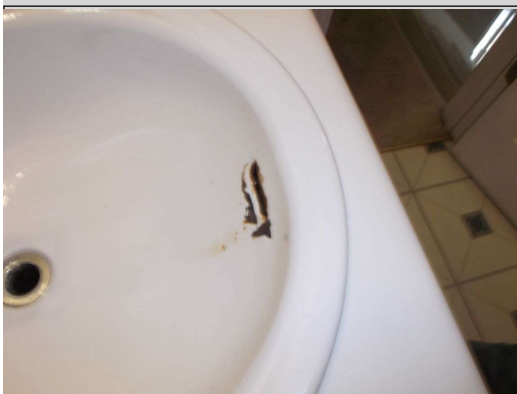
Rust at sink and stopper missing

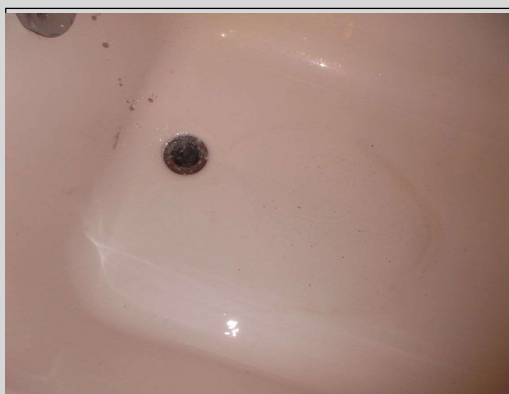
Missing stopper, rust, stains in tub

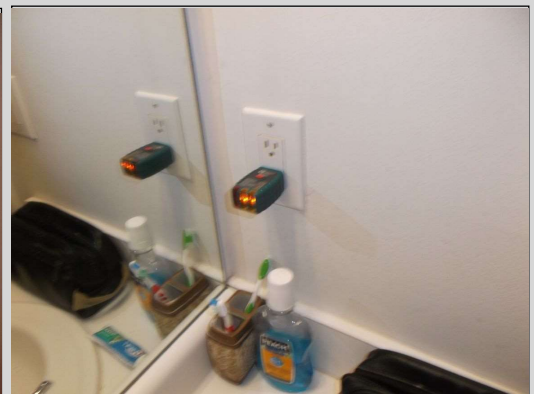
Outlet did not trip when tested

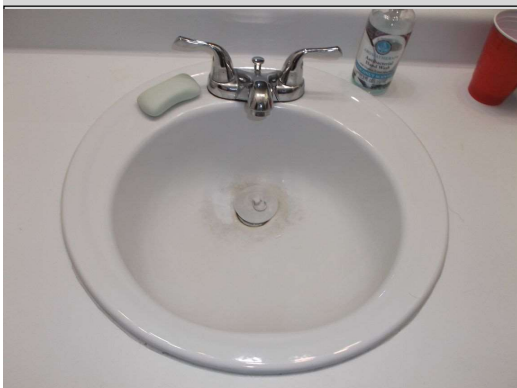
Stains in sink and stopper missing

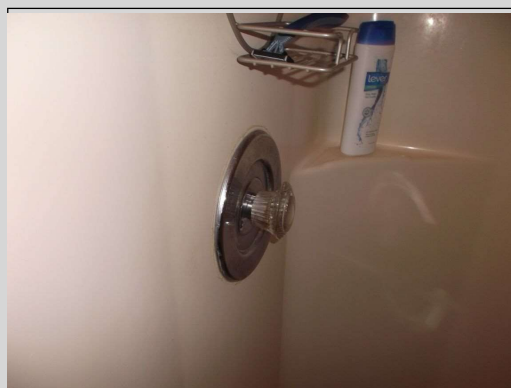
Shower faucet loose in the wall

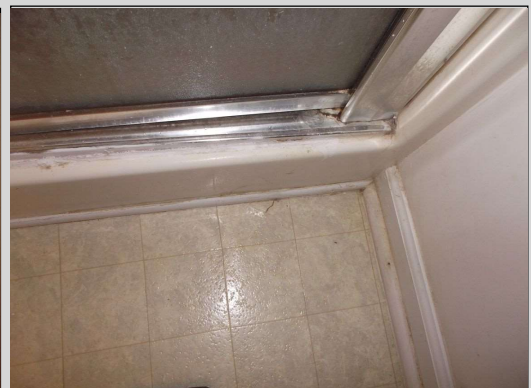
Excessive caulk at shower door and curb

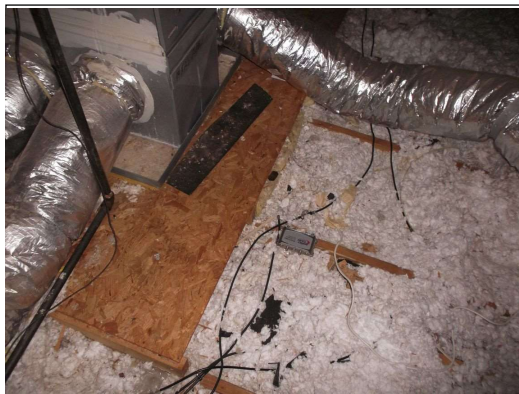
Missing floor at entry and to furnace

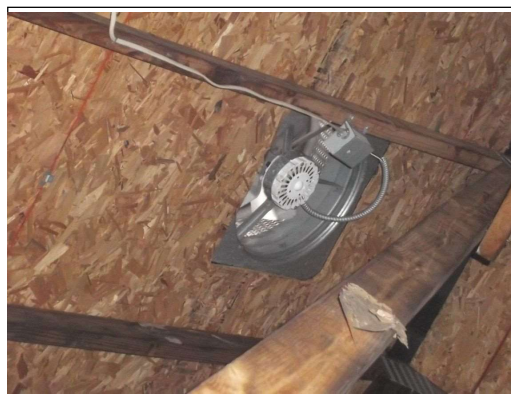
Exhaust fan not operating

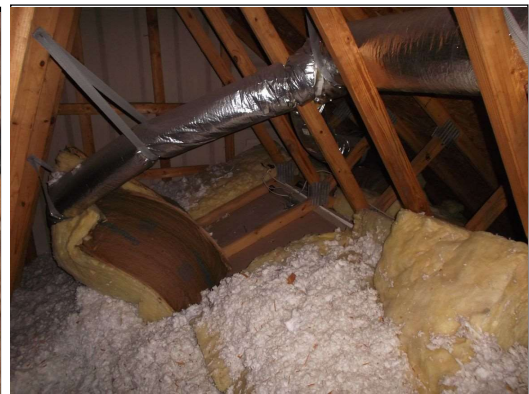
Insulation pulled back

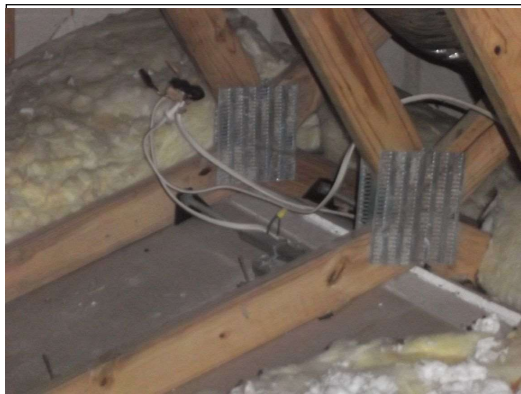
Exposed wire connections in attic
