# Property Inspection Report

60 Hollinger Way, Marietta, GA.

May 5, 2021

1599

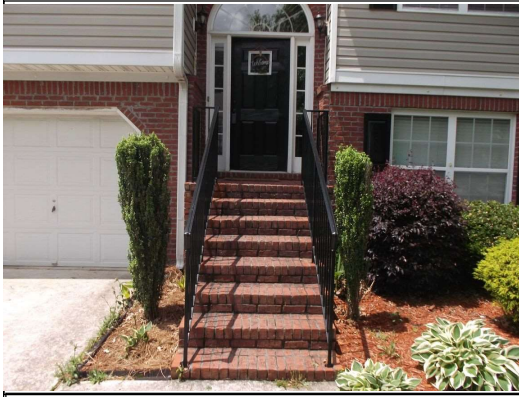
The front stair railings are loose in the brick; there are ants entering the home at the front porch and going under the front door threshold; there is dog damage to the wood deck stair guardrails; the wood deck floor slopes to the house door (house floor slopes to the door to the deck also at this area); the right exterior hose faucet did not have water; the wood deck floor is connected to the house cantilever floors which is not allowed (must be support posts under the cantilever floor corners; some wood deck support posts in contact with the soil can cause rot; there is defective flashing and gaps in the flashing where the deck floor connects to the house (can allow water to get into the wall space);

Front stair railing loose

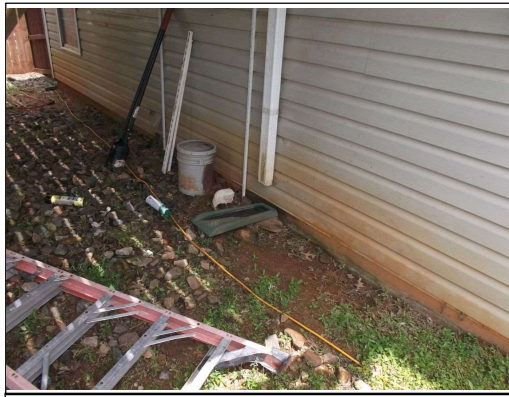
The soil grading at the rear of the home and at the left side has poor slope away from the foundation and soil water logged at the rear foundation areas and at the left side of the house; the water table is very high at the rear of the foundation and at the left side of the house and can see standing water in the ground; the wood deck support posts are not notched and bolted to the deck floor rim joists; missing handrails at the rear stairs;

Soil very wet under deck/poor soil slope away

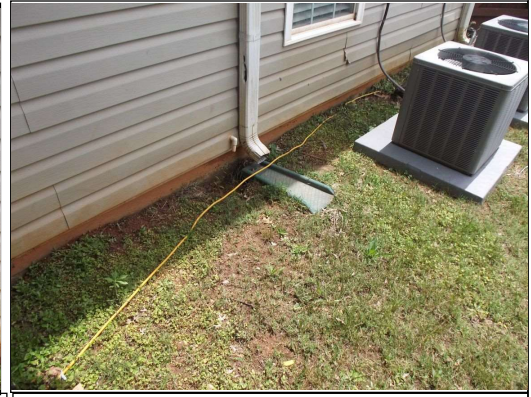
Water in ground at AC area/poor slope away

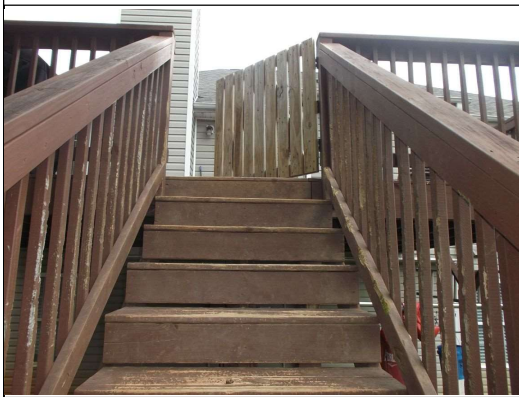
Deck railing has dog damaged

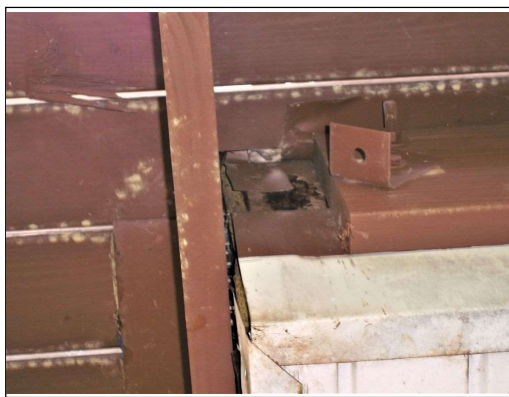
Defective deck floor-to-wall flashing

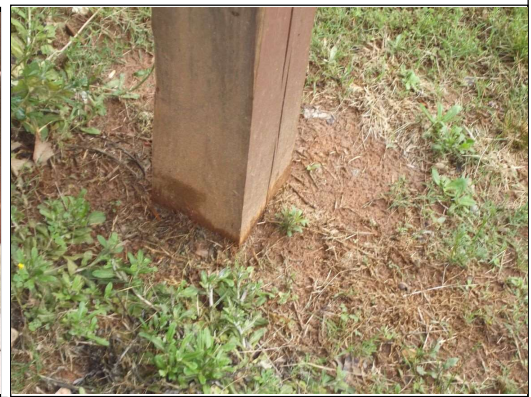
Deck posts contact soil

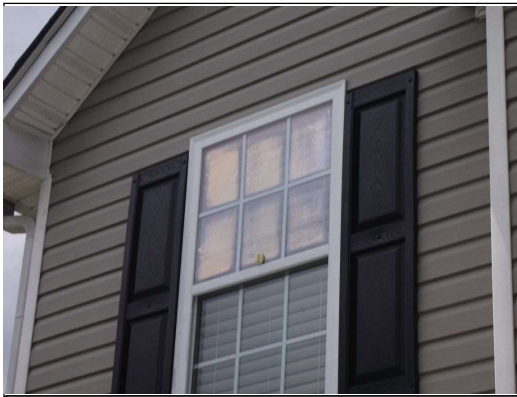
Glass fogged

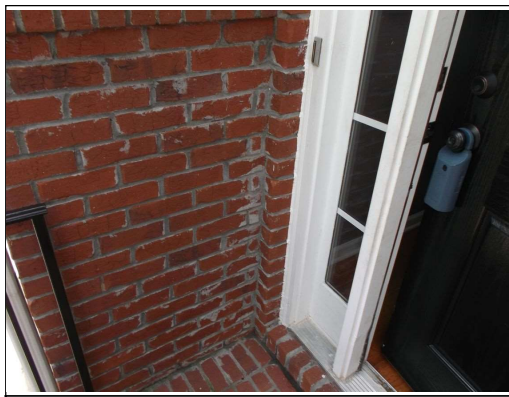
Fresh mortar at several brick areas at front

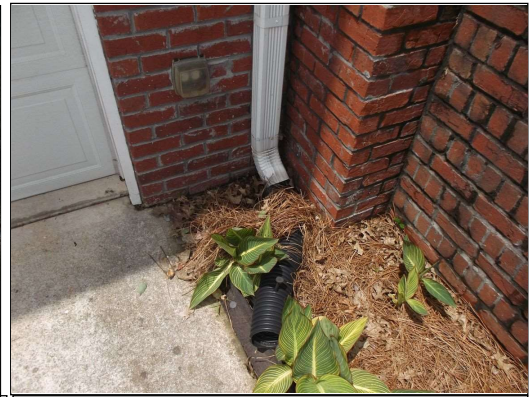
Downspouts pour in the soil

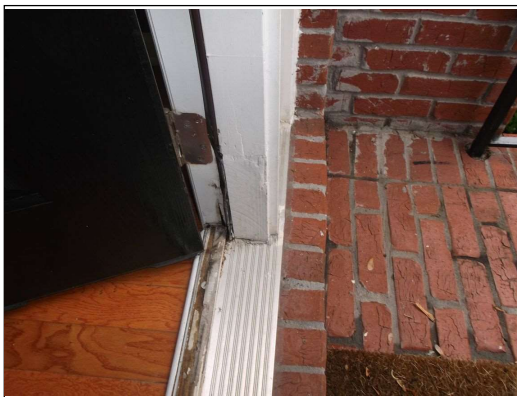
Front door frame has defective repairs and water damage at the bottom; window glass broken at the upper front right windows; upper front left window fogged; the water meter was turning at the time of the inspection (verify there are no water leaks); the water meter box in the ground is crushed by the soil; several window screens are worn and damaged; front brick at the front porch appears to have fresh mortar at several areas and also at the garage (verify were there settling cracks that were filled); downspouts pour at the foundation at several areas; missing downspout elbow at the rear of the home under the deck; downspouts should be routed 4 feet from the foundation at all areas; siding damage a the rear of the home at the deck floor and at the lower siding panel at the rear of the home;

Defective repairs & water damage front door

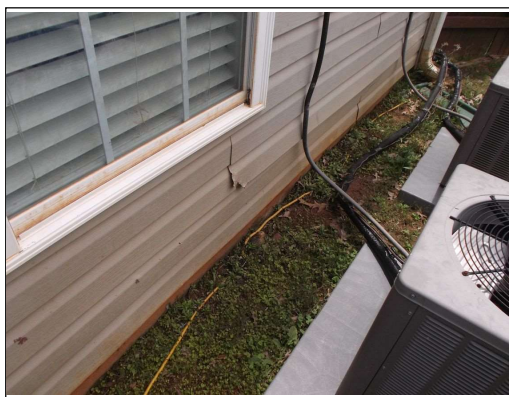
Damaged siding several areas at rear

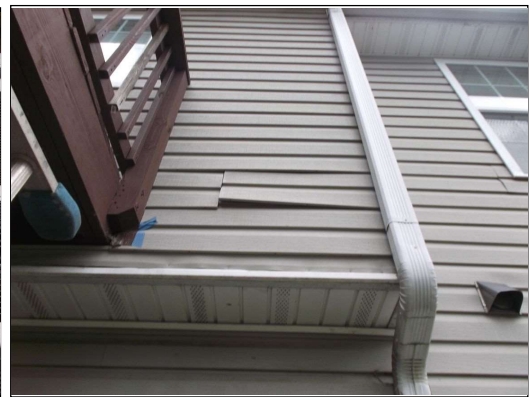
Detaching siding some areas and at deck

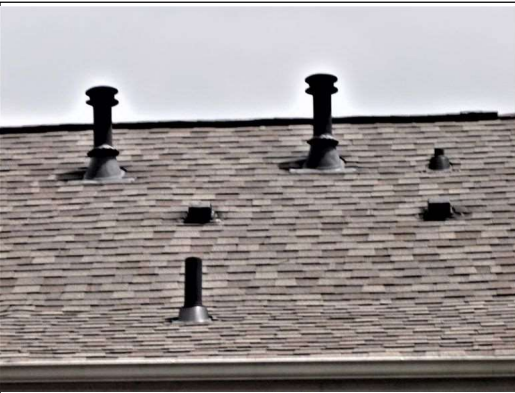
**Maintenance:**  
 Vent and pipe flashing has been installed on top of the shingles and face nailed at the bottoms can cause leaks over time (there should be no no nails and no exposed nail heads showing at the bottom flange of the flashing and any nails should be on the side flashing covered with the shingles); gutter downspouts pour at the rear foundation and missing elbow at one downspout (can erode soil and cause floor settling)

Pipe & vent flashing face nailed

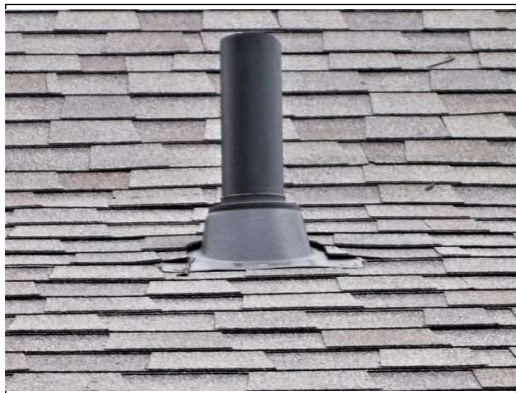
Pipe flashing on top of shingles face nailed

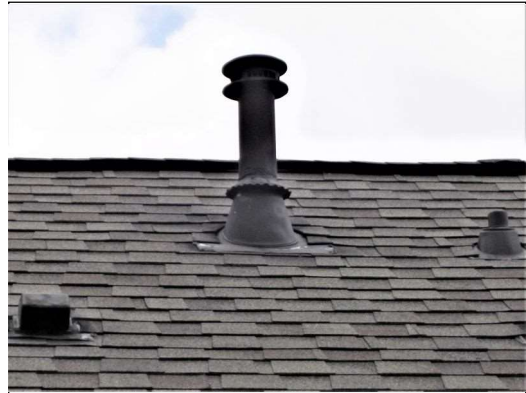
Vent flashing on top shingles face nailed

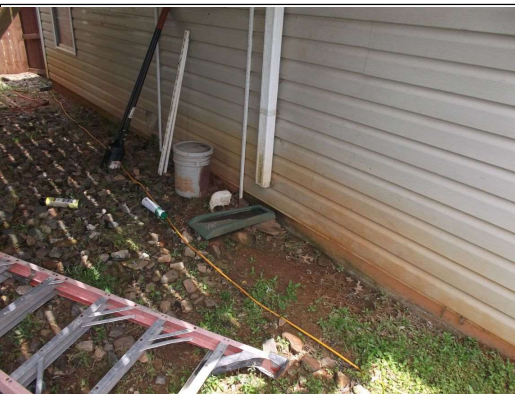
Downspouts pouring at the rear foundation

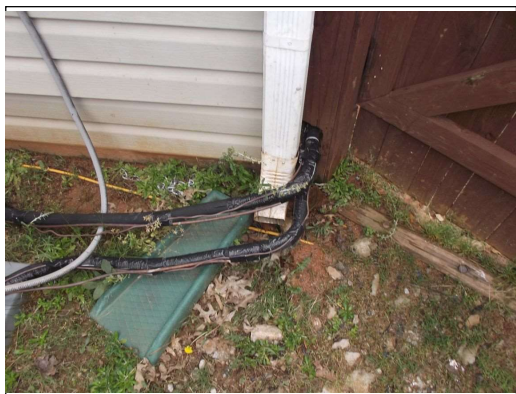
Downspout pours at the rear foundation

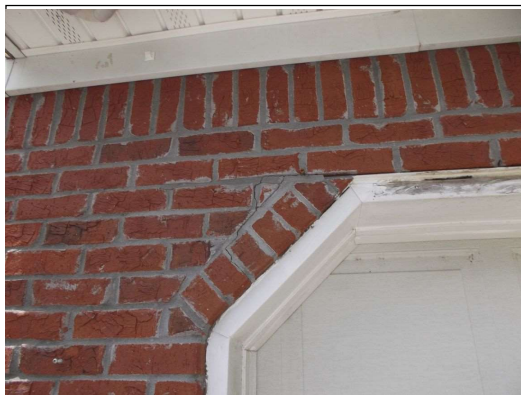
There are settling cracks in the brick veneer mortar at the top of the garage door; the vehicle door frames appear to be in contact with the concrete floor can allow termite entry and absorb water if there is no air gap between wood and concrete floor;

Cracks in brick mortar above vehicle door

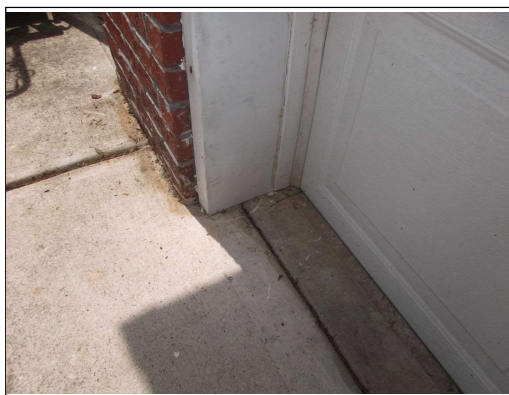
Vehicle door frame contact the concrete

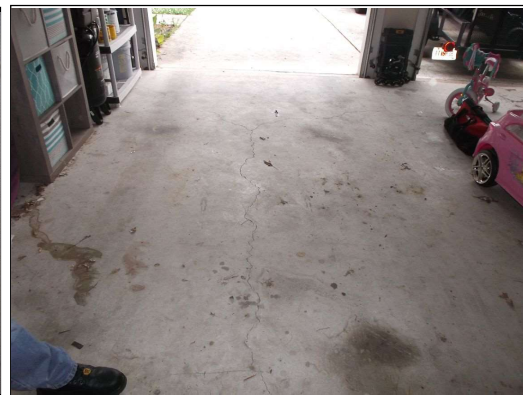
Cracks in the floor and oil stains in finish

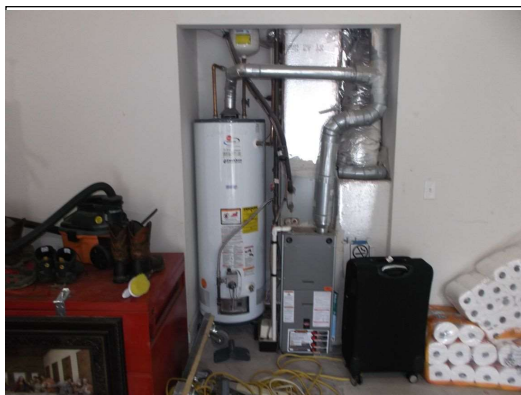
Water heater is not raised 18 inches above the floor can be a fire and explosion hazard under certain conditions;

Water heater not raised 18 inches off floor

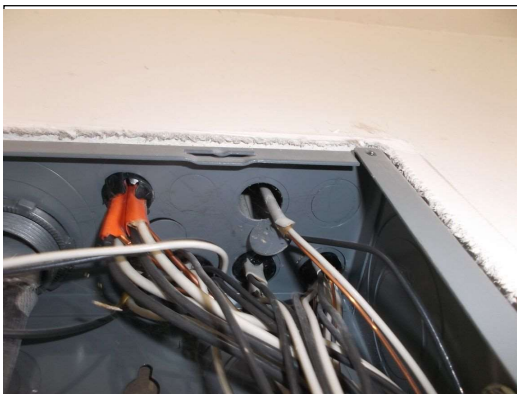
At the garage there is a electrical cable entering a hole in the top of the distribution panel in contact with sharp metal and the hole is missing a bushing (safety hazard); There is a hole in the top of the distribution panel where the cable enter that can let sparks escape into the wall space and can be a fire safety hazard; the rear exterior outlet at the deck door did not trip when tested with the device; AC electrical conduit is not clamped to the exterior wall to prevent movement can be damaged;

Cable contact sharp metal is safety hazard

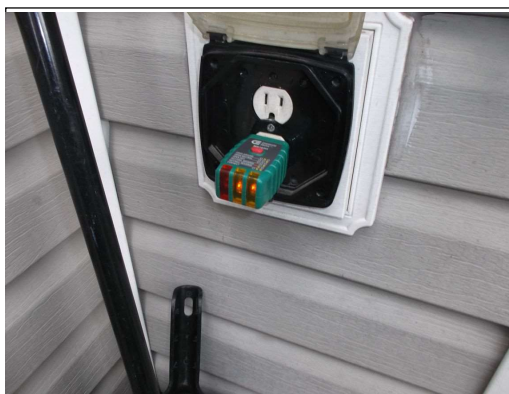
Deck outlet did not trip when teated

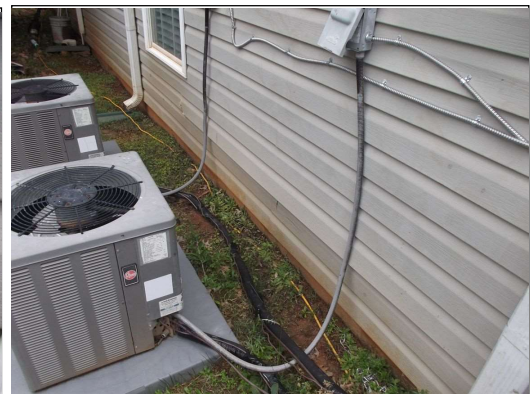
AC conduit not clamped to wall

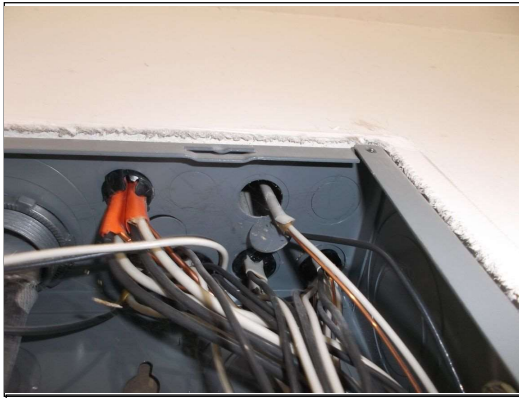
Hole in panel box can let sparks escape

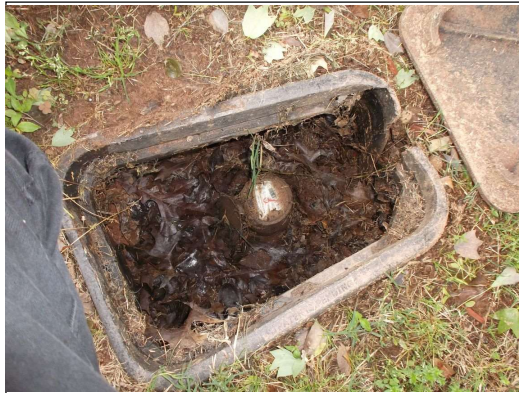
Water meter dial was turning

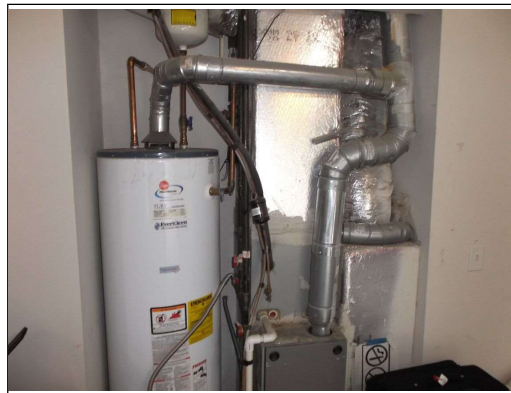
gas vent pipe slopes downward

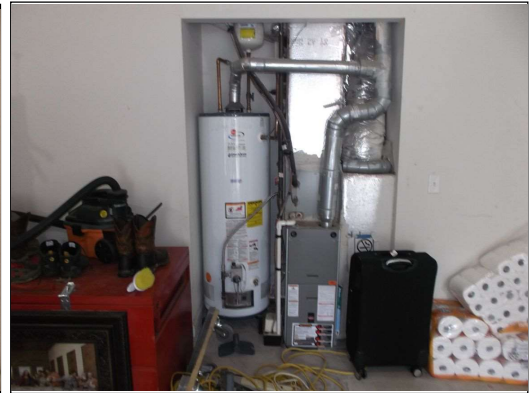
Water heater not 18 in. above garage floor

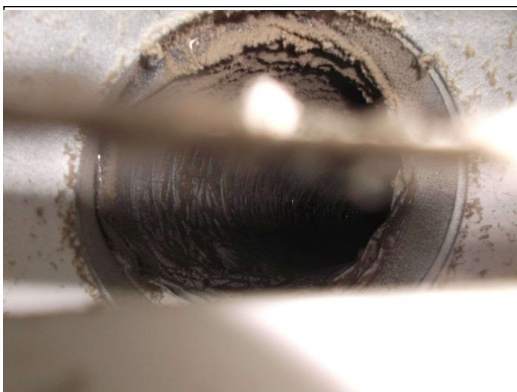
There is excessive dust in the air ducts at various areas (it is advised to have air ducts cleaned for health and safety); the garage gas vent pipe has improper slope in the attic; there is rust on the top of the attic furnace;

Air ducts are dirty

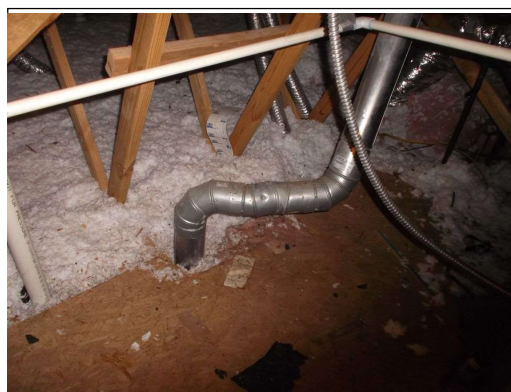
Improper slope in furnace gas vent pipe attic

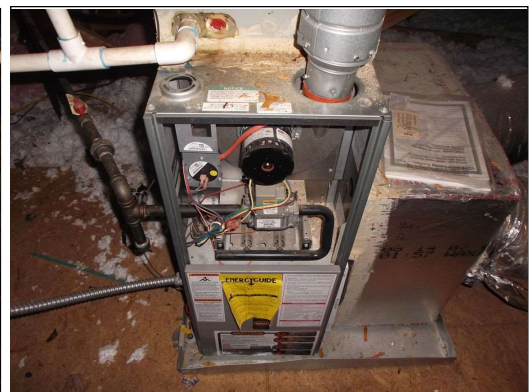
Rust on top of the attic furnace

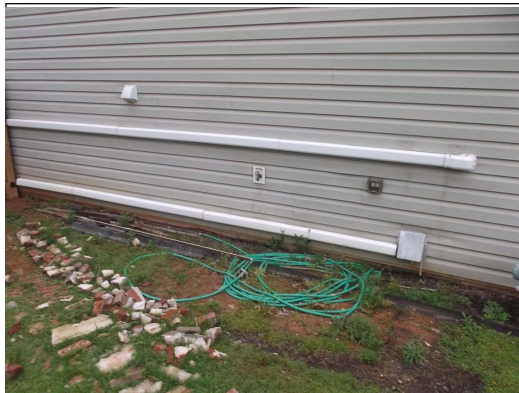
The AC units were originally installed on the left side of the house and have been relocated to the rear of the house; refrigerant line insulation missing where refrigerant pipe enters the hole in the siding on the left side of the house can sweat water into the wall space; AC units installed date is 2007 (AC units have a good life of 15 to 18 years (after this time may need ongoing repairs and parts and or replacement); it is advised to have a certified HVAC tech check and service both AC systems for service and operation before closing; condensate drain pipe pours into soil at the foundation and is not routed 3 feet away from the foundation;

AC units moved from here to back of house

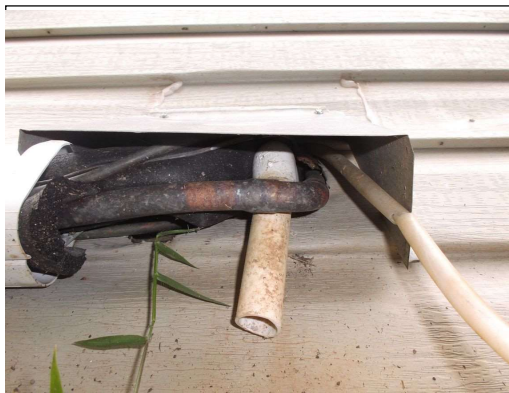
Missing refrigerant line insulation

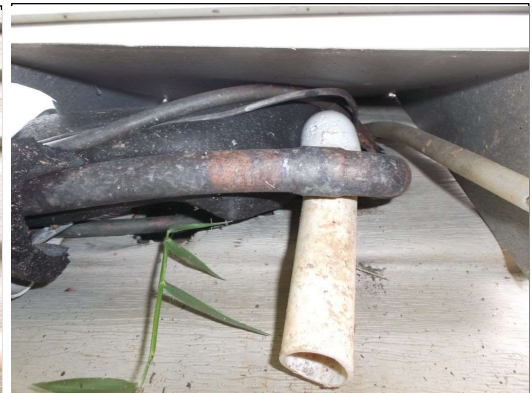
Condensate pipe pouring at siding into soil

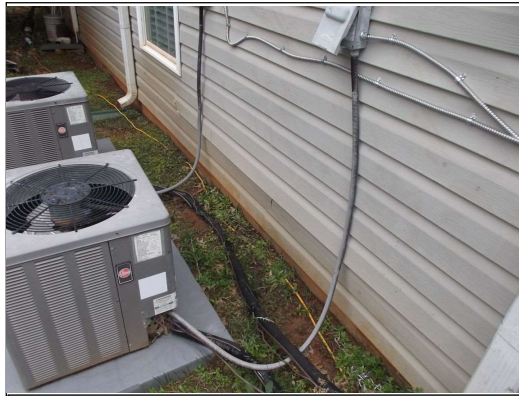
AC electrical conduit not secured to wall

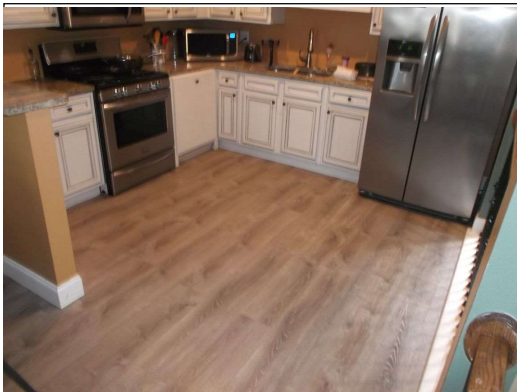
Floor slopes to the sink

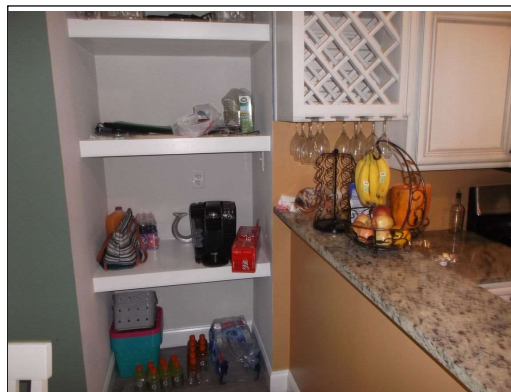
Light switch located in wrong place

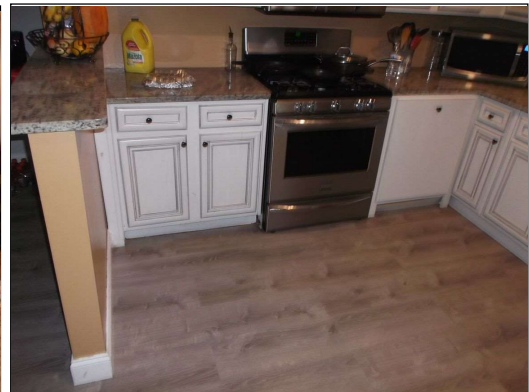
Floor settles at the stove and cabinet

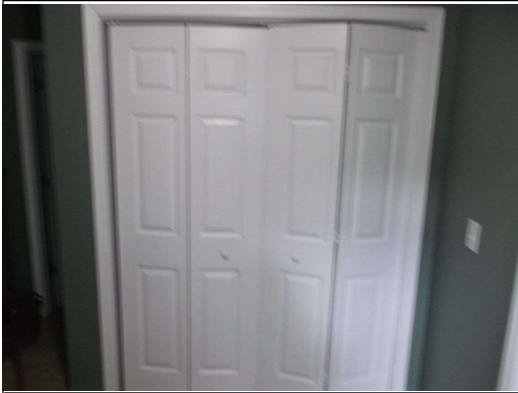
Doors to the laundry closet defective (needs adjusting and repair); light in laundry did not operate when switched on;

Laundry doors defective

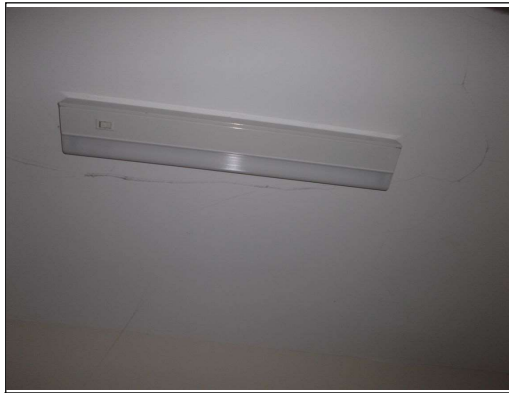
Laundry light not operational

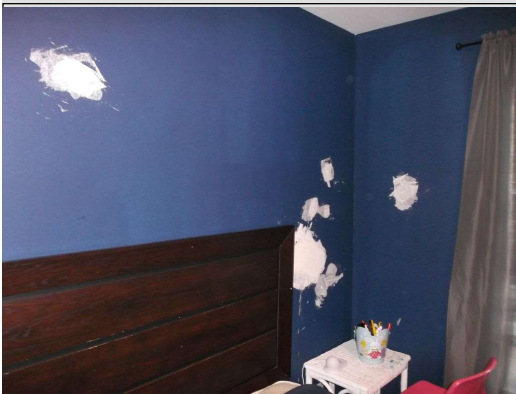
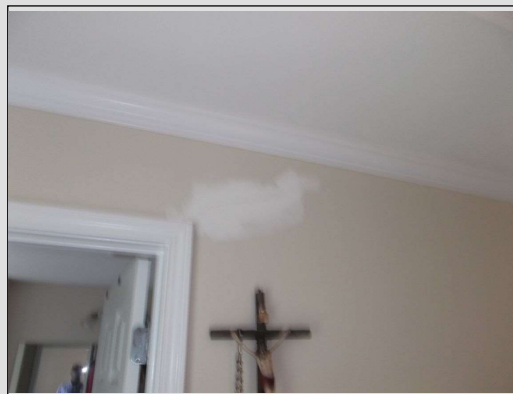
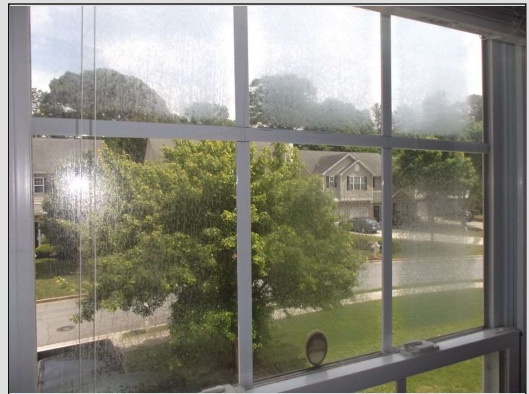
The carpet is soiled in several rooms; there is a settling crack in the wall of the master bedroom near the bath door; smoke alarms are detached in the ceilings at several areas; there are holes in walls at some bedrooms; window glass fogged at the front bedroom;

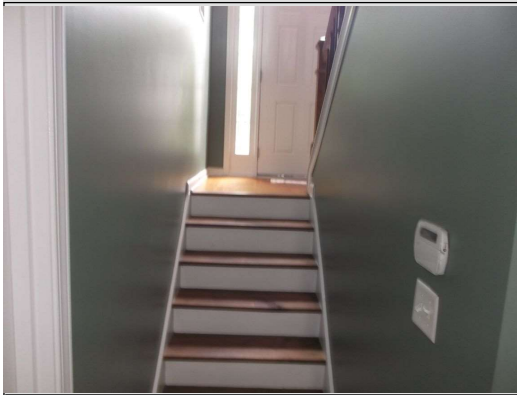
Lower Level: No handrail at stairs to lower level; rear bedroom ceiling has dry stains painted over (verify no active water leaks); door to the room under the kitchen was locked and could not access (buyer is advised to gain access to lower room under the kitchen and verify no issues and no conditions of concern; laundry doors have defective installation;

Missing handrail at lower level stairs

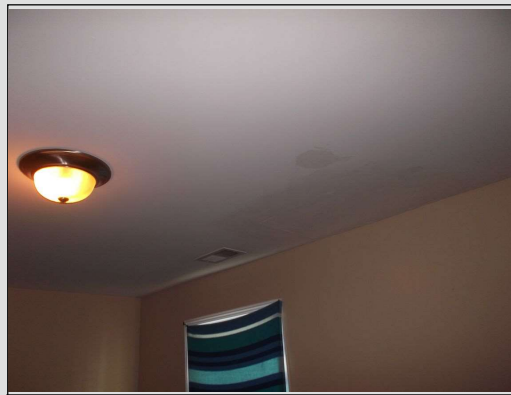
Dry stains in lower bed ceiling painted over

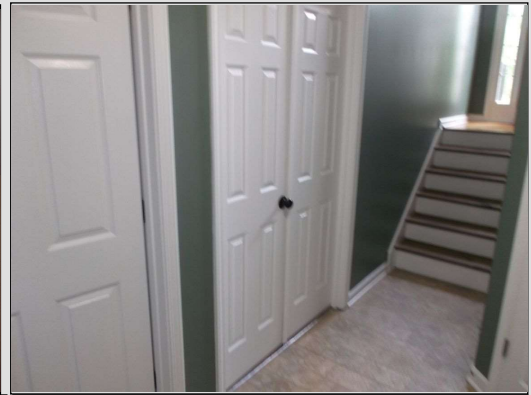
Door locked to room under kitchen

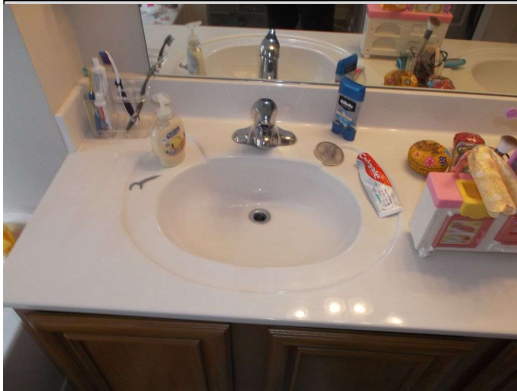
Hall bath sink stopper and tub stoppers missing; holes in ceiling near entry door;

Sink stopper missing

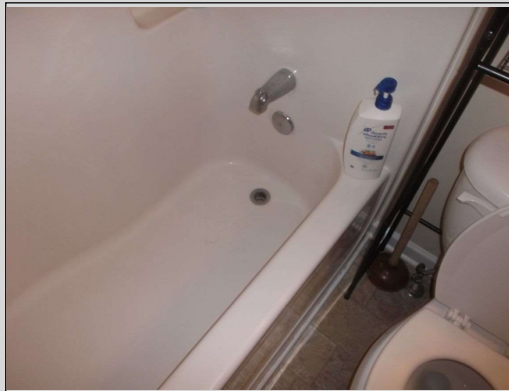
Tub stopper missing

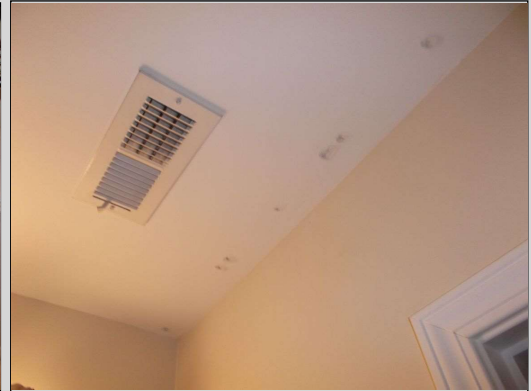
Holes in ceiling over door

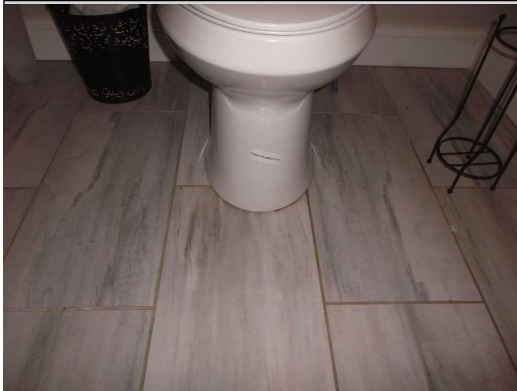
Lower Bed bath has no exhaust fan, missing caulk where toilet rest on the floor, dry stain on sink cabinet floor;

Missing caulk where toilet rest on the floor

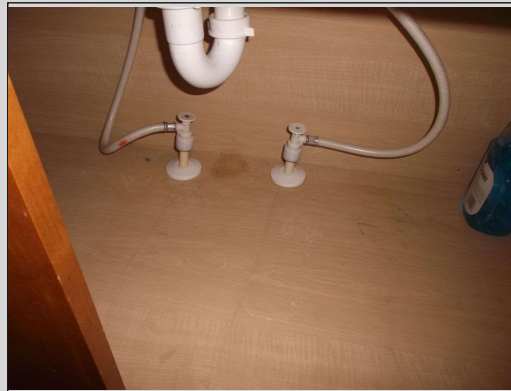
Dry stain on sink cabinet floor

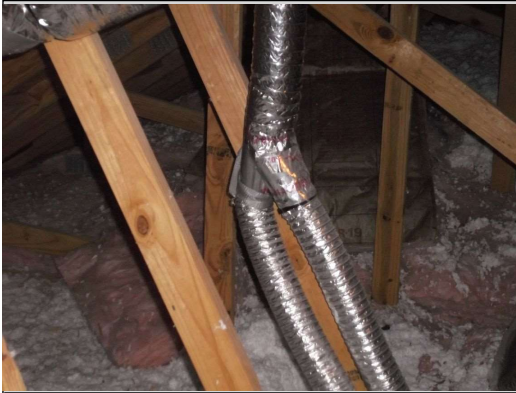
Master bath sink stoppers missing; bathroom exhaust vent pipes join to one pipe in attic is improper (each bath fan exhaust pipe shall exhaust to the exterior and have its own vent terminal on the roof, where two pipes join to one pipe air can blow back to the other bath and when both fans operating air discharge to the exterior can be restricted);

Two bath fan ducts join to one is improper

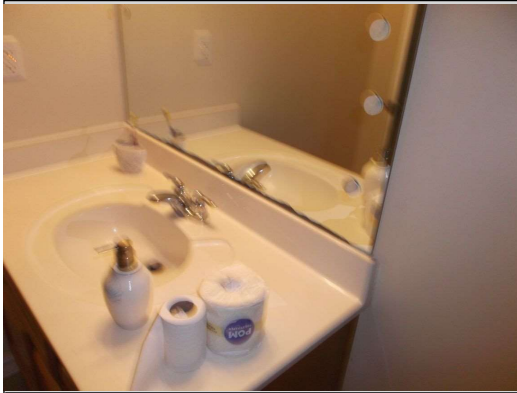
Lower hall bath has rust in the mirror and tub stopper missing

Rust in mirror

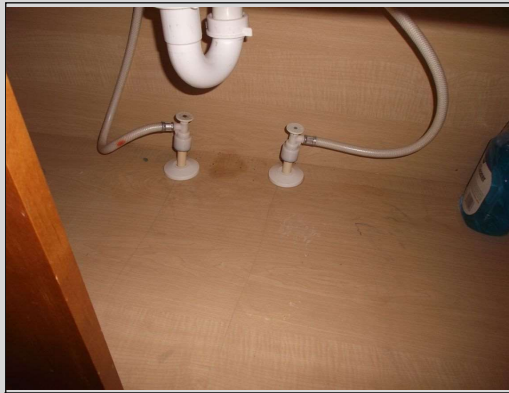
Stain on cabinet floor

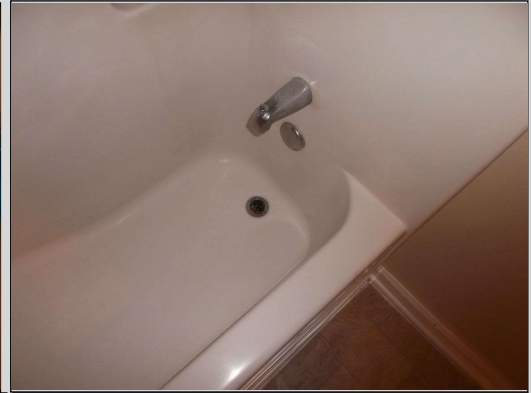
Missing tub stopper

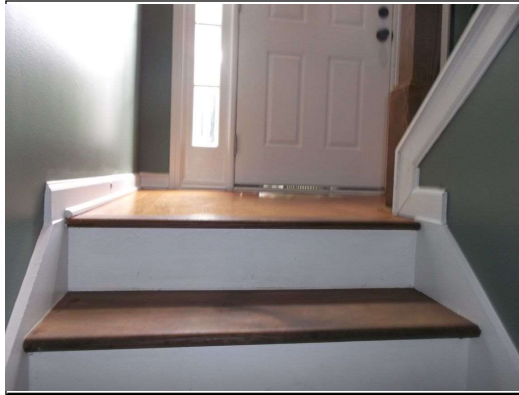
Daylight visible under front door (damaged and defective weather strip); missing section of ceiling insulation seen in the attic over the front bedroom;

Daylight visible under front door

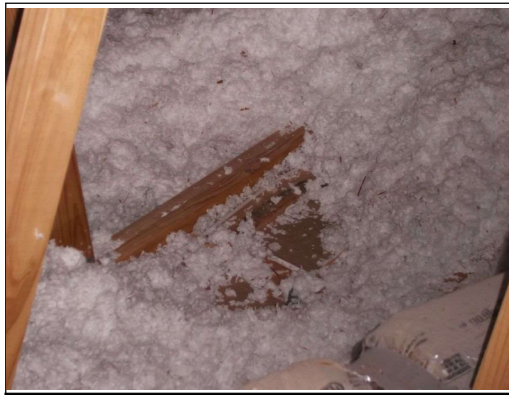
Missing insulation over front bedroom
