PROPERTY INSPECTION REPORT

3951 Glenhurst Dr. Smyrna, GA.

Oct 23, 2021

1599

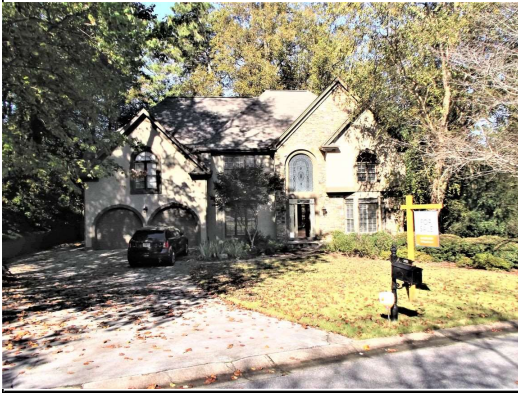
River birch tree planted close to house at the front right side is a large tree leaning which can have roots to uplift the foundation if keep growing or if the tree falls.

Driveway show slight signs of settling at the right side of the garage entry and can see soil eroded under the driveway where it joins the garage floor. Soil erosion under the walkway has caused it to settle too much down from the front porch stoop (can be a trip hazard when stepping up to the porch).

Right tree lean/soil slope to house/walk settle

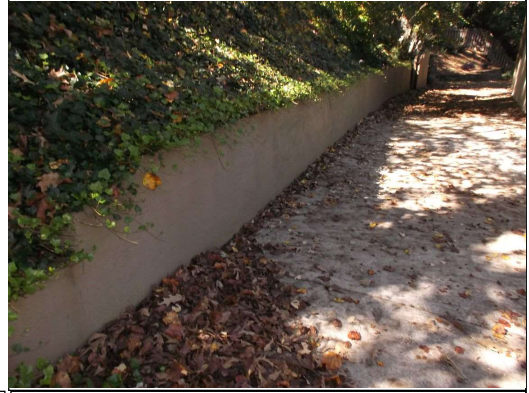
There are no holes in the retaining wall along the driveway (can cause water pressure and and erosion in the soils). Retaining wall timbers contact the foundation at the right corner of the house.

No holes in retaining wall

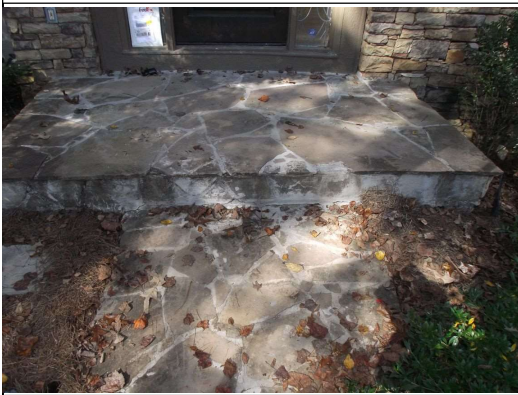
Front porch floor has loose stone on the left, soil erosion underneath, stones have had mortar repair and replacement (verify garage downspout is properly routed onto the driveway).

Porch stones repair, high step up

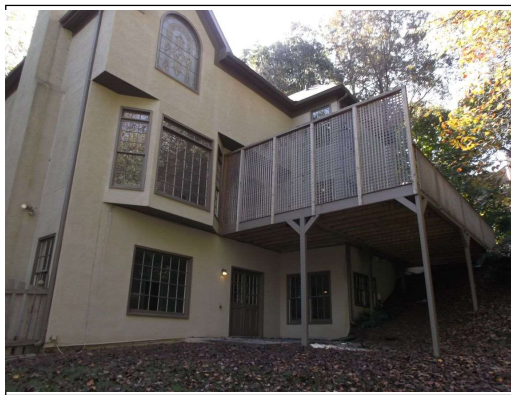
Wood deck support posts are not notched and bolted to the rim joists, support posts in the soil, missing joist hangers and wood wall or lattice panel not secured to the house.

Posts in soil, not notched, missing joist hanger

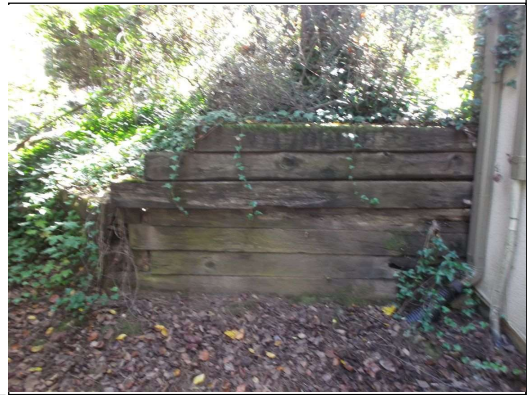
Soil has poor soil slope away at the front left of the front porch stoop. Soil slopes to the foundation at the rear of the house at the side of the driveway leading behind the chimney corner. Retaining wall imbers are rotting at some areas in the landscape. There are no drainage holes in the retaining wall along the side of the driveway.

Retaining walls deteriorating

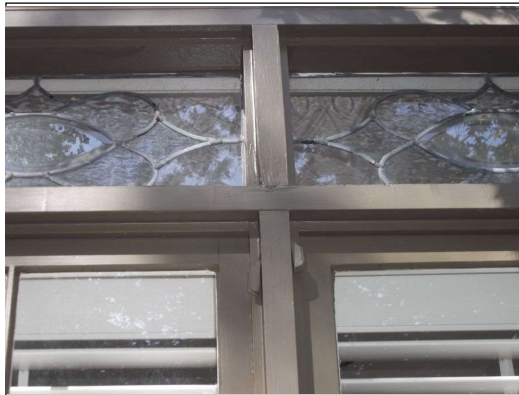
Water damage to living room window frame

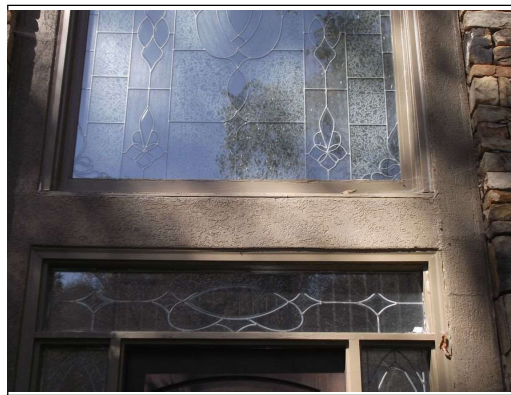
Water damage to foyer window frame

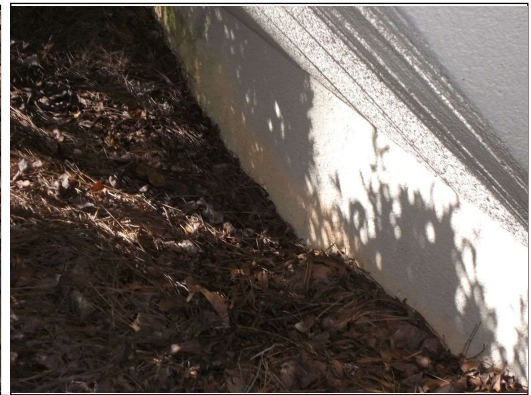
Exterior stucco below the ground at the front under the bay window (can attract termites), stucco needs pressure wash, wood trim needs scrape and paint, deck wood fence not secured to the wall. There is water damage to the soffit at the right front corner where the gutter is leaking. There is squirrel damage to the wood soffit freeze board to the right of the foyer wall corner. There is stucco deterioration at the right side of the basement wall behind the AC units where refrigerant line enters the wall (verify there is no water intrusion behind stucco)

Stucco below soil below front bay window

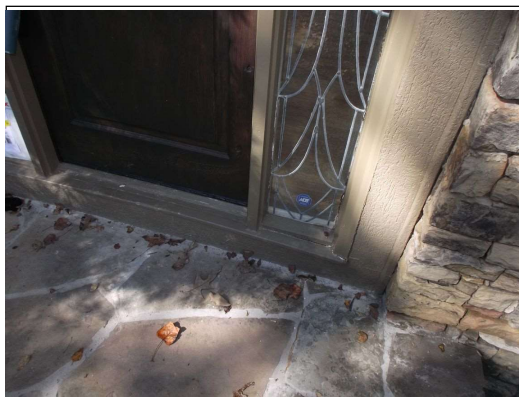
Front door threshold settles on the right

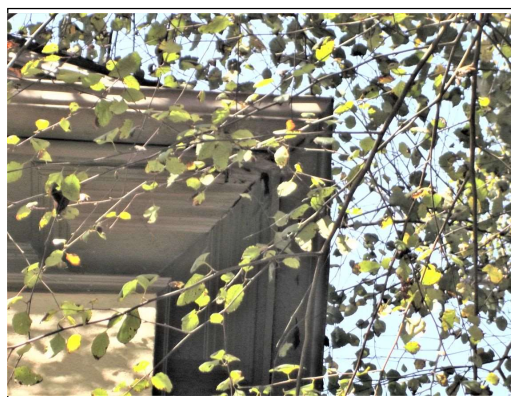
Water damage to soffits at right and areas

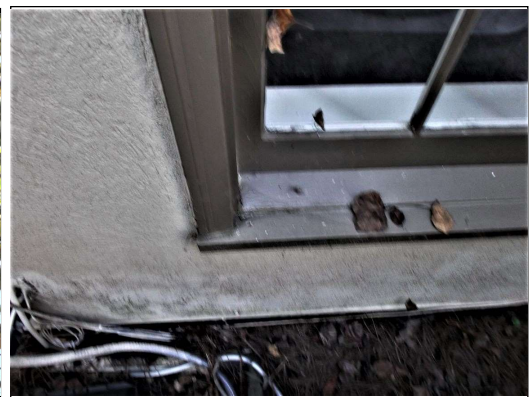
Water damage at window, stucco defective

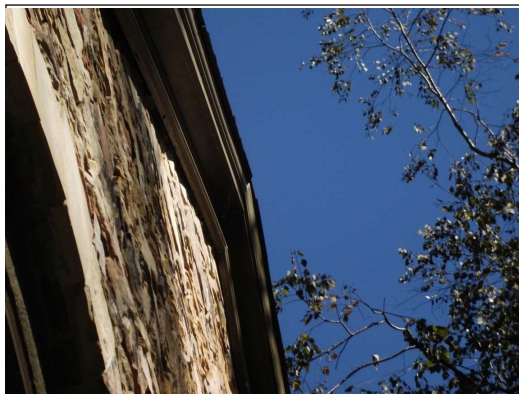
Cap shingle not extend over wood fascia

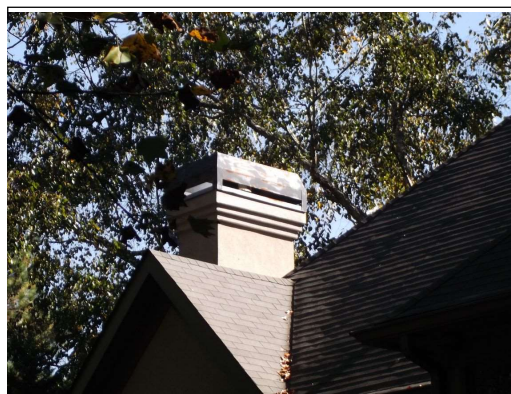
Chimney metal caps need painting.

Metal chimney cap needs paint

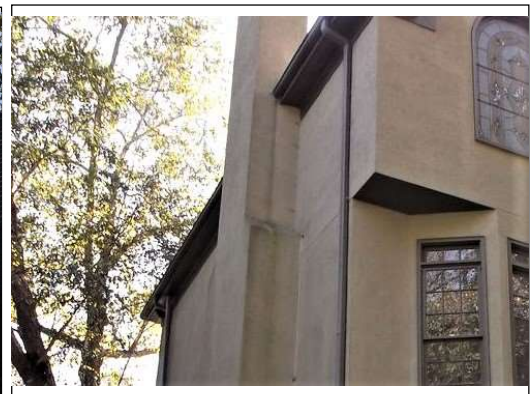
Water stains on stucco from roof or flashing

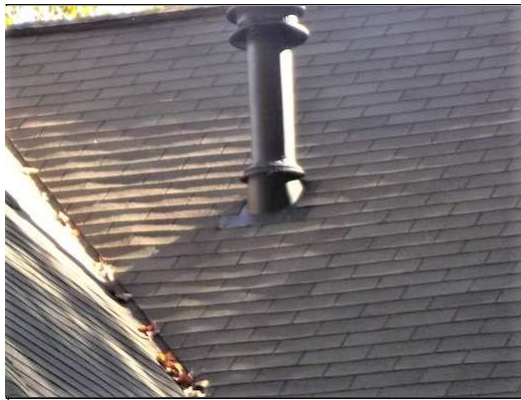
Flashing on top shingles face nailed can leak

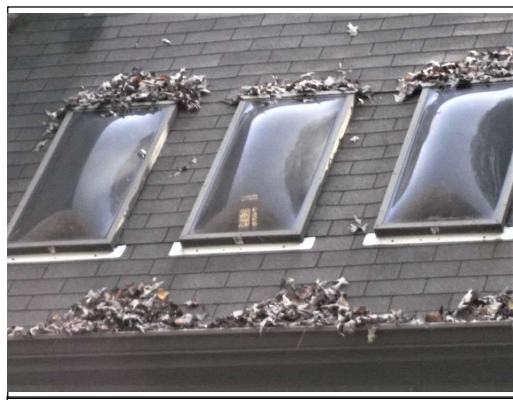
Sky light flashing screws in bottom flange

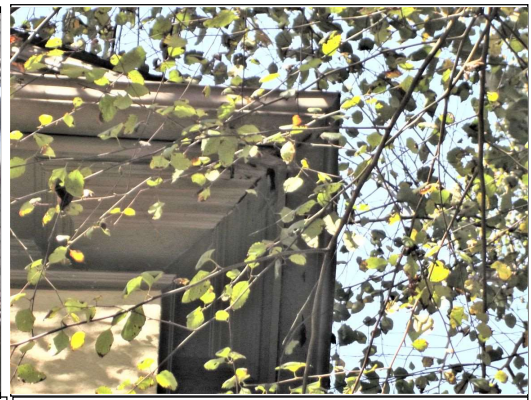
Gutter leaking and water damage to soffit

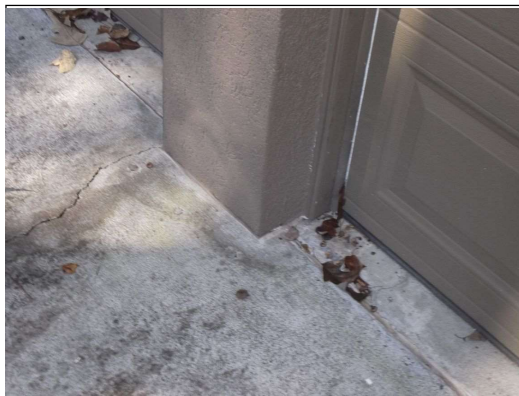
Stucco below concrete can absorb water

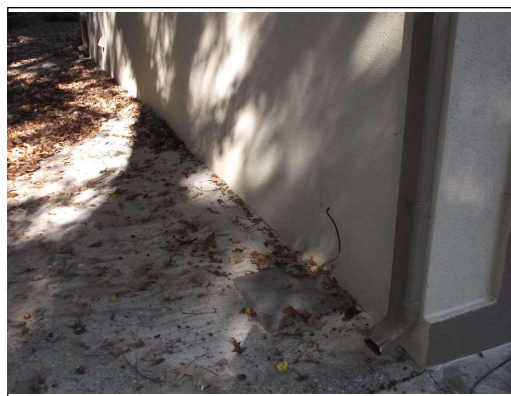
Stucco below concrete can allow termites

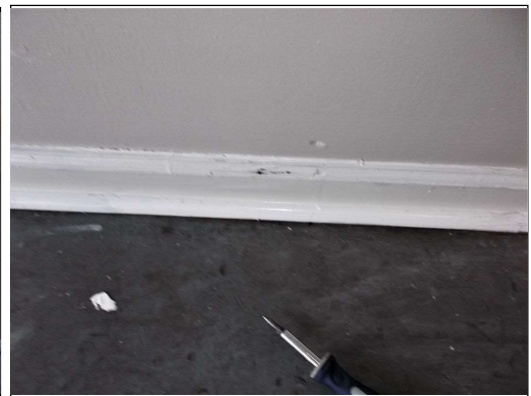
Termite intrusion at baseboard exterior wall

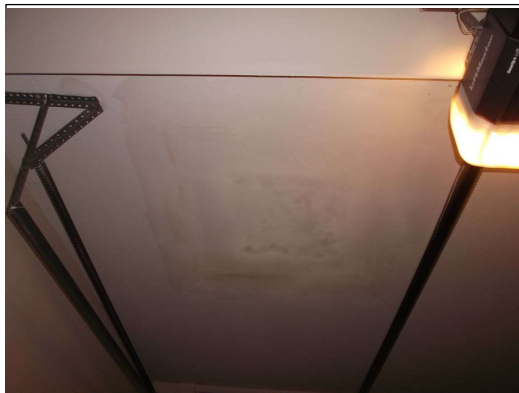
Water intrusion painted over, mold, stains?

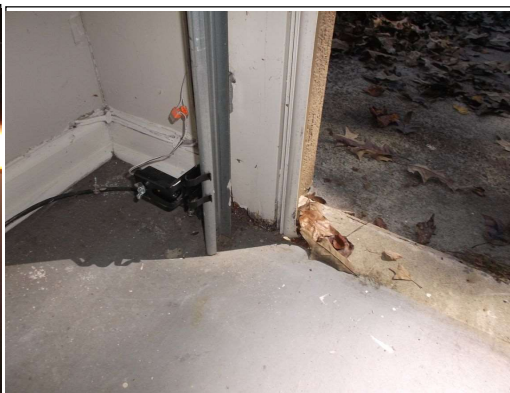
Water damage at door frames

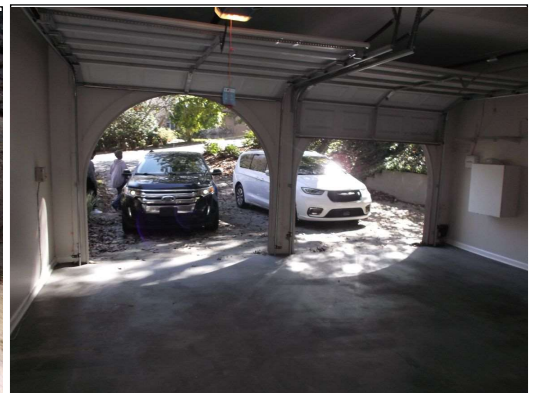
Sensors defective, pops...

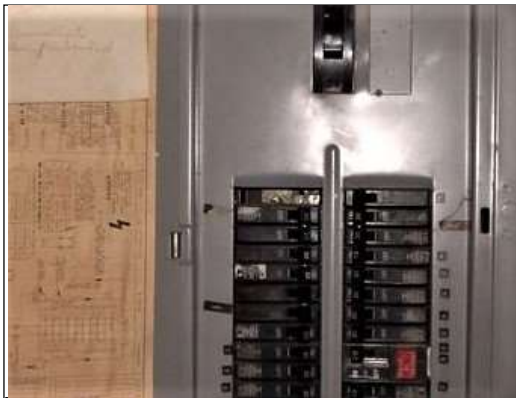
Opening in breaker cover @ panel in basemer

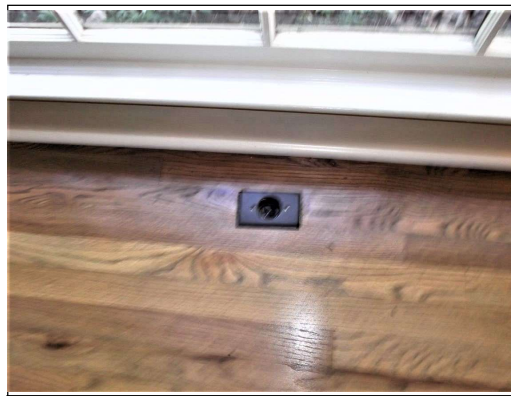
Missing floor outlet covers safety hazard

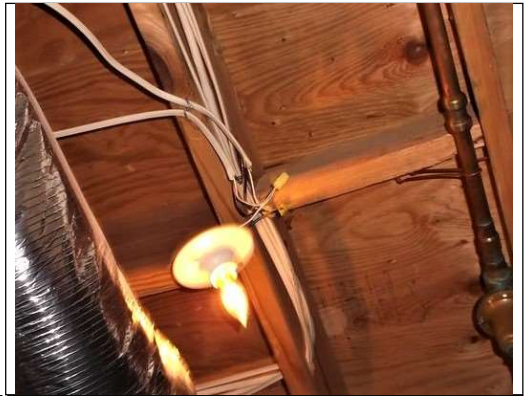
Exposed wire connections at the utility room

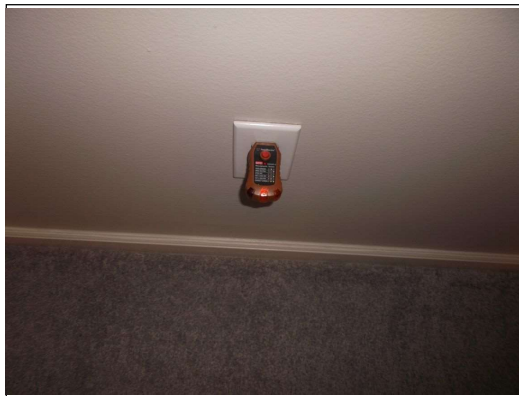
Outlets not energized at master bedroom

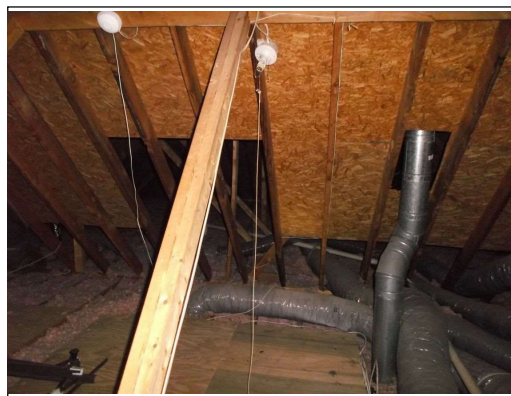
Attic light not illuminating

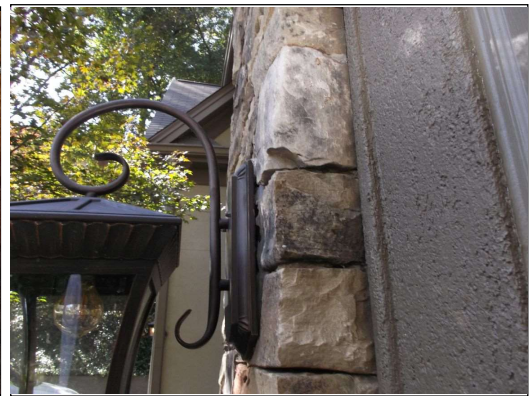
Missing caulk where light attach to walls

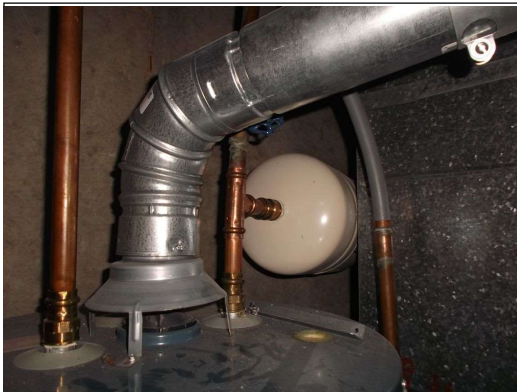
Expansion tank rest on pipe/plastic pipe

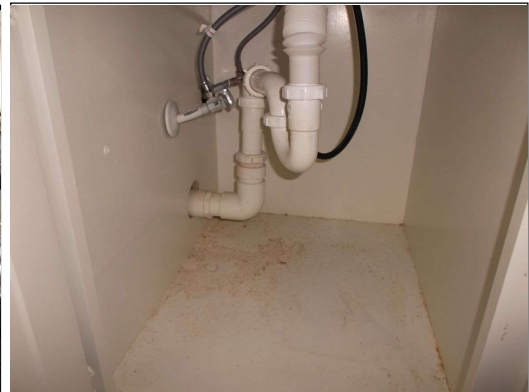
S-Trap at basement bar sink pipes

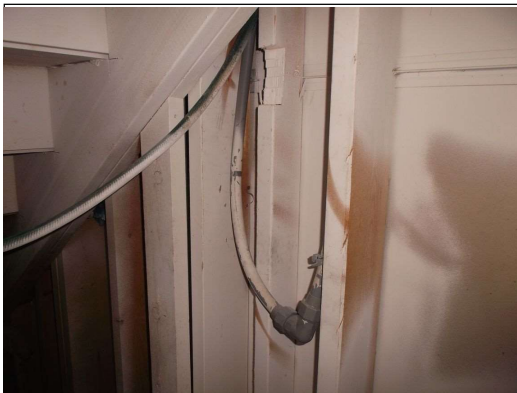
Gray plastic water pipe

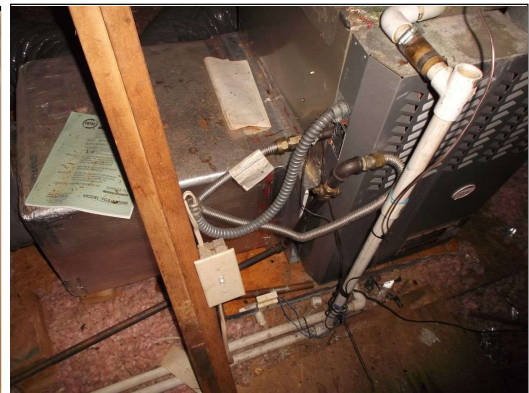
No sediment trap in gas pipe to attic furnace

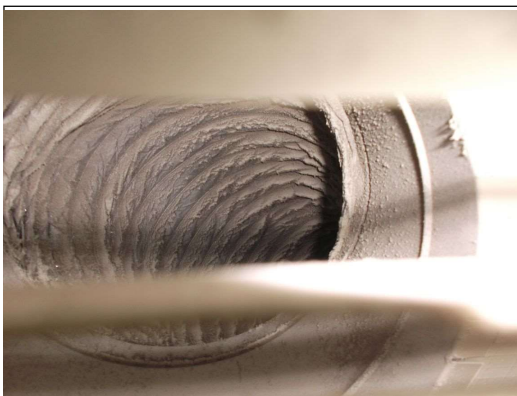
Air ducts dusty

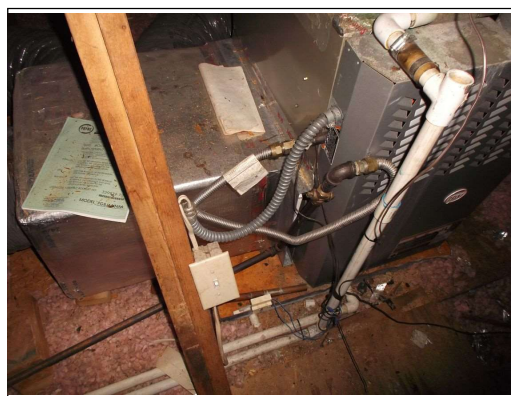
Rust in attic furnace drain pan

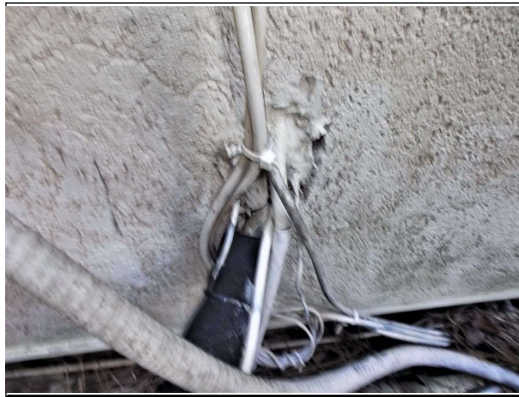
Missing refrigerant line insulation in wall

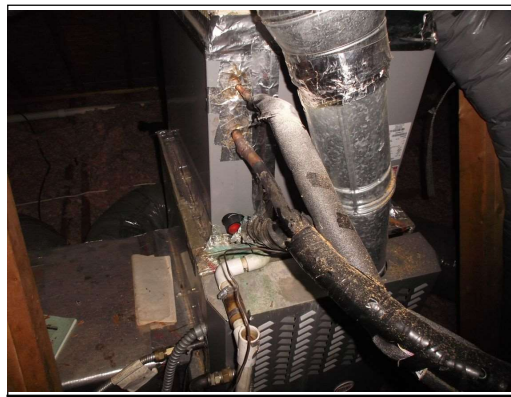
Missing refrigerant line insulation attic furnace

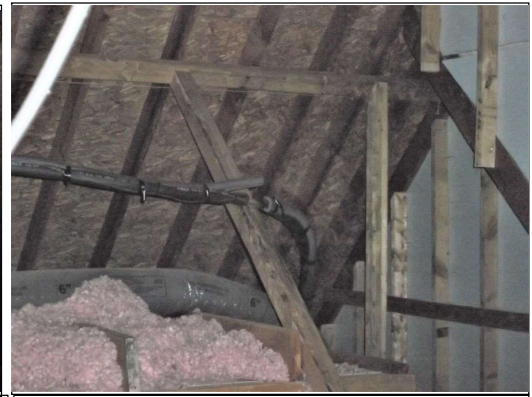
Missing refrigerant line insulation in attic

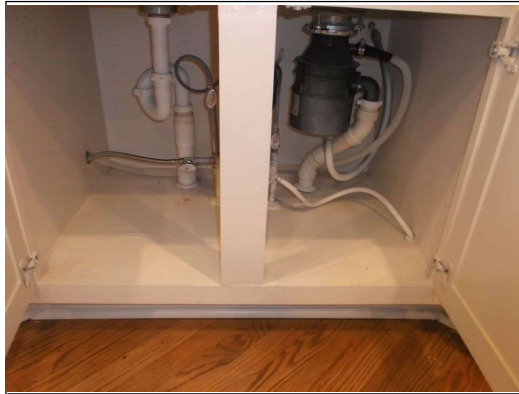
Drain pipes improper and unsafe

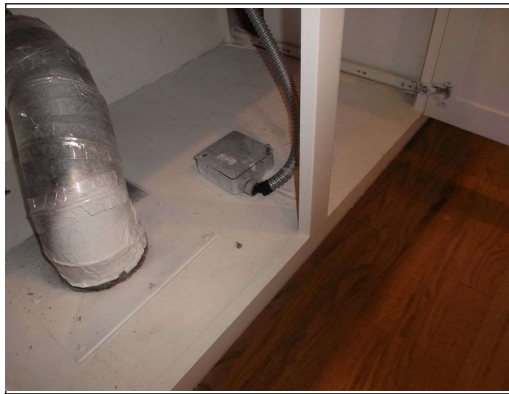
Detached conduit at junction box

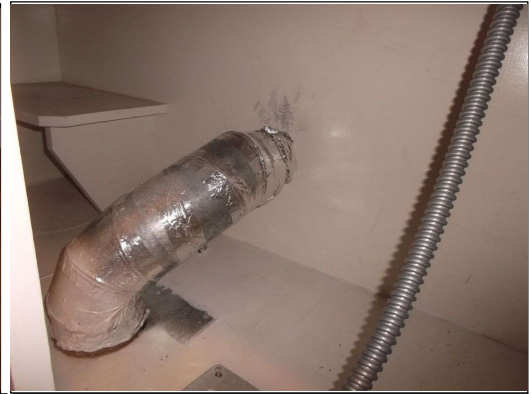
Exhaust fan duct pipe

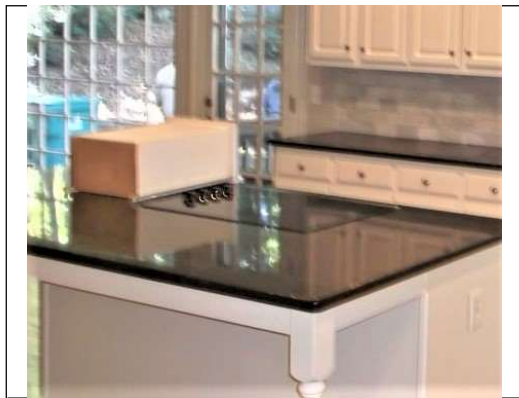
No exhaust fan at cook top

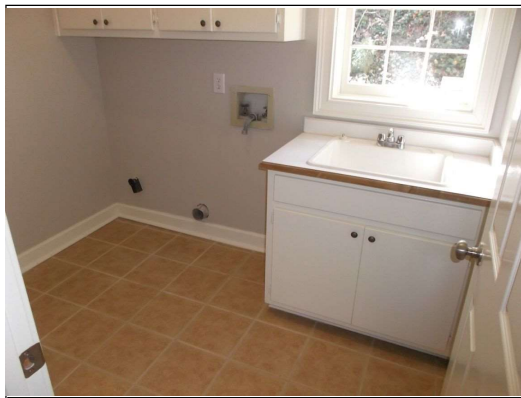
No washer drain pan

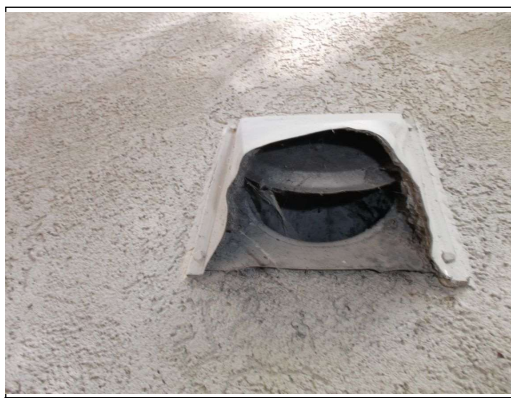
Dryer vent terminal door stuck open

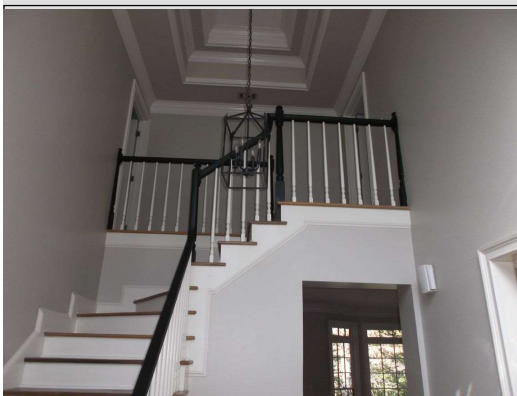
Rail guards spaced more than 4 inches apart

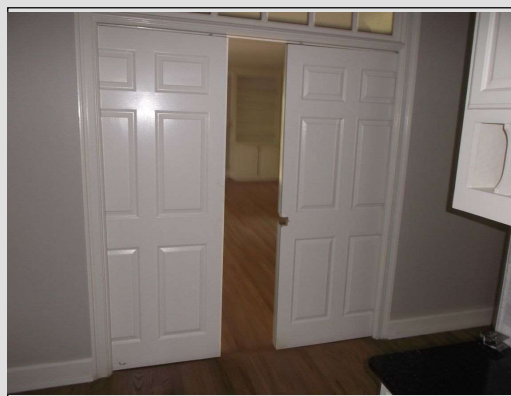
Pocket doors defective/locks defective

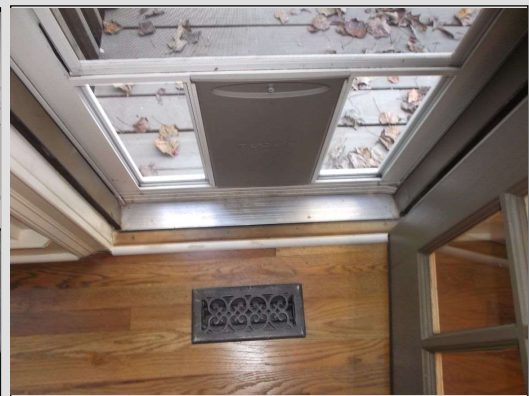
Door frame split at the bottom

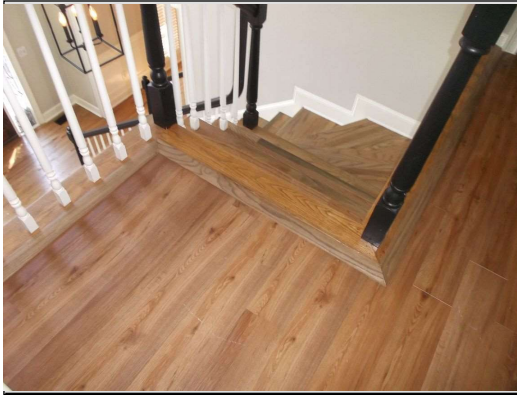
Trip hazard at flooring and top of steps

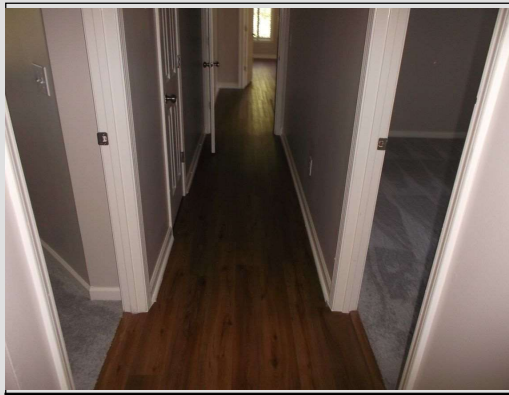
2nd level hall floor slopes from the bedrooms towards the foyer hall.

Hall floor slopes to balcony

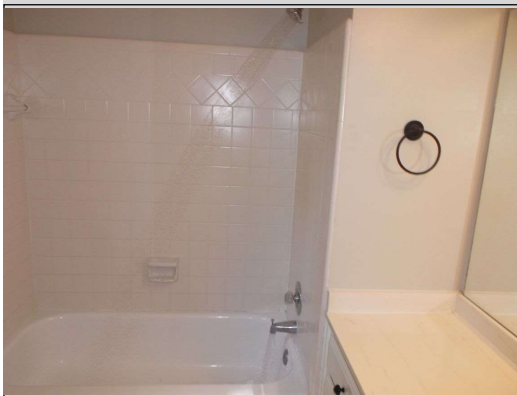
Water flows at spout while shower flowing

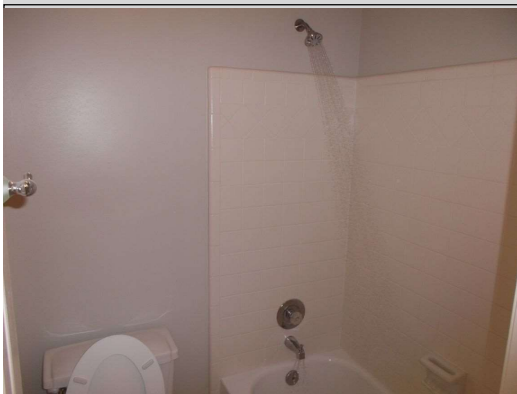
Water flow at the spout and shower head

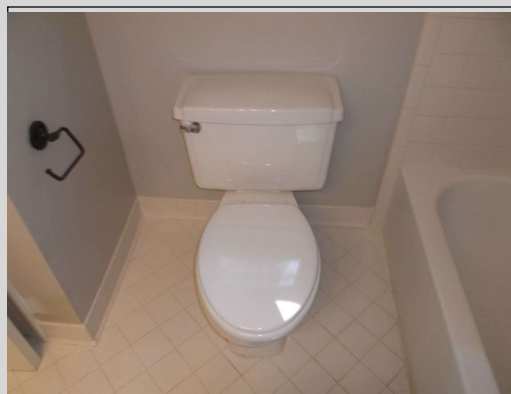
Toilets not water savers

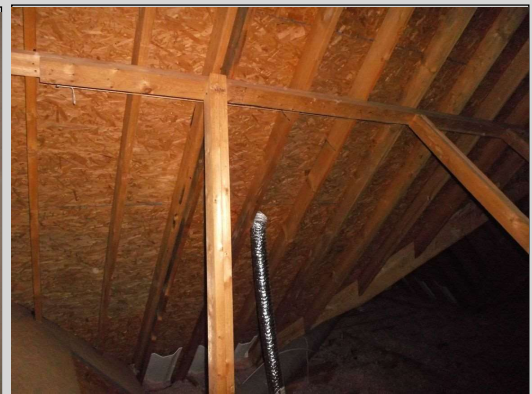
Fan exhaust into attic

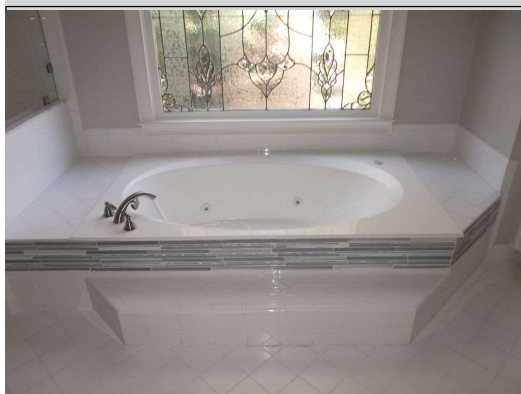
Master bath floor tile high where it meets the master bed floor can be a trip hazard for some, tub jets did not flow water when turned on, tub stopper defective, tile cracked in tub deck, defective tile repair at the right side of the tub deck, dry stains on sink cabinet floor, right sink faucet handle loose at the base, missing grout at the base tile corner in the toilet room to the left of the toilet, toilets not water savers, shower faucet handle restrictive to turn when turning on water on and off. Debris in grout at shower seat. Grout was not cleaned after shower tile repair (excessive grout spills out joints at seat and floor tiles.

Tiles defective, jets not operating, stopper

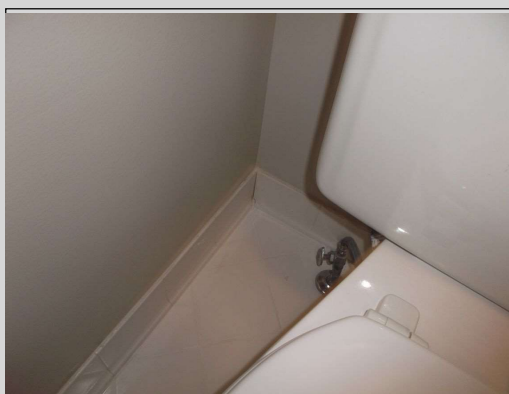
Missing grout at base tile in corner

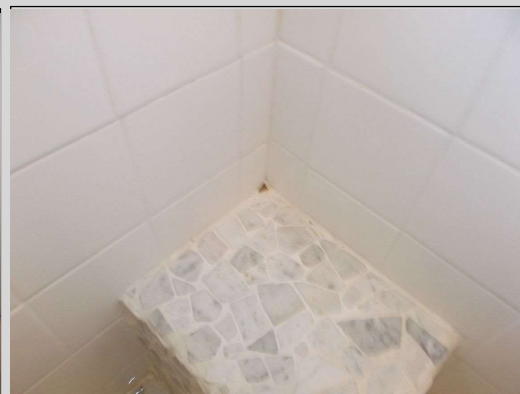
Debris in shower grout

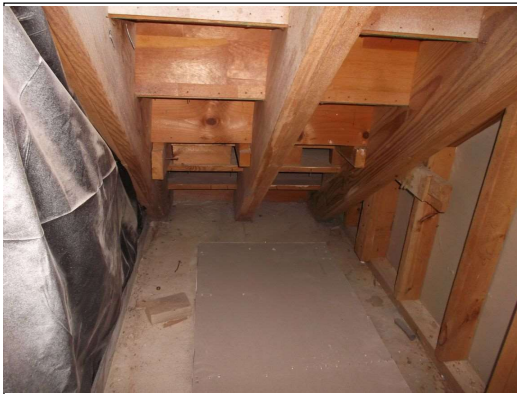
Stairs rest on concrete?

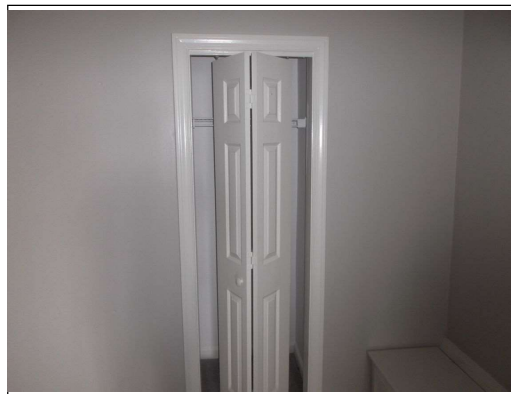
Closet doors defective

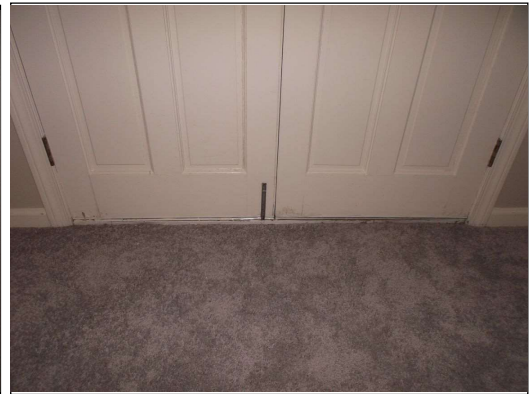
Dry stains at the bottom of french doors

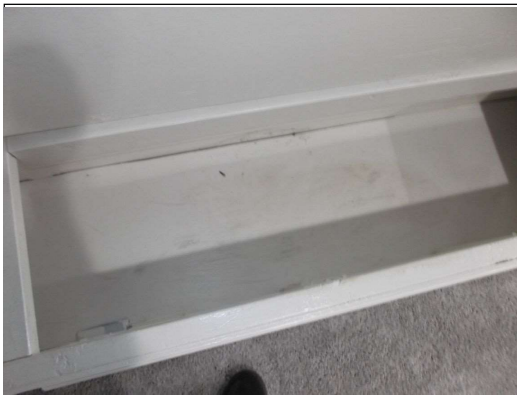
Stains in bench seat box bottom

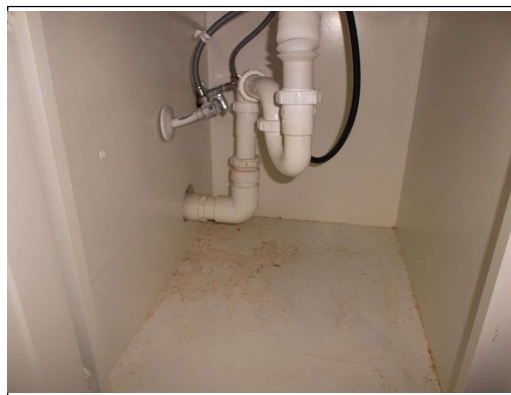
S-Trap in bar sink drain pipe

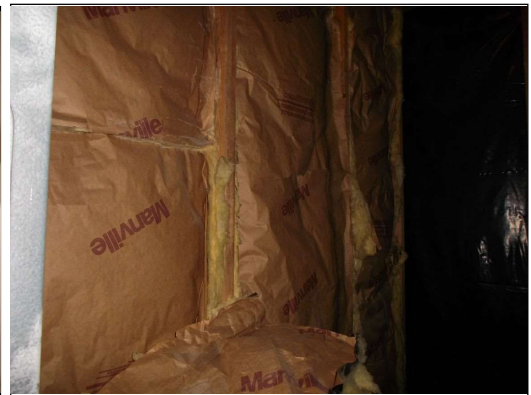
Insulation installed in walls backwards

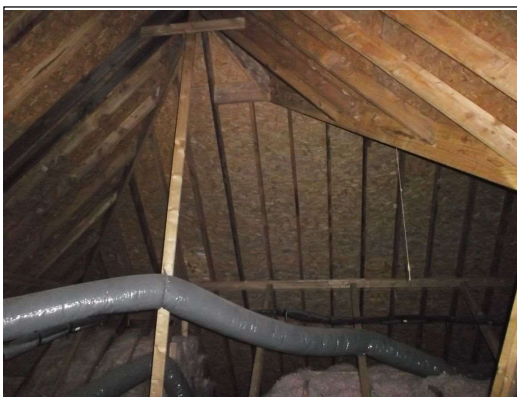
Missing spacer clips between deck panels

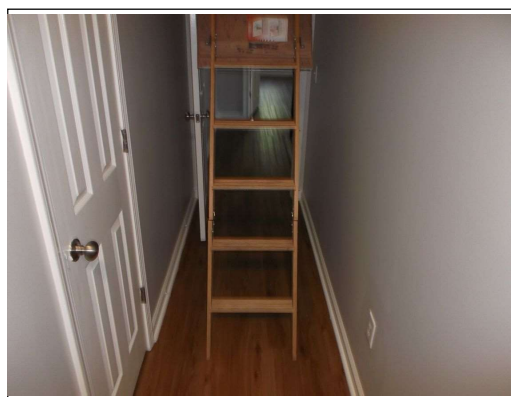
Ladder slightly too long

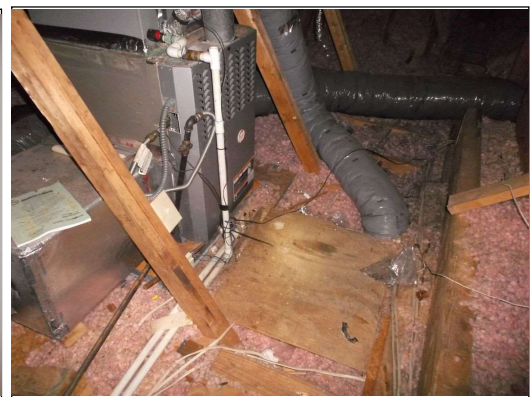
Defective and missing floor leading to furnace

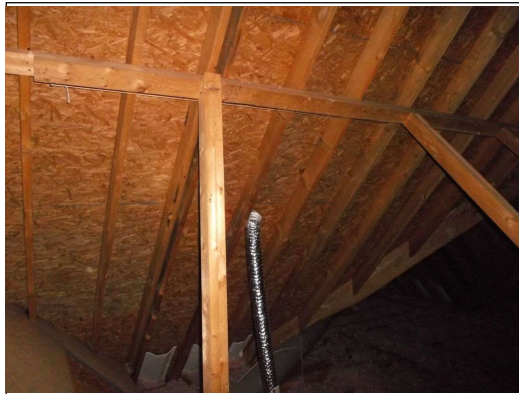
Bath exhaust into attic

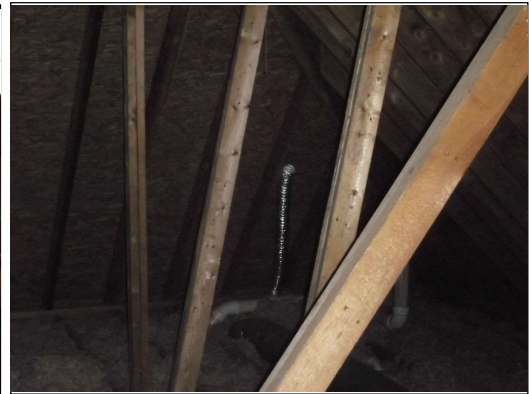
Bath exhaust into attic
