PRE-DRYWALL INSPECTION REPORT

Client: Arthur Tarantino
Address: 190 Guthrie Rd. Whitesburg, GA. 30185
Date: 11-25-2024

This document is a summary of various conditions found at the reinspection.

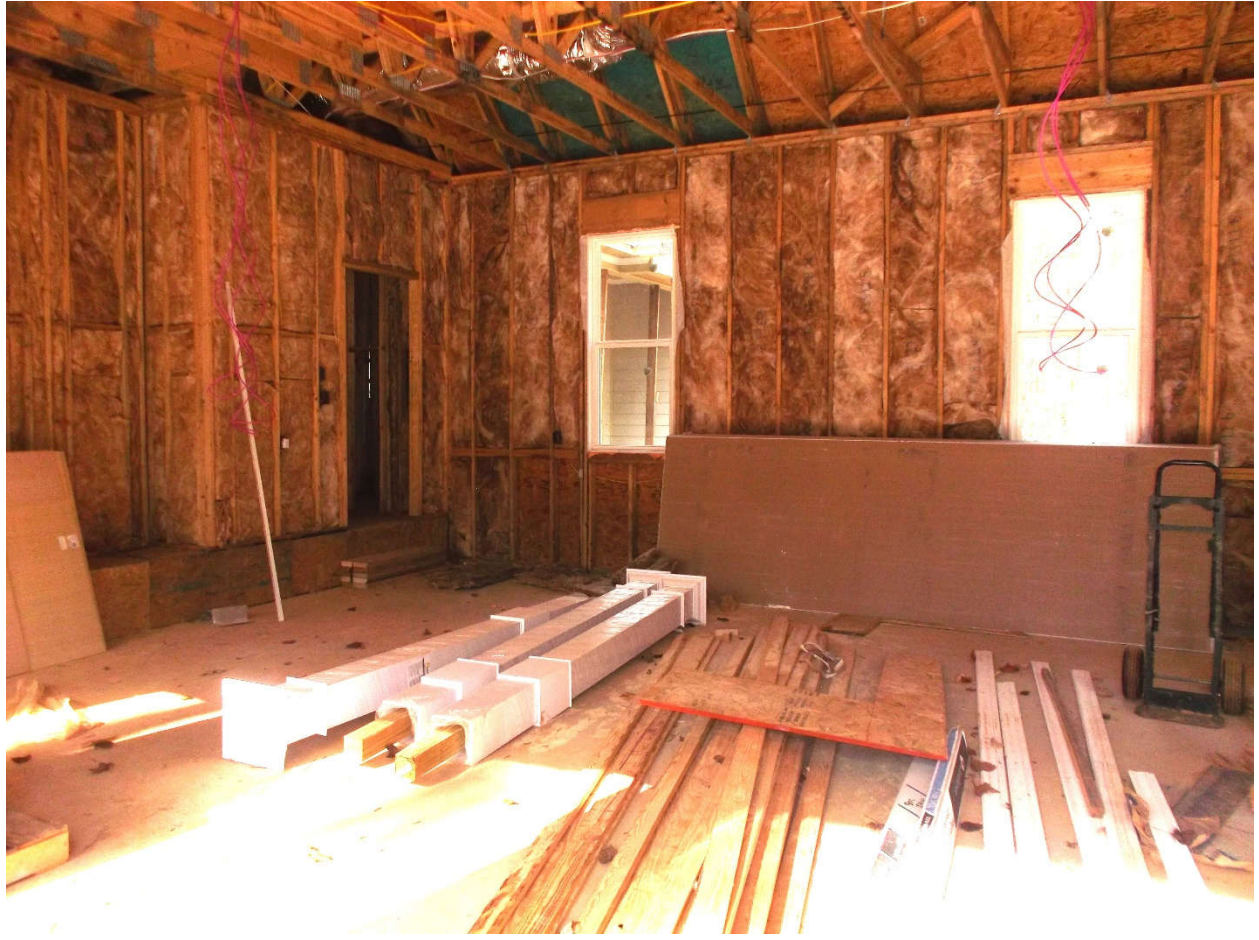
5. Garage: It appears the foundation tie-down metal straps are not wrapped around both sides of the exterior wall bottom plates (verify this county allows wrap around only one side). Cannot see anchor bolts or straps in place within 12 inches from wall corner ends at the bottom plates. Verify all garage wall bottom plates have proper tie-down straps spaced and installed at least 6 feet apart. There is missing foam behind electrical boxes at the exterior walls. There is a wall frame top plate too short nearing the right corner of the garage wall. Wind brace single stud should be double stud.

NO STRAPS

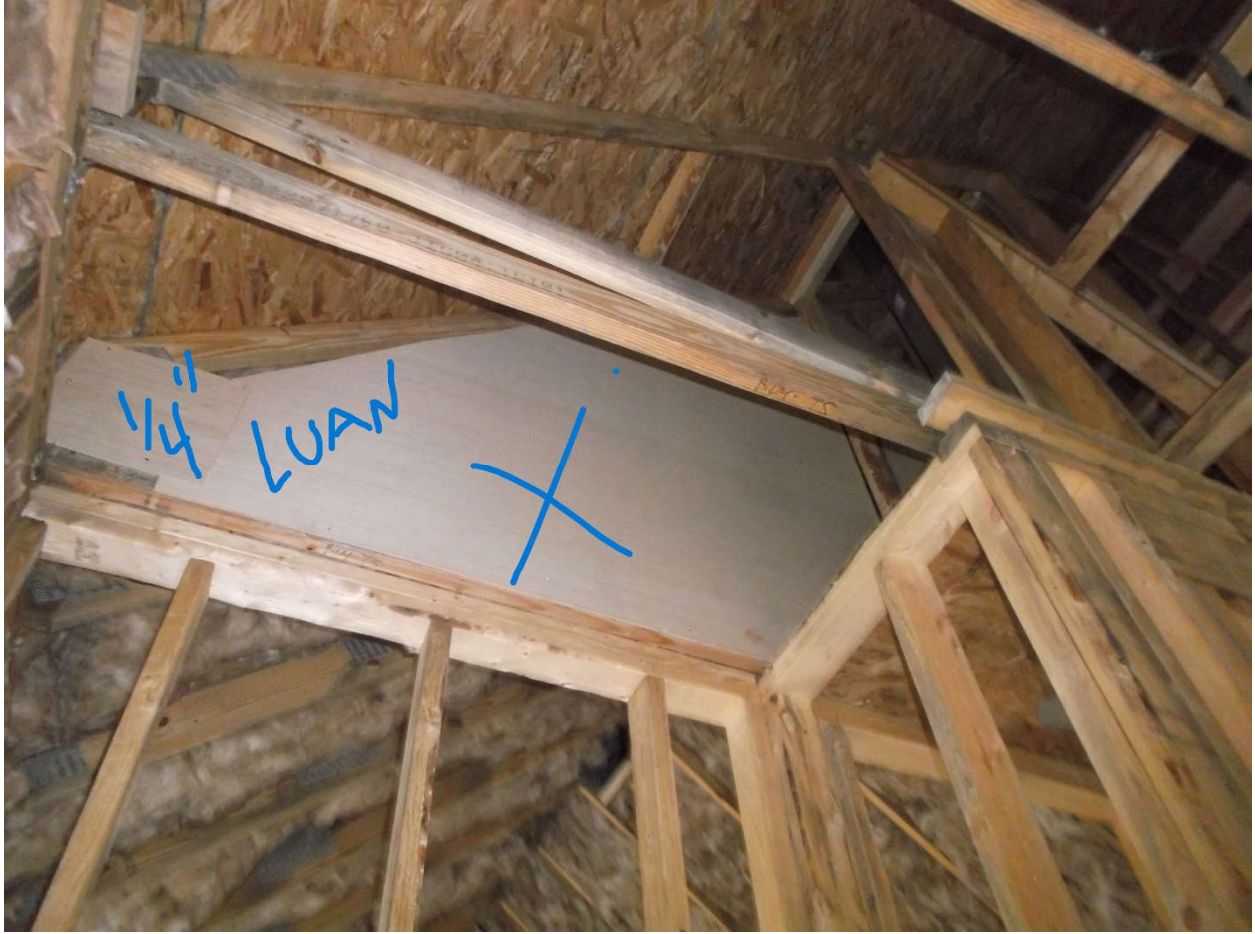
20. There appears to be ¼ inch Luan plywood used for fire block at the master bed wall to the attic, at the foyer and attic wall... (should be at least ½ inch sheetrock). Some counties require 5/8" or fire-resistant drywall.
