PROPERTY INSPECTION REPORT

1802 Walker Ave. College Park, GA.

Sep 27, 2021

1599

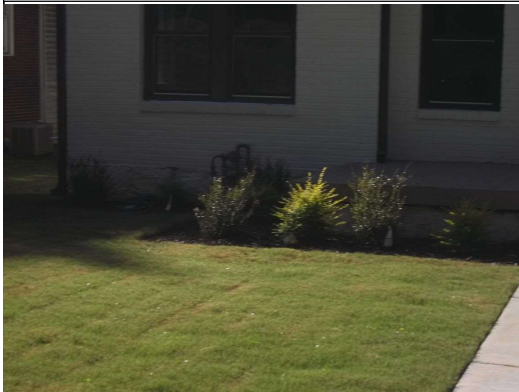
Poor site drainage at the front of the house on the left side and soil slopes to the foundation; poor grading and site drainage at the left side of the house; there is a open storm water drain opening at the rear yard (can be a safety hazard).

Soil slopes to the front of the house

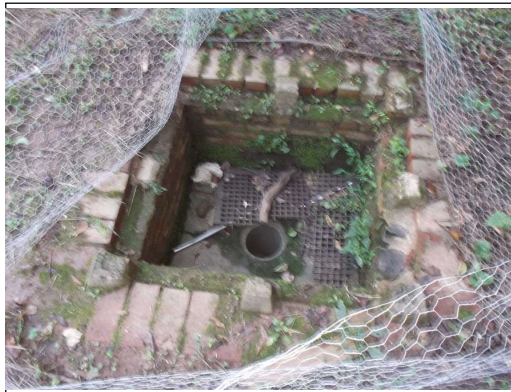
Open pit in rear yard

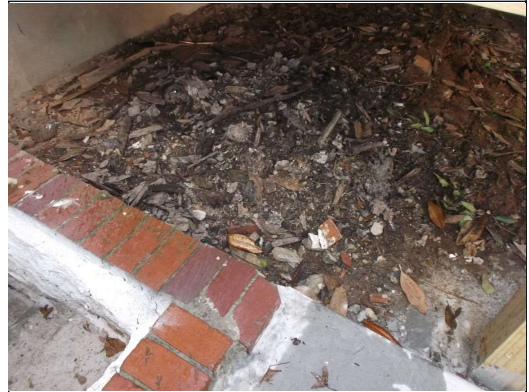
Debris placed under the deck

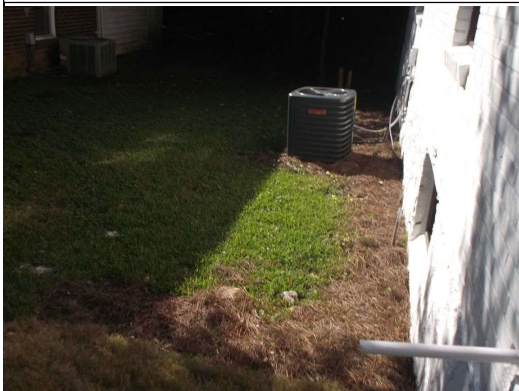
Poor soil grading and slope away

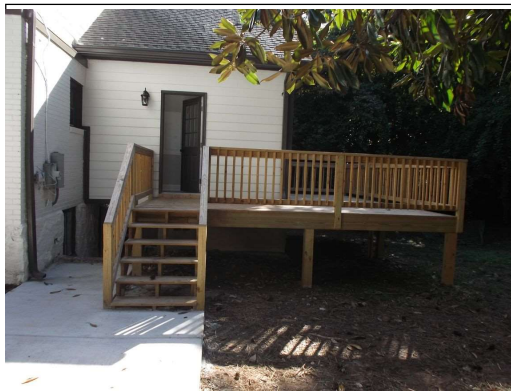
The rear wood deck stairs is missing a handrail, support posts are not bolted to the rim joists, deck floor poorly fastened to the house wall, there is support wood contacting the soil, there is a missing joist hanger where the deck floor beam terminates at the rim joist, debris under the wood deck,

Deck needs corrections several areas

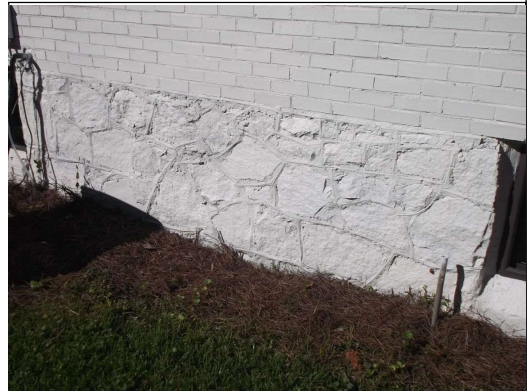
There is defective mortar repairs at various areas at the foundation at left side of the house.

Defective mortar joints in foundation

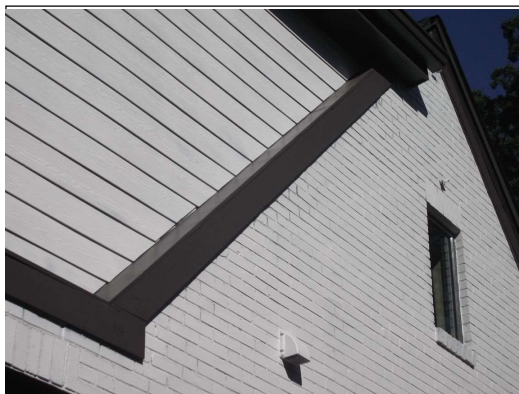
Siding rest on roof flashing

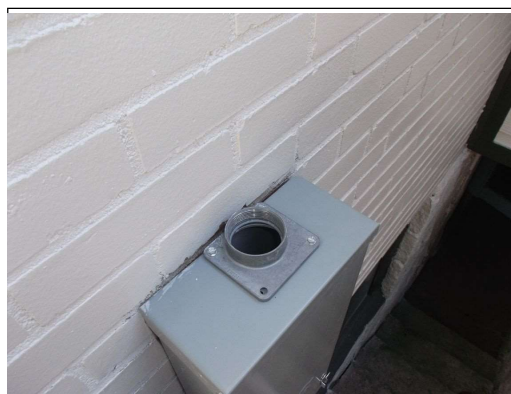
The electrical meter disconnect box at the rear of the house has a hole in the top and missing a bead of caulk across the top of the meter box (water can get inside box and into holes in the brick);

Hole in top of panel box

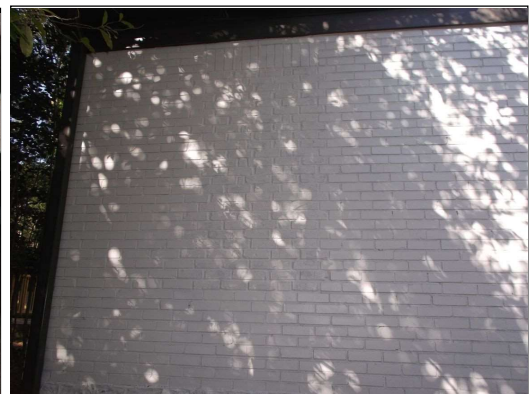
Different bricks

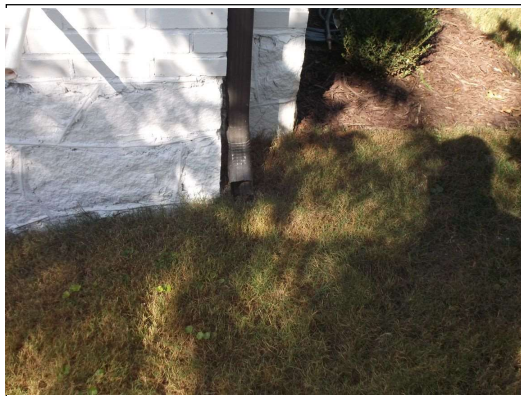
Downspouts pour at foundation

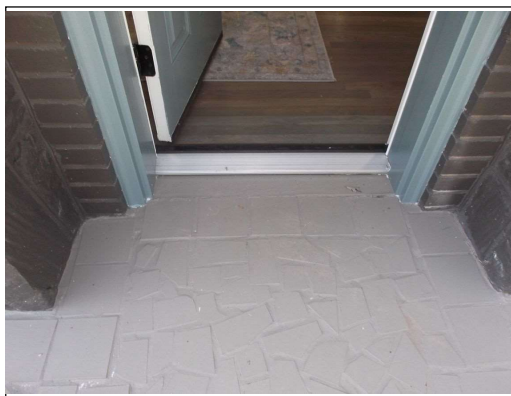
Front door threshold is not supported can be damaged over time; rear door threshold wood support appears to not be treated can rot;

Threshold not supported

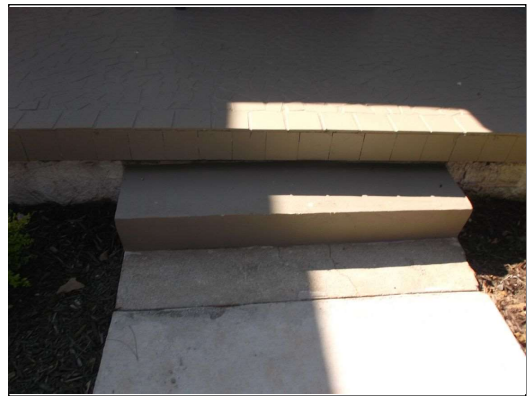
The front masonry steps have risers uneven and too high (trip hazard); the front porch floor has been painted and there is a moderate crack painted over (this paint may not remain on tiles after several rains);

Front steps trip hazard

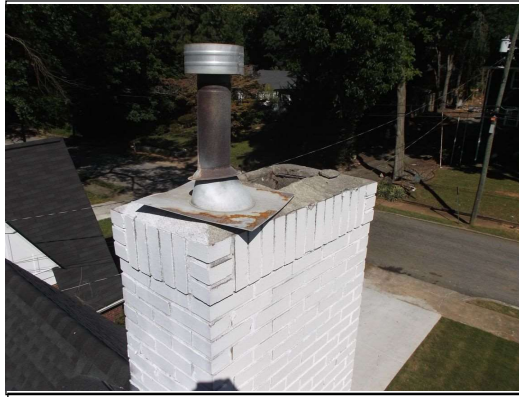
The chimney is missing a rain cap; the gas vent pipe coming out of the chimney is improper, defective and can cause leaks. There is no spark screen on top of the chimney.

Defective cap, missing screen, defective vent

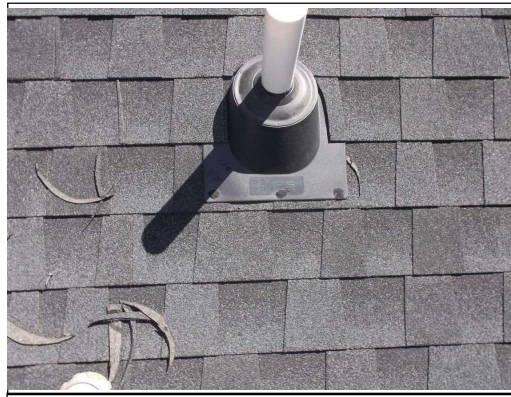
Plumbing pipe flashing has been installed on top of the shingles and face nailed (nails can extract and cause leaking over time). Cannot verify the roof system has proper ventilation.

Flashing on top shingles face nailed

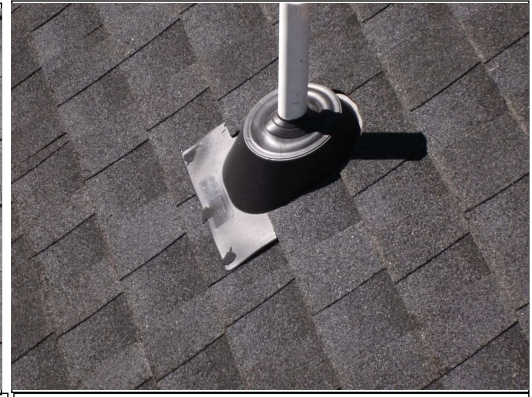
Flashing on top shingles face nailed can leak

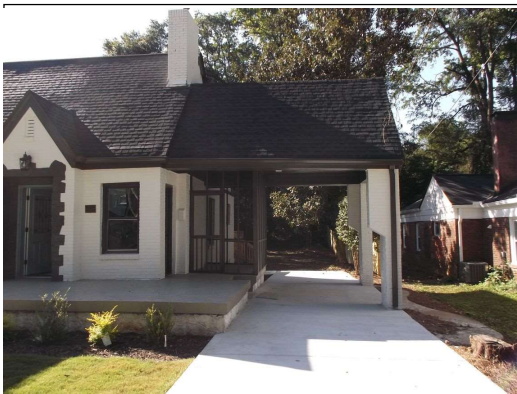
Carport roof system slopes to the right and show signs of settling at the brick column. There is a downspout pouring at the carport front column that is needing a elbow and routed away.

Roof structure slopes to the right

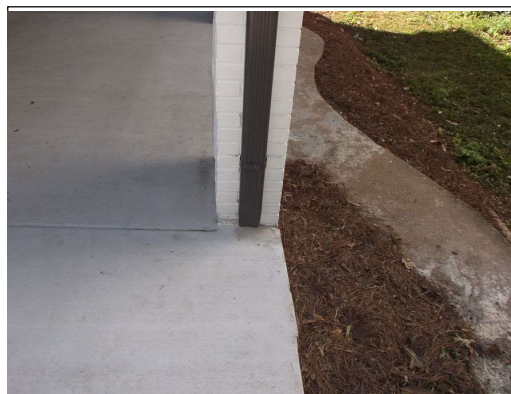
Missing downspout elbow

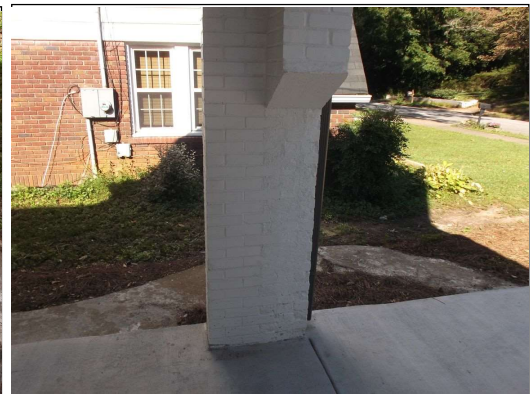
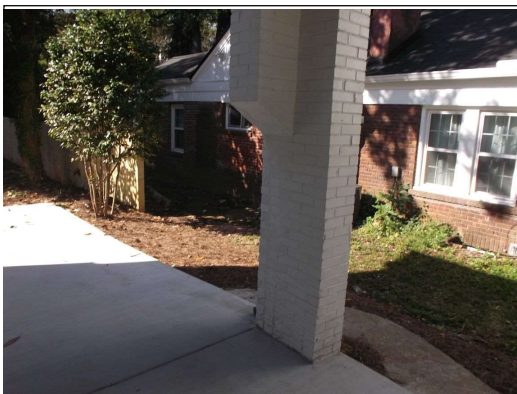
Carport post bricks removed at the bottom half that can cause the remaining upper section to come loose over time.

Brick removed at the bottom half of column

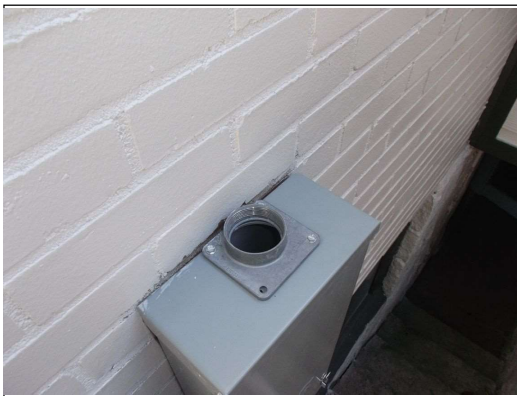
Hole in top of electrical disconnect box

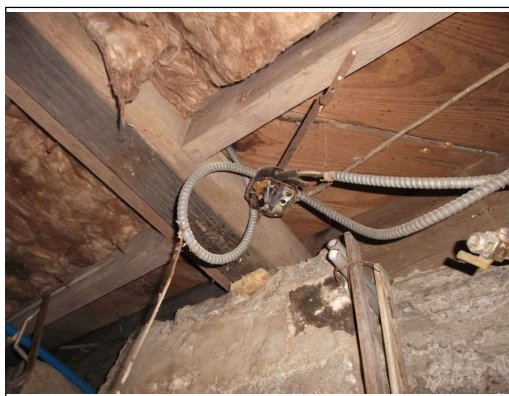
Open junction boxes in the basement

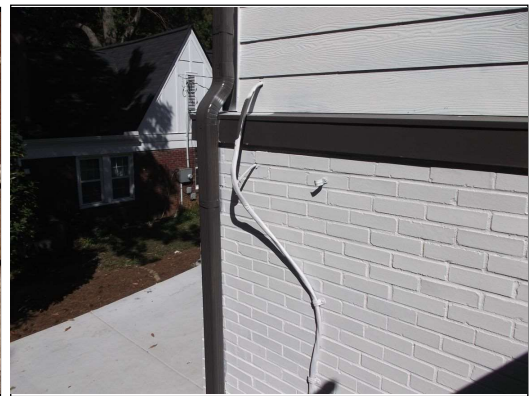
Feeder cable not clamped to brick

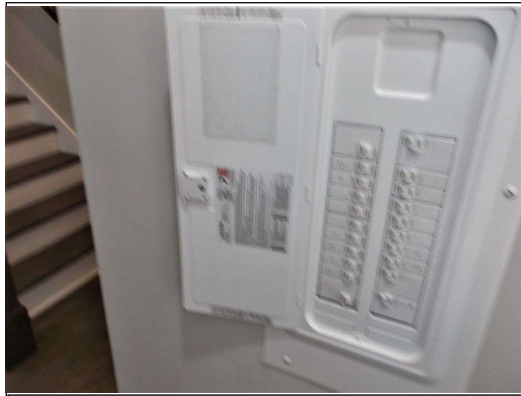
The distribution panel box in the house does not have the proper breaker list. Defective lighting in basement. Dining room lights not illuminating.

No breaker list inside panel door

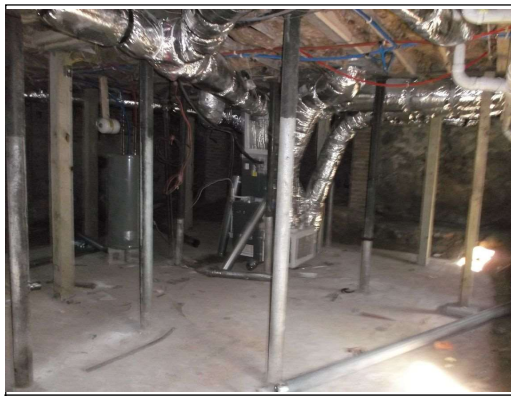
Defective lighting in basement ceiling

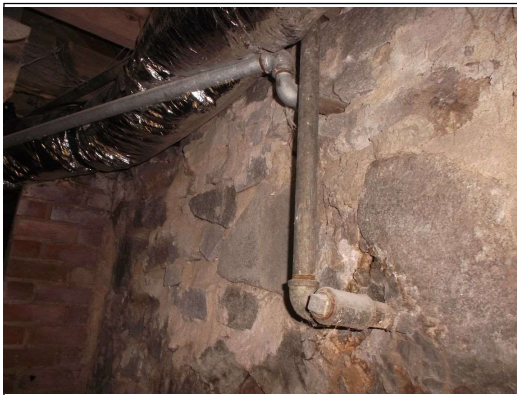
Water pipe for gas

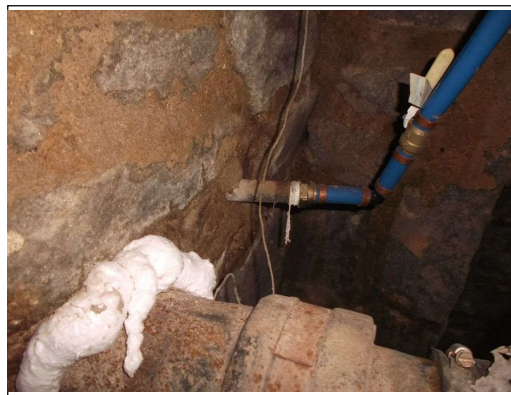
Main water pipe from the street appears to be steel which may be nearing end of service (steel pipe can rust inside). Main waste pipe leading from the basement to the street is the original cast iron (cast iron pipe can rust and corrode over time).

Main pipe in foundation appears to be steel

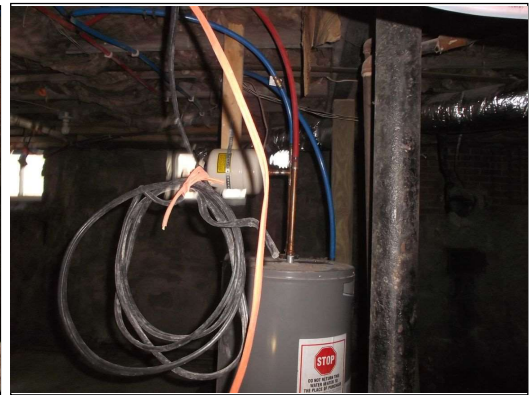
Water heater setup not complete

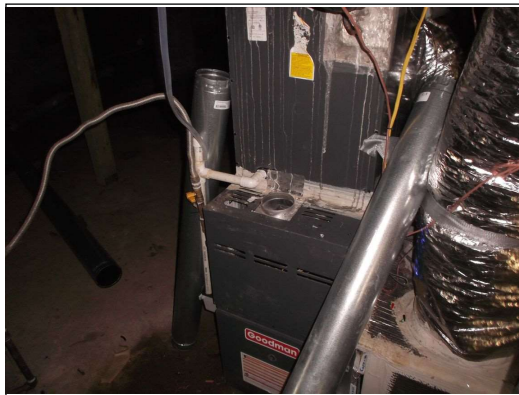
The furnace gas vent pipe system is not installed properly and components missing. There are calcium stains on the air handler at the top of the furnace.

Furnace defective, missing flue, stains

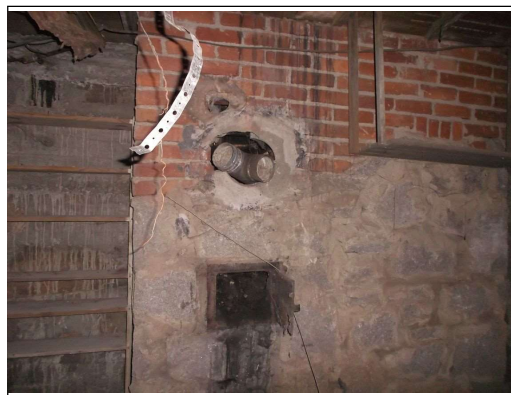
Defective furnace flue pipe assembly

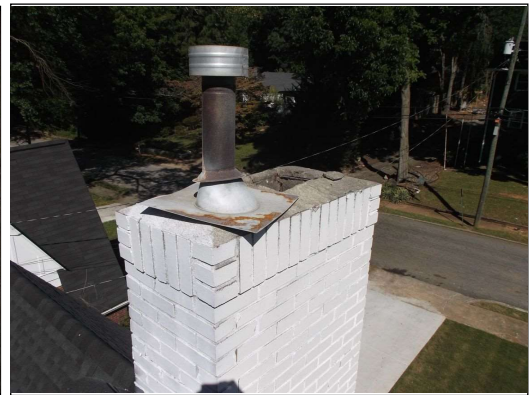
Defective furnace vent pipe atop chimney

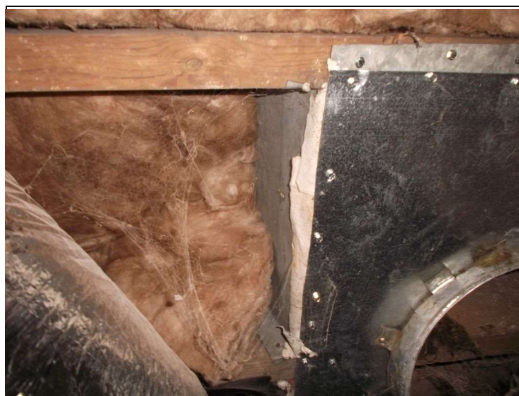
Damaged Asbestos tape found on old air duct components in basement ceiling. It appears that there may have been improper Asbestos removal in the basement and there can be contamination in the soil, on the floor and ledges if not removed properly. There can be Asbestos fibers in the house if people and workers went from the basement to the house during renovations and repairs.

Asbestos tape damaged in basement ceiling

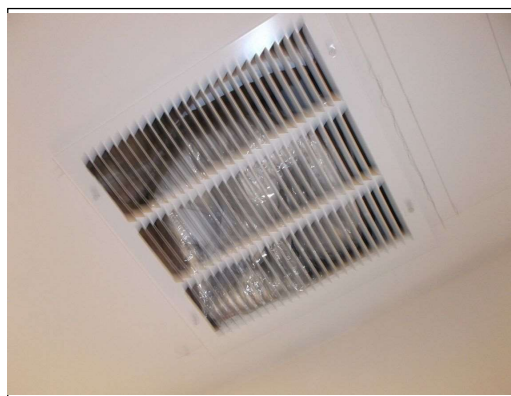
Air duct inside return air register

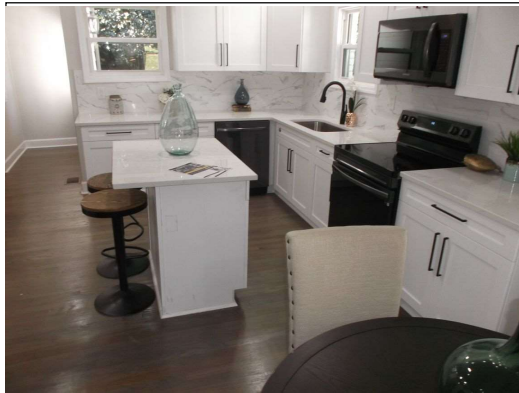
Floor slopes to the sink

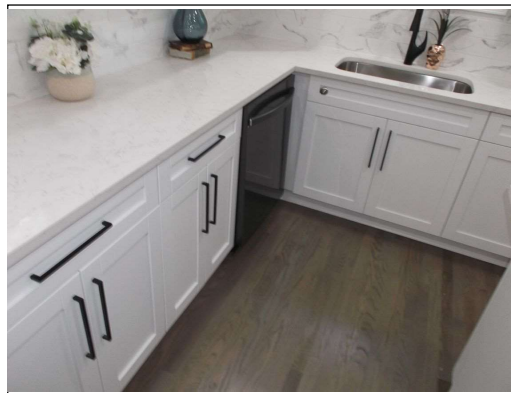
Dishwasher not plumbed

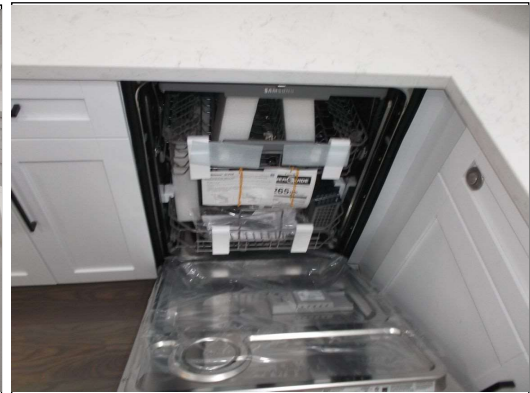
Packaging in dishwasher

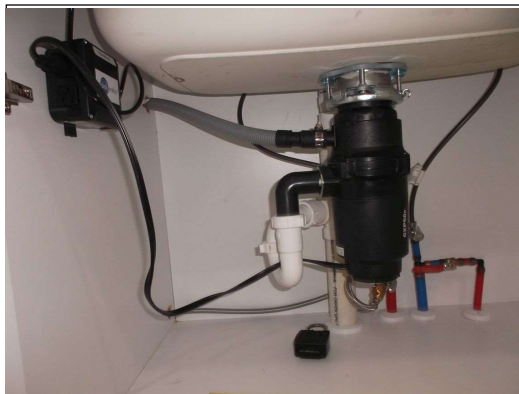
Dishwasher drain pipe not high looped

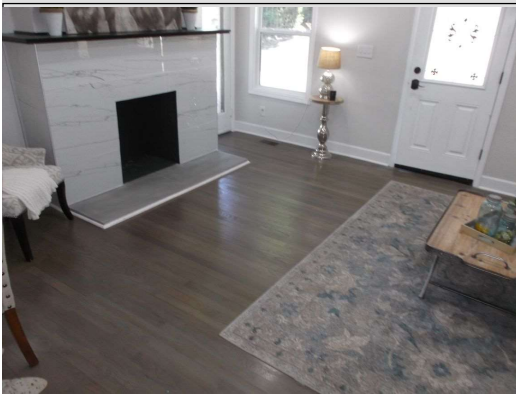
Floor slopes to the front corner

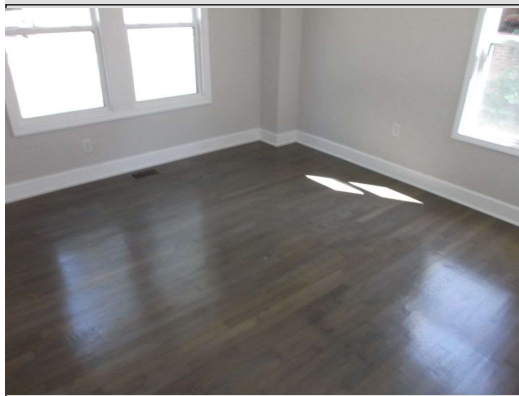
Front bed floor slopes to exterior corner

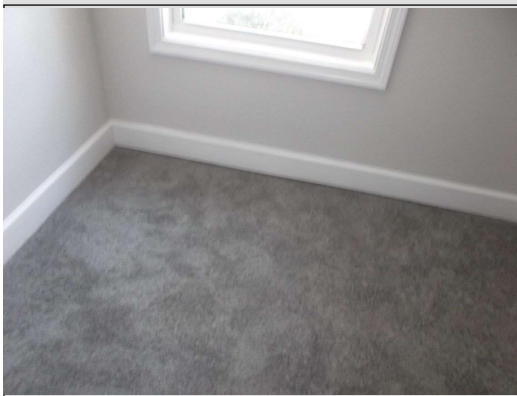
Gap at carpet and floor

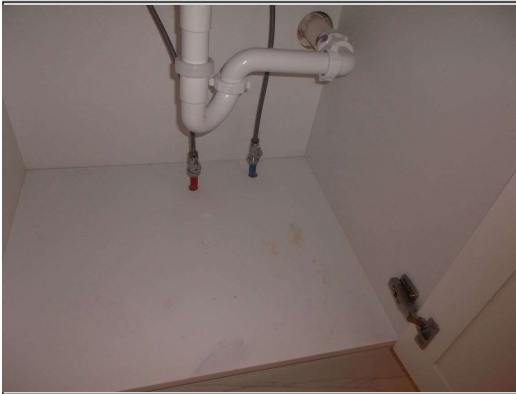
Missing cover plates at pipes in cabinet floor

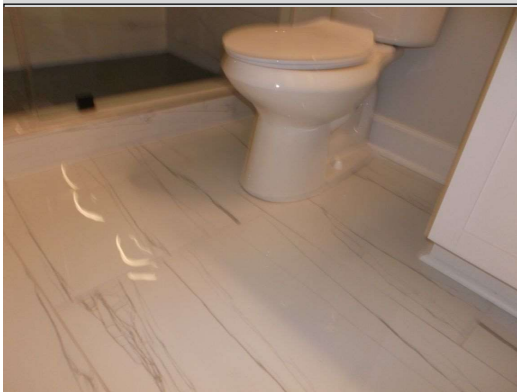
Toilet missing caulk at floor/Spout crooked

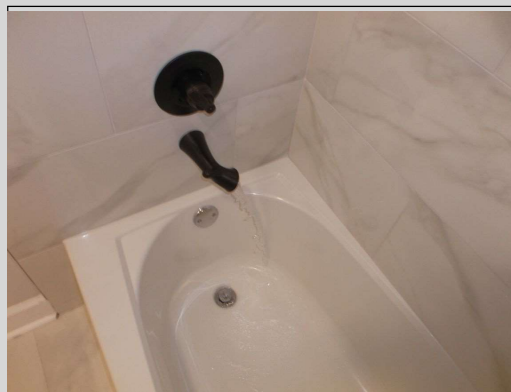
Spout turned to the side

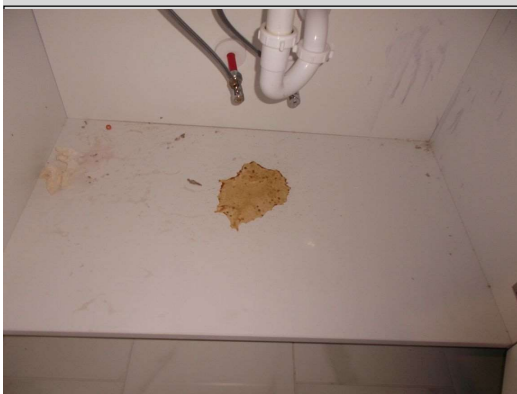
Major stain on cabinet floor

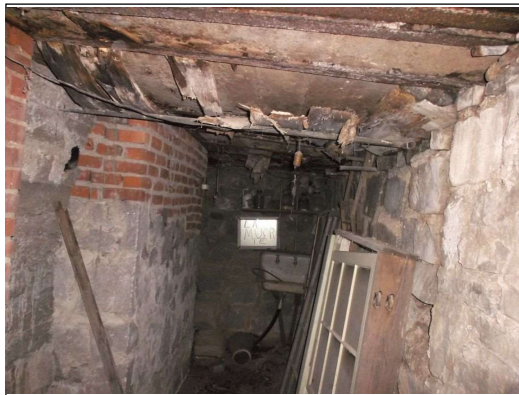
Rotted wood and debris

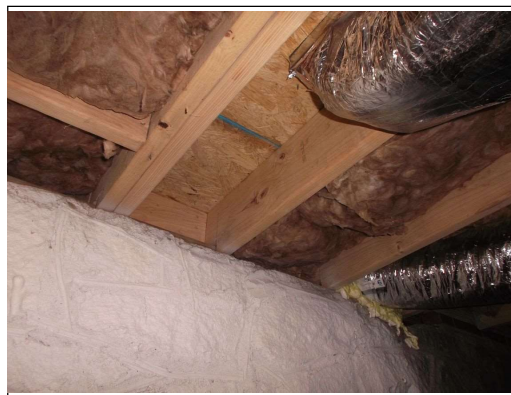
Missing insulation

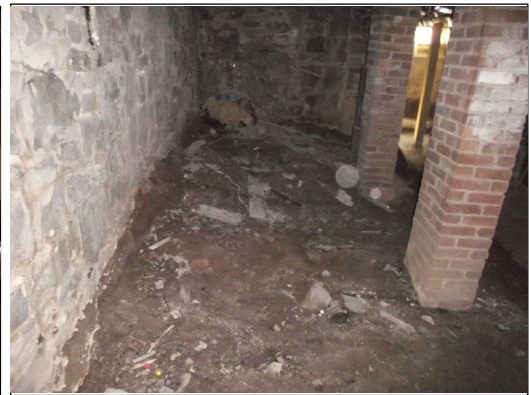
debris and missing moisture barrier

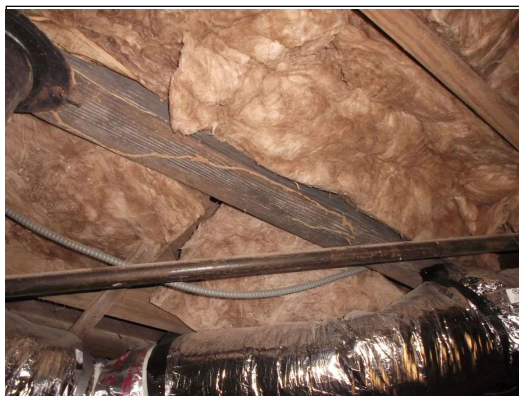
Termite trails

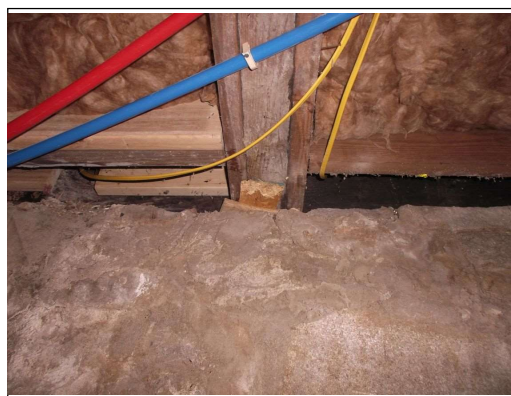
Cannot verify wood is treated on masonry

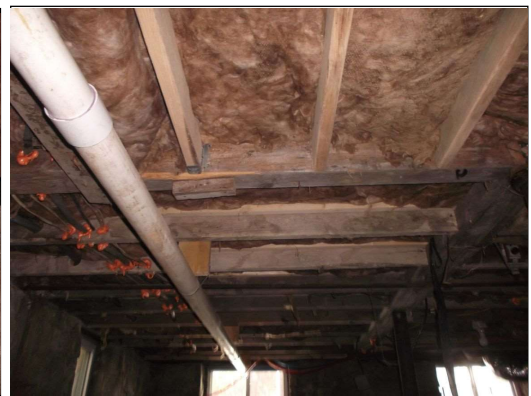
Mold and Fungus on floor joists
