PROPERTY INSPECTION REPORT

2030 Main Street NW. #306, Atlanta, GA. 30318

Oct 13, 2021

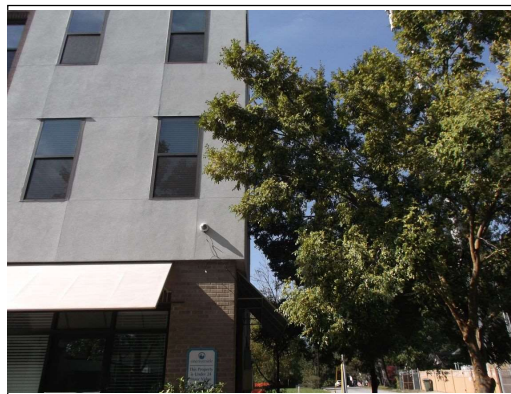
Trees touch building

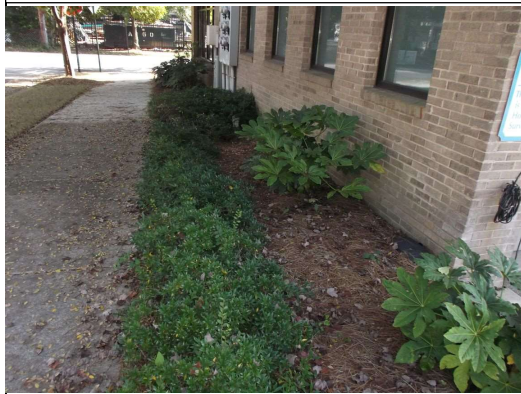
The asphalt driveway at the rear of the building has poor slope to the storm water drains and poor slope away from the garages at this end of the building; the grading has poor slope away from the building at the right side and can hold ground water during lonk and heavy rains; tree limbs are touching building; there are settling cracks in patio floor and paio floor has excessive slope away from the building;

Poor soil slope away from foundation

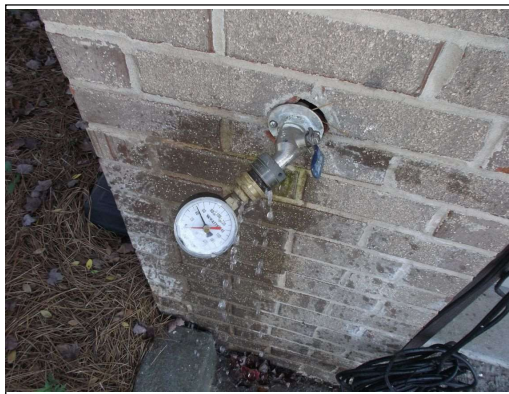
Defective anti siphon device at the hose faucet at the rear of the building and missing anti siphon device at the patio or deck of the building.

Anti siphon device leaks/hole not sealed

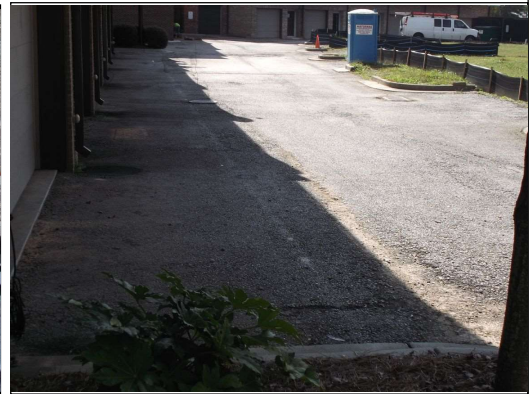
Poor slope and drainage at driveway

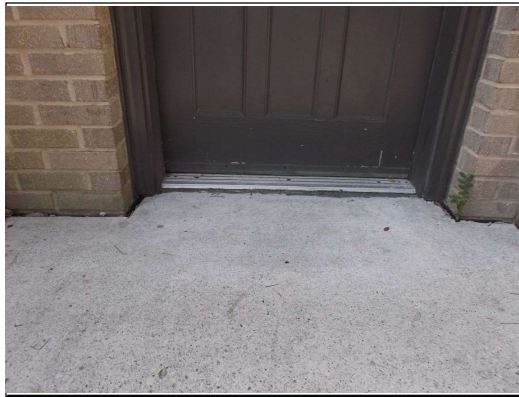
Rear window screens are deteriorating from UV rays. The front door threshold has been screwed down to the floor with non-galvanized screws causing the metal threshold to have poor slope away from interior (can cause water to not drain away from door opening under certain conditions)

Front door threshold defective

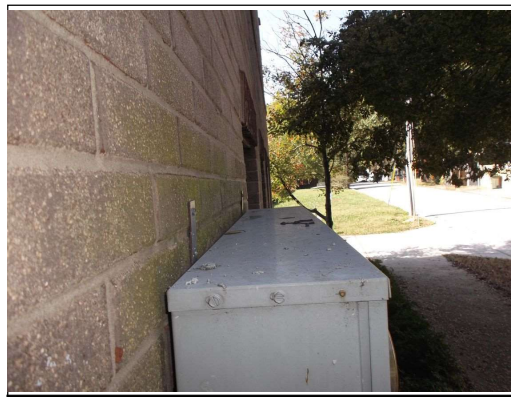
Missing bead of caulk across the top of the panel boxes attached to the brick veneer on the right side of the building (can let water behind and into holes in the brick wall).

Missing caulk across top of electrical boxes

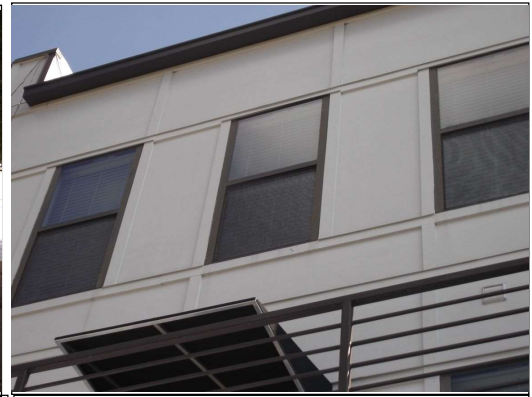
Screens rotting

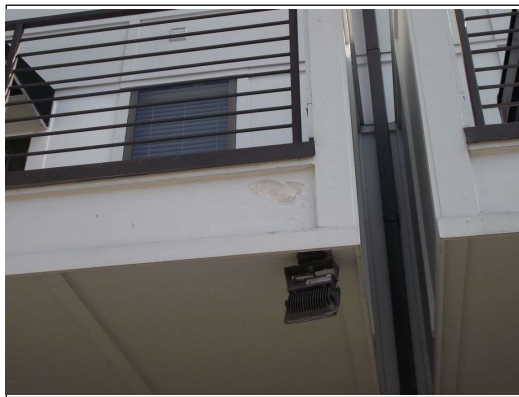
Defective paint at patio floor rim

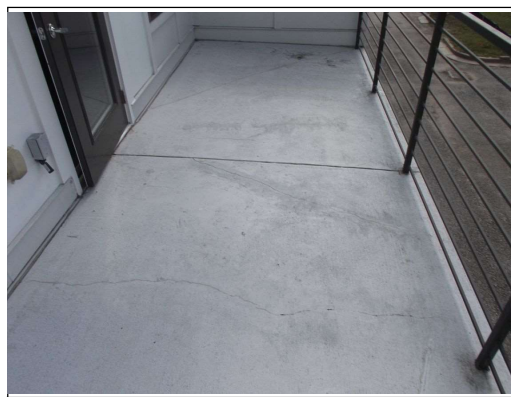
Cracks and excessive sloping in patio/deck

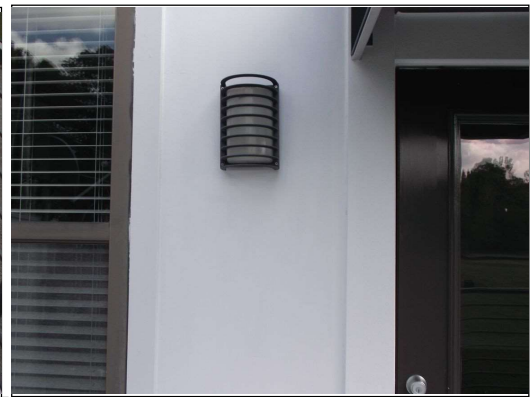
Incomplete painting

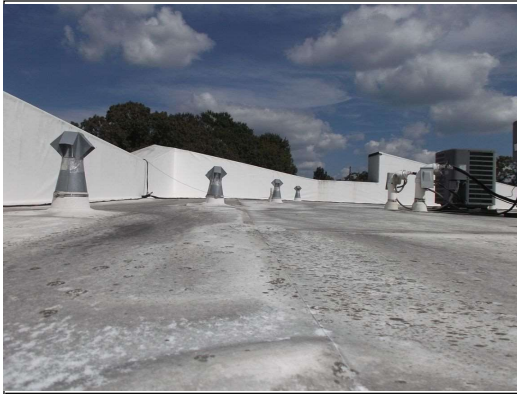
Roof show staining/check laps and seals

Based on the age of the building (2008) and visible roof areas, it is advised to have a professional, commercial roof company inspect the townhouse's roof and provide maintenance condition letter before closing. Verify who is responsible for roof covering, roof leaks, roof replacement... i.e. HOA or townhouse owner.

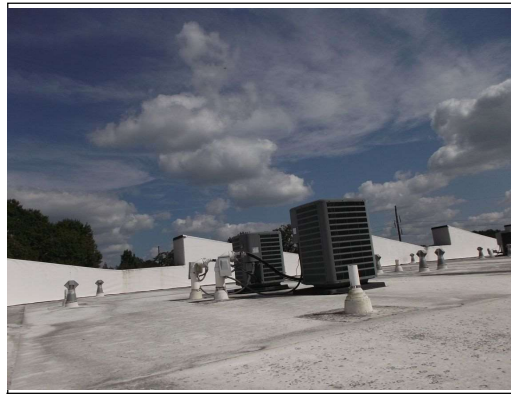
Penetrations in roof near master bath ceiling

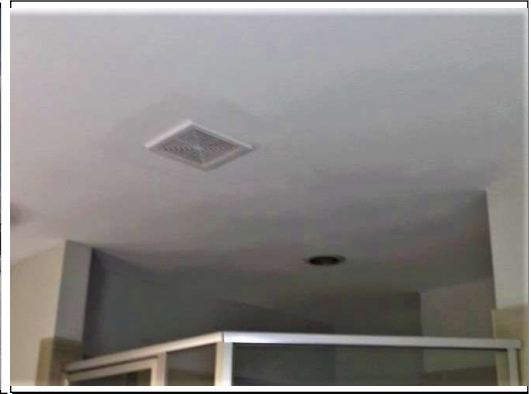
Stains painted over@ master bath ceiling area

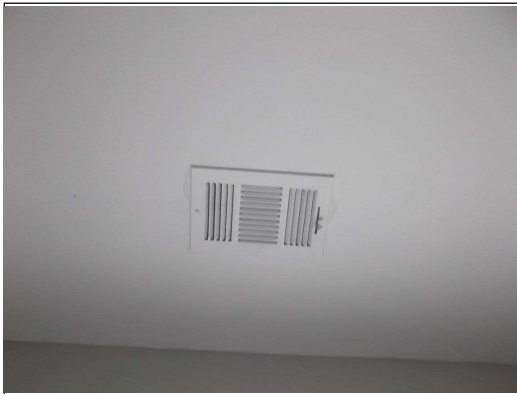
Ceiling stains at rear bed air vent

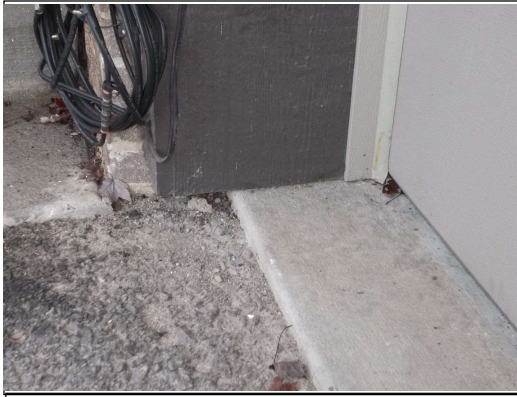
Vehicle door frame side jambs contact the concrete floor (should be a air gap to prevent termite entry and water absorbing. The water heater closet door threshold is loose and not supported (can be damaged and detached when continued walking on).

Vehicle door frame contact concrete floor

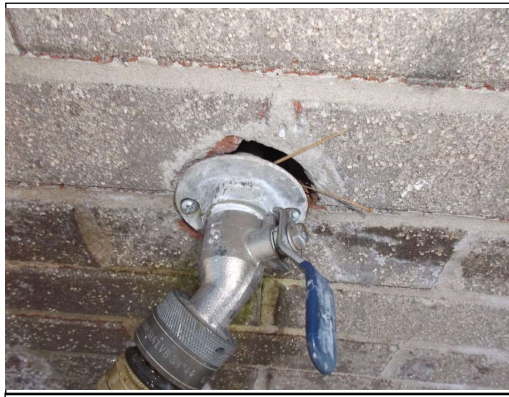
Opening in the brick veneer

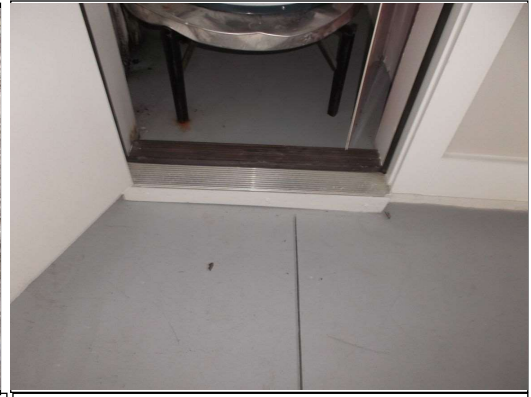
Door threshold not fully supported

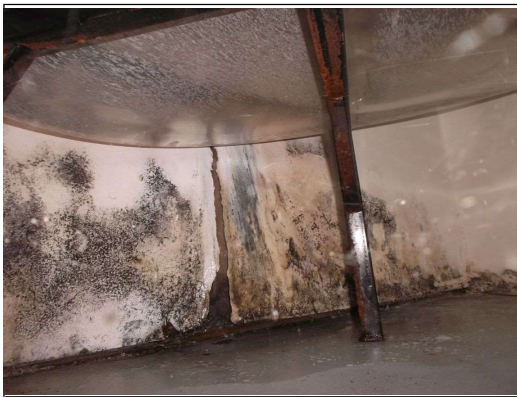
Pipe leaking in the water heater closet has caused major water saturation to wall, mold like substance on sheetrock and sheetrock damage (verify there is no wall framing and wall materials damaged behind sheetrock). Verify water leak has been repaired ASAP to prevent further damage.

Major water intrusion and damage at wall

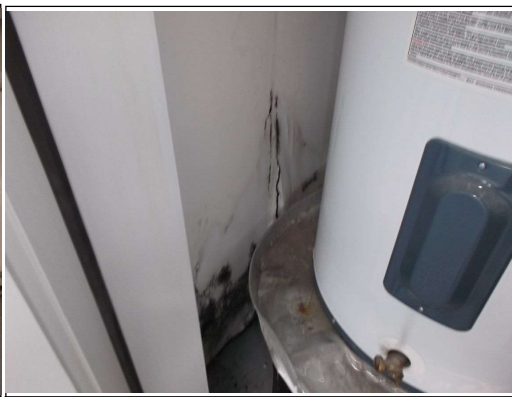
Water in and coming down wall

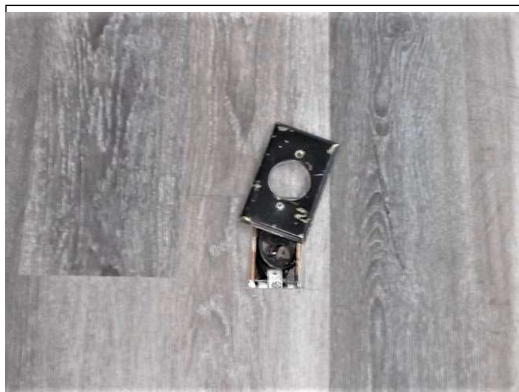
Defective receptacle in the great room floor and cover plate is defective (install properly and verify accessible).

Floor outlet unsafe and defective

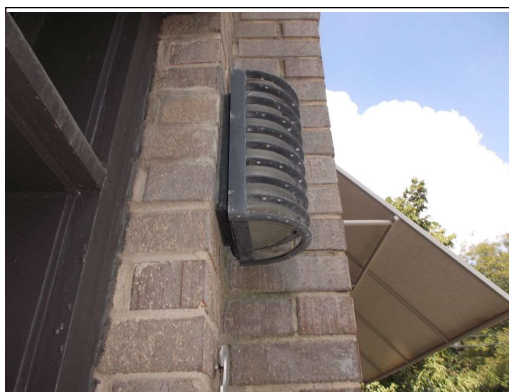
Front light did not illuminate

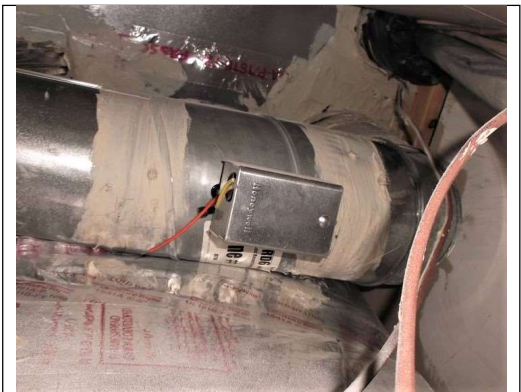
Damper wires not connected to source

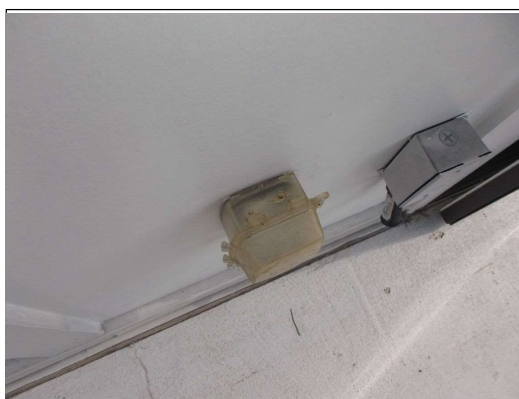
The front door exterior light did not illuminate when switched on. Verify building supplied flood lights are operational at this townhouse. Electrical outlet box in the exterior wall at the patio is loose and missing a caulk seal or proper gasket to prevent water from getting into the wall space.

Missing caulk at electrical boxes/box loose

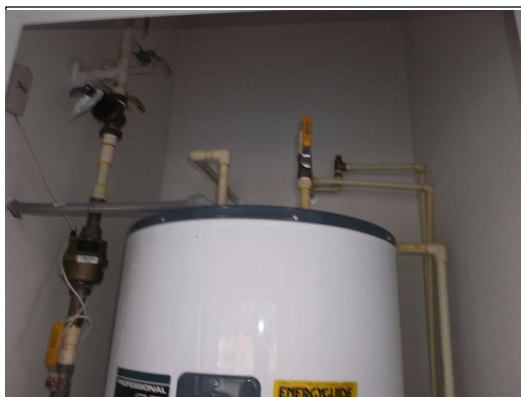
There is no expansion tank installed above the water heater. There is water leaking in the wall at the left of the water heater. The water heater drain pan has been crushed and bent.

No expansion tank above water heater

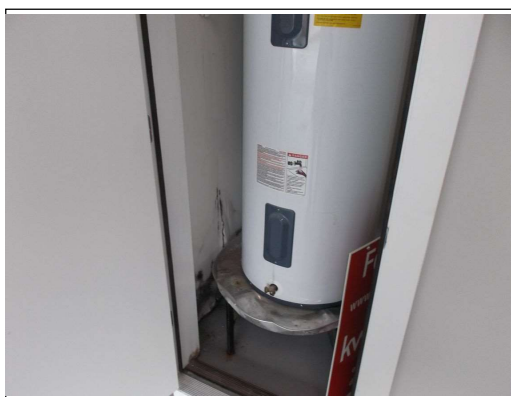
Water leak in wall left of water heater

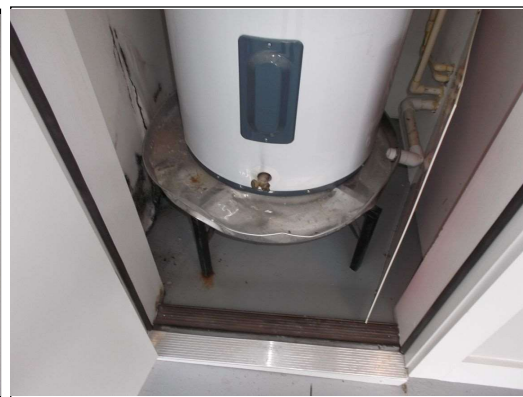
Drain pan bent and crushed

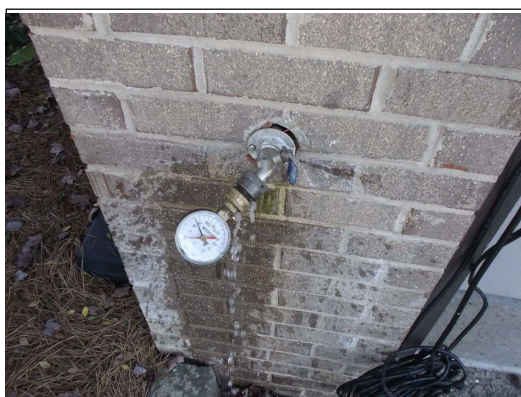
The rear hose faucet has a defective and leaking anti siphon device. The hose faucet at the patio is missing a anti siphon device.

Anti siphon device leaking when water on

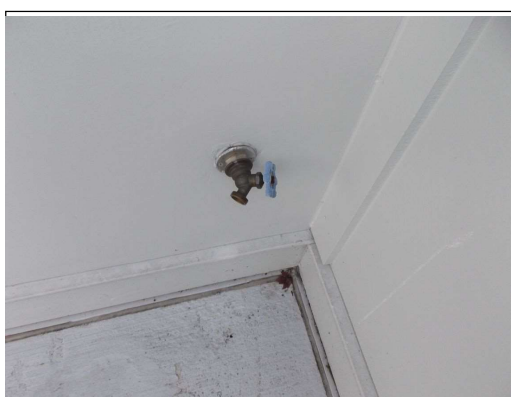
Missing anti siphon device on hose faucet

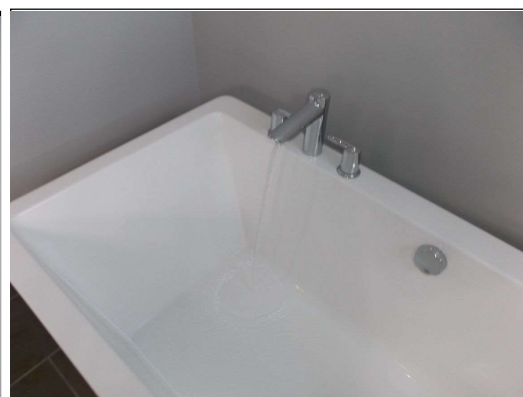
There was low water flow noted at the master tub and rear bed faucets.

Low water flow at tub's faucets

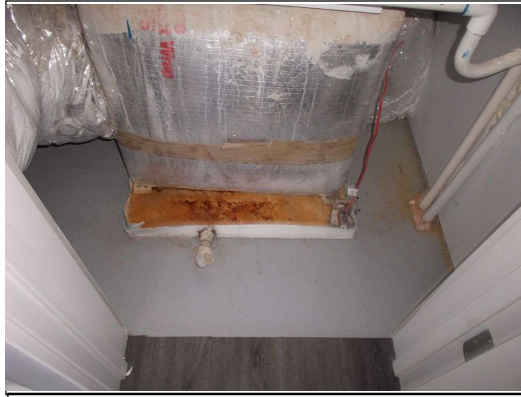
The main floor furnace has rust stains in the drain pan and air filter had rust stains; the evaporator coil inside the air handler above the furnace has a little rust at areas. Verify there is no condensate issues or heat pump defects in the HVAC system. Missing filter door at both furnaces.

Rust in main floor furnace drain pan

It is advised to have both HVAC systems checked for maintenance and operation before closing.

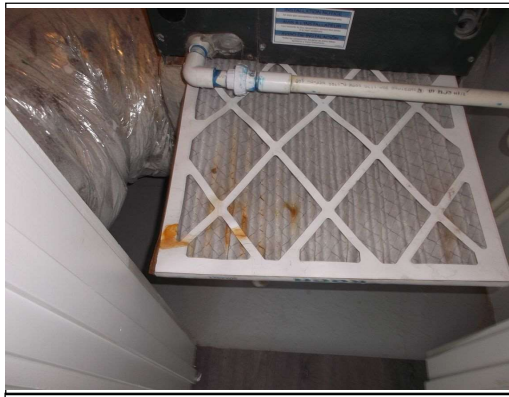
Rust stains on main floor furnace filter

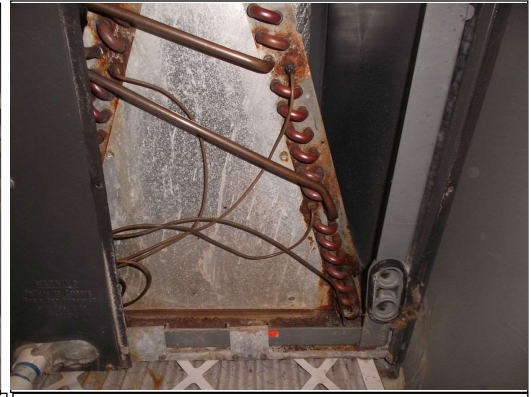
Rust on evaporator coil

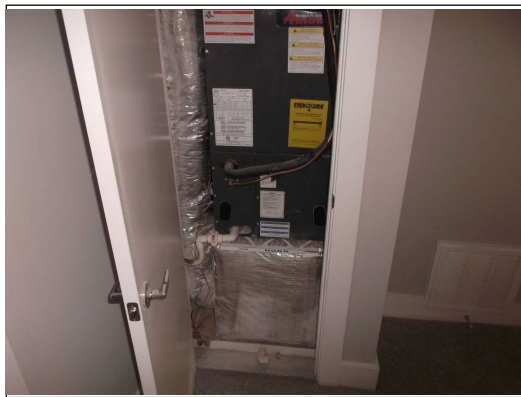
Missing filter door at 3rd floor furnace

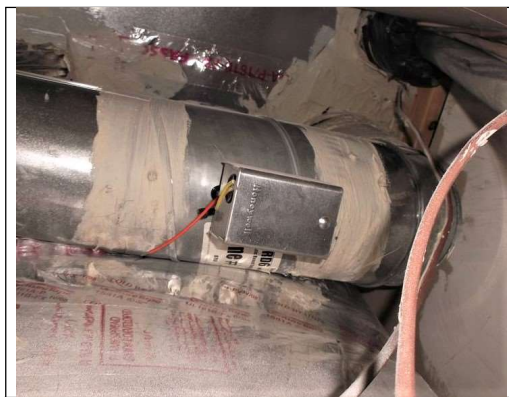
Damper not wired to electrical source

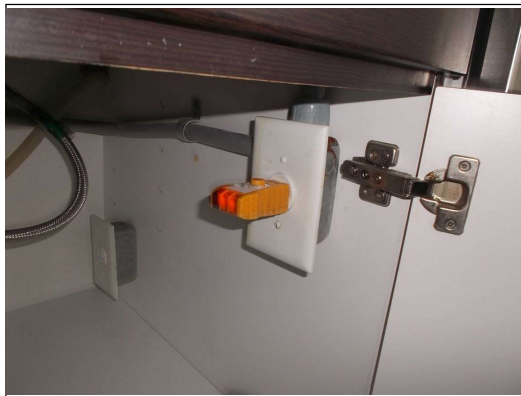
Outlet did not trip when tested

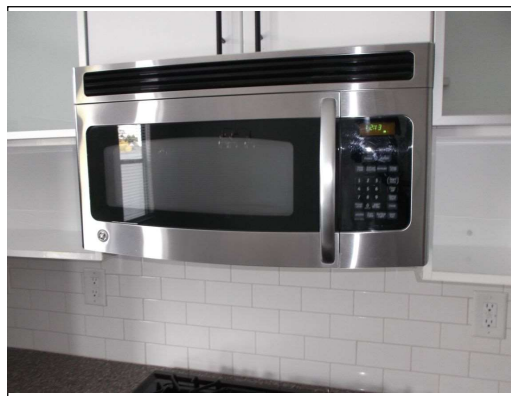
Microwave door loose at hinges

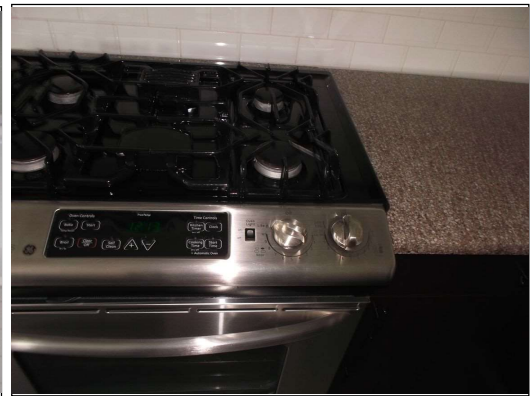
The stove right rear gas burner did not light.

Rear right burner not operational

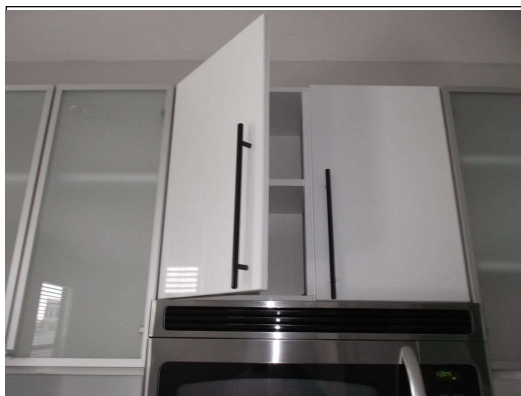
Loose door hinges at wall cabinet

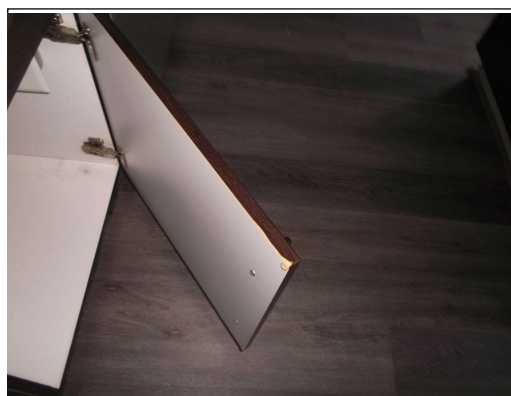
Laminate peeling at sink cabinet door

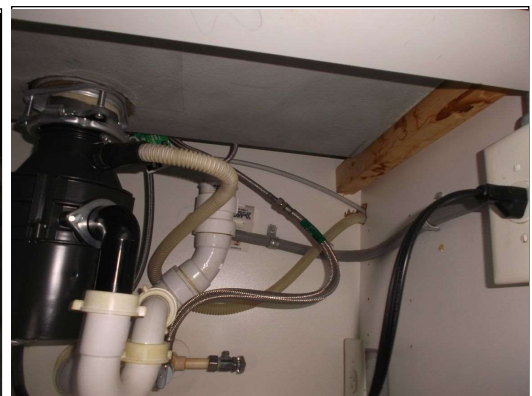
The dishwasher drain pipe is not high looped up to the sink counter and back down to the sink drain pipe and then connecting (under certain conditions sink water can go back into the dishwasher drain pipe).

Dishwasher drain pipw not high looped up

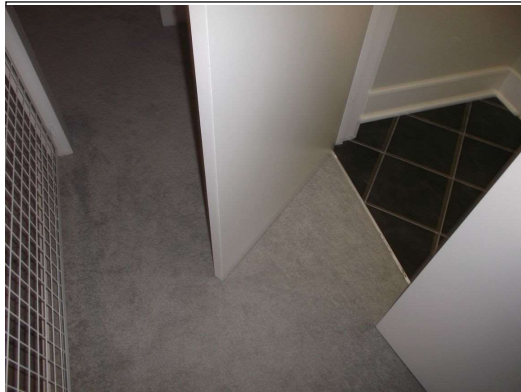
Laundry room doors drag on the floor and latches are restrictive when closing and opening doors. Missing shoe molding on baseboard behind washer drain pan.

Door drags on the floor

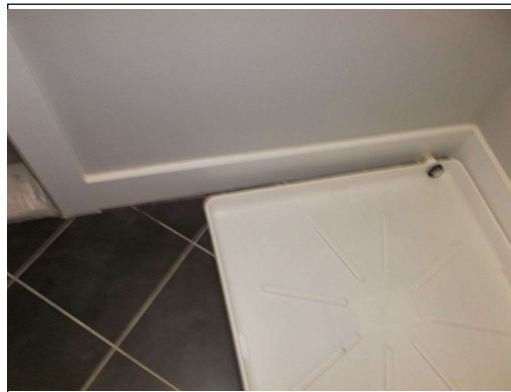
Missing shoe molding at baseboard

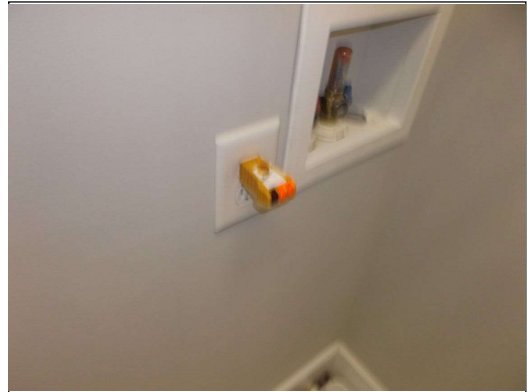
Outlet no GFCI protected

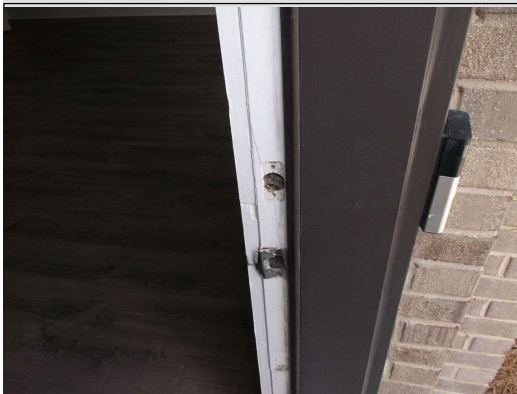
1st floor front entry door frame wood is split at the strike plate and trim has been cut and partially replaced (the deadbolt strike plate was not put back onto the door frame, bottom strike plate has only one screw holding it into place). The front door entry lock is not striking the plate properly and sealing the door closed at the weather strip (can see daylight at the weather strip when the entry door is closed).

Front door frame split/missing strike plate

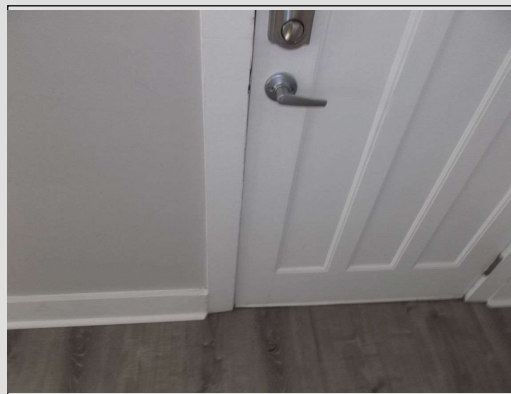
Daylight at the front door

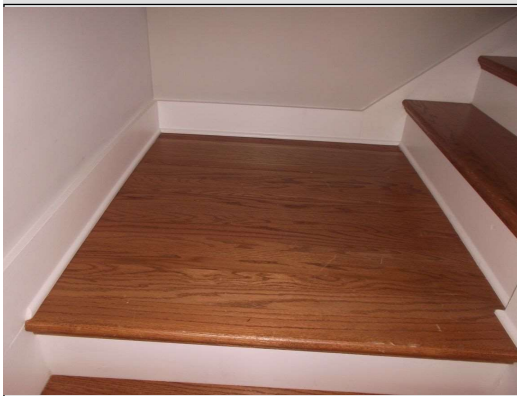
2nd floor: Stairs leading up to the 2nd level landing flooring has gaps between boards; the stair handrail appears to be too wide and can be a safety hazard when trying to grip during during stair travel or a fall (stair railings should be between 2 and 2.8 inches wide for optimum grip).

Gap in landing flooring boards

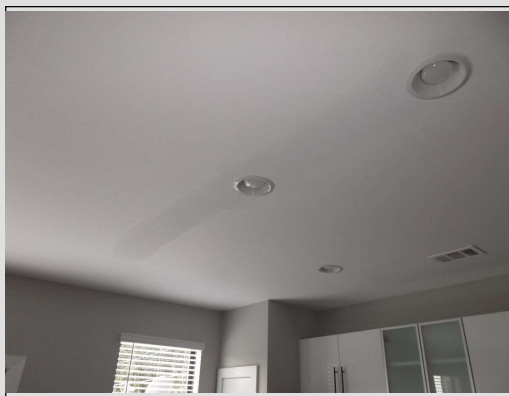
Can see touch paint in the kitchen ceiling and the great room ceiling (verify there are no water leaks above).

Stains painted over

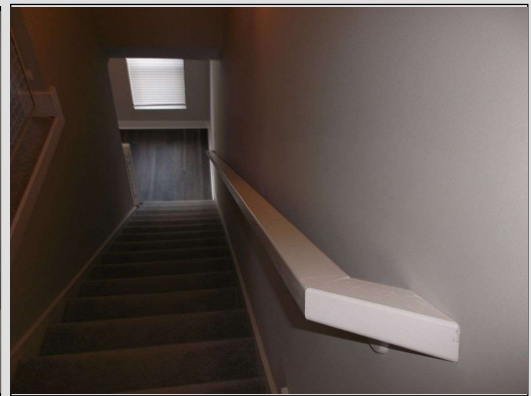
Handrail too wide

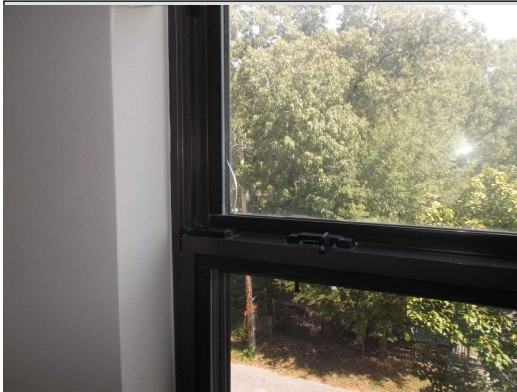
Front bedroom door rubs door frame; crack in left window glass at the front wall;

Crack in front bed glass

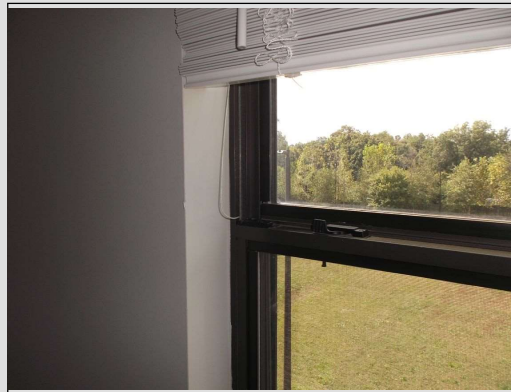
Bedroom window sash cord defective at the left side; left window could not let all the way down to be locked; right window sash cord defective.

Defective sash cord at rear bed window

Seller is advised to check all windows for conditions found and verify all windows are properly operating.

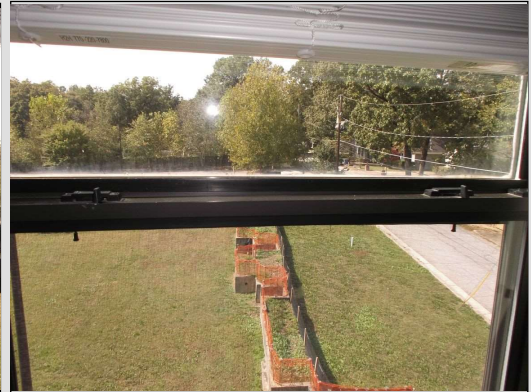
Could let down and lock rear bed window

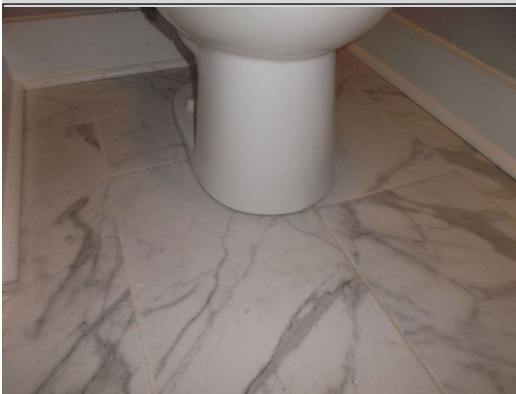
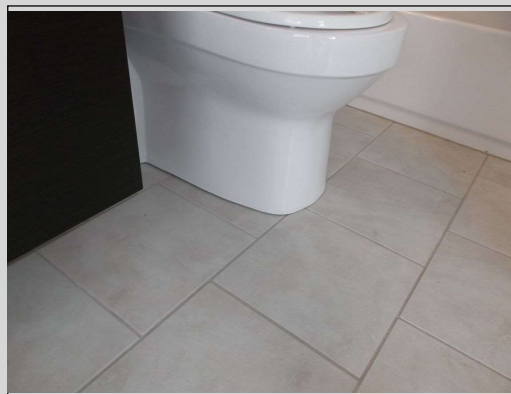
1st floor 1/2 bath and the 2nd floor 1/2 bath toilets missing a bead of caulk around the toilets where the toilets rest on the floor.

Missing bead of caulk on the floor

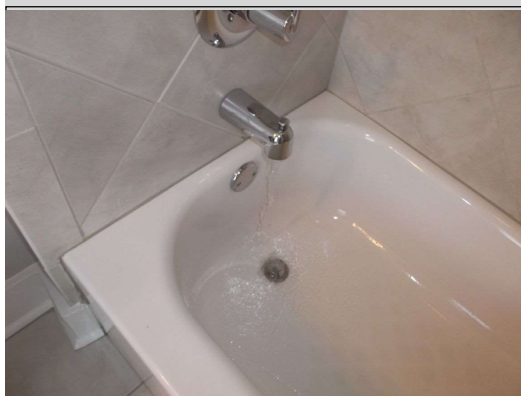
Rear bedroom bath tub faucet has poor or low water flow. The mirror glass was broken at the right side while cutting.

Low water flow at tub spout

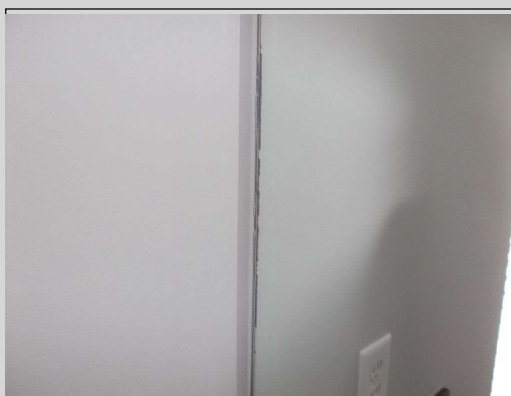
Mirror glass broken

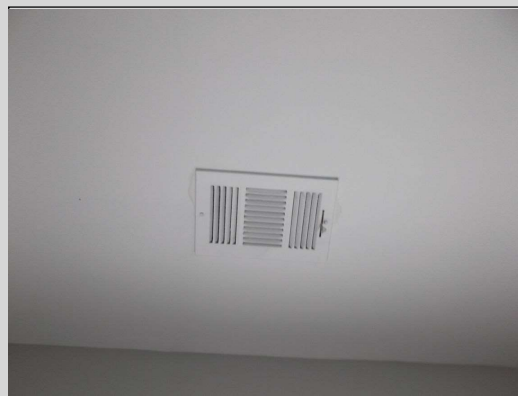
The rear bedroom bath door rubs on the floor, there is no caulk where the toilet rest on the floor, there are small dry stains on the sink cabinet floor. There are dry water stains around the air vent in the bath ceiling (verify there are no roof leaks or leaks above the ceiling). Can hear the furnace vibration when in the toilet room. Toilet missing caulk where it rest on the floor.

Dry stains at ceiling at vent

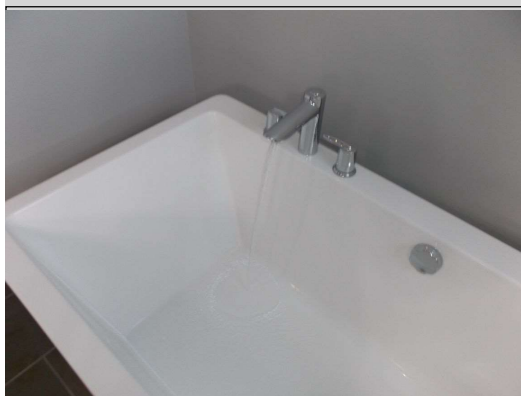
Master bath: Poor water flow at the tub spout. There appears to be several areas of touch paint visible in the master bath ceiling (verify there is no roof leak or leaking above the ceiling).

Low water flow at the tub spout

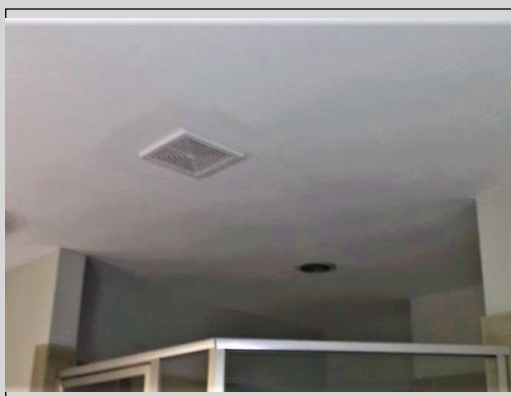
Master bath toilet missing caulk where it rest on the floor, can hear furnace vibration noise when in the toilet area, defective painting in the ceiling (verify there is no roof leaks above master bath ceiling). The linen closet door rubs the door frame.

Paint patching in the master bath ceiling
