# Property Inspection Report

4152 Magnolia Glen Walk, Norcross, GA.

Dec 16, 2020

1599

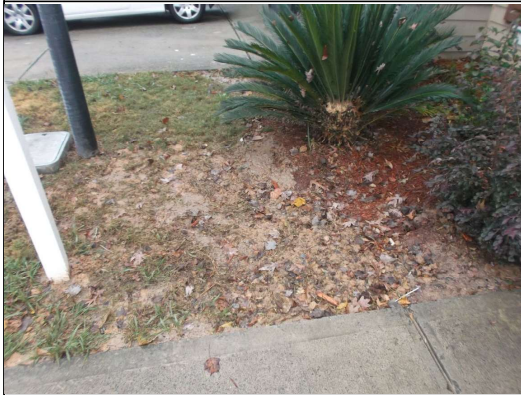
Front yard dug up, sink hole in the front yard (fill hole, install ground cover to prevent erosion and water logged yard. Moderate settling crack in the driveway near the house foundation. Patio needs pressure wash.

Yard dug up, sink hole, exposed soil

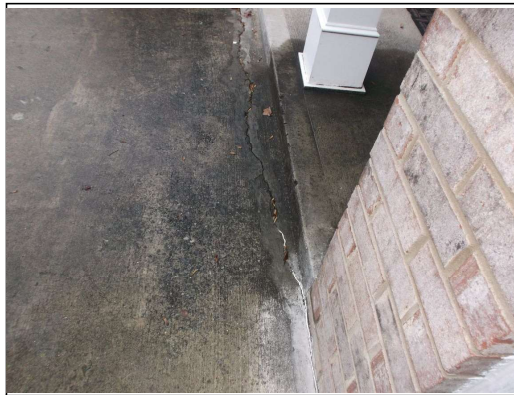
Moderate crack in driveway at front porch

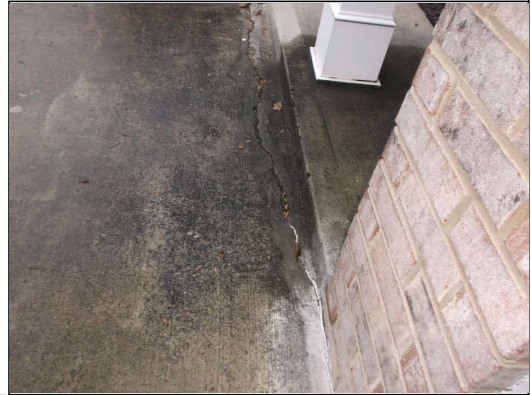
Driveway needs pressure wash

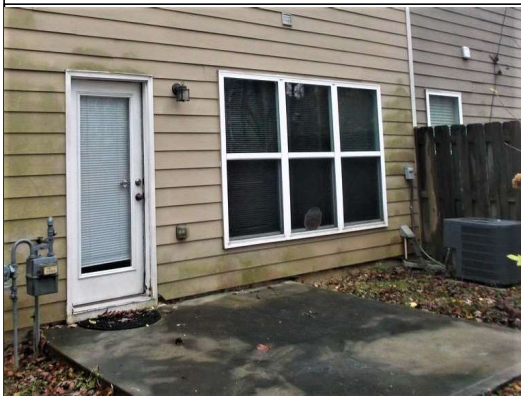
Patio needs pressure wash

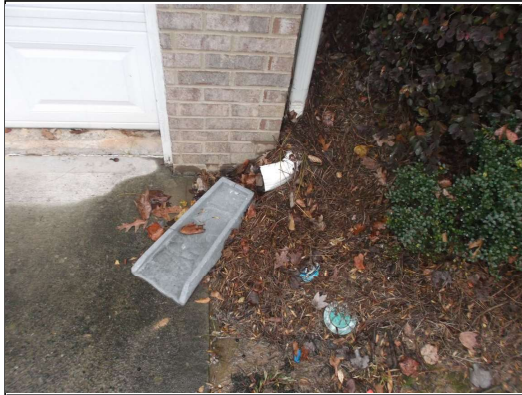
Route downspout away from garage

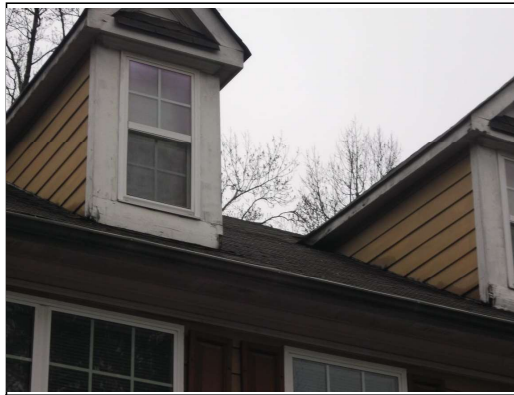
Siding touch roof ans some water intrusion

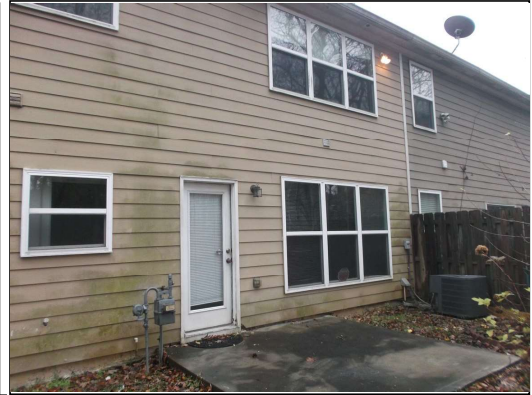
Rear siding and patio needs pressure wash

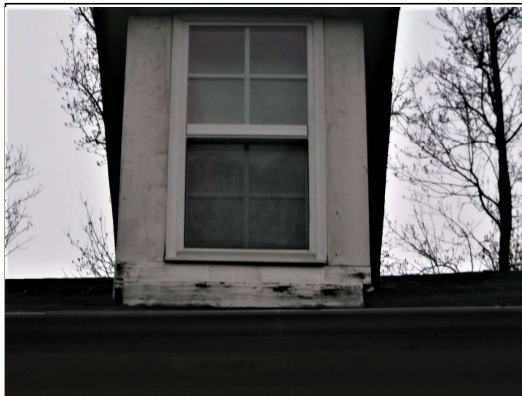
**Comments** Trim has water damage.

Water damage at dormer trim

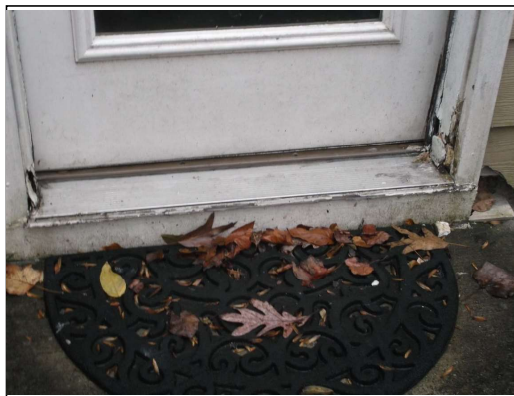
**Comments** Rear door has water damage at the door frame and threshold.

Water damage to rear door frame & threshold

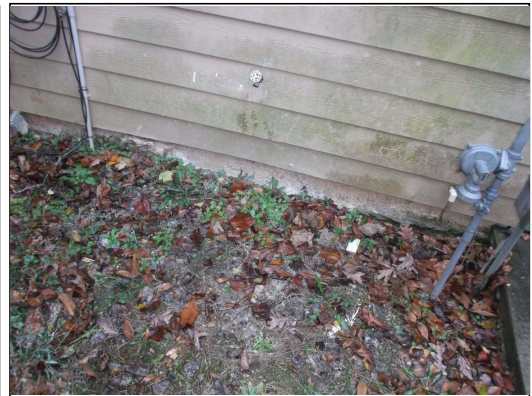
**Comments** House wall sits out past the foundation at the rear of the building;

Some of the rear wall installed off the slab

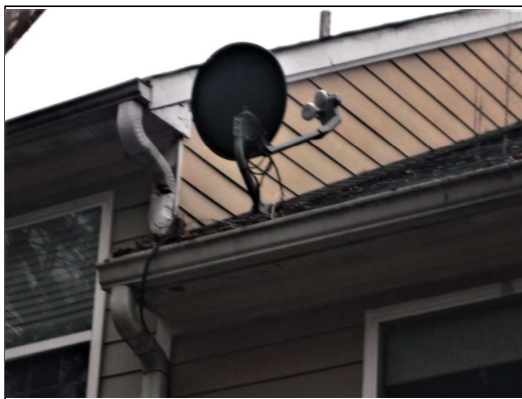
Dish bolted to the roof

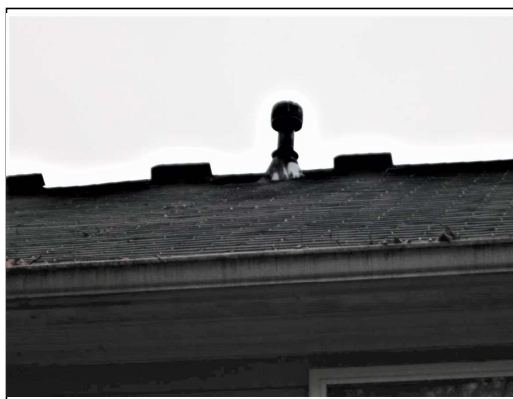
- Condition**  Satisfactory  Marginal  Poor  Not Visible  Not Present  
**Comments** Some vent pipe flashing appears to be installed on top of shingles and face nailed (can leak over time)

Pipe flashing installed on top shingles nailed?

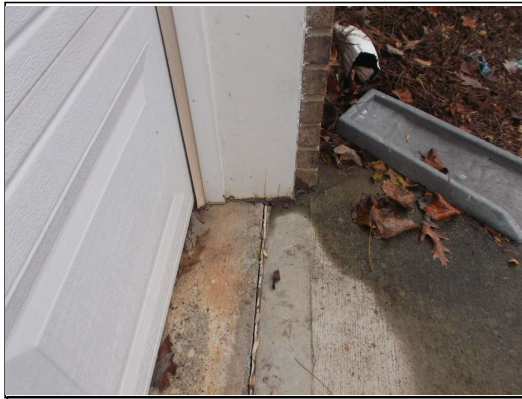
Vehicle door frames contact concrete

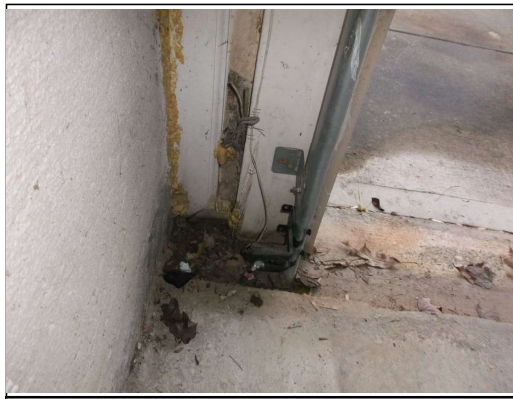
Water damage inside garage at vehicle door

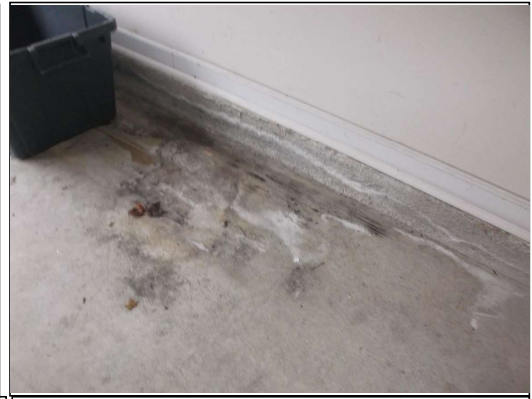
Dry water and calcium stains on the floor and concrete knee wall behind the garbage can.

Dry stains

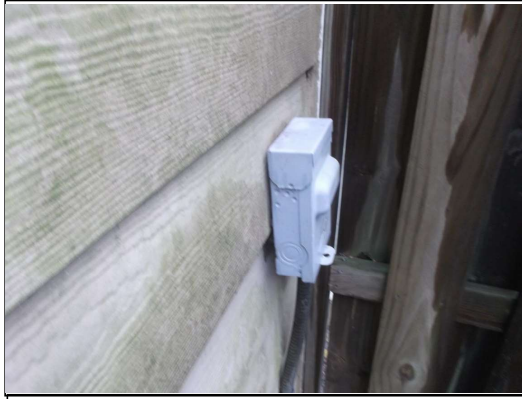
Missing caulk bead at the top of the AC box

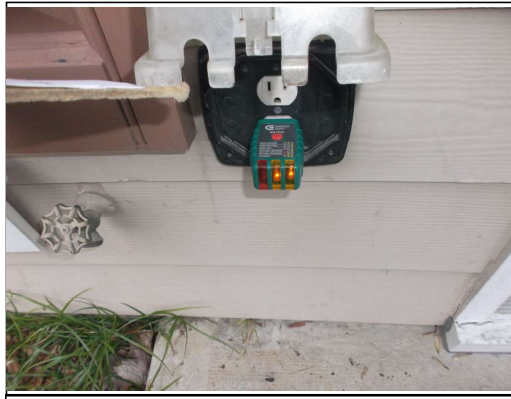
Front and rear outlets not GFCI protected

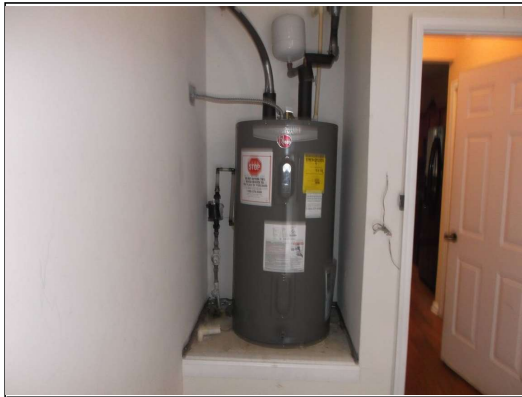
No drain pan under water heater

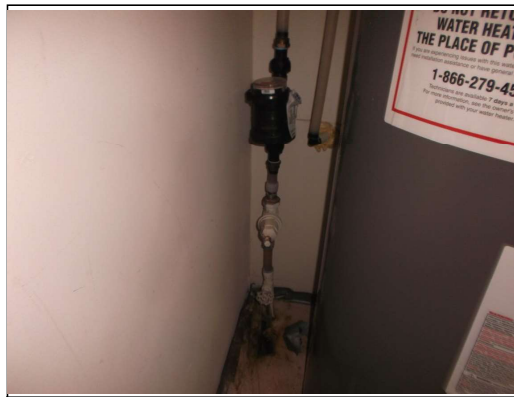
Pressure gauge wet under the bottom (leak?)

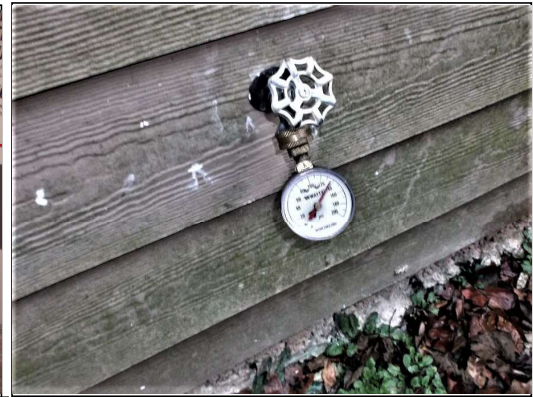
Water pressure is very high (can cause damage to fixtures);

Water pressure 135 psi is very high!

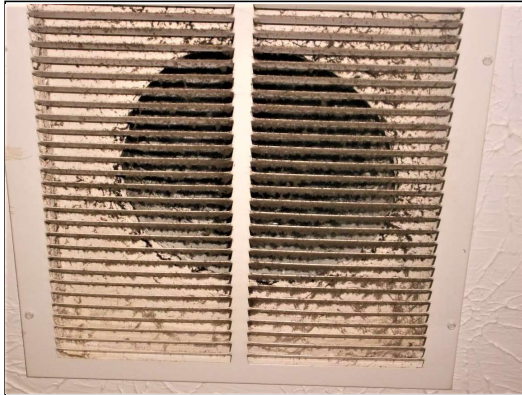
Air duct system dusty and dirty.

Air duct system dirty and dusty

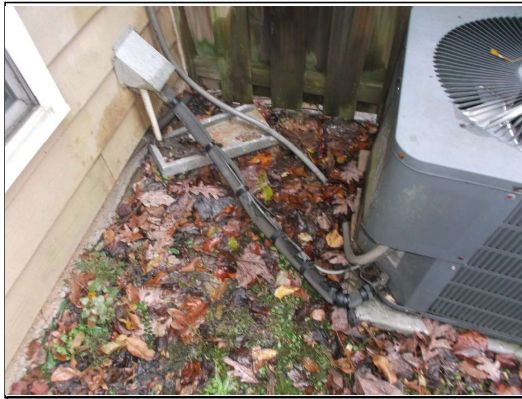
Refrigerant line insulation deteriorated

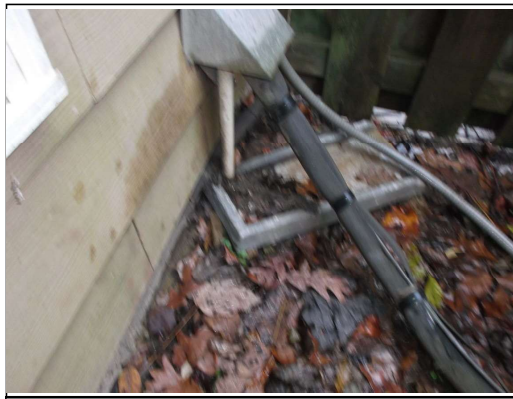
Condensate pipe not extended away

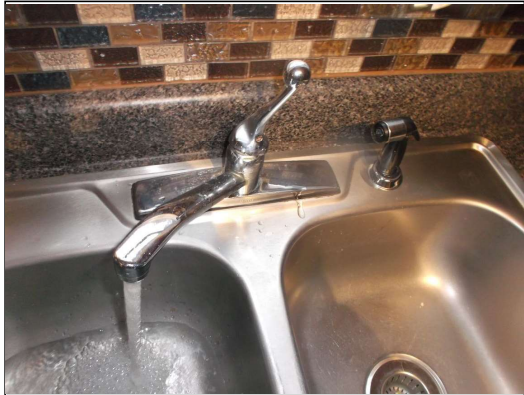
Faucet leaks at handle

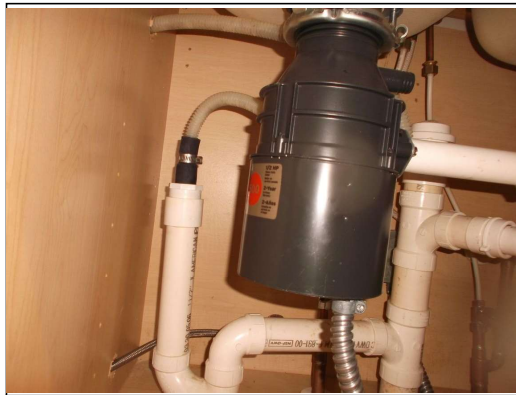
Dishwasher drain pipe not high looped

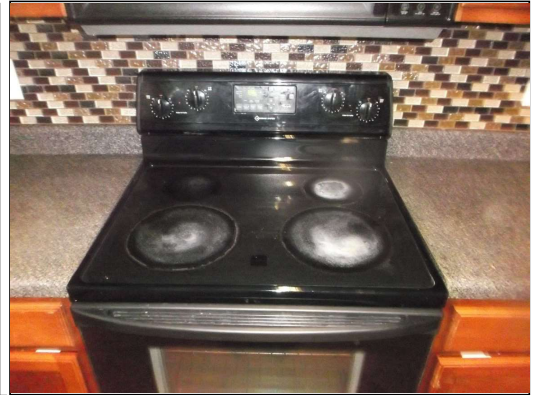
Stove top glass corroded & no anti tilt device

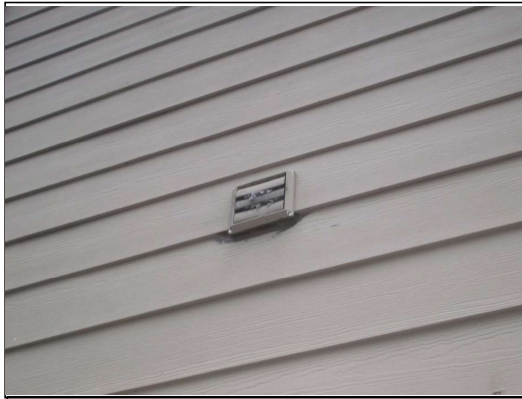
**Maintenance:**  
 Vent terminal at for the dryer at the exterior wall clogged with lint and wrong type (there shall be no grills not louvers on vent terminal)

Wrong type of vent terminal for dryer

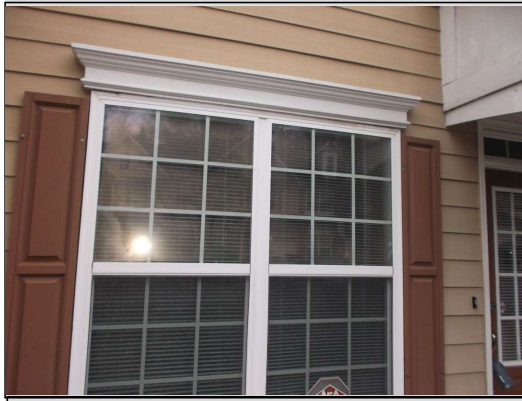
Top window sash fogged

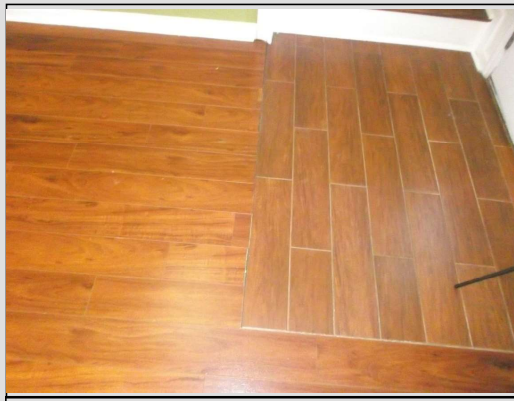
Gaps at repaired flooring at front door

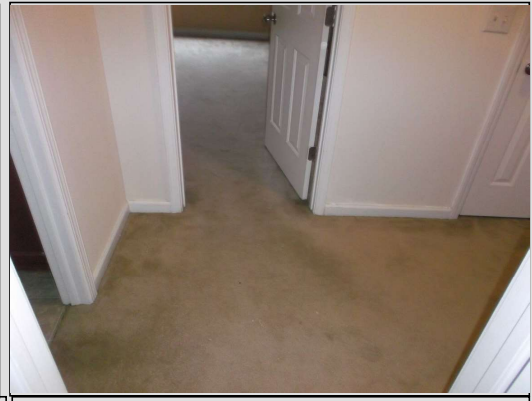
Front bed floor slopes to master doorway

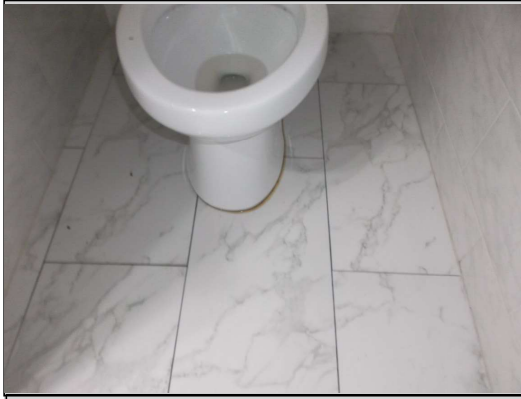
Toilet has loud seeping noise when flushed (high water pressure can damage valves); verify toilet seal at the floor is not leaking (stain on floor);

Verify stains on floor not leaks

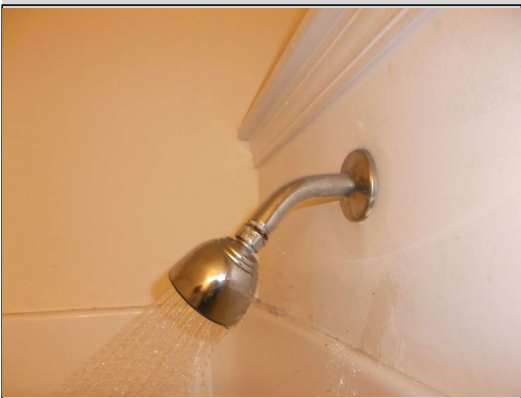
Master shower head leaks onto wall

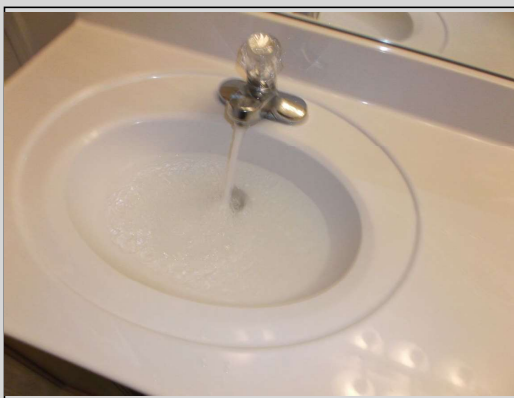
Left sink water slow to drain out
