## INSPECTION REPORT

Address: 1073 Mayson Turner Rd NW Atlanta, GA 30314

These are the general results for "Water Intrusion Conditions" at the home, property or structure located at the address above. This is not a warranty but it is a visual inspection and survey of the systems and components of this property based on National Professional Guidelines.

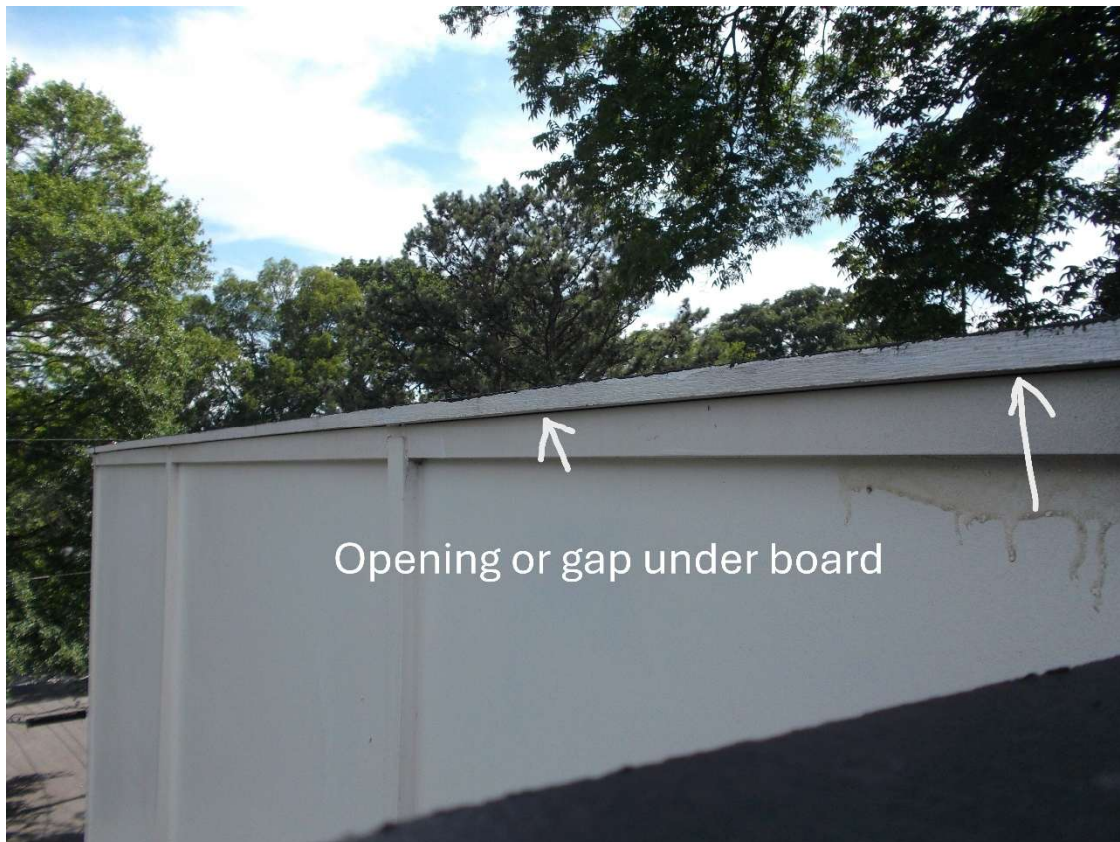
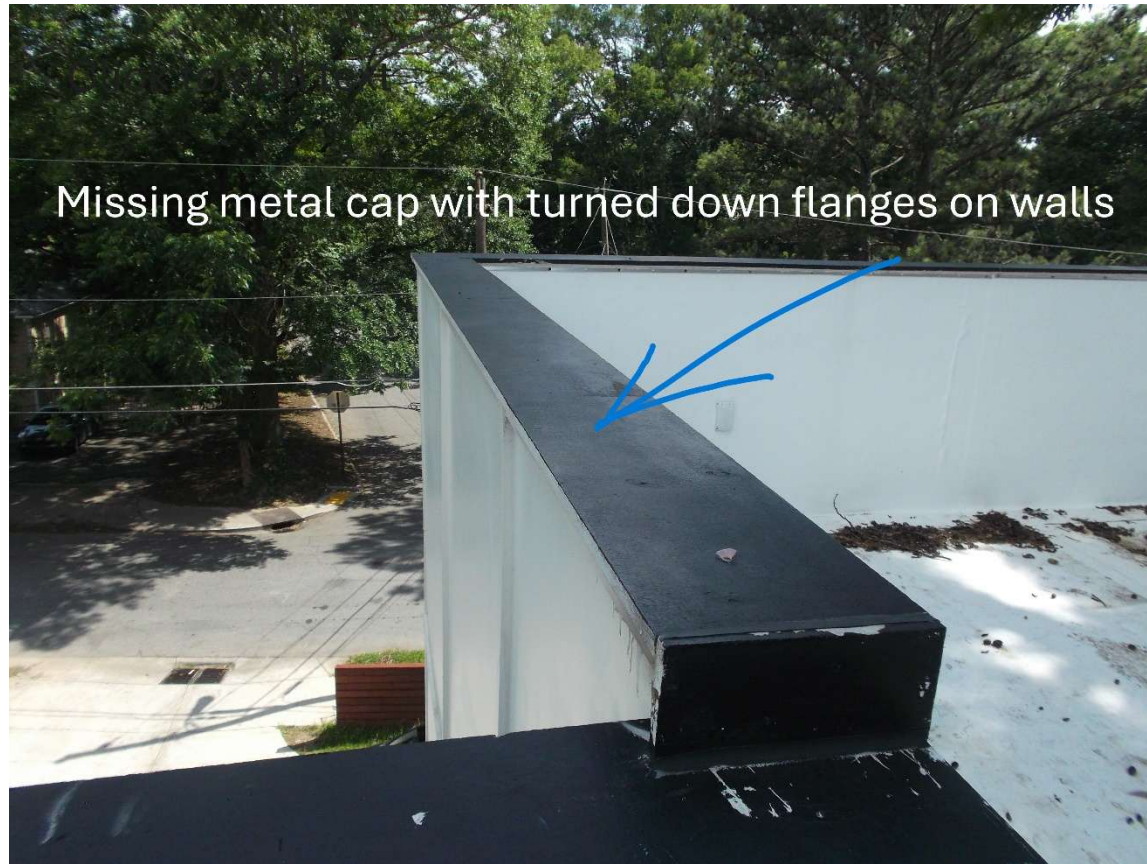
1. There is no metal cap with turned down rims on both sides of the top of the parapet walls all the way around the roof perimeter. Contractors or roofer installed only a piece of 1 by 8 cement fiber board on the top of the wall and left off the metal caps. Water is pouring over the board and entering the joints where the siding ends under the cap board. This water intrusion is running down into the wall behind the siding all the way down to the first level exterior walls. The roofer did install the rubber fastener or metal transition strip under the board (to hold the roof rubber onto the wall) which is correct on the roof side of the wall and installed a bead of 50-year caulk seal at the metal strip. It is advised to have a sheet metal contractor install the cap flashing as required.

Missing metal cap with turned down flanges on walls

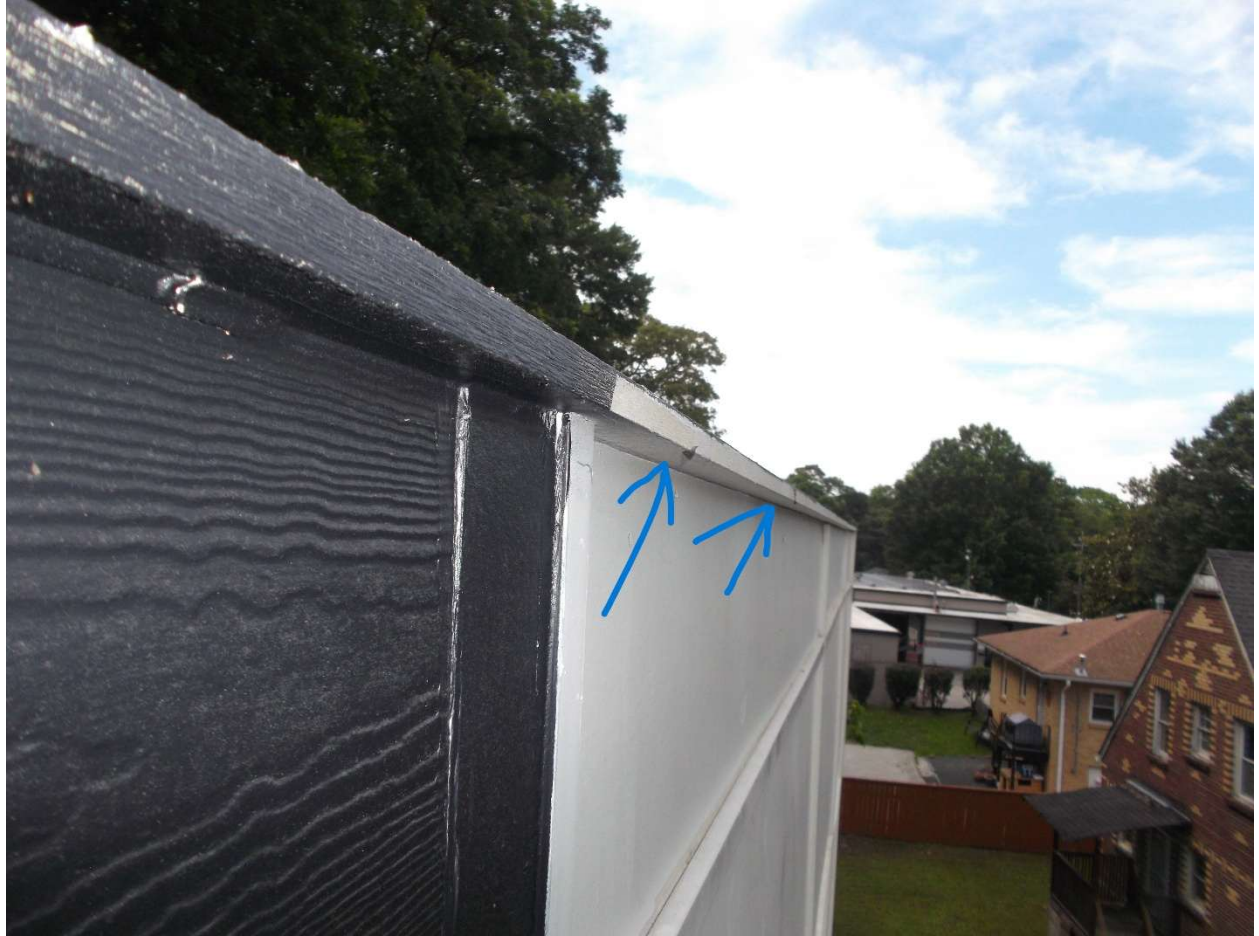
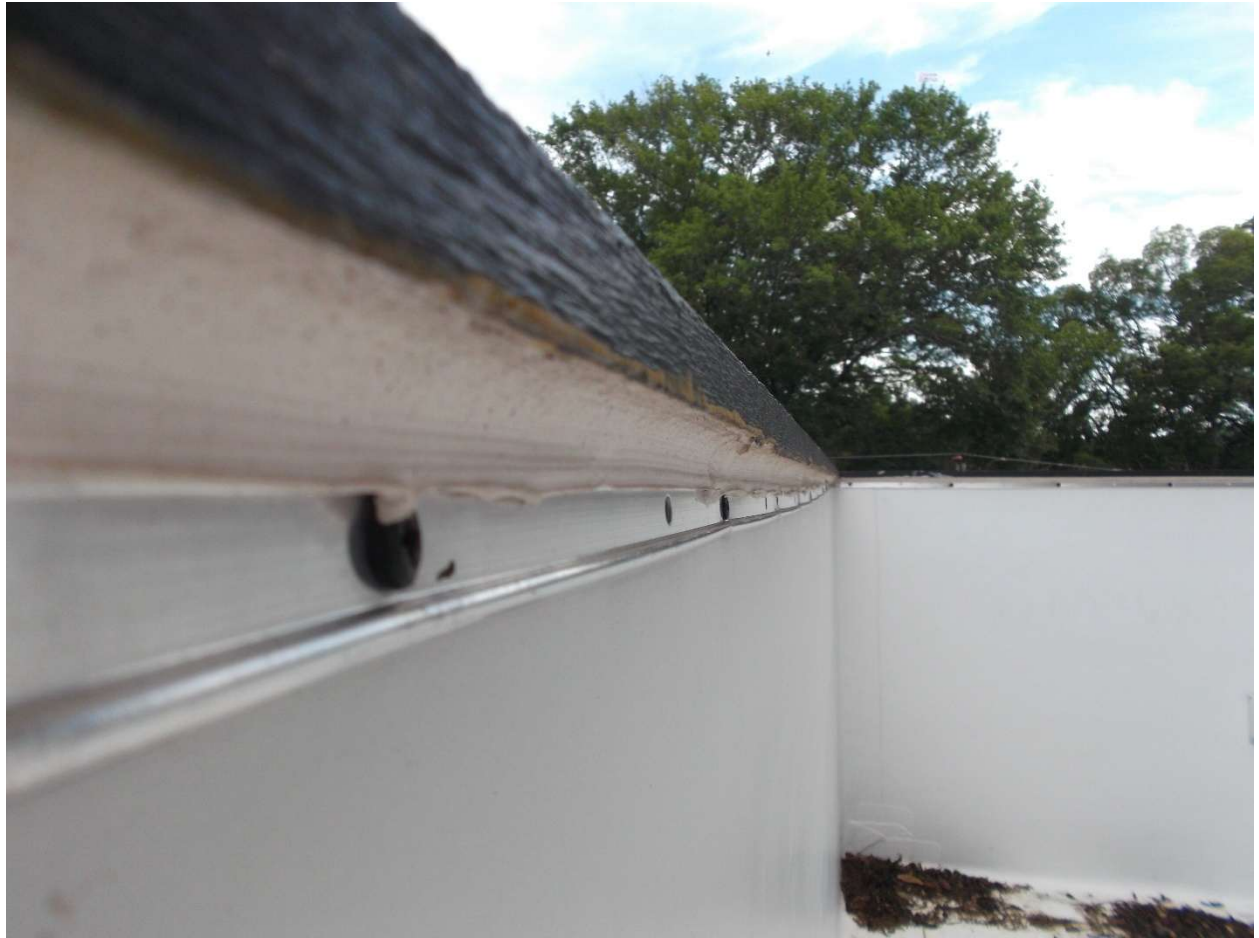
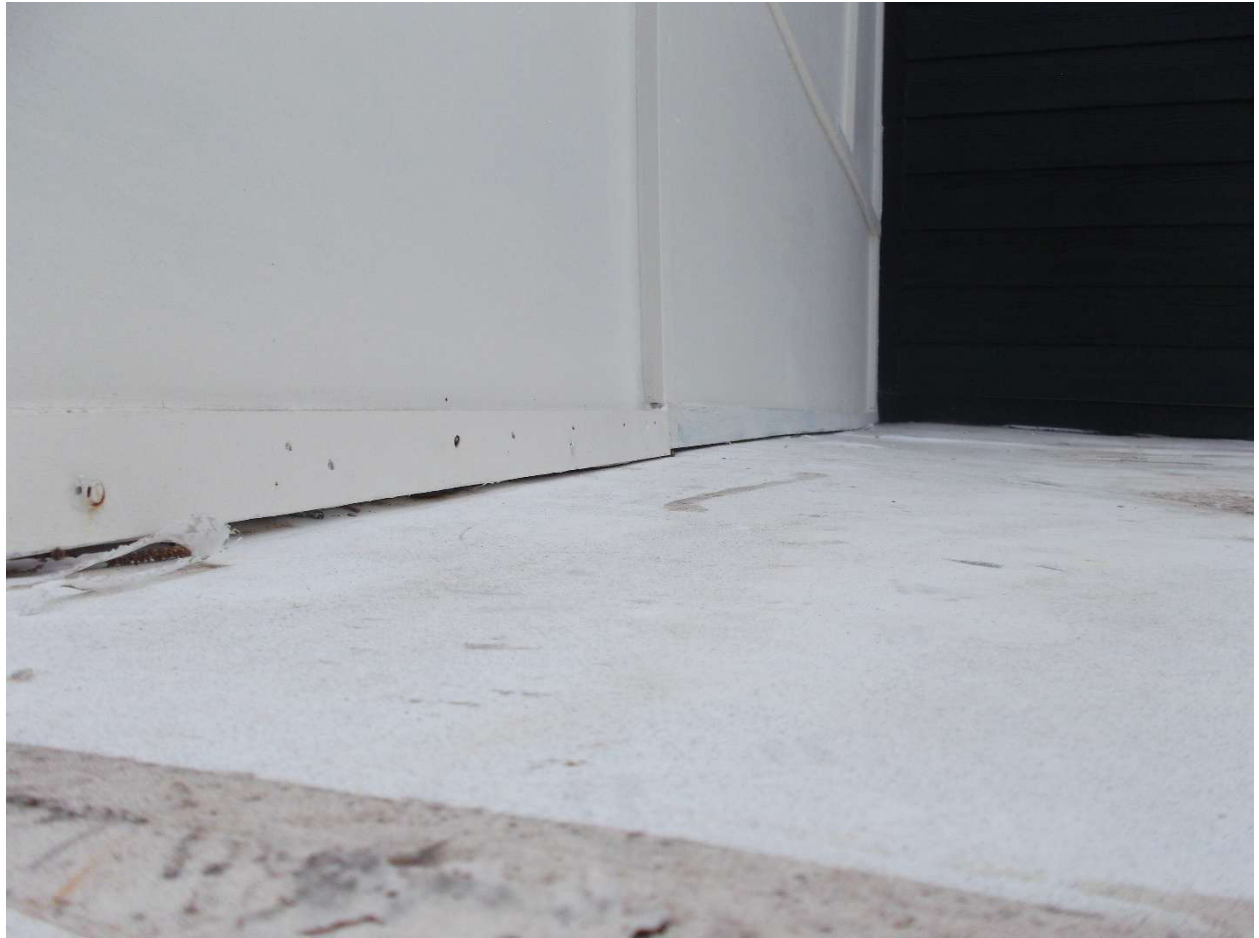
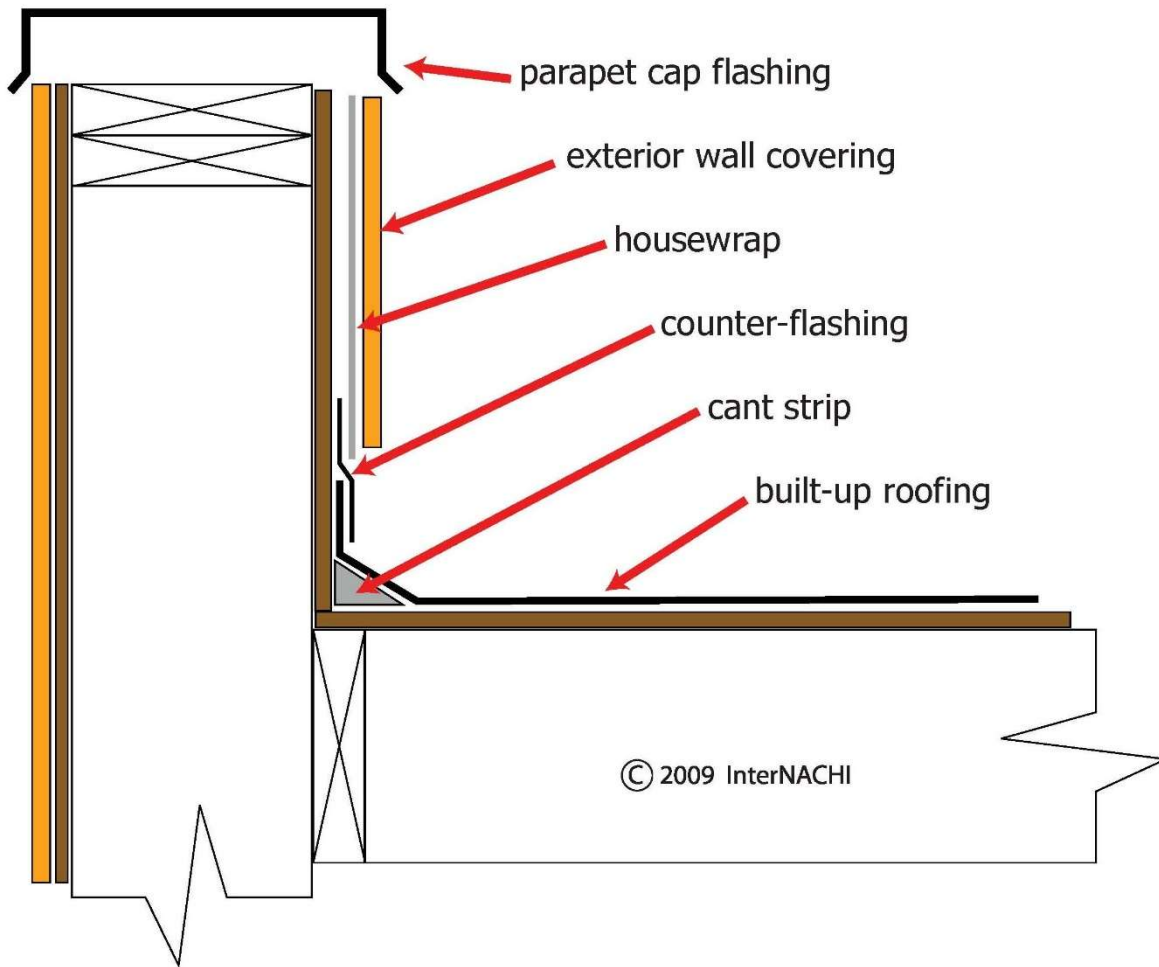
## Parapet Wall Flashing

3. Because there is a missing metal cap on top of the parapet walls around the roof perimeter and a gap between the siding and the underside of the cap board, there may be water entering the exterior walls behind the siding at many areas. Can see bulging siding at the right side of the side door.

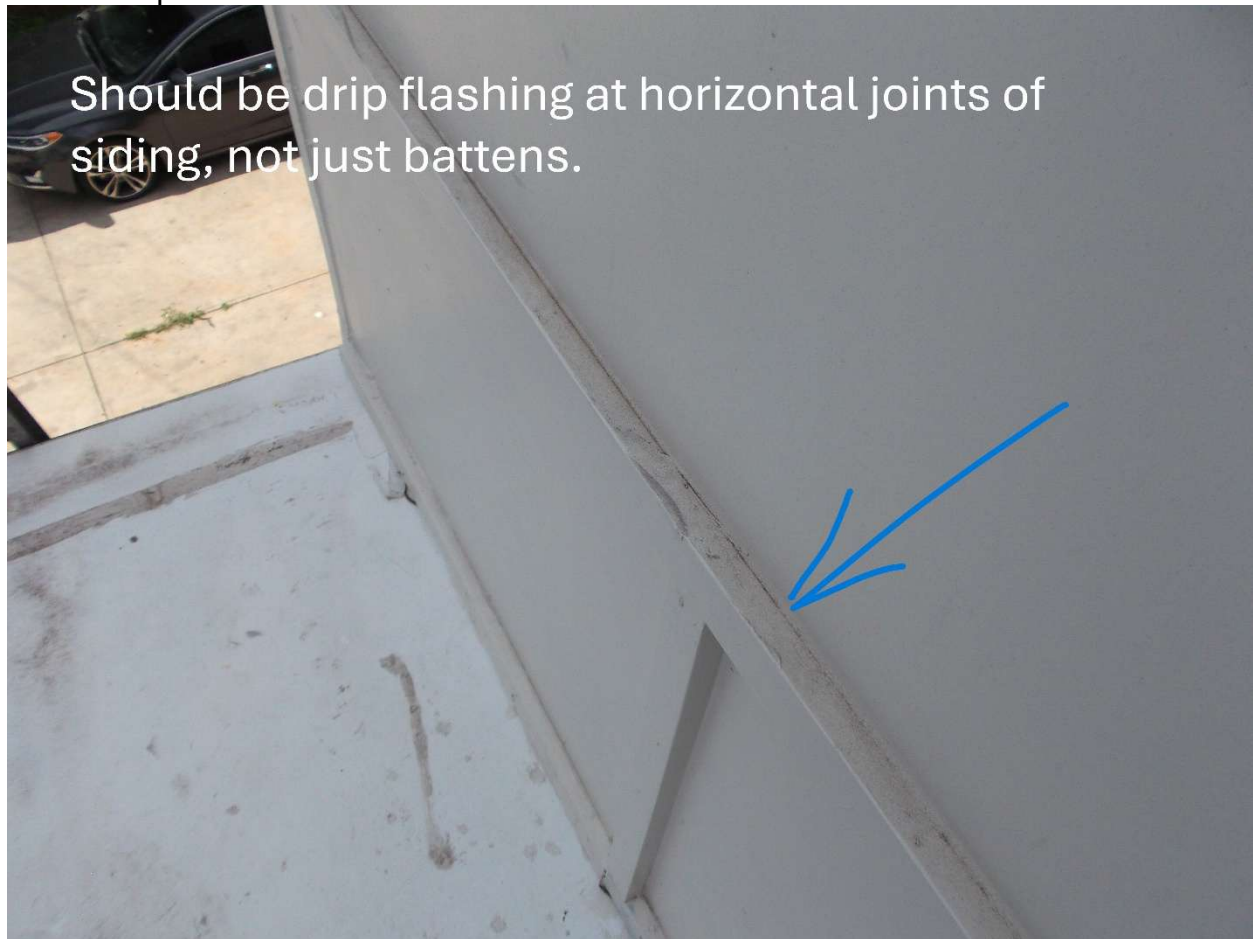
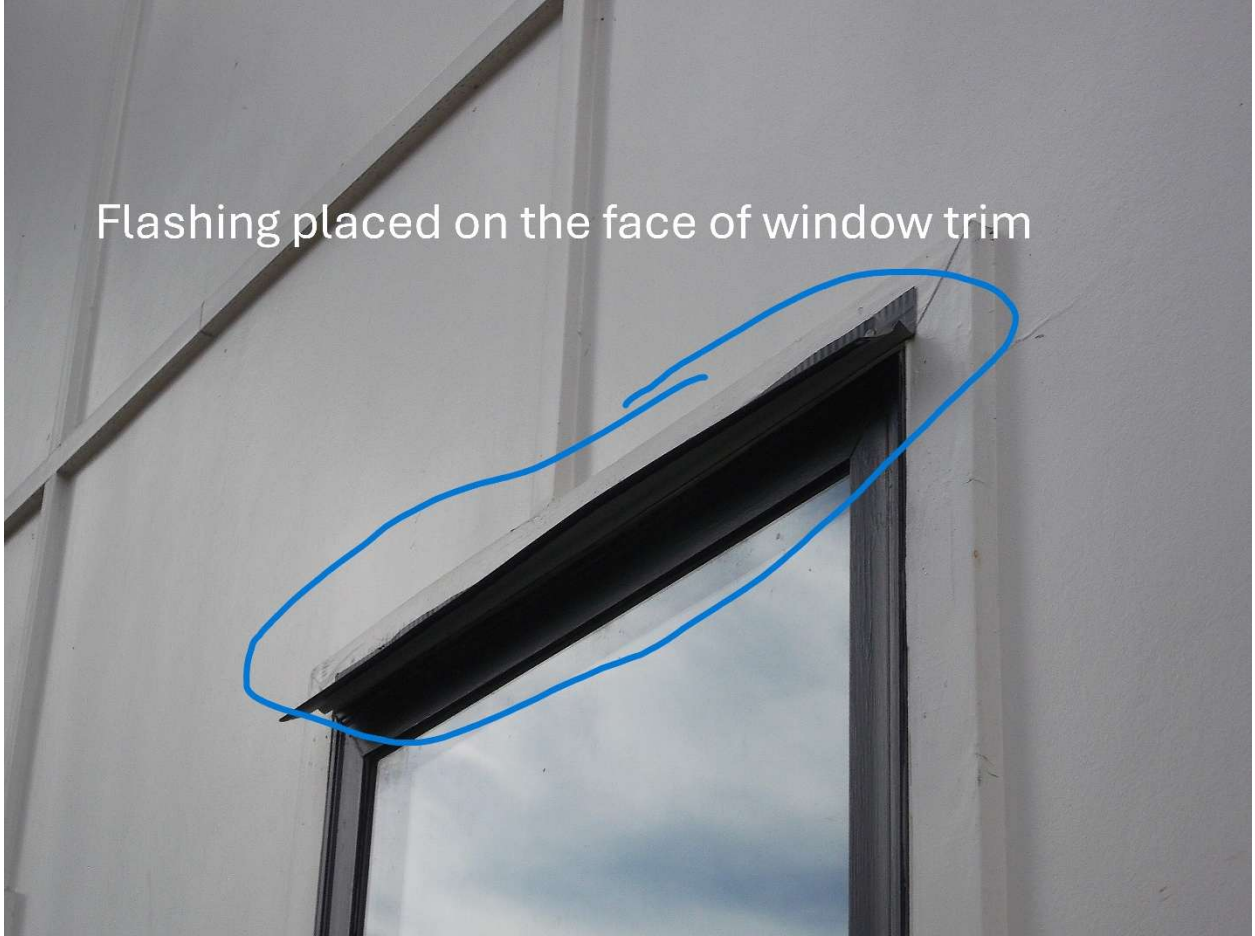
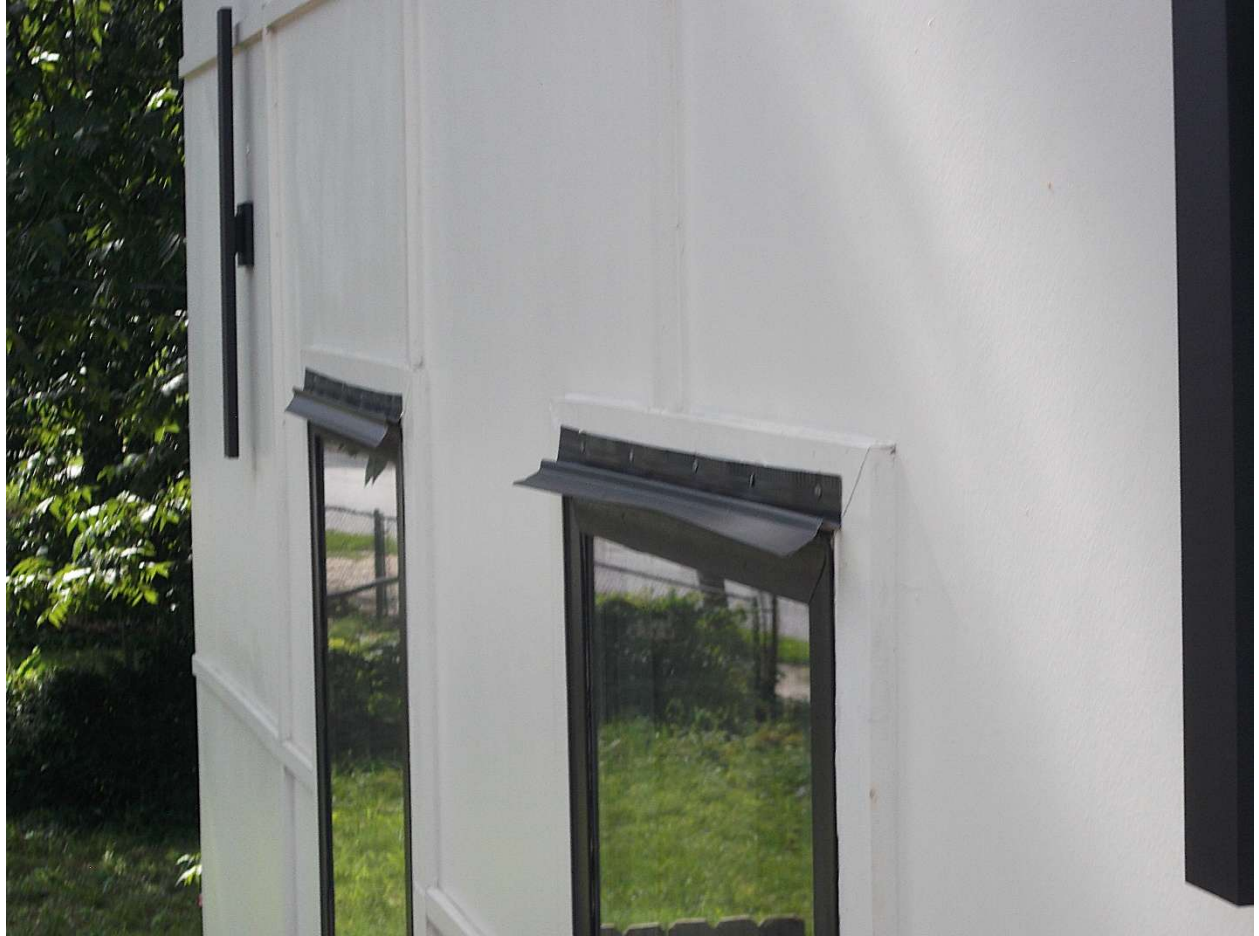
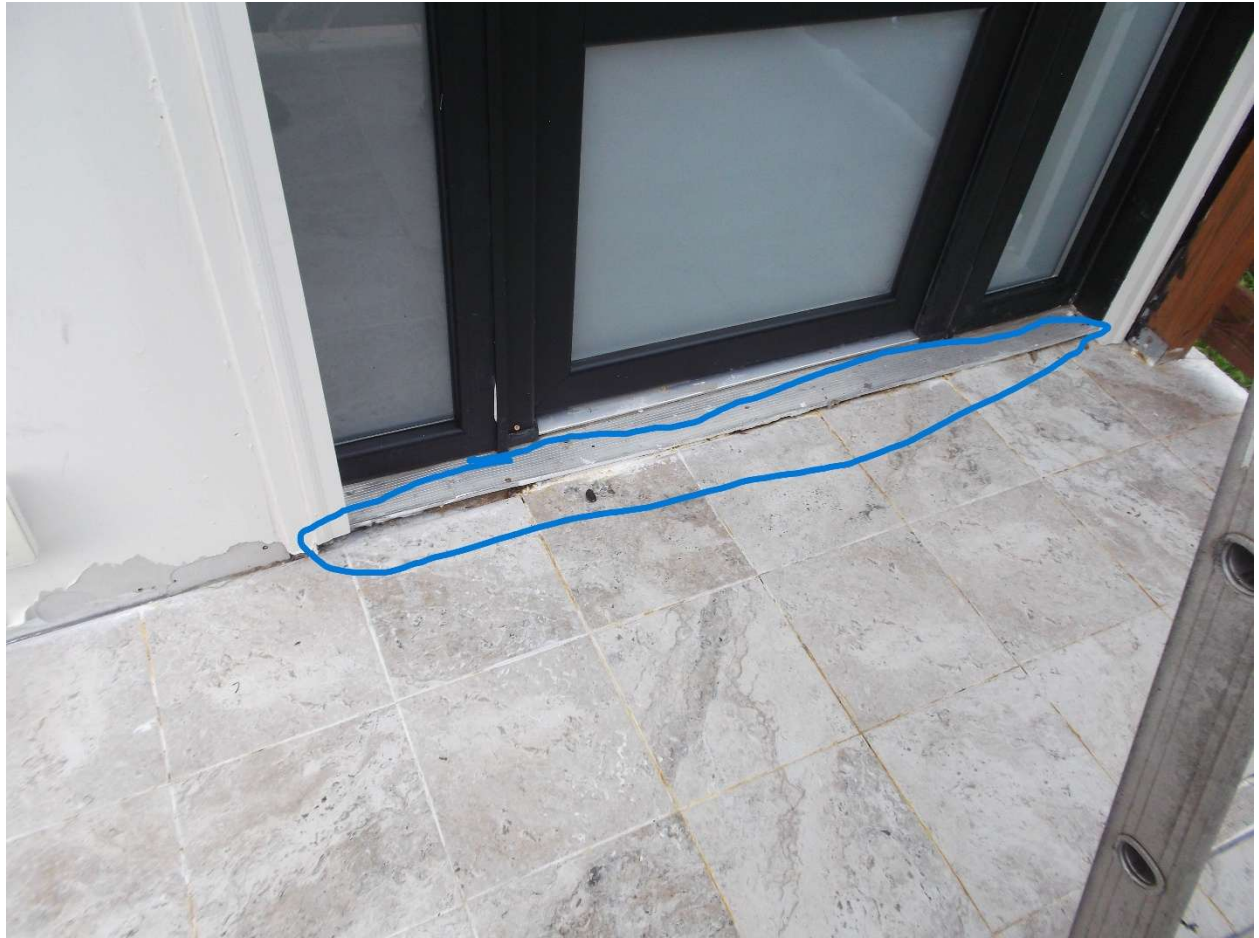
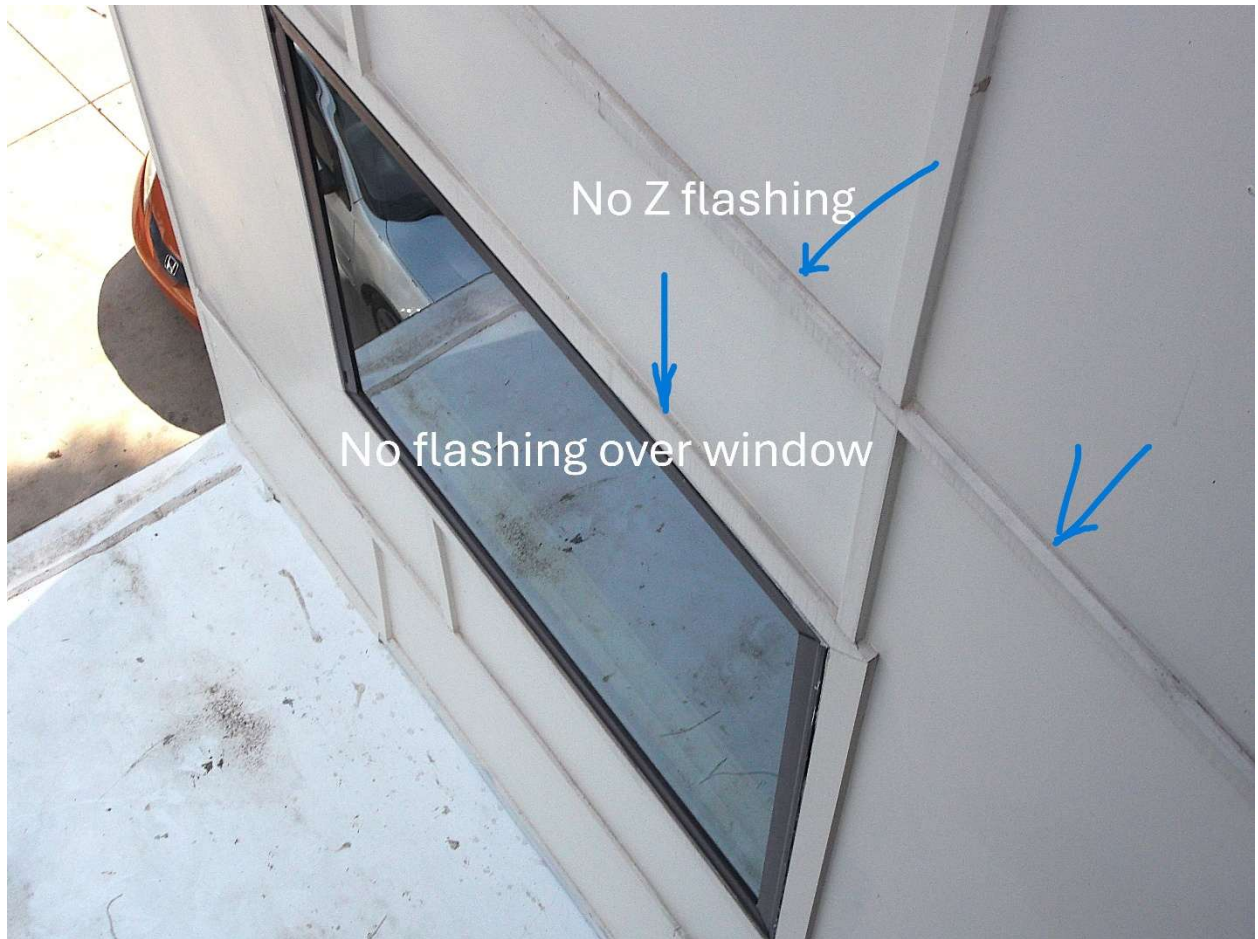
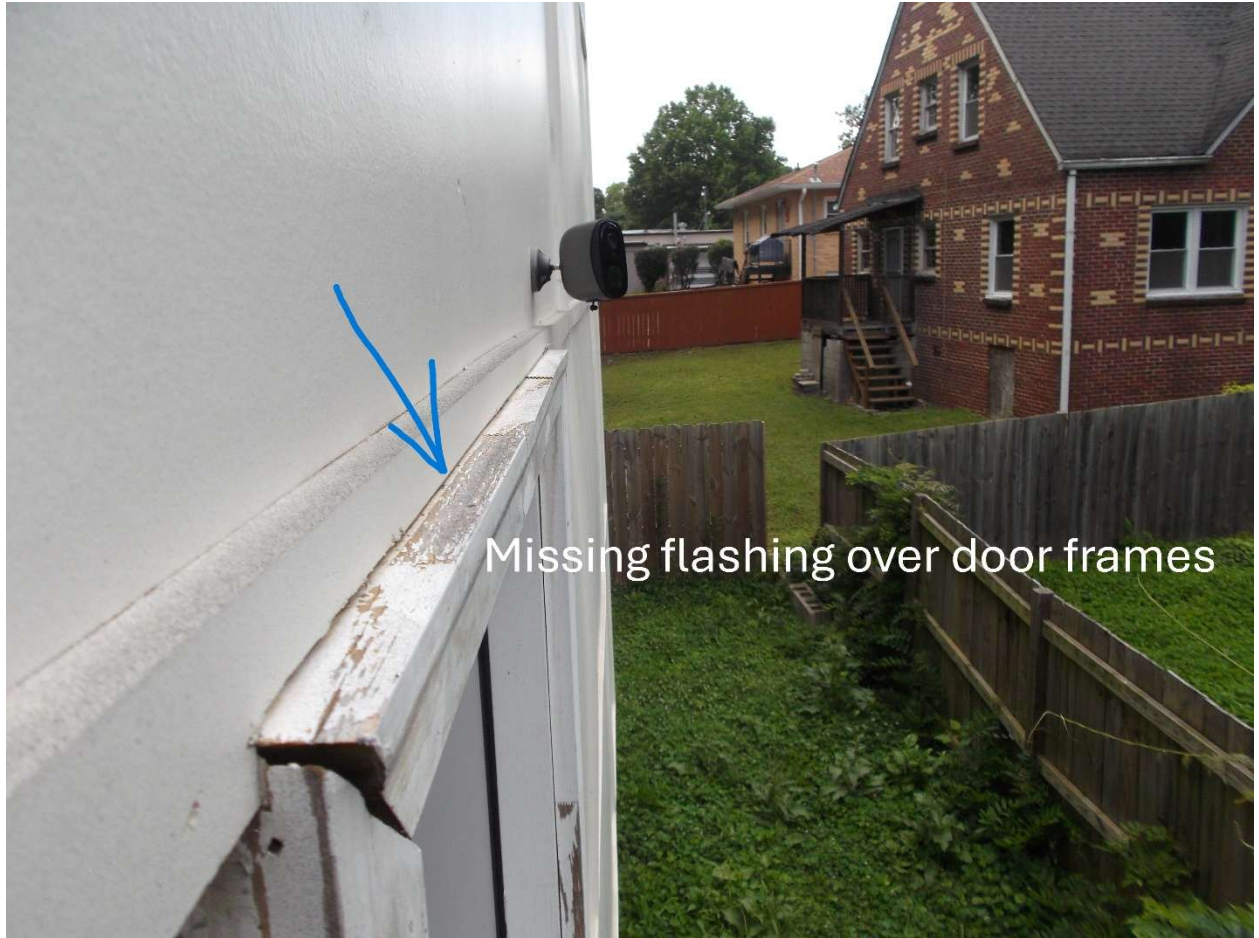
1. There is missing flashing over doors and windows.
2. Contractors installed flashing on the face of the window molding at several areas but the flashing must be under the siding above the window trim to flash water away.
3. There is missing Z flashing between siding panels where there are horizontal joints. Contractors installed only battens over the siding joints and caulked the seams and some seams have started to open up allowing water to penetrate openings between the battens and siding.
4. There is a large gap under the front door threshold and floor that can allow water on the floor to get in and cause rot to the floor framing and rim joist under the door.

Flashing placed on the face of window trim

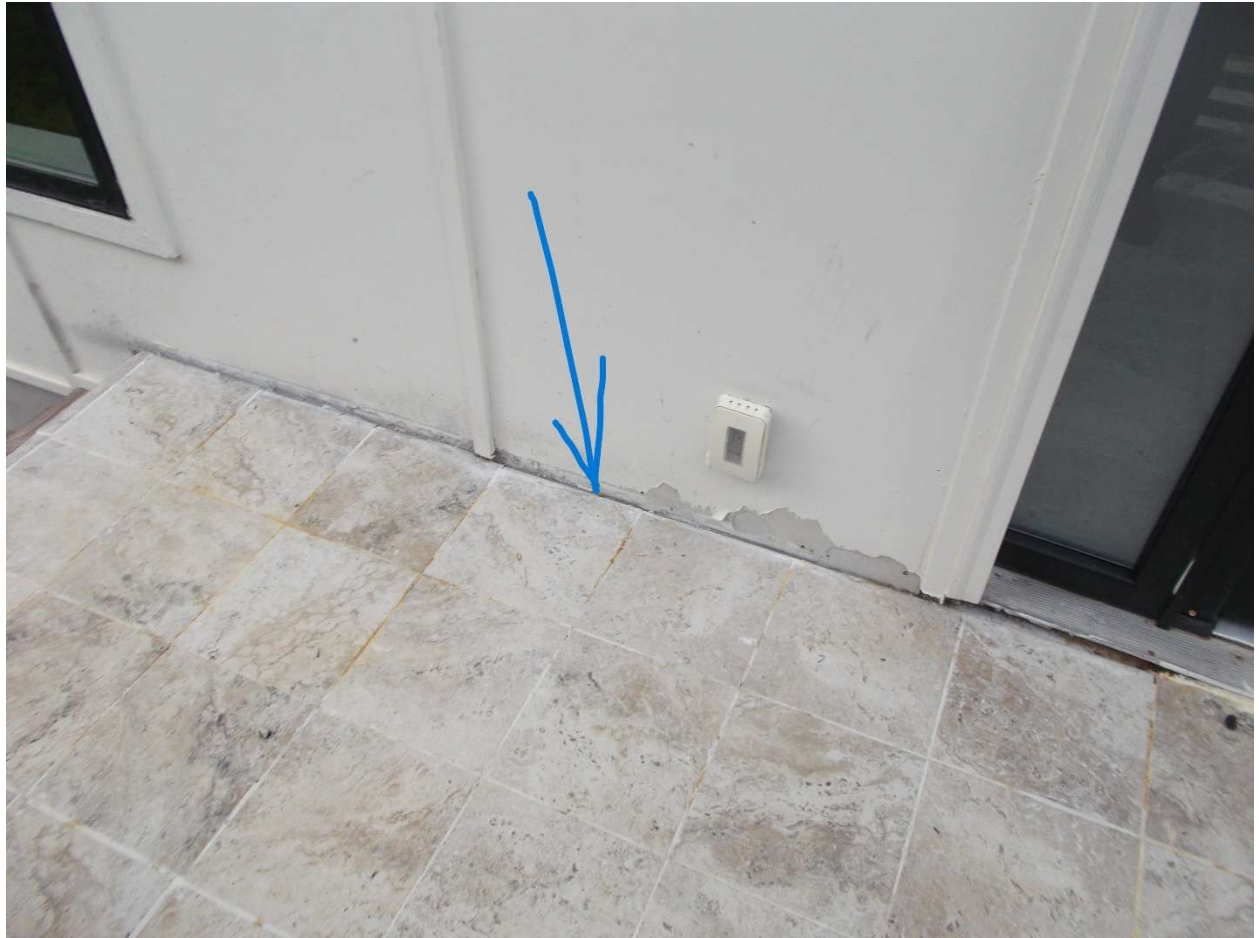
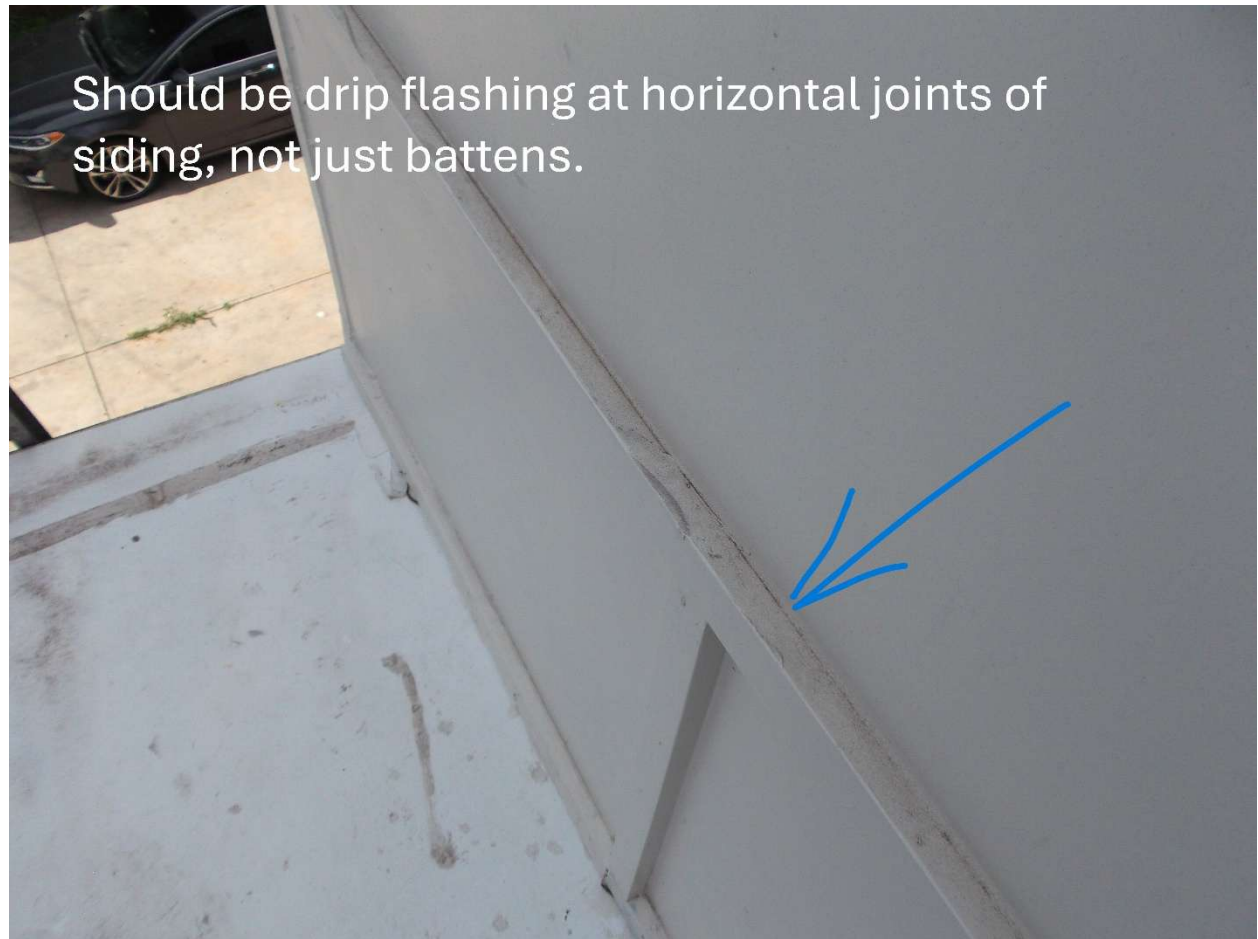
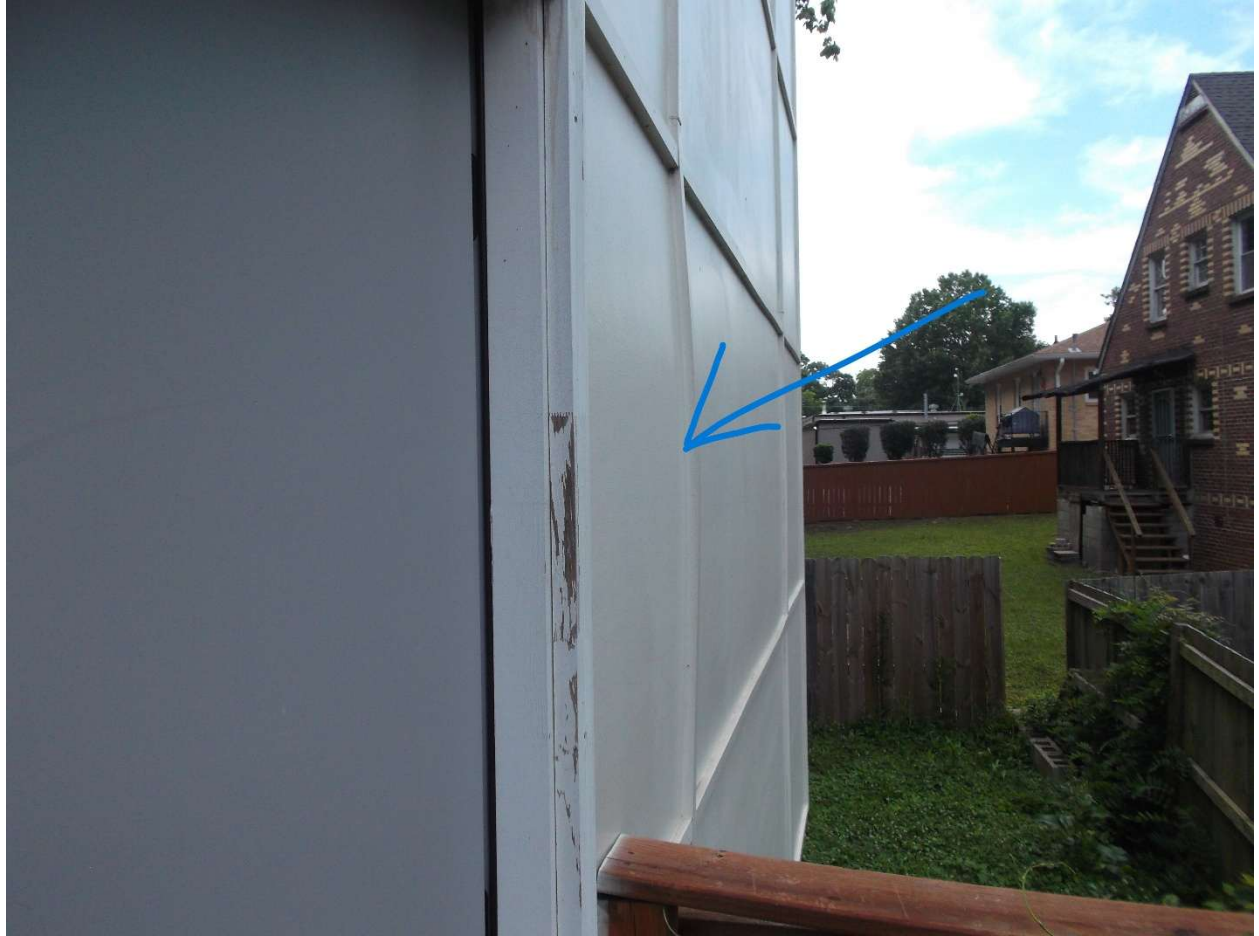
Missing flashing over door frames
