# Property Condition Assessment

42-Unit Apartment Complex

Shamrock Building Inspection Consultants, LLC

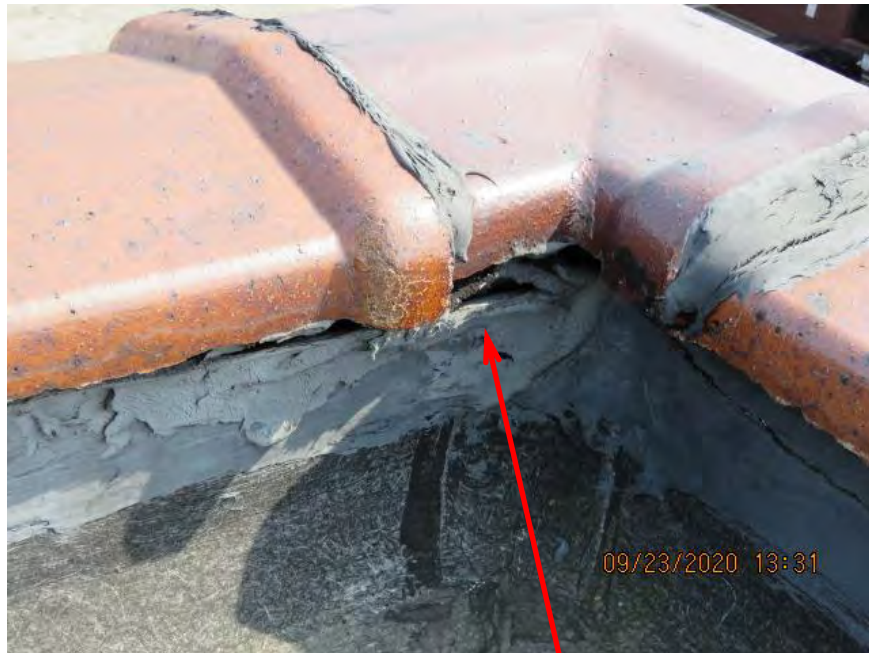
General roof area- membrane has pulled open

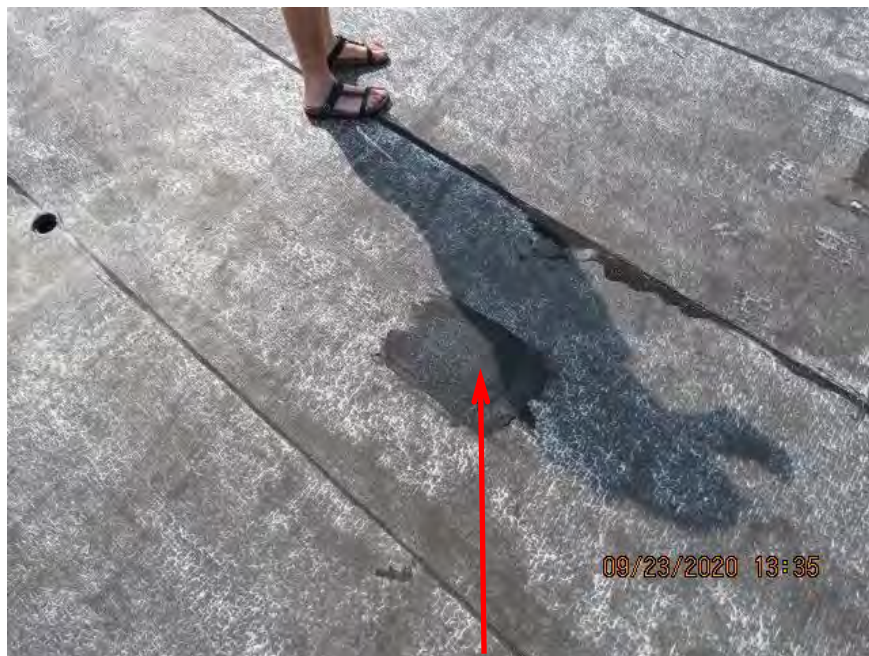
General roof area- prior repairs

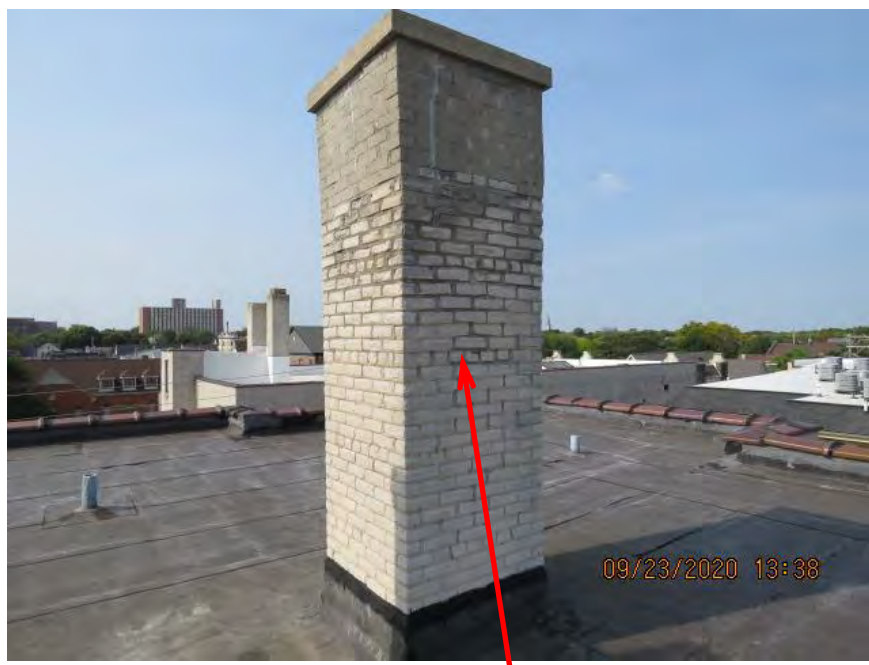
- 9.2.4 The exterior chimney brickwork is in fair condition.
- 9.2.5 The south chimney is no longer in use and could be removed down to a level below the roofline when reroofing.

General roof area- Idle chimney should be removed

Recommendations		Costs	Time Frame
9.3.3	General roof repairs.	\$4,000 - \$5,000	Immediate
9.3.5	Remove idol chimneys	\$3,000 - \$4,000	Discretionary

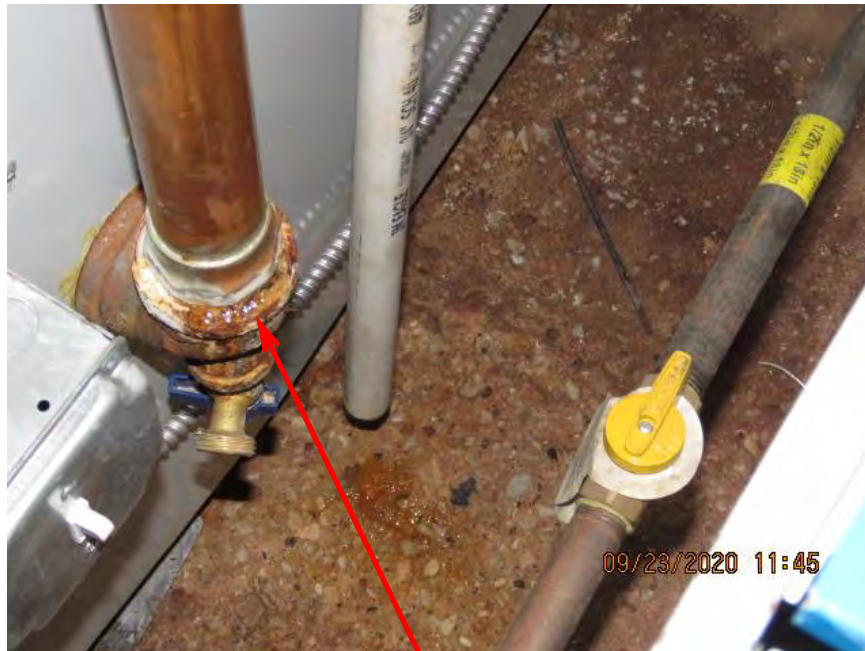
- 5.2.9 There was a leak noted on boiler #3 at the supply side at the time of the inspection.

Main heating equipment- # 3 boiler leaks at return line

Recommendations		Costs	Time Frame
5.3.9	Service heating equipment.	\$1,000- \$2,000	Immediate

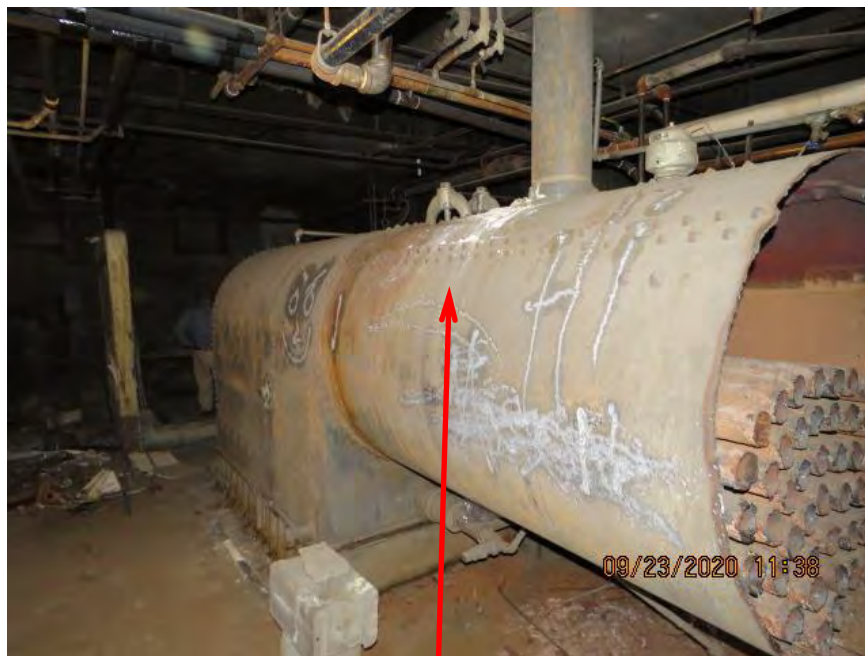
Main heating equipment- old asbestos lined boiler should be removed

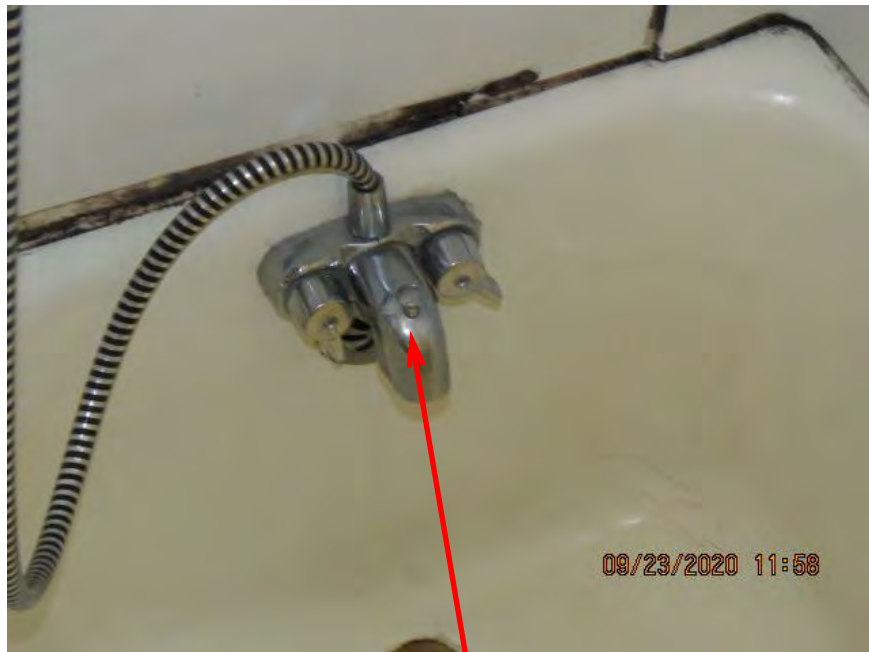
- The caulking in the bathtub enclosure requires attention.
  - Plumbing cross connections in bathroom should be repaired. These cross connections occur when the plumbing supply fixture is below the flood level of the tub in these units # 2, 6, 14.

Typical building interior- plumbing cross connection # 2

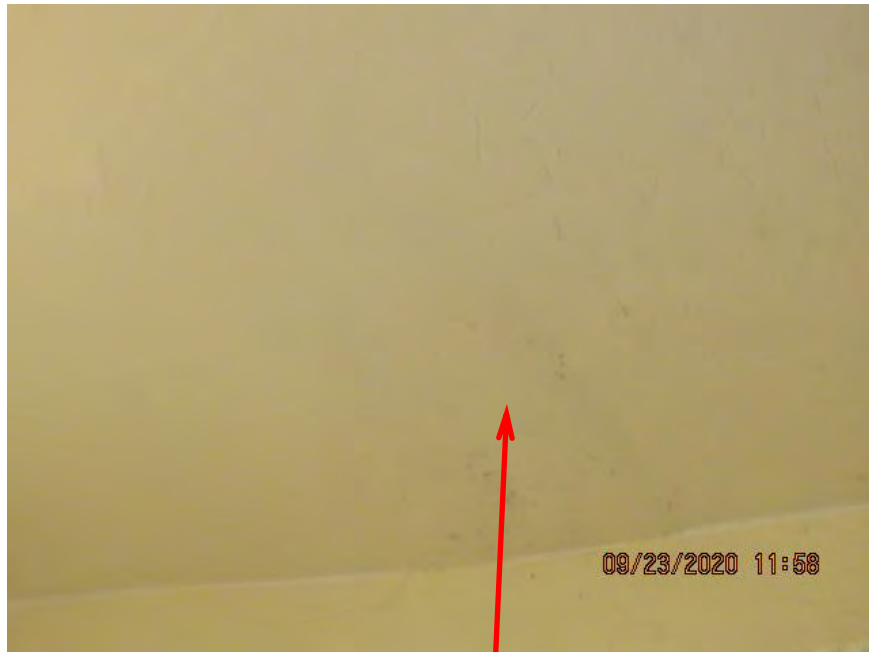
- 8.2.7 Evidence of past leakage was noted in the waste piping below the laundry room, storage locker room #10, 34, 37 and all bathroom tub traps as evidenced by water damaged ceilings above the tubs.

Typical building interior- water damaged ceiling above tub #2 trap leak

Recommendations		Costs	Time Frame
10.3.5	Replace water damaged ceilings.	\$4,000 - \$5,000	Immediate
10.3.17	Provide hand railing on the 2 <sup>nd</sup> floor east stairway.	\$1,000- \$2,000	Immediate

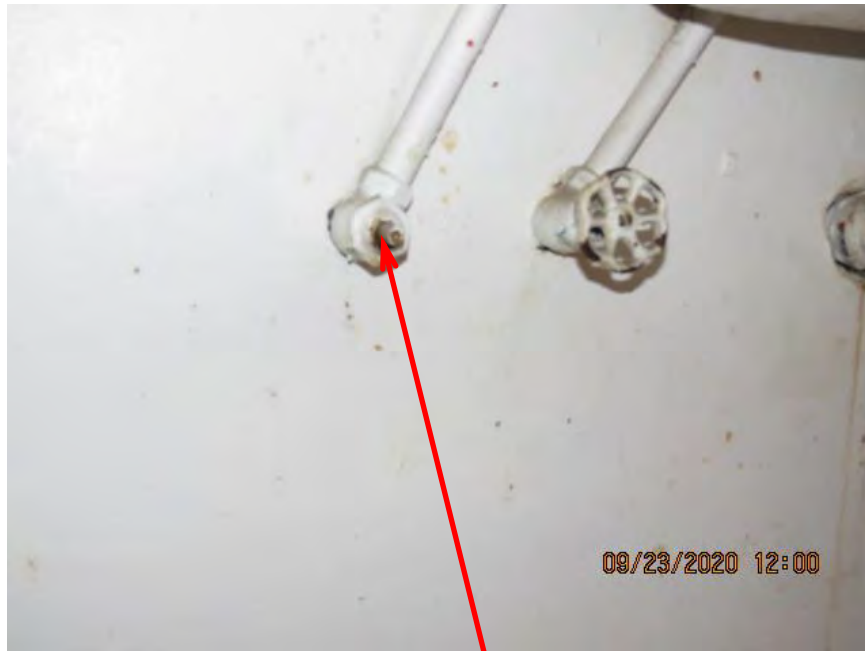
- Damaged plumbing supply water valves need repair in units # 1, 2, 9

Typical building interior- damaged valve handle #1

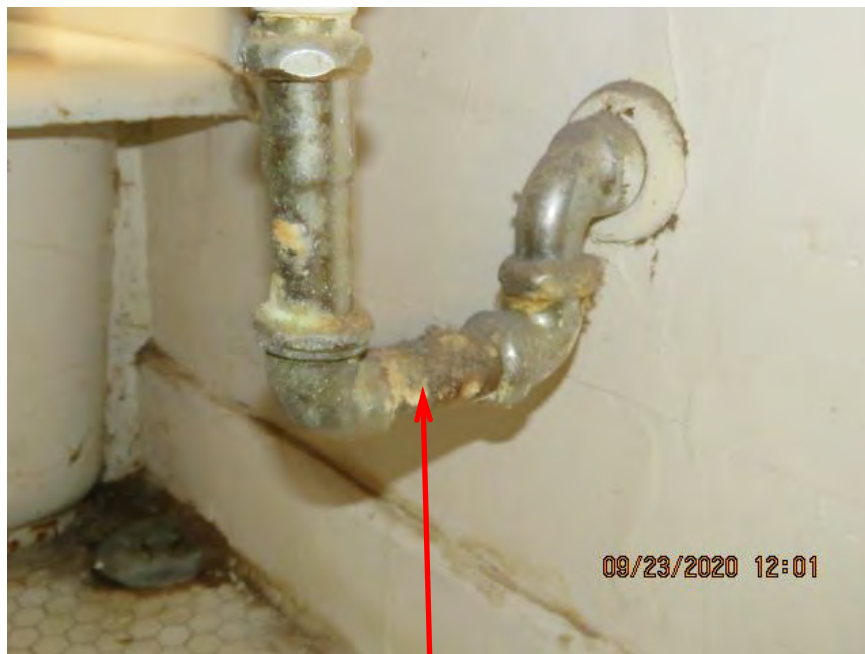
- The sink in the units #19, 18, 17, 16, 1, 26, 30, 34, drains slowly. An obstruction may exist.
  - A minor leak was noted in the waste piping below the bathroom sink in units # 1 37, 34.

Typical building interior- Trap leak #1

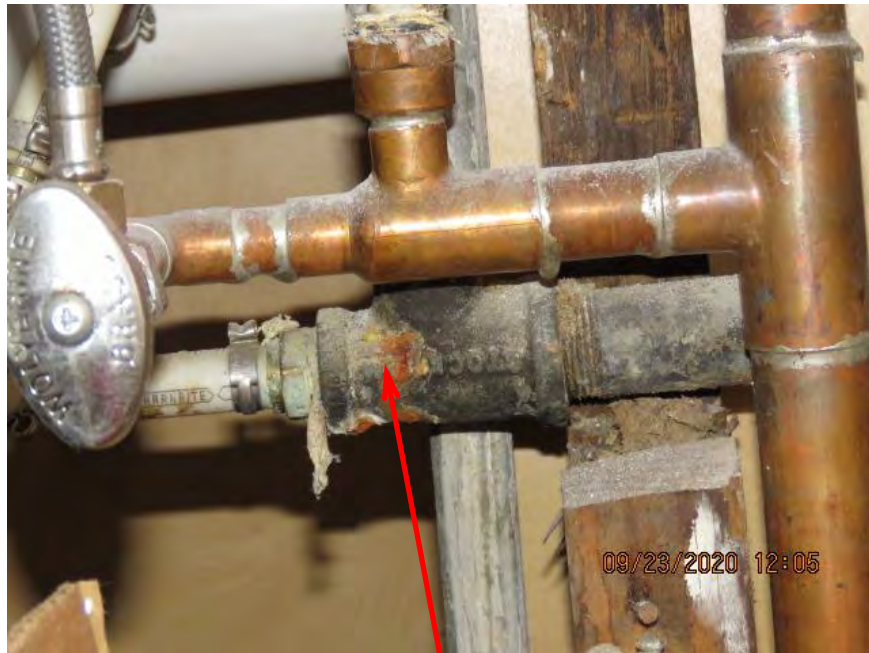
- 8.2.5 Galvanized steel pipe should be replaced with copper during any kitchen or bathroom remodeling project.
  - 8.2.6 Minor leaks were noted in the supply piping in the laundry room restroom, laundry room storage locker room and units # 3, 8, 40.

Typical building interior- galvanized pipe leak #3

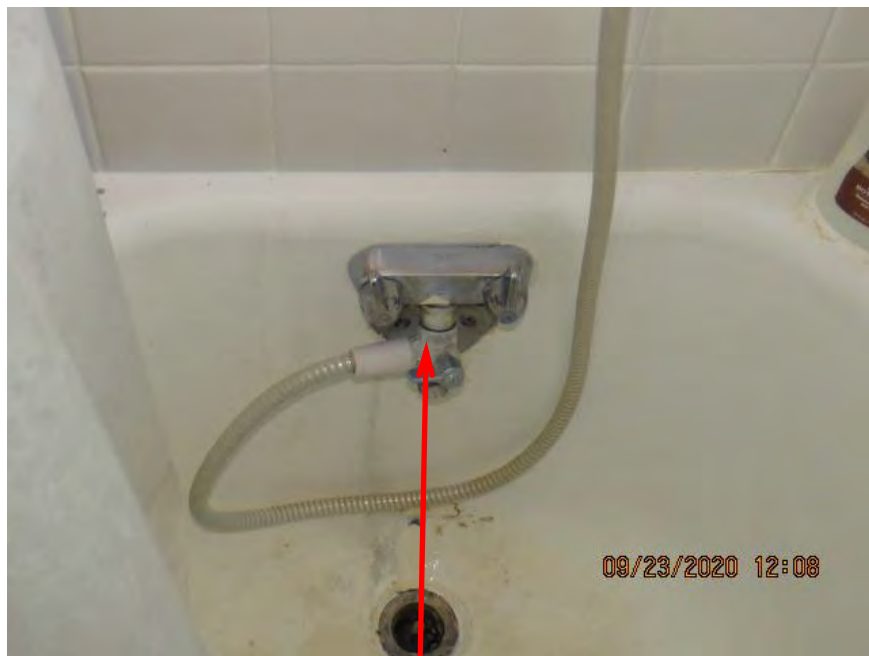
Typical building interior- cross connector #6

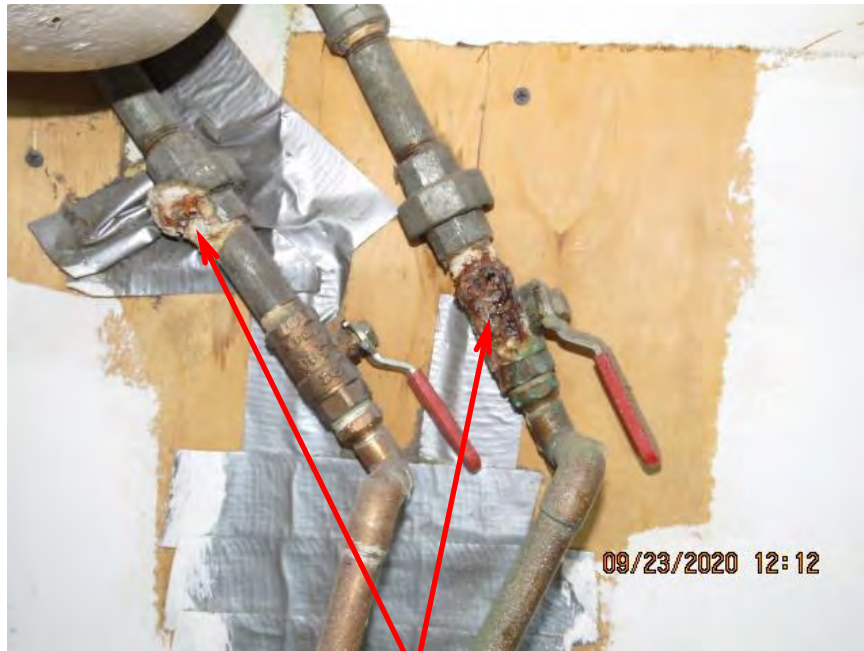
Typical building interior- corroded shutoff valves # 8

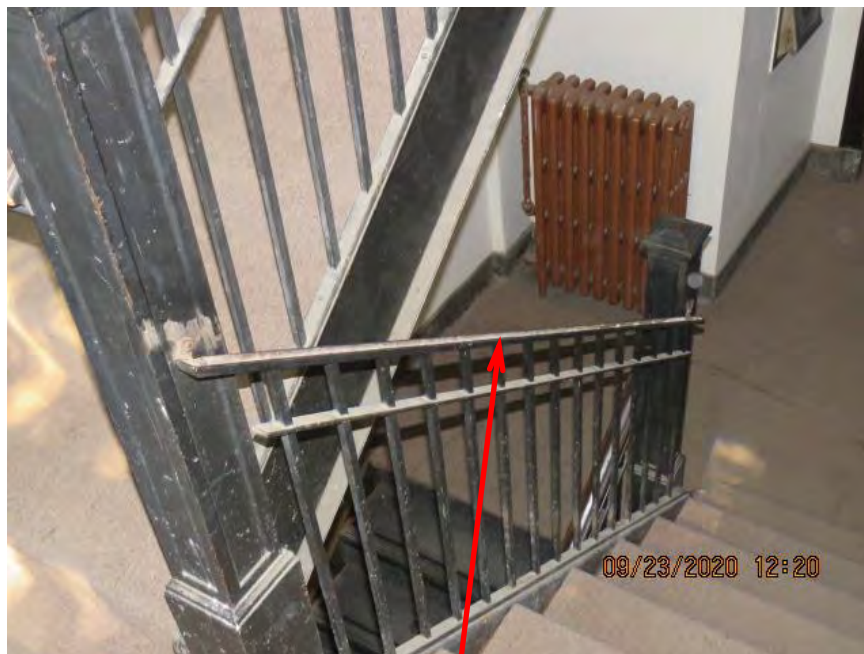
- 10.2.16 The stairwells are generally in serviceable repair.
- 10.2.17 It is recommended that a handrail be provided on the 2<sup>nd</sup> floor east-floor stairway.

Typical building interior- missing handrail 2<sup>nd</sup> floor east stairway

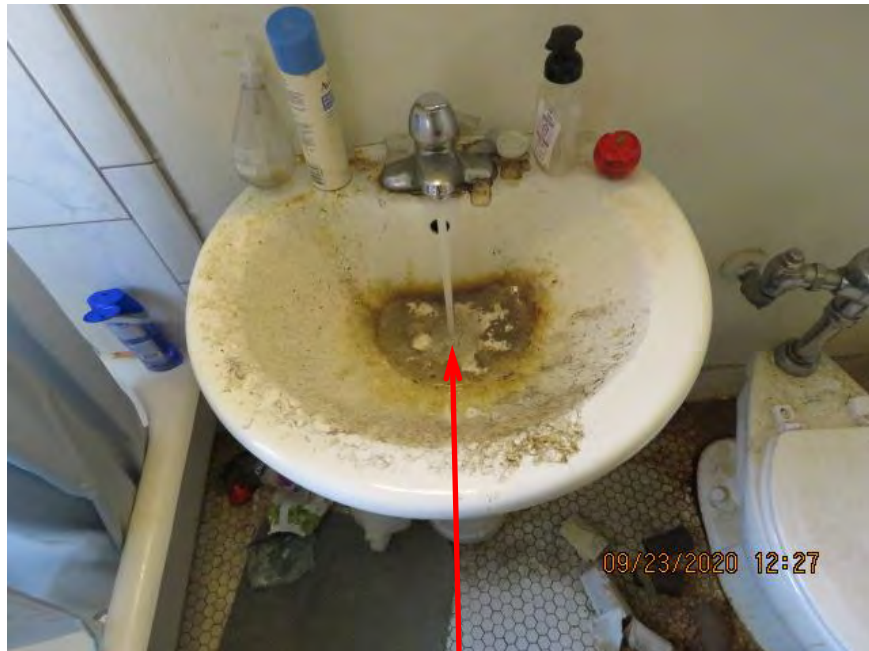
Typical building interior- slow drain #18

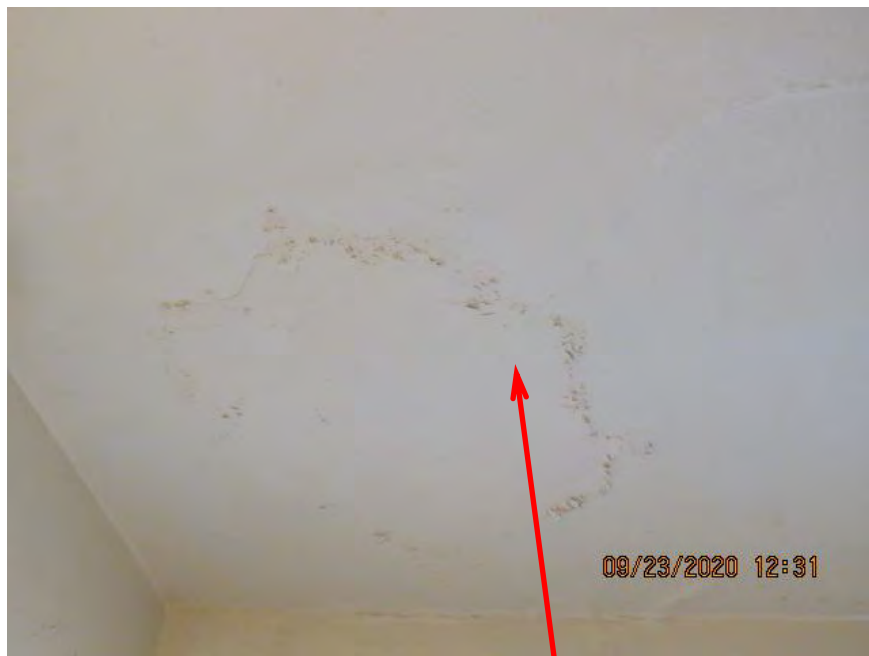
Typical building interior- water stains # 6 bathtub trap leak

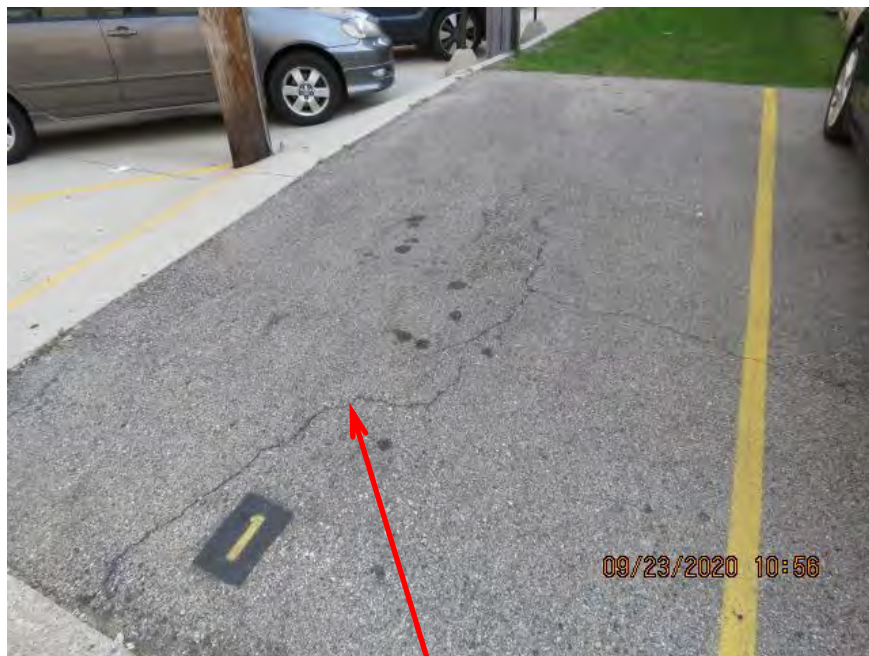
- 11.2.22 The asphalt paving is in serviceable repair.
- 11.2.23 The large cracks in the asphalt should be sealed with an asphalt slurry.

Building parking area- seal cracks

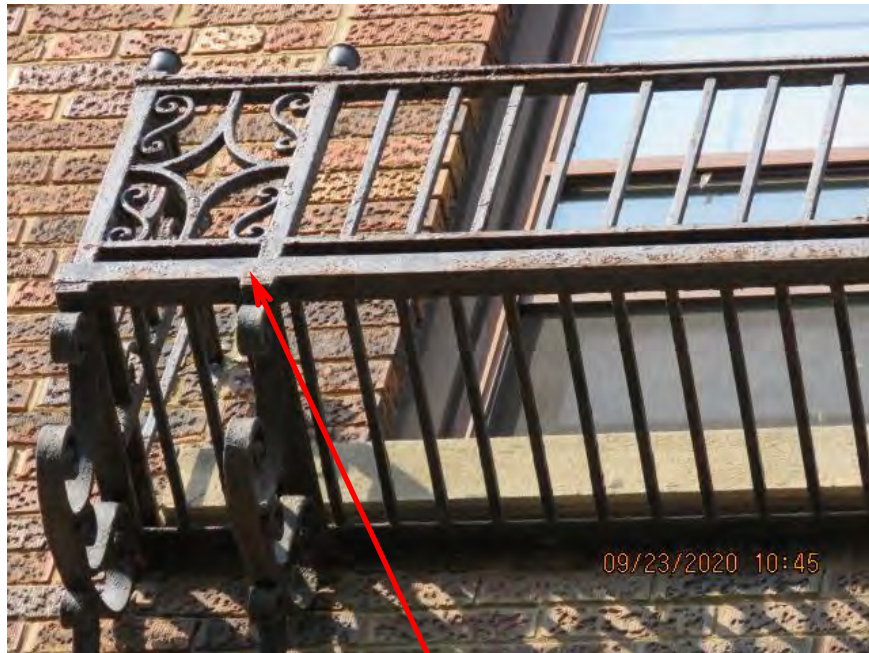
Wrought Iron is rusting and needs maintenance

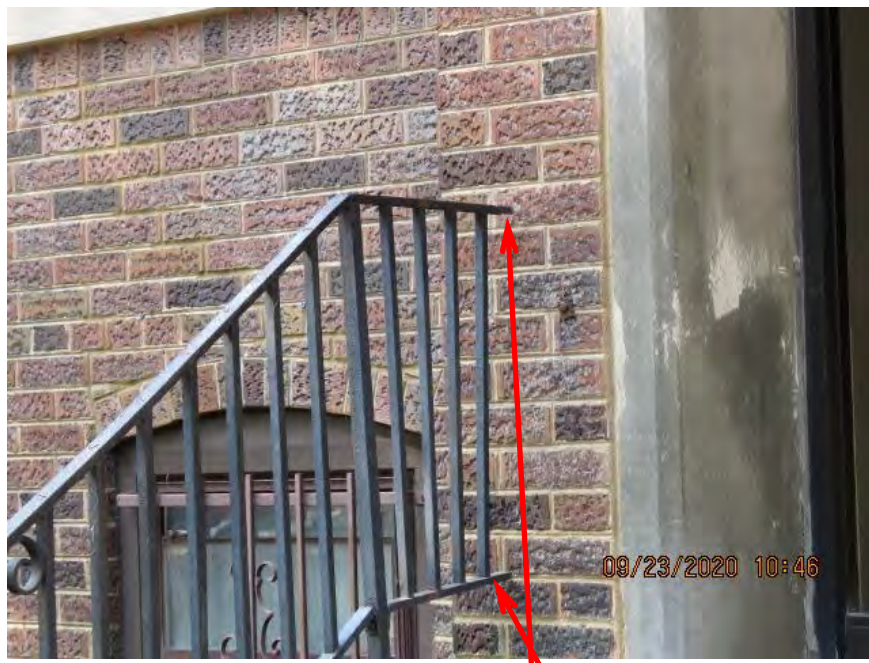
Handrail is not attached to the wall

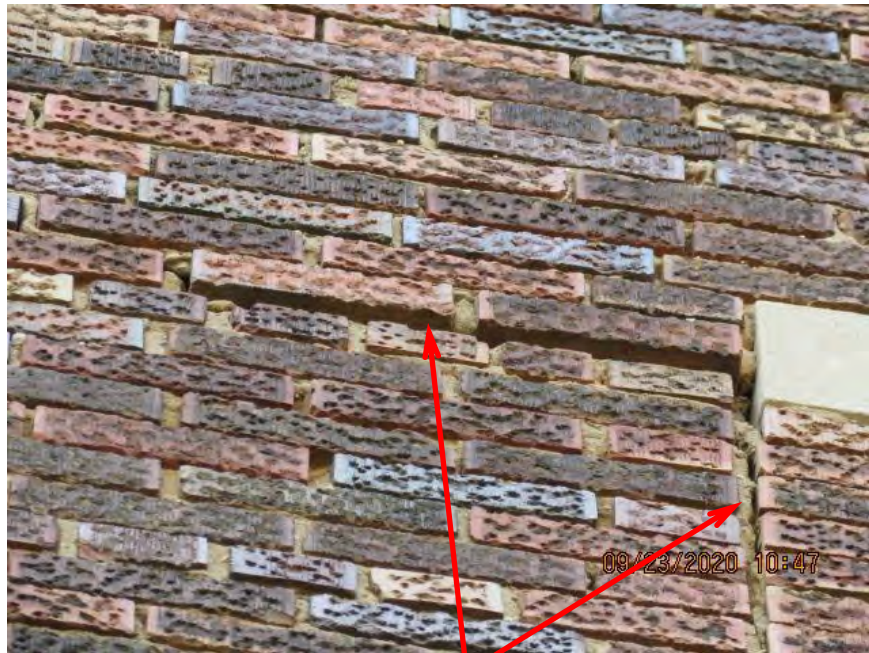
Tuck pointing needed- north side

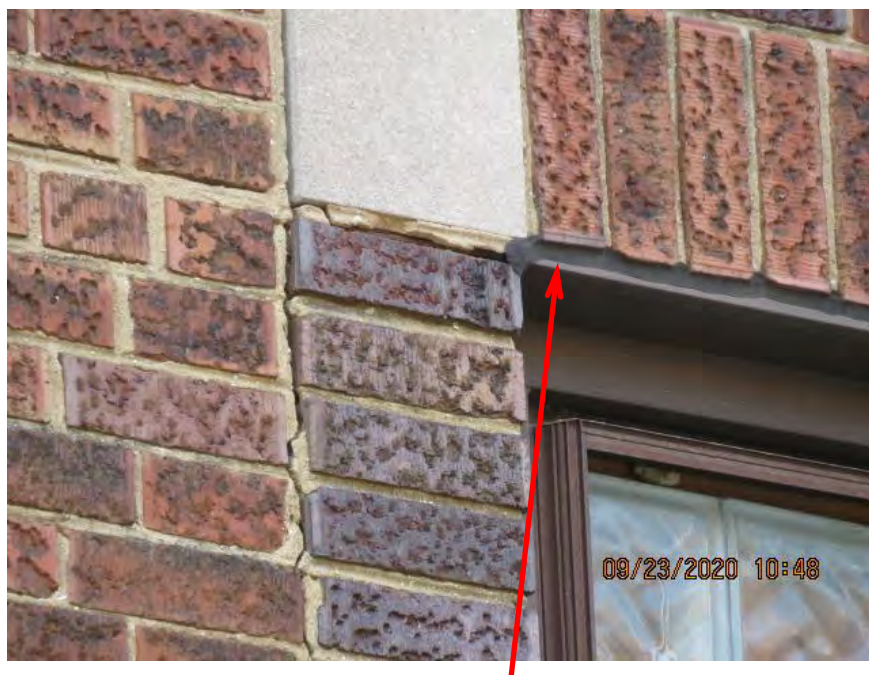
- 3.2.6 The lintels above the windows and doors in the exterior façade are corroded and deformed. This appears to be due to moisture accumulation on the steel. As steel corrodes, it expands. The expansion of the steel has caused cracking in the masonry above the top corners of the windows and doors. Although this is not a major structural concern, ongoing cracked of the masonry and the need for periodic repairs should be anticipated.

Lintels are corroding and cracks are forming- north side

Replacement of this steel is not considered warranted at this time; however, the steel should be scraped clean and repainted to minimize future corrosion.

Recommendations		Costs	Time Frame
3.3.5	Repair crack in the water main closet and monitor for future movement.	\$1,000-\$2,000	Immediate
3.3.6	Repair and paint lintels	\$4,000 -\$5,000	Immediate

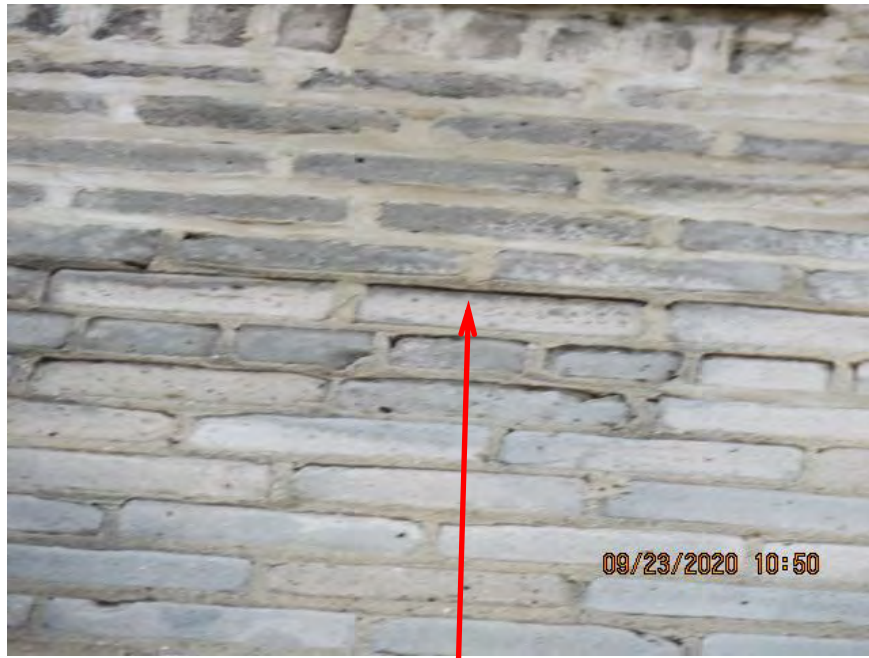
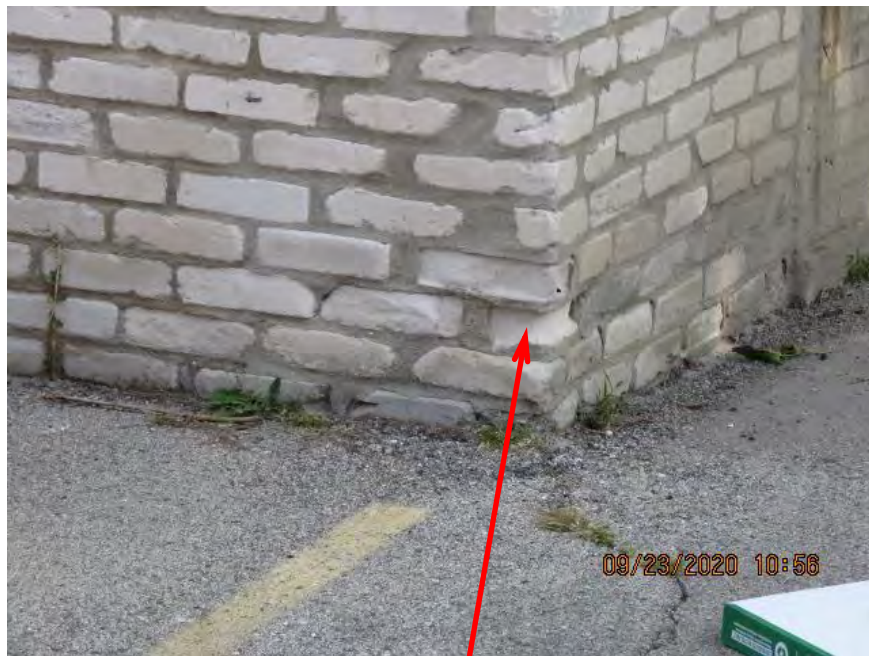
Damaged brick- west side

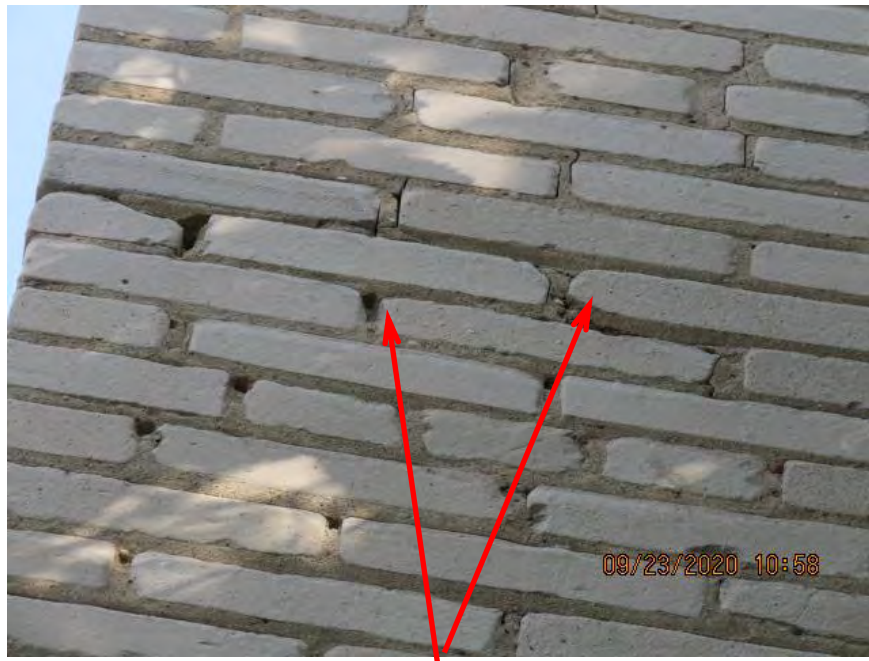
Tuck pointing needed- south side

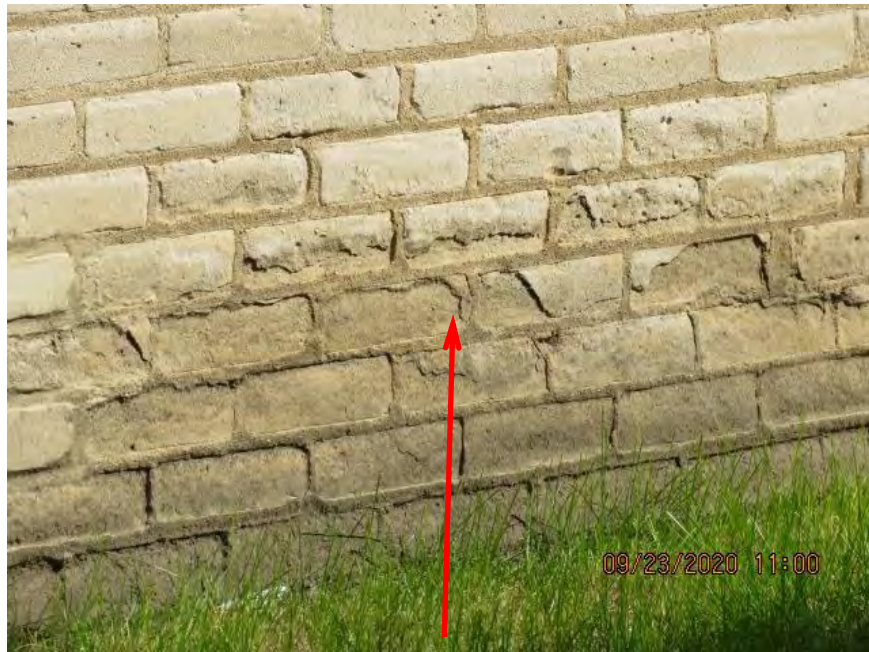
Damaged brick- south side

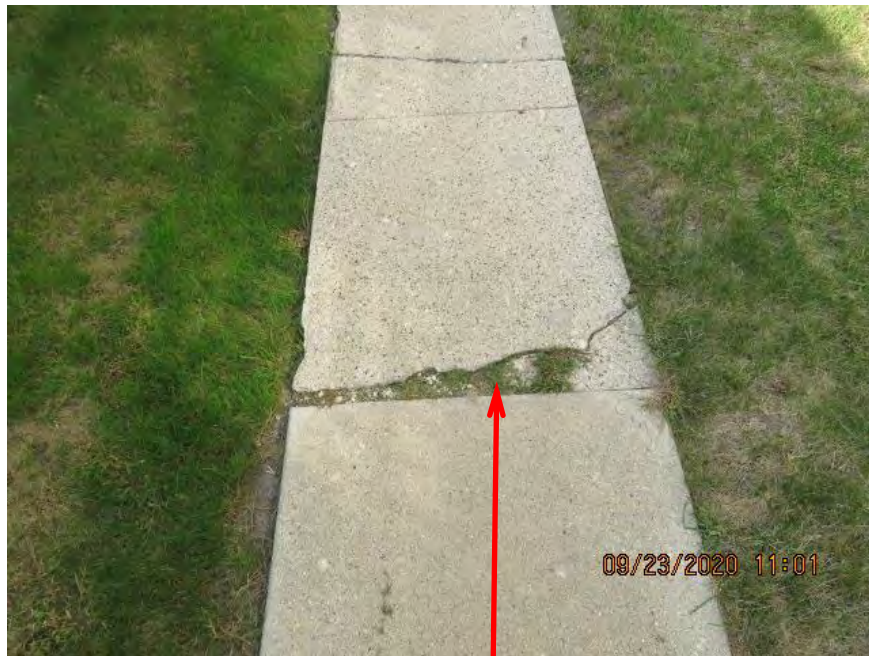
- 11.2.21 The poured-concrete sidewalks are in fair condition.
  - The sidewalk at the south side in its present state is considered a trip hazard.
  - The sidewalk at the south side is deteriorated. This sidewalk should to be replaced.

Deteriorated sidewalk

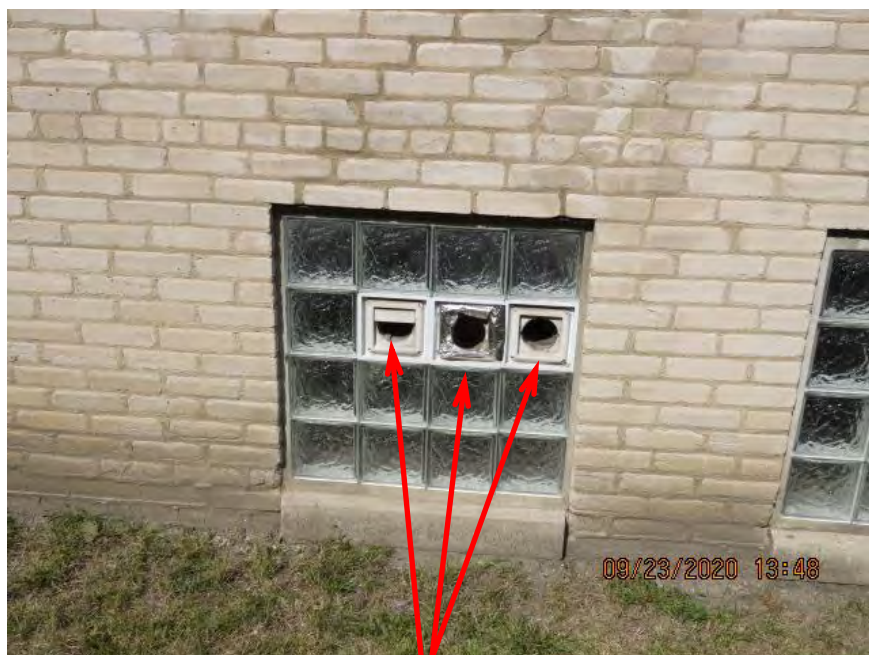
Damaged dryer vents

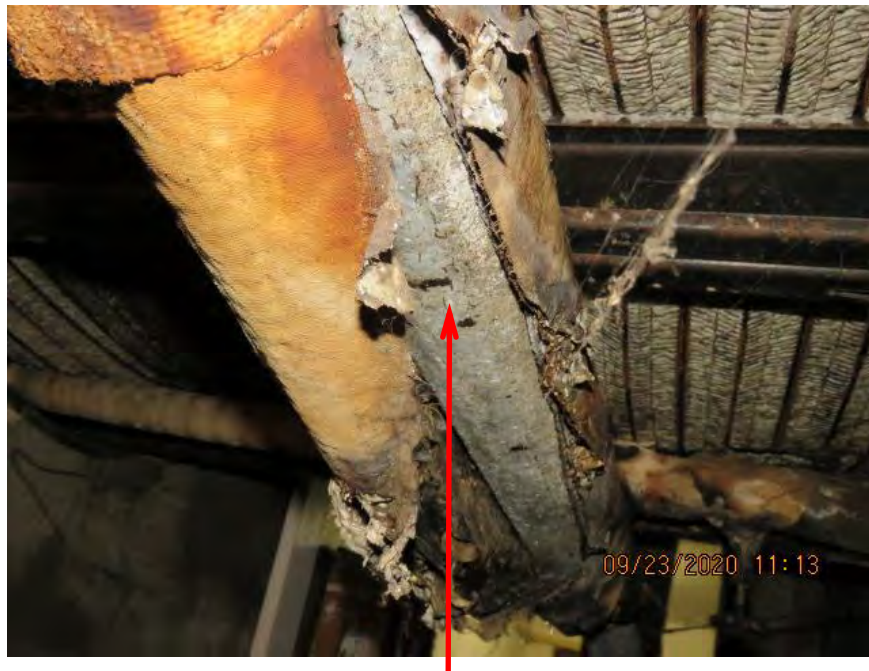
- 5.2.7 The heat distribution appears adequate in most areas.
- 5.2.8 Asbestos like pipe wrap should be removed by a certified contractor.

Damaged asbestos like pipe wrap

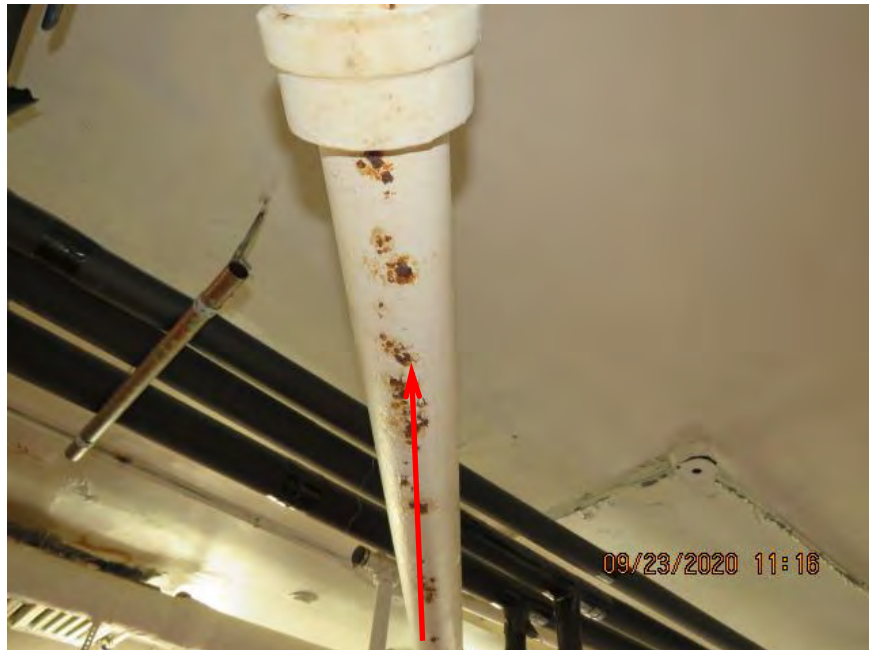
Corroded and leaking waste pipes

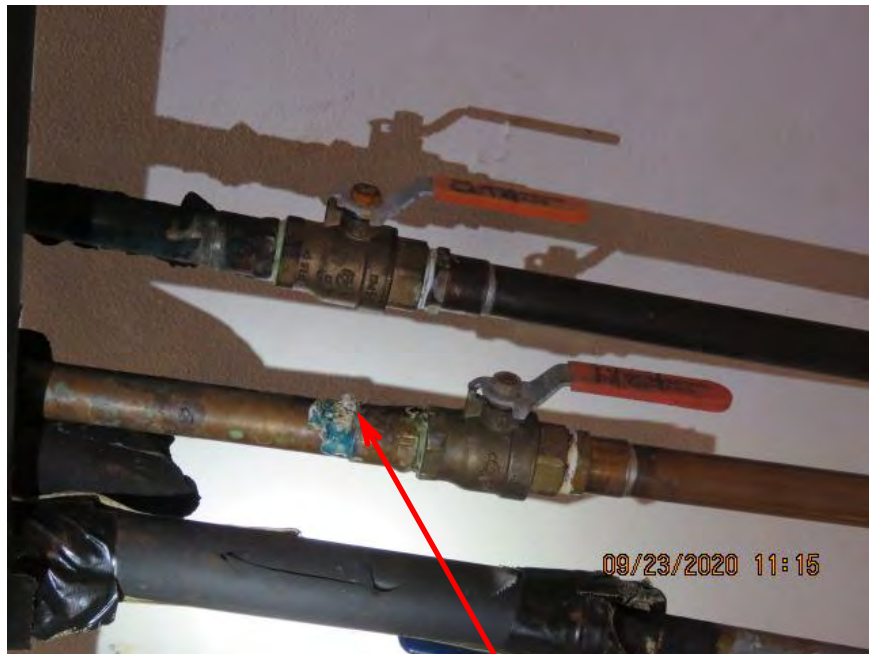
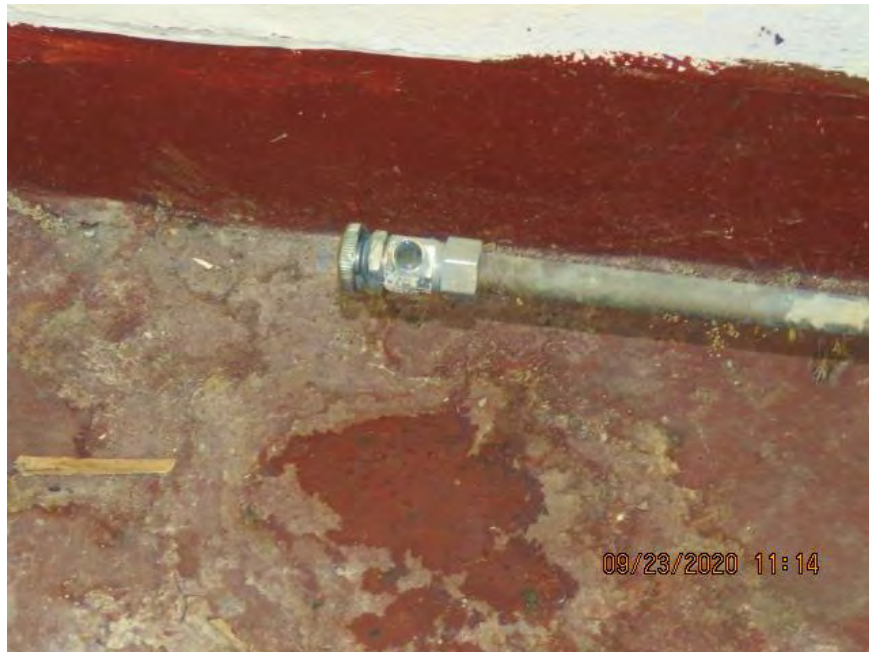
Pipe leak laundry room

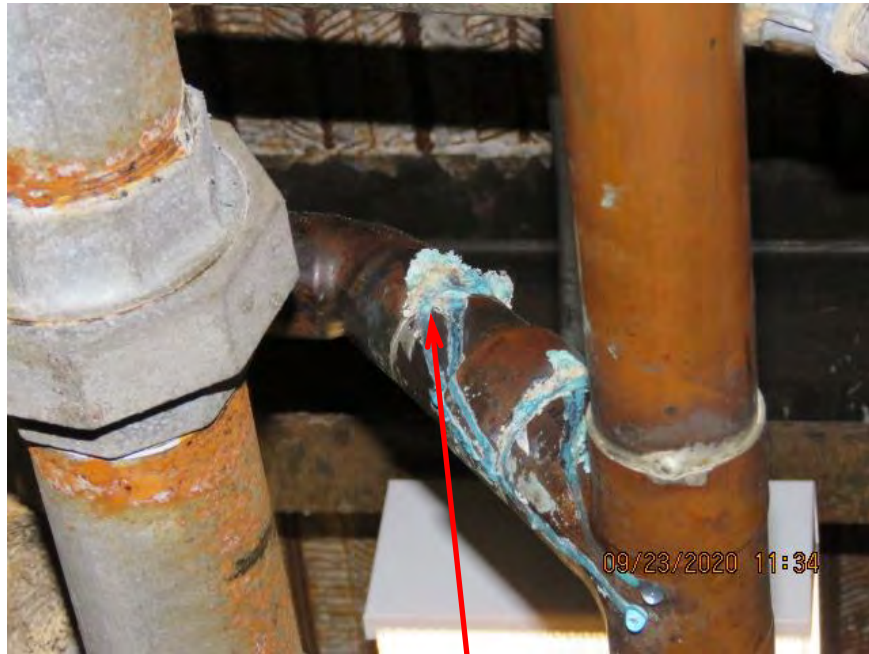
Plumbing supply leak- storage locker room

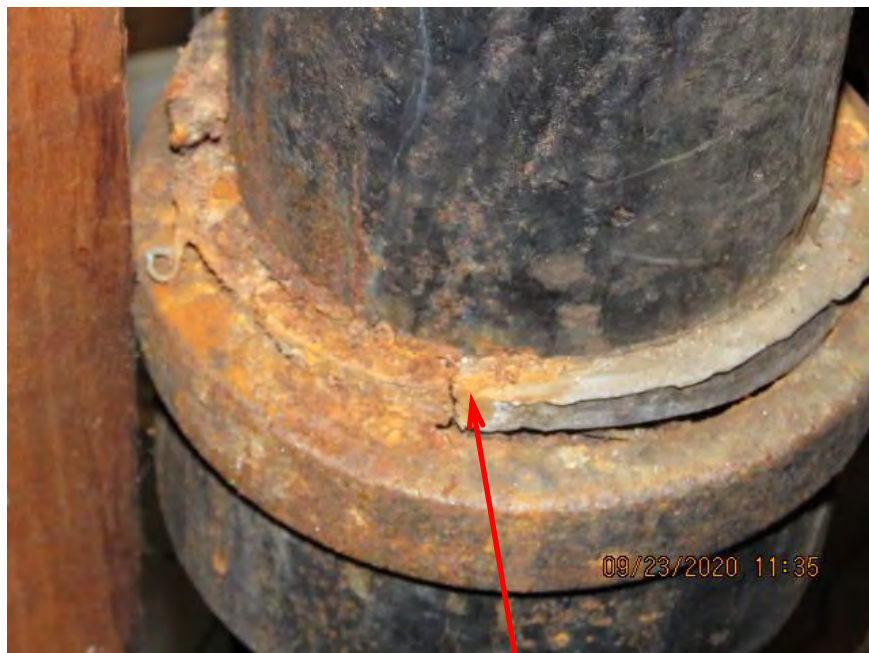
Cracked seal on waste stack- storage locker room
