# Property Condition Assessment

INDUSTRIAL

Shamrock Building Inspection Consultants, LLC

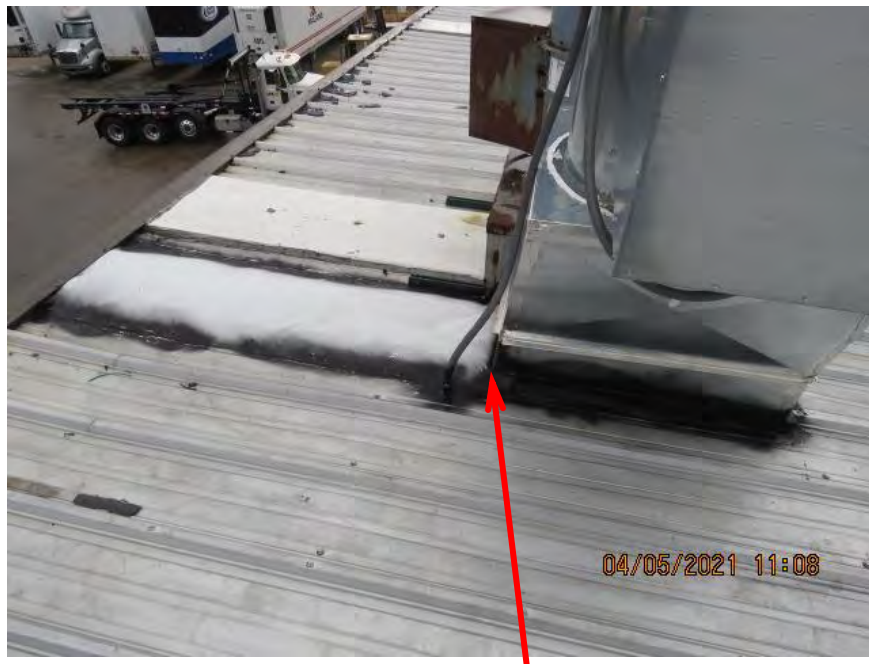
- 9.2.1 The steel panel roofing is in serviceable condition.
- 9.2.2 The steel panel roofing is estimated to be 15 years old.
- 9.2.3 The normal life expectancy for this type of roof covering is approximately 50 years or more.
- 9.2.4 Minor repairs should be undertaken to ensure weather tightness.
  - The steel panel roofing and screws are rusting and need paint.
  - The roof is leaking around the poorly flashed exhaust fans.

General Roof Area - Improper flashing of exhaust fans they leak

Recommendations		Costs	Time Frame
9.3.4	General roof repairs.	\$3,000 - \$4,000	Immediate

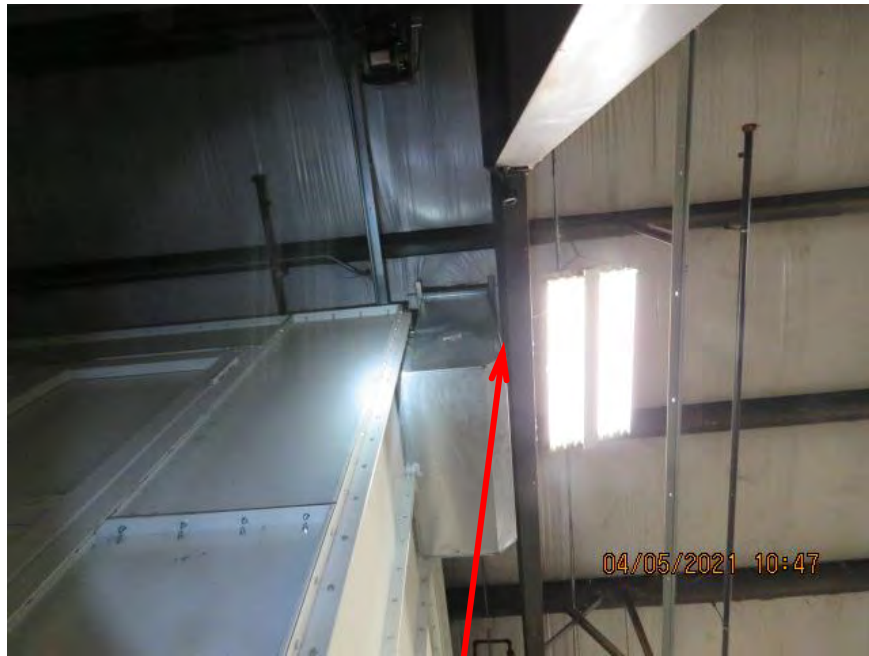
General Roof Area - Roof leak at exhaust duct

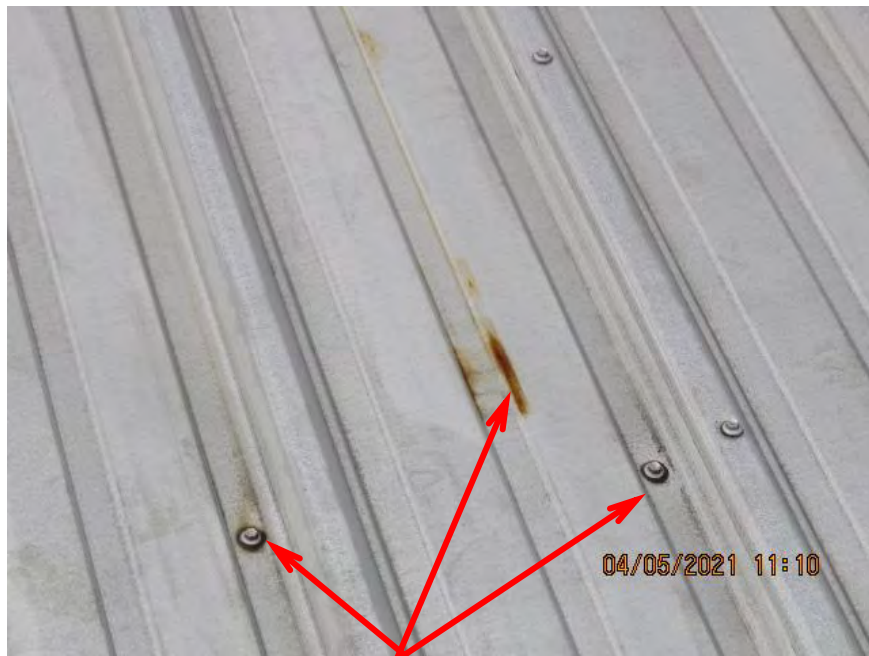
General Roof Area - Main shop roof is rusting and the fasteners are rusting

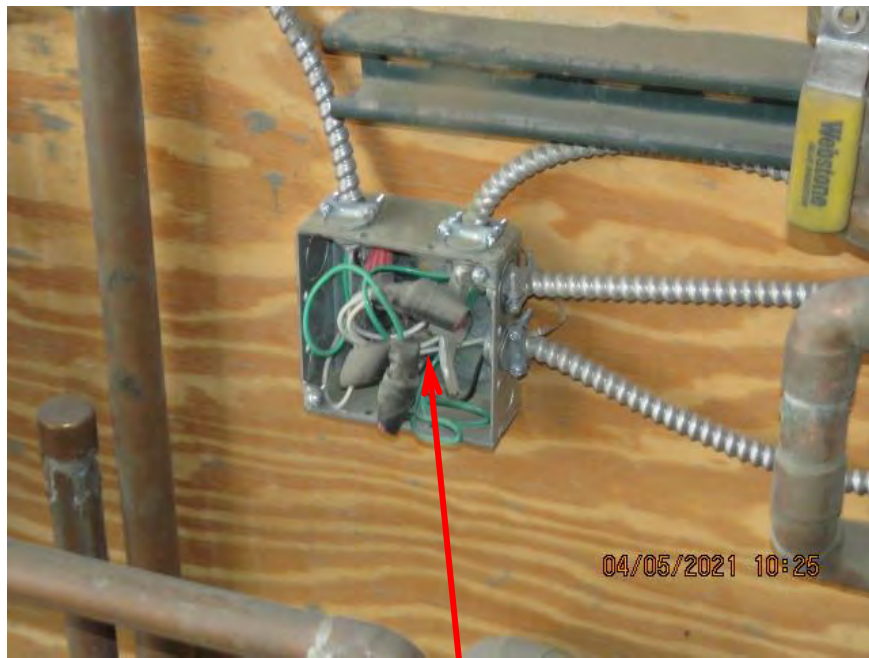
- 4.2.6 Representative samples of accessible wiring were examined and electrical switches were spot tested in the areas inspected.
- 4.2.7 All switches tested operated satisfactorily.
- 4.2.8 No major deficiencies were noted.
- 4.2.9 The general condition is considered to be satisfactory; however, improvements are recommended as follows:
  - Missing cover plates in the east shop should be replaced.

Main Electrical Service Equipment – Open Junction Box East Shop

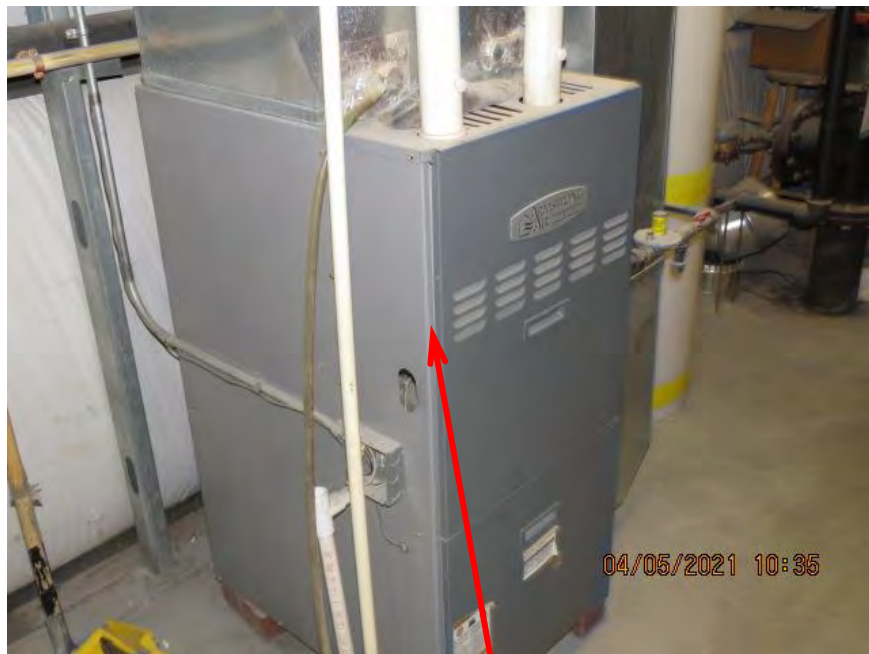
5.2.10 The office unit is approximately 14 years old.

5.2.12 Therefore, this unit is approaching the end of its useful life.

Main Heating Equipment - Office furnace 2007

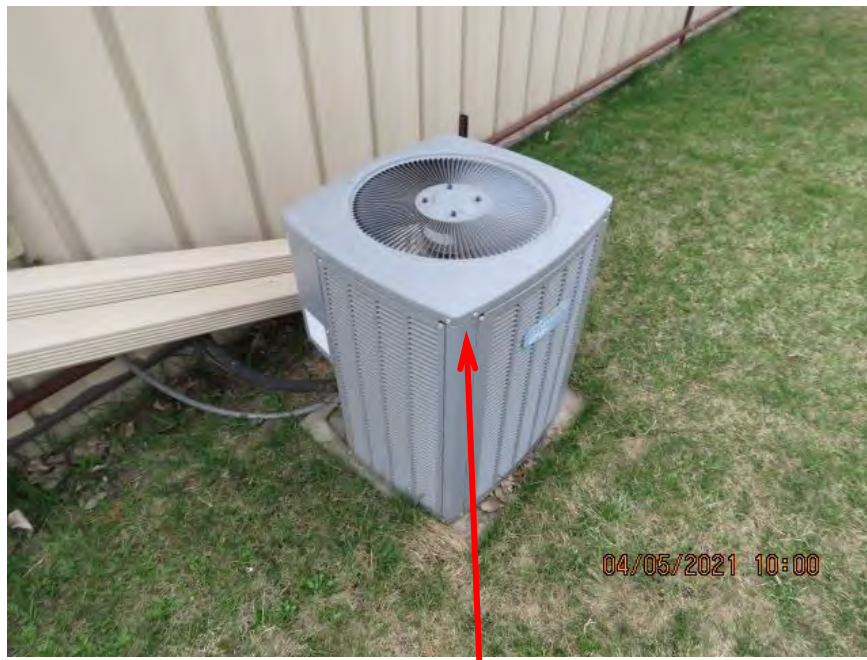
- 6.2.2 These units are approximately 14 years old.
- 6.2.3 The air conditioning compressor normally determines the life expectancy of this equipment.
- 6.2.4 Air conditioning compressors have an average life span of 20 years.
- 6.2.5 All compressors were found to be original.
- 6.2.6 The coolant used in these units is R-22 Freon. This product is no longer manufactured and will be illegal to recharge these systems after 1-1-20. So, replacing these units will be a high priority.

Main Air Conditioning Equipment 3.5 ton 2007 R-22 Freon

Recommendations		Costs	Time Frame
6.3.6	Replace older AC units.	Over \$10,000	Two Years

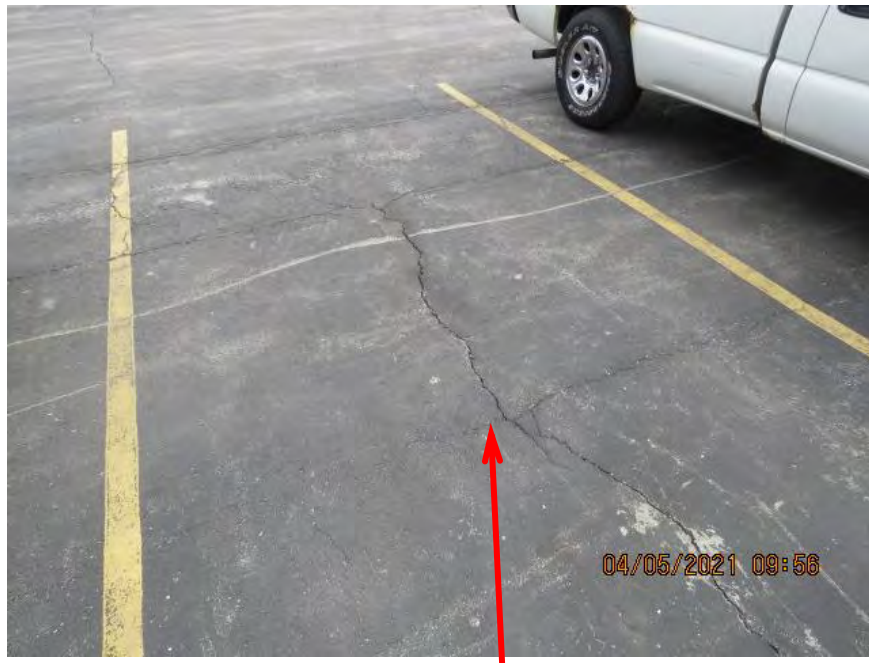
- 11.2.9 The asphalt paving is in mild disrepair but considered serviceable.
- The depressions in the asphalt should be repaired.
  - The large cracks in the asphalt should be sealed with an asphalt slurry.

Building Parking Area - North lot seal cracks

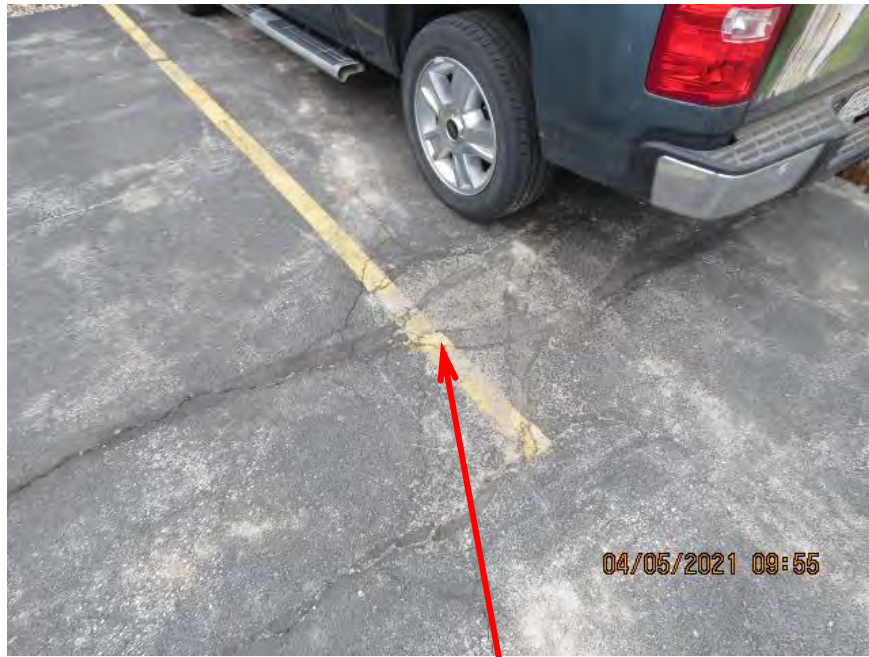
Building Parking Area - North lot seal cracks

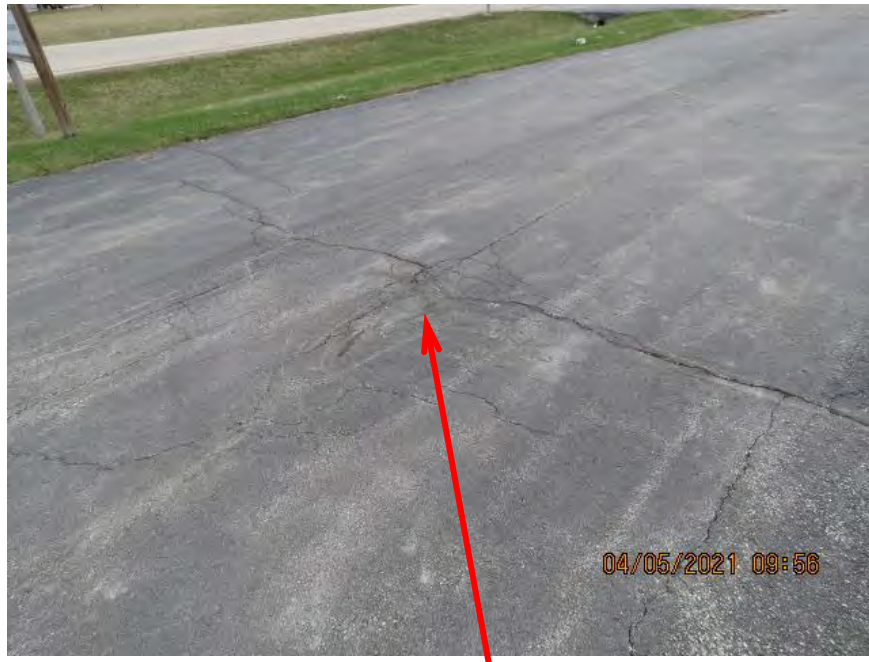
Building Parking Area - North lot seal cracks and repair depressions

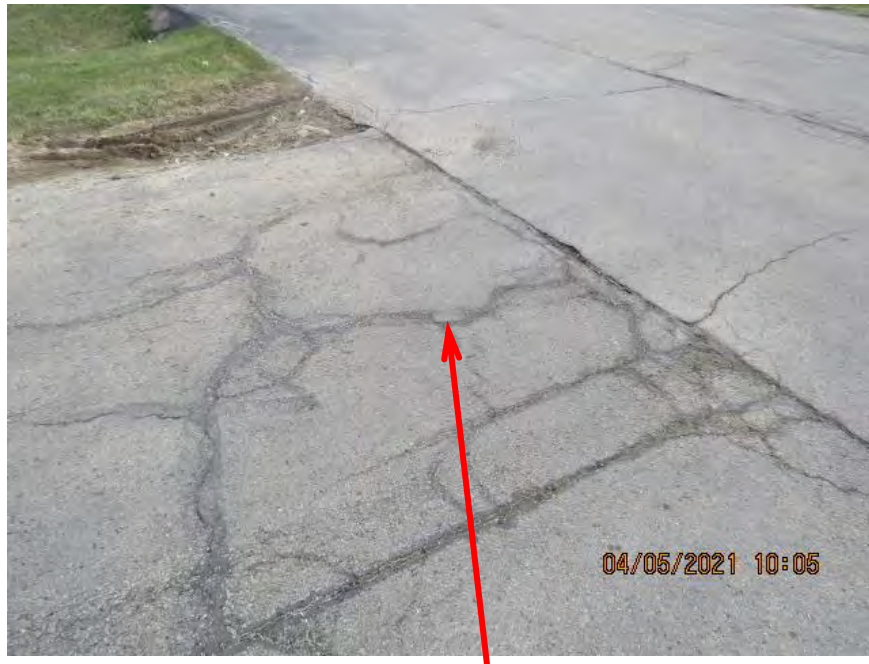
Building Parking Area - East lot seal cracks and repair depressions

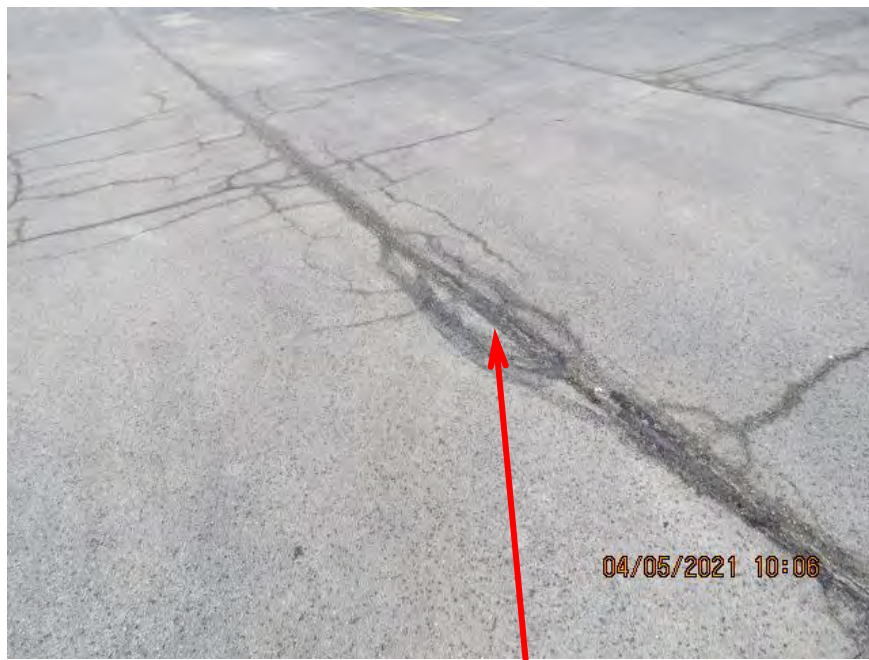
Building Parking Area - East lot seal cracks and repair depressions

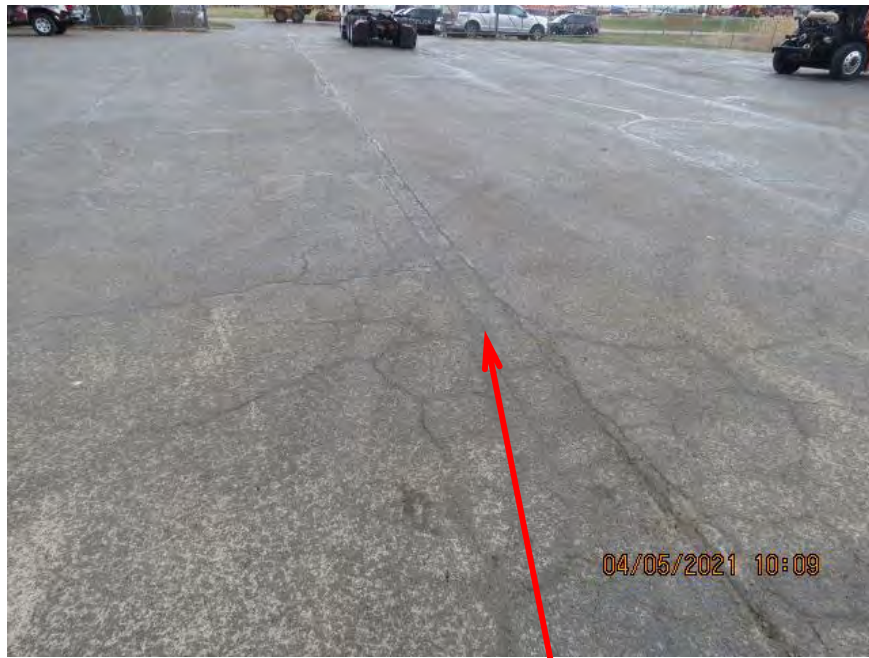
Building Parking Area - East lot seal cracks and repair depressions

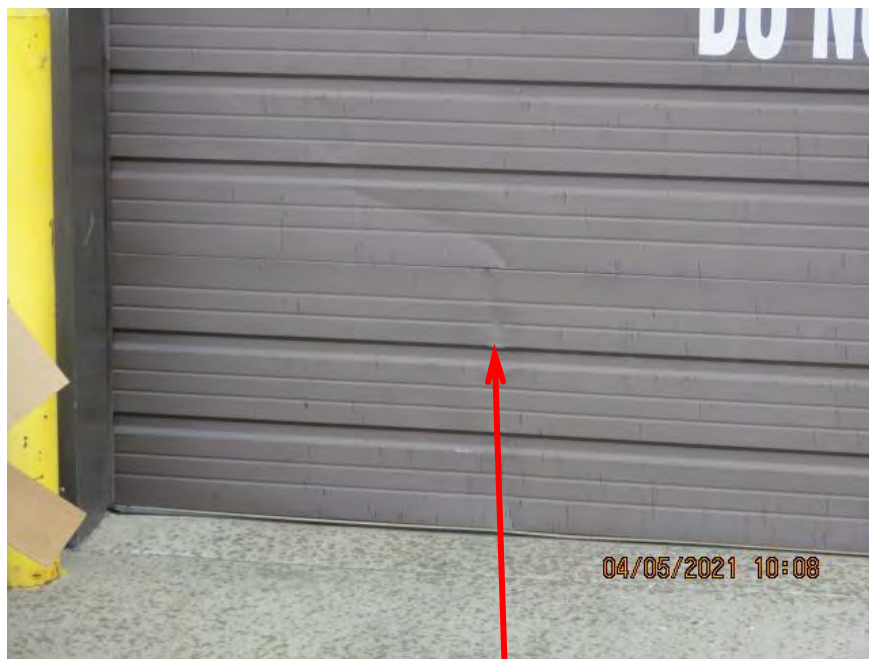
- 11.2.5 The overhead doors are in serviceable condition.
- Damaged metal panels on the overhead doors were noted. These doors should be repaired.
  - The weather-stripping around the overhead doors is damaged and should be replaced.

Damaged overhead door panels

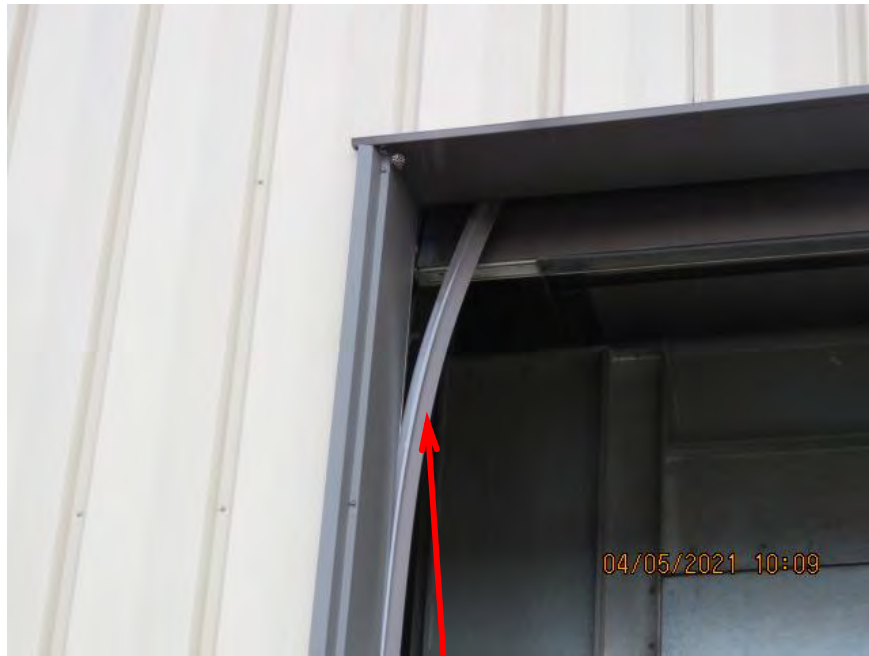
Overhead door weather-stripping is damaged

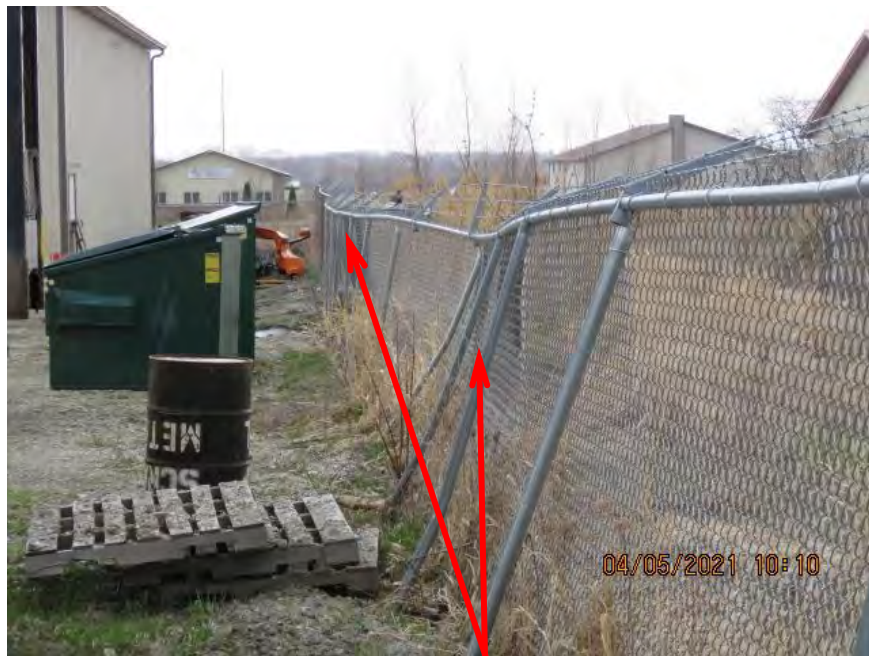
- 11.2.10 The chain link fence is in poor repair and will require major improvement or replacement on the south side.

South fence damaged

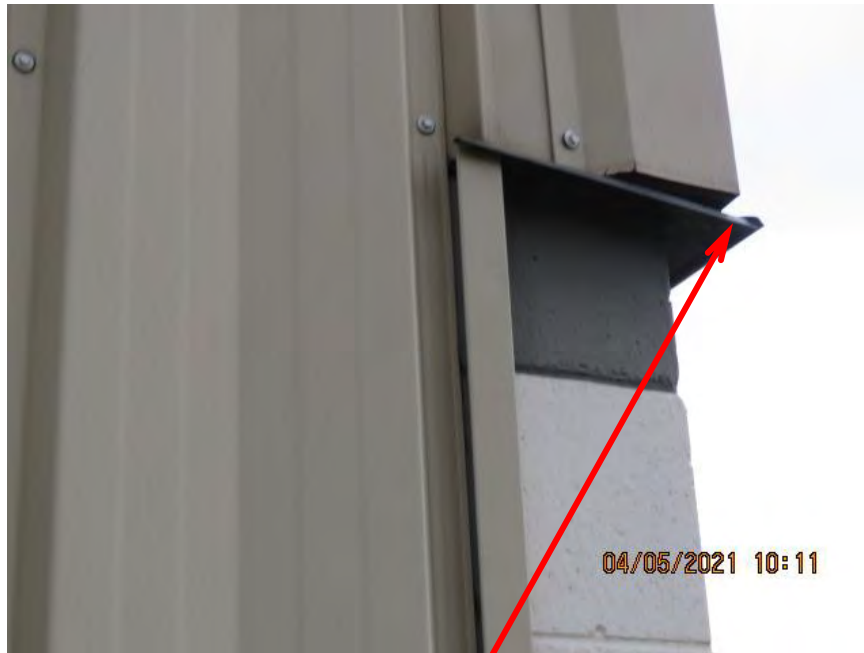
Damaged Trim - Southeast corner

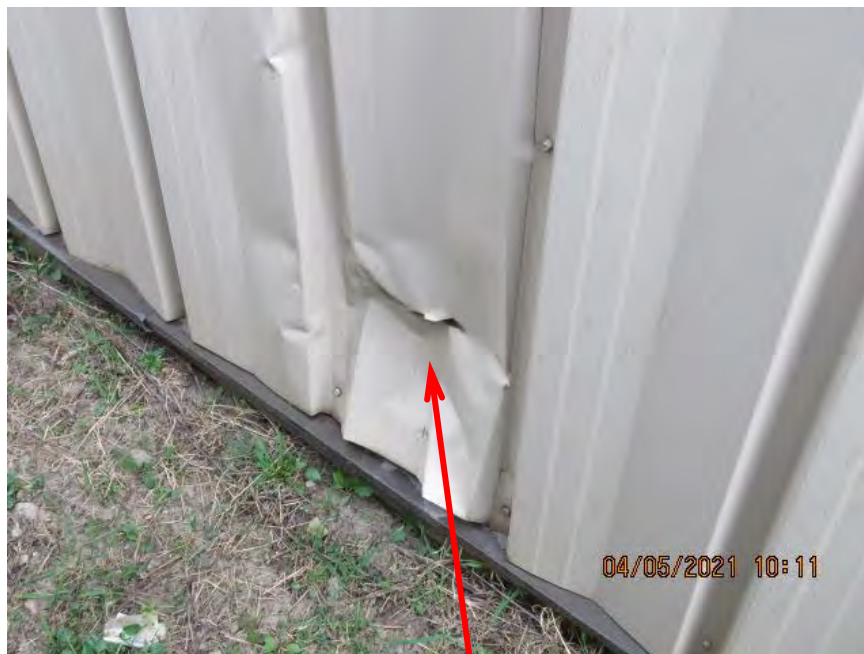
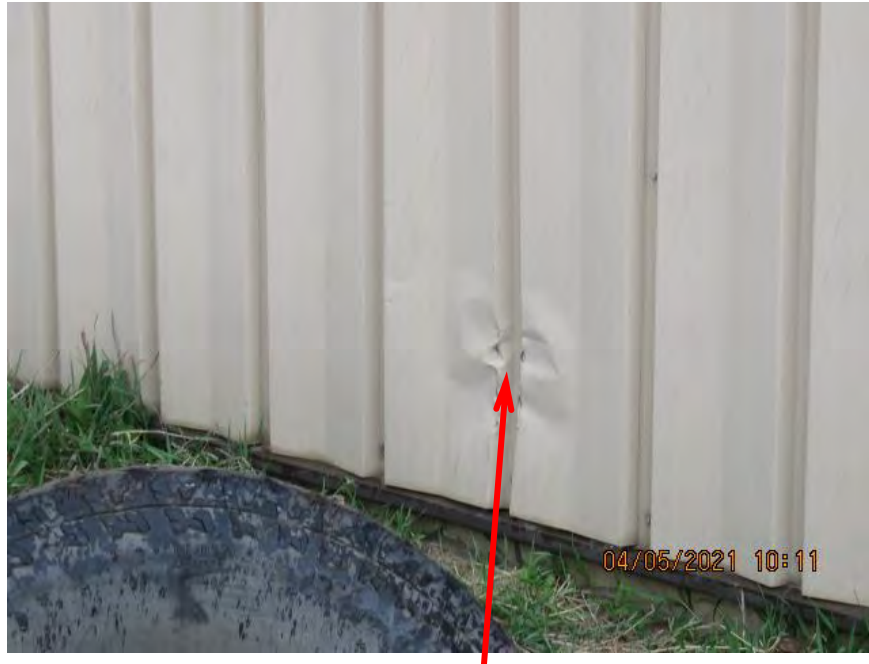
- 11.2.1 The corrugated metal cladding is in serviceable repair.  
 11.2.2 The corrugated metal cladding requires repair at the south side of the main building.

Damaged siding panels south side main building

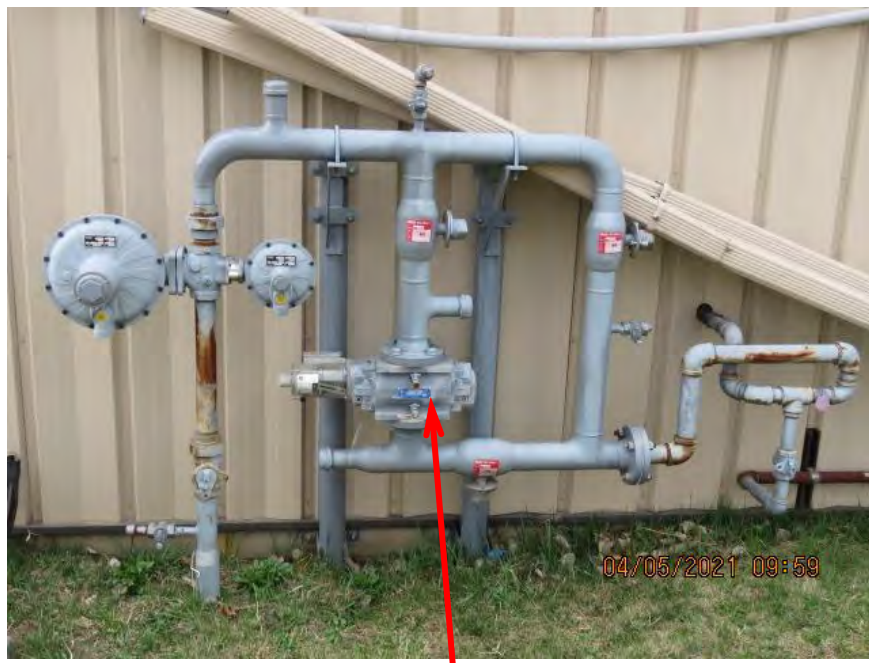
Gas Main

5.2.17 The gas lines on the exterior are corroded and require repainting.
