Property Condition Assessment

OFFICE

00/00/2021

Shamrock Building Inspection Consultants, LLC
300 Cottonwood Ave., Suite 3
Hartland, WI 53029
262-367-1536

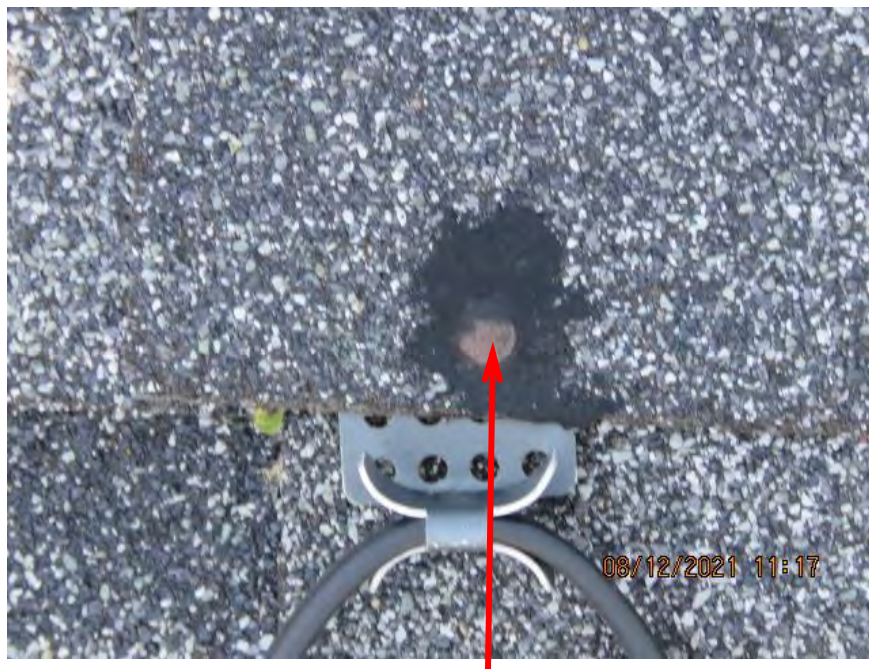
General roof area- nail heads need to be caulked

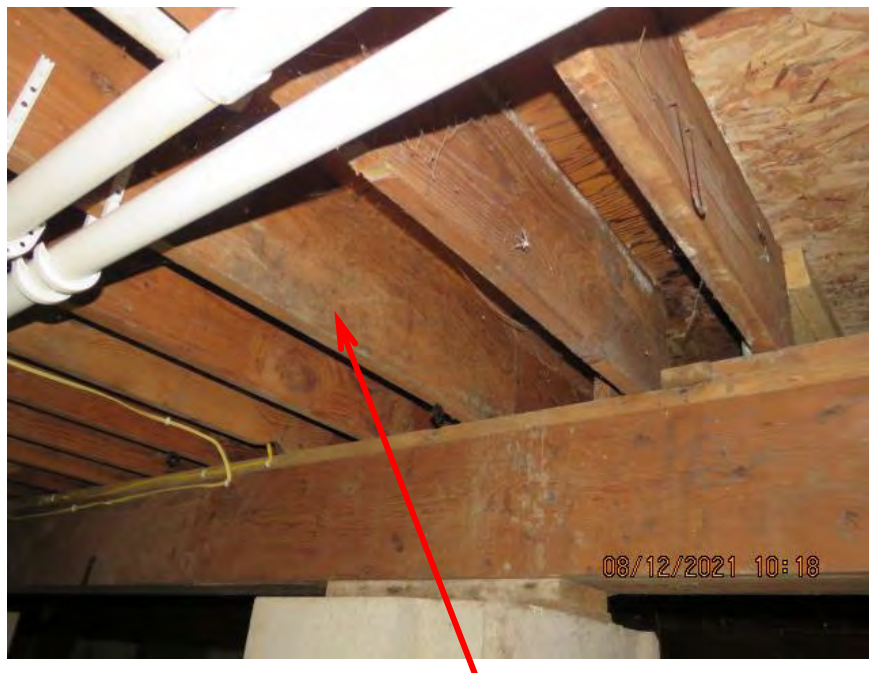
- 12.2.1 The crawlspace is not vented to the building exterior. This may allow excessive moisture build-up and damage the building structure.

Typical building interior- stain on structural framing due to poor crawlspace ventilation

Recommendations		Costs	Time Frame
12.3.1	Crawlspace improvements	\$1,000 - \$2,000	Immediate

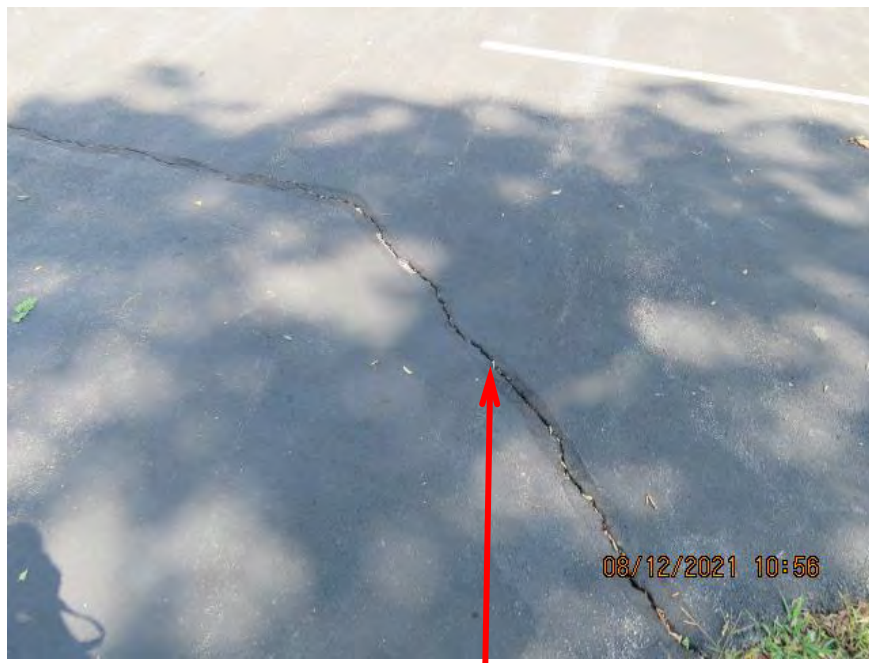
- 11.2.17 The asphalt paving is in mild disrepair but considered serviceable.
 - The large cracks in the asphalt should be sealed with an asphalt slurry.

Building parking area- cracks in the asphalt need to be sealed

Recommendations		Costs	Time Frame
11.3.2	Repair EIFS siding.	\$3,000 - \$4,000	Immediate
11.3.8	Re-caulk windows and expansion joints.	\$1,000 - \$2,000	Immediate
11.3.9	Paint and repair wood windows.	\$1,000 - \$2,000	Immediate
11.3.19	Deck repairs and paint	\$3,000 - \$4,000	Immediate
11.3.16	Mud jacking of walkways at west side.	\$1,000 - \$2,000	Immediate
11.3.17	Asphalt paving repairs.	\$3,000 - \$4,000	Immediate

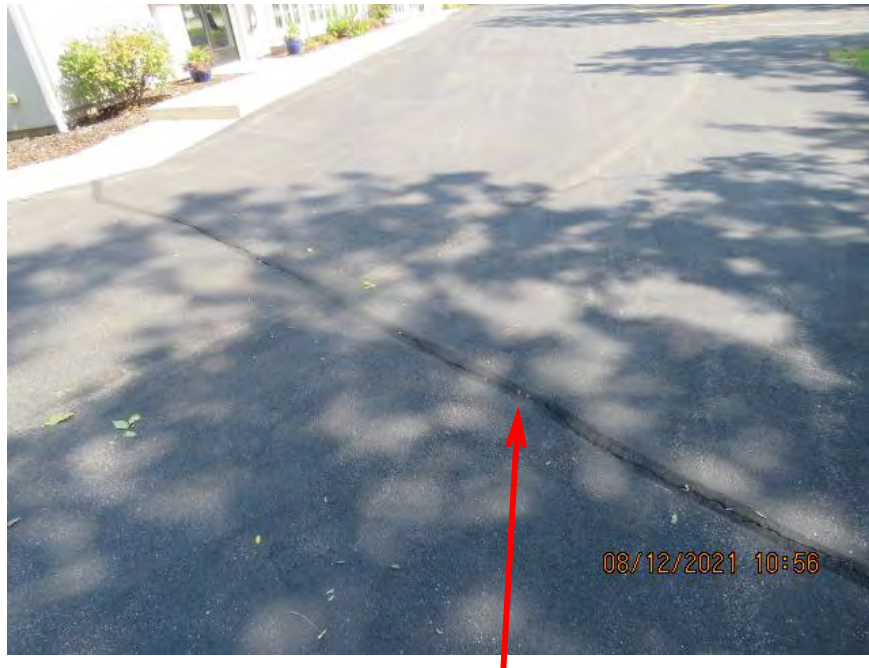
Building parking area- cracks in the asphalt need to be sealed

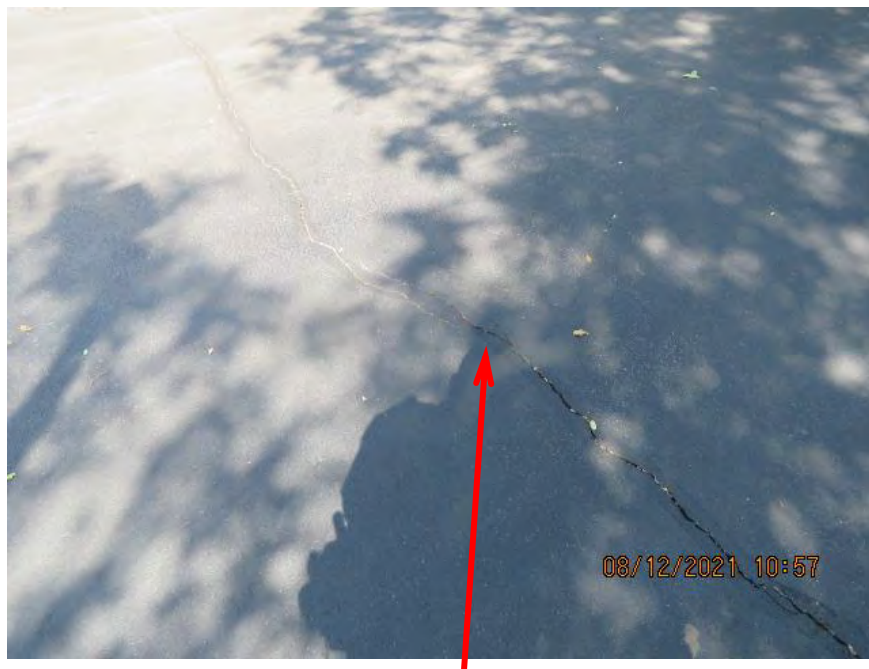
Building parking area- cracks in the asphalt need to be sealed

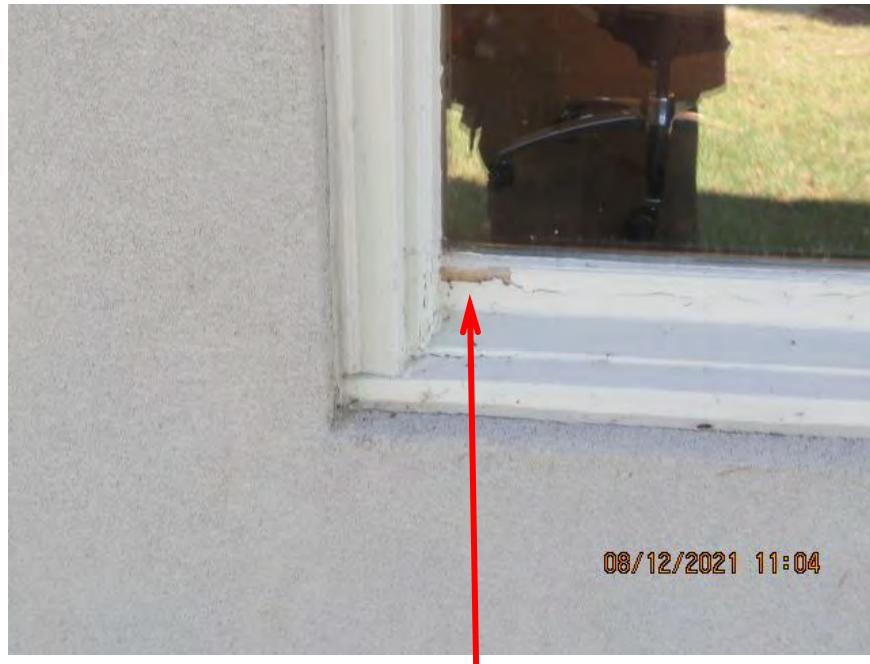
- 11.2.5 The windows are in satisfactory condition, for the most part.
- 11.2.6 All windows that were tested operated properly.
- 11.2.7 Some windows have been replaced.
- 11.2.8 The caulking around the windows is deteriorated and should be renewed.
- 11.2.9 The wood trim around the windows requires repainting.
- 11.2.10 Evidence of condensation was noted on some windows. Reduced humidity levels will help to minimize this.

Windows need repair

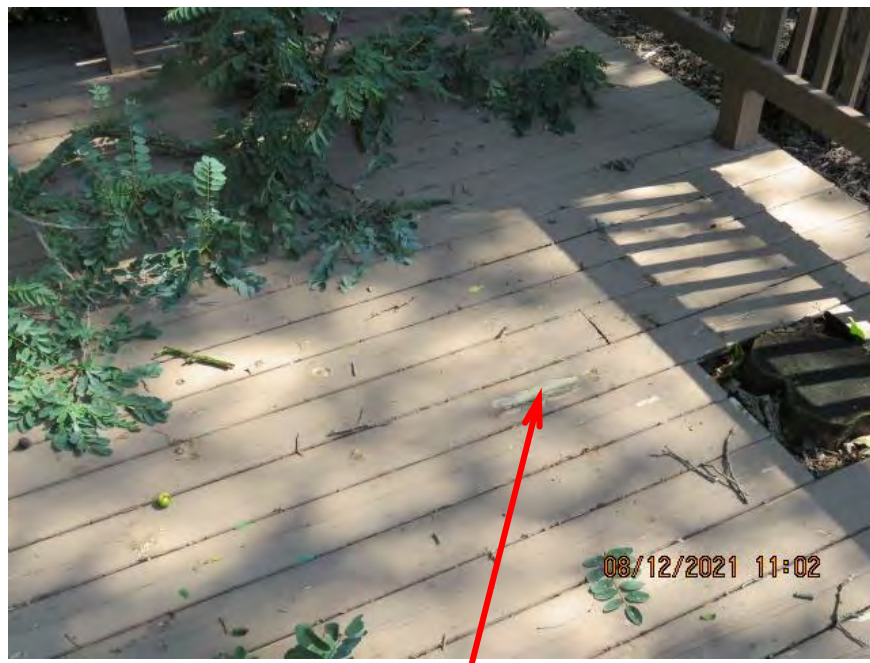
- 11.2.18 The rear deck is in mild disrepair but considered serviceable.
 - Exterior wood should be kept six inches above the earth, where practical. The deck needs paint or stain to protect wood surfaces.

Deck needs repair

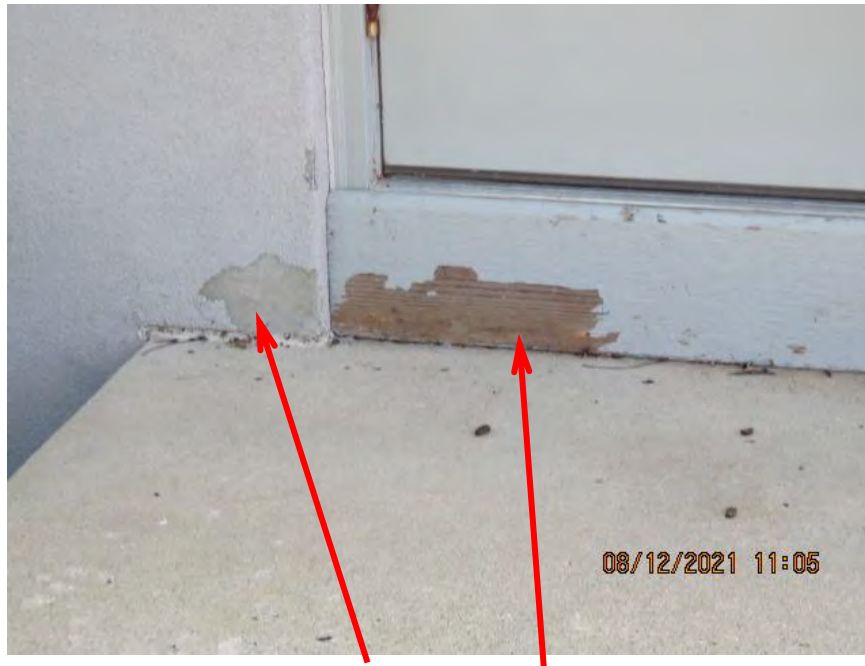
- 11.2.1 The EIFS cladding is in fair repair.
- 11.2.2 The EIFS cladding requires repair. There are cracks and stains in the EIFS siding. In EIFS systems the water barrier is the outside cover on traditional siding like masonry, wood and metal sidings the water barrier or drainage field is behind the siding. So, it is paramount that the exterior finish of the EIFS be water tight.

EIFS sides needs repair- wood surfaces need repair

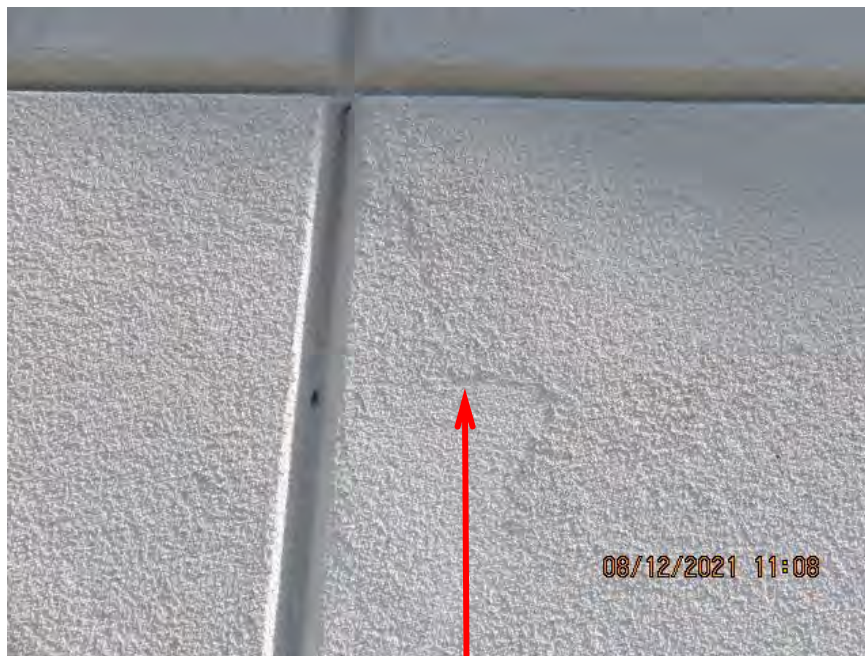
EIFS sides needs repair

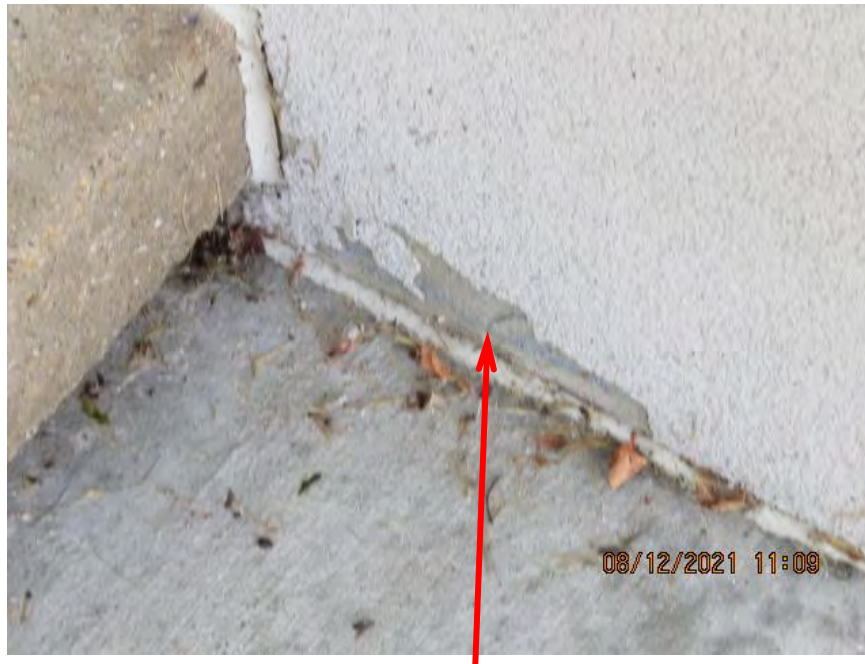
EIFS sides needs repair

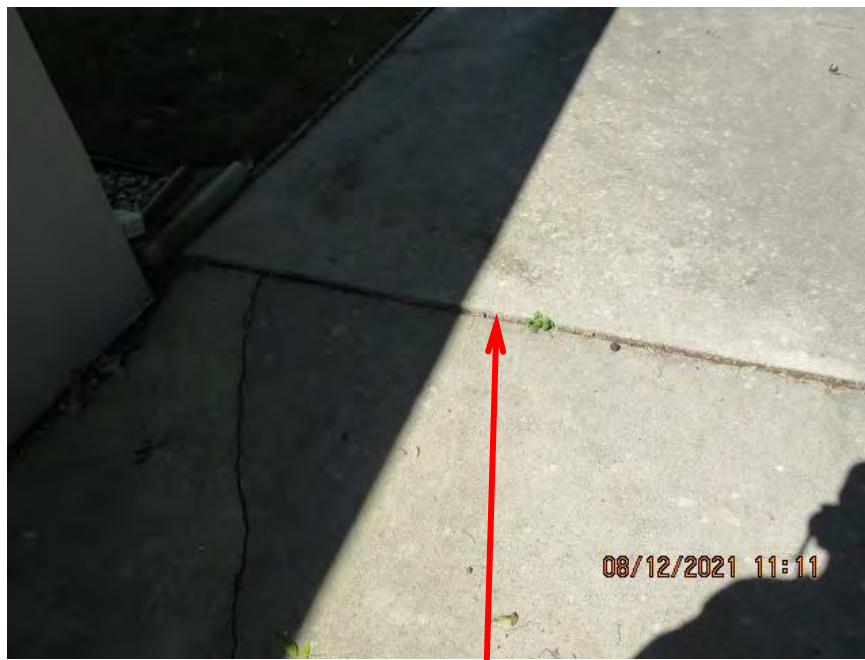
- 11.2.15 The poured-concrete sidewalks are in serviceable repair.
- 11.2.16 The sidewalk in its present state is considered a trip hazard.

North patio- trip hazard
