Home Inspection Report

PROPERTY INSPECTED:
2925 Nantwich Lane
Saint Charles, MO 63301

Date of Inspection: 08/25/2025

Inspection No. 55661-4-26088

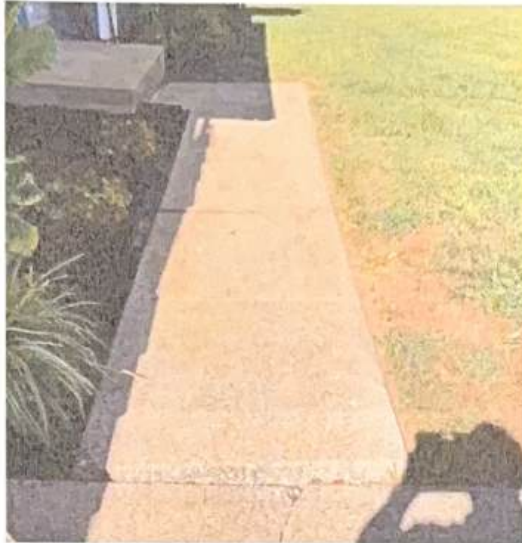
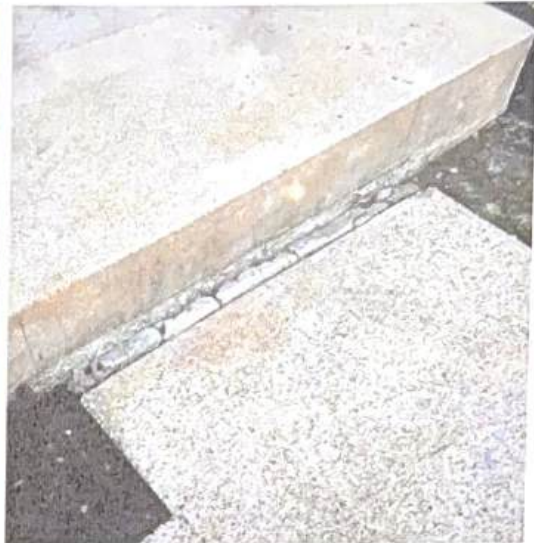
2.4.1 Settlement observed in the concrete surfaces and poses a minor trip hazard. Recommend re-sealing cracks and expansion joints to provide a more even surface, monitor for additional activity and repair as needed. (Exterior Front)

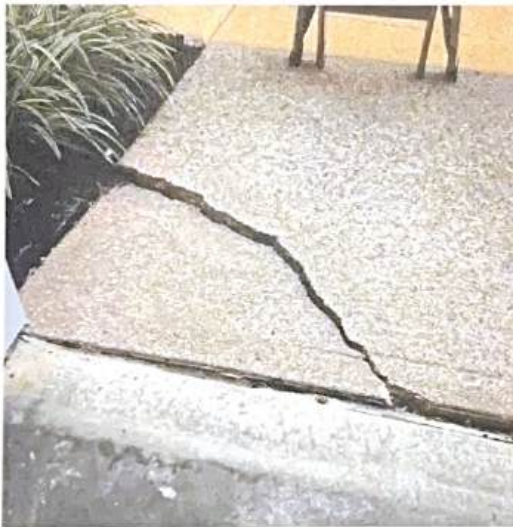
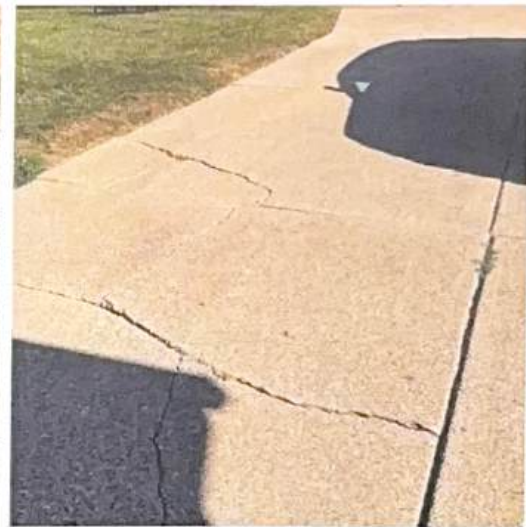
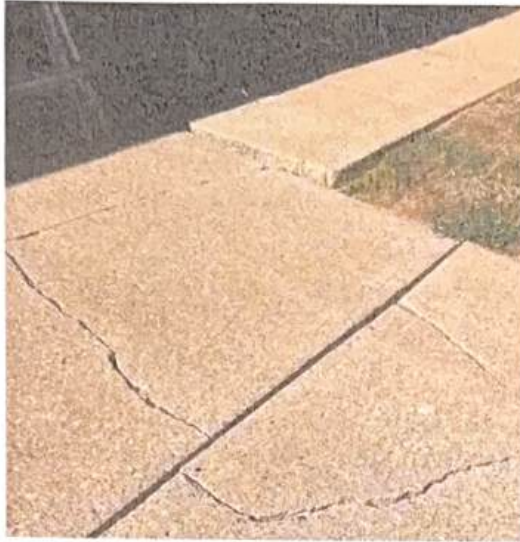
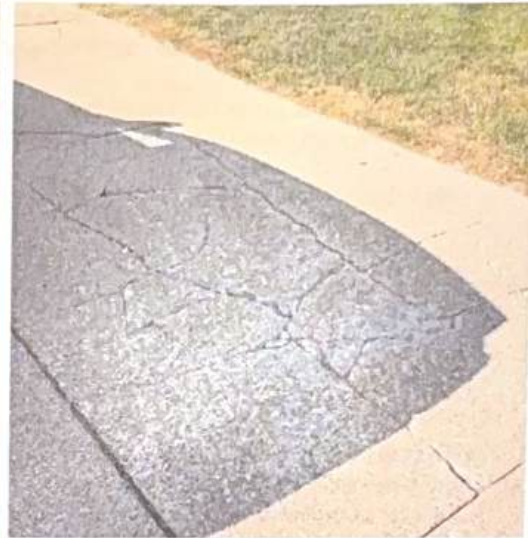
2.5.1 Cracking and vertical displacement (heaving or settling) noted. Repair or replace, as required, to limit further deterioration and related trip hazard. (Exterior Front)

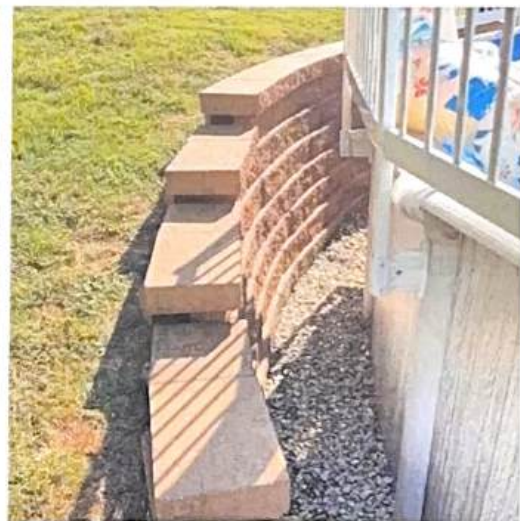
2.6.3 Retaining walls are showing signs of normal age and wear and appears to be performing as intended. Monitor retaining wall for signs of settlement or movement and repair as need to maintain intended soil retention. (Exterior Back)

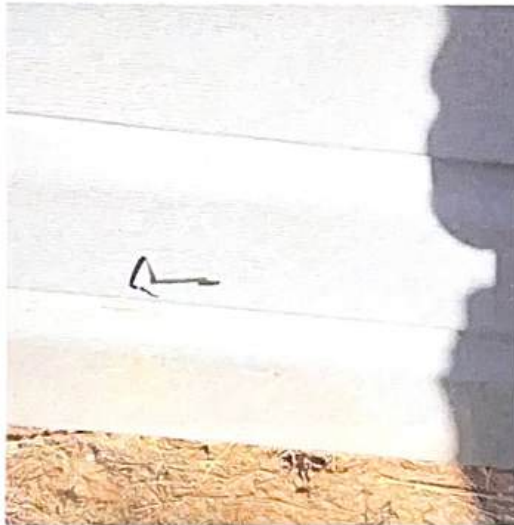
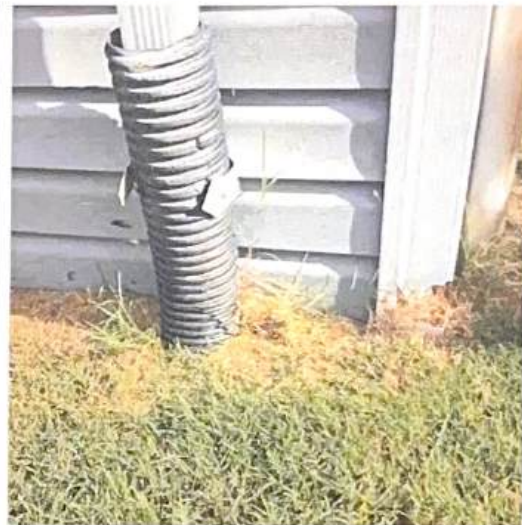
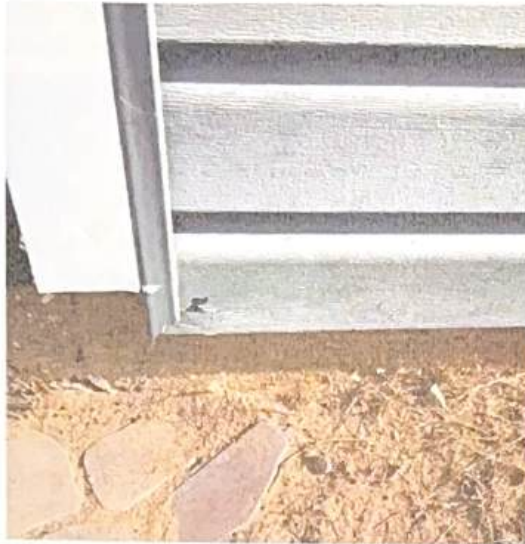
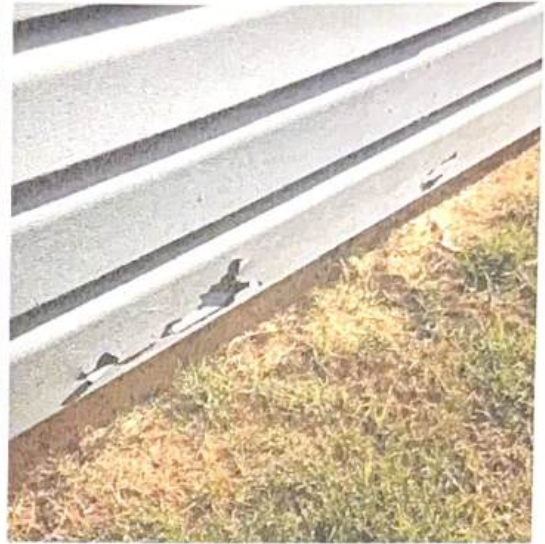
3.3.1 Minor damage and imperfections to the vinyl siding. Recommend sealing and/or replacing damaged siding to help prevent water/weather entry and related damages.

- Exterior Back
- Exterior Left

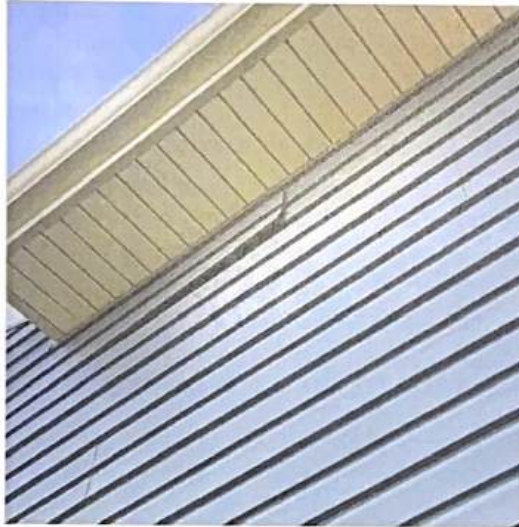
3.3.2 Observed loose siding piece. Secure loose siding to prevent further damage and/or moisture entry. (Exterior Right)

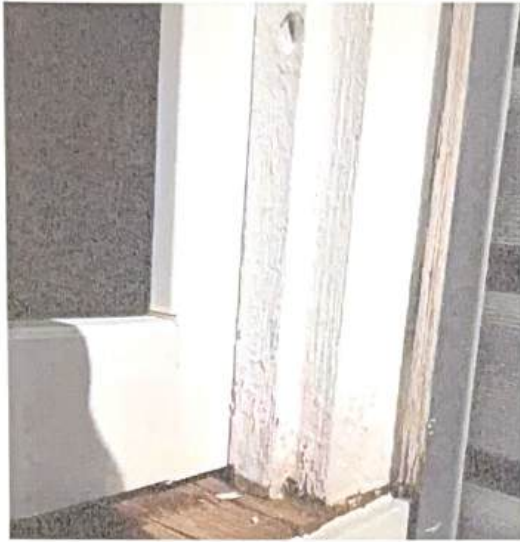
3.5.2 Wood trim will require routine maintenance. Scrape, repair, paint, and caulk to limit weather exposure and related deterioration. (Exterior Back)

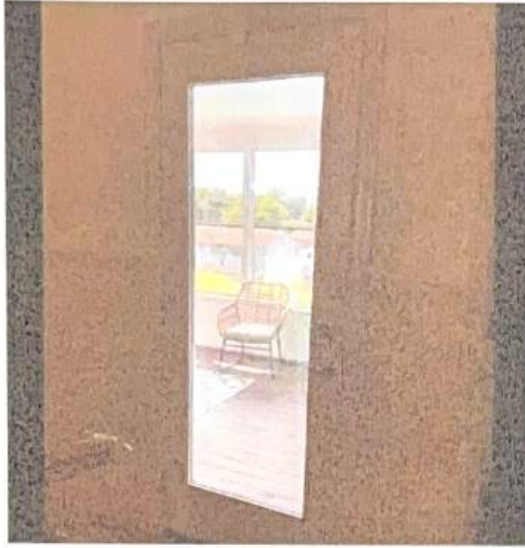
3.7.3 Observed failed seal at glass door pane. Recommend a qualified contractor repair as needed to limit fogging and staining of the glass. (Sun Room)

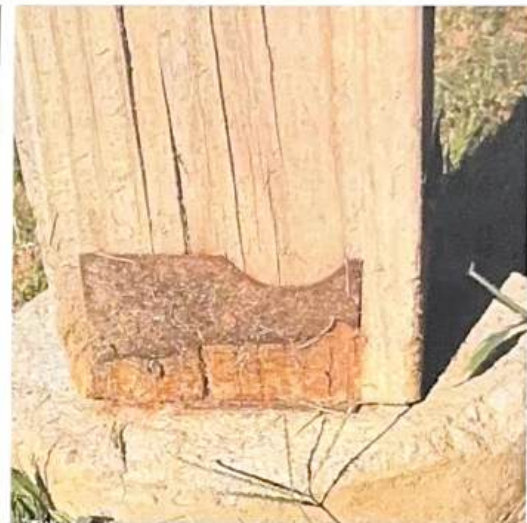
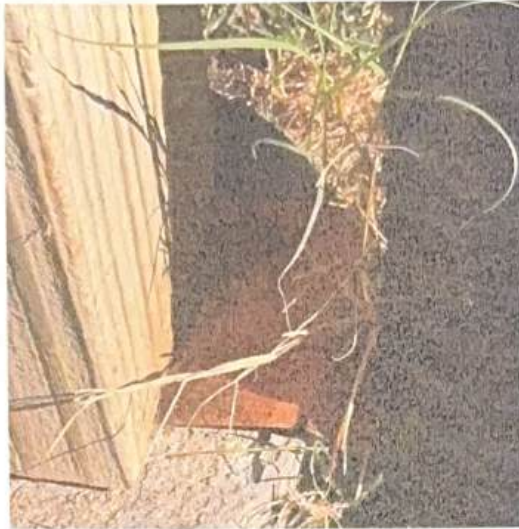
3.9.1 Corrosion observed/ improper installation at select base plates for the support posts. Recommend replacement as needed by a qualified contractor of the damaged base plate to ensure proper support. (Exterior Back)

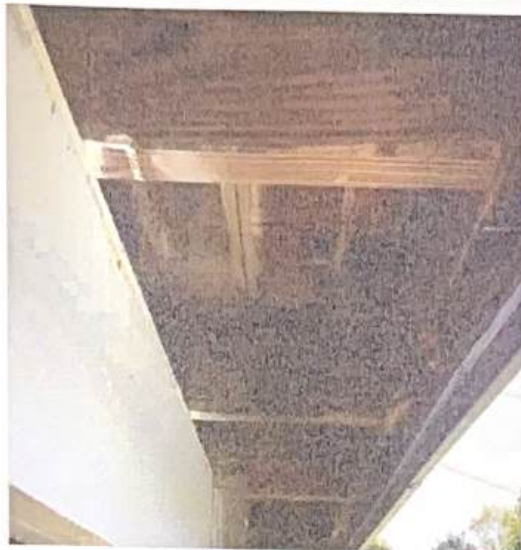
3.9.3 Joists are missing joist hangers at the outer band board. Recommend the installation of joist hangers to ensure proper support. Consider installation of hurricane clips at the wood beam to bring the deck to today's standards. (Exterior Back)

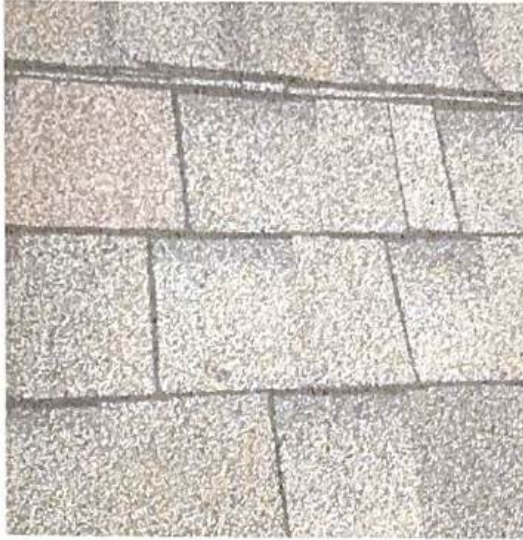
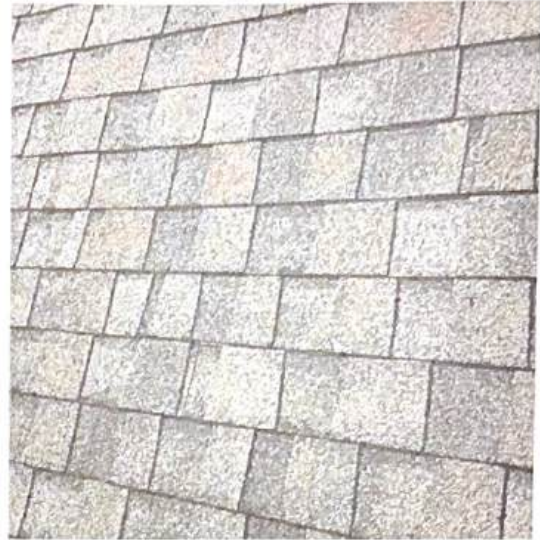
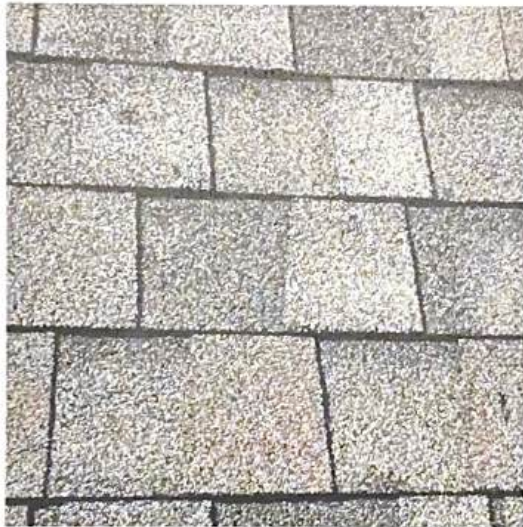
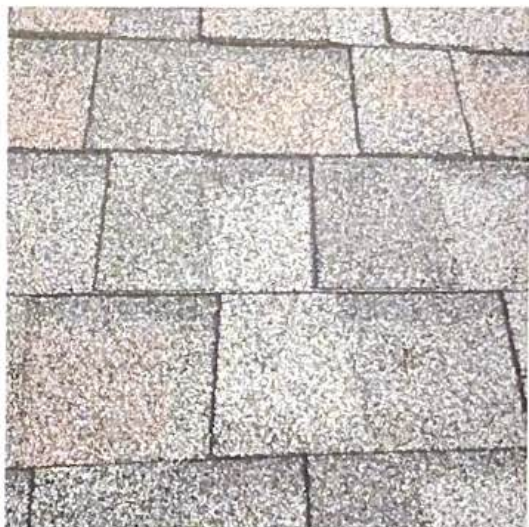
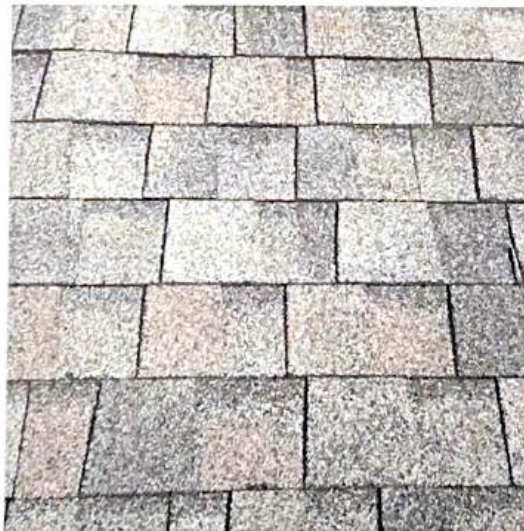
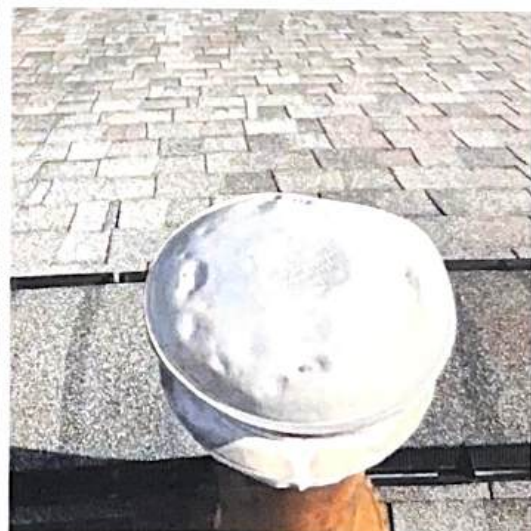
4.3.2 Suspect previous hail and/or heat related damage. This type of activity is common (especially in this region). This type of deterioration may prematurely age the shingles but no repair or replacement is recommended at this time.

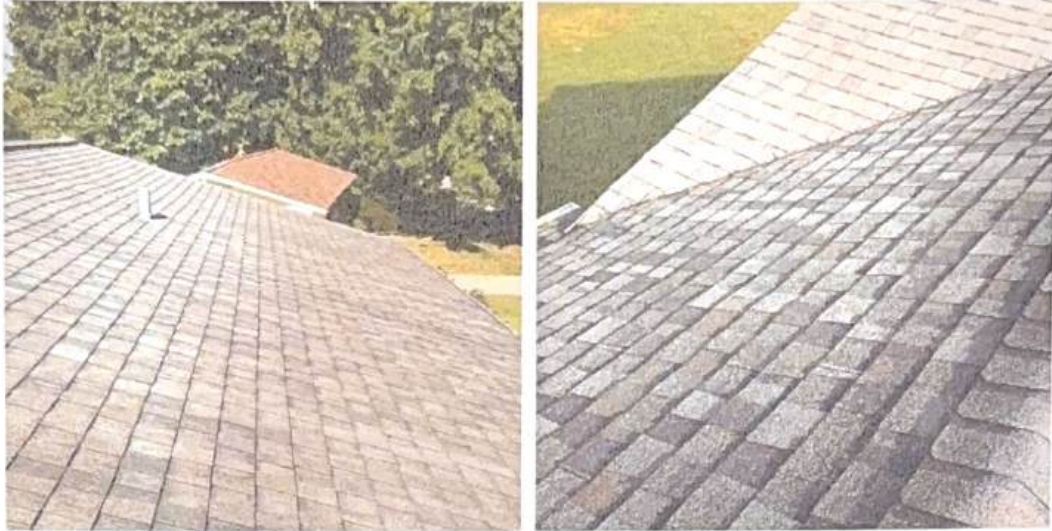
4.3.3 Staining present on the roof covering is an indication of an algae or fungal growth which can prematurely age the shingle, but is of minimal concern. A qualified contractor can clean the roof covering if desired.

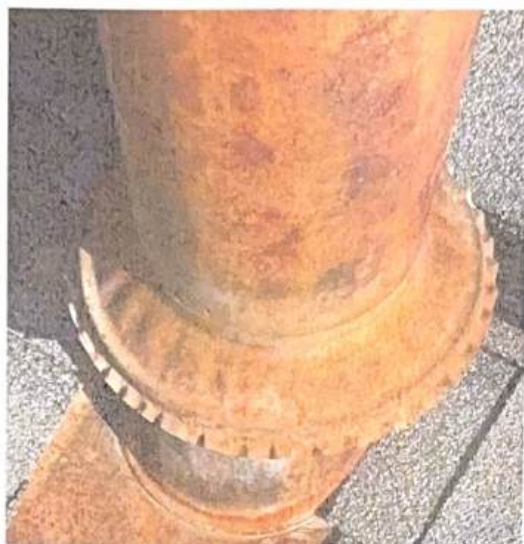
4.6.2 Recommend a qualified person properly seal around flue collar to limit water entry and related damages.

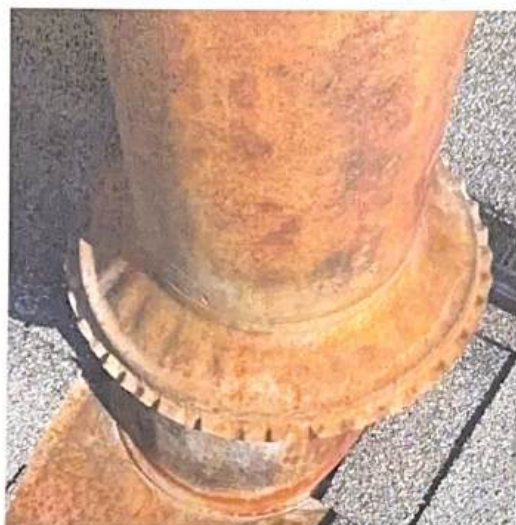
4.6.3 Recommend a qualified person properly seal around flue collar to limit water entry and related damages.

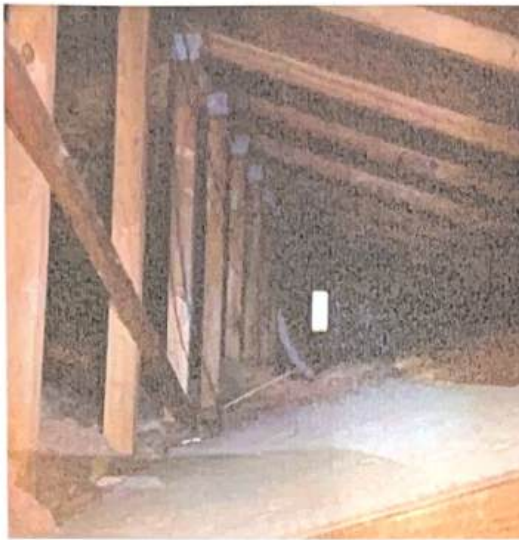
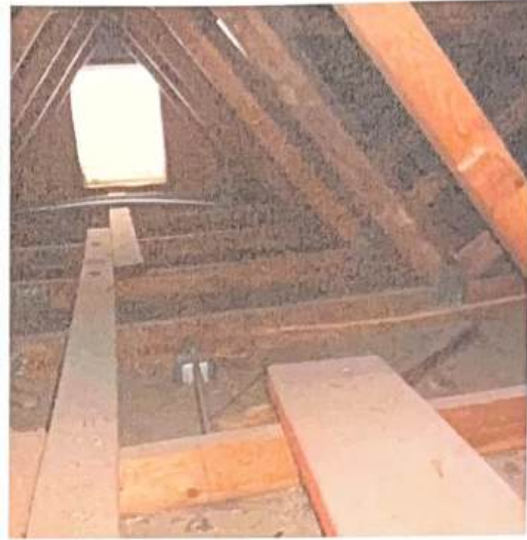
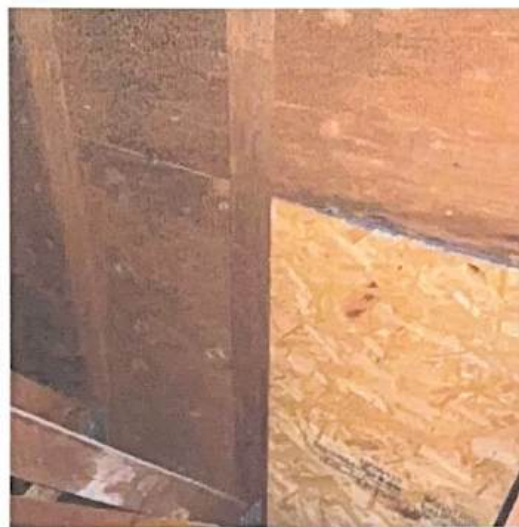
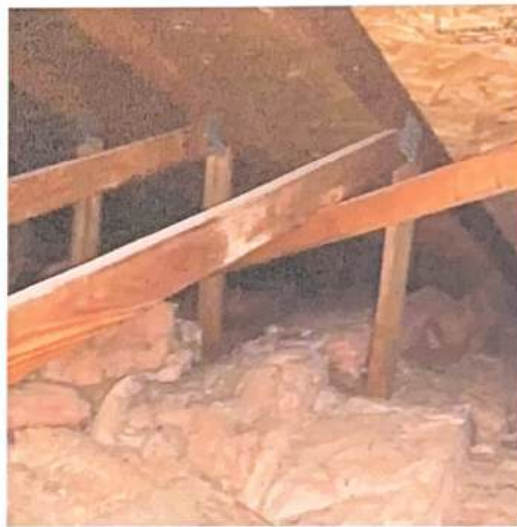
5.3.3 View of the Attic Structure. Select pieces of sheathing were replaced when the roof covering was last replaced. This is common practice when a roof is replaced. Recommend inquiring with the seller as to scope and reason of replacement.

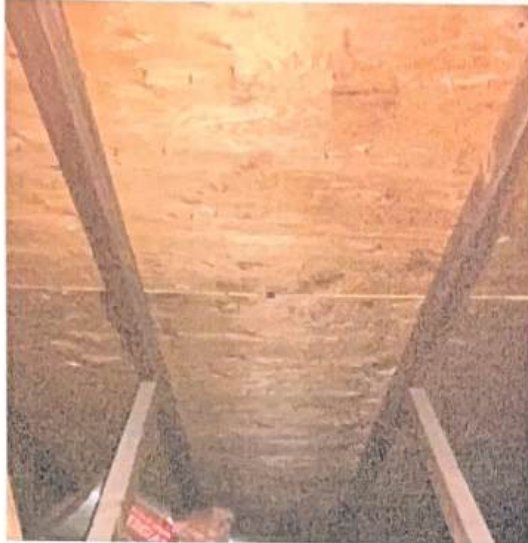
5.4.1 Attic insulation appears to be covering/blocking soffit vents. Clear restricted soffit vents and provide baffles to ensure proper operation which will prolong the life of the roof covering, limit moisture related issues in the attic space, and lower energy bills.

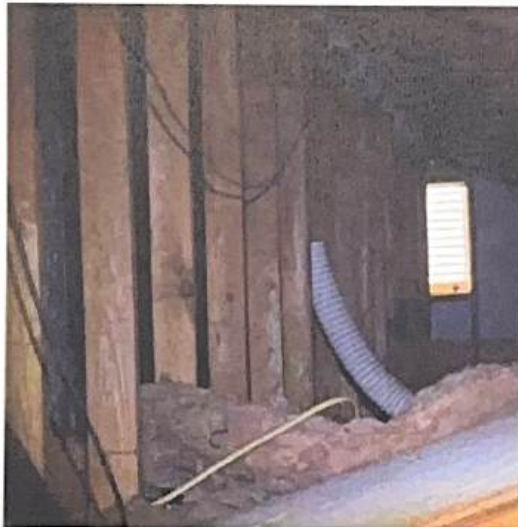
5.5.1 Bathroom exhaust discharges into the attic which is a common practice but not recommended in my opinion. Consider extending the exhaust to the exterior to limit moisture related activity in attic space.

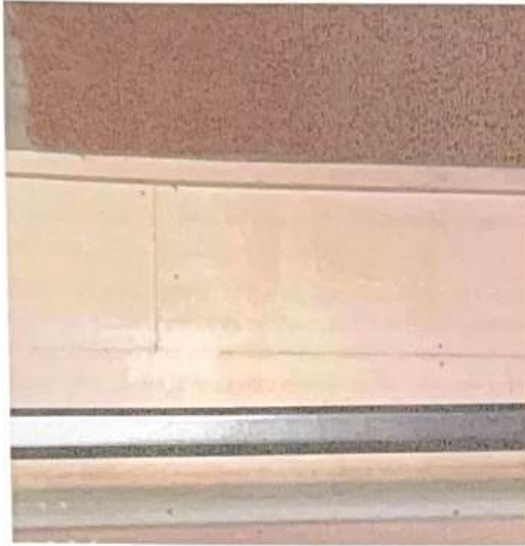
6.6.1 Damaged, loose or open tape seams noted at the garage walls. Recommend repair to provide proper fire barrier protection. (Garage)

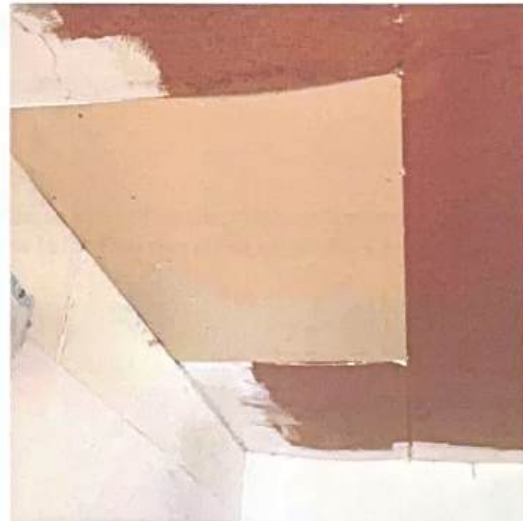
6.7.1 Damaged, loose or open panels on the ceiling with open seams noted at the garage ceiling. Recommend repair to provide proper fire barrier protection. (Garage)

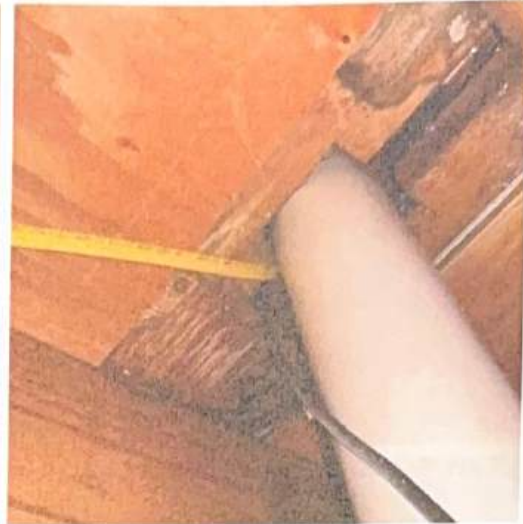
7.4.2 Several areas of staining from previous leaking noted in sub floor below bathrooms. This is very common in a building this age. Monitor for additional activity and repair as needed. (Unfinished basement)

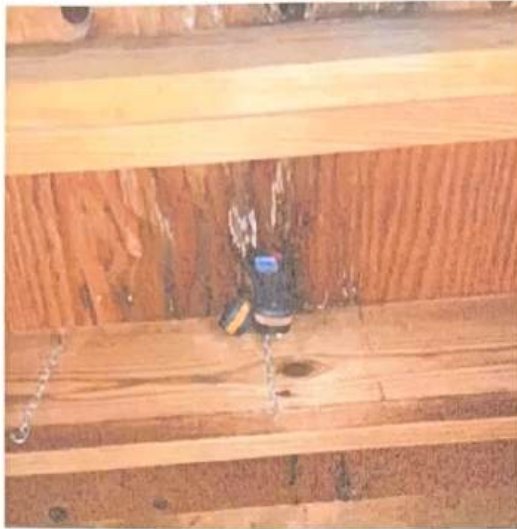
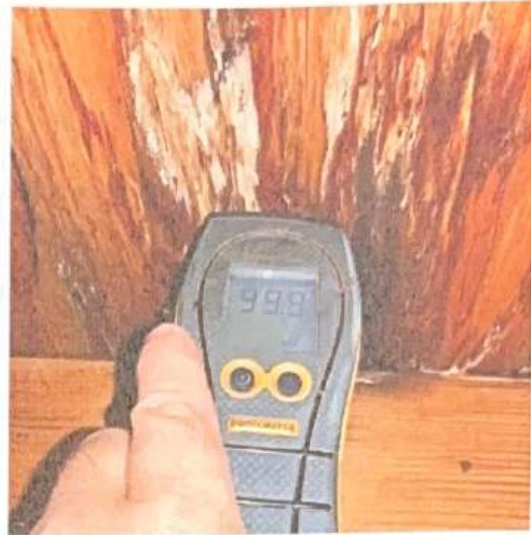
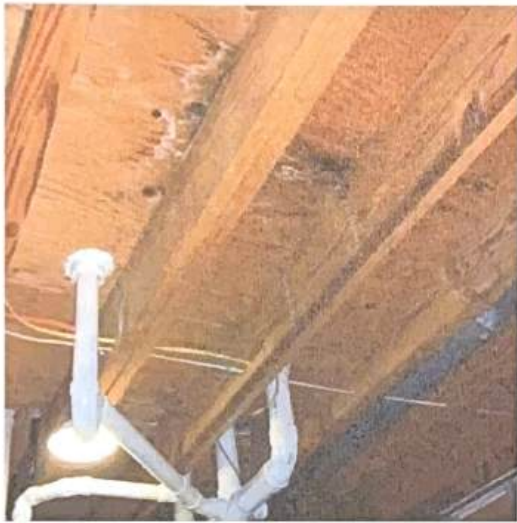
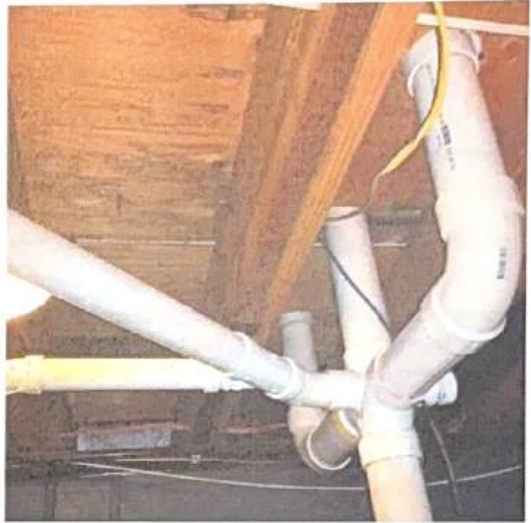
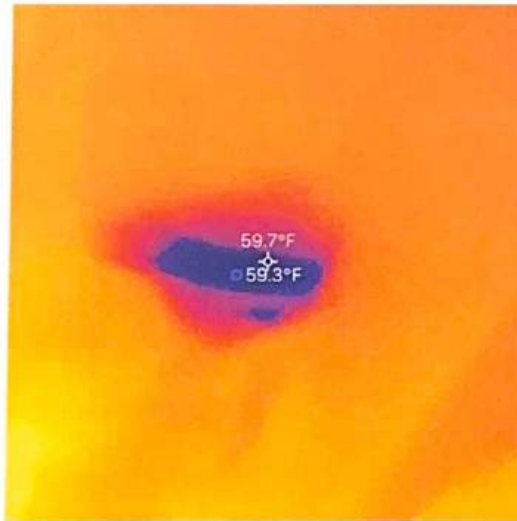
7.4.3 Staining from moisture activity noted. These areas were tested with a moisture meter and found to contain elevated moisture levels at the time of inspection. I suspect it to be related to loose toilet in the hall bathroom and something with primary shower. Recommend further evaluation and repair as needed by a qualified contractor to prevent continuing moisture entry and related damages. (Unfinished basement)

Shower leak identified in primary bathroom. Edges of shower professionally caulked and no further dampness or moisture has been observed since repair.

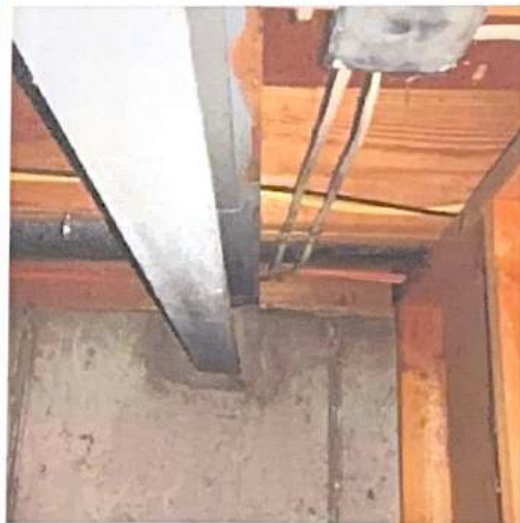
8.5.2 Unprotected wiring noted. Recommend providing conduit to reduce hazards associated with unprotected wiring. (Utility Room)

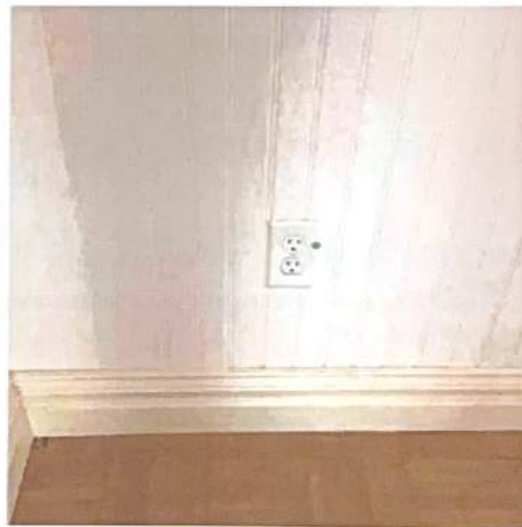
→ 8.5.4 Original branch circuit in the home is serviced by Aluminum Wiring and it appears that some receptacles and switches have been changed. For example, Dining room receptacle and kitchen wall marked with a green sticker was not CO/ALR stamped and/ or have a proper Alumicon connector, but are done correctly. Not all were inspected and for that reason, I recommend further evaluation of the branch circuit wiring (receptacles, switches and lighting) with correction only as necessary by a qualified electrical contractor to limit potential hazards.

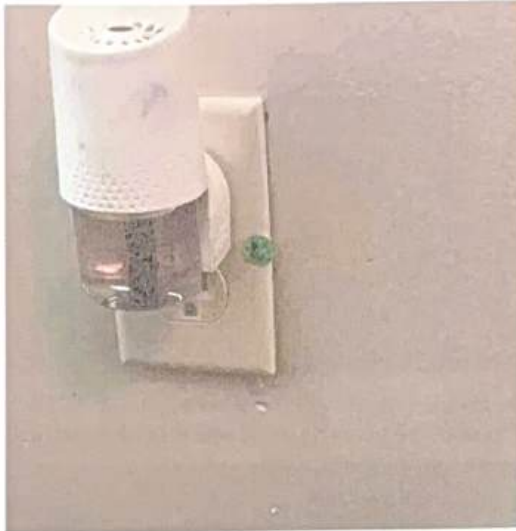
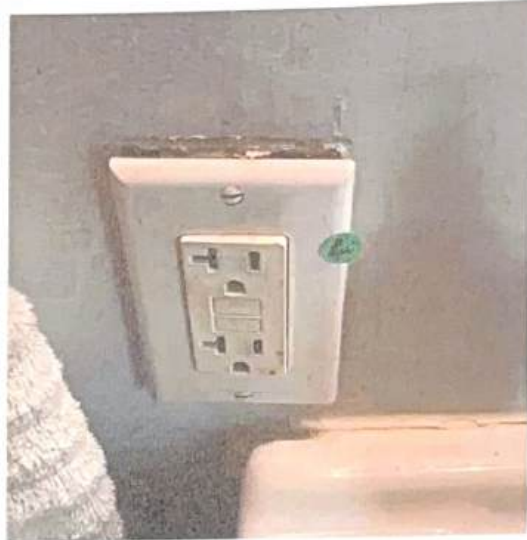
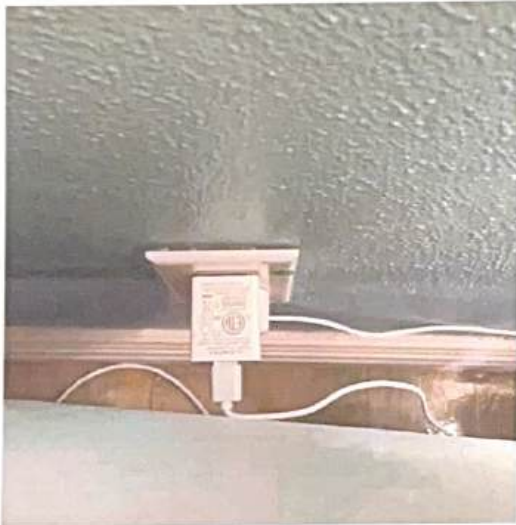
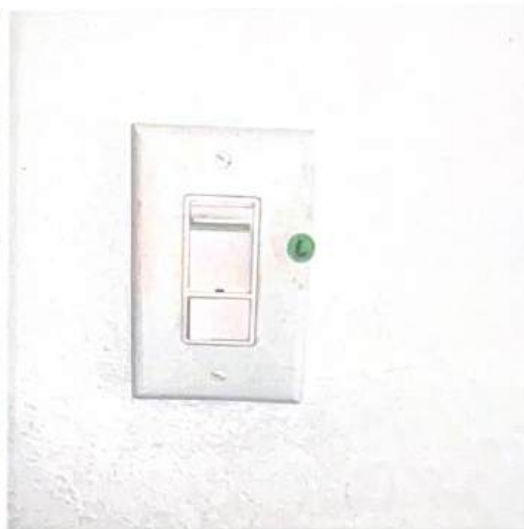
8.6.2 Loose receptacle/s noted with a green "L" sticker. Secure loose receptacle/s to limit risk of future damage and related hazards.

- Back bedroom
- Finished basement
- Living Room
- Primary Bathroom
- Primary Bedroom

Repaired as recommended
by licensed electrician.

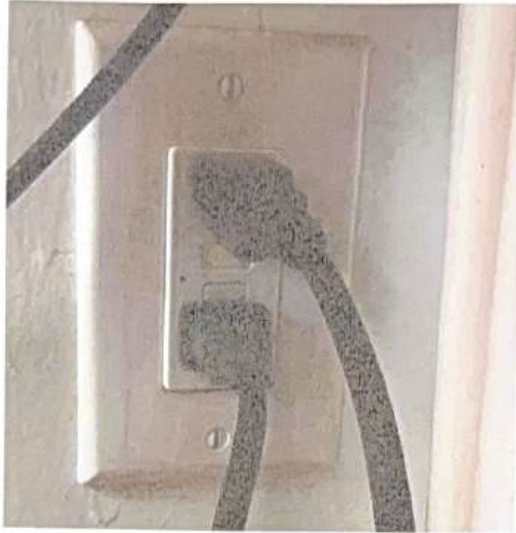
8.6.3 Missing proper exterior receptacle cover noted. Recommend correction to limit moisture related damage to receptacle. (Sun Room)

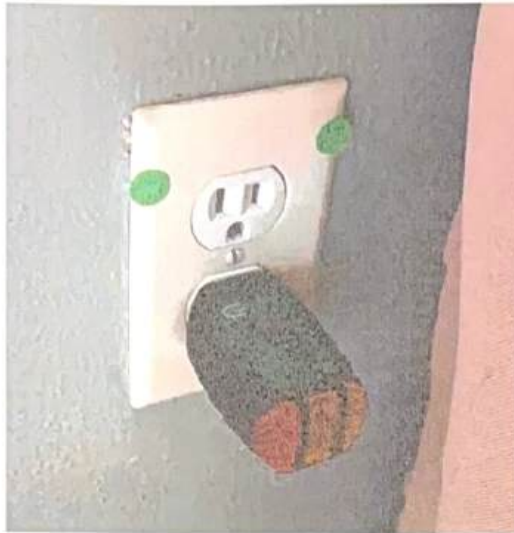
8.6.5 Receptacle marked with 2 green stickers was not operational. Recommend repair by a qualified contractor to ensure proper operation. (Primary Bedroom)

Repaired as recommended
by licensed electrician.

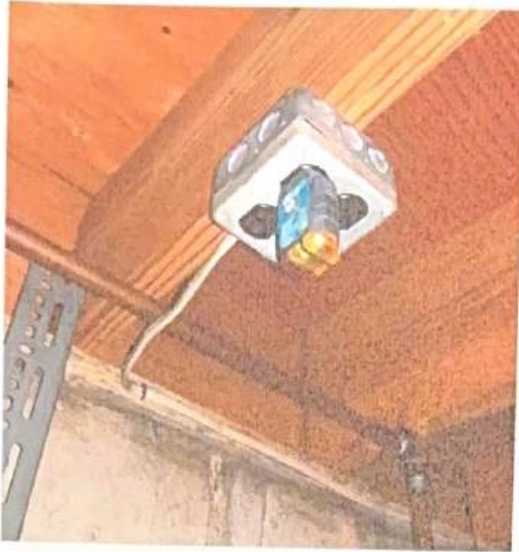
8.6.7 GFCI protected receptacles were not present in all areas of the basement with a concrete floor surface. Recommend correction by a qualified contractor to reduce shock hazard. (Utility Room)

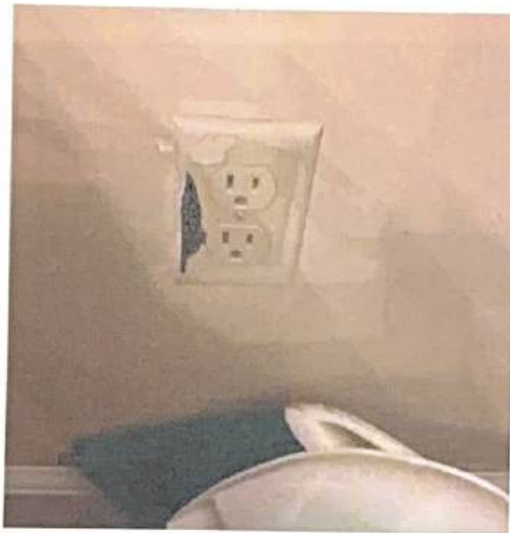
→ 8.6.8 Damaged cover plate noted. Recommend replacement to reduce shock hazard. (Finished basement)

X
Cover replaced/evaluated
by electrician.

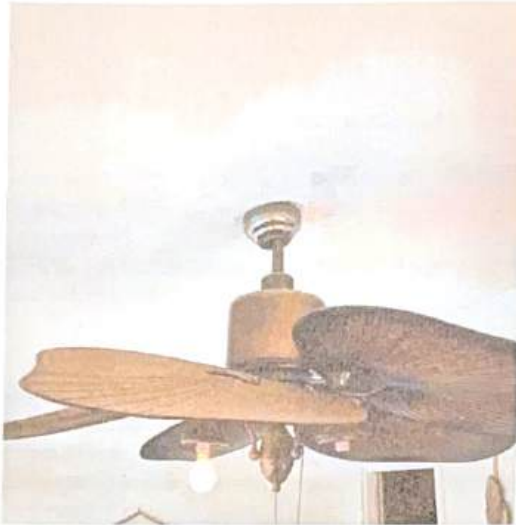
8.7.1 Ceiling fan is loose or not properly installed. Recommend correction by a qualified contractor to limit damage to wiring, fan and any potential hazards. (Sun Room)

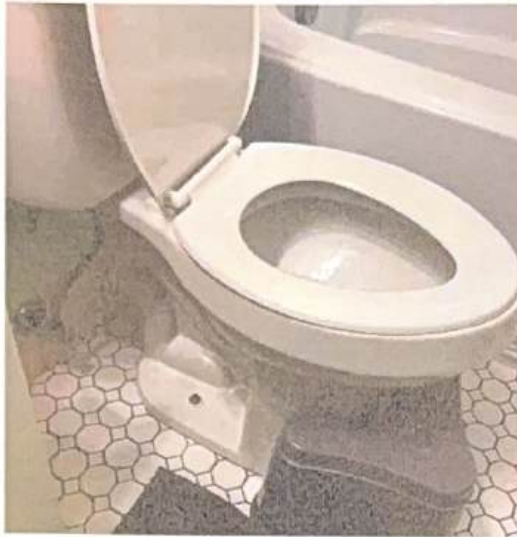
10.9.2 Toilet was loose at the base of the floor. Recommend securing toilet and caulking around the base on three sides to limit movement on tile and provide a proper seal to the floor. (1st Floor Hall Bathroom)

Toilet seured
as recommended.

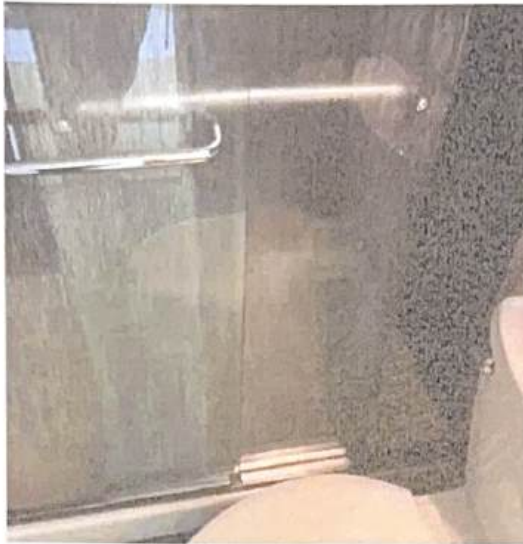
10.10.3 Shower door is off track or missing bottom guide. Recommend repair to ensure safety, proper operation, and to limit damages. (Primary Bathroom)

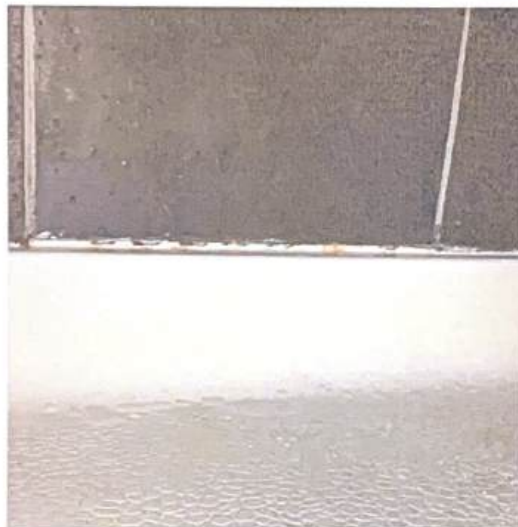
→ 10.10.4 Damaged caulk noted at the tub/shower. Recommend repair of damaged caulk to limit moisture entry and related damage. (Primary Bathroom)

~~X~~
Caulk repaired.

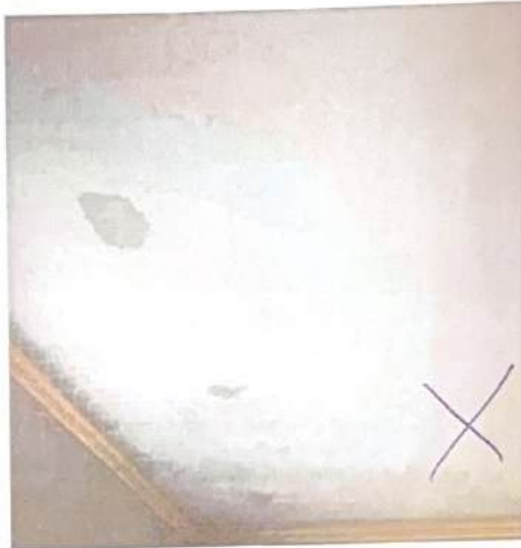
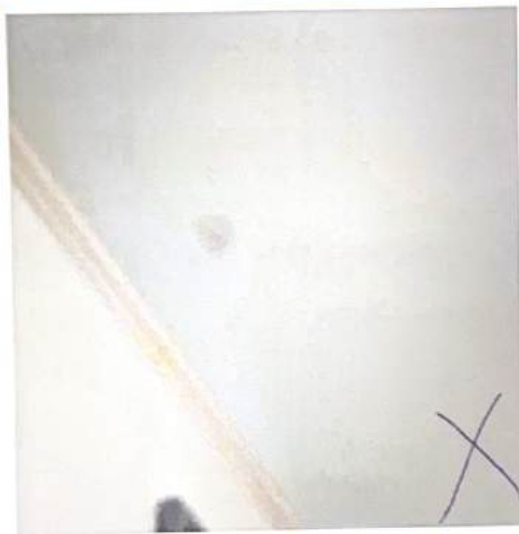
11.3.3 Typical drywall defects noted throughout the house (exposed tape seams, nail pops, cracks, etc). Recommend repair by a qualified contractor as needed.

Painted

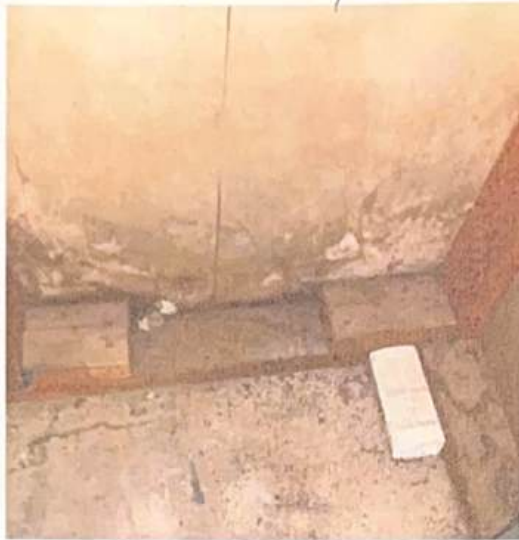
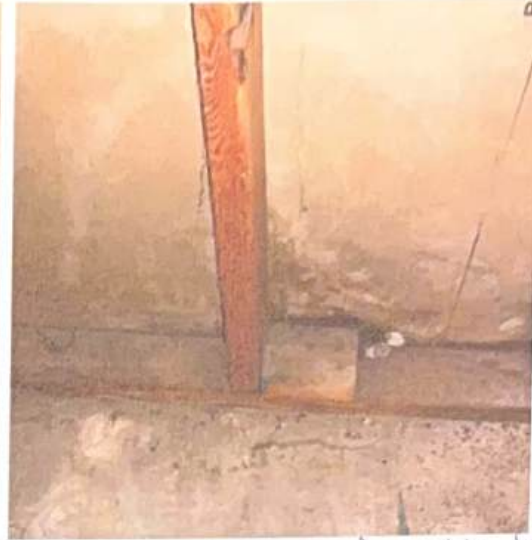
11.3.4 Suspect mold/ mildew related growth in an isolated area likely relates to elevated humidity and/ or minor moisture intrusion. It appears to be older and from a previous moisture event. Recommend treatment and/ or proper removal of affected areas. (Utility Room)

no active moisture. Area cleaned with bleach.

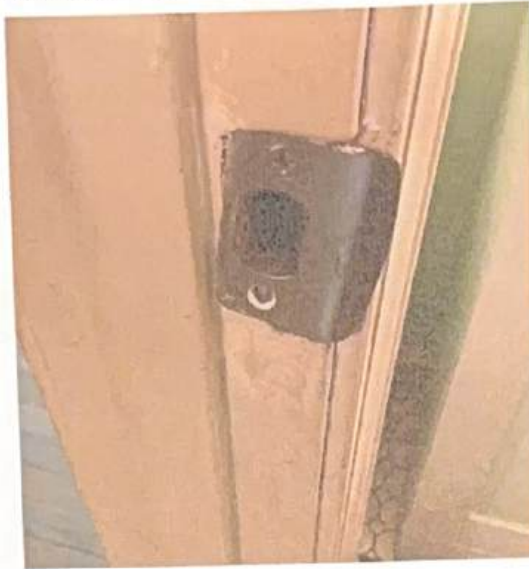
11.5.3 Door has loose hardware. Replace damage/missing door hardware throughout to ensure proper operation, lock and latch, and safety. **(1st Floor Hall Bathroom)**

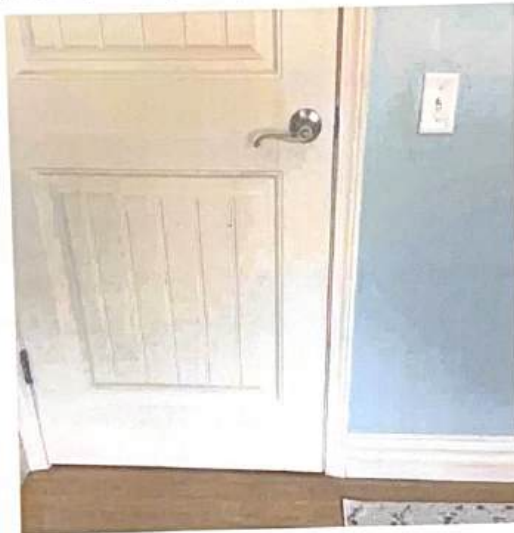
11.5.4 The door binds which makes it difficult to operate. Recommend correction or adjustment to ensure proper operation. **(Primary Bedroom)**

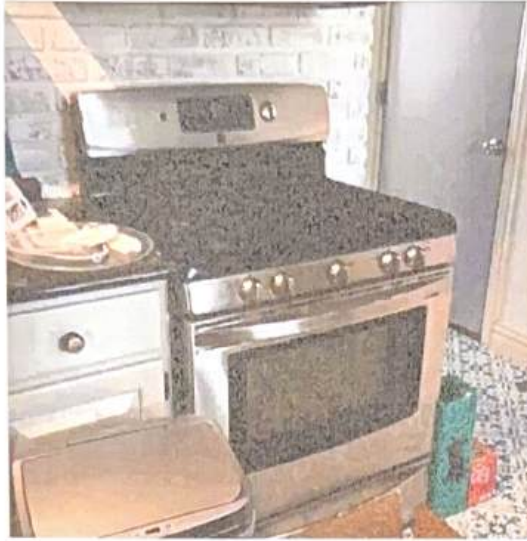
12.2.1 Anti-tip device for the stove is missing or not properly aligned/installed. Recommend correction to limit safety hazards. (Kitchen)

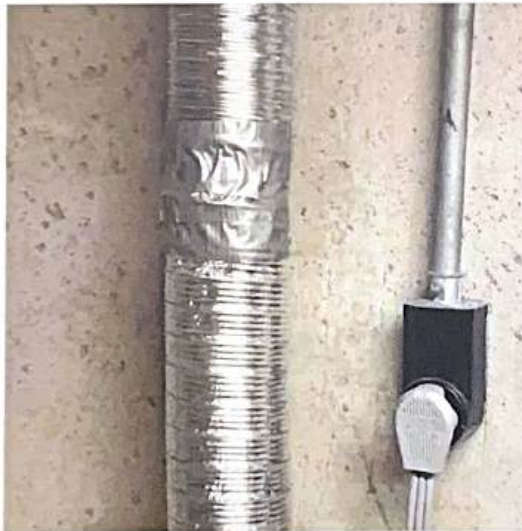
12.7.1 Recommend replacement of all plastic or duct tape dryer vent material with metal to limit safety hazard. (Laundry area)
