MILESTONE INSPECTION REPORT

MOUNT VERNON & HERMITAGE

MOUNT VERNON BUILDING

ISSUE DATE:

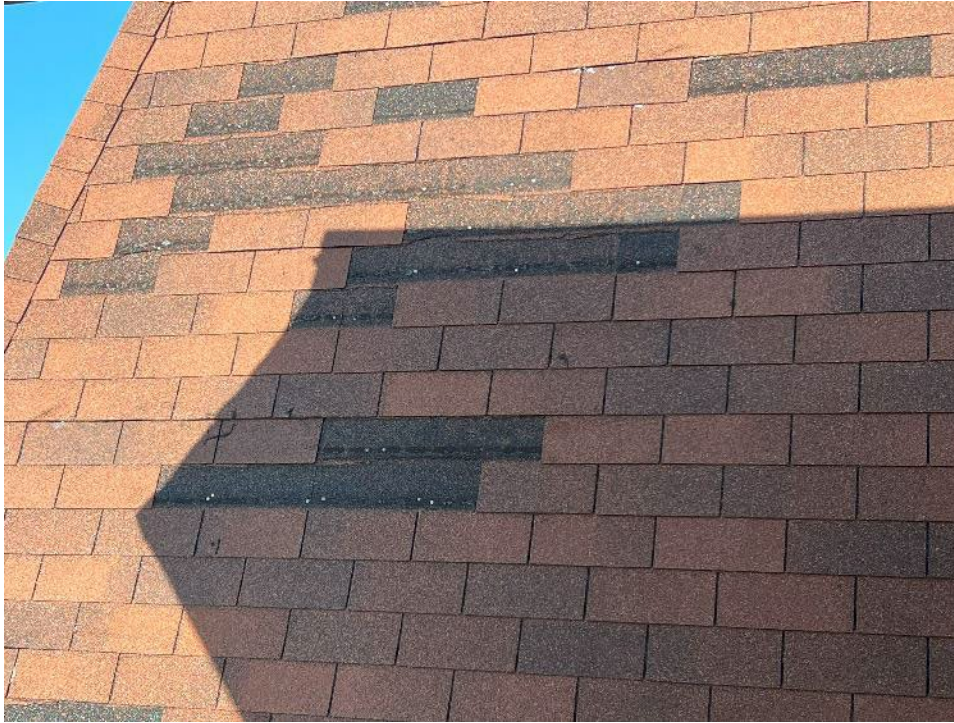
Figure E- 7

- Multiple areas of missing asphalt shingles were observed along the perimeter sloped roof areas (Refer to Figure E-7).
- Localized areas of exterior wall cracking were observed along the building exterior (Refer to Figure E-8).

- Regular maintenance of the roofing systems, which should include repair of missing and/or dislodge roof shingles. Please note maintenance of roofing systems is typically dependent on the product manufacturer’s specifications/recommendations and age and effectiveness of the roofing system, which is outside of the intent of the Milestone Inspection as Elevated Engineering understands it and therefore no comments on the recommended maintenance of the roofing system are included.

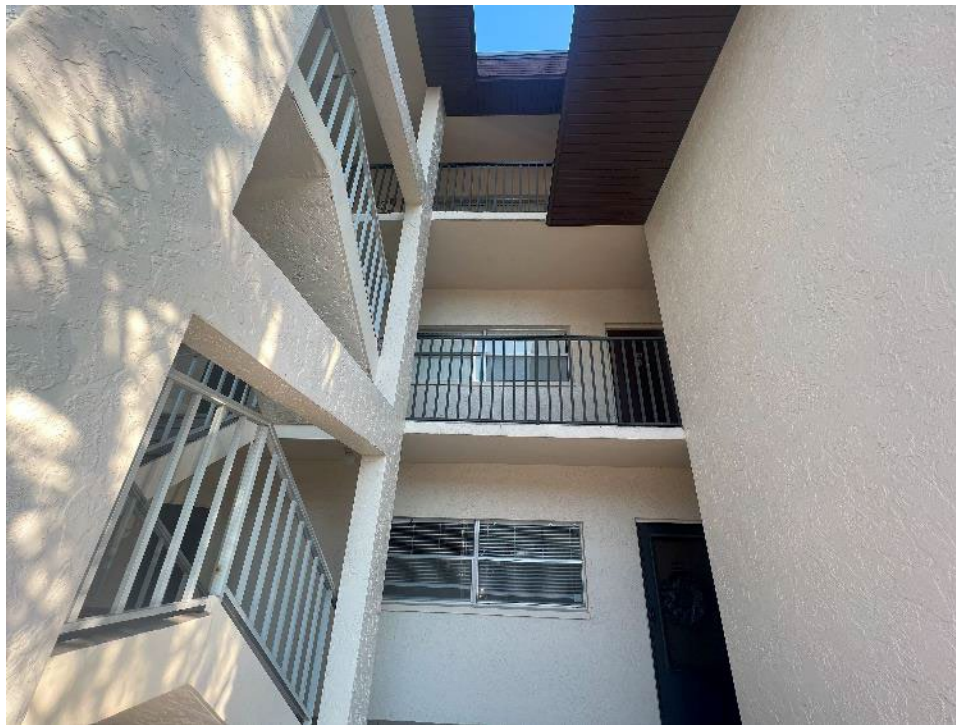
Figure W- 1

- The exterior walkways appear to be constructed of cast-in-place reinforced concrete elevated slabs and slabs on grade (Refer to Figure W-1).
- The exterior walkway floor surfaces appear to be finished with an exterior paint coating or concrete stain over a cementitious textured finish (Refer to Figure W-2).

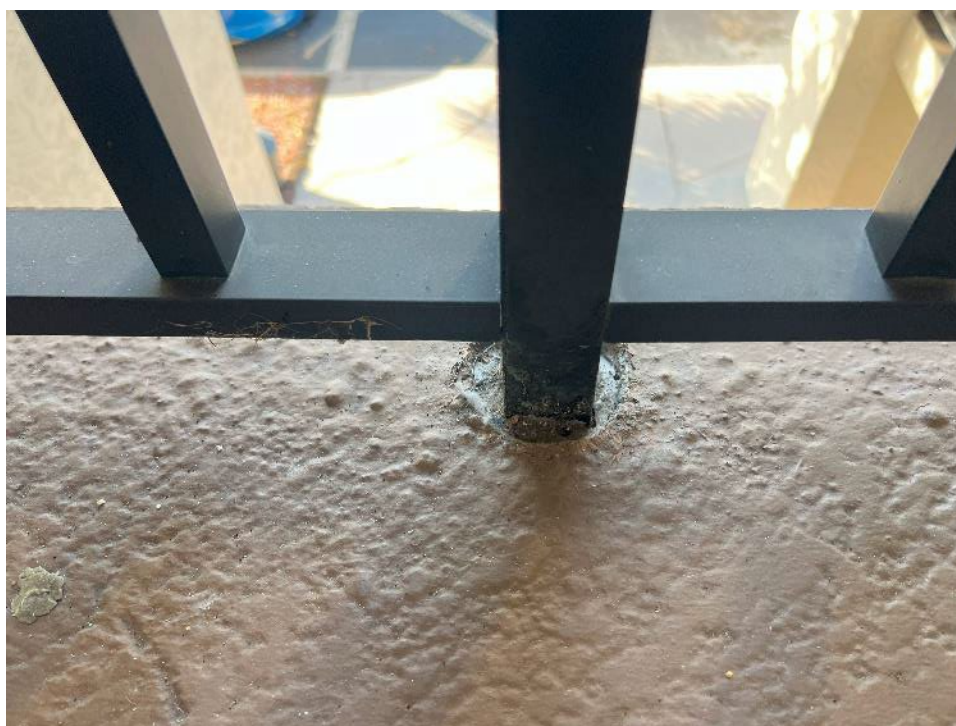
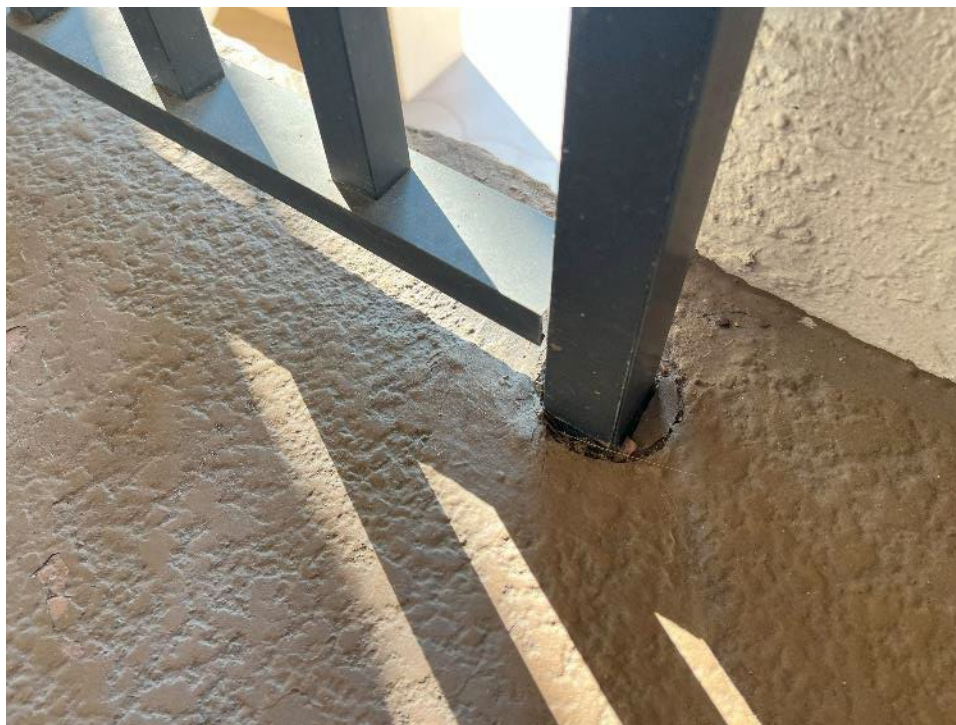
- Multiple deteriorated guardrail post pockets were observed along the elevated walkways (Refer to Figure W-6 and Figure W-7).
- Localized areas of delaminated stucco and/or unsound concrete were observed along the underside of the walkway slabs (Refer to Figure W-8 and Figure W-9).

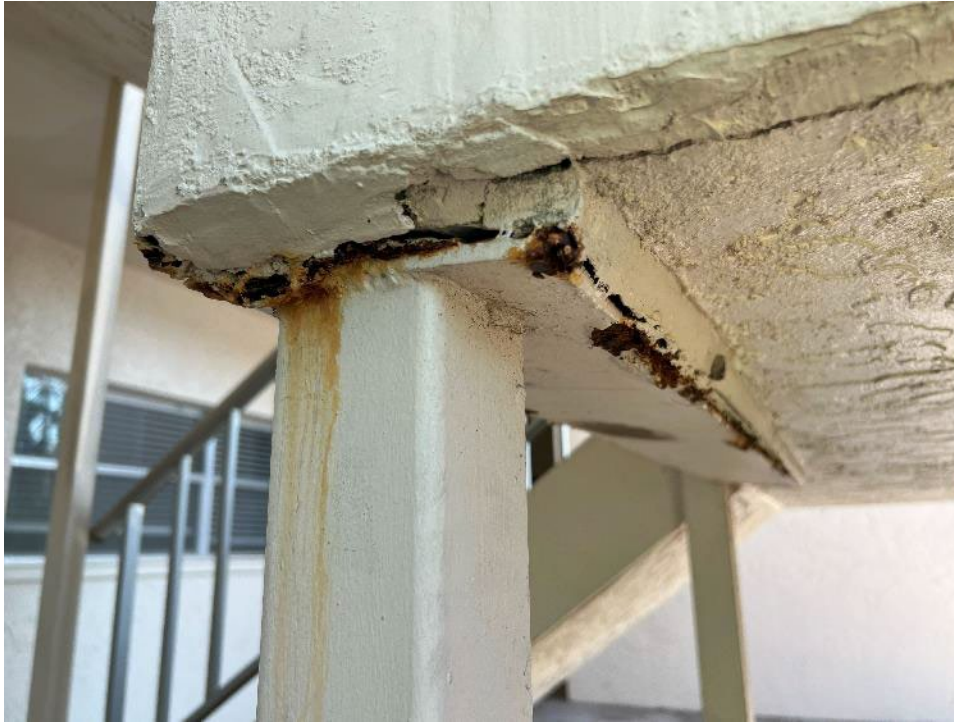
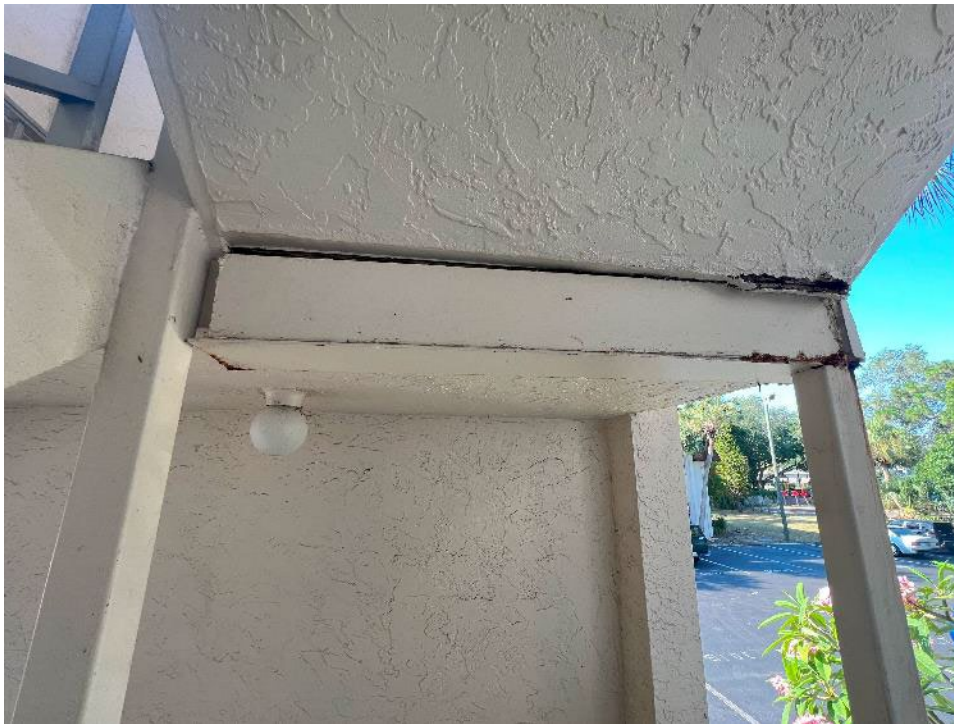
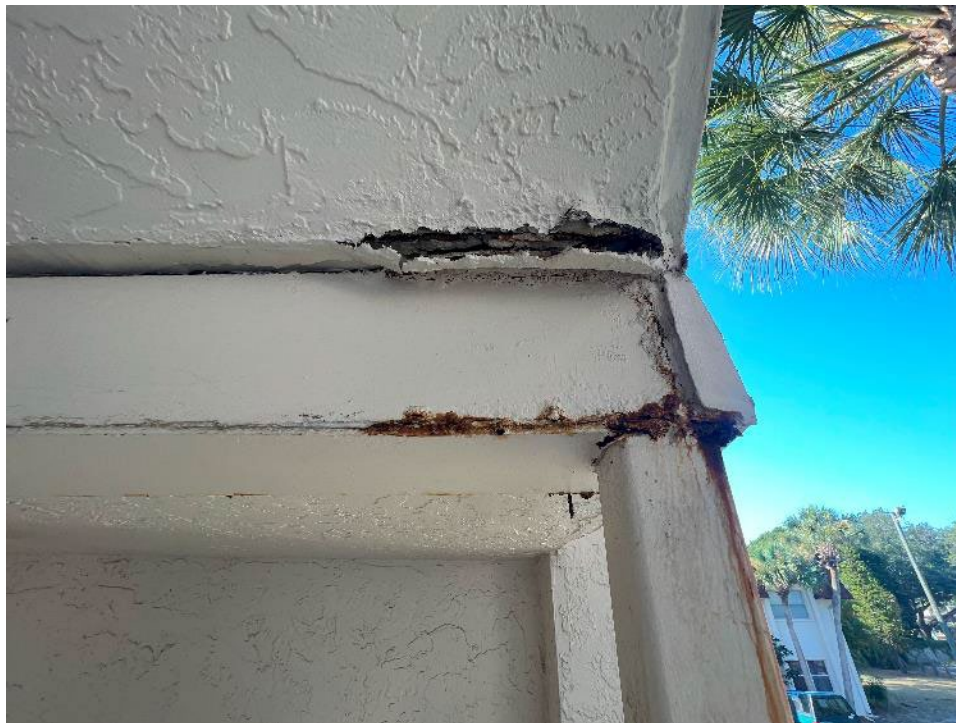
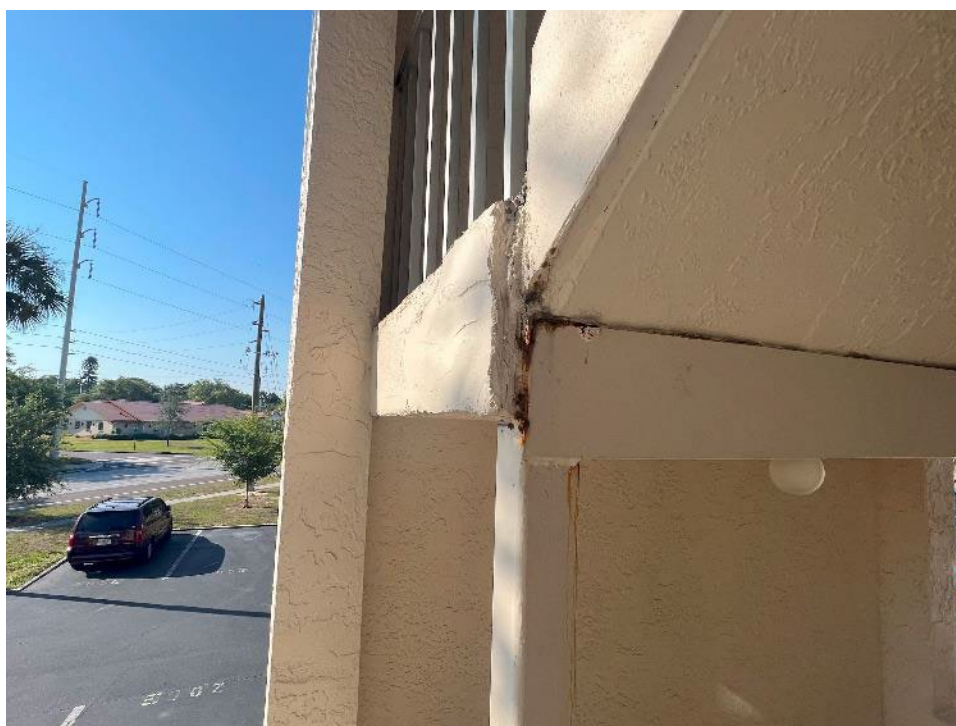
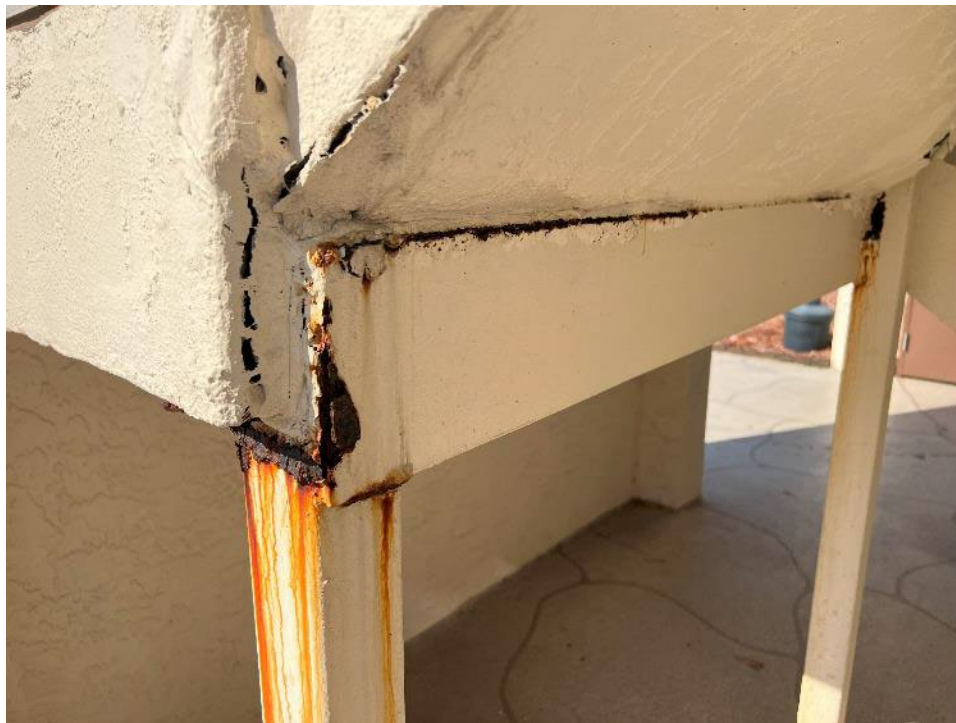
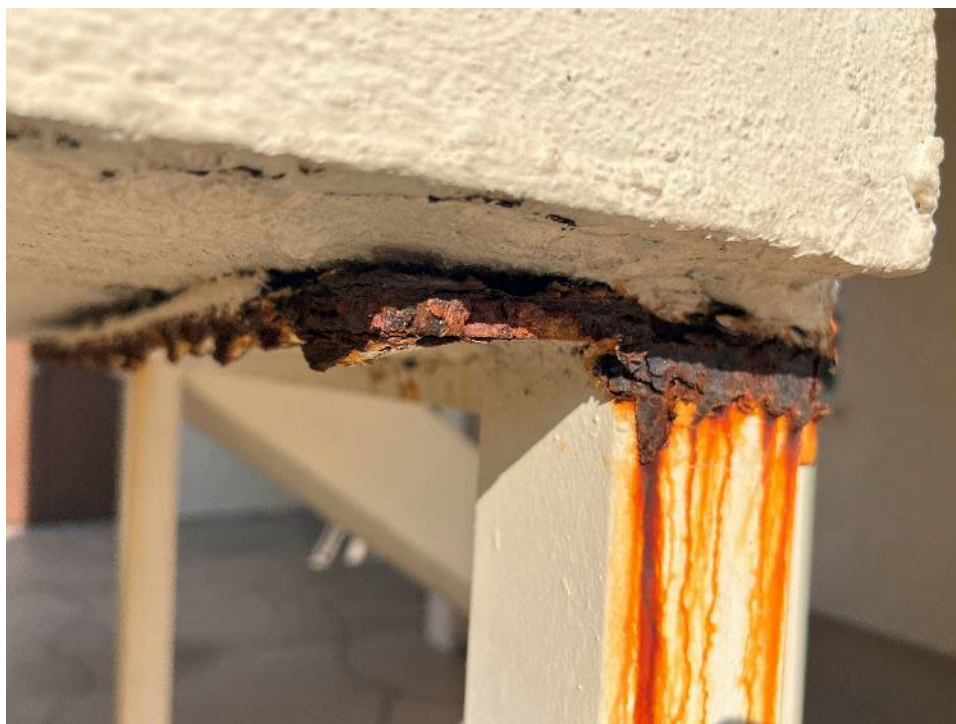
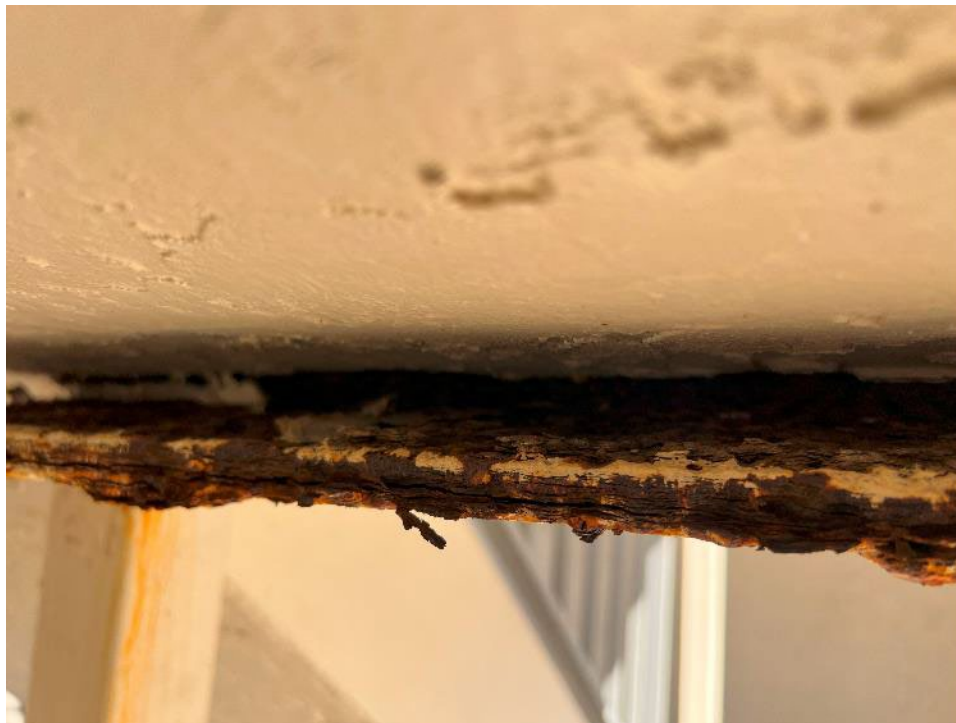
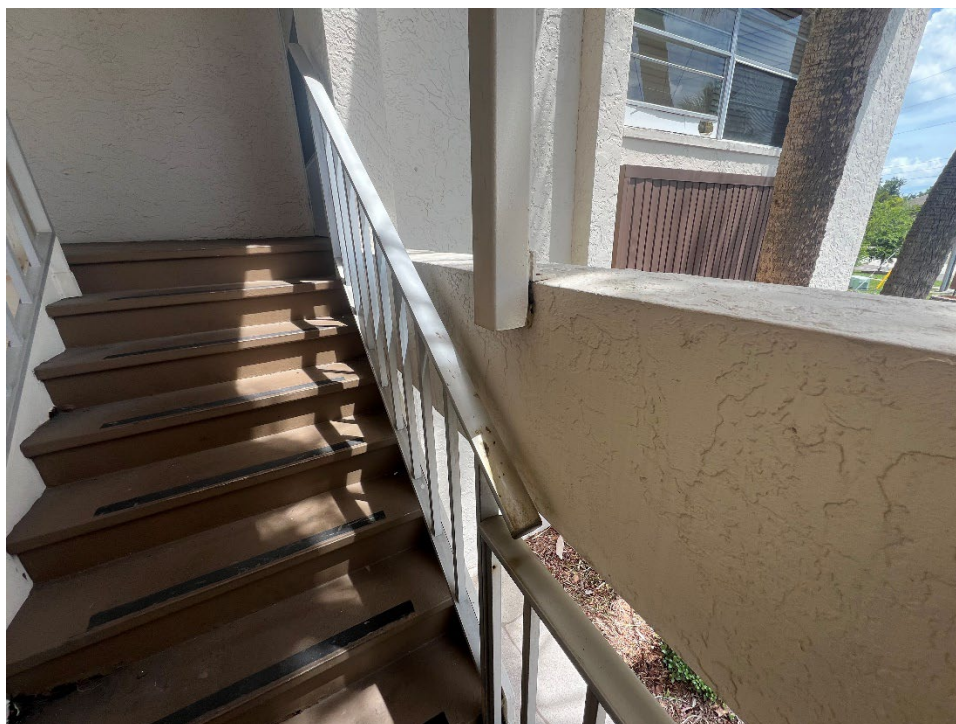
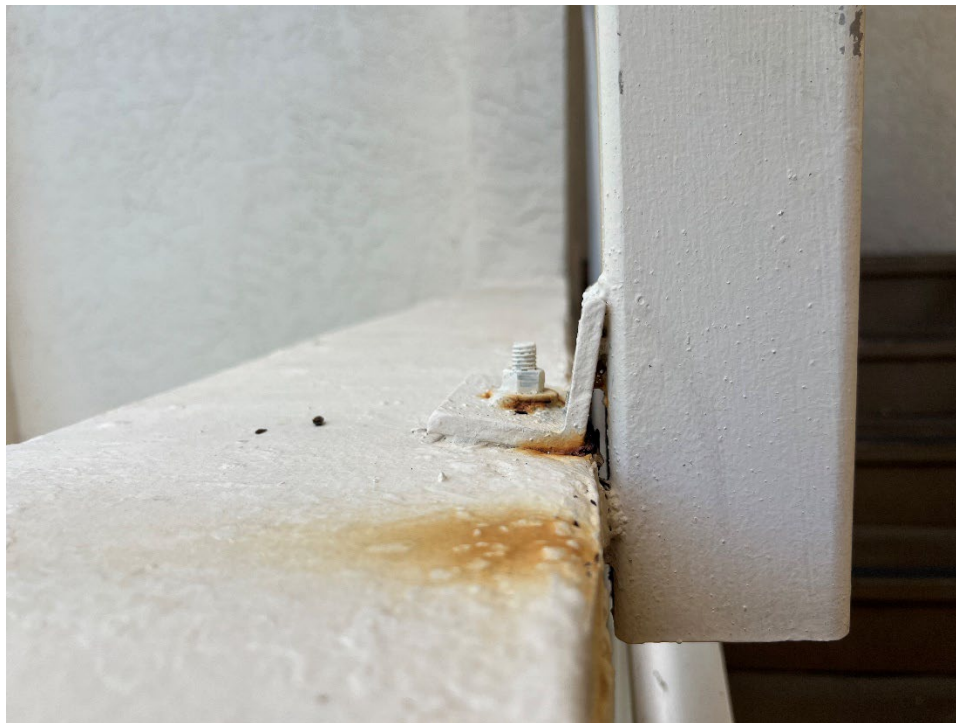
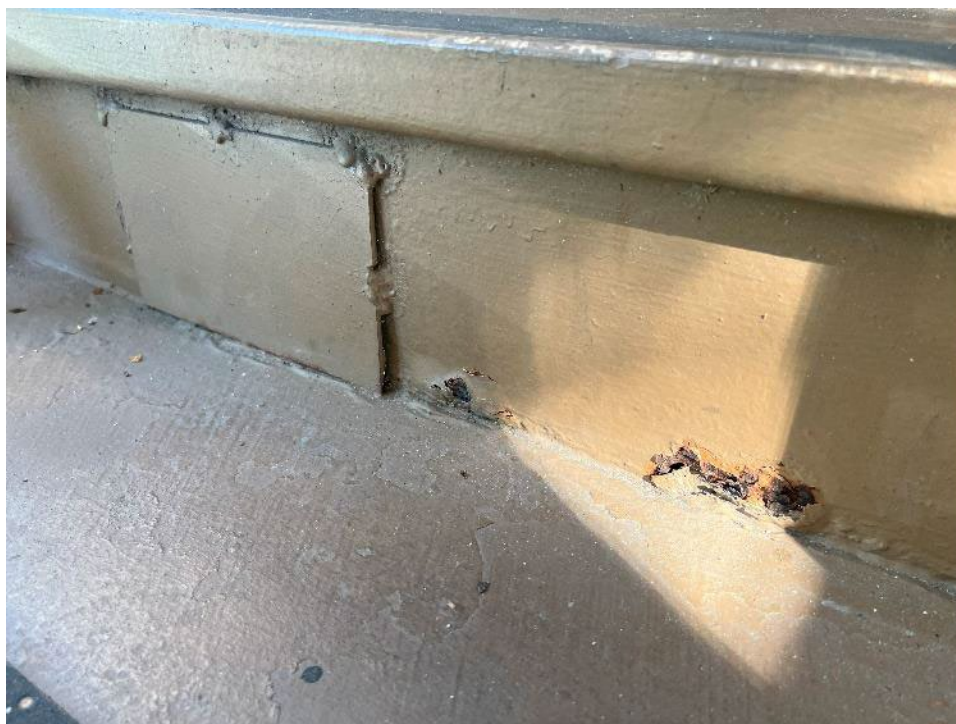
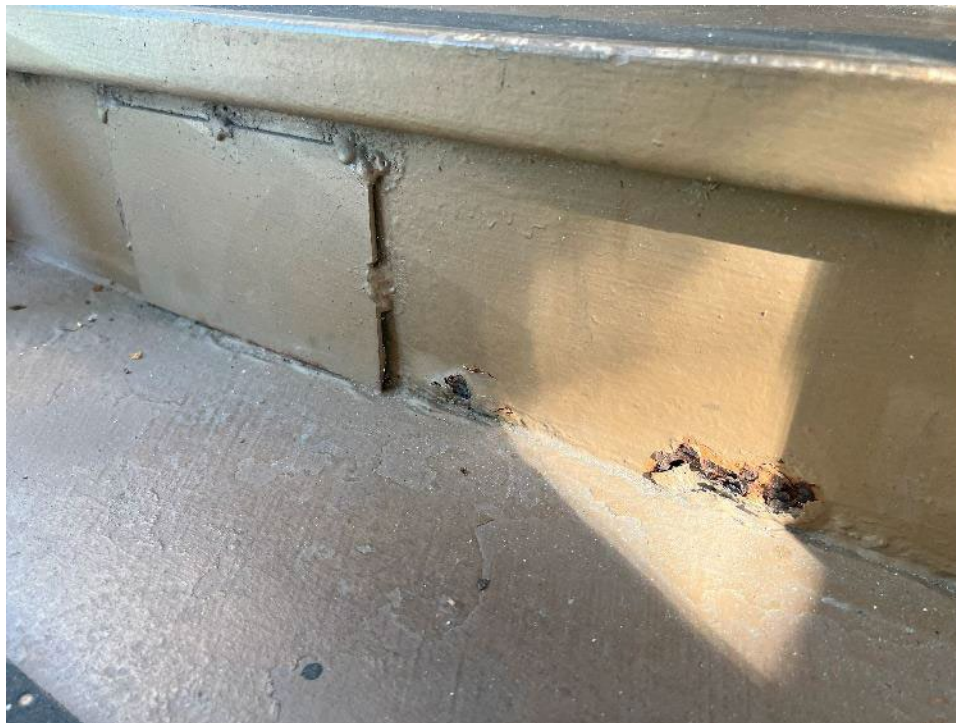
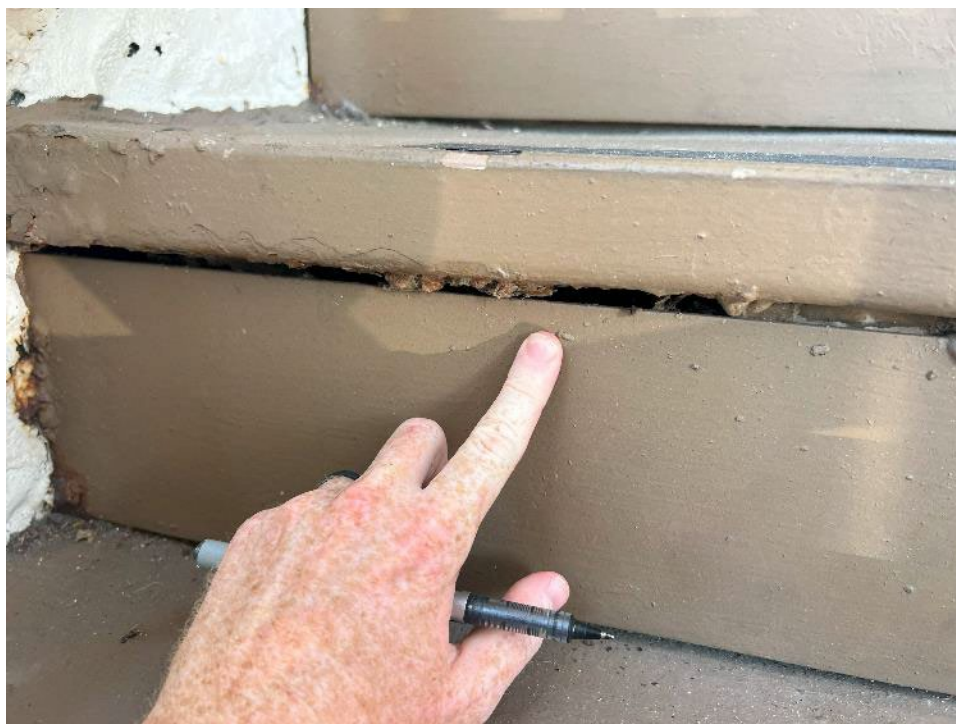
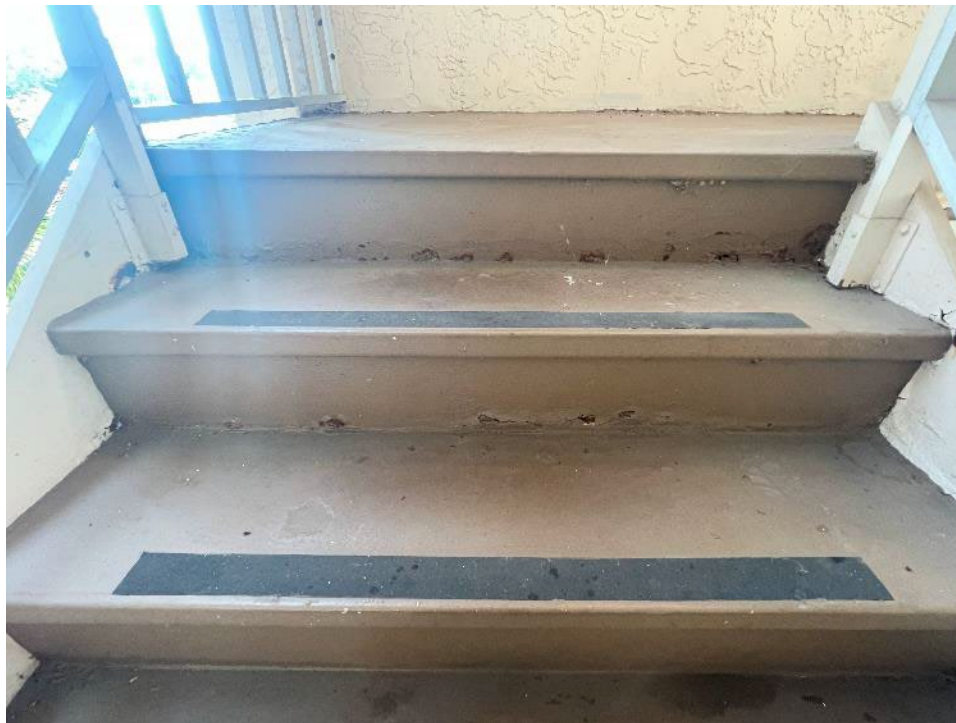
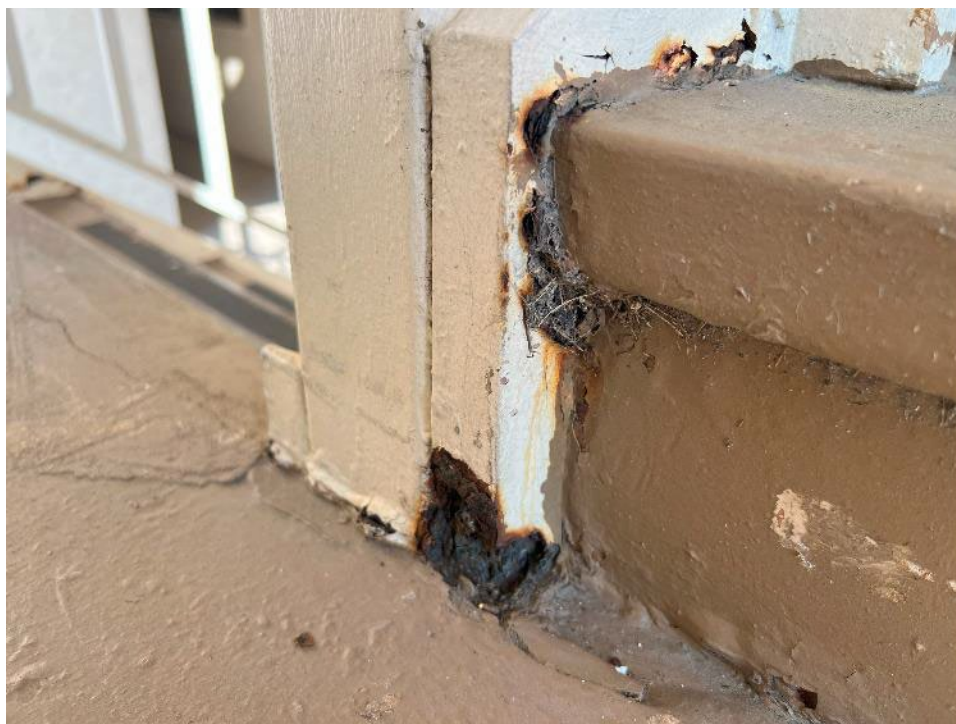
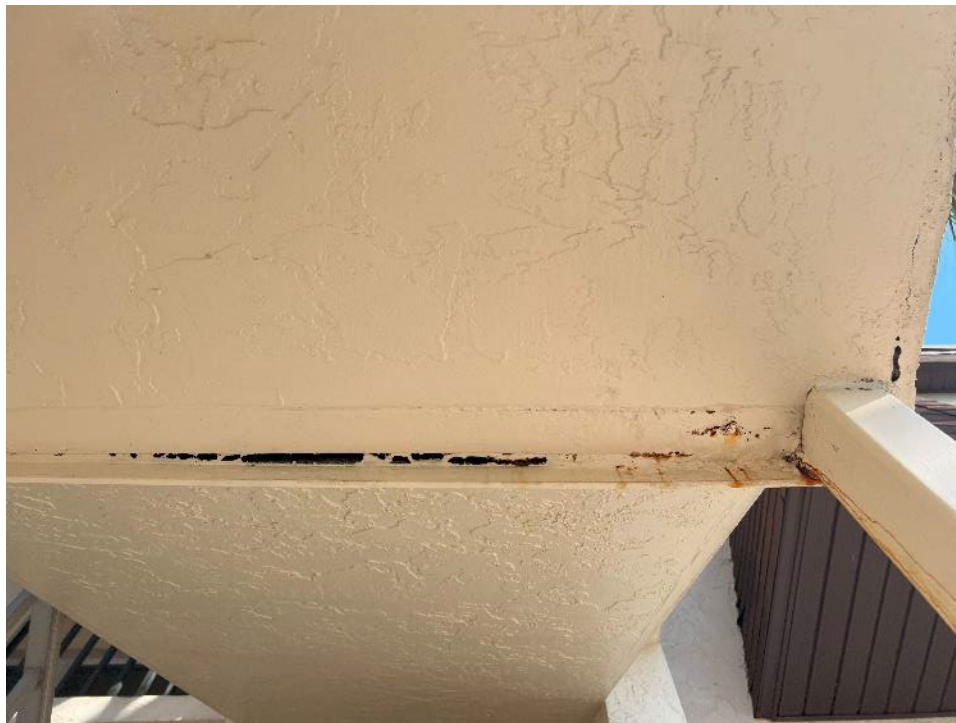
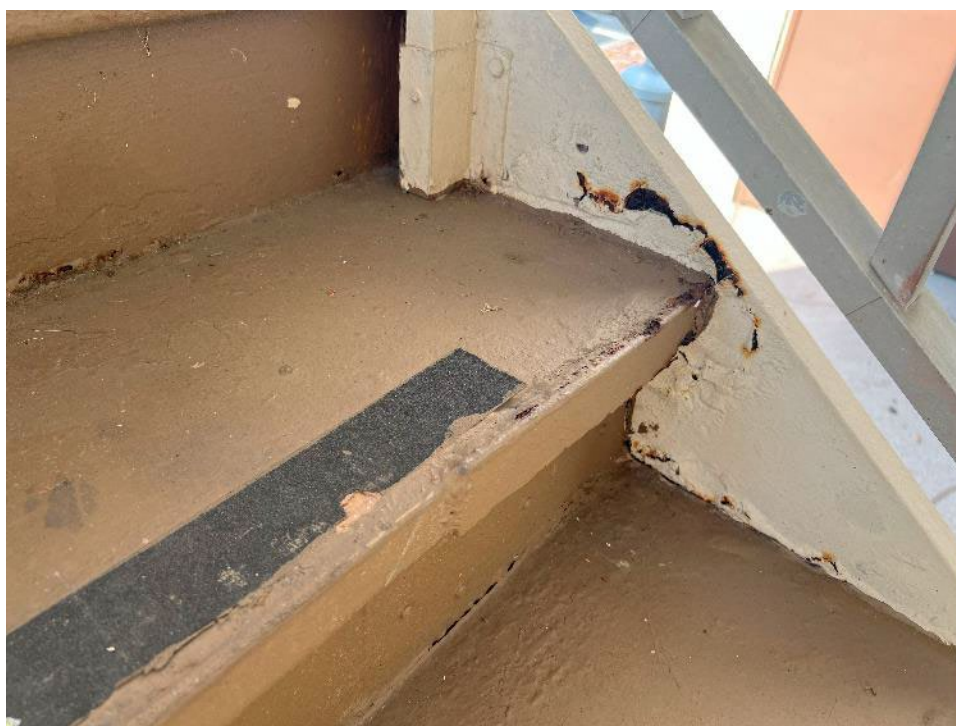
- Multiple areas of corroded metal framing were observed along the visible structural components of both exterior stairways with portions exhibiting significant section loss (Refer to Figure S-1 through S-16). It is evident that multiple previous modifications and/or repairs have been attempted throughout the life of the exterior stairways, which appear to be showing signs of structural deterioration/distress. Please note that portions of the structural framing components are concealed beneath stucco finishes, which have been applied along the underside and sides of the stairway landings and risers (Refer to Figure S-17 and Figure S-18).

- Elevated Engineering believes based on the condition of the visible structural components (and modifications/repairs) that both exterior stairways appear to be potentially exhibiting Substantial Structural Deterioration within the scope of the Milestone Inspection and further inspection of the concealed structural framing components is required to determine the full extent of structural deterioration. **Elevated Engineering recommends commencing a Phase 2 Milestone Inspection,** which should include removal of portions of the existing stucco finishes along the underside and sides of the stairway landings and risers to expose the concealed structural framing components to determine the extent structural deterioration present and provide further repair recommendations.
