Strategic Tribal Transportation Safety Plan

Organized Village of Kasaan

Organized Village of Kasaan
STRATEGIC TRIBAL TRANSPORTATION SAFETY PLAN

Tribal Transportation Program
Number: E09-238

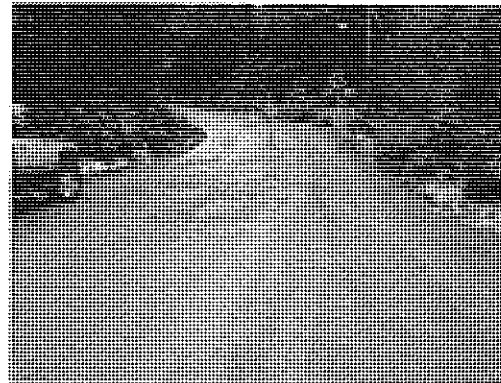
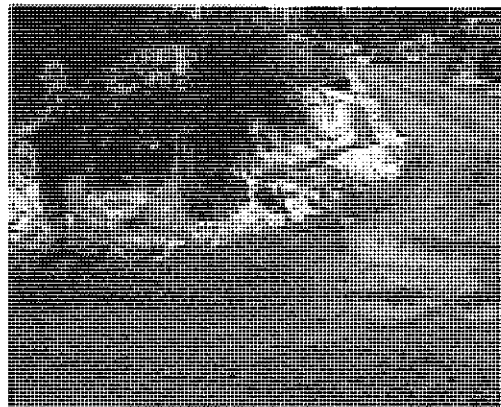
The water runoff from this approach road was directed onto the Kasaan road.

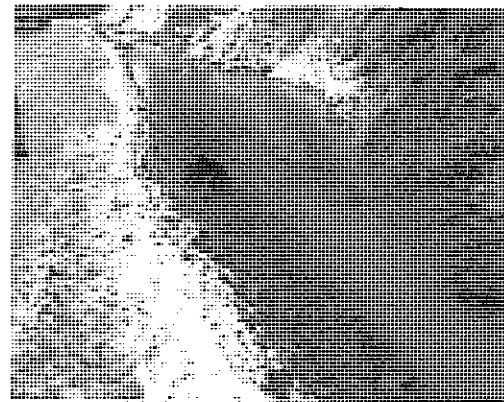
Culvert end damaged and plugged.

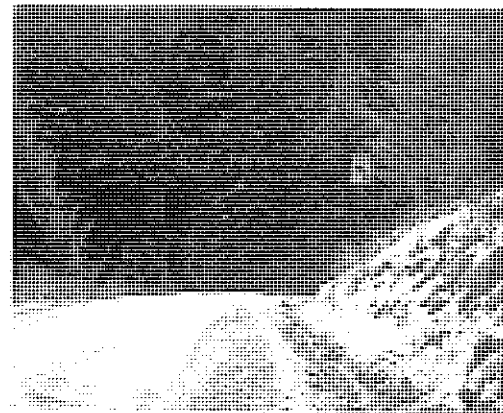
Advance curve warning signs were missing or were inappropriate. The example shows a left curve sign located in advance of a right curve.

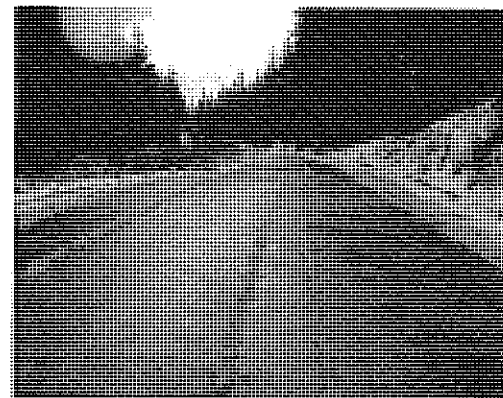
Speed limit signs were missing and/or not appropriately located.

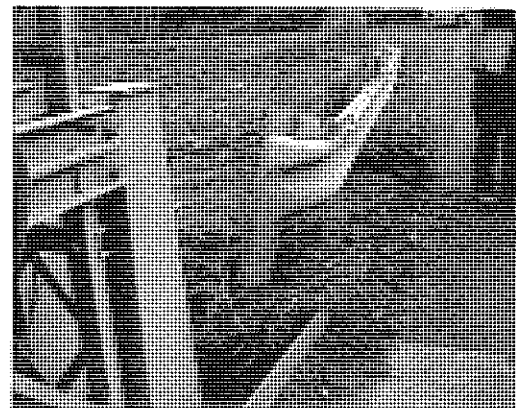
Guardrail damaged and did not have bridge transitions.

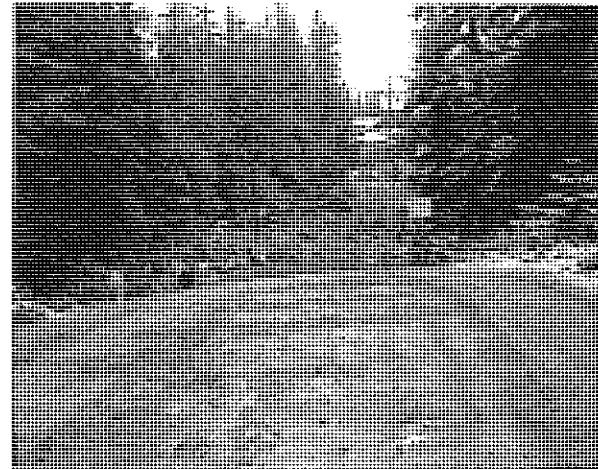
The Kasaan road is an unpaved road with no delineation. The photo at right is a crest left curve that goes into a sharp right curve. There is no advance warning for the sharp curve.

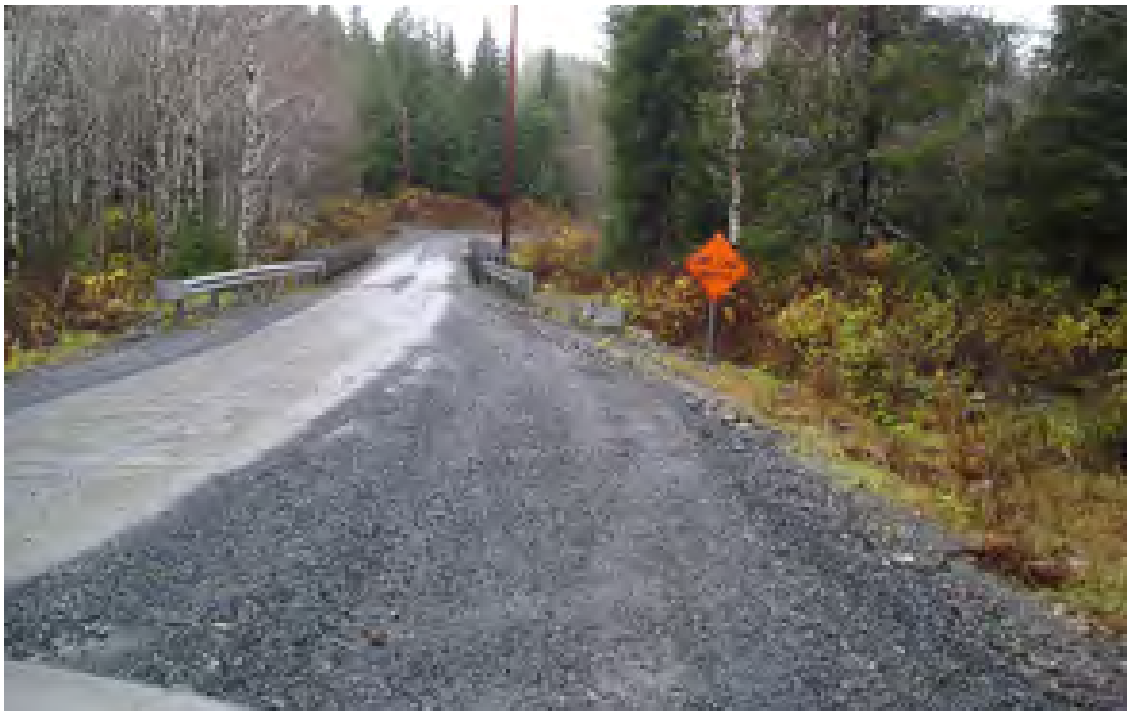
Figure A.2. Narrow bridge on Kasaan Road

1. Replace all narrow bridges, possibly with reinforced concrete box or pipe culverts to reduce future maintenance needs. Realign roadway as needed at these sites to eliminate severe curvature of approaches.
2. Study existing intersections, especially Ellen Lake Road and Ron's Road, for realignment needs and sight distance improvement. Also study current visibility to and from higher-traffic intersections, such as the Thorne Bay Solid Waste Site, for needed improvements and undertake those upgrades.
3. Reconstruct all roadway sections with a top width less than 24 ft to a minimum of 28 ft or more as design standards dictate. Realign road through those areas as well.
4. Complete reconstruction of all remaining sections to a minimum of 28 ft wide or more, as design standards dictate. Realign where needed.
5. Pave road when traffic volumes warrant and funding becomes available.

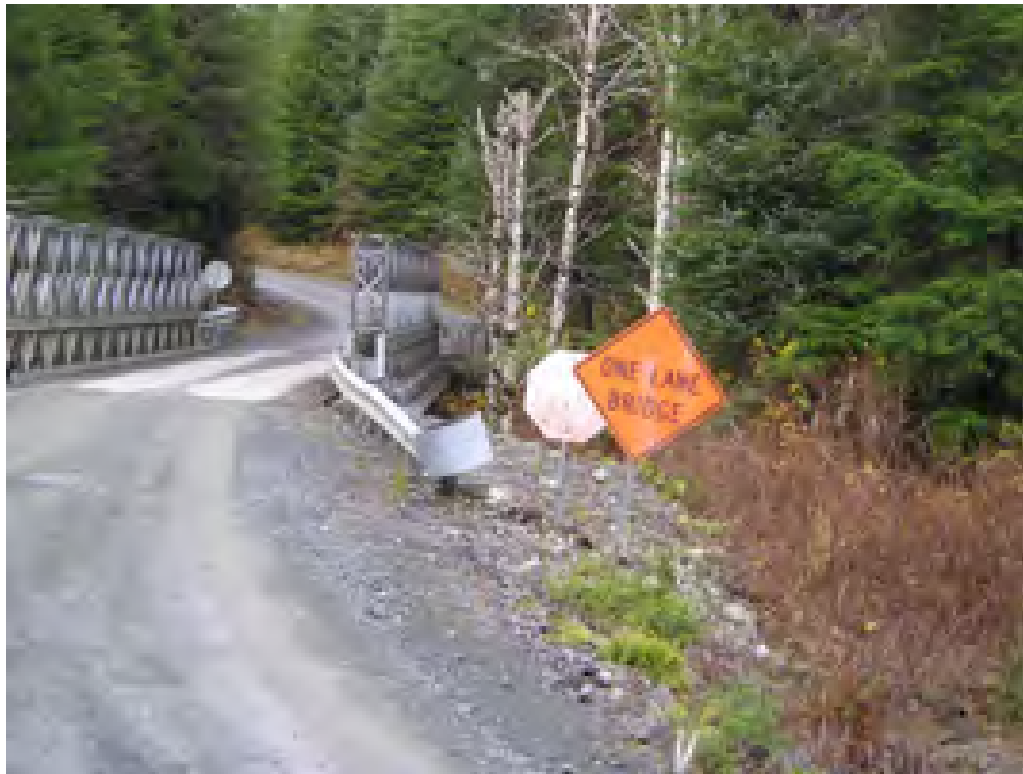
Figure A.3. Signing and beam guardrail at narrow bridge on Kasaan Road

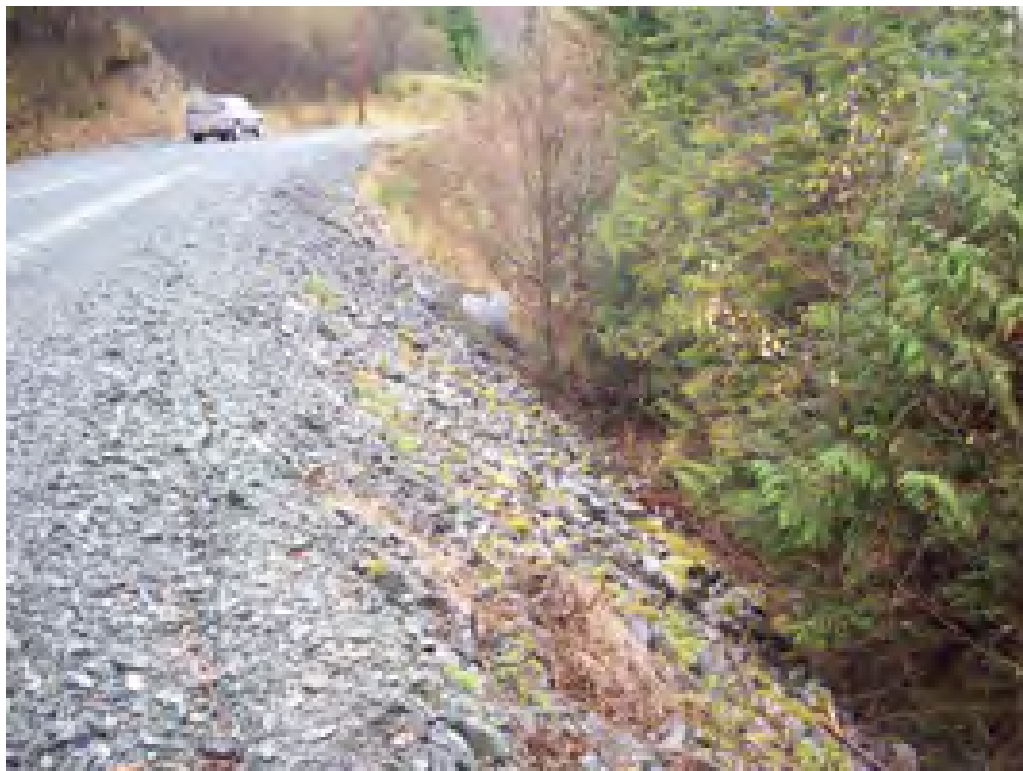
Figure A.4. Steep foreslope on Kasaan Road

4. Review all noted potentially-hazardous side hazards, especially steep slopes, for need of additional shielding with guardrail, either w-beam or high-tension cable rail.

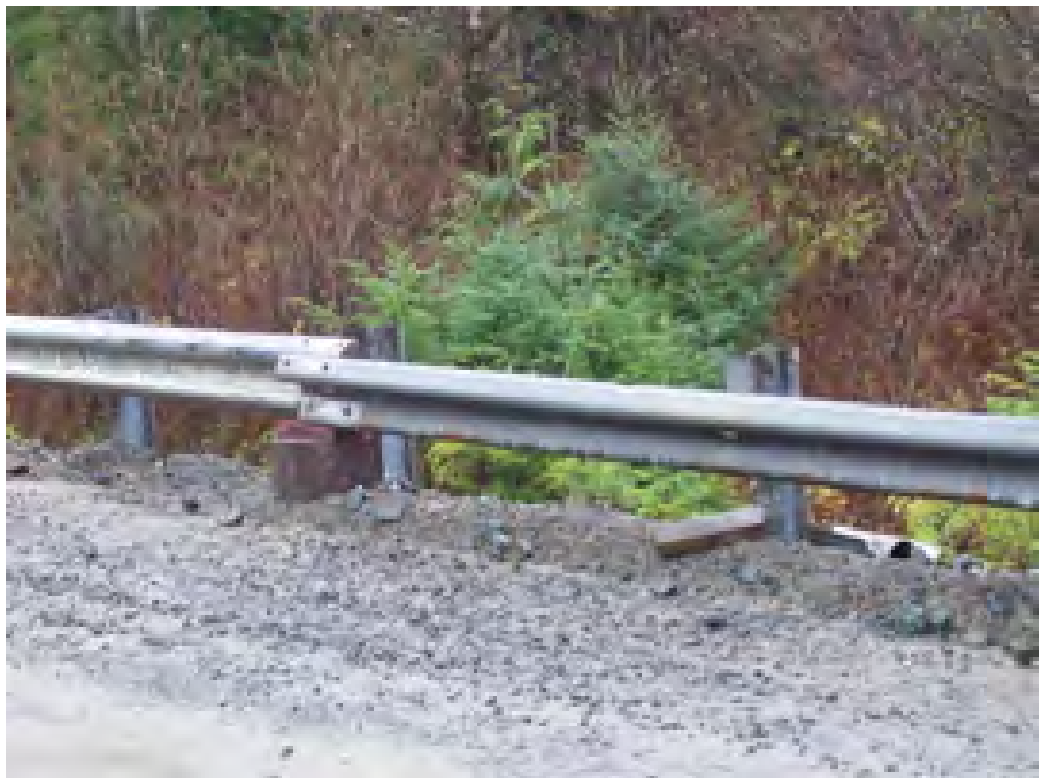
Figure A.6. Damaged beam guardrail on Kasaan Road

10. Review all guardrail installations and upgrade to current design standards as needed. Consider removal of existing installations where hazards do not warrant shielding. Review noted locations for installation of additional w-beam guardrail where hazards justify shielding. Enhance nighttime guidance at guardrail locations using delineation in or behind the rails.

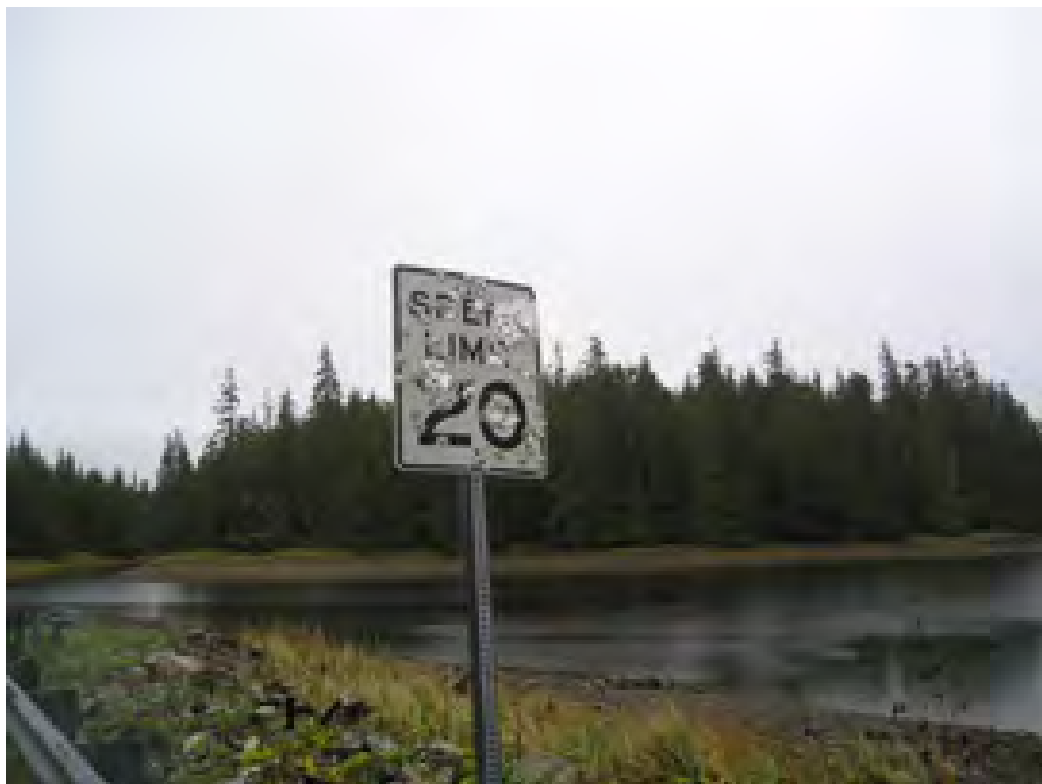
Figure A.7. Vandalized regulatory sign on Kasaan Road

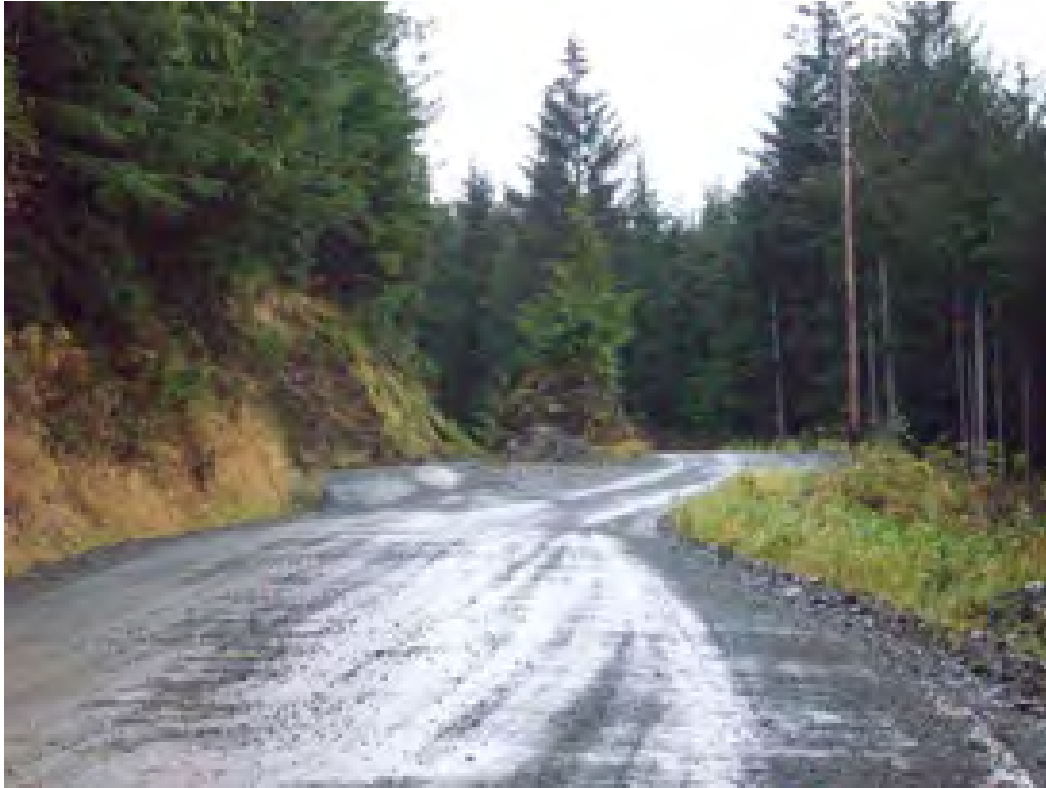
For Kasaan Road, Sgt. Brown thought the most-hazardous locations were the several narrow bridges and the large rock in the middle of the road that should be removed. Some roadway lighting would be effective at locations, such as the intersections of Ron's Road, Salt Chuck Road, and South Thorne Bay Road, the waste-disposal site, and the narrow bridges. Many areas should be reviewed for regulatory speed modifications.

Figure A.9. Large rock in center of Kasaan Road

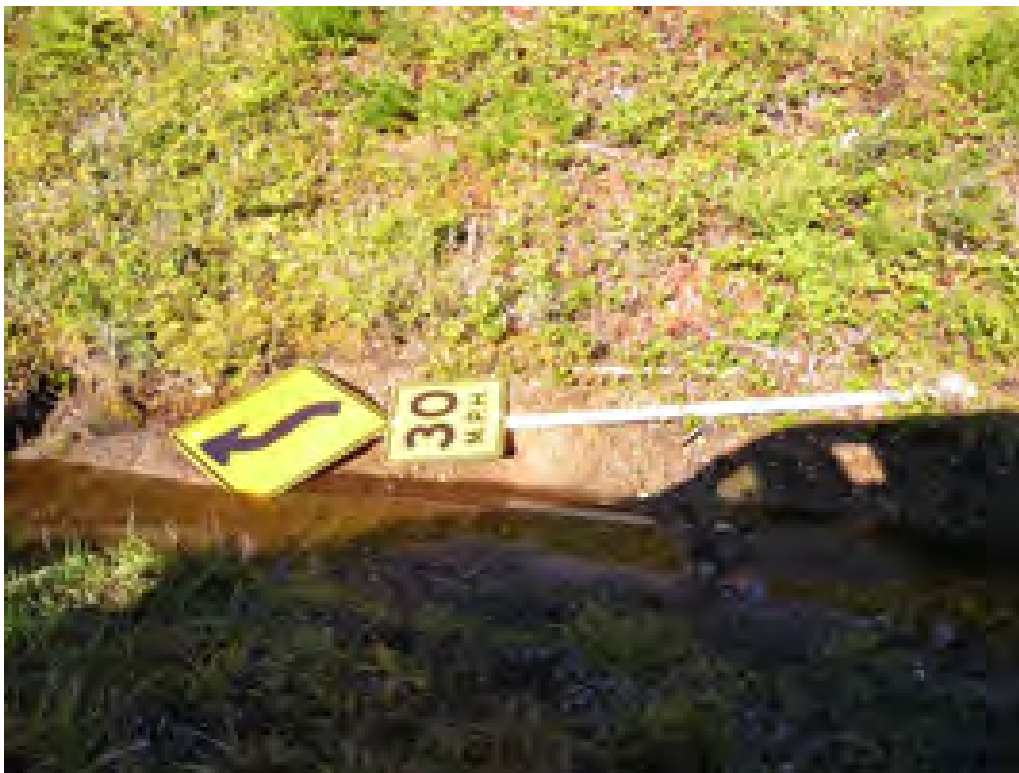
Figure A.16. Damaged warning sign on Hydaburg Highway
