BUILDING SURVEY

**House
The Lane
Town
County
Postcode**

1. INTRODUCTION

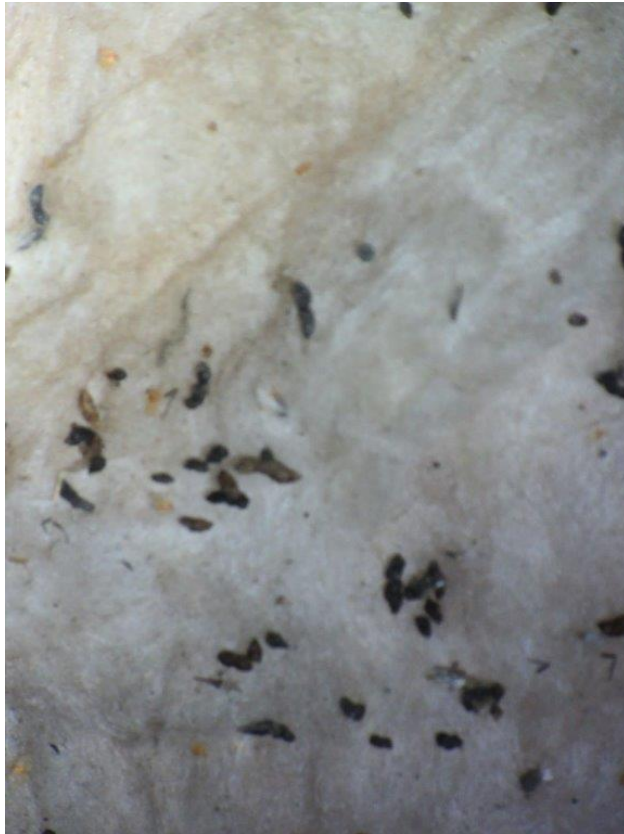
MICE DROPPINGS

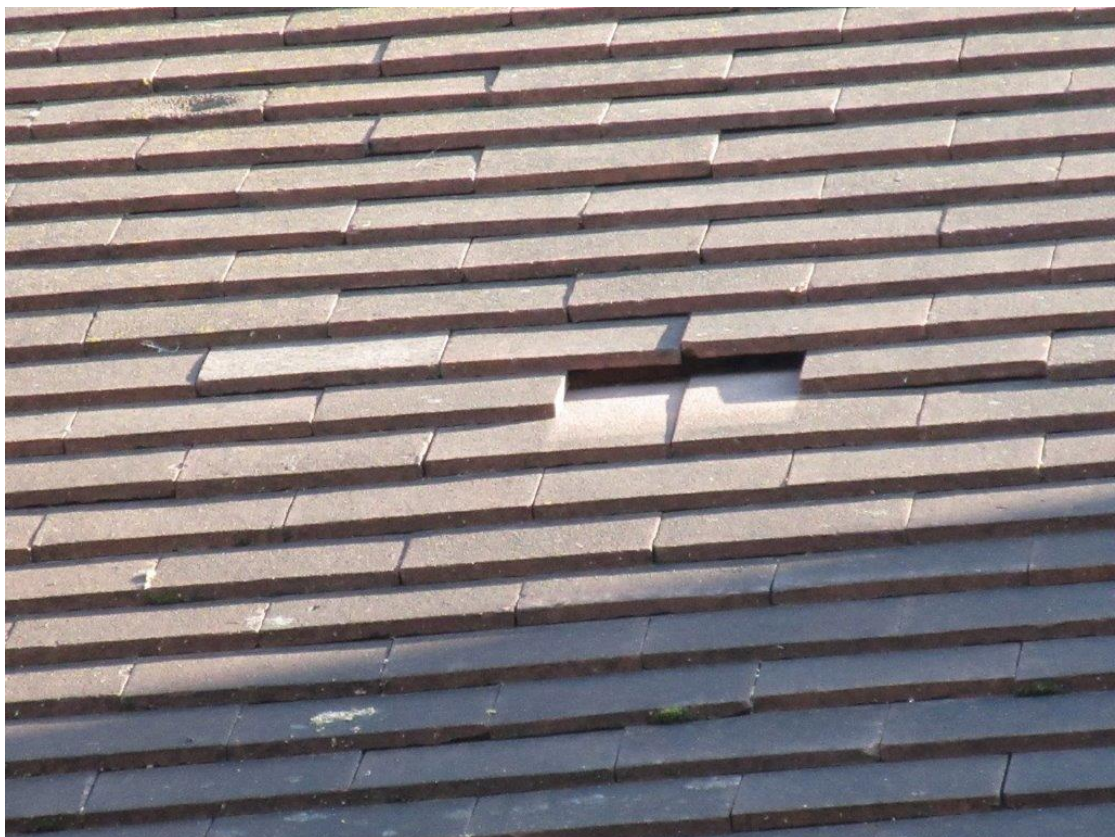
MISSING TILE

- i. Carry out minor roof overhaul to replace missing and chipped tiles, and re-bed hip tiles to 1950s extension. Seriously consider stripping and re-covering roof to original property to enable felt to be provided as a secondary protection against damp penetration. Clear blocked valley to rear of property.
- ii. Replace cement fillets to utility room roof with lead flashings.
- iii. Overhaul/replace wet rot affected softwood window to front bay.
- iv. Overhaul/replace all fascias, soffits and bargeboards.
- v. Commission specialist report into electrical installation by an NICEIC approved contractor, as it has not been tested for 8 years and some upgrading may be required.

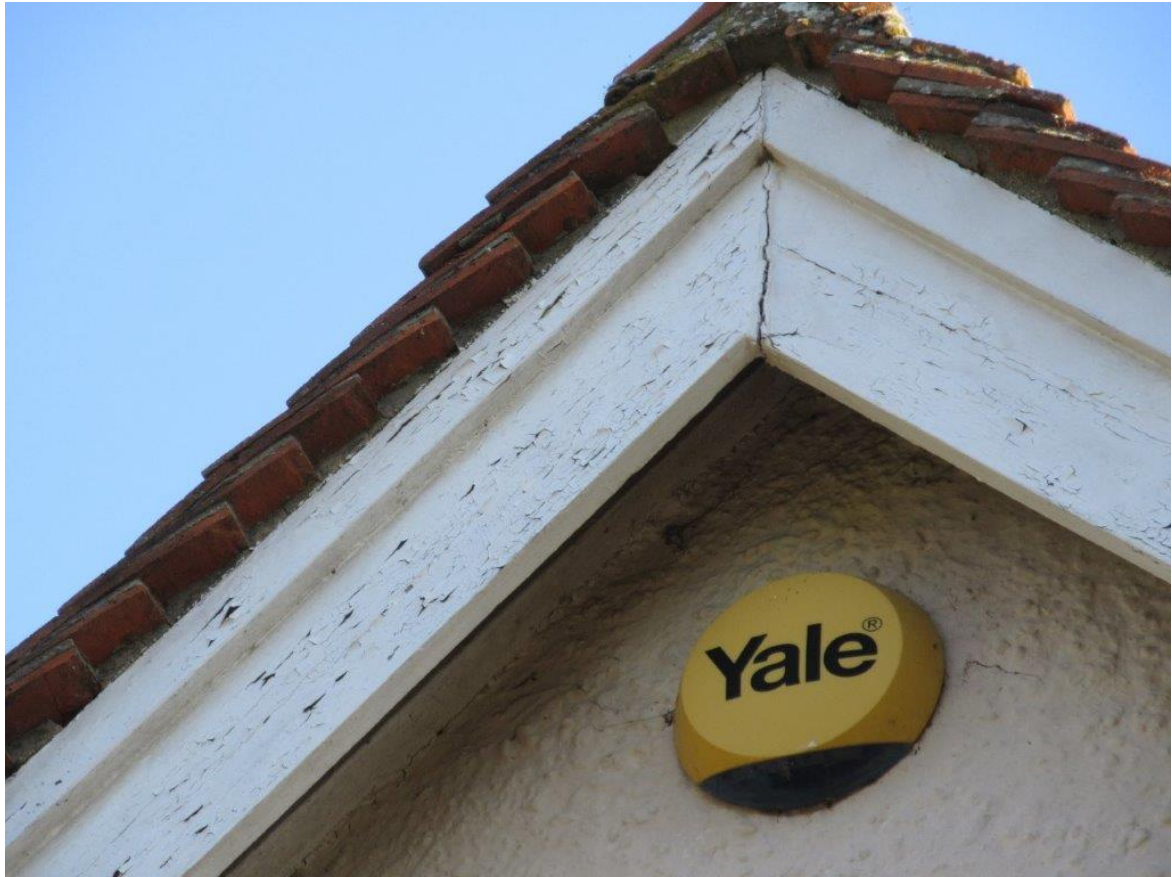
NEGLECTED BARGEBOARDS

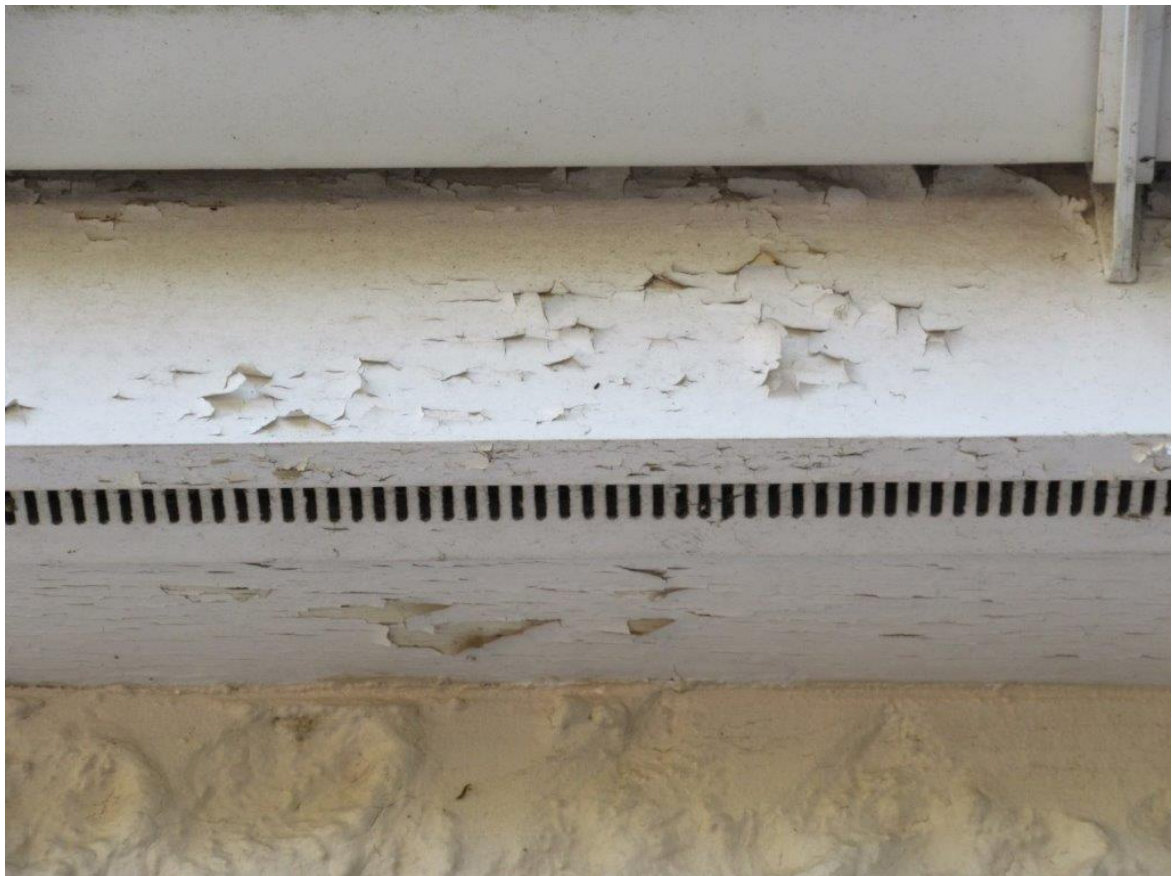
NEGLECTED FASCIAS

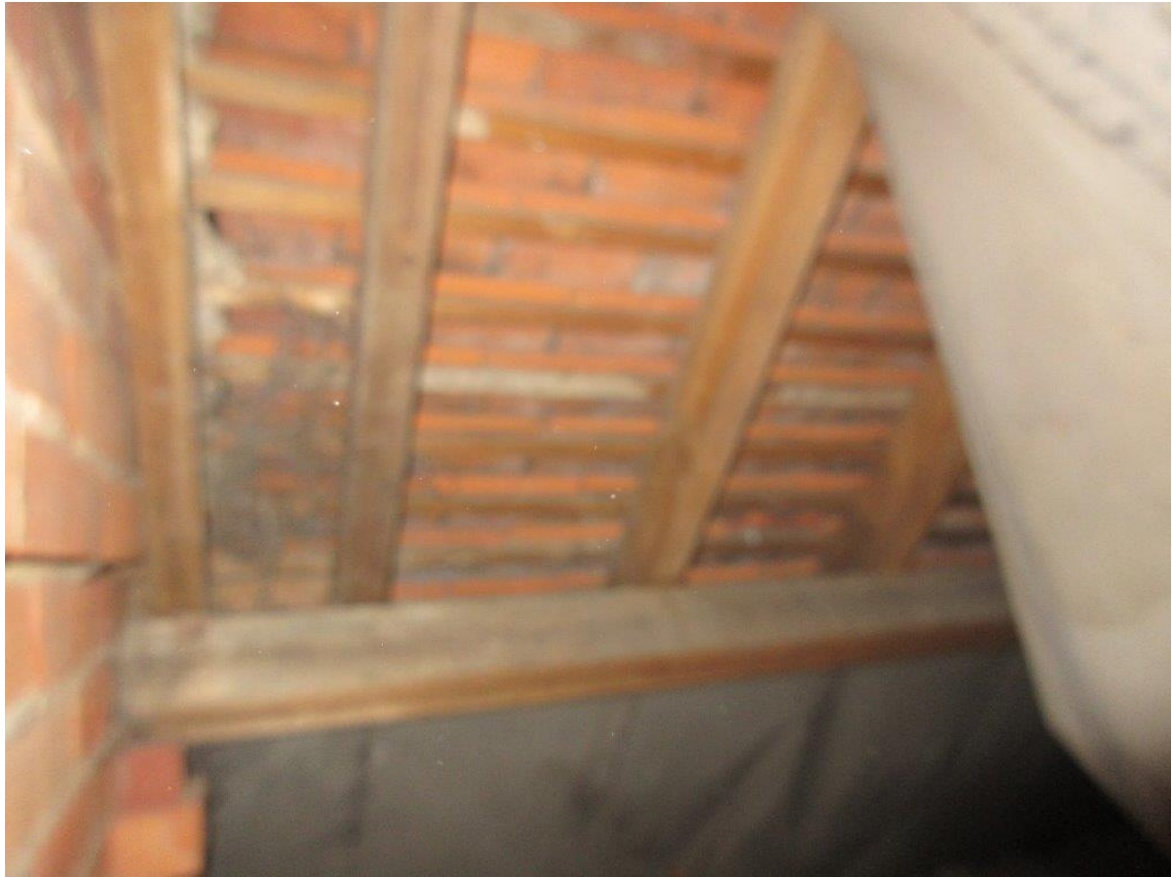
From ground level observation no distortion to the roof slopes was noted, but my internal inspection confirmed that the original roof has no felt to the underside of the tiles as a secondary protection against damp penetration and, as a result, some dampness is inevitable during periods of driving rain and snow. This could only be alleviated by the complete stripping and re-covering of the roof which would enable felt to be provided.

The roof structure to the original property comprises of hand-cut rafters supported by purlins and struts, but unfortunately, there is no felt to the underside of the tiles as a secondary protection against damp penetration. As a result, dampness is inevitable during periods of driving rain and snow, and it is essential to maintain the external roof covering in good condition to limit damp penetration. Some daylight was noted, and a roof overhaul is required, although serious consideration should be given to the stripping and re-covering of the roof which would enable felt to be provided.

Dampness is inevitable through the roof of the original house due to the lack of felt to the underside of the tiles as a secondary protection against damp penetration. It is important to maintain the original roof in good condition if stripping and re-covering is not undertaken.

NO FELT UNDER TILES

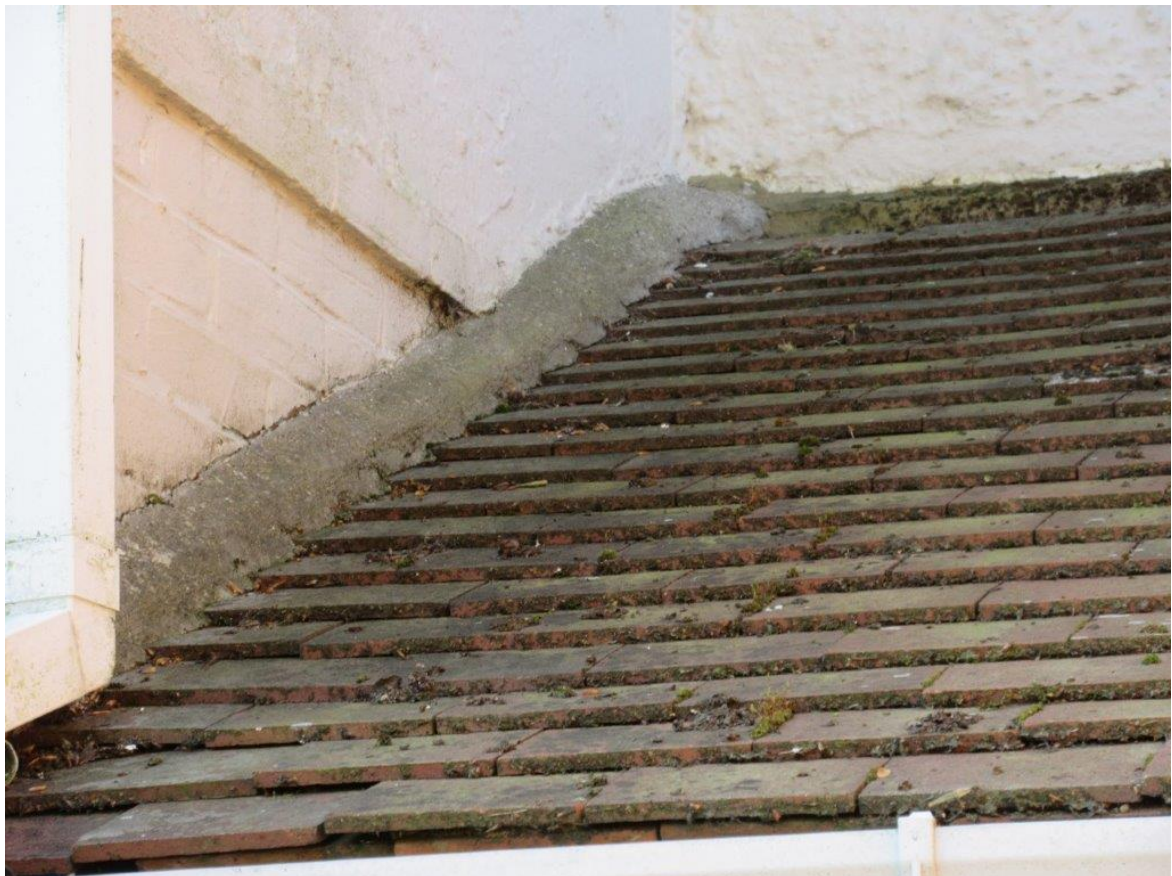
This single storey section has a mono-pitched roof clad with clay plain tiles. It has been poorly sealed to the adjoining rendered walls with a cement fillet to part of the roof. This will permit damp penetration over time and should be replaced with more durable lead flashings. The roof covering is in satisfactory condition, although there is unlikely to be felt to the underside of the tiles.

POOR SEAL TO UTILITY ROOM ROOF

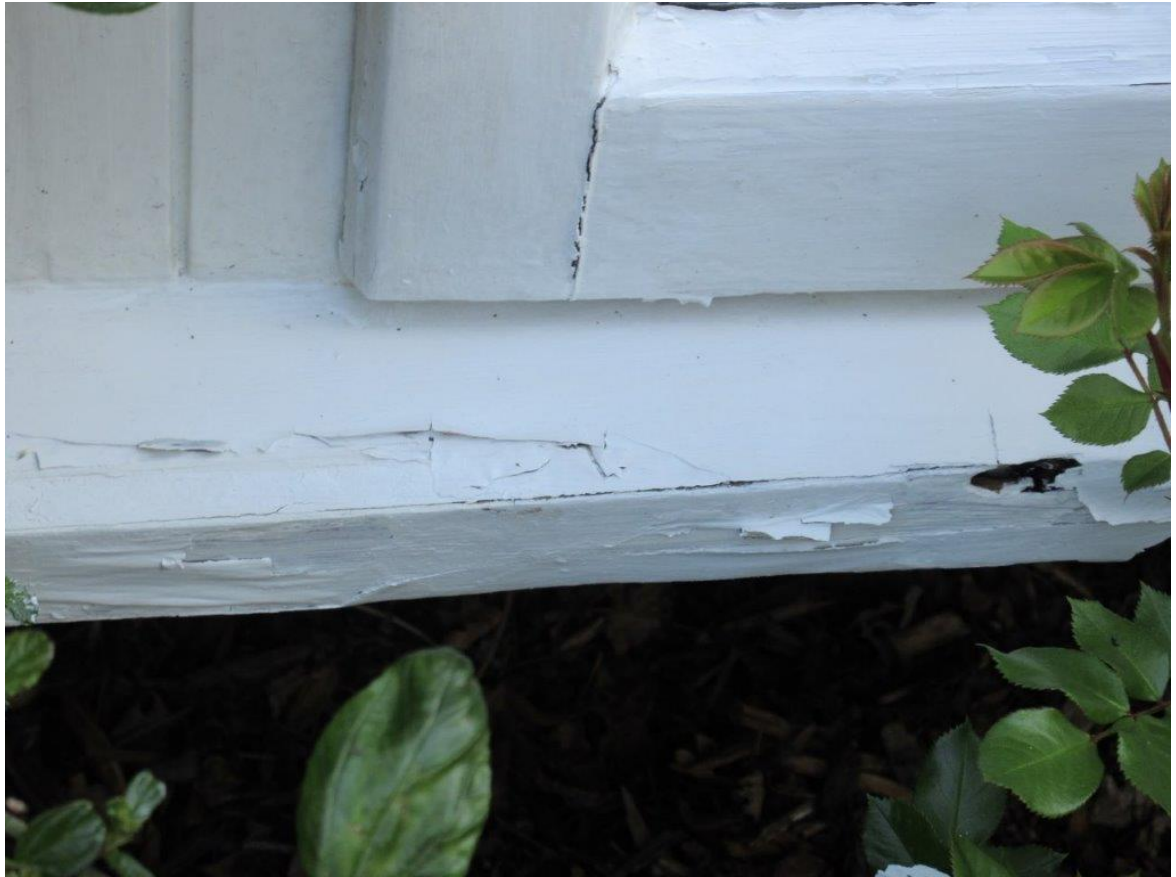
The bay window to the 1980s extension is still of the original softwood construction, with minimal sealed double glazing. This window is in a deteriorating condition with some wet rot noted, and it requires either repair, or preferably replacement to match those already renewed.

The softwood window the front bay is deteriorating and requires considerable repair, or preferably replacement to match existing replaced windows.

ROT TO WINDOW

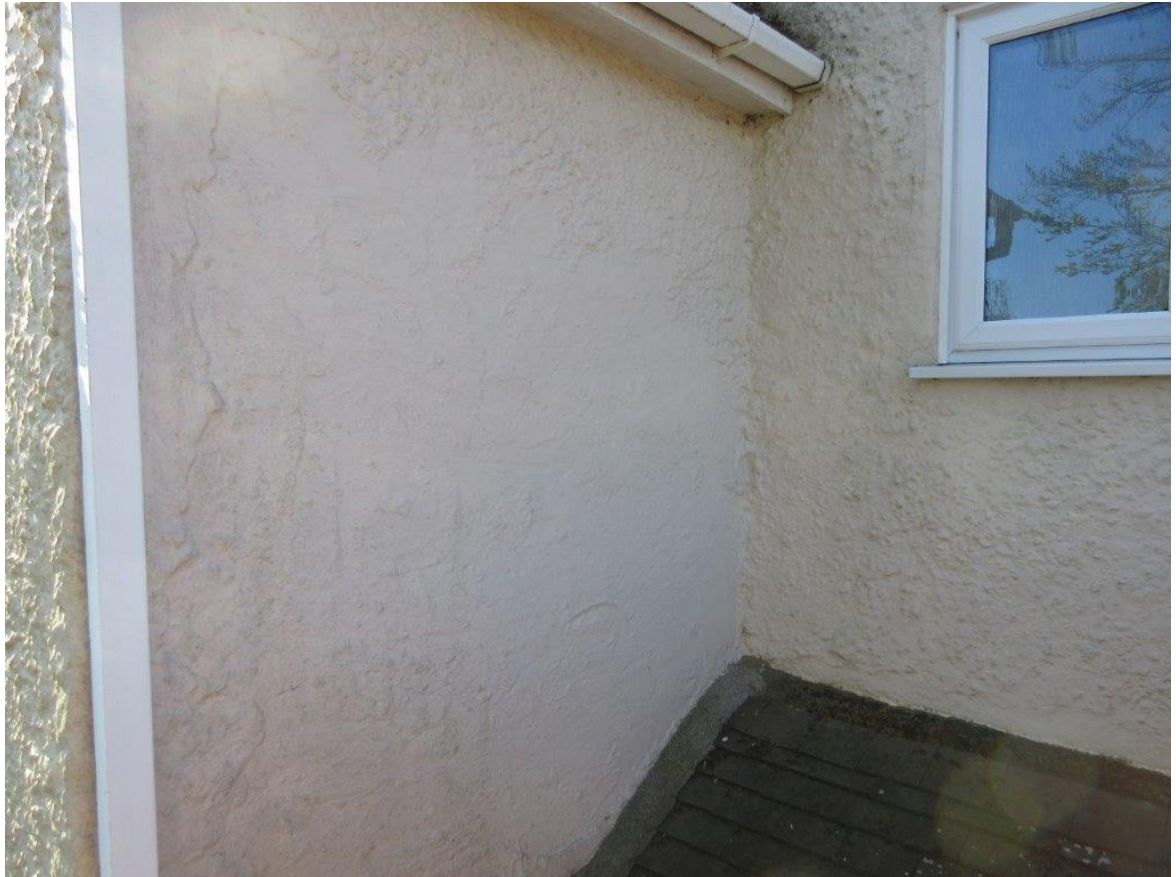
Rendering to upper elevations is unattractive in a number of areas. Rendering can sometimes be applied to conceal defects in the underlying structure and should usually be viewed with caution, although the subject property was constructed with a rendered finish. Regular inspections of the render should be carried out to look for shrinkage cracking and loose areas. No significant cracking was noted, although there is considerable scope for cosmetic improvement particularly to the rear of the property. Rendered finishes to all extensions are of a different style which leaves an unattractive appearance. Complete re-rendering of the property would greatly improve the visual appearance of the house. Small areas of rendering are pulling away with painted finishes also flaking, and some minor attention is required.

UNSIGHTLY RENDERING

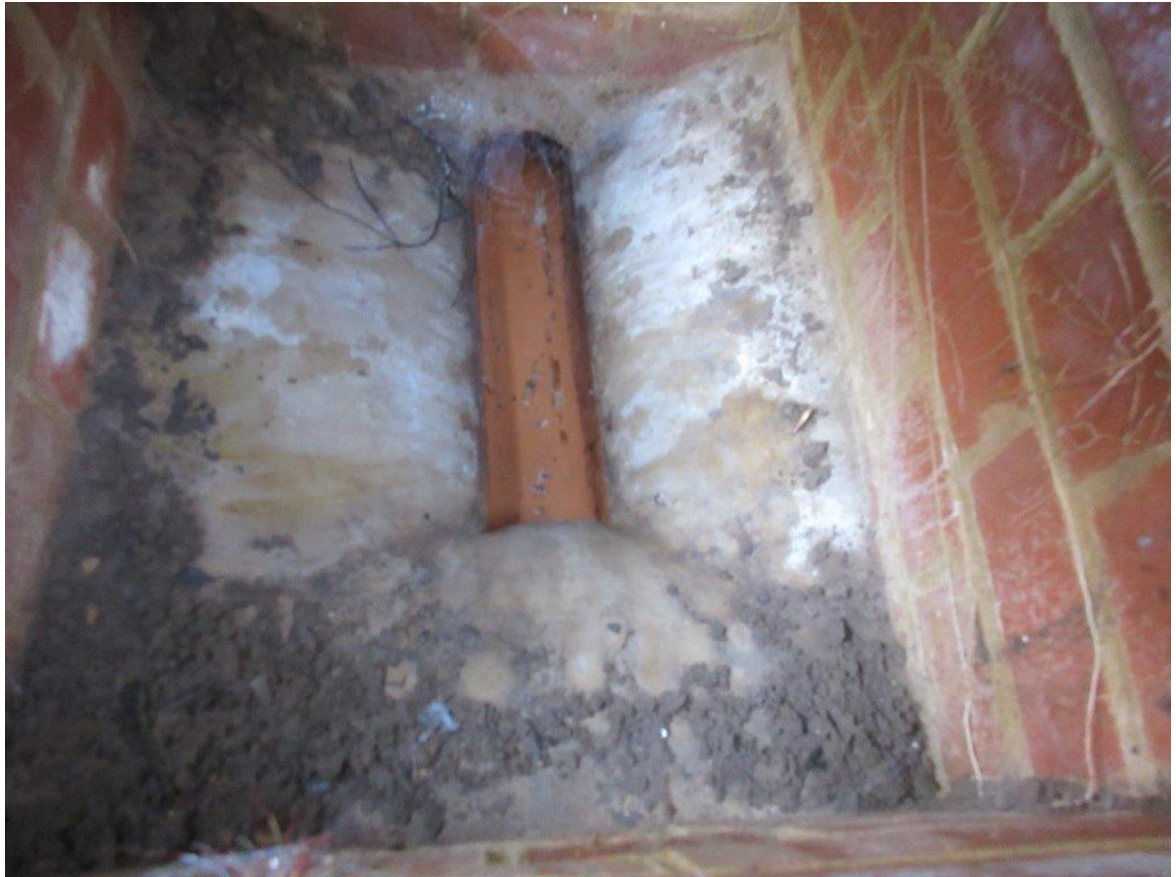
CLEAR DRAIN

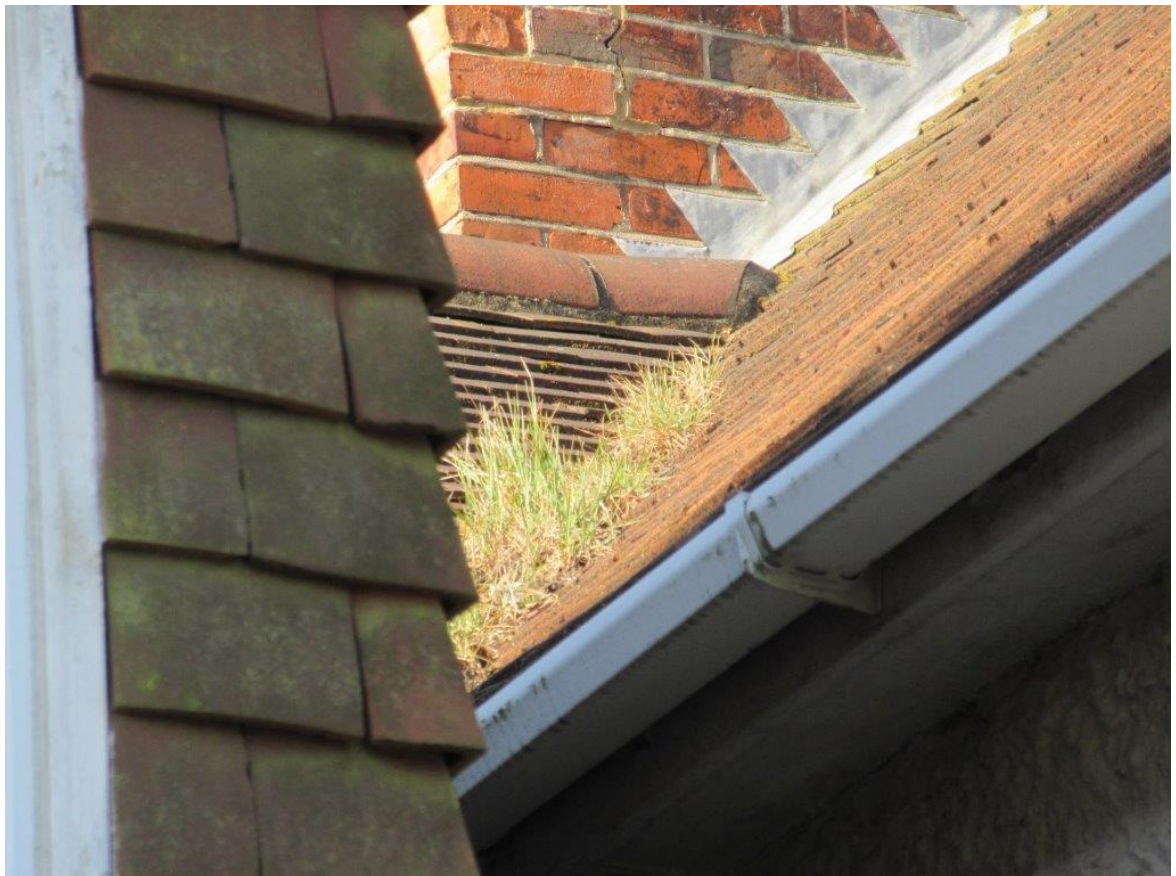
It was not raining at the time of inspection and the condition and alignment of goods appears satisfactory although it is important to check for leaks during heavy rainfall for leaks, and any noted should be immediately attended to. Guttering will require regular clearing of leaves and other debris, and it should all be checked at the same time that the rear valley is cleared.

CLOGGED REAR VALLEY

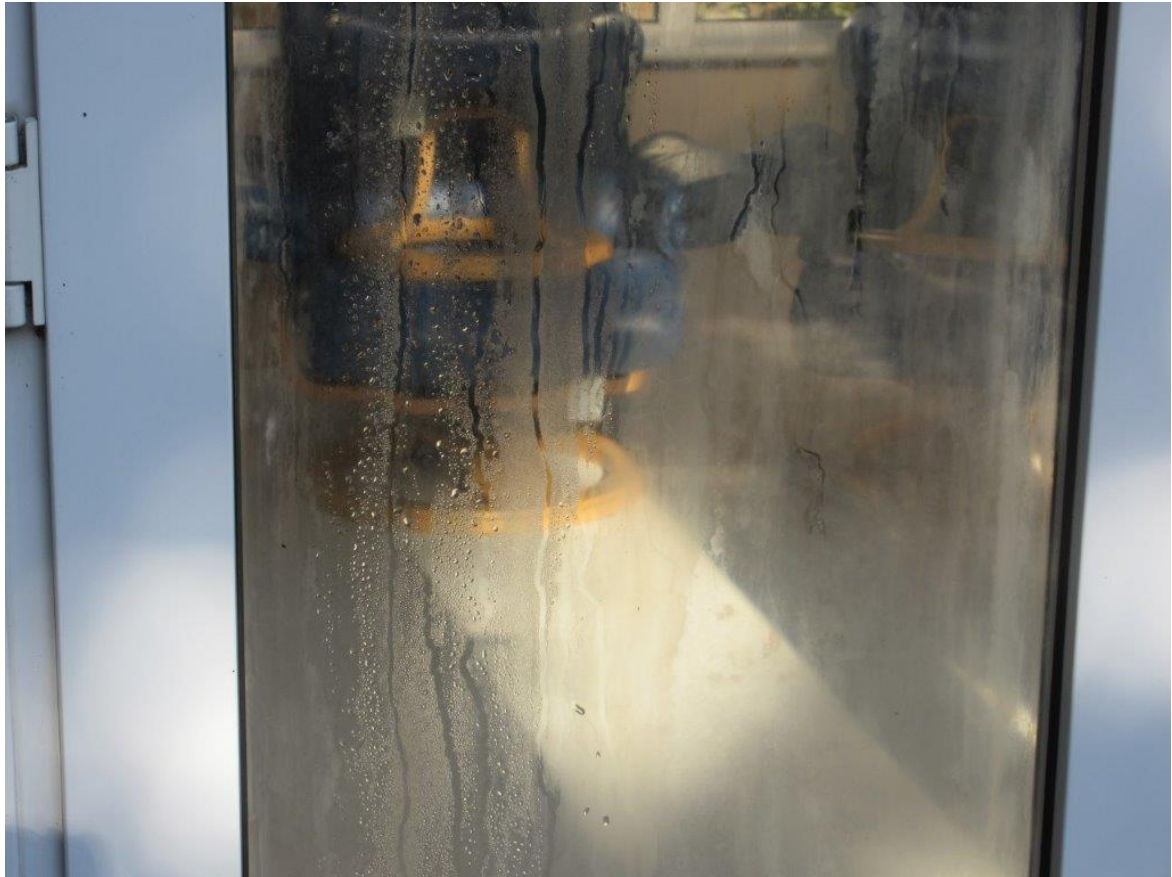
This conservatory is of a fairly basic quality. Thermoplastic roofs have a tendency to split and permit damp penetration over time. There is a failed sealed unit to one of the doors, which requires replacement. Some of the seals to the windows are beginning to fail although no misting of double glazing was noted. No heating has apparently been provided internally. No significant structural defects were noted.

FAILED GLAZING TO CONSERVATORY

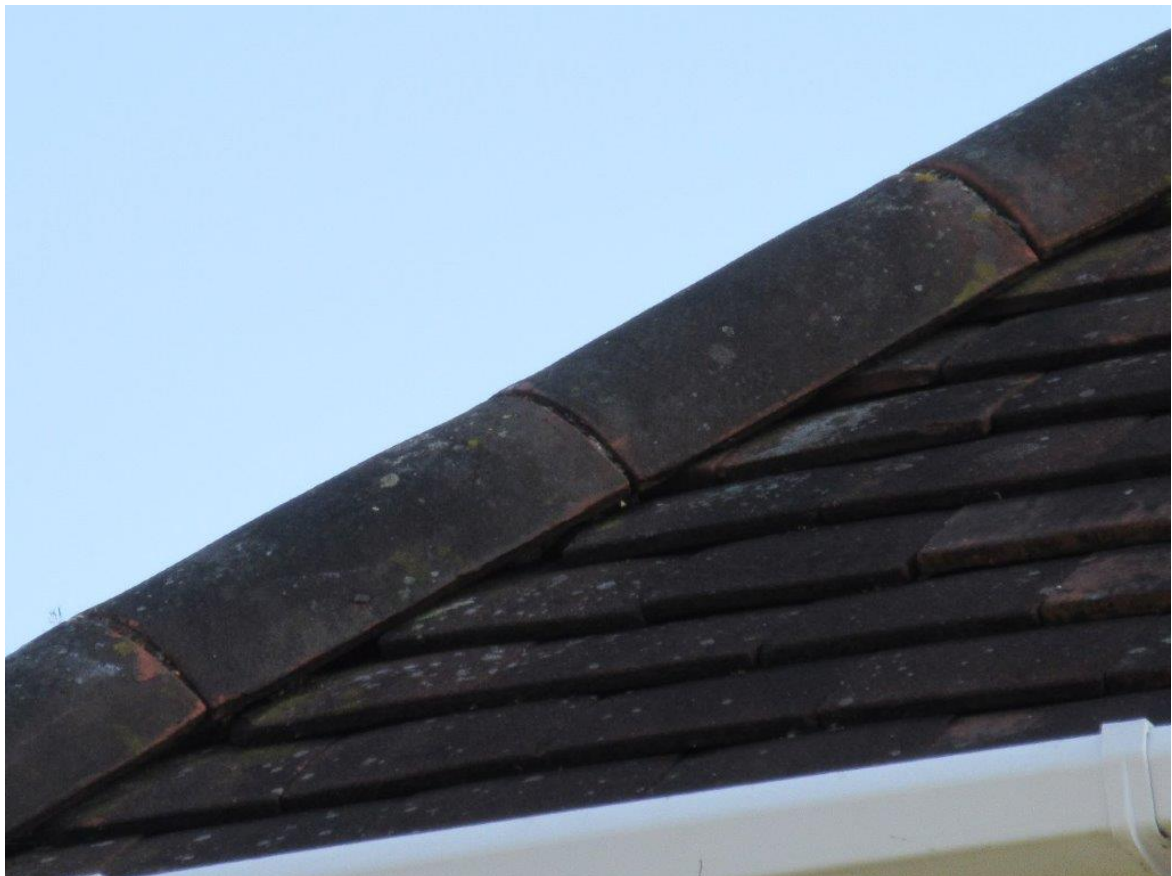
The roofs appear to be in good condition with only a few damaged tiles requiring replacement, although hip to tiles to the extension require re-bedding in sand and cement mortar. It could not be confirmed whether this extension roof has been felted, as no access was available.

HIP TILES NEED RE-BEDDING
