TUNKH25002

**RE: AHERA 3-year Asbestos Reinspection Report
Tunkhannock High School
135 Tiger Drive, Tunkhannock, PA**

AHERA 3 Year Reinspection

Tunkhannock High School
135 Tiger Drive
Tunkhannock, PA

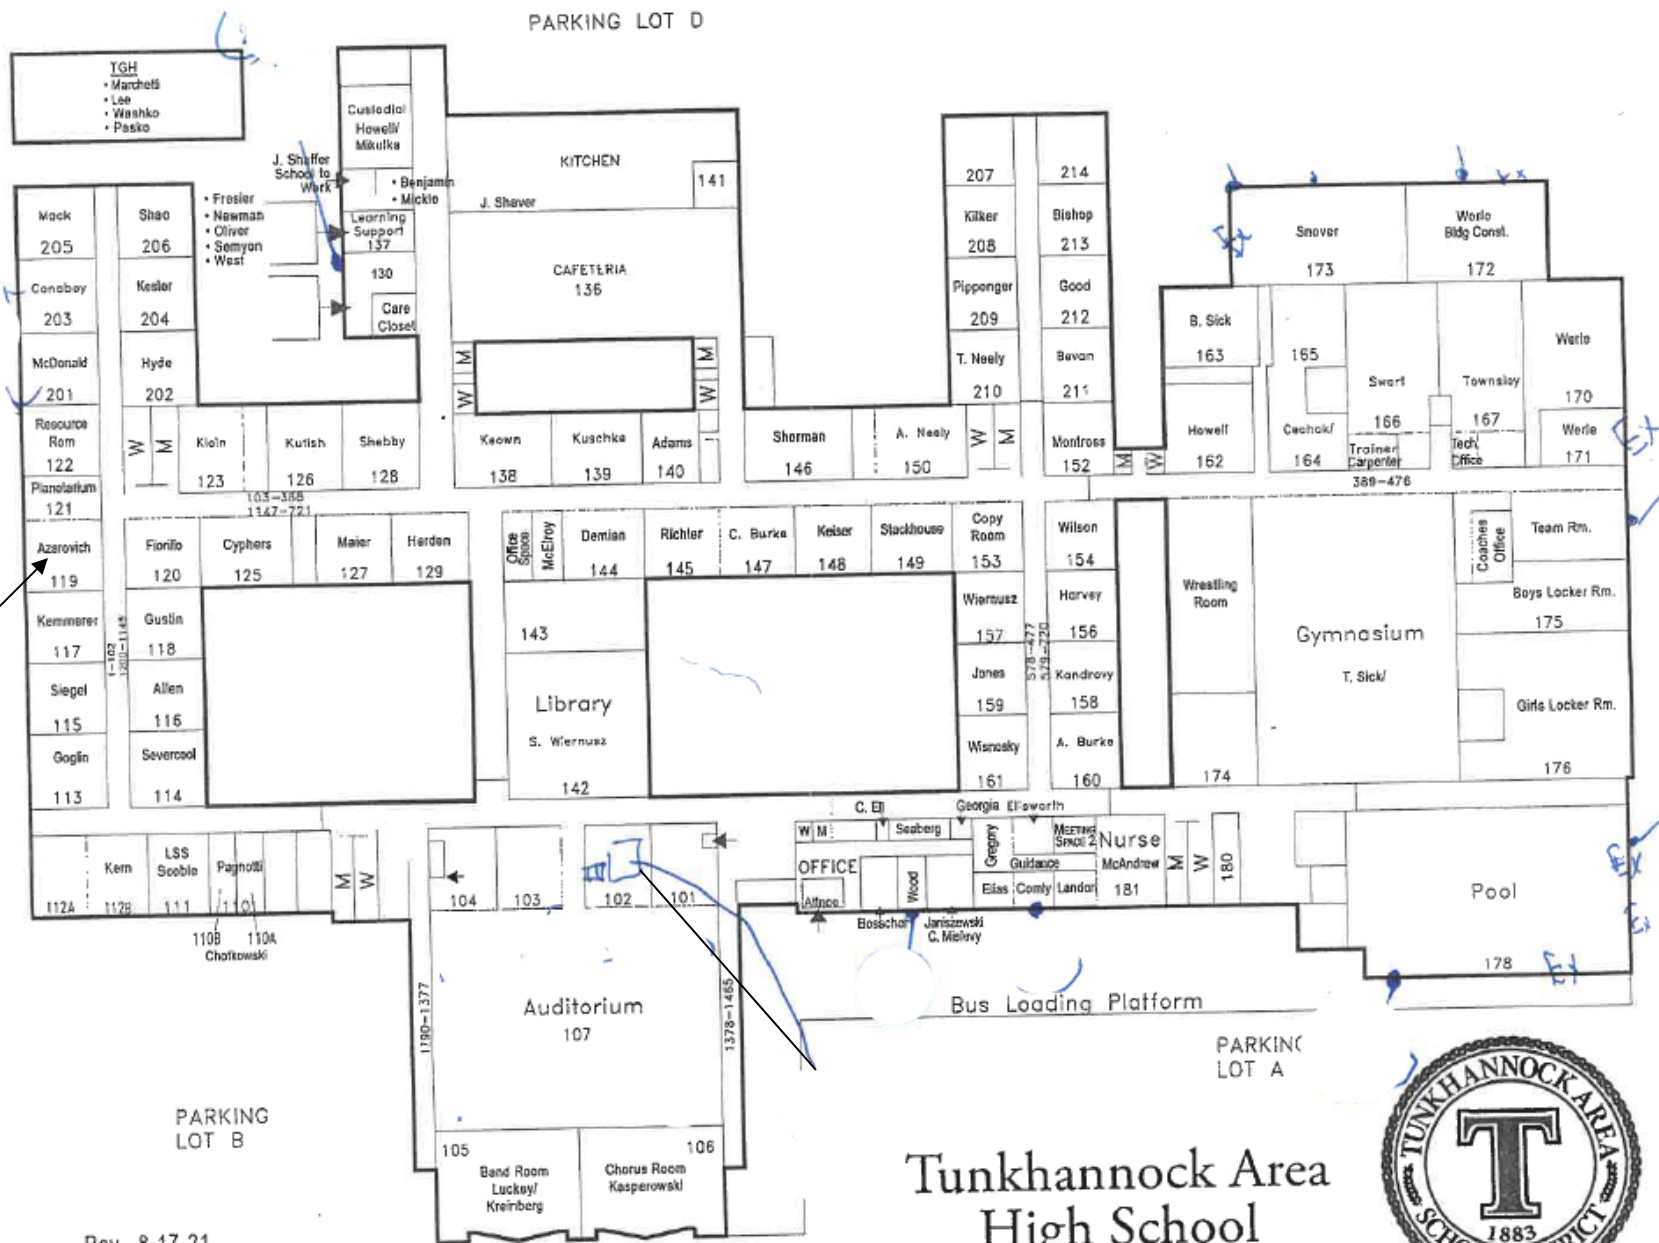
First Floor Plan South

Homogeneous Material	Sample ID	Sample Location	Result	Classification
Pink Floor Leveler, Under Floor Tile	Sample #01	Room 119	None Detected	Non-ACM

Sample #01
