Inspection Report

5221 Samrick Rd. Belmont MI 49306

Brigade Home Inspection Services LLC.

Date: 9/10/2020	Time: 10:00 AM	Report ID: 091020D
Property: 5221 Samrick Rd. Belmont MI 49306	Customer: Mrs. Julie Smith	Real Estate Professional:

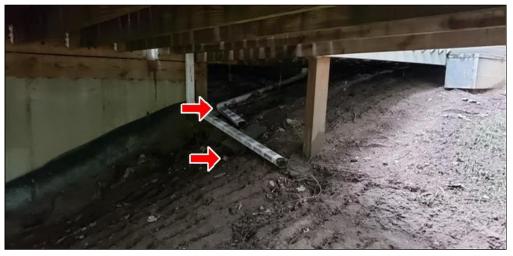
1.3 Item 2(Picture) Drain lines

- 1.3 Item 1(Picture) Covered gutters
- (2) The ground drain lines need extending and burying below the surface.

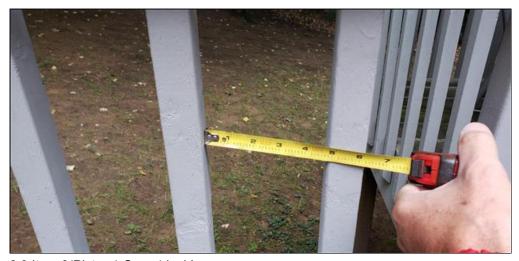
(2) The pickets on deck at the rear of home are spaced to far apart for safety. Spacing more than 4 inches apart could allow an adult, child or pet to fall through A fall or injury could occur if not corrected. The maximum space between pickets should be four inches I recommend repair as needed.

2.3 Item 3(Picture) Over 4 inch's

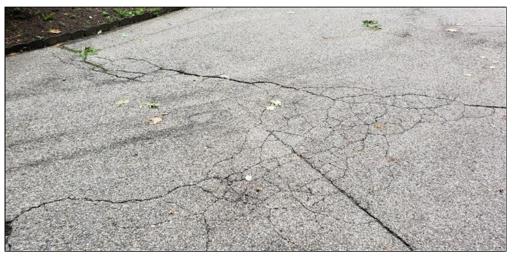
(2) The concrete drive at the front of home has settlement cracks. . I recommend repair as desired.

2.4 Item 4(Picture) Settlement cracks

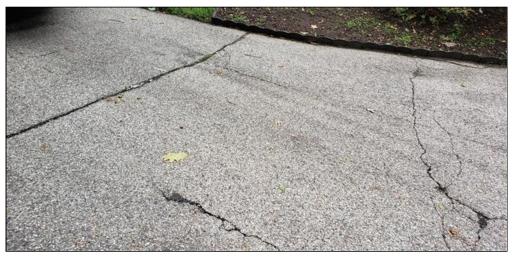
2.4 Item 5(Picture) Settlement cracks

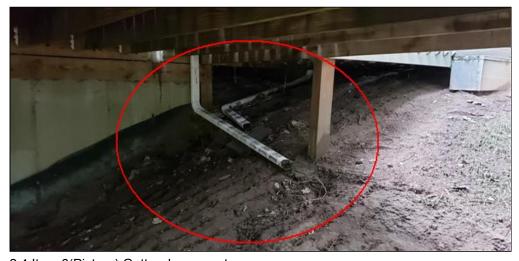
(3) Gutters terminate underneath deck causing erosion. Recommend extending downspouts to a lower part of the yard.

2.4 Item 6(Picture) Gutter downspouts

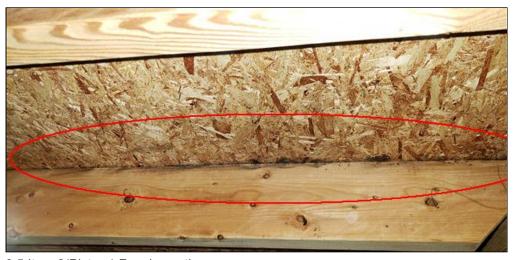
(2) The roof sheathing is "blackened" and has fungi growth indicating moisture intrusion in areas. Signs of fungi growth indicate that moisture is entering inside the attic.. The cause of moisture needs to be found and corrected.

3.5 Item 2(Picture) Fungi growth

Recommend investigating method used to kill and stop fungal growth since it does not appear to be encapsulated.

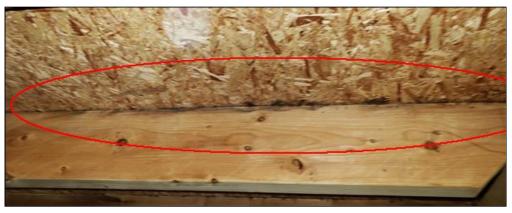
3.5 Item 3(Picture) Fungi growth

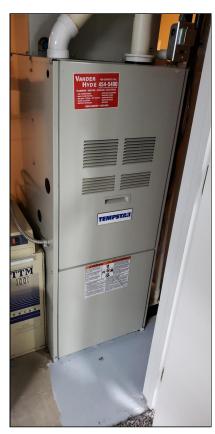
Average life expectancy of forced air furnace is 20 to 30 years,

Tested working at the time of inspection.

4.0 Item 1(Picture) Furnace

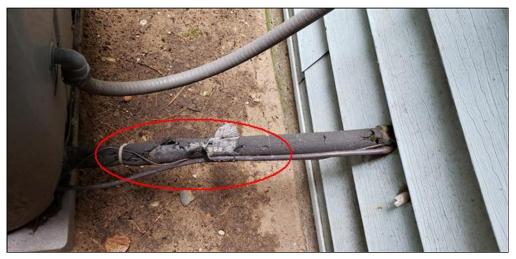
(2) The foam sleeve on suction line is missing foam sleeve in area(s) at outside unit. Missing foam on suction line can cause energy loss and condensation. I recommend service or repair as needed.

4.8 Item 3(Picture) foam sleeve on suction line is missing foam

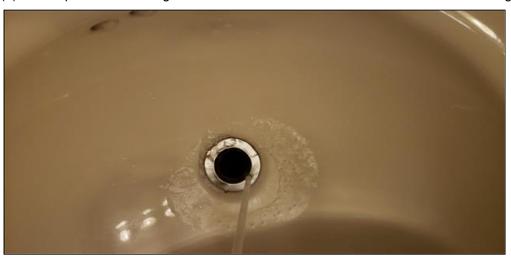
(2) The stop-valve is missing at the bathtub for main floor bath. . Recommend installing stopper..

5.0 Item 2(Picture) Tub stopper.

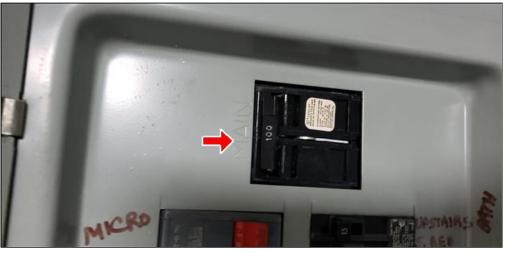
(2) Inspected 100 AMP service.

6.1 Item 5(Picture) Main circuit breaker 100 AMP

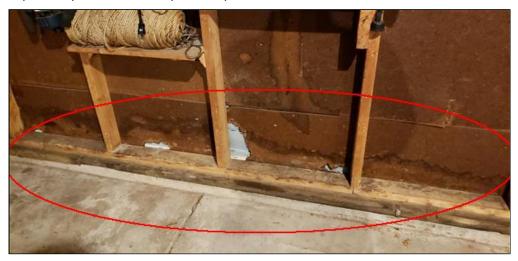
(1) The composition board on the wall is missing in areas at the garage. This is a small repair issue for your information. A qualified person should repair or replace as needed.

9.1 Item 1(Picture) Damaged wall board

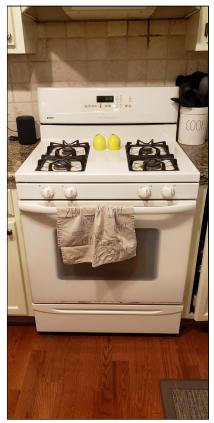
Tested- Working at the time of inspection.

10.1 Item 2(Picture) Burners

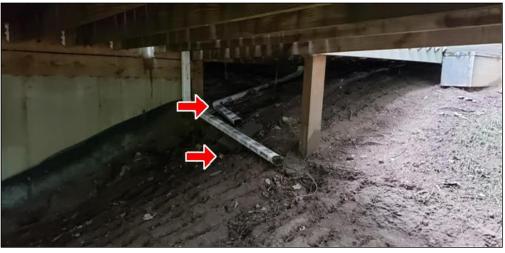
1.3 Item 2(Picture) Drain lines

(2) The ground drain lines need extending and burying below the surface.

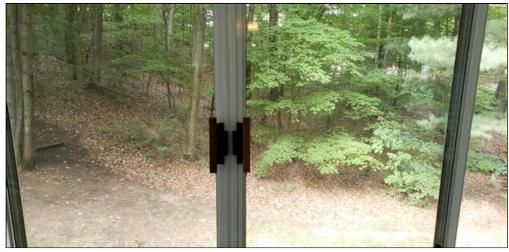
2.1 Item 3(Picture)

(2) The screen door is stretched or torn at rear entry door. I recommend repair or replace by a qualified person.

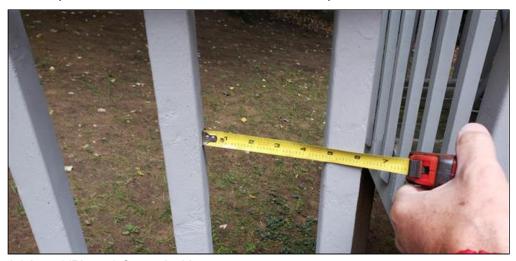
(2) The pickets on deck at the rear of home are spaced to far apart for safety. Spacing more than 4 inches apart could allow an adult, child or pet to fall through A fall or injury could occur if not corrected. The maximum space between pickets should be four inches I recommend repair as needed.

2.3 Item 3(Picture) Over 4 inch's

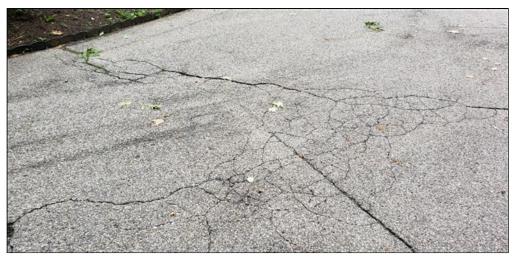
(2) The concrete drive at the front of home has settlement cracks. . I recommend repair as desired.

2.4 Item 4(Picture) Settlement cracks

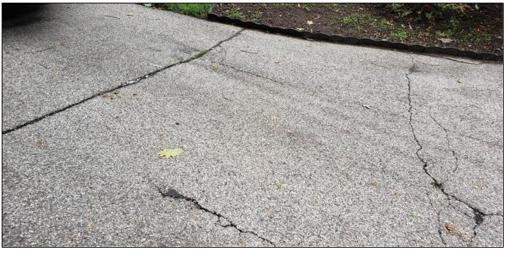
2.4 Item 5(Picture) Settlement cracks

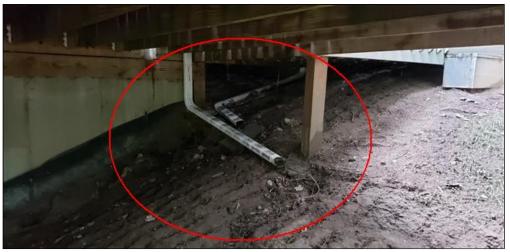
(3) Gutters terminate underneath deck causing erosion. Recommend extending downspouts to a lower part of the yard.

2.4 Item 6(Picture) Gutter downspouts

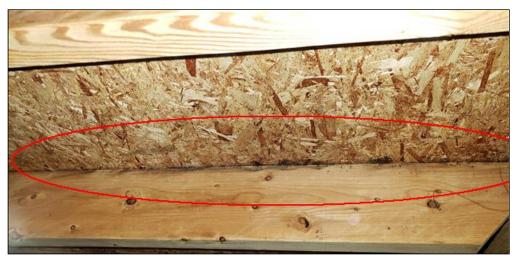
(2) The roof sheathing is "blackened" and has fungi growth indicating moisture intrusion in areas. Signs of fungi growth indicate that moisture is entering inside the attic.. The cause of moisture needs to be found and corrected.

3.5 Item 2(Picture) Fungi growth

Recommend investigating method used to kill and stop fungal growth since it does not appear to be encapsulated.

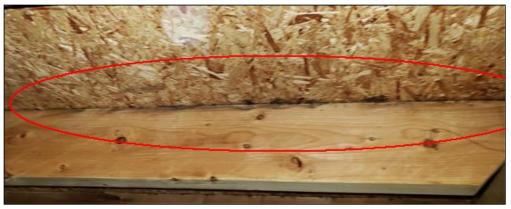
3.5 Item 3(Picture) Fungi growth

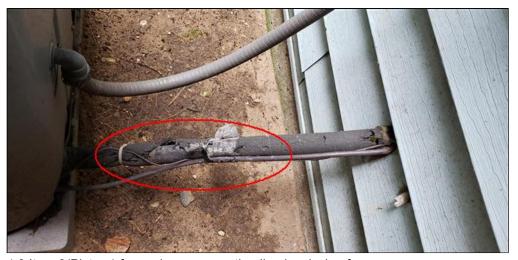
(2) The foam sleeve on suction line is missing foam sleeve in area(s) at outside unit. Missing foam on suction line can cause energy loss and condensation. I recommend service or repair as needed.

4.8 Item 3(Picture) foam sleeve on suction line is missing foam

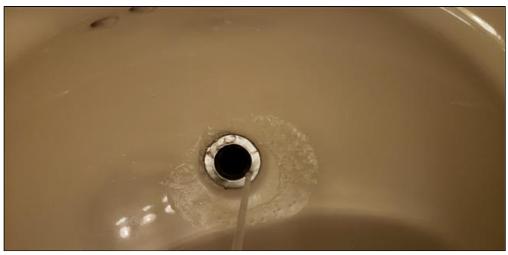
(2) The stop-valve is missing at the bathtub for main floor bath. . Recommend installing stopper..

5.0 Item 2(Picture) Tub stopper.

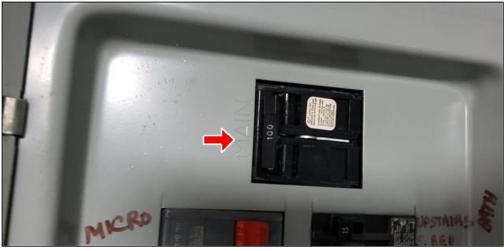
(2) Inspected 100 AMP service.

6.1 Item 5(Picture) Main circuit breaker 100 AMP

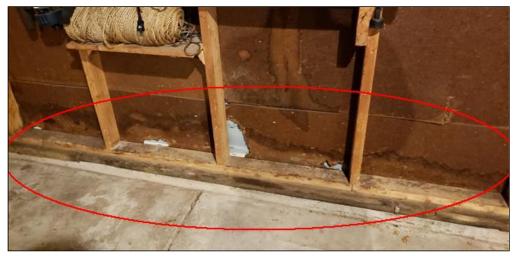
(1) The composition board on the wall is missing in areas at the garage. This is a small repair issue for your information. A qualified person should repair or replace as needed.

9.1 Item 1(Picture) Damaged wall board
