BEFORE AND AFTER APPLICATION

Project Number:	ES11614
	Client:	Sharlston School
	Description/ Location of Works:	Basement Boiler Room Direct connection to Decontamination Unit. Unoccupied building. A mixture of airless encapsulation spray and hand held brushes.
Before		
Comments:	<p>Asbestos abatement work under ASB5 notification is required for an environmental clean-up of the boiler room due to the deterioration of existing paint following previous asbestos removal work.</p> <p>The scope of work includes:</p> <ul style="list-style-type: none"> ▪ Encapsulating the walls with RZ-EcoSeal E ▪ Addressing issues caused by paint falling off, leading to dust and debris. <p>Key concerns:</p> <ul style="list-style-type: none"> ▪ The area becomes a permit-to-work zone. ▪ Access is restricted without appropriate RPE and PPE. ▪ Risk of children gaining unauthorized entry into a contaminated space. ▪ A re-clean under enclosure is necessary as a precautionary measure.

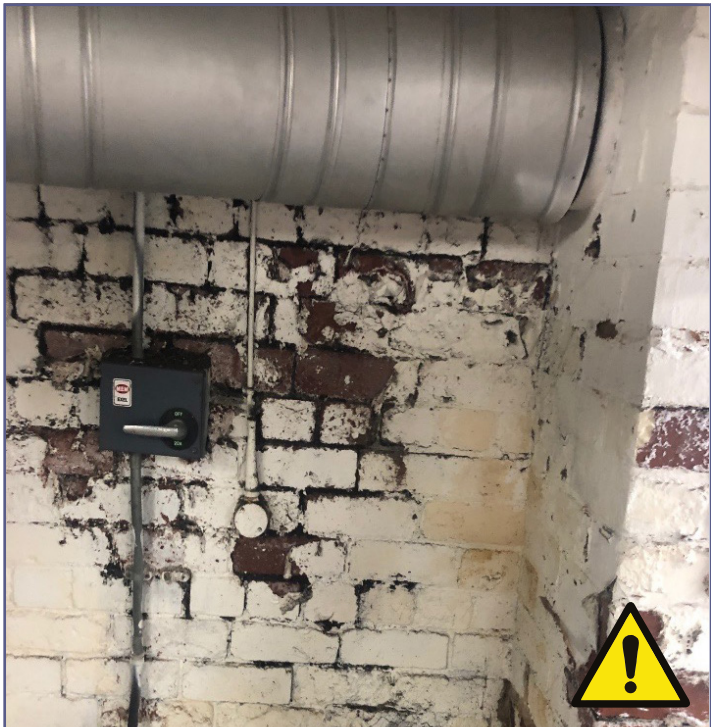
Project Number:	ES11614
	Client:	Sharlston School
	Description/ Location of Works:	Area shows deterioration due to condensation
Before		
Comments:	<ul style="list-style-type: none"> A clean of the walls using wire brush with shadow vacuum ensuring rough surface to apply sealant. See Permeability Testing, Sheffield Hallam University Reference Number CIM 438 Water Vapour Permeability.

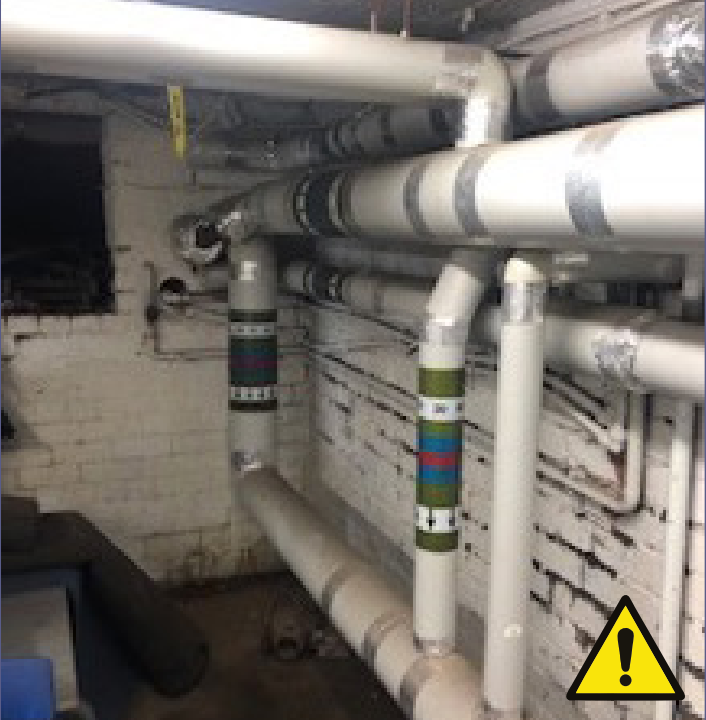
Project Number:	ES11614
	Client:	Sharlston School
	Description/ Location of Works:	Area shows deterioration due to condensation
Before		
Comments:	<ul style="list-style-type: none"> ▪ Condensate from the pipe work creating damage to the paint and flaking from the walls. ▪ See Sheffield Hallamshire University Testing for condensate, Reference Number CIM 438 Condensation test.

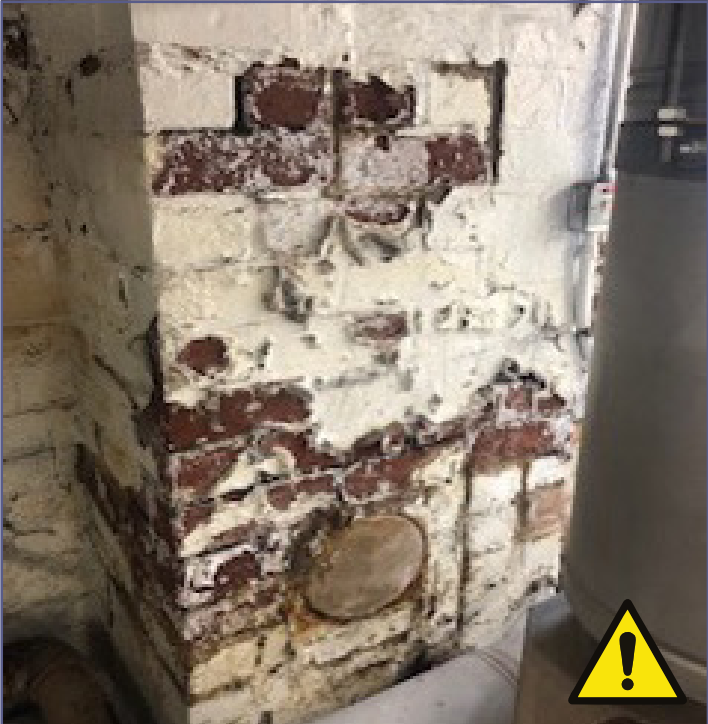
Project Number:	ES11614
	Client:	Sharlston School
	Description/ Location of Works:	Area shows deterioration due to condensation
Before		
Comments:	<ul style="list-style-type: none"> Damp areas of the basement, loss of encapsulant resulting in contamination to the floor and associated pipe work.

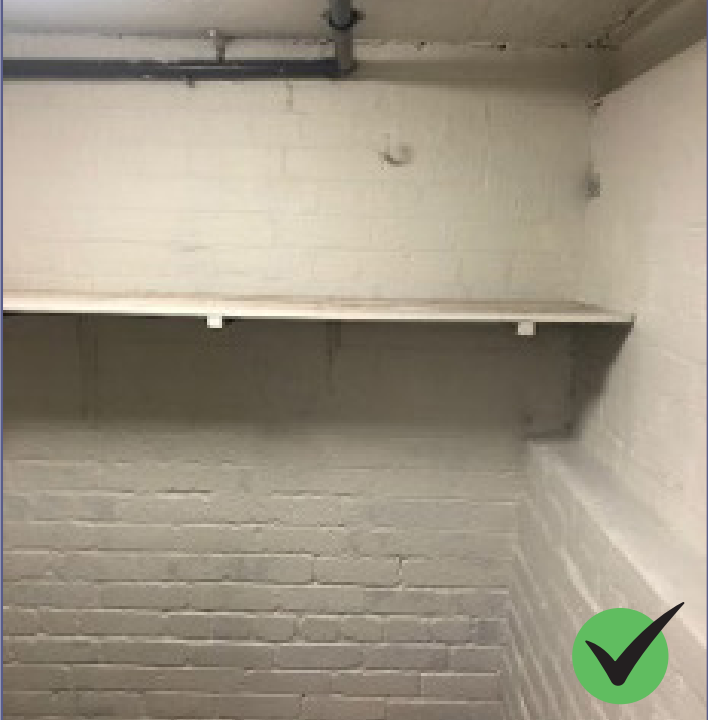
Project Number:	ES11614
	Client:	Sharlston School
	Description/ Location of Works:	Area sealed with RZ-Ecoseal E with 10 year guarantee, applied at 1.5mm thickness
Before		
Comments:	<ul style="list-style-type: none"> Area now sealant with layer RZ-Ecoseal creates a barrier layer between the area it is protecting and the area at risk from fibre release. The 1.5MM layer will protect the area from fibre release as per LW-NBO-19040801 test by SGS Search

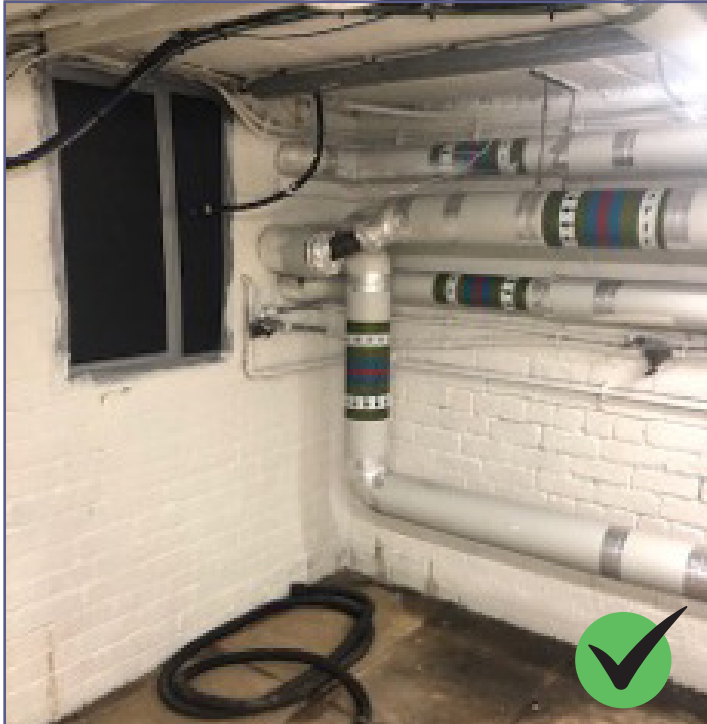
Environmental clean complete

- Both airless and hand applied (2 ½ brush stroke) sealant to walls, including behind pipe work and difficult to reach areas to the satisfaction of UKAS analyst as part of stages 3 and 4.
