Joyland Roofing

Inspection Report

Main Roof and Garage roof

Roof Inspection report

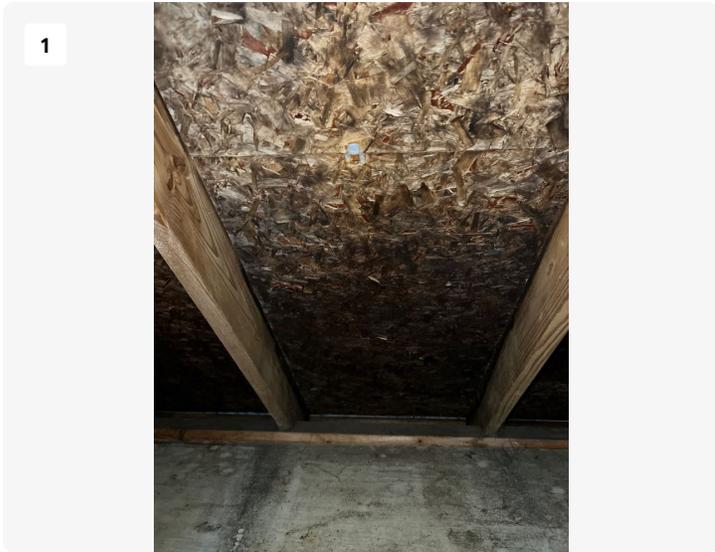
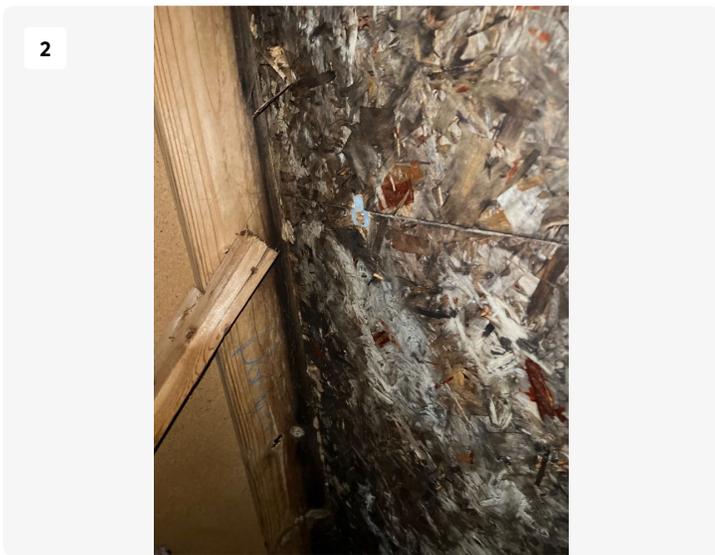
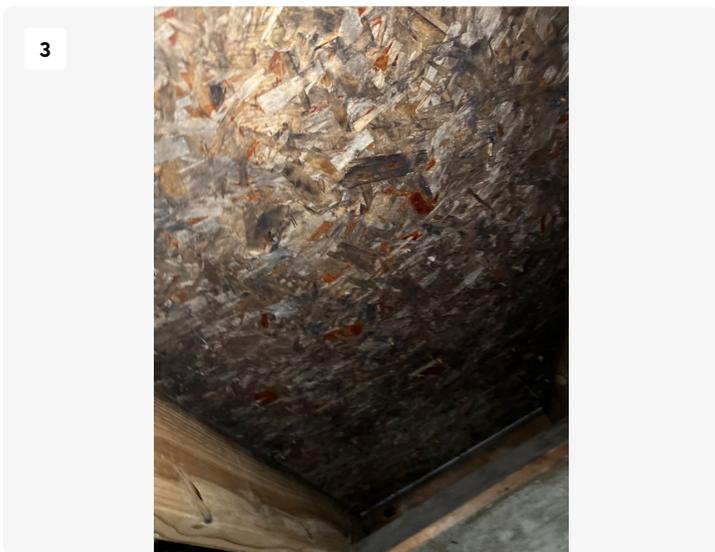
Sheathing in the back side of the roof is slowly deteriorating due to ventilation issue.

The bathroom exhaust fans are currently venting directly into the attic instead of being properly ducted to the exterior. This is causing elevated humidity levels and has resulted in deterioration of the roof sheathing (plywood) in the affected area on rear side of roof

Attic pictures - Notice the black growth on the OSB sheathing - this is likely due from the bathroom vents exhausting into the attic - these should be exhausting through the roof with the installation of a roof vent to prevent further deterioration and possible mold growth.

Recommendation: Redirect all bathroom exhaust vents to the exterior through proper roof . Replace any damaged or rotted plywood sheathing and inspect for potential mold growth.

Reroute bathroom vents to exhaust outside.

Repair or replace any deteriorated plywood as needed.

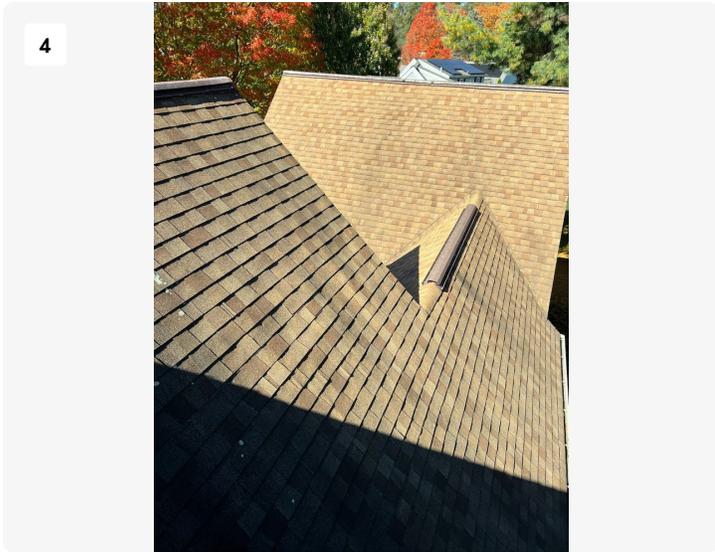
Roof overview picture - generally good condition

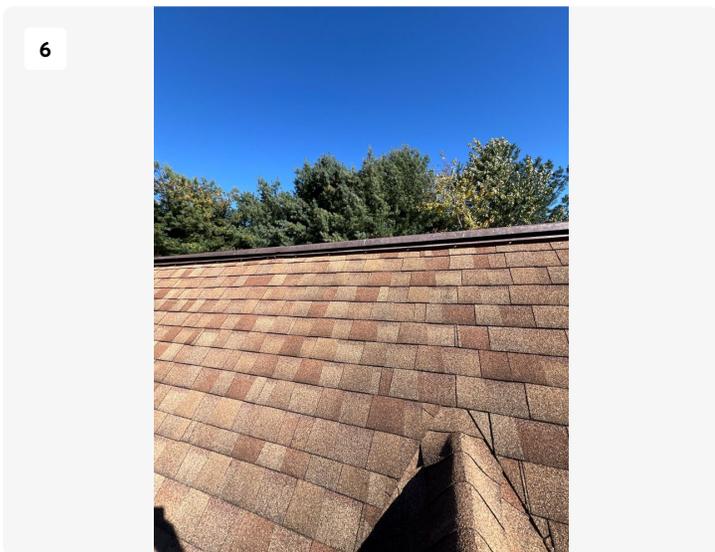
Aluminum ridge vent - this style is prone to leaking 15-20 years after installation. Recommend replacement of the ridge vent before this happens.

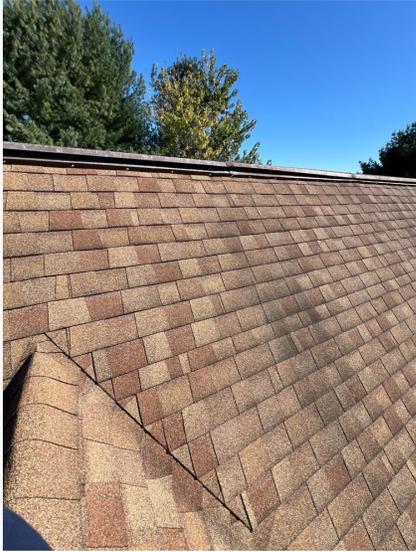
Shingles on house - generally good condition; some algae beginning to form but should not affect longevity of the system.

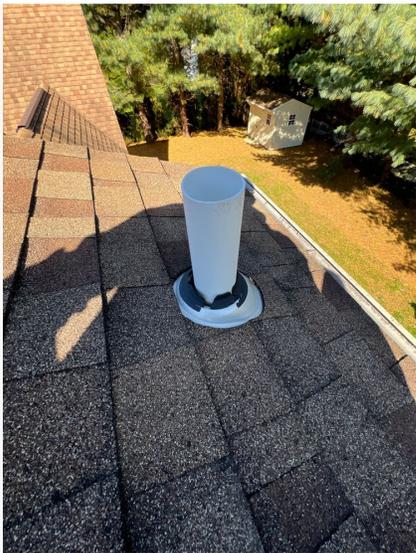
Rear Pipe boot in rear side of roof needs replaced

Pipe boot collar has deteriorated and is allowing water into the attic.

Replace pipe boot

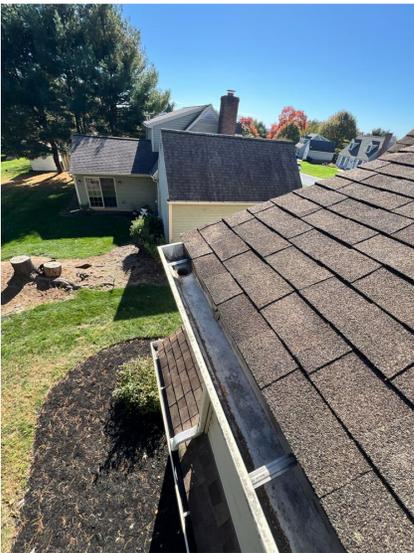
Gutters are clean and in good condition.
