**Client:** Cindy Daffron  
Executive Director Pony Express Museum  
914 Penn Street, St. Joseph, MO 64503  
**Phone:** (816) 279-5059  
**Email:** [pxdirector@ponyexpress.net](mailto:pxdirector@ponyexpress.net)

## TREATMENT REORT # 5704

November 17<sup>th</sup>, 2022

**Subject:** *The Missouri Swamp Fox Mural*

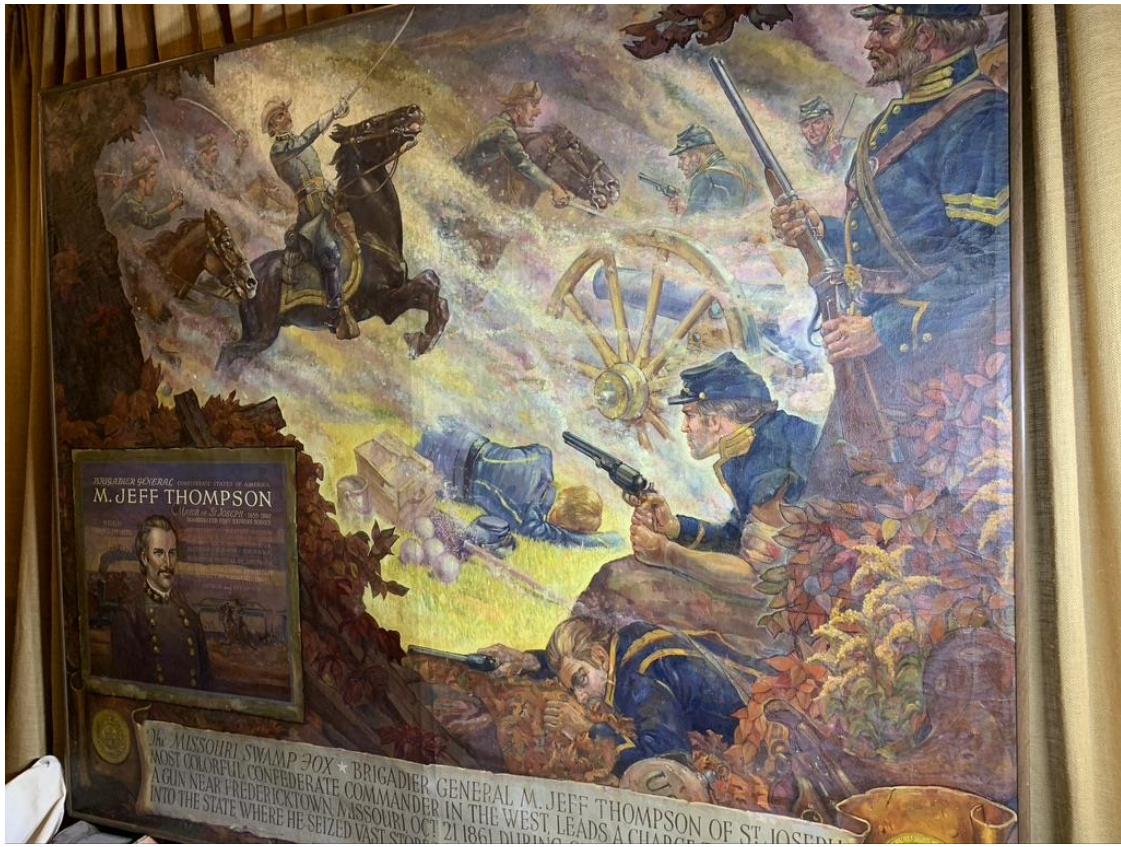
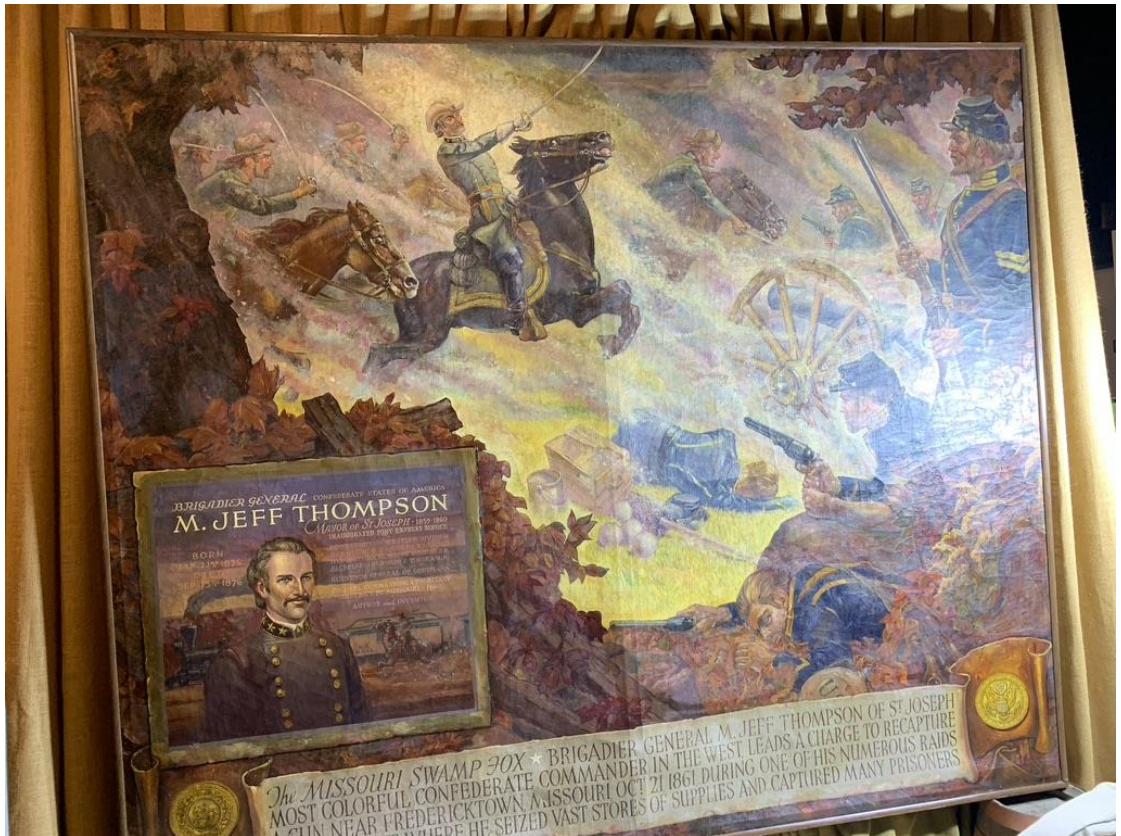
There is no varnish present. Surface appears to be coated in a heavy layer of nicotine and grime that gives the painting a darkened, dulled, yellowish hue.

### *Darkened and yellowed before treatment*

*Top: before cleaning. Bottom: After cleaning*

- Cleaned painting with Naphtha Oil, (Oleate Acid, Petroleum Distillates, Triethylamine, Methyl Salicylate) and cleared with OMS and Polar solvents by blotting and swabbing

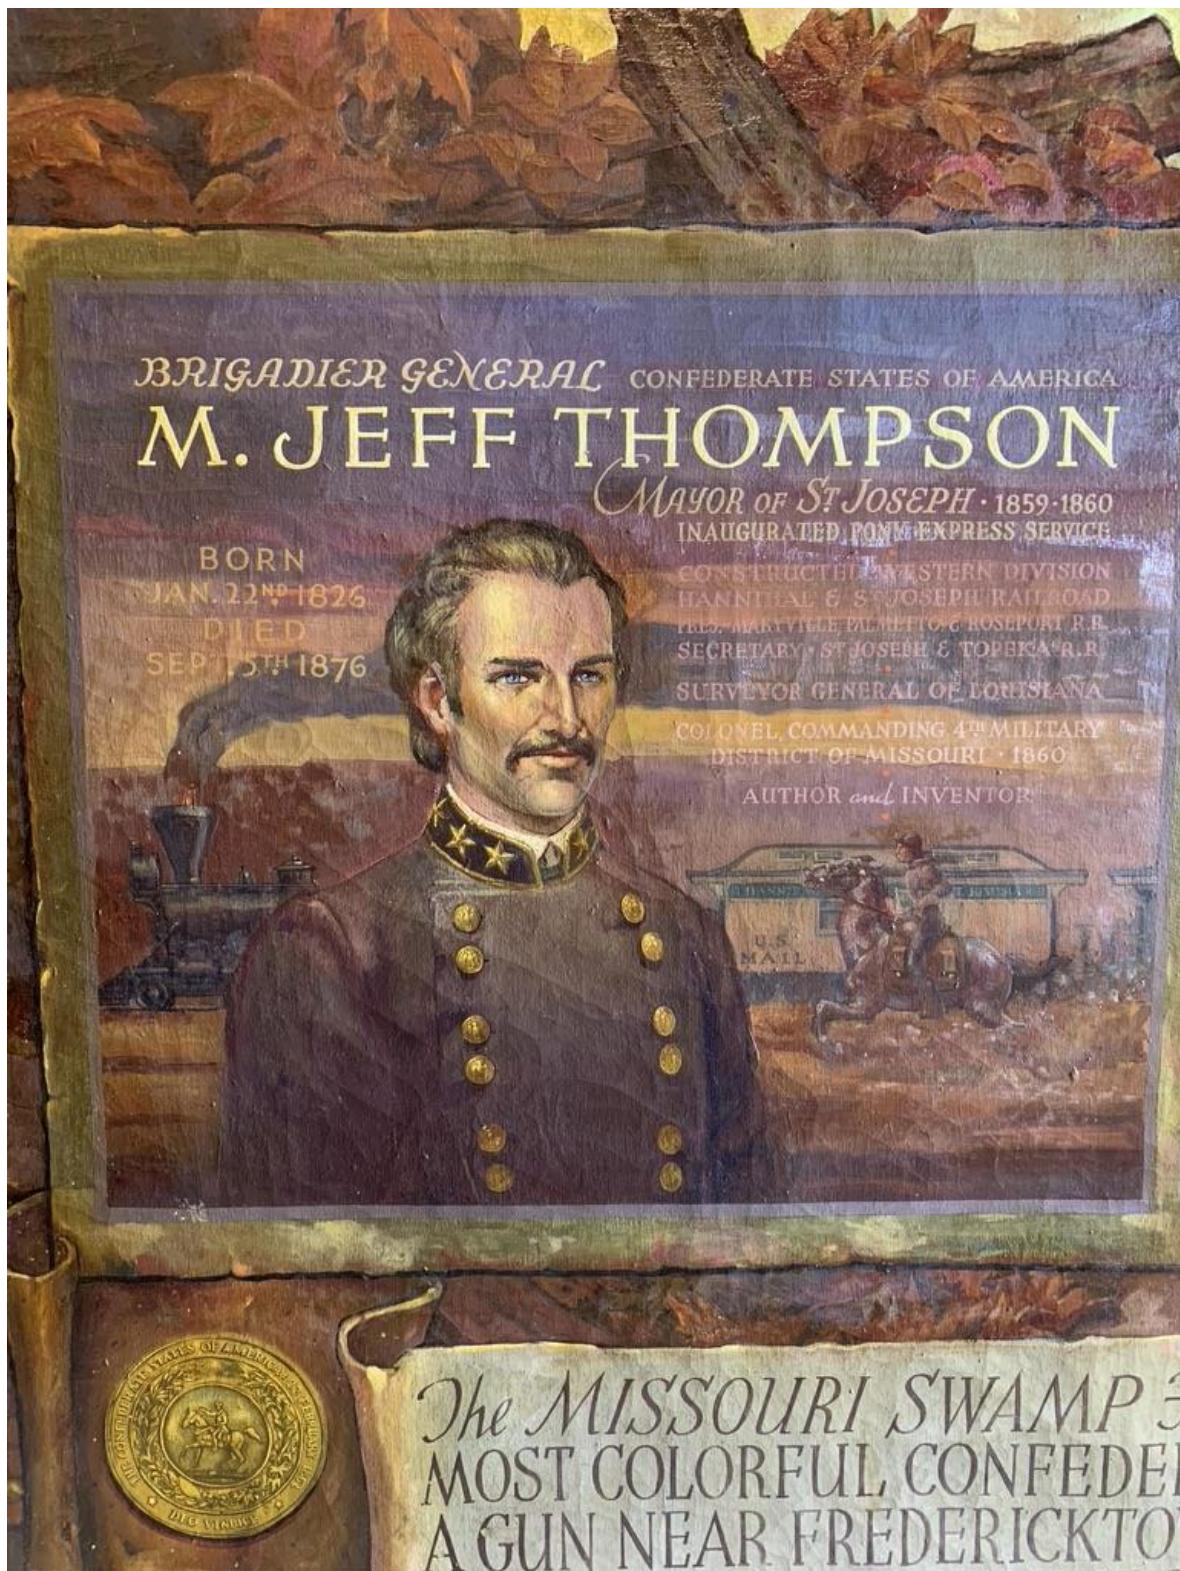
The painting was installed onto two 'L- brackets in the upper center and supported on both right and left lower side by two antique barrels. Tacking edges are covered with a 3-inch strip of brown plastic. The facing is a 1-inch quarter round plastic strip nailed into strainer covering the tacking edges. The four- member strainer is custom fabricated non-original; it has one protruding cross bar in the center that is pressing through the canvas. Canvas is a heavy cotton duck sailcloth. There are large undulations billowing and corner draws in the lower region from sagging canvas that is slack on the strainer bars.

*See protruding center support and sagging after cleaning*

- Brought the canvas back into plane and pulled the deformations into plane with stretcher pliers
- Stapled stretched painting to strainers
- Inpainted minor losses with reversible conservation paints in raw pigments in Aquazol and MSA Golden conservation paints which were most prominent around the perimeter

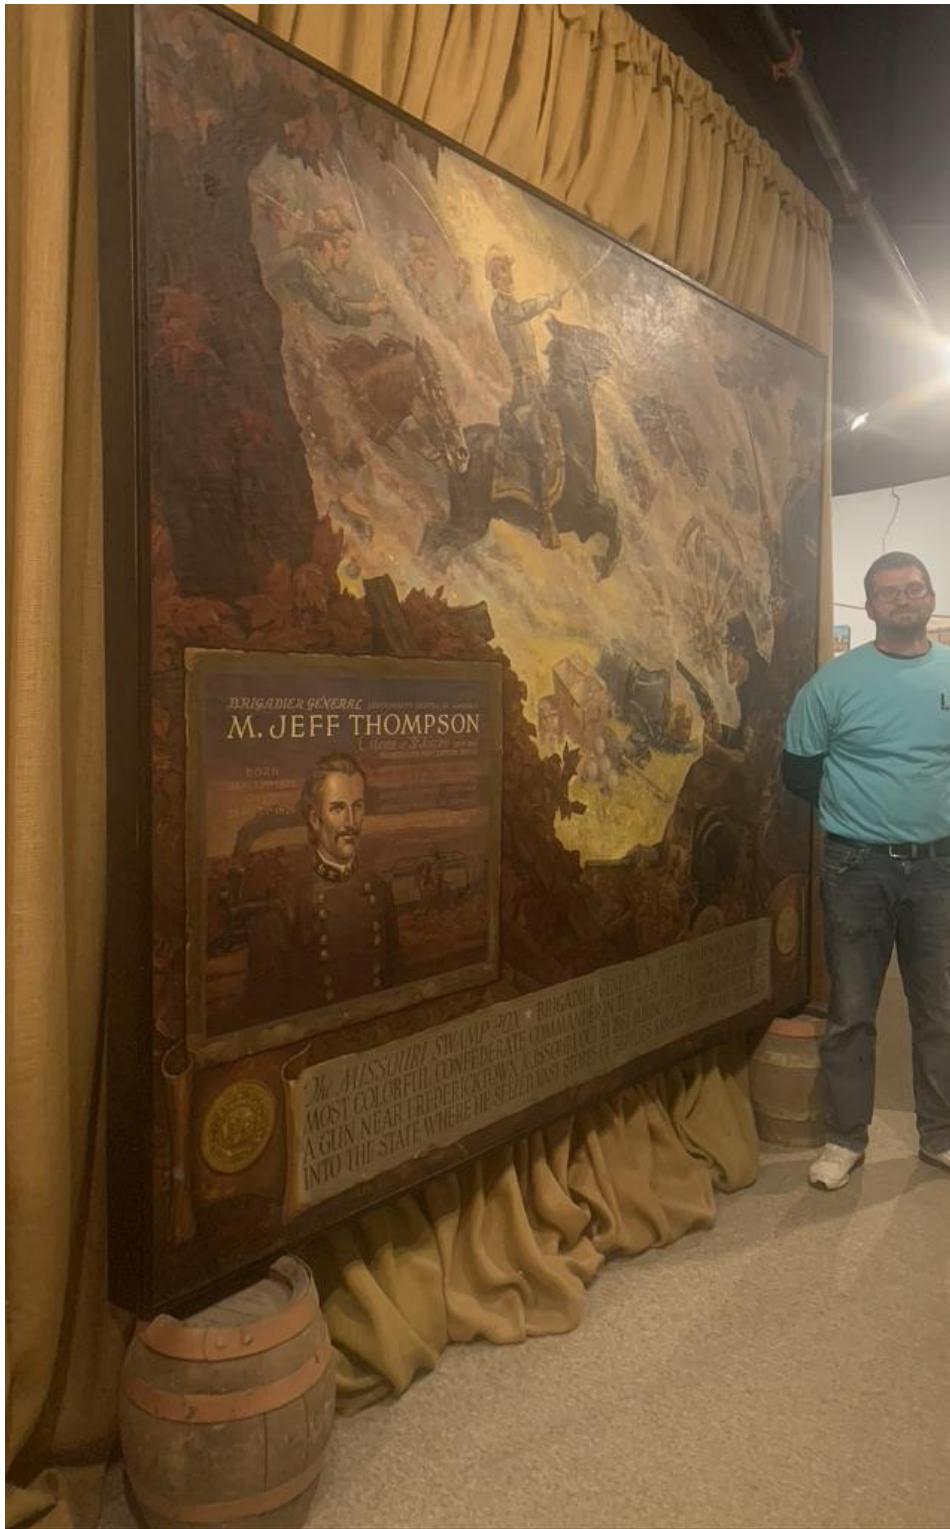
*Painting after installation with new frame installed*

- Adhered the covering strips of stained black wood to sides and perimeter to cover the tacking edges
- Reinstalled painting on the museum wall, supported with barrels
