## 10 YEAR NDT INSPECTION REPORT

**Client:** Ziggy's Cranes

**Job Identification:** Liebherr LTC 1045-3.1 Serial: 056538 Built:2015

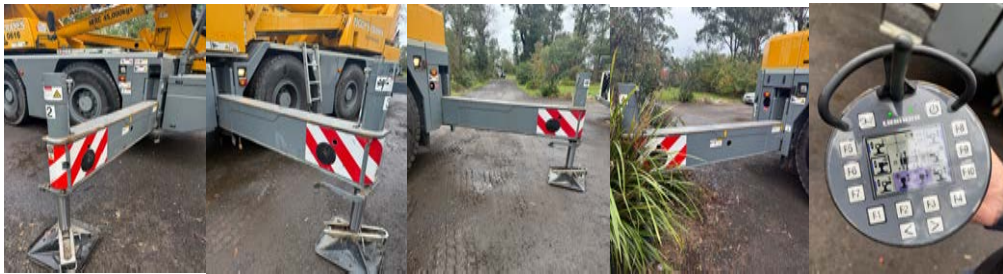
### Outriggers

All chassis components are in good order and there was no excessive wear evident, the chassis revealed no evidence of cracking during NDT examination, areas were tested as per manufactures guidelines.

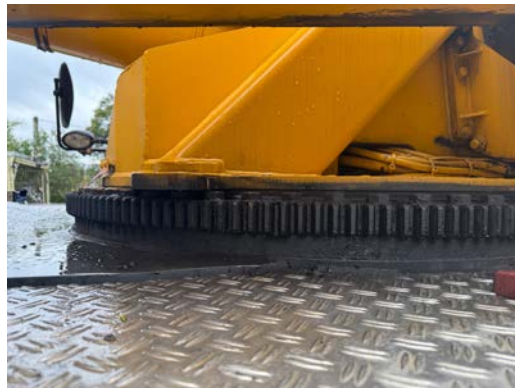
### Slew ring

Slew ring was inspected and found to be in good order, there was no excessive wear in any of the components and no evidence of any leaking or weeping seals.

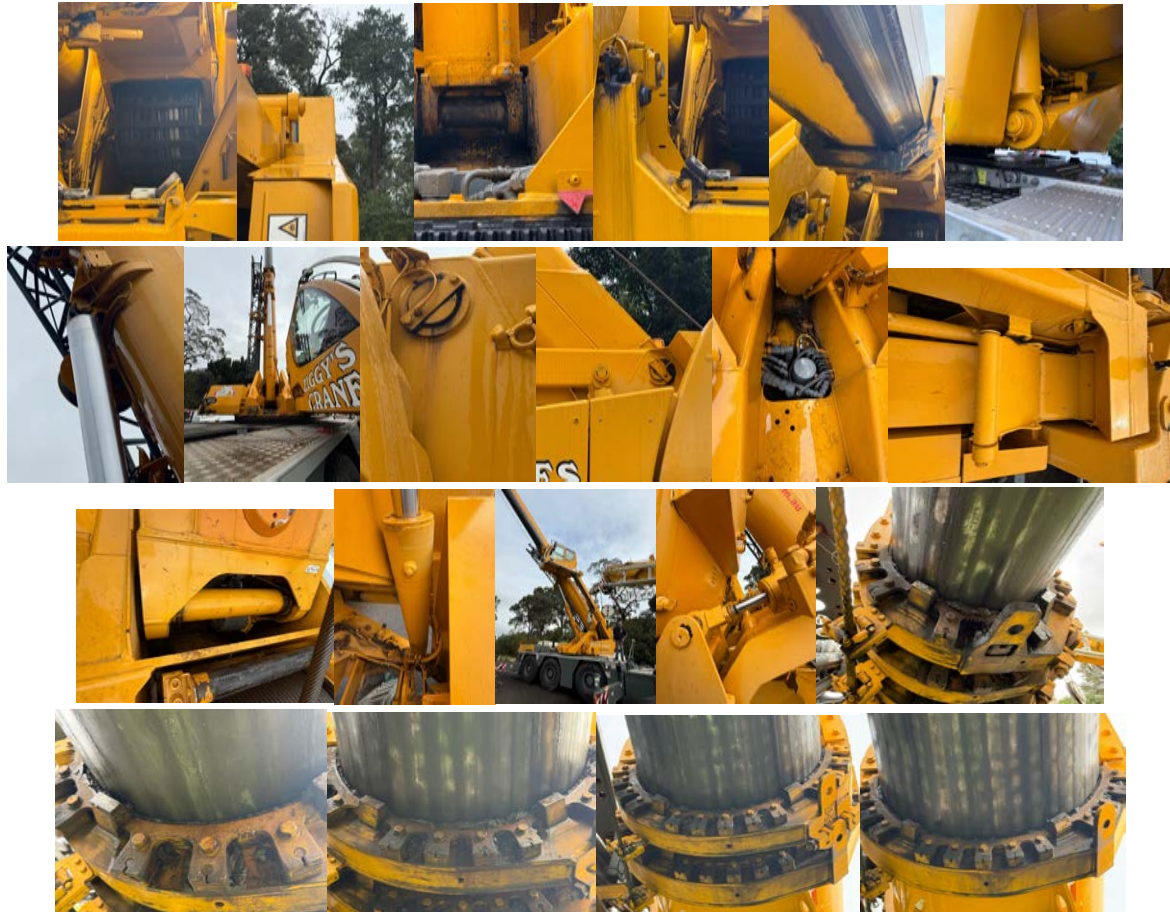
### Boom and Rams

Main Lift Cylinder and outrigger cylinders underwent a thorough NDT inspection as per Australian Standards. There was no evidence of stress fractures or cracking at time of test. All cylinders are in good working order with no apparent leaks, seepage or wear.

There was no excessive wear in any of the boom sections at the time of test.

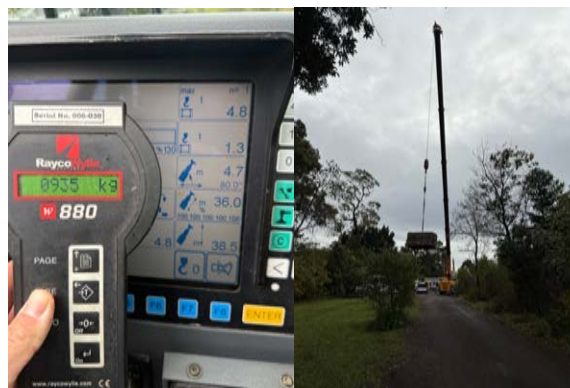
## Weight Test

This document is to certify that the crane manufactured by Liebherr LTC 1045-3.1 Serial: 056538 has undergone full load, stability, and structural testing as per AS2550, AS1418.1 and as per the manufacturer's recommendations.
