# Right Way Home Inspectors

## Inspection Report

Inspected on Mon, Mar 16 2026 at 11:30AM

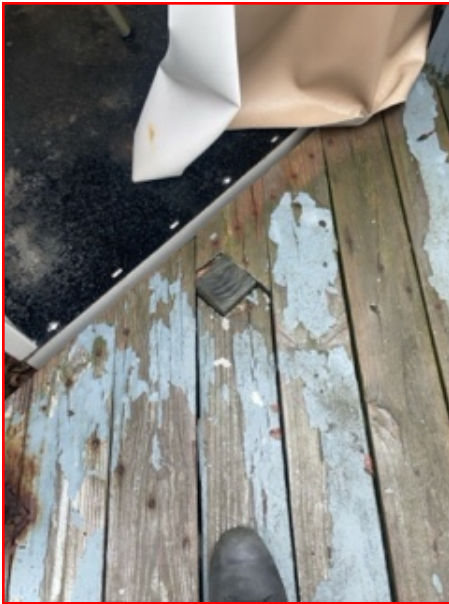
Figure 12-1

1) Safety issue : Floor joist of the rear deck appeared to be broken and was moving under foot, causing deck boards to be unsupported.

Railings of both decks were damaged and loose.

Further evaluation by a qualified contractor is needed for repairs or replacement.

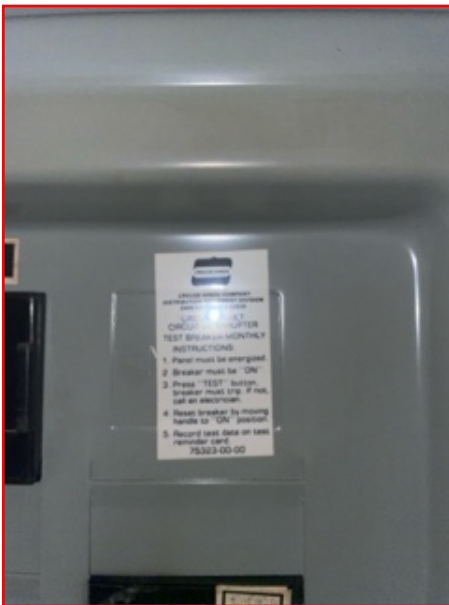
Figure 83-1

2) MARGINAL- The electrical panel appears to be an older Crouse-Hinds model, likely installed several decades ago. While no immediate defects may be visible, the panel and breakers are considered obsolete and may not meet current performance expectations. Replacement parts are limited. Recommend evaluation and budgeting for future upgrade by a qualified electrician.

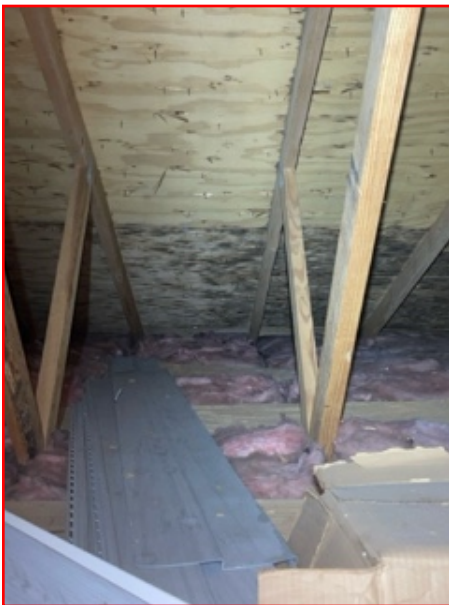
Figure 149-1

6) Large garage- POSSIBLE MAJOR CONCERN: A suspicious discoloration or stain was noted. Discoloration may indicate a larger issue adversely affecting the building materials and the structure. Recommend a qualified specialist ( Who is accountable to you) be contacted to evaluate the area and recommend corrective course. Additional areas of the house may require assessment at the discretion of the specialist.

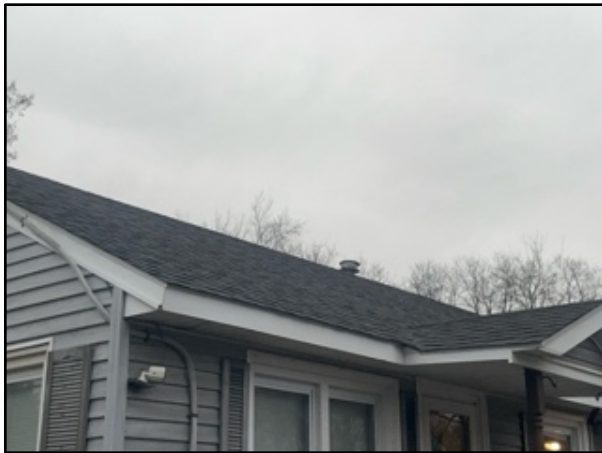
Figure 1-1

FUNCTIONAL: Main roofing material appeared in good condition on the day of the inspection.

Although some areas of minor maintenance may have been needed.

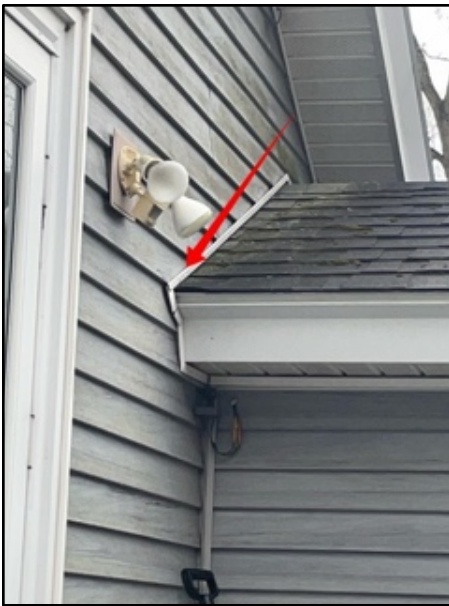
Figure 4-1

Comment 4:  
ATTENTION REQUIRED: Flashing that kick water out to the exterior of the siding appeared missing. Kick out flashing prevent excess water from intruding into substrates and are a vital part of the flashing system. Recommend their installation and be aware that damage to the substrates may be present that was not found or commented on with this limited non intrusive inspection.

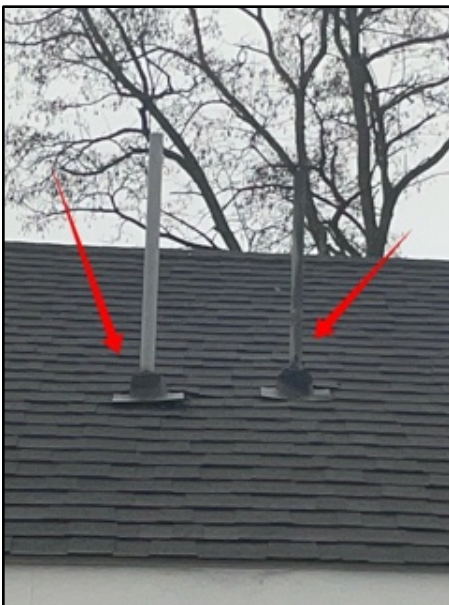
Figure 5-1

ATTENTION REQUIRED: Roof penetrations appeared to be in need of maintenance or repairs.

Roof penetrations tend to require attention before the rest of the roof. It is recommended that these areas be inspected regularly and kept in good repair to prevent water intrusion.

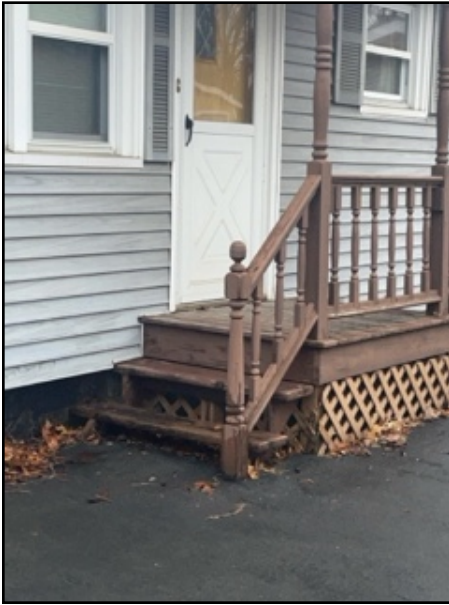
Figure 9-1

Comment 9:  
Wood in direct contact/proximity with the ground or masonry was noted. This condition can prematurely cause deterioration that may allow water or insects to infiltrate the building or damage the support timbers.  
Recommend implementing A seasonal plan of treatment to prevent wood rot.

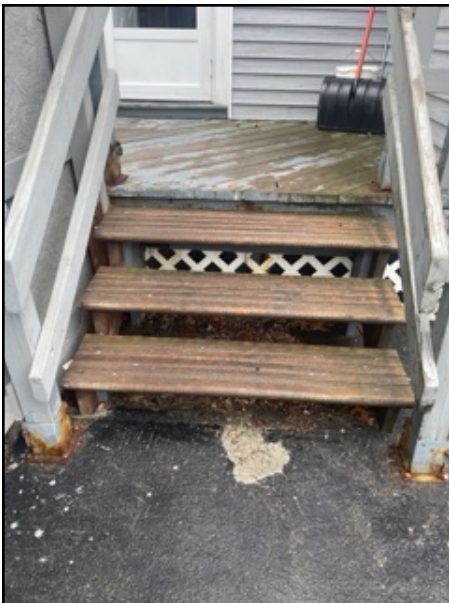
Figure 10-1

ATTENTION REQUIRED: The steps were not uniform in their layout, and may present a trip hazard.

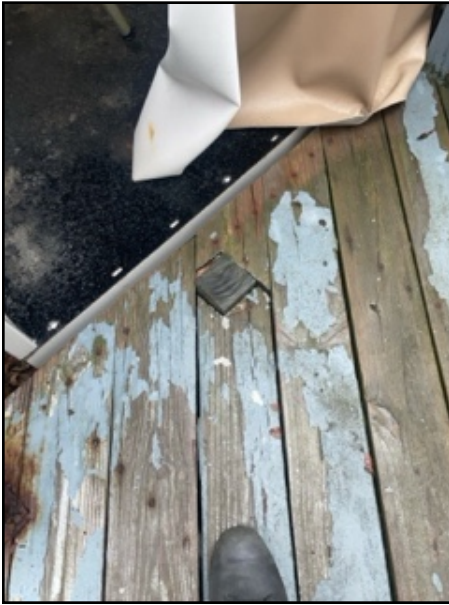
Figure 12-1

Safety issue : Floor joist of the rear deck appeared to be broken and was moving under foot, causing deck boards to be unsupported.

Railings of both decks were damaged and loose.

Further evaluation by a qualified contractor is needed for repairs or replacement.

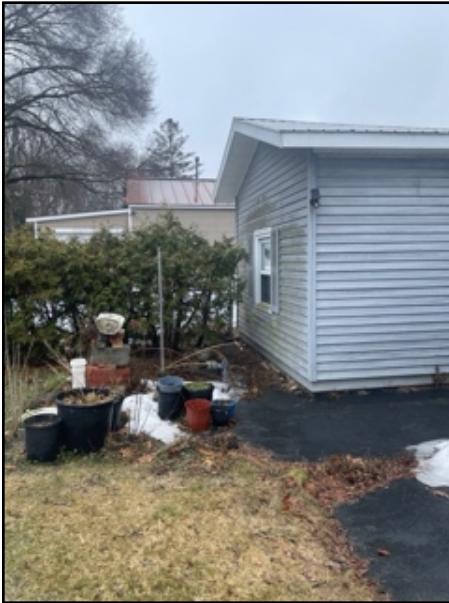
Figure 18-1

Mulch near the structure or at bottom of siding also should be avoided.

This will help reduce the frequency of having to clean out gutters, be less inviting to pest etc and provide air and sunlight to structure, while minimizing potential damage, debris, and dampness.

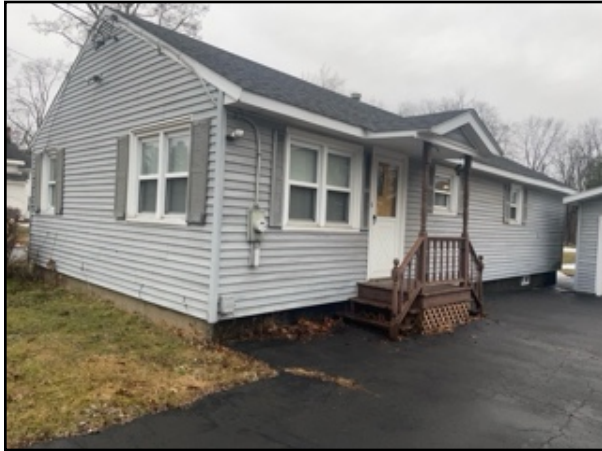
Figure 21-1

FUNCTIONAL: Exterior covering overall was in good shape although some areas may require minor repairs or maintenance.

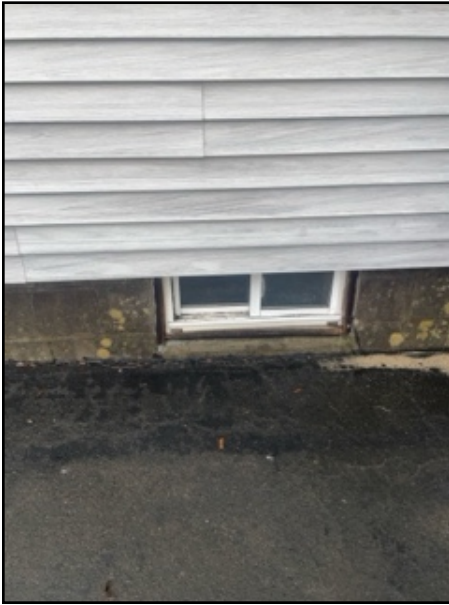
Figure 23-1

Note: Windows or doors that are installed at or near grade require extra diligence to prevent moisture intrusion and or damage to the structure and of the casing etc.

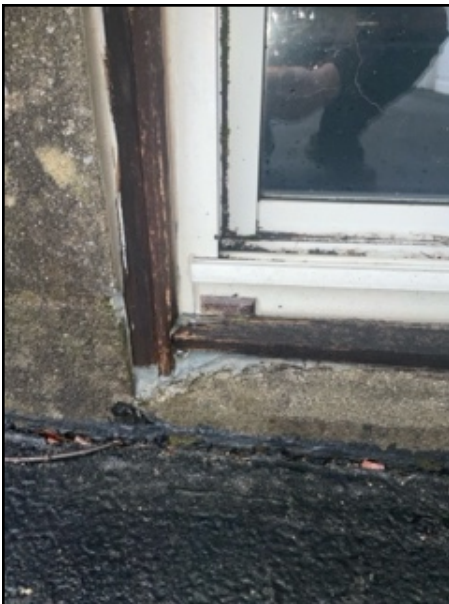
Figure 24-1

NOTE: Door or window casings in contact with the earth or masonry was noted. This condition can prematurely cause deterioration that may allow water or insects to infiltrate the building over time. Recommend treating and sealing on a seasonal basis.

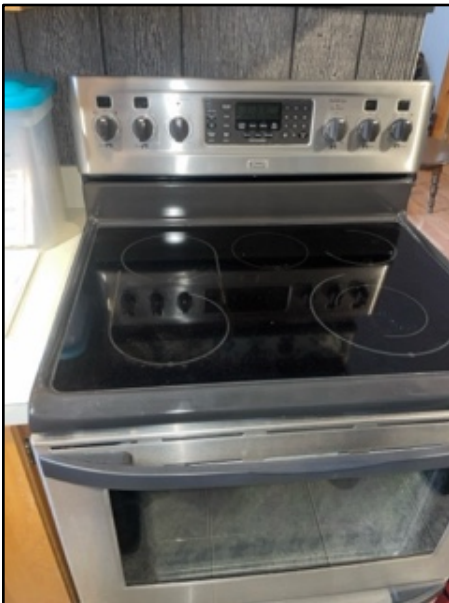
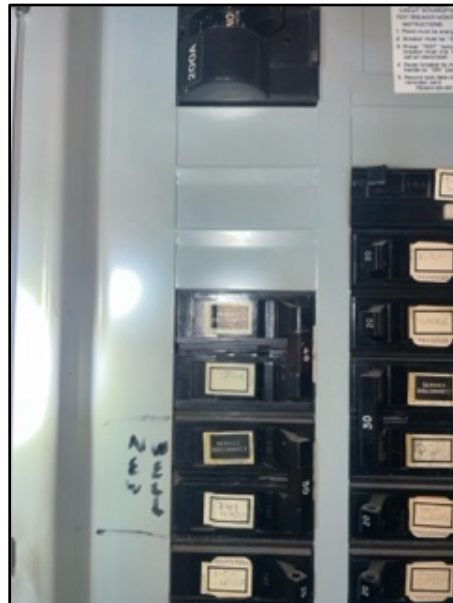
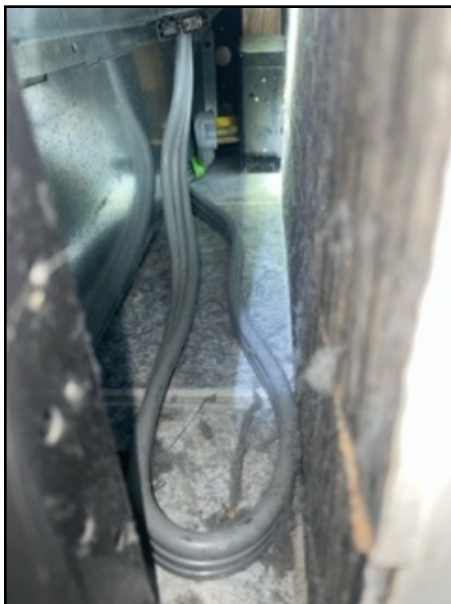
Stove and refrigerator were unplugged.

Recommend confirming function at final walkthrough, prior to final commitment.

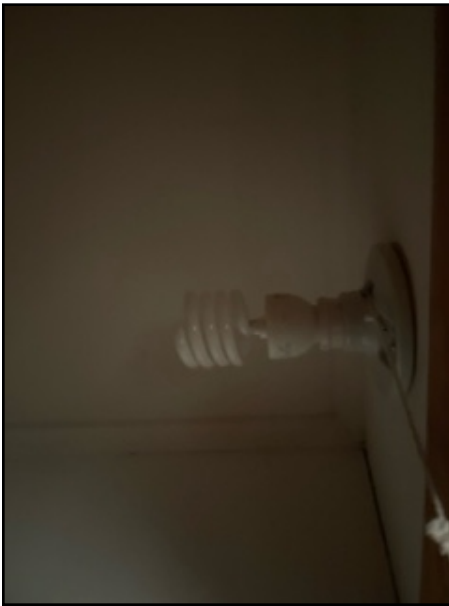
Figure 30-1

ATTENTION REQUIRED: Exposed bulbs were found in closet areas.

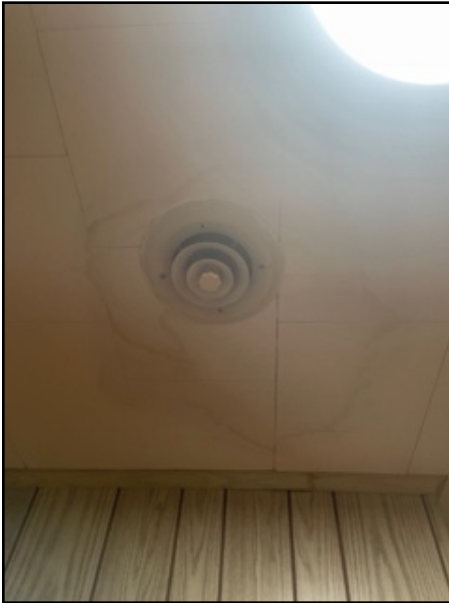
Figure 32-1

Signs of past moisture issues were noted in multiple small areas but appeared to be dry and not active issues.

Recommend regularly monitoring the areas for any changes.

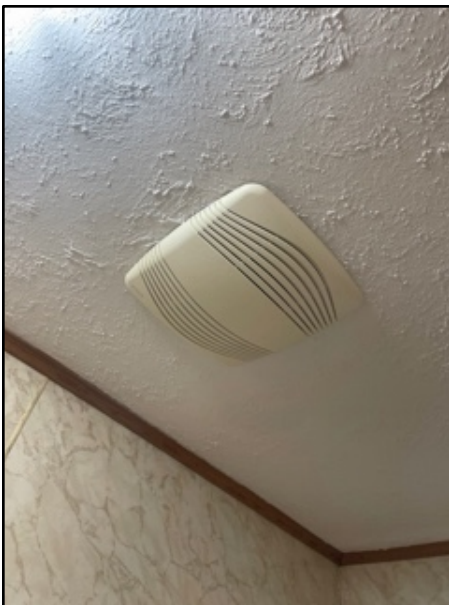
Figure 37-1

Attention required: Bathroom ventilation appeared in need of general maintenance and cleaning. Duct work was damaged.

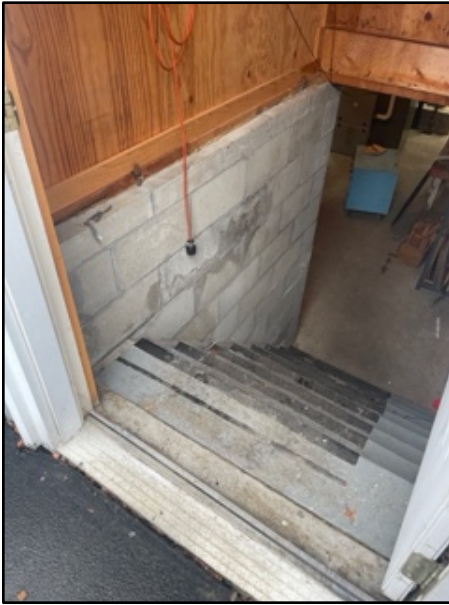
Figure 41-1

ATTENTION REQUIRED: Handrail was missing.

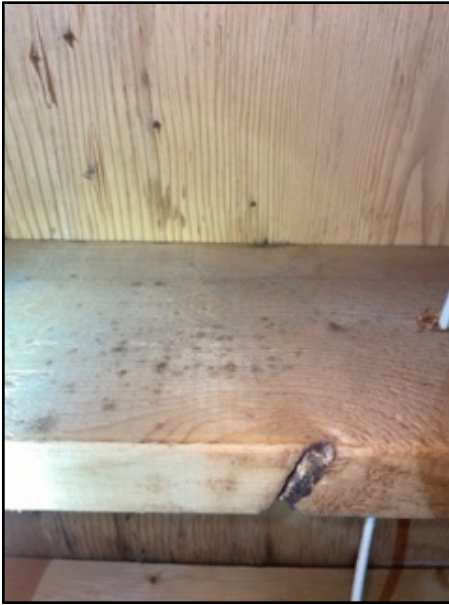
Figure 42-1

MARGINAL: Small areas of a suspicious discoloration was noted on the joist and personal items.

Recommend further evaluation by a qualified contractor for cleaning, disinfecting and monitoring for any changes.

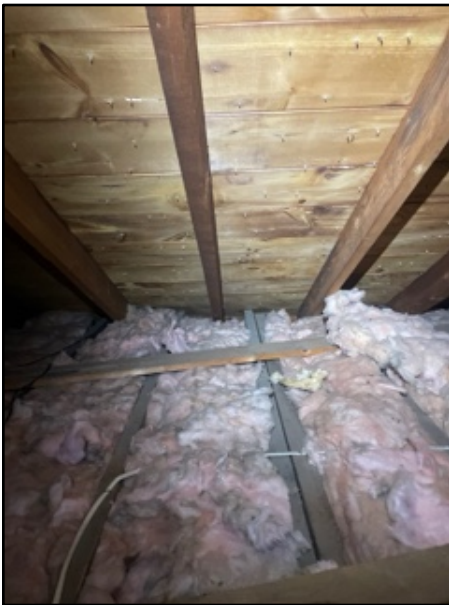
Figure 54-1

Comment 54:  
Note: Areas were found where additional supports or bracketing may be desired. Attic rafters did not all have cross ties or brackets and may be found desirable to install to prevent settling and movement due to the age and design structure.

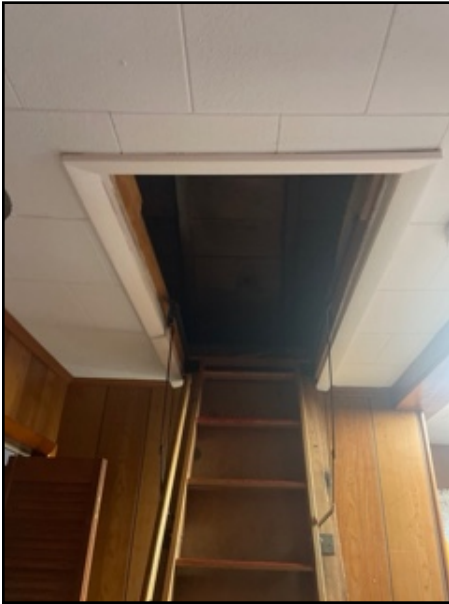
Figure 60-1

Note: Attic hatches are a major source of heat loss out of the home, as well as moisture vapor escaping up into the attic.

Older homes that have not been renovated typically do not have well sealed attic hatches, whereas modern best practice is to use a well sealing insulated hatch.

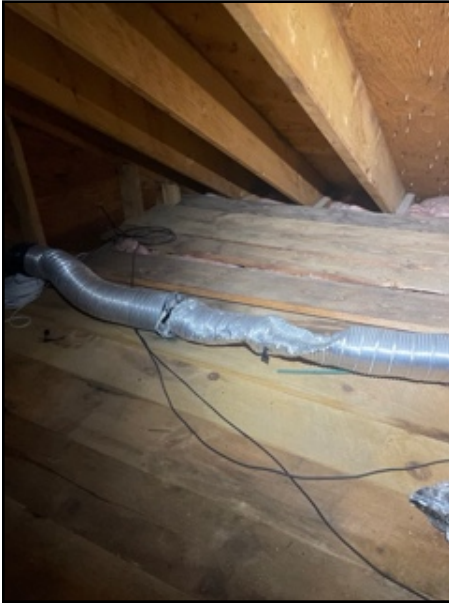
Figure 61-1

ATTENTION REQUIRED: Exhaust fan duct was damaged and venting into the attic.

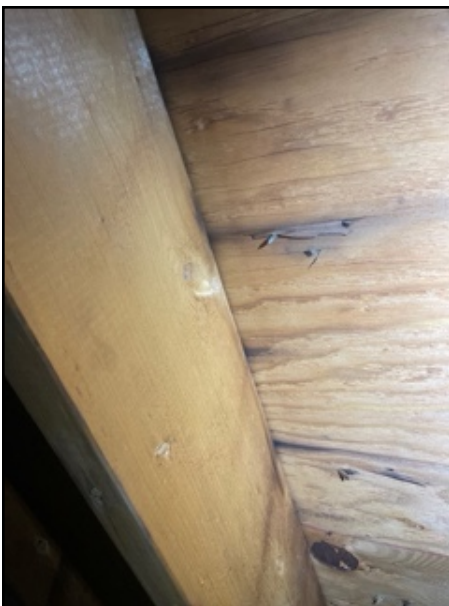
Figure 64-1

ATTENTION REQUIRED: Staining noted around nails .Small areas of possible growth noted. Staining of this type can be an indication of past high temperature or high humidity issues in the attic.

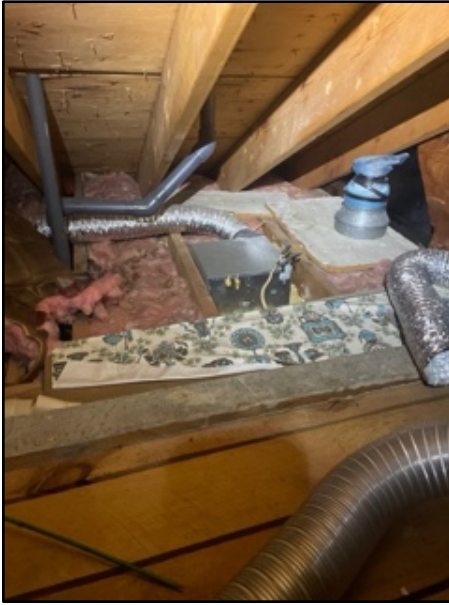
Figure 65-1

ATTENTION REQUIRED: Insulation was missing or had been moved. Repair or replace as needed.

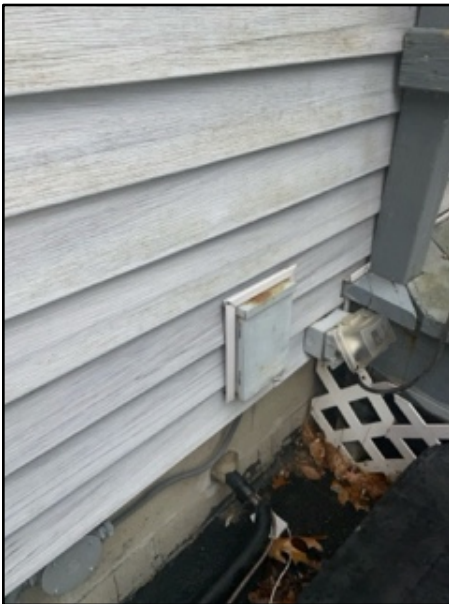
Figure 73-1

NOTE: The disconnect was easily accessible to anyone, including children. Recommend it be properly latched to prevent injury.

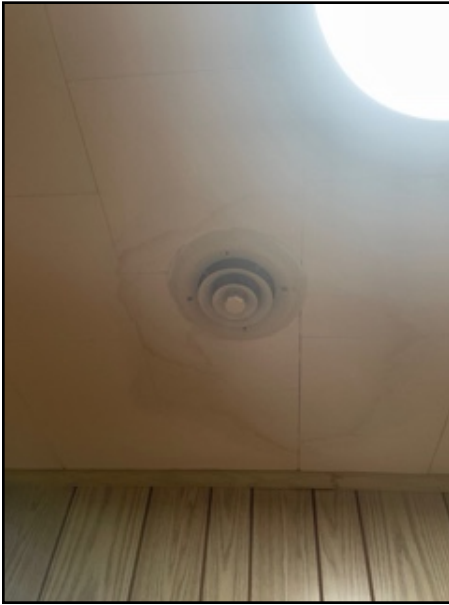
Figure 75-1

**ATTENTION REQUIRED:** Evidence of possible conversation issues noted at the ductwork.

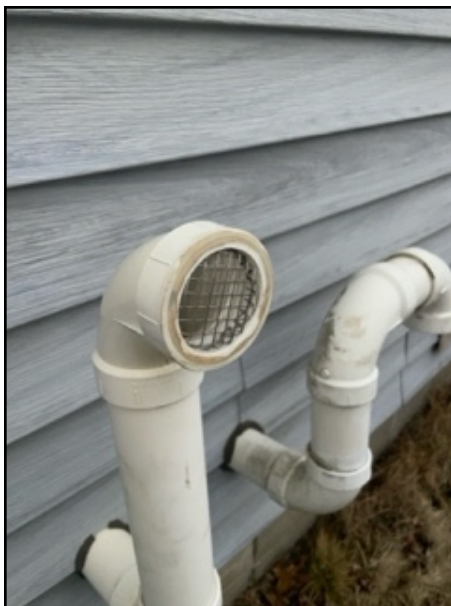
Figure 78-1

ATTENTION REQUIRED: A screen was noted on the exhaust side of the high-efficiency furnace. The screens can trap condensation and freeze in winter months, blocking off the exhaust to the furnace and trapping moisture.

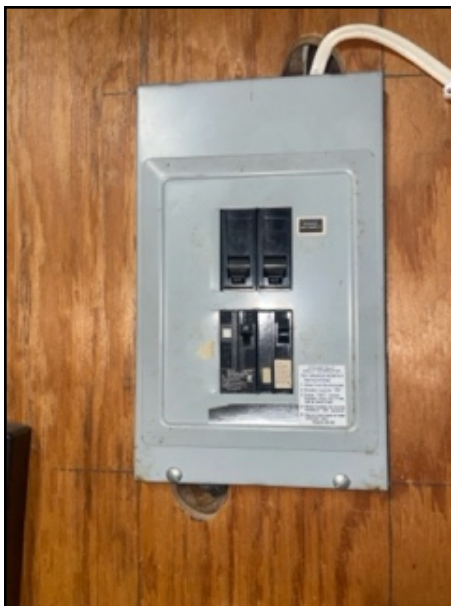
Figure 82-1

ATTENTION REQUIRED: A 20amp subpanel was noted in the garage. The wiring appeared unconventional. Recommend further evaluation by a qualified electrician.

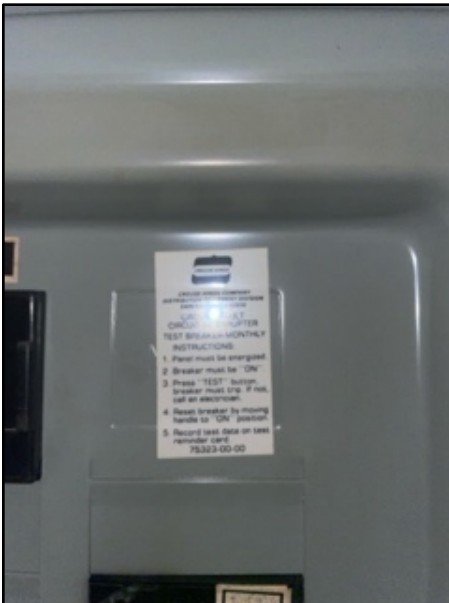
Figure 83-1

MARGINAL- The electrical panel appears to be an older Crouse-Hinds model, likely installed several decades ago. While no immediate defects may be visible, the panel and breakers are considered obsolete and may not meet current performance expectations. Replacement parts are limited. Recommend evaluation and budgeting for future upgrade by a qualified electrician.

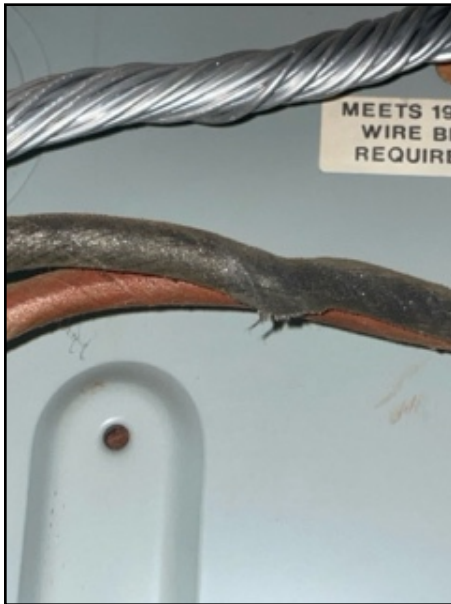
Figure 88-1

**ATTENTION REQUIRED:** The wire for the kitchen stove appeared damaged in the panel.

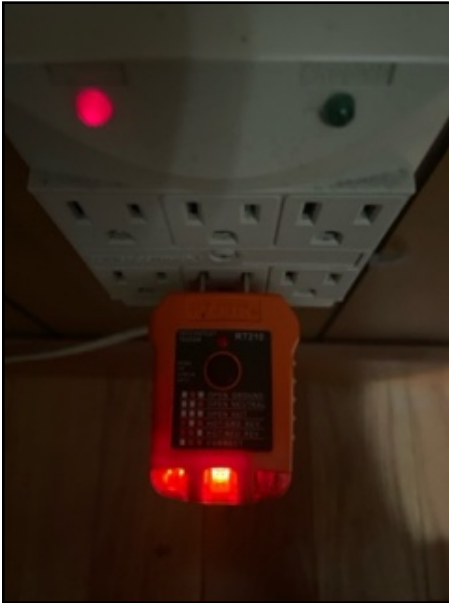
Figure 90-1

ATTENTION REQUIRED: Multiple outlets tested as being wired incorrectly or having other faults.

Recommend further evaluation by a qualified electrician for the cost of repairs.

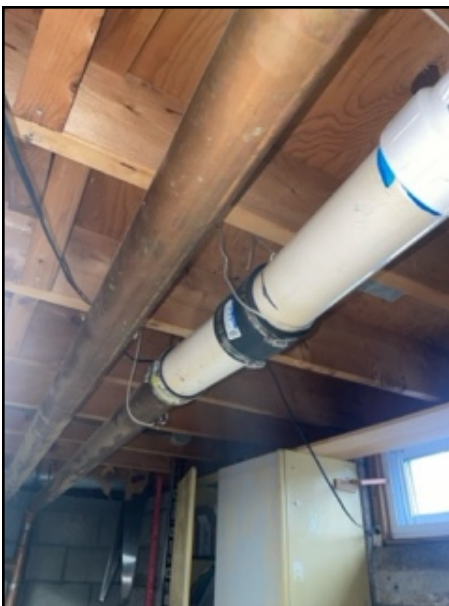
Figure 103-1

Unconventional waste lines were found that may prove problematic at times.

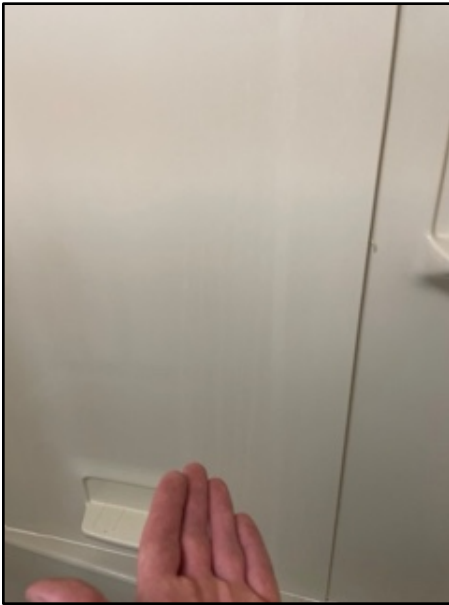
Figure 104-1

The water temperature was turned down to just warm.

Recommend having the temperature turned up and confirming there's hot water at the final walk-through prior to final commitment.

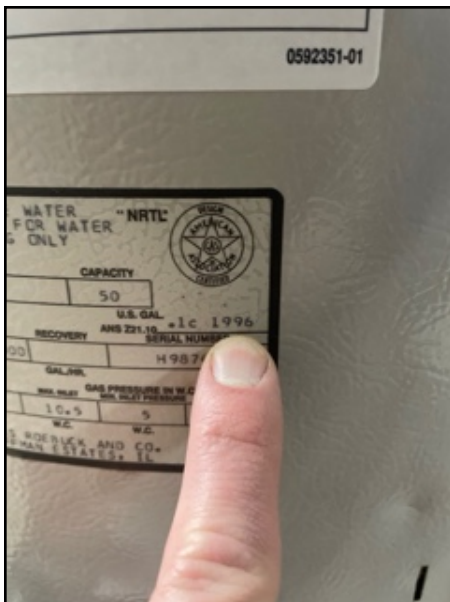
Figure 106-1

Unit appeared older. Average lifespan of water heaters is approximately 10 years. Unit may require replacement at any time. Recommend budgeting for replacement in the near future.

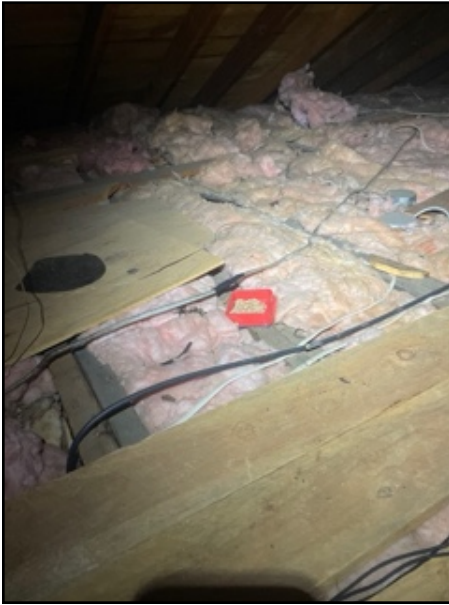
Figure 121-1

Note: Evidence of possible vermin or other pest were found on the premises. The identification and assessment of species was outside the scope of this inspection as this inspection focuses on wood destroying insect only, but we strongly recommend a follow up inspection by a nuisance control expert as many are not only destructive to the property but may transmit diseases.

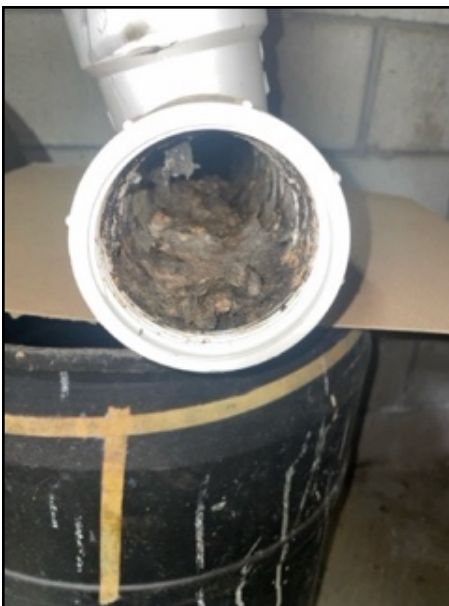
Figure 132-1

**Comment 132:**  
Debris found in clean out hub .

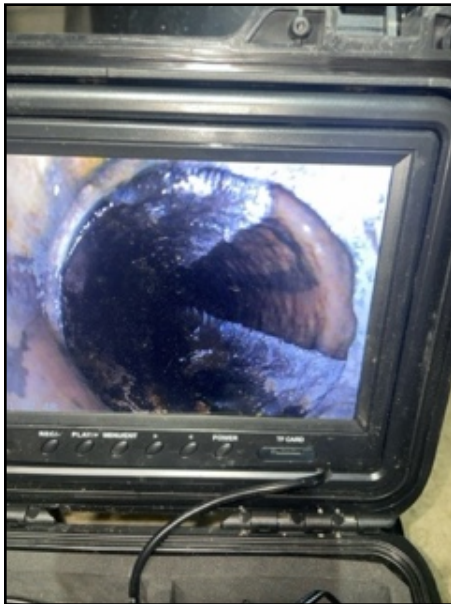
Figure 134-1

4) MAJOR CONCERN: A possible popped seam was noted just passed the foundation wall.

Also evidence of past and active backing up or high waste levels were noted in the outlet pipe, as well as debris.

Evidence noted typically indicates a failure of the pipe or of the absorption area.

Recommend a full reinspect once the tank has been pumped and the waste line is cleaned out.

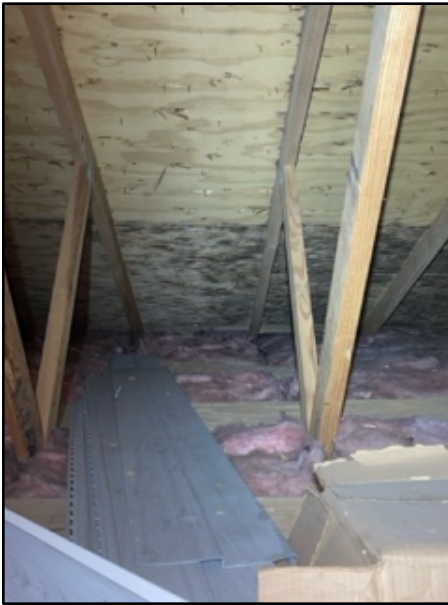
Figure 149-1

Large garage- POSSIBLE MAJOR CONCERN: A suspicious discoloration or stain was noted. Discoloration may indicate a larger issue adversely affecting the building materials and the structure. Recommend a qualified specialist ( Who is accountable to you) be contacted to evaluate the area and recommend corrective course. Additional areas of the house may require assessment at the discretion of the specialist.
