INSPECTION REPORT

RIDGEFIELD, CT 06877

Inspection Date: Saturday, November 18, 2023

RE: Report No. 1183, v.0
Ridgefield, CT 06877

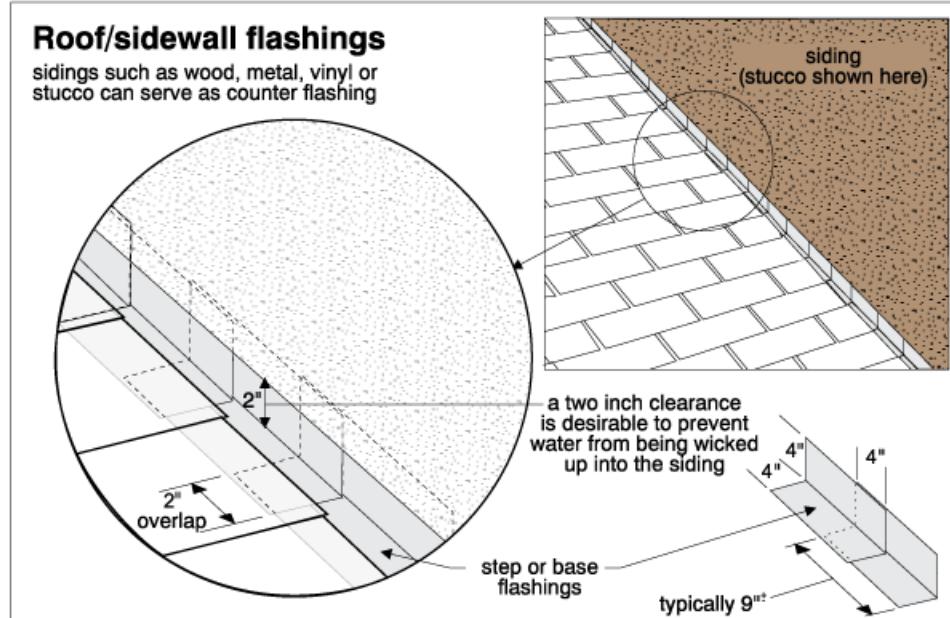
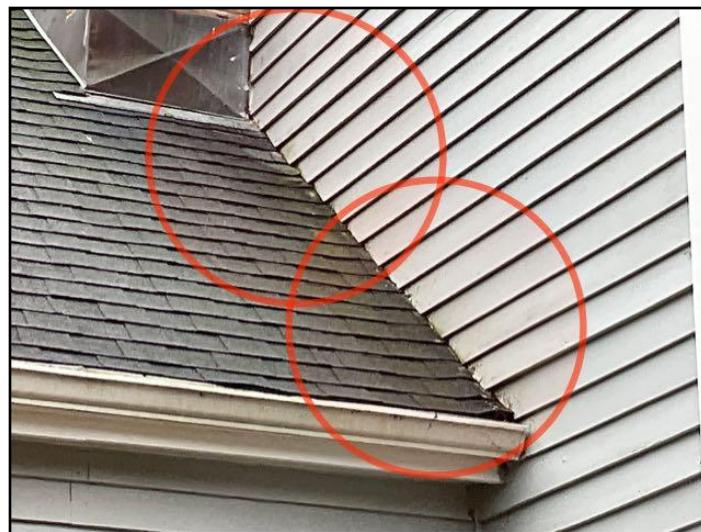
3. Siding not cut back

2. Condition: • Siding not cut back

The siding was too close to the roof at the north side. This allows water from the roof to wick up into the wood and cause premature aging. Recommend evaluation and repair by a qualified siding or painting contractor.

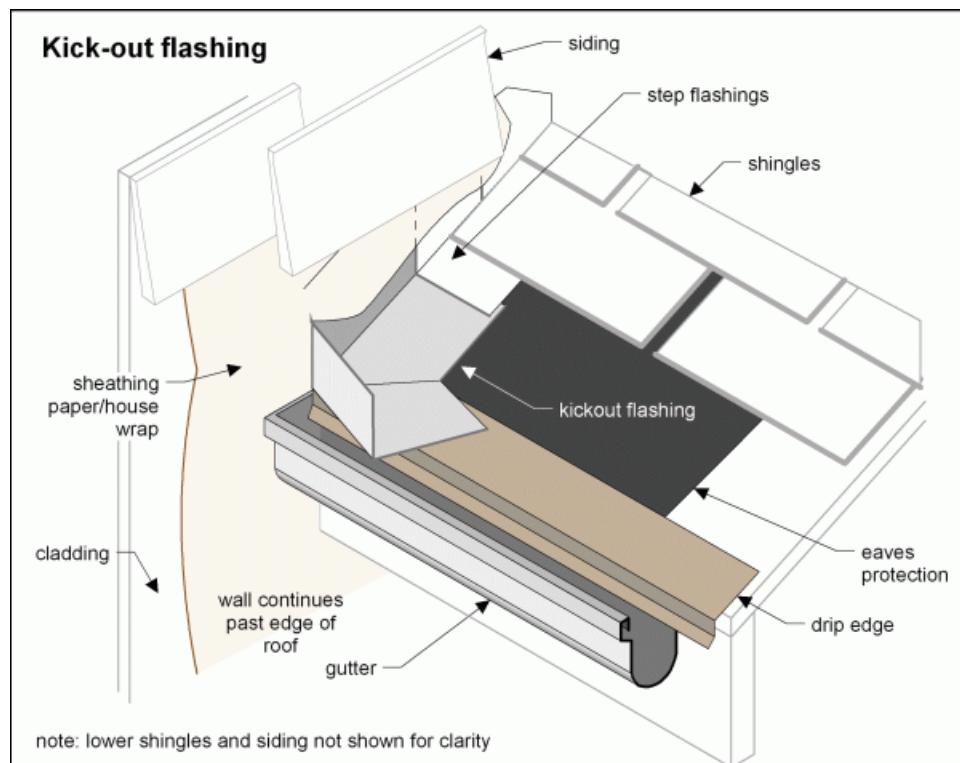
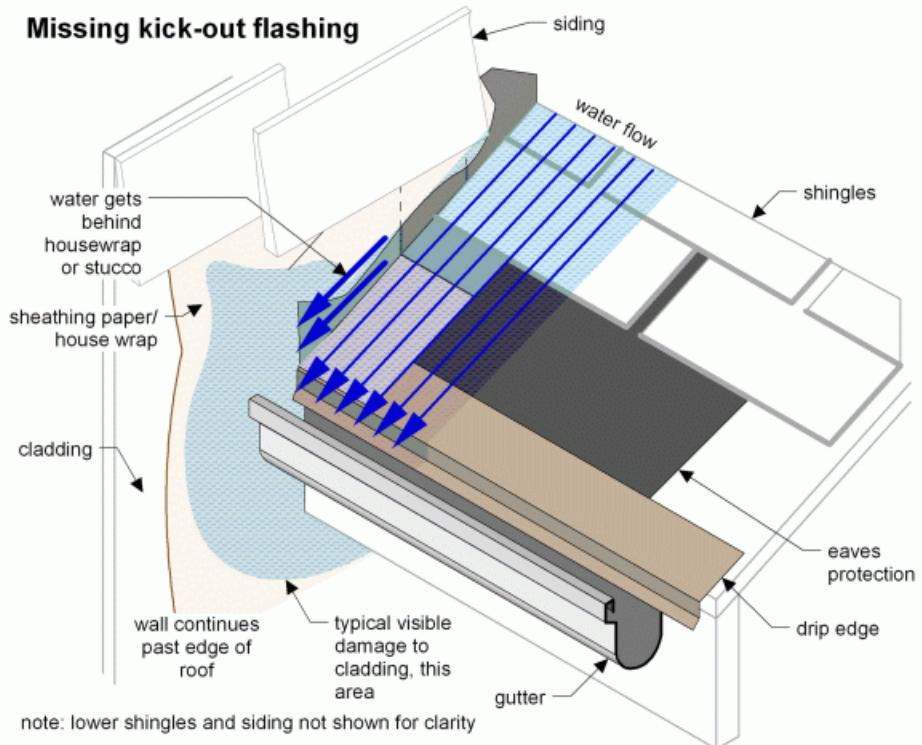
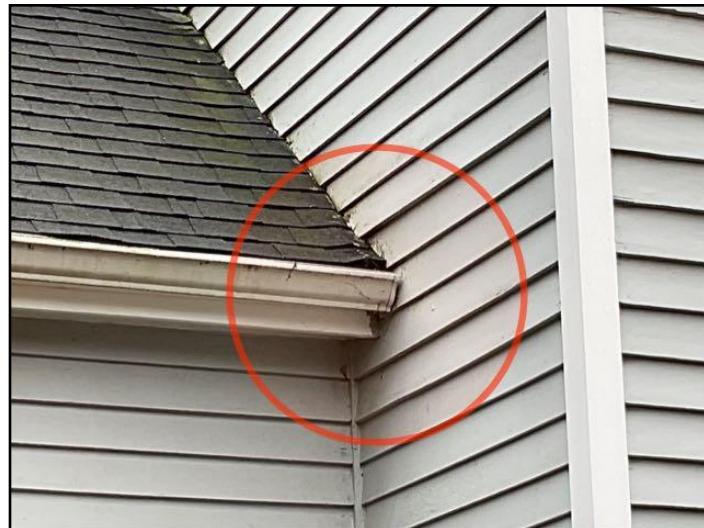
4. Kickout flashing - missing

There's no kick out flashing at the northeast roof. As a result, water can run down the wall causing damage. Recommend the addition of kick out flashing by a qualified roofing contractor.

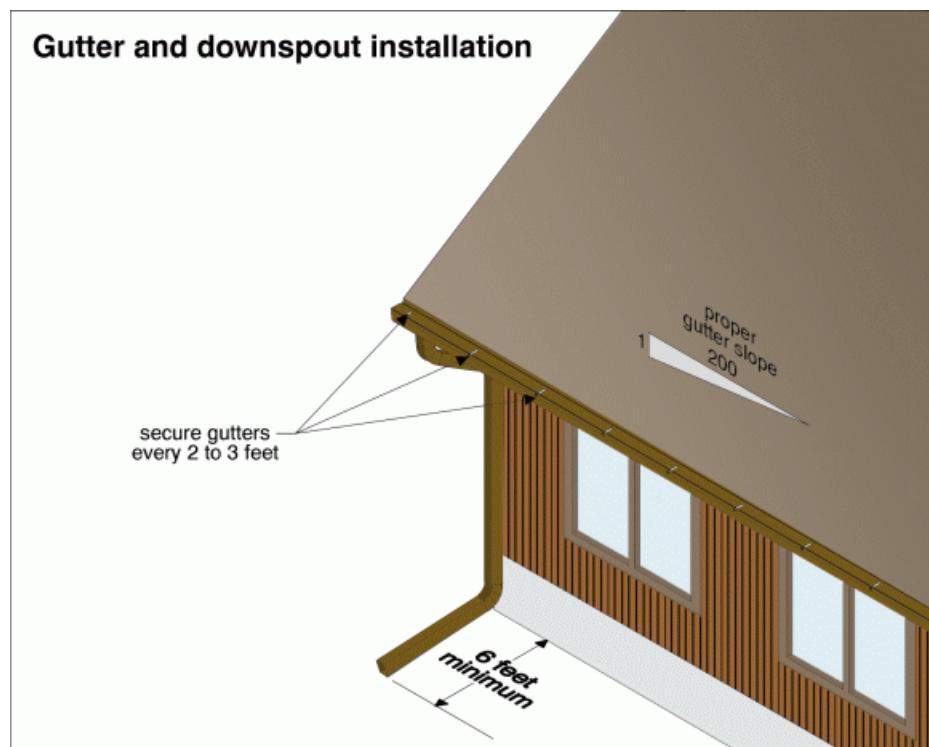
Downspout extension too short

The downspout at the southwest corner needs to have an extender to channel the water away from the foundation. In addition the downspout at the northeast corner discharges right to the bottom of the deck stairs which can deteriorate the wood at the stairs. Recommend extending both downspouts away from the home. This can be done by a qualified gutter specialist.

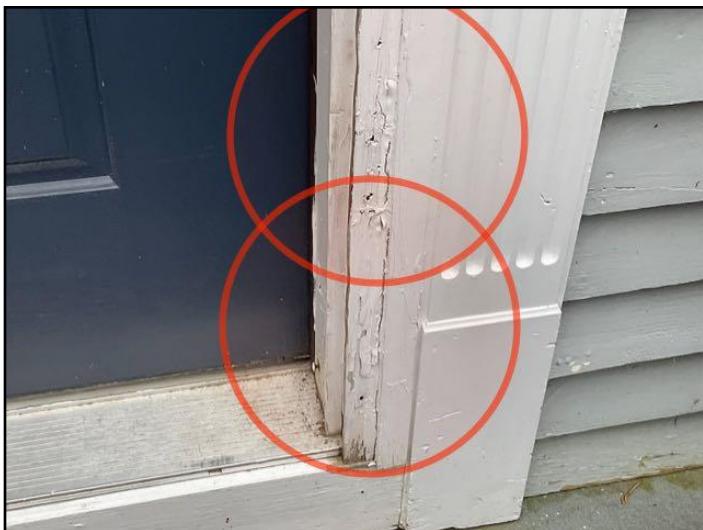
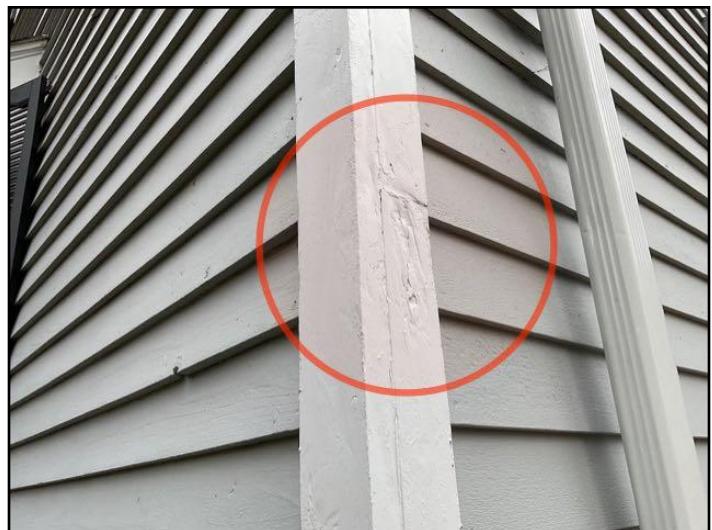
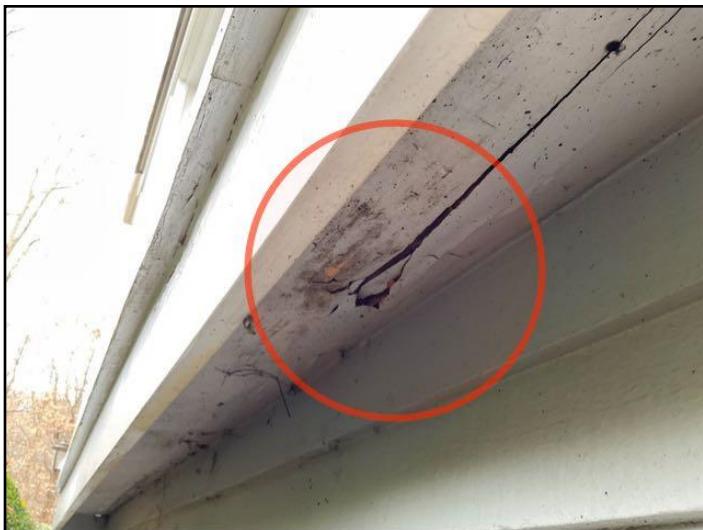
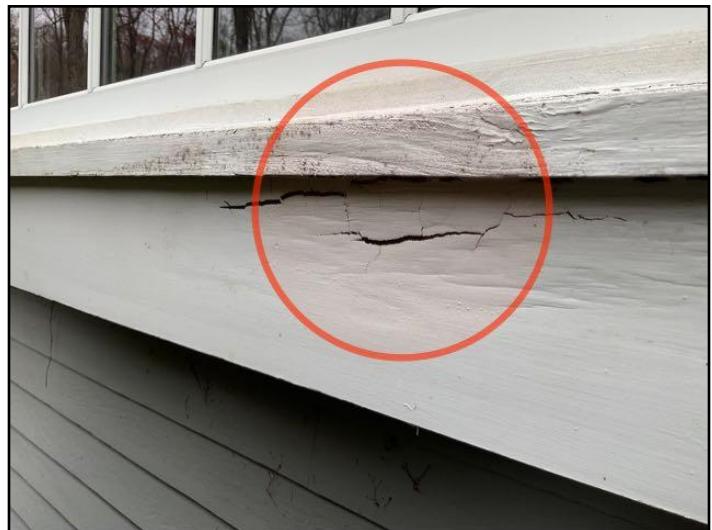
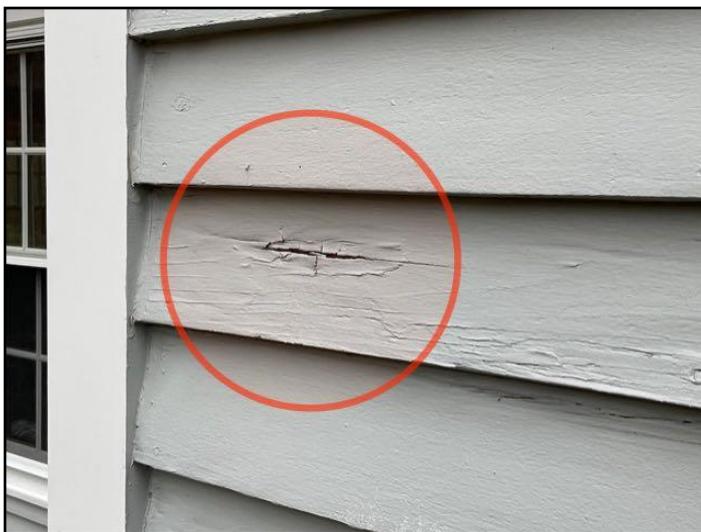
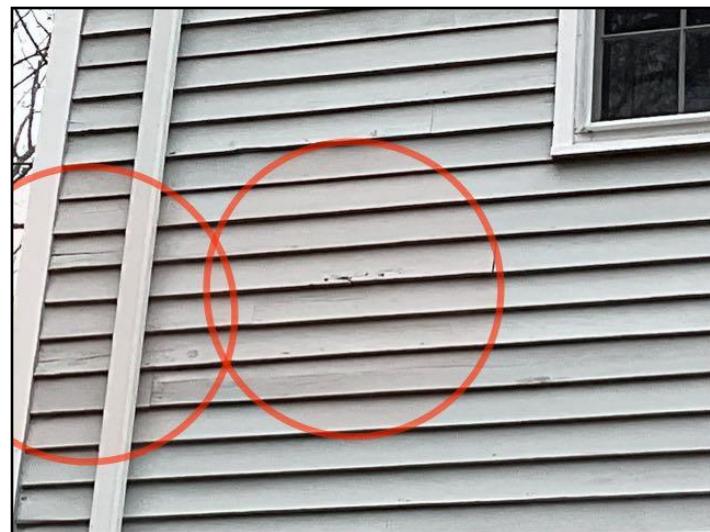
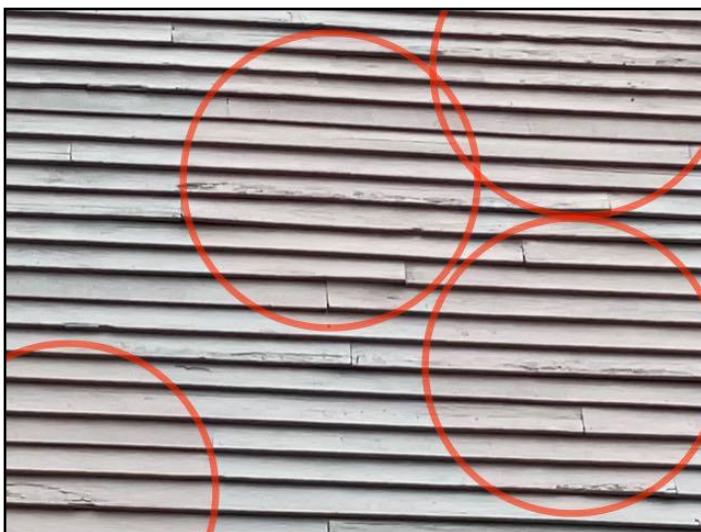
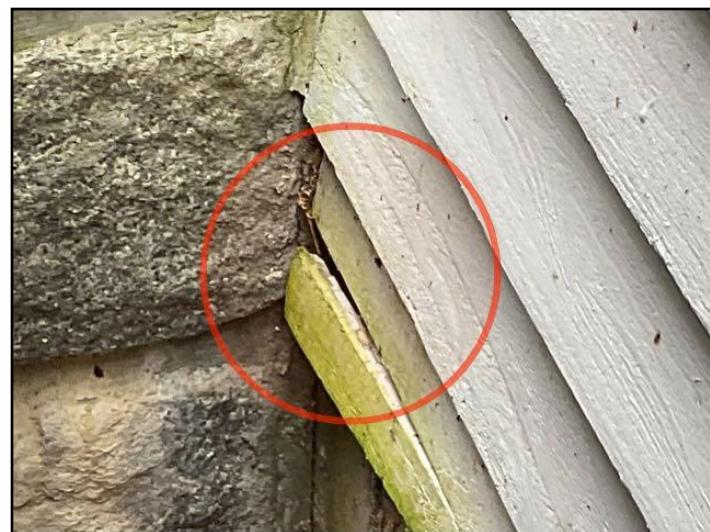
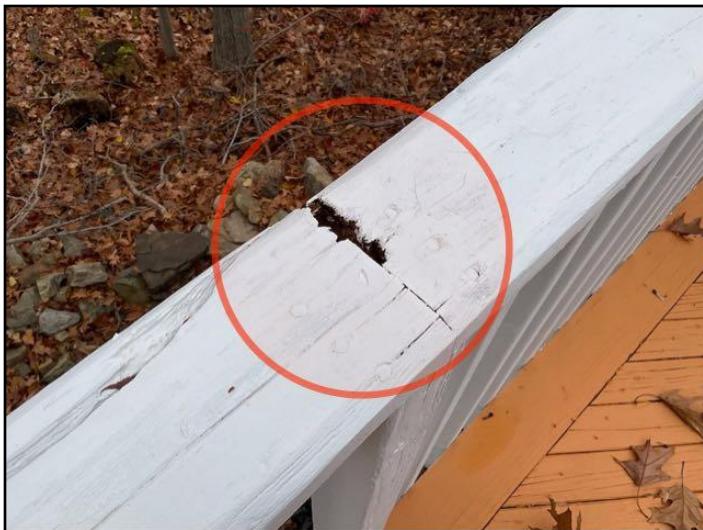
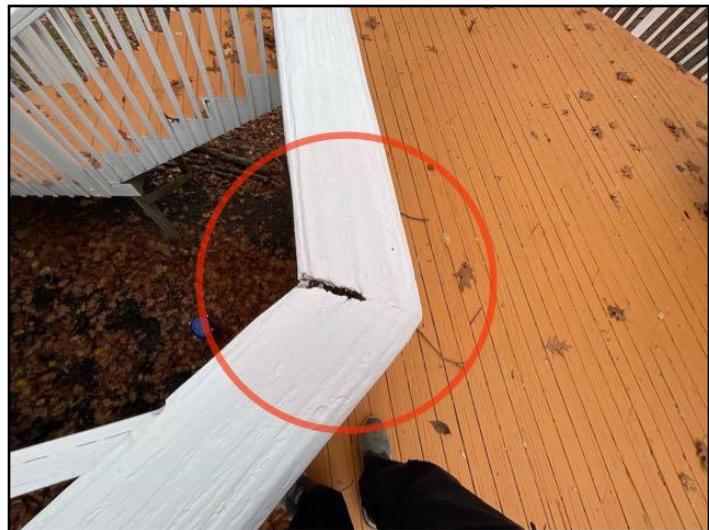
6. Condition: • Rot

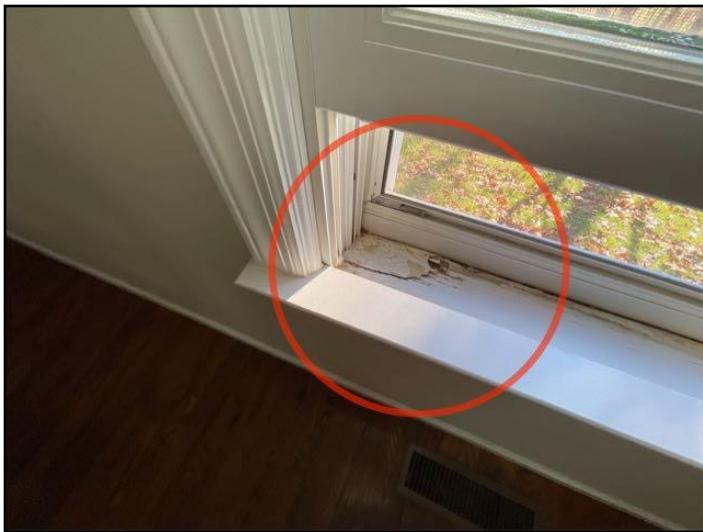
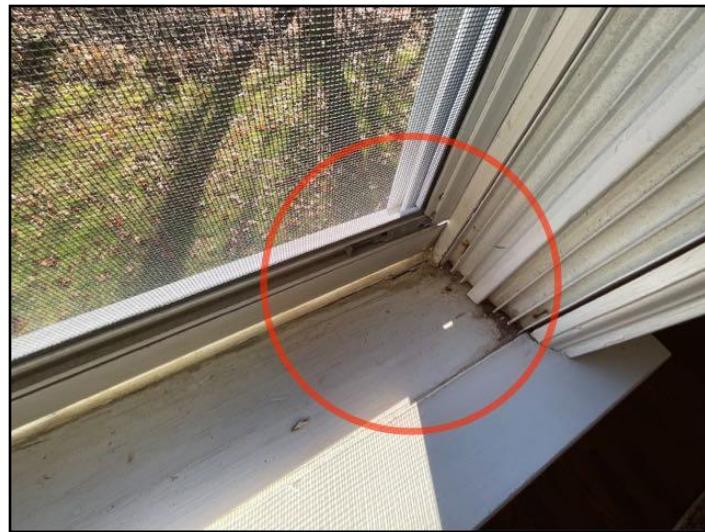
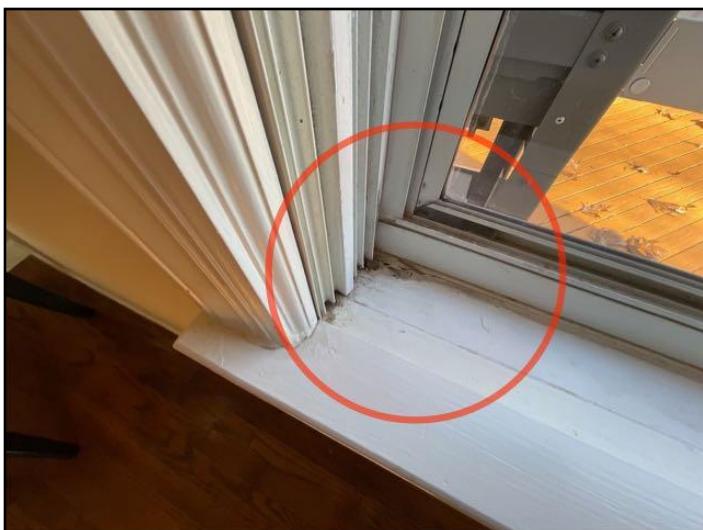
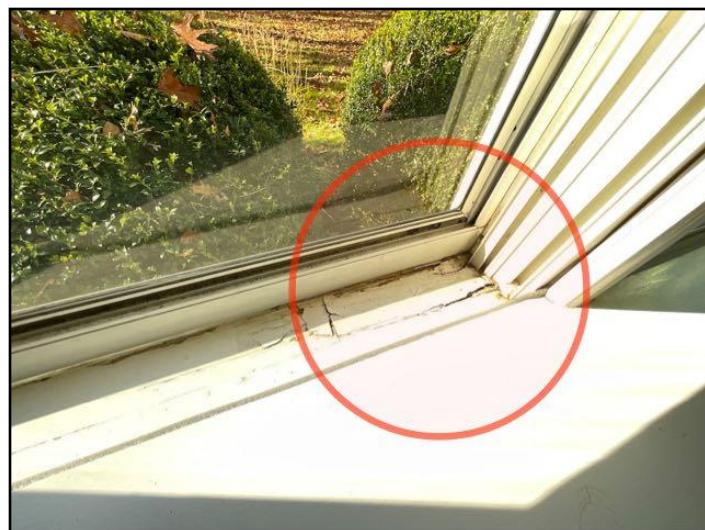
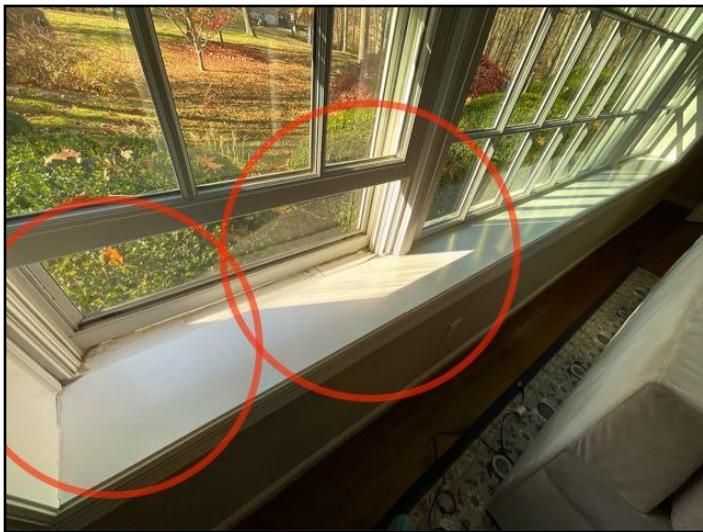
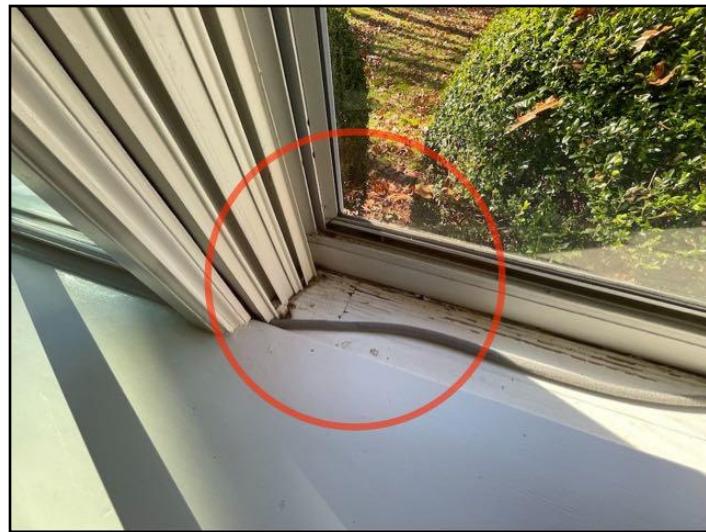
9. Condition: • Rot

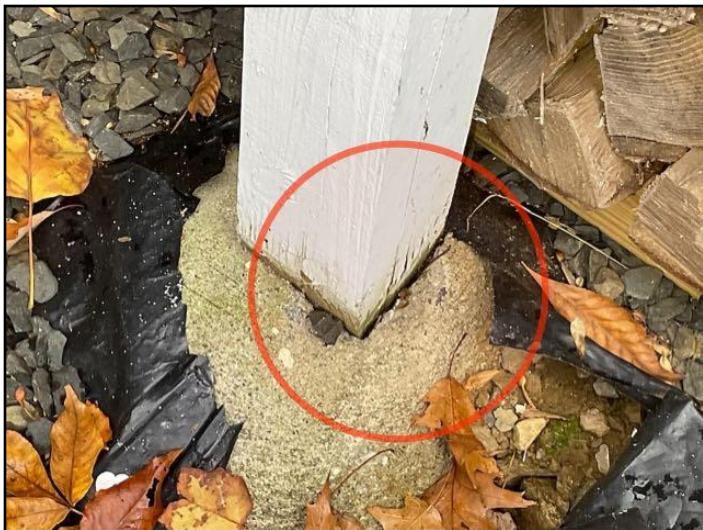
31.

11. Condition: • The deck support posts that were set in concrete had a gap between the concrete and the wood which could allow for water intrusion and subsequent rot. Recommend caulking the gaps to prevent water intrusion. This can be done by a qualified handyman.

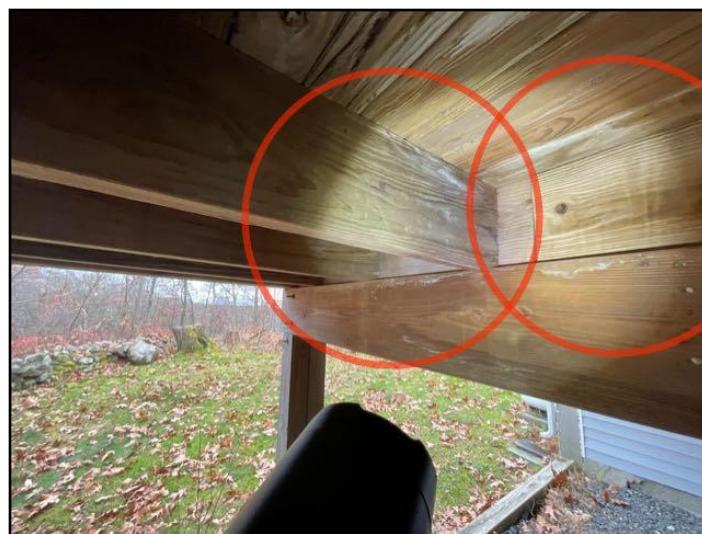
34. End bearing inadequate

The joists under the hot tub are only held up by half of the beam. This weakens the structure - especially under the hot tub which is very heavy once the water and people are added. Recommend making sure that all the deck and hot tub work was permitted properly with the town. If no proof can be provided, then I would recommend evaluation by structural engineer.

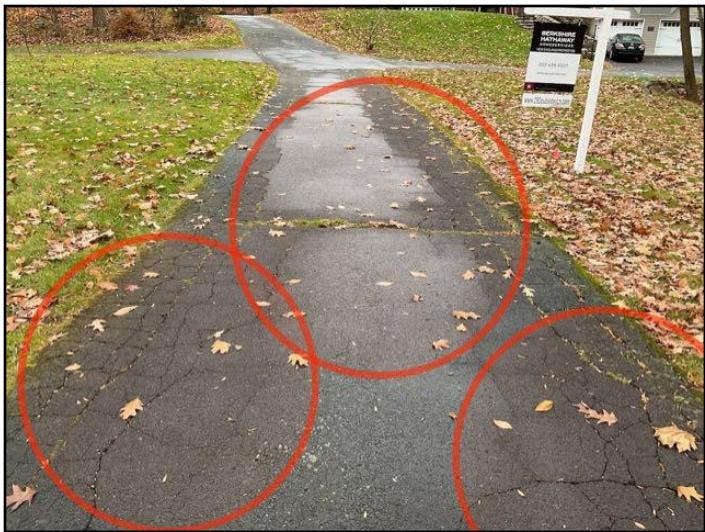
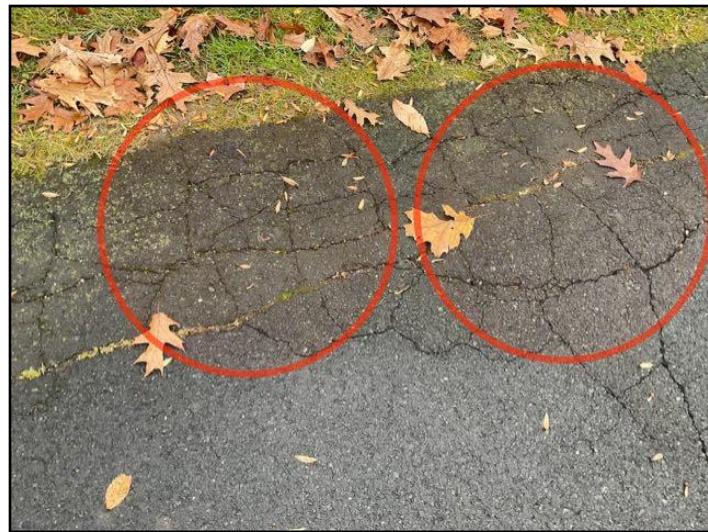
40. Cracked or damaged surfaces. Recommend...

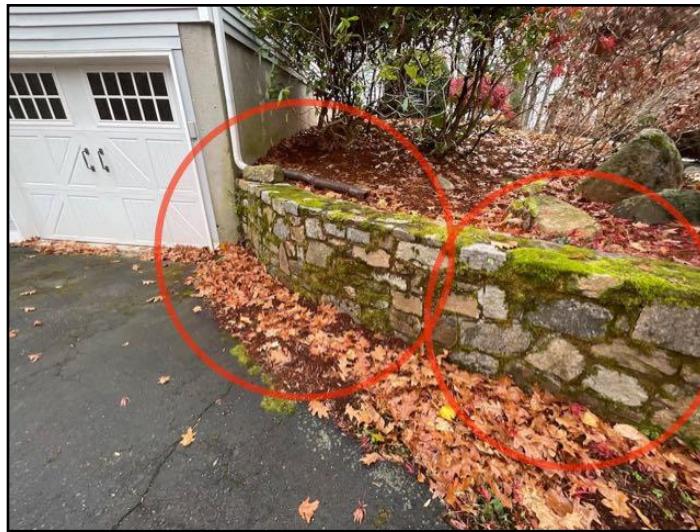
20. Condition: • There was a large amount of moss growing at the retaining wall. Moss can contribute to deterioration of the mortar between the stones. Recommend a soft-wash with algicide to kill any organic growth.

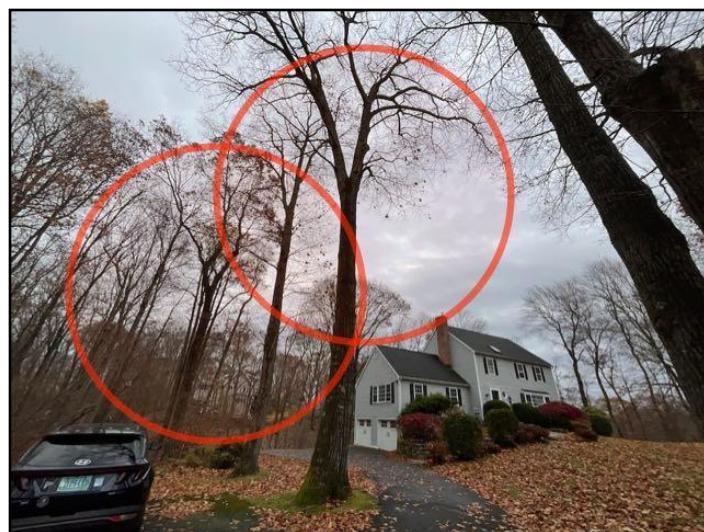
22. Condition: • Noted large trees on the property which can potentially come down in a storm causing damage to structures. Recommend consultation with a qualified arborist to discuss health of the trees and pruning if necessary.

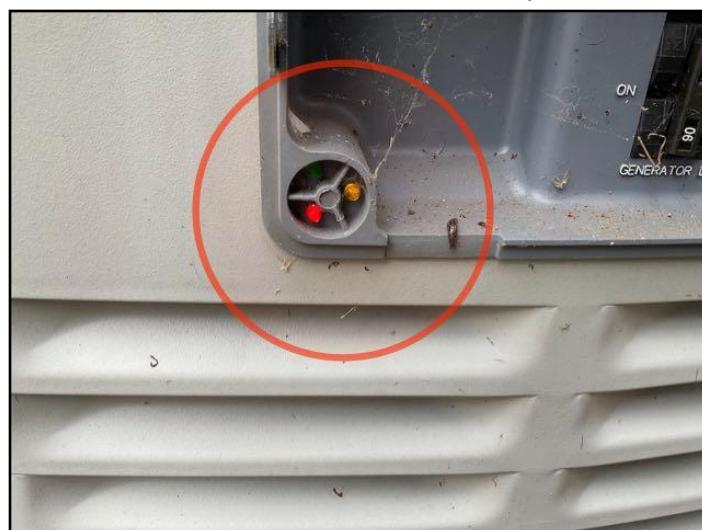
- Generator. Observed, but not inspected.
- There was a red/yellow indicator at the generator indicating that it might not be working or needs to be serviced. Recommend discussing operations with the current homeowner or service provider to learn more.

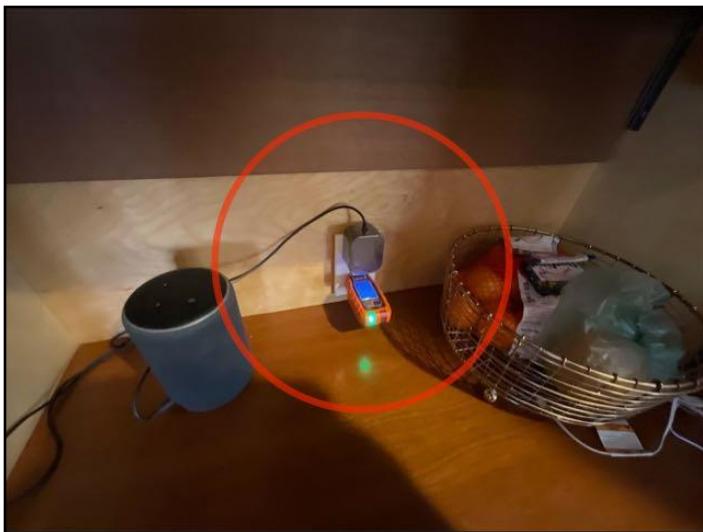
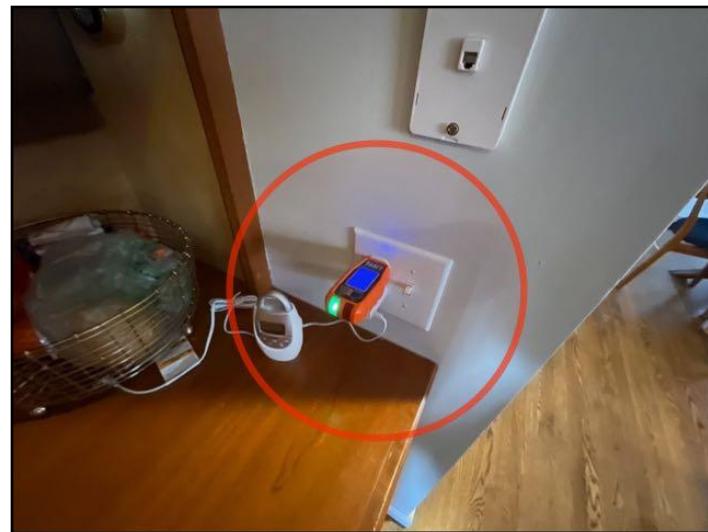
27. Condition: • Recommend GFCI protected outlets for all kitchen counter outlets including the island if there is one.

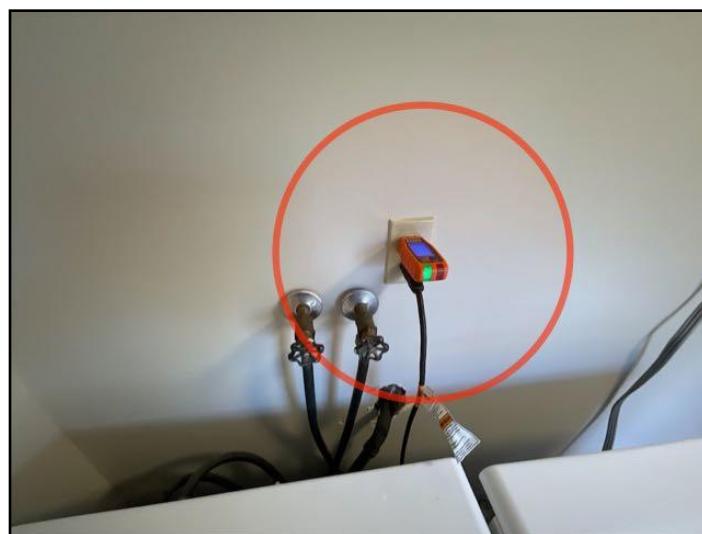
29. Condition: • Recommend GFCI-protected outlets for all receptacles in the laundry rooms, garages and basements

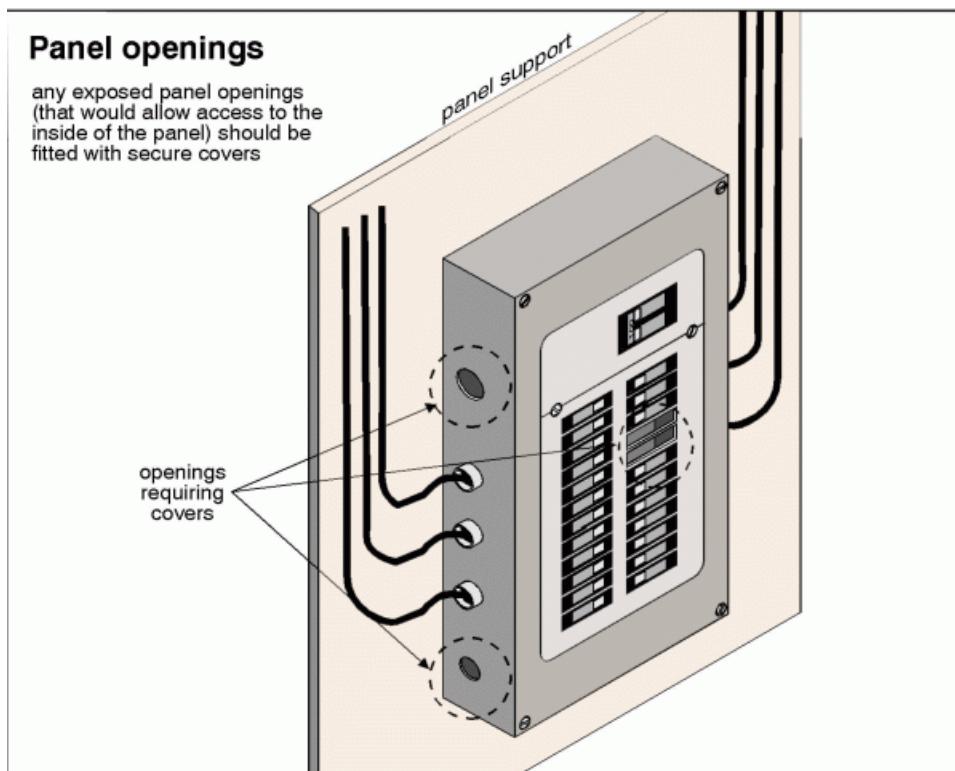
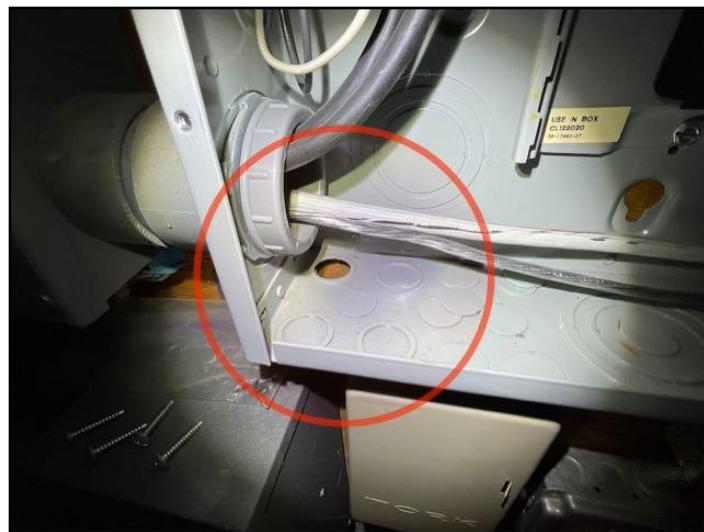
51. Openings in panel

There was a knockout missing in the distribution subpanel. This can attract pests which can cause damage and a potential electric fire. Recommend evaluation and repair by a licensed electrician.

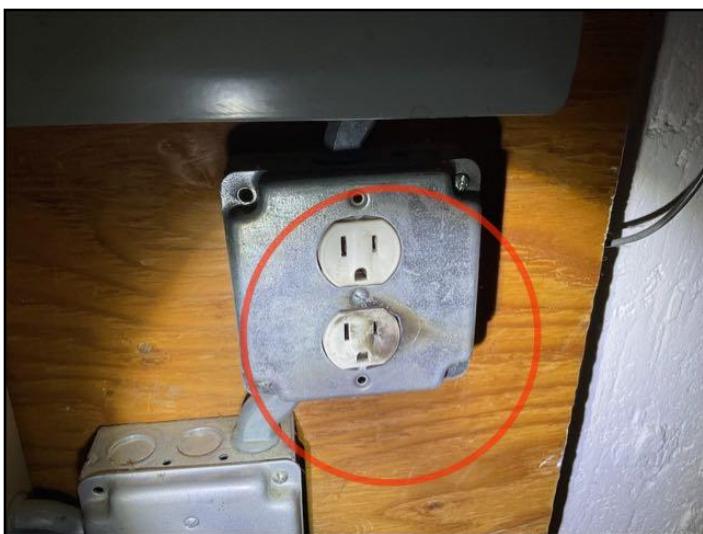
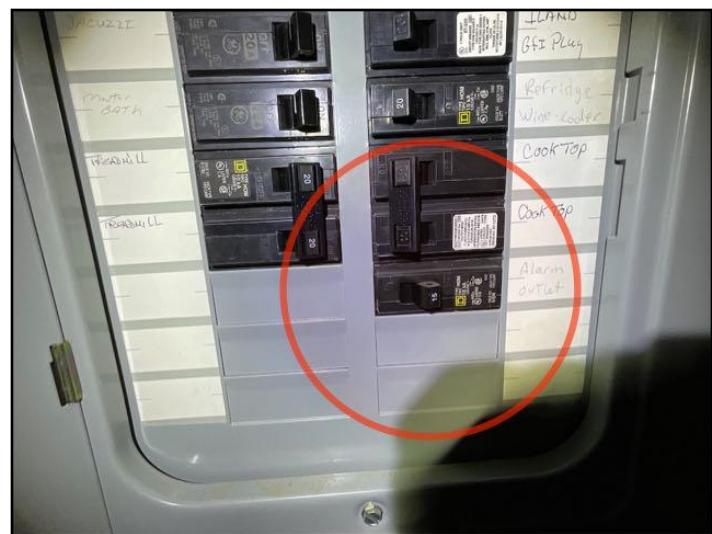
There was a melted/burned electric receptacle next to the breaker panels at the bottom of the basement stairs. The breaker to this receptacle was turned off. Recommend evaluation and repair by a licensed electrician prior to re-engaging the breaker.

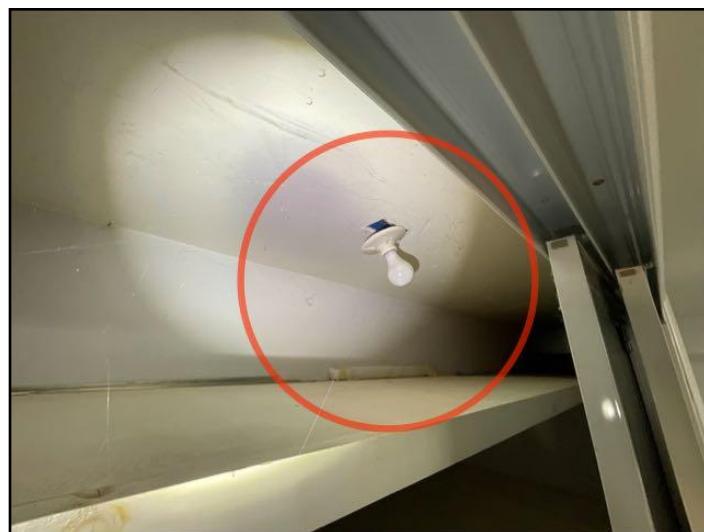
33. Condition: • There was the use of "bare-bulb" light fixtures in the home. These bare-bulb fixtures are subject to be knocked and broken easily. In addition, when found in closets they can be a potential fire hazard if they come in contact with items on shelves. Recommend replacing bare-bulb fixtures with covered bulb fixtures by a licensed electrician.

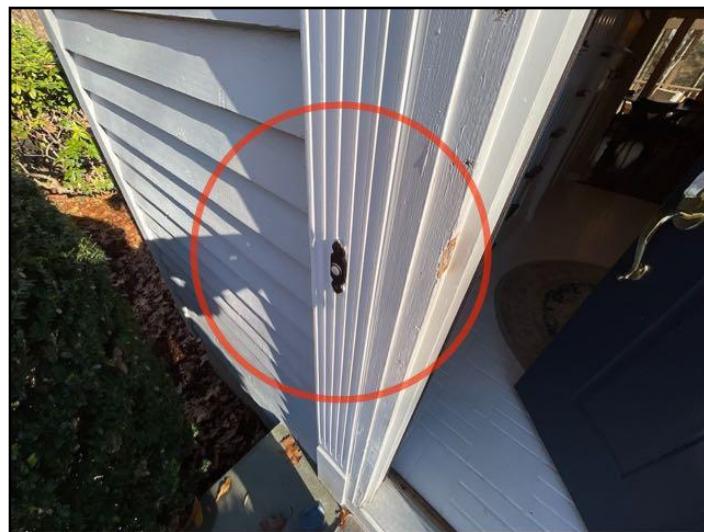
56.

34. Condition: • The doorbell did not respond to the button being pushed outside. Recommend evaluation and repair by a qualified handyman or electrician.

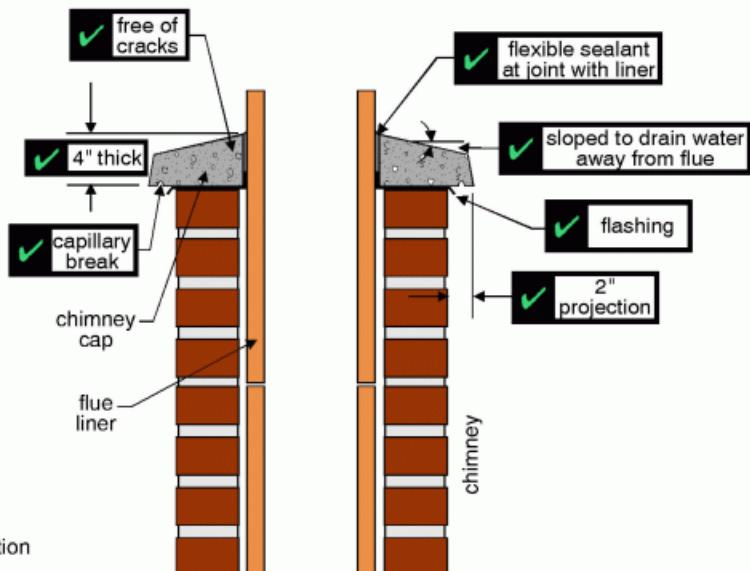
Condition: • Cracked - The crown at the top of the masonry chimney had cracks in it. This can result in water intrusion to the bricks, which freezes and thaws, eventually breaking the bricks. Recommend evaluation and repair by a qualified chimney mason.

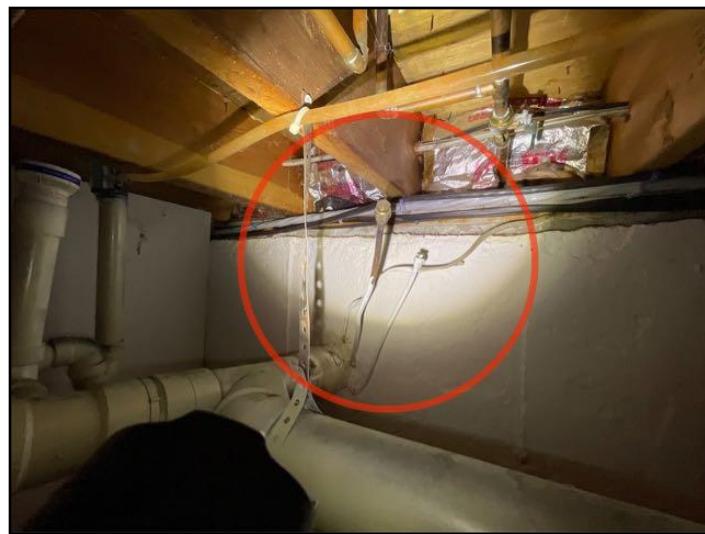
45. Condition: • Copper oil lines were observed coming through the foundation into the home. This generally indicates that there is, or used to be an in-ground oil tank. Recommend evaluation and tank removal if necessary by a tank specialist. If the tank has already been removed, I recommend the requirement of proof by the current owner that the tank has been legally removed.

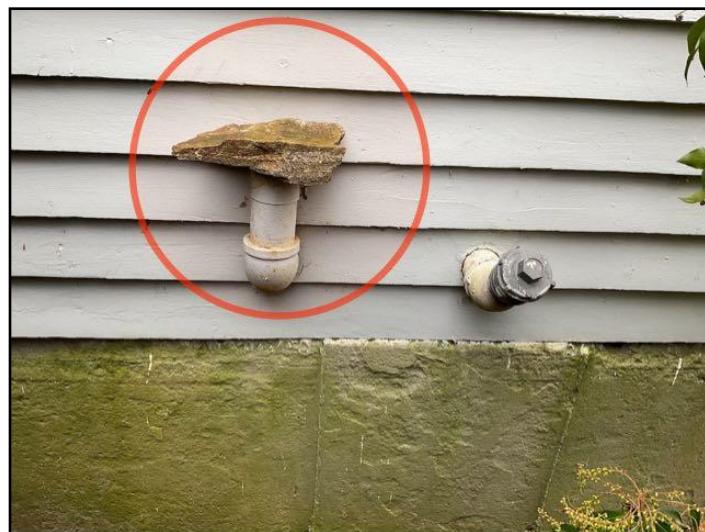
66.

46. Condition: • The oil tank vent cap was missing and covered by a stone. This can lead to water intrusion into the tank. Recommend evaluation and repair by your heating oil company.

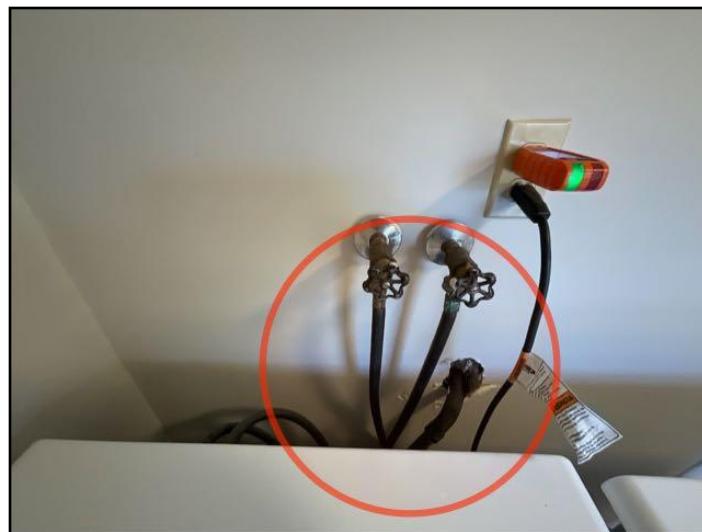
61. Condition: • The rubber hoses to the washing machine, while serving their intended purpose, have the potential to burst. Recommend replacing rubber hoses with metal-clad hoses. This can be done by a qualified handyman.

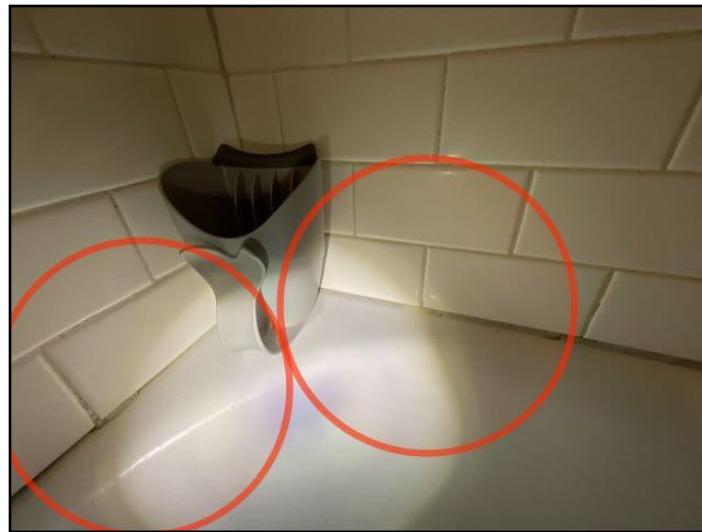
62. Condition: • The caulk between the bathtub/shower and the tile wall is starting to deteriorate. Recommend re-caulking to prevent water from getting into the walls behind which can lead to water damage or mold. This can be done by a qualified handyman.

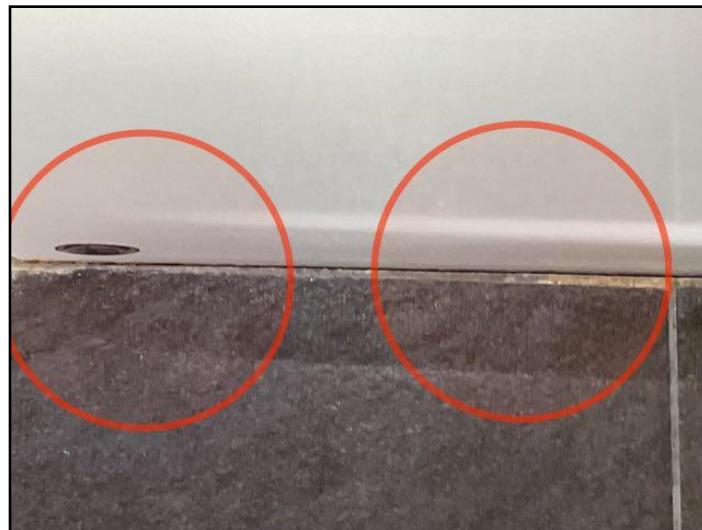
63. Condition: • The gap between the bathtub/shower and the floor is not sealed properly and can lead to water intrusion and possible mold. Recommend evaluation and repair by a qualified handyman.

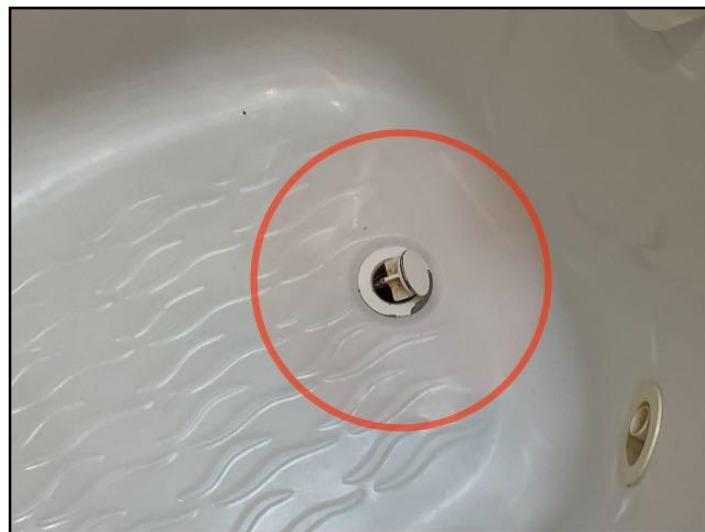
64. Condition: • The drain stopper in the jet tub did not work and thus the jet tub could not be filled and tested. Recommend evaluation and repair by a licensed plumber.

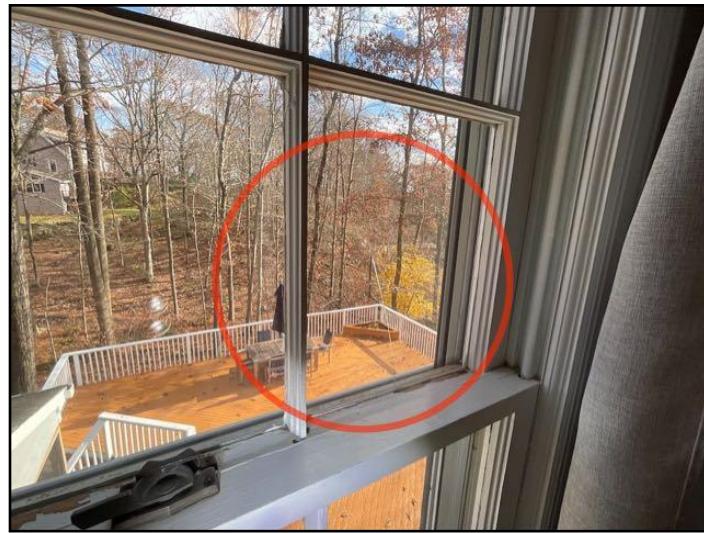
87. Cracked Pane

There was a cracked pane in one of the windows at the second-floor middle bedroom. Recommend evaluation and repair by a qualified glazier.

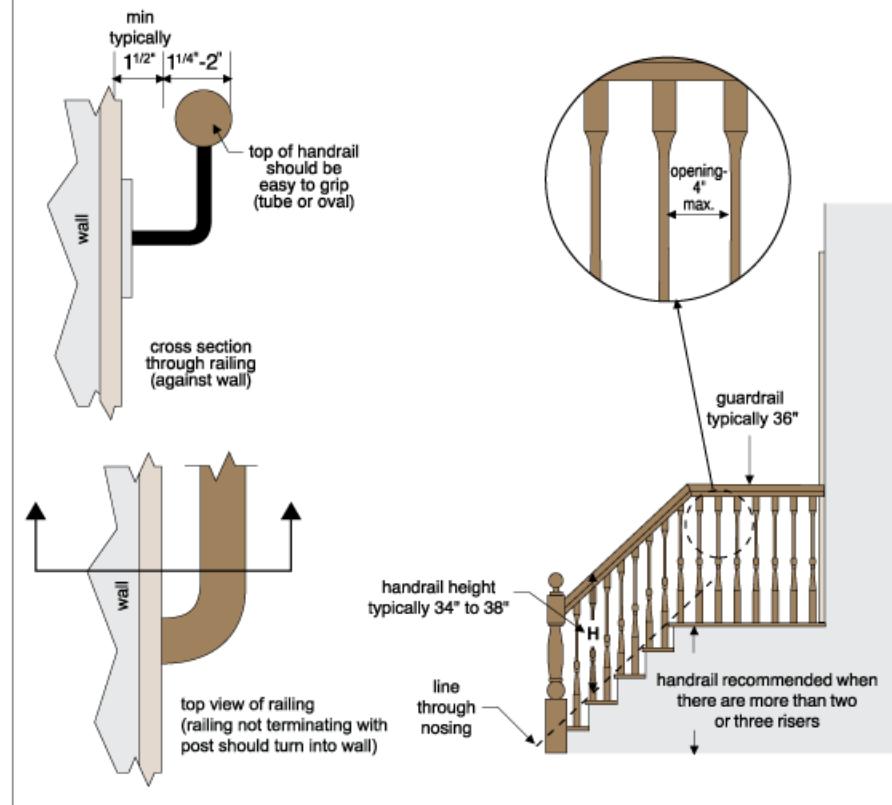
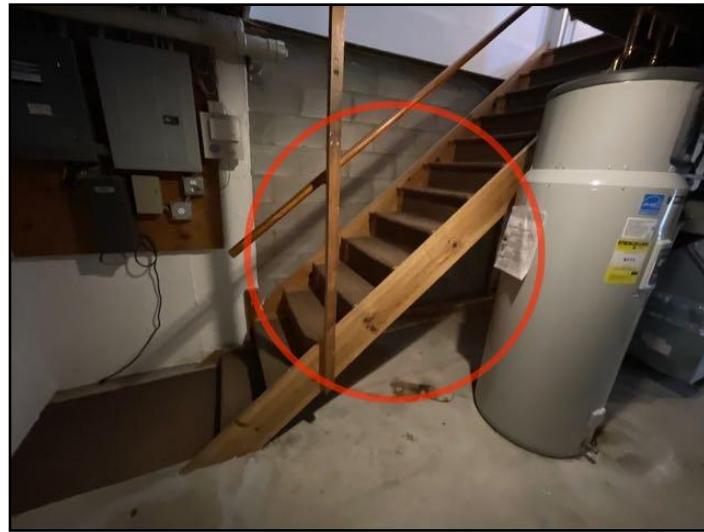
There were no balusters at the basement staircase, which could present a falling hazard for young children. Recommend evaluation and repair by a qualified handyman or carpenter.

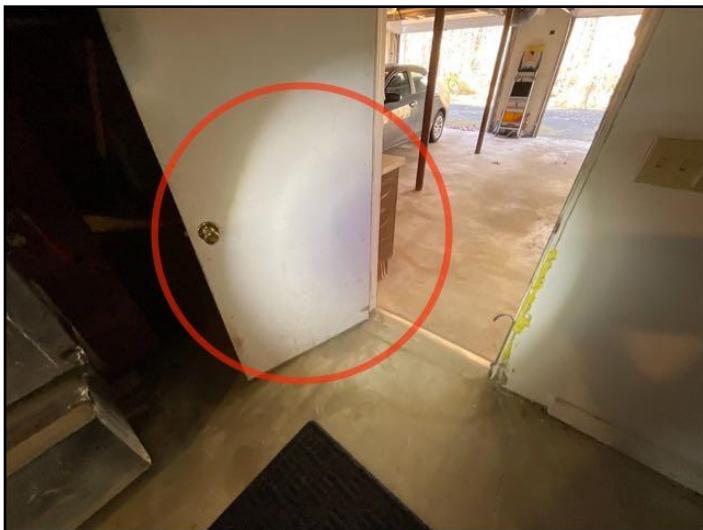
91. Self-closer missing

71. Condition: • Self-closer on the door between the house and the garage is missing or ineffective. This is a security hazard as well as a safety hazard as it could allow noxious fumes to enter the home. It is also a fire hazard. Recommend adjustment/addition of self-closing hinges by a qualified handyman.

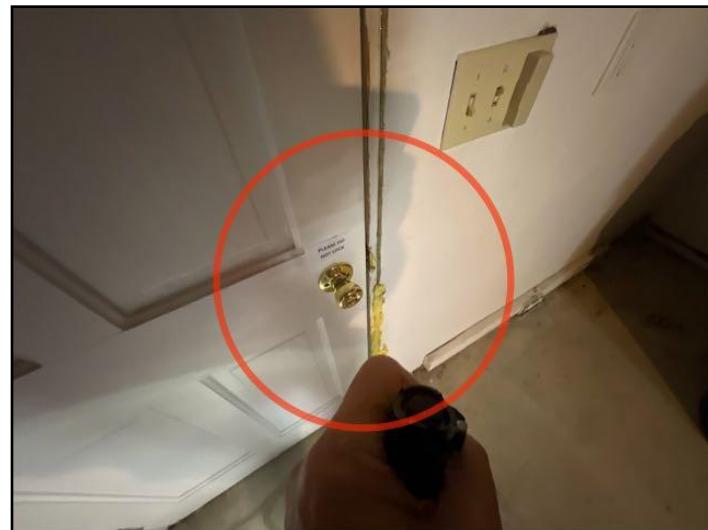
92. Loose strike plate

In addition, the strike plate was loose on the wall, thus the garage door did not close tightly.

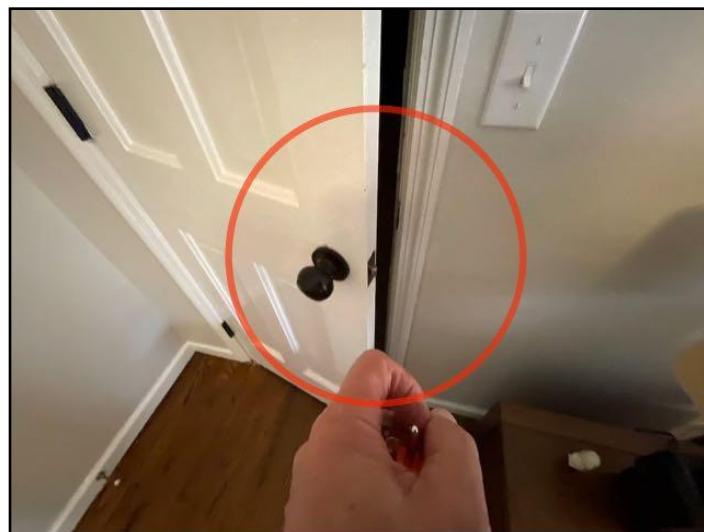
97.

75. Condition: • The closet door at the north east bedroom did not latch properly. Recommend evaluation and repair by a qualified handyman.

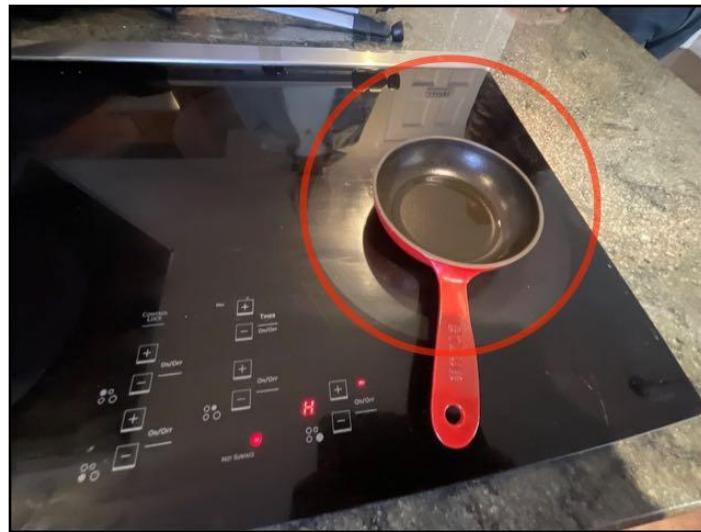
98.

76. Condition: • The front right burner at the cooktop did not appear to work. Recommend evaluation and repair if necessary by a qualified appliance service specialist.
