INSPECTION REPORT

RIDGEFIELD, CT 06877

Inspection Date: Saturday, November 18, 2023

RE: Report No. 1183, v.0
Ridgefield, CT 06877

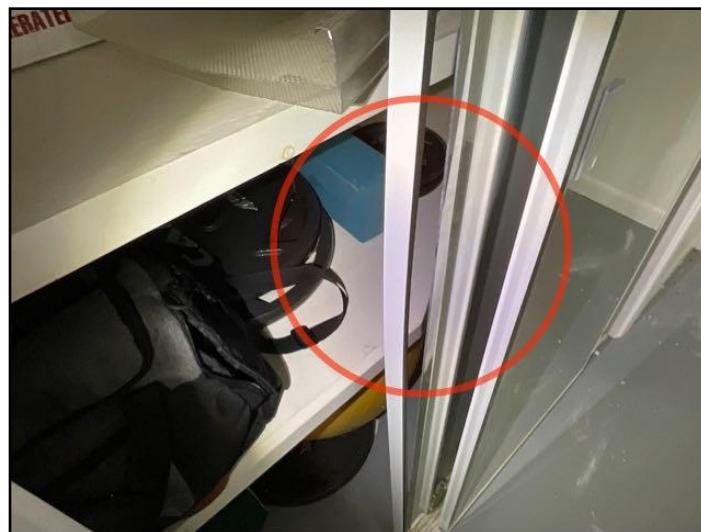
99.

77. Condition: • One of the mirror doors had a bent frame. This could result in the mirrors coming loose and breaking. Recommend evaluation and repair if possible by qualified handyman.
