123 Anywhere Street Charlotte, NC 28215

Inspection Prepared For Valued Client

Date: 10/2/2024 Time: 11:00 AM

Year Built: 2000 | Size: 1748 sq.ft.

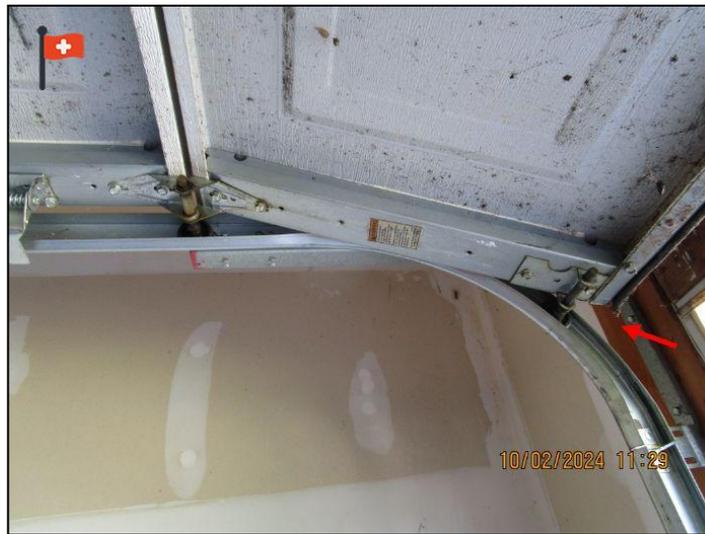
5.0 Garage/Carport		
Page 20	5.5 Garage Door's Reverse Status	<ul style="list-style-type: none"> • SAFETY CONCERN: Garage vehicle door safety/auto-reverse did not pass the resistance test. Recommend a qualified individual/garage door specialist repair for proper function/safety.

Resistance Test Did Not Pass Safety Test

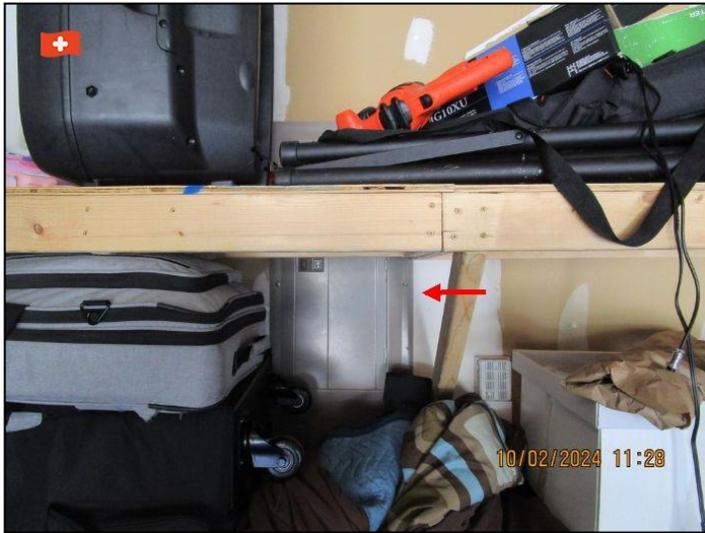
- **SAFETY CONCERN:** Shelving is restricting access to the main panel. All electrical panels must have a service clearance of 3 feet in front of them. Recommend a qualified individual/contractor relocate the shelving and/or panel for ease of access (especially in an emergency).
- **SAFETY CONCERN:** Black wire was used to extend the neutral at the time of inspection. This is unprofessional/not a common practice. Recommend further evaluation by a qualified electrical contractor and professionally repair/install the wiring as necessary for optimal/safe function.

Missing Minimum Clearance (Main Panel) (Garage)

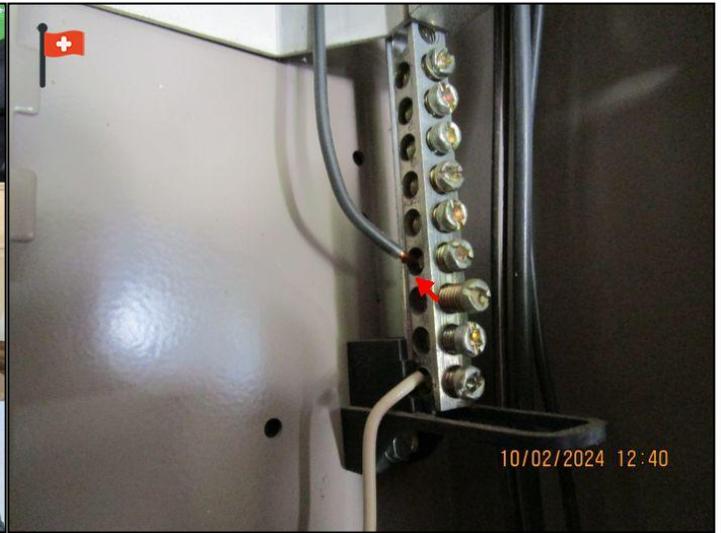
Black Wire Used To Extend Neutral (Unprofessional) (Main Panel)

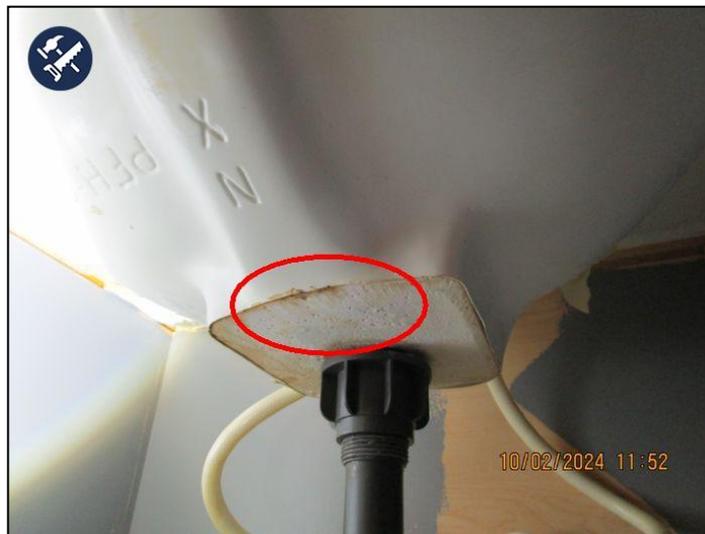
- **REPAIR:** Bathroom sink was leaking from the overflow at the time of inspection. Recommend a qualified individual/plumbing contractor repair/replace the sink to avoid water overflow and/or damage to cabinets/building materials.

Active Leak From Overflow (2nd Floor Guest Bathroom)

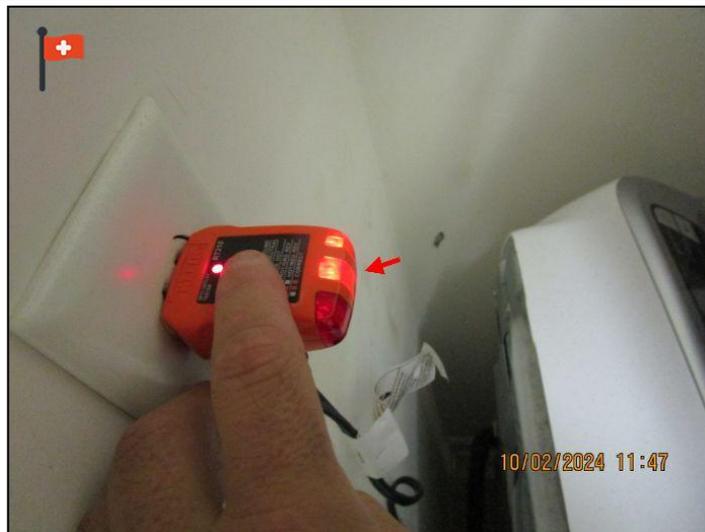
• SAFETY CONCERN: Laundry **GFCI** receptacle did not respond to tests at the time of inspection. Recommend a qualified individual/electrical contractor repair/replace for safety.

Did Not Respond To Tests

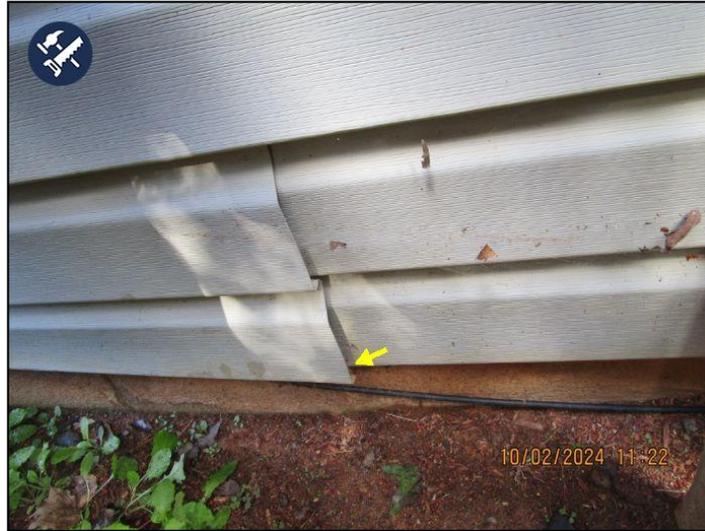
- IMPROVE: Siding materials were detaching at the time of inspection. Recommend a qualified siding contractor repair/replace to prevent further deterioration/water intrusion.

Detaching (Rear)

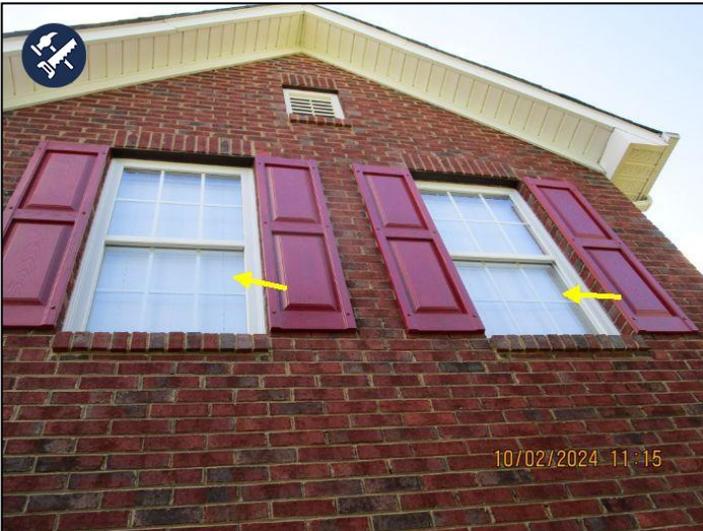
- IMPROVE: Some window screens were missing/damaged at the time of inspection. Recommend a qualified individual/window contractor repair/replace to avoid insect/pest intrusion.

Missing Screens

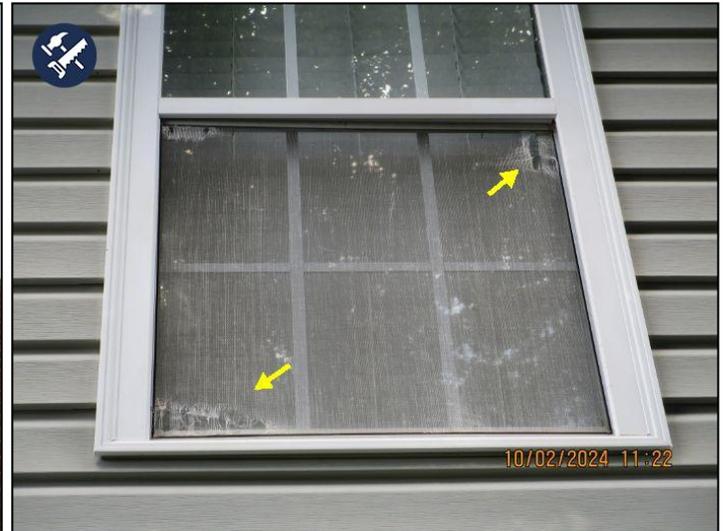
Damaged Screens

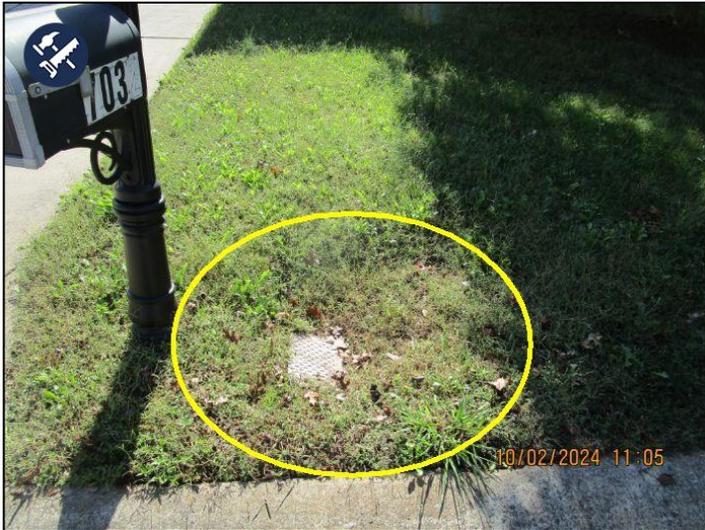
- **IMPROVE:** Low spots observed around the city water box at the time of inspection. Recommend further evaluation by a qualified individual/contractor and repair/fill the low spots as necessary to prevent future issues (such as ponding) and to rectify the current aesthetic issues.
- **IMPROVE:** The fence was damaged at the time of inspection. Recommend a qualified contractor further evaluate and repair/replace as necessary for proper function.

Low Spot At City Water Box

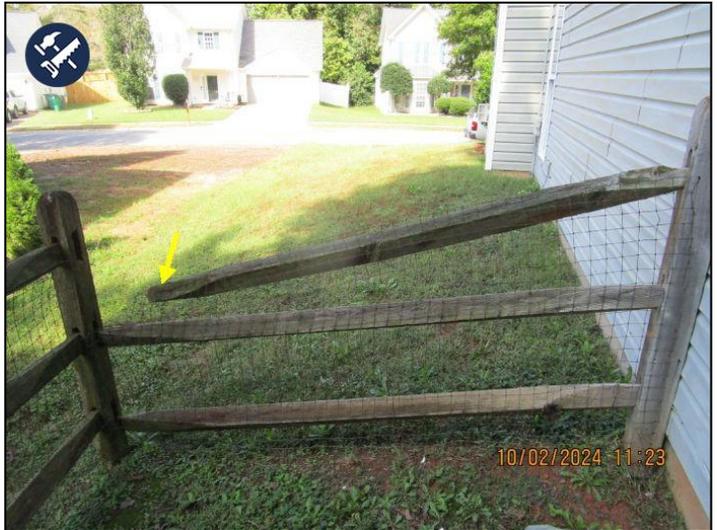
Damaged Fence

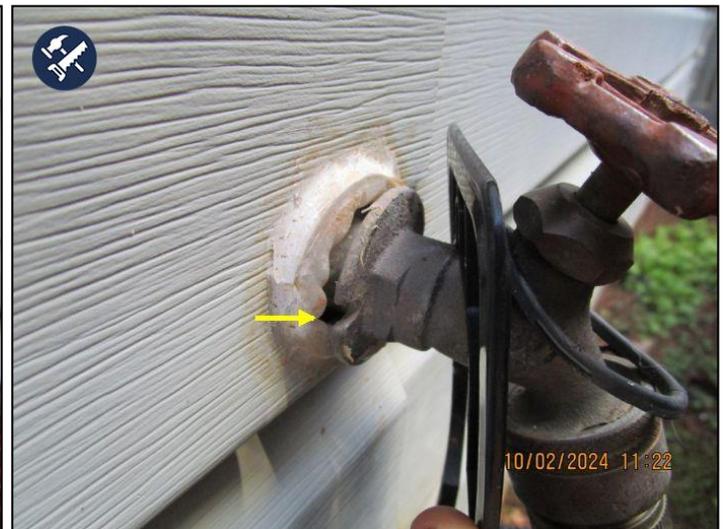
- **IMPROVE:** Exterior faucets were missing hardware/loose to the structure at the time of inspection. Recommend a qualified individual repair/secure the faucets to prevent potential damage to the supply lines.

Missing Hardware/Loose

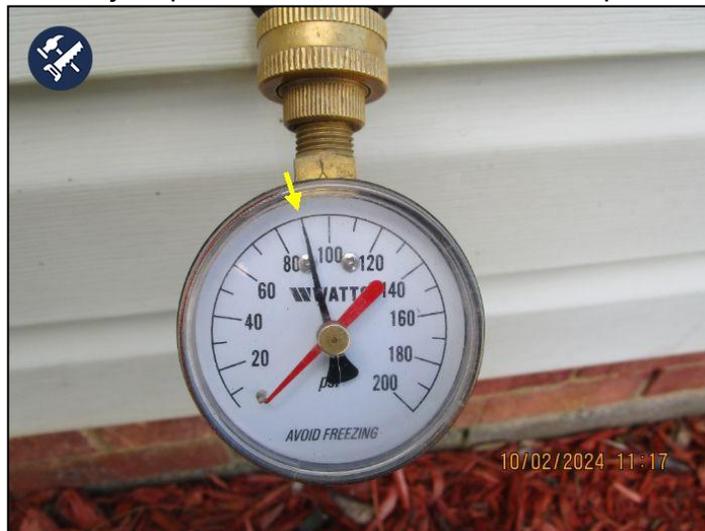
- **IMPROVE:** Water pressure noted as 90 PSI at the time of inspection. This is high. Recommend a qualified plumbing contractor adjust pressure to the recommended pressure (60 to 80 PSI).

90 PSI

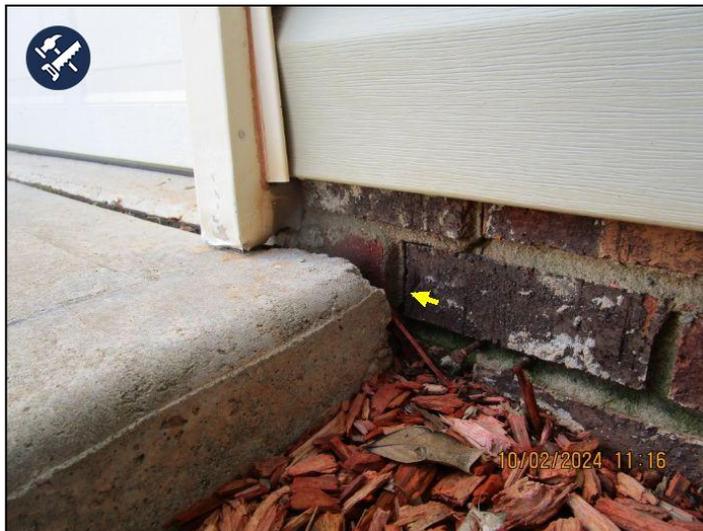
- **IMPROVE:** Vertical cracking observed in the foundation perimeter at the time of inspection. Recommend a masonry contractor point up and for the owner to monitor the area(s) periodically for any deficiencies. Should the condition worsen, contact a structural engineer for further evaluation/repairs.

Vertical Crack(s) (Front Of Structure)

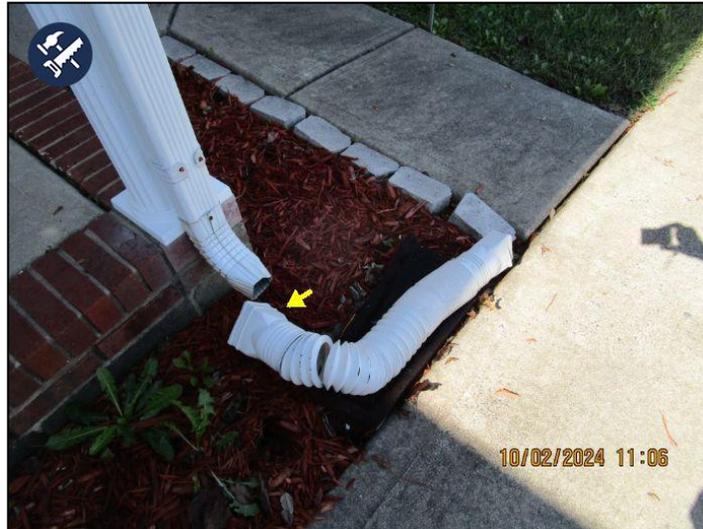
- **IMPROVE:** Extension(s) were missing or insufficient at the time of inspection. Recommend a qualified individual/gutter specialist install to divert water away from the foundation.

Extension(s) Missing/Insufficient

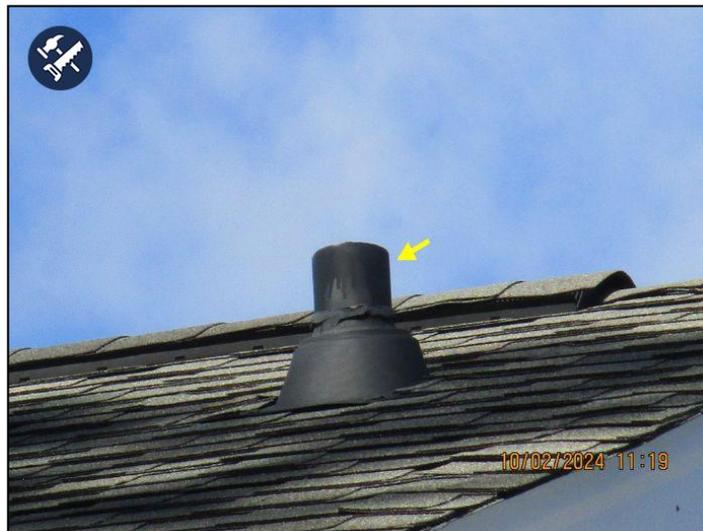
- **IMPROVE:** The plumbing vent stack(s) are less than 1' above the roof. Recommend a qualified individual/plumbing contractor replace the vent stack(s) for correct function/as per current standards.

Less Than 1'

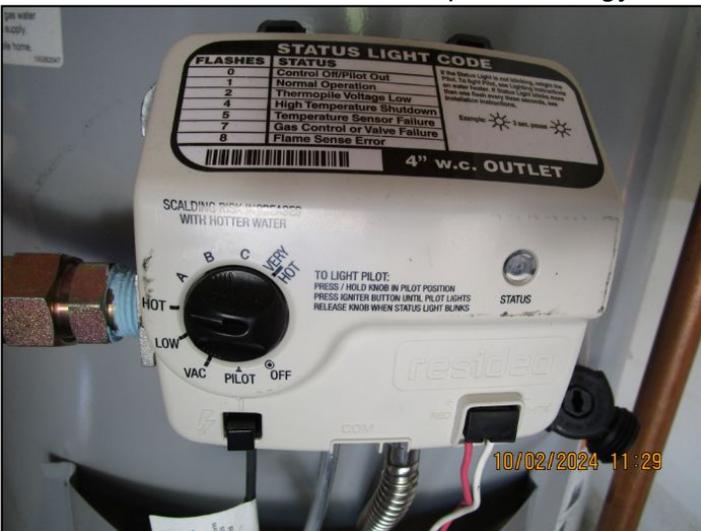
- **IMPROVE:** Water temperature observed at 125.2 degrees F. This is high. Recommend a qualified plumbing contractor adjust the temperature to between 118-122 degrees F to prevent scalding, extend water heater life and improve energy efficiency and conservation.

Current Setting

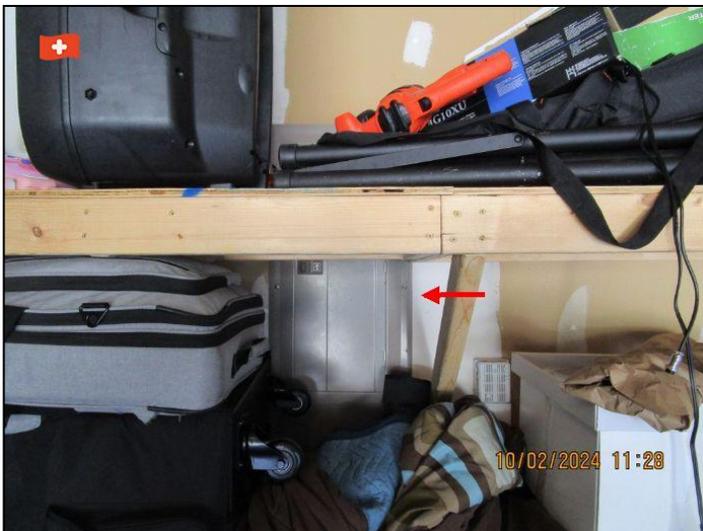
- **NOTE:** Main panel was properly labeled at the time of inspection.
- **SAFETY CONCERN:** Shelving is restricting access to the main panel. All electrical panels must have a service clearance of 3 feet in front of them. Recommend a qualified individual/contractor relocate the shelving and/or panel for ease of access (especially in an emergency).
- **SAFETY CONCERN:** Black wire was used to extend the neutral at the time of inspection. This is unprofessional/not a common practice. Recommend further evaluation by a qualified electrical contractor and professionally repair/install the wiring as necessary for optimal/safe function.

Missing Minimum Clearance (Main Panel)
(Garage)

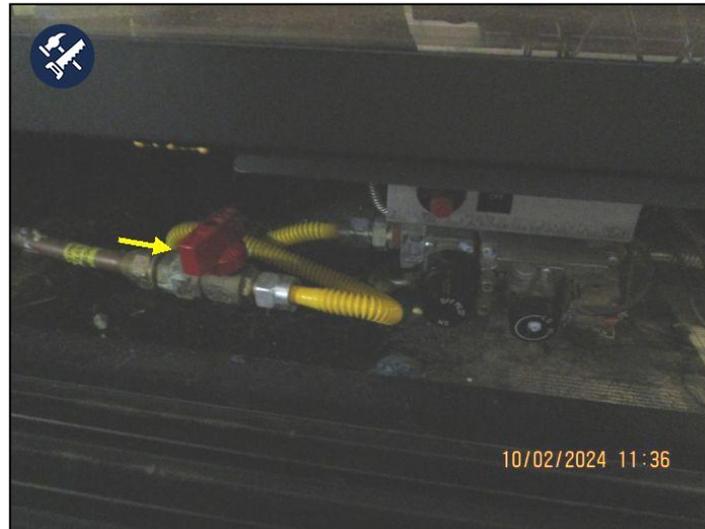
- **NOTE:** Vent was installed at the time of inspection.
- **IMPROVE:** The gas fireplace was not tested as the gas valve was in the 'OFF' position at the time of inspection. Recommend a qualified fireplace specialist service/repair for proper function.

Gas Valve Was In 'OFF' Position

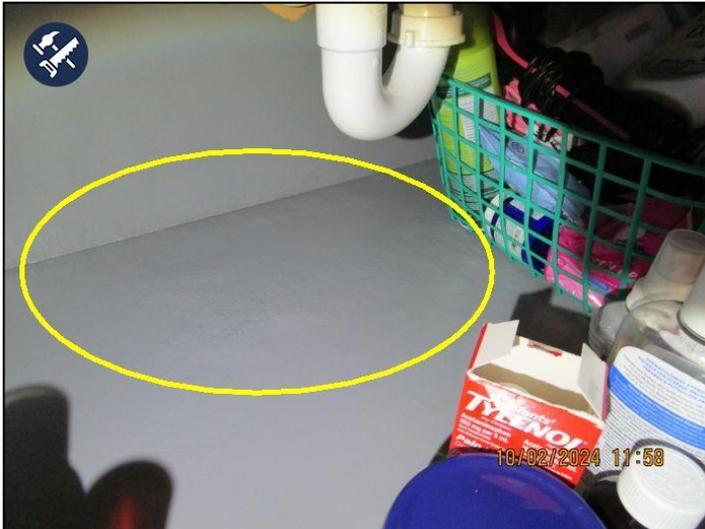
- **IMPROVE:** Evidence of water damage observed in multiple locations. The areas were dry at the time of inspection. Recommend a qualified individual/contractor repair/replace all compromised materials to prevent further deterioration.

Water Damaged (Dry At Time) (Primary Bathroom)

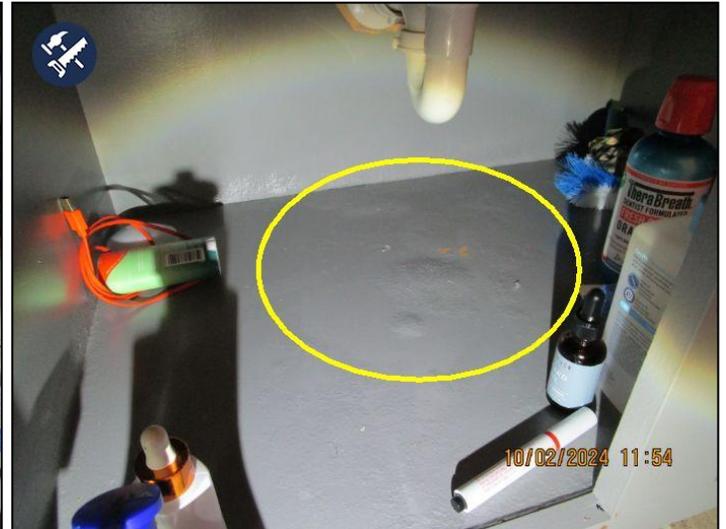
Water Damaged (Dry At Time) (2nd Floor Guest Bathroom)

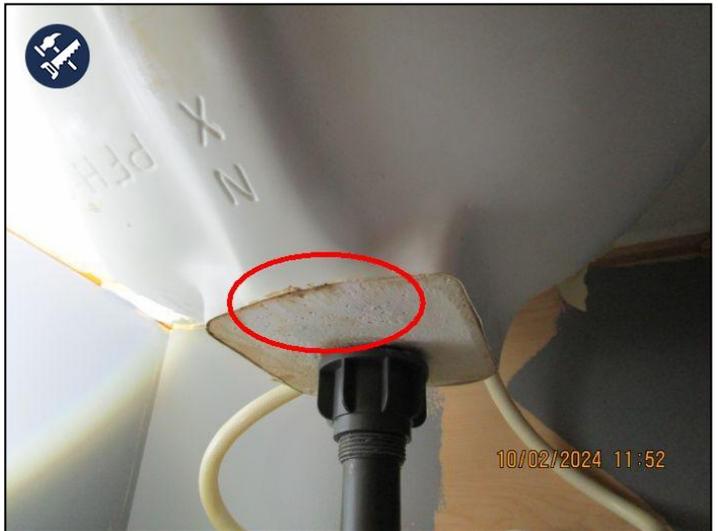
- **IMPROVE:** There was a slow drain observed at multiple bathroom sink overflow holes/lines at the time of inspection. Recommend a qualified individual clear the blockages for optimal function. If the issues continue, have a plumbing contractor further evaluate and repair as necessary.
- **REPAIR:** Bathroom sink was leaking from the overflow at the time of inspection. Recommend a qualified individual/plumbing contractor repair/replace the sink to avoid water overflow and/or damage to cabinets/building materials.

Active Leak From Overflow (2nd Floor Guest Bathroom)

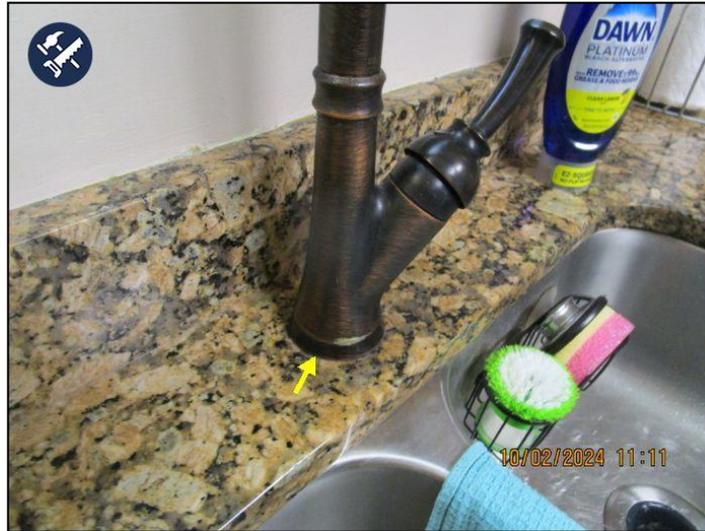
- **IMPROVE:** Loose hardware observed at the time of inspection. Recommend a qualified individual/plumbing contractor repair/secure to prevent moisture intrusion/for optimal function.

Loose Hardware

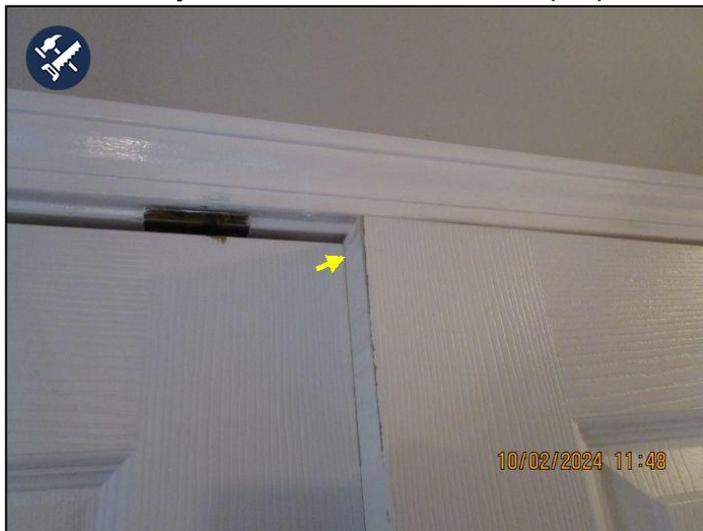
- **IMPROVE:** Laundry room door was difficult to open/shut (misaligned) at the time of inspection. Recommend a qualified individual adjust the door/hardware for proper function.

Misaligned

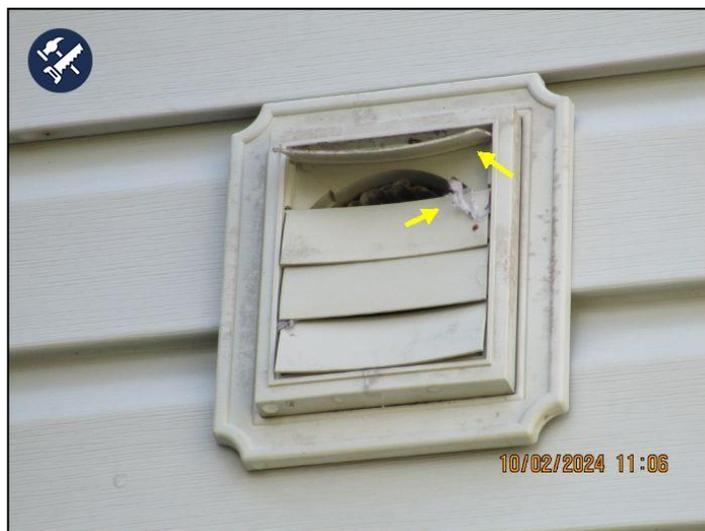
- **IMPROVE:** Minor lint was observed in the dryer vent cover/vent pipe at the time of inspection. Recommend the owner clean the vent periodically to prevent any future issues (such as fire, etc.).
- **IMPROVE:** The dryer vent has a louver stuck in the open position at the time of inspection. Recommend a qualified individual repair to prevent insect/pest intrusion.

Minor Lint With Stuck Louver

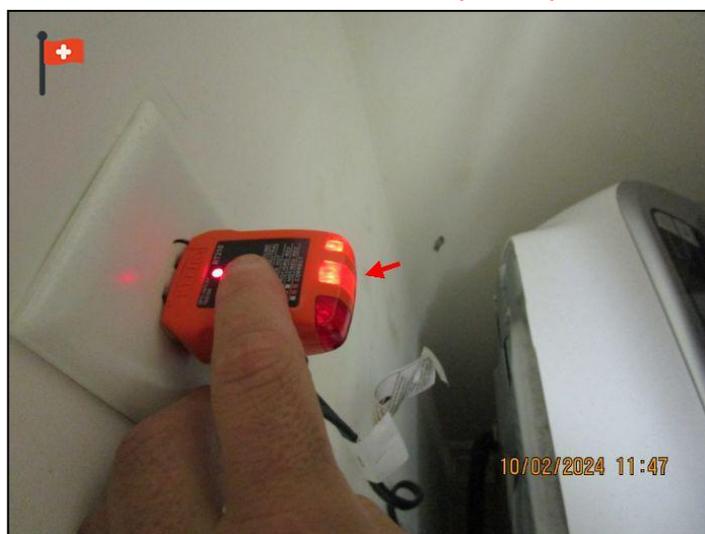
- **SAFETY CONCERN:** Laundry GFCI receptacle did not respond to tests at the time of inspection. Recommend a qualified individual/electrical contractor repair/replace for safety.

Did Not Respond To Tests

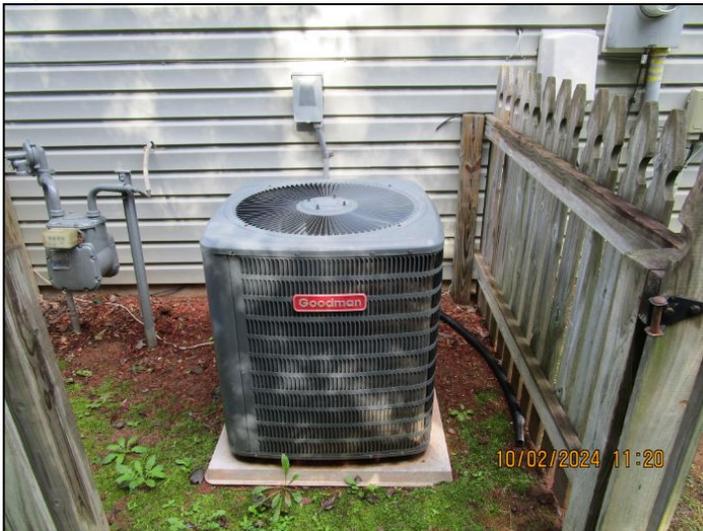
LOCATION: Rear Of Structure

- **IMPROVE:** Dirty cooling fins noted on the compressor at the time of inspection. Recommend a qualified individual/HVAC specialist further evaluate and repair/clean the unit as necessary for optimal function.

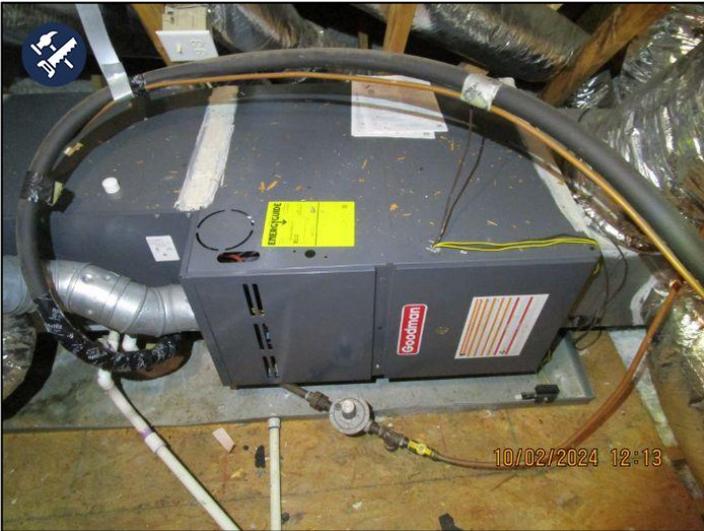
LOCATION: Attic

- **IMPROVE:** Gas Unit - Last service date is over one year ago, or is unable to be determined. Although this unit appears to be operating properly from controls, there are areas which cannot be seen without specialized equipment and training. One such area is the combustion chamber/heat exchanger where cold air blows across the 'fire box,' becoming the hot air that circulates throughout your home. During the life span of any furnace, this metal wall may develop a crack or a broken weld, allowing carbon monoxide to circulate throughout the home. This is why furnace specialists recommend a complete inspection annually; consider having the unit inspected by certified HVAC contractor.

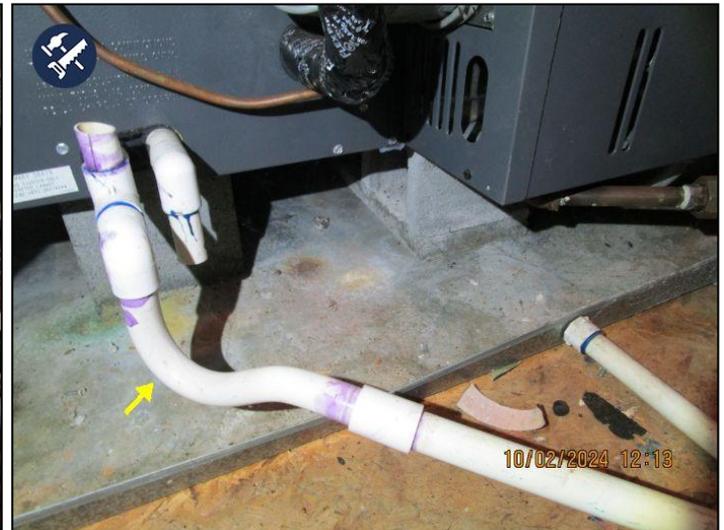
Trap Missing Insulation
