Inspect Hawaii
Property Inspection Report

45-123 Leilehua Place, Kaneohe, Hawaii 96744
Inspection prepared for: John Doe
Date of Inspection: 11/6/2014

Inspector: Oscar Libed
ASHI License #257117
Honolulu, HI 96825

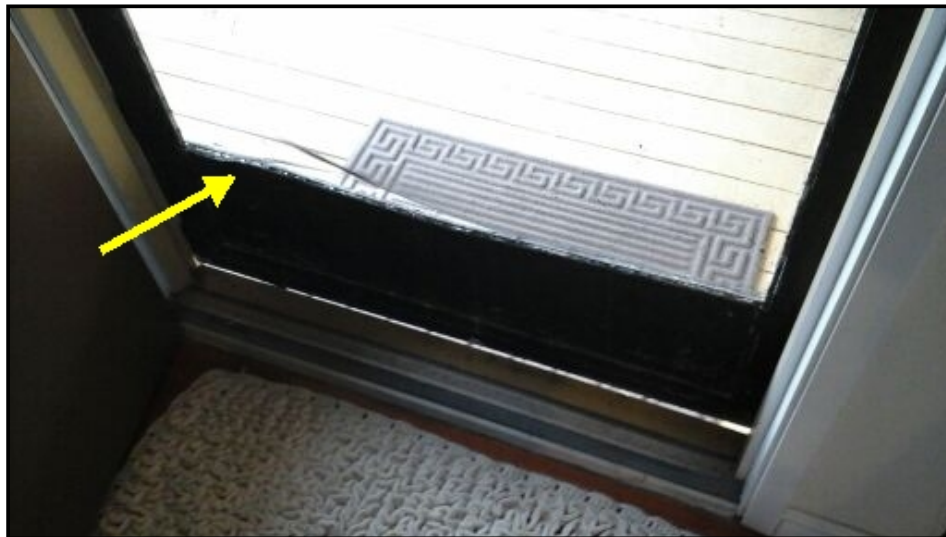
- Front screen door is damaged.

Front screen door is damaged.

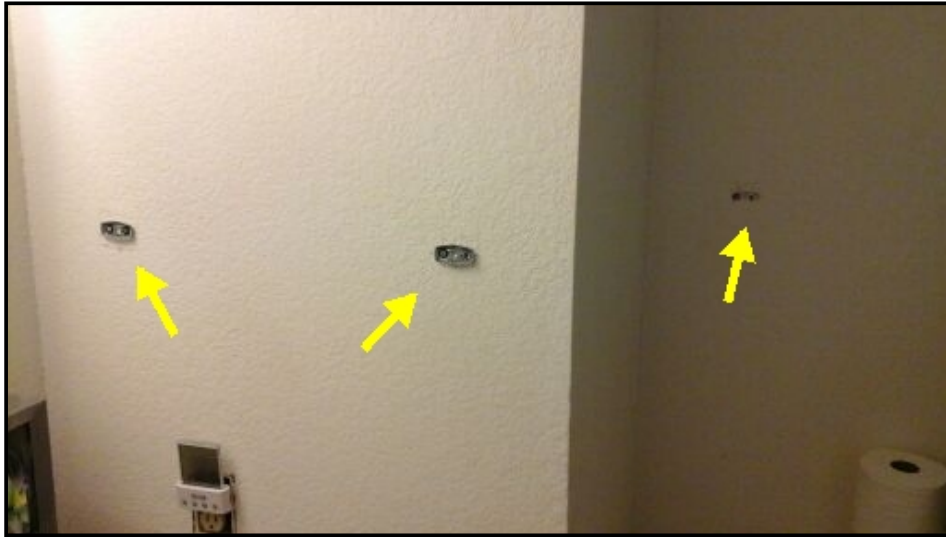
Anchors on wall above toilet and near sink for missing towel bars.

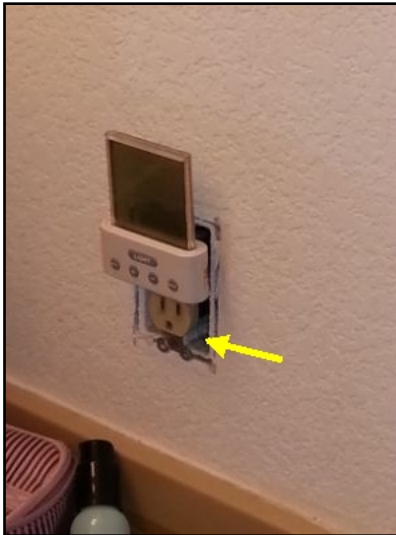
No cover on receptacle. This is a safety hazard and poses a risk for an electric shock.

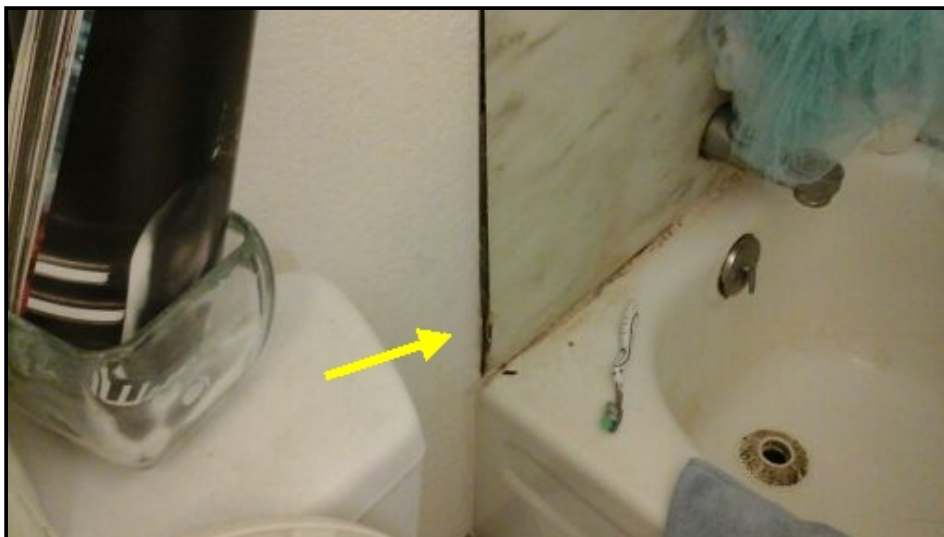
- Recommend that all tile edges and tub/shower walls be caulked and sealed to prevent moisture penetration. All missing/damaged grouting should be replaced. Failure to keep walls sealed can cause deterioration and extensive moisture damage to the interior walls and surrounding sub-flooring.

Some caulking repair needed at tub in main bath. Surround paneling edges not sealed, edging material is broken.

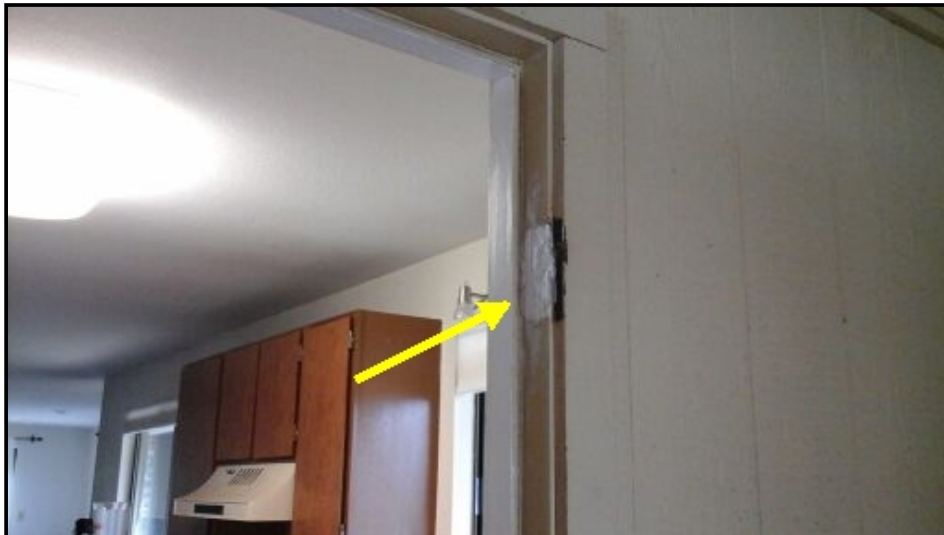
- Entry door frame has been patched and needs sanding/sealing for a final finished look.

Door frame not finished.

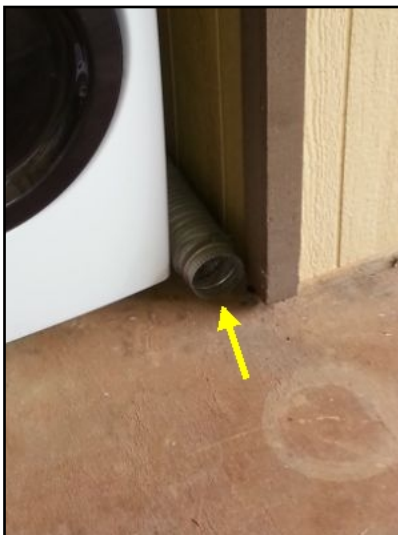
Laundry Dryer Vent

- The dryer vent is missing the exterior cover. Cover will prevent pests from intrusion into dryer.

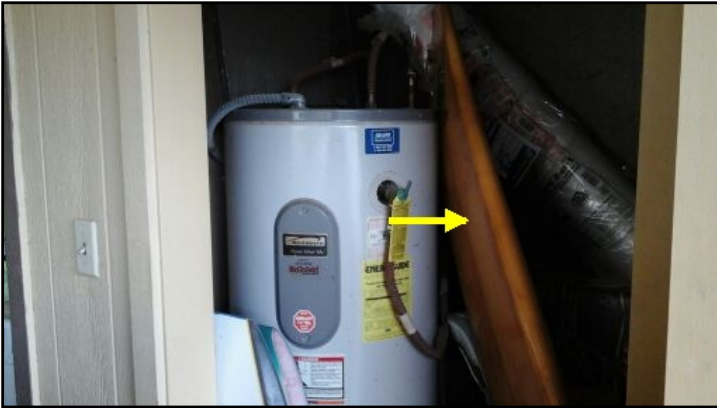
Items should not be resting on heater.

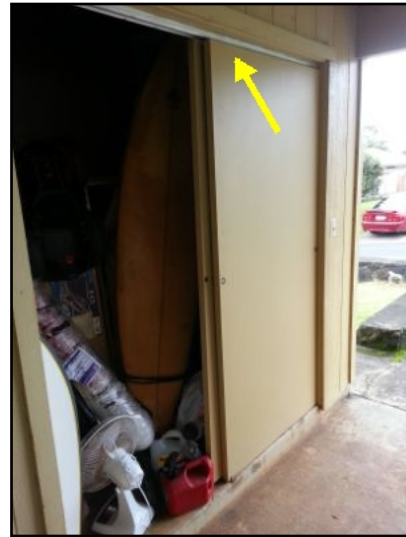
Door does not slide properly.

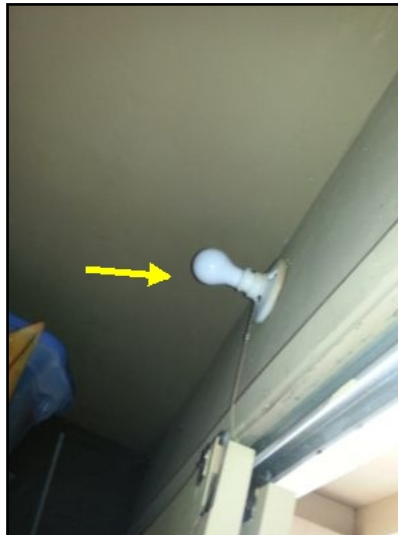
Bulb susceptible to physical damage.

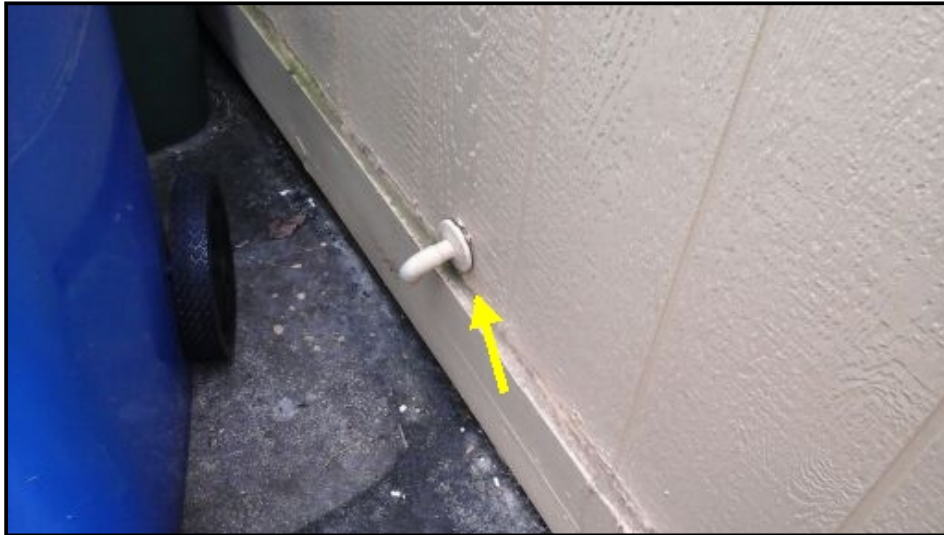
- A pressure & temperature relief valve & extension is satisfactory. Outside cover plate is detached from wall and needs caulking.

A pressure & temperature relief valve & extension is present and appears satisfactory. Outside cover plate is detached from wall.

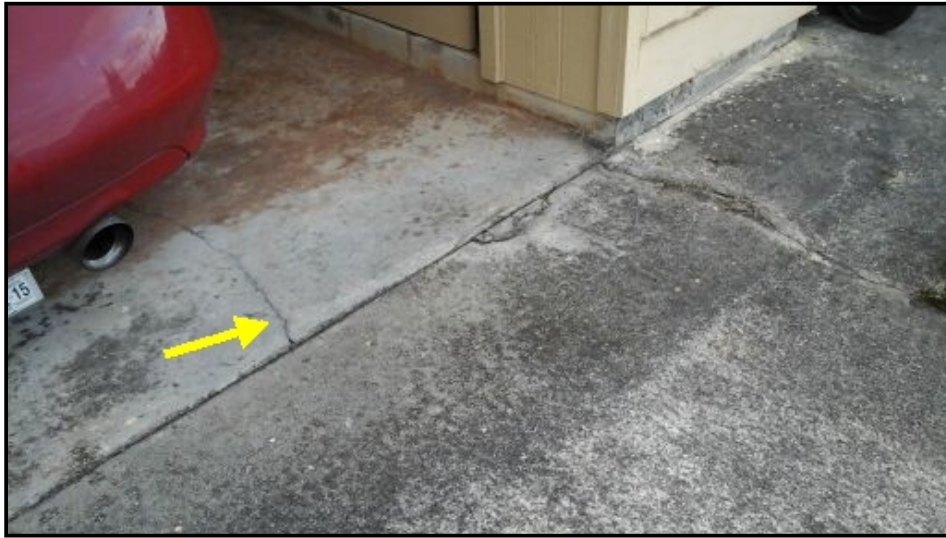
Normal cracks on concrete floor.

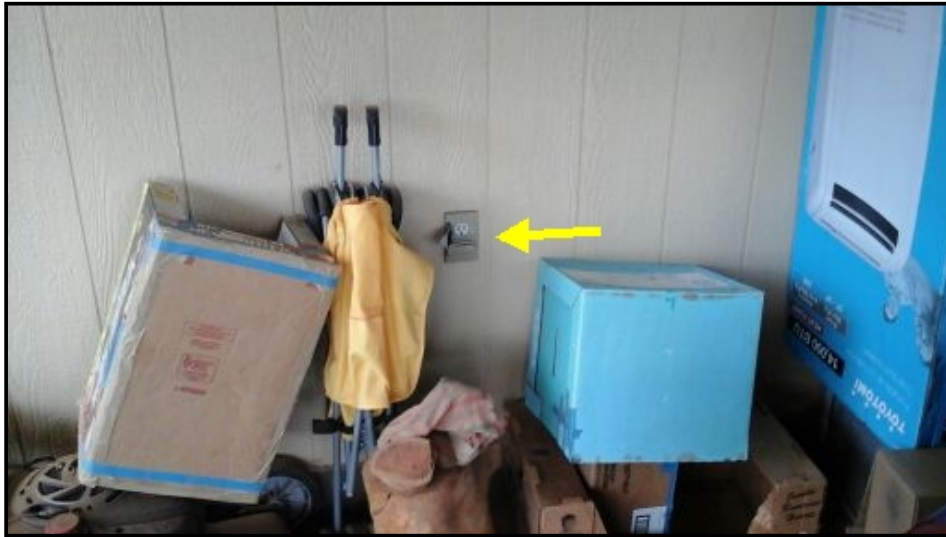
Loose receptacle outlet to left of entrance door. Top receptacle not working.

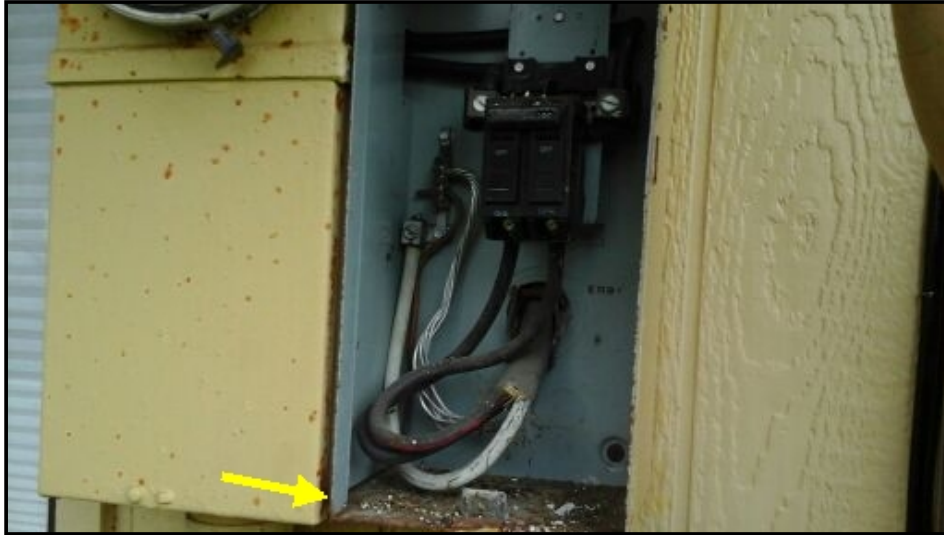
- Rust buildup on outside of panel box. Difficult to remove front cover.

Cover is rusting and was difficult to remove.

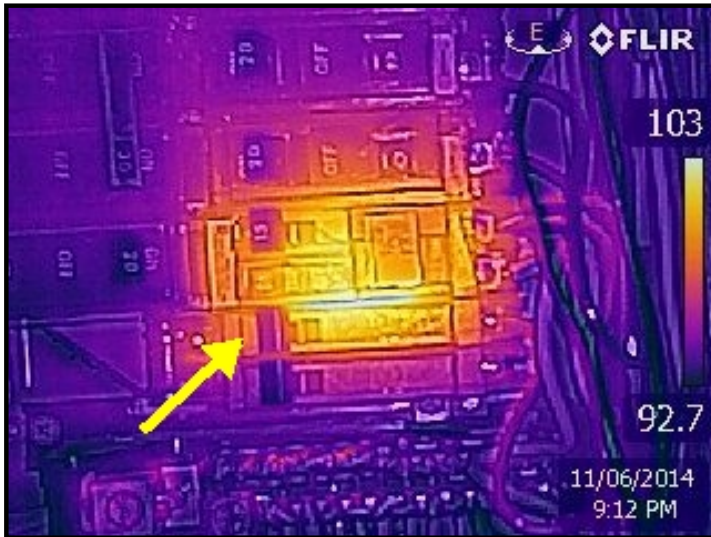
Infrared picture of overheated breaker

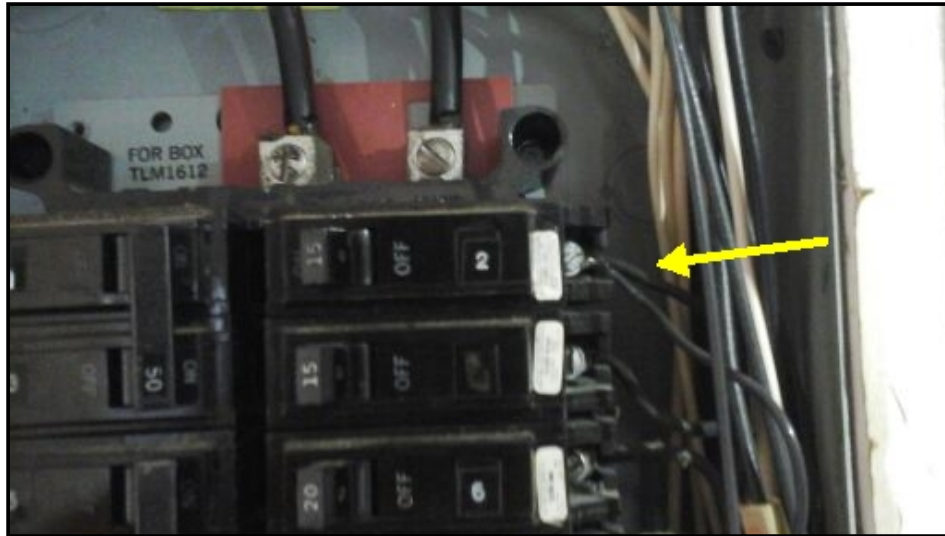
- All of the circuit breakers appeared serviceable.
- Double tapped breakers inside panel box (more than one electrical conductor attached). This is not standard practice, and may cause overheating or even an electrical fire. Recommend evaluation and repair by a licensed electrician.
- GFCI breaker is overheating and may be due to double-tapping. Recommend evaluation and repair by a licensed electrician.

Double tapped breaker(s) inside panel box (more than one electrical conductor attached). This is not standard practice, and may cause overheating or even an electrical fire. Recommend evaluation by an electrician.

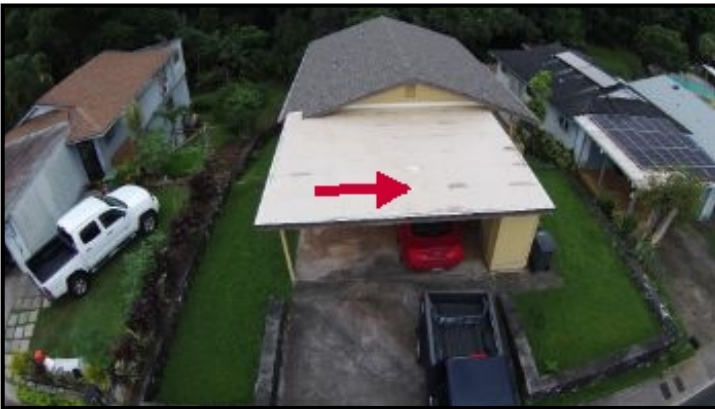
Recommend roofing contractor to evaluate flat roof due to ponding.

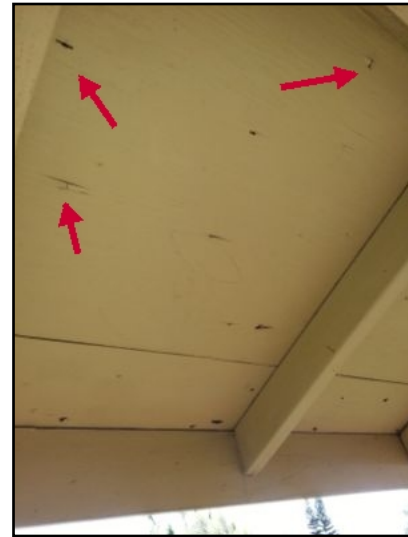
Long nails on underside of roof protruding through plywood. Recommend licensed Roofer for review and repair.

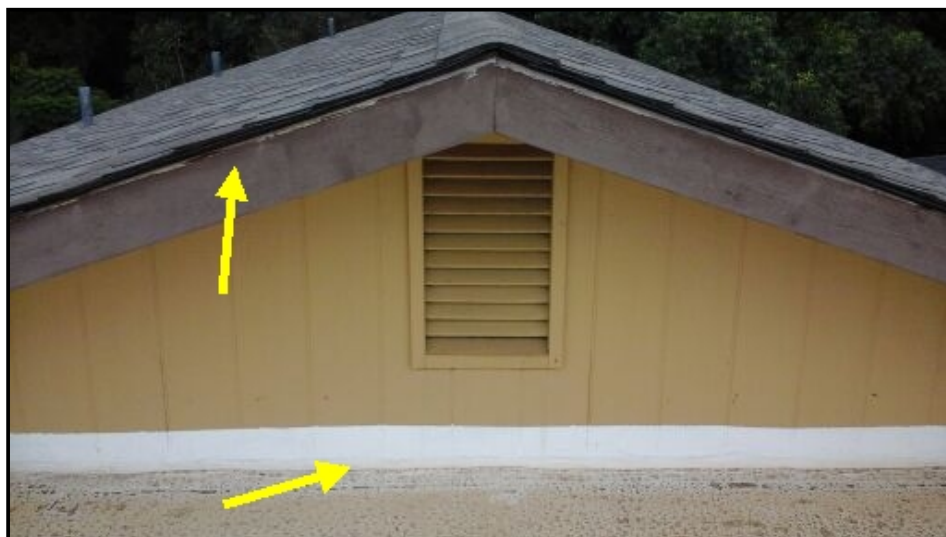
- No roof flashing and drip edges installed.
- Missing edge flashings exposes underlying framing to wet weather. This condition may result in deterioration of roofing materials from moisture intrusion.
- Recommend review by a licensed roofer for repair as necessary.

Poor roof flashing. There are no drip edges installed.

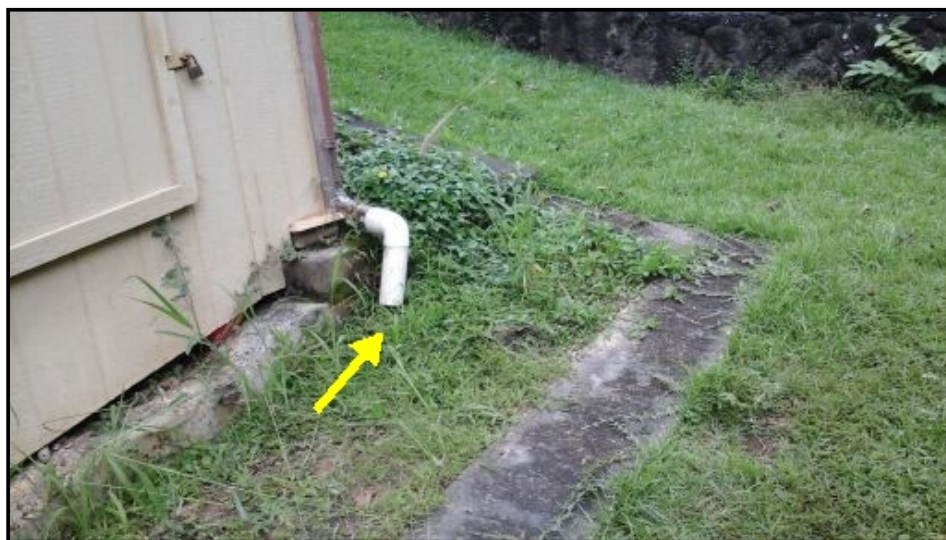
- Extensions / Splash blocks missing or insufficient. The purpose is to divert water away from the foundation.

Extensions / Splash blocks missing or insufficient: Install to divert water away from the foundation.

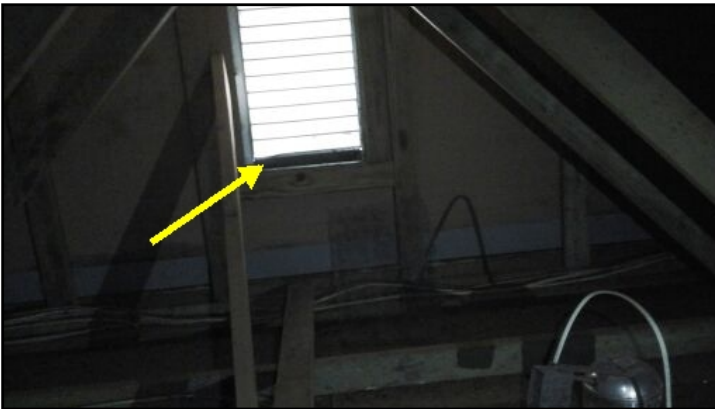
Vent screens are damaged or missing, suggest repairing or replacing screens as necessary to prevent pest intrusion.

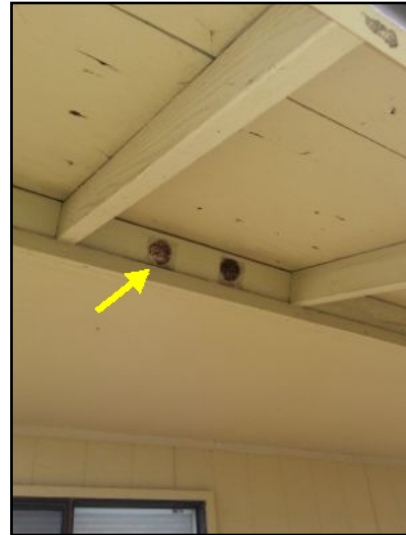
Soffit vents are rusted and painted. Recommend replacement by carpenter for improved air flow to cool roof.

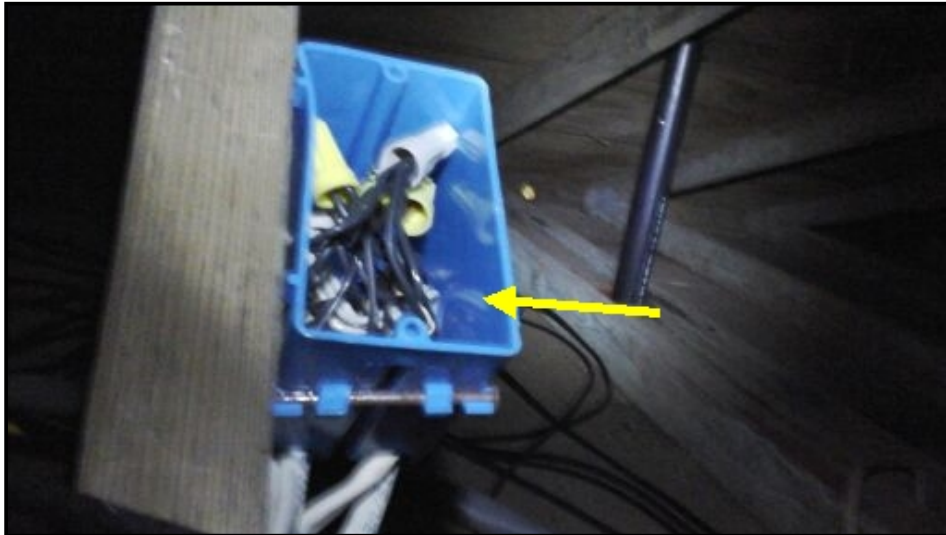
Page 22 Item: 5	Electrical	<ul style="list-style-type: none"> Electrical Box Cover missing. This is an electric shock hazard. Recommend installation of a cover plate.

Electrical Box Cover missing. This is an electric shock hazard. Recommend installation of a cover plate.

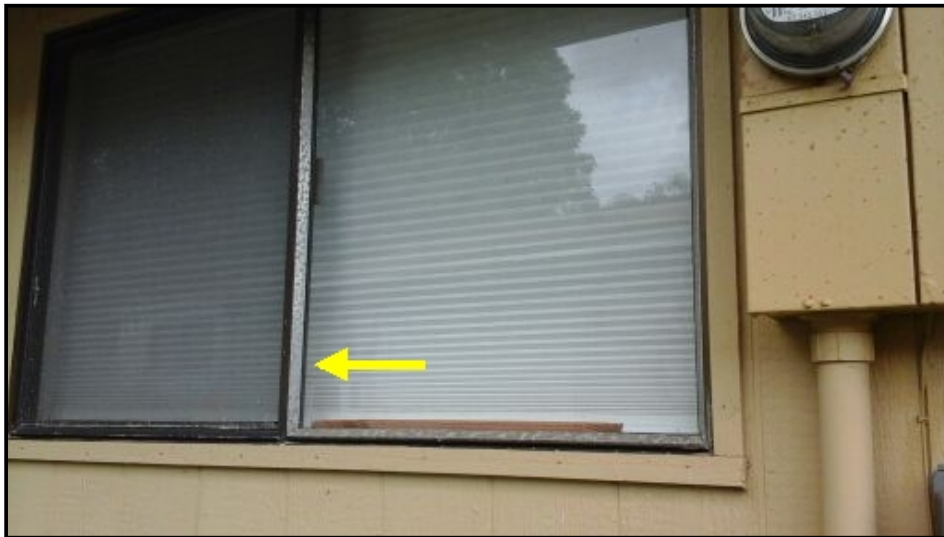
Deteriorated frames at windows due to corrosion.

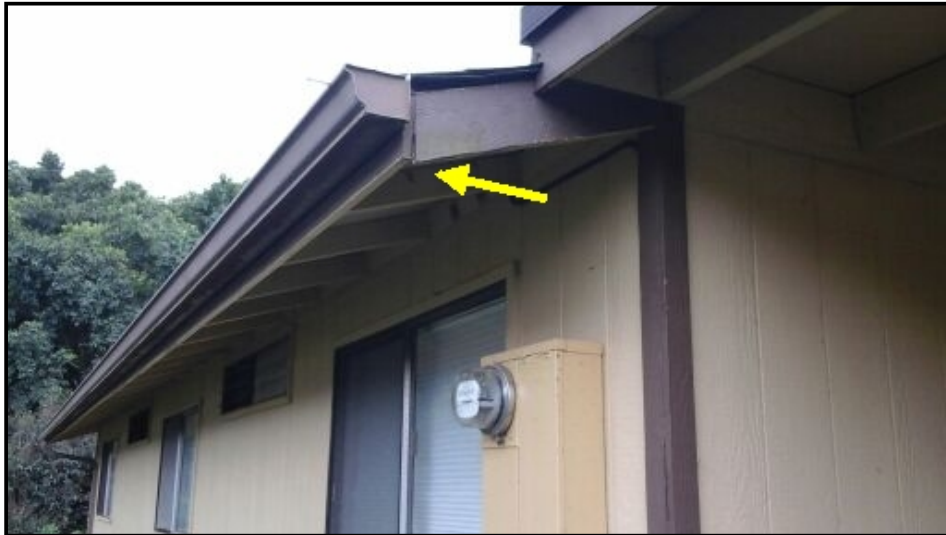
- Monitor trim work (fascia, soffits etc.) Contact carpenter for any needed maintenance and repairs. For example, loose trim under eave near left side of garage.

Fascia covering the ends of rafter is separating at end.

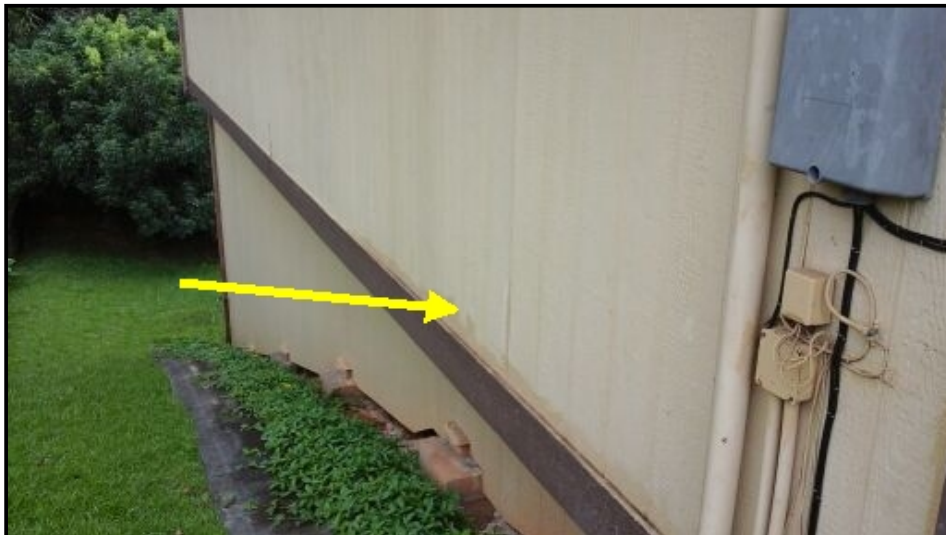
Paint on exterior wall is beginning to get weathered.

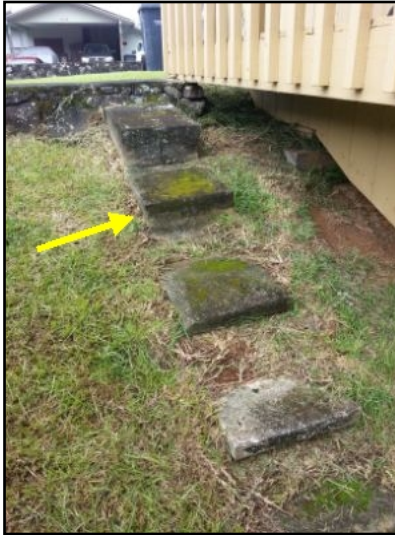
- There are minor predictable and common cracks in the concrete driveway. Monitor these areas for further movement or expansion and repair/seal as needed.
- Pavers are loose and are a trip hazard. Recommend securing concrete pavers to prevent tripping.

Loose pavers.

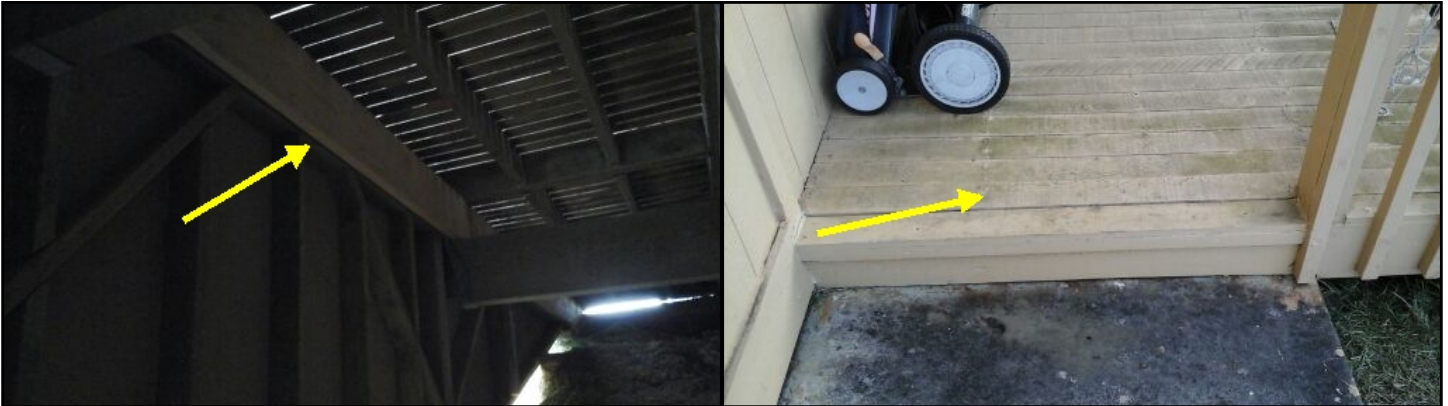
New Beam under front porch deck

Some floor boards at step-up sagging due to moisture.

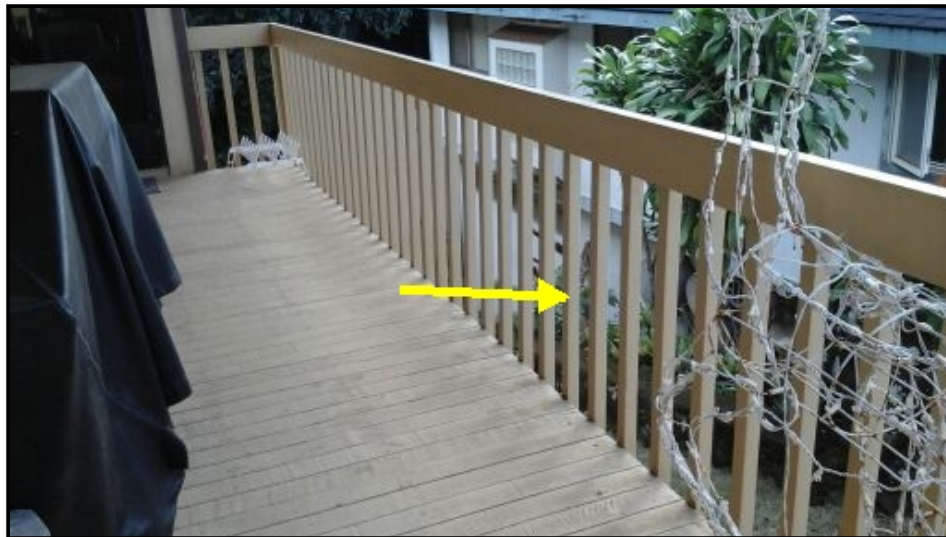
Vertical rails spaced too far apart. Existing spacing was acceptable at time of initial building, but current standards are a maximum of 4 inches to prevent small objects from falling.

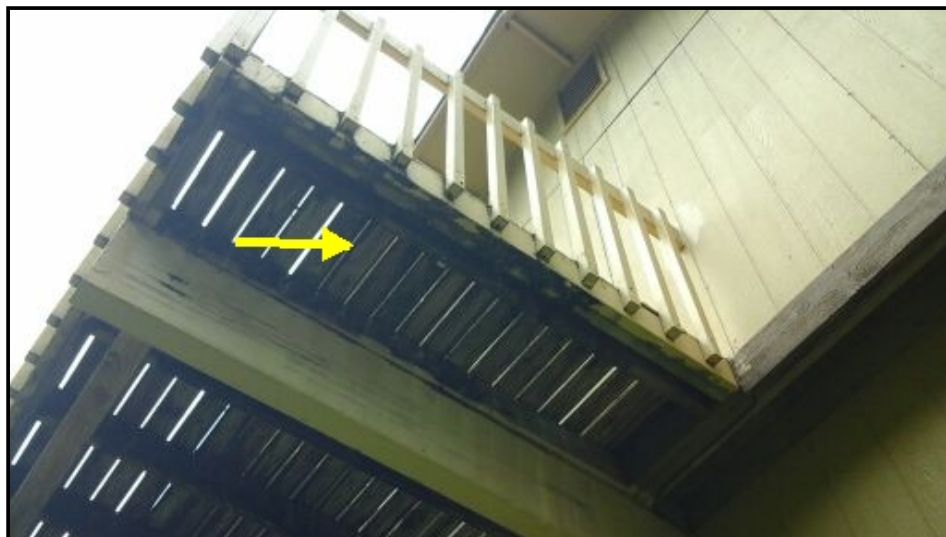
- Floor boards rotted due to wet weather. This is a SAFETY hazard. Highly recommend that the balcony not be used until a licensed contractor examines and repairs the floor boards.

Floor boards rotted on balcony.

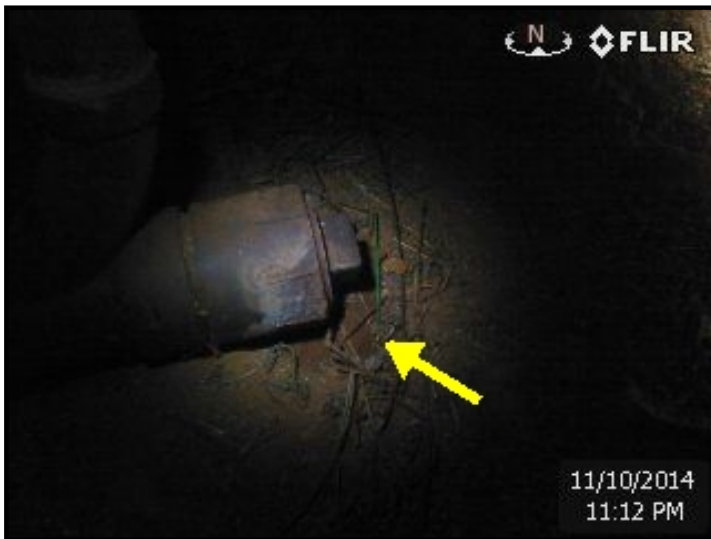
- [Leaking observed and needs immediate repair by a qualified Plumbing Contractor to prevent unwanted moisture in crawl space. See "Crawl Space" section for pictures.](#)

Drain pipe leaking at clean-out cover at the end.

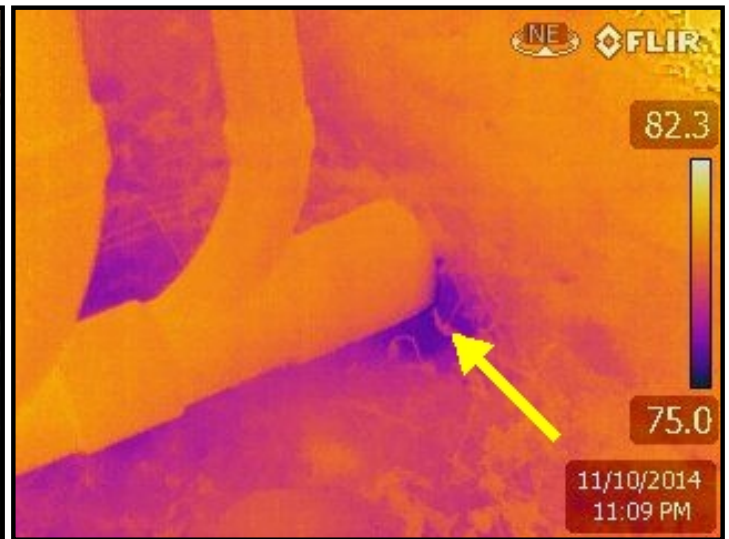
Infrared picture of drain pipe leaking at clean-out cover at the end.

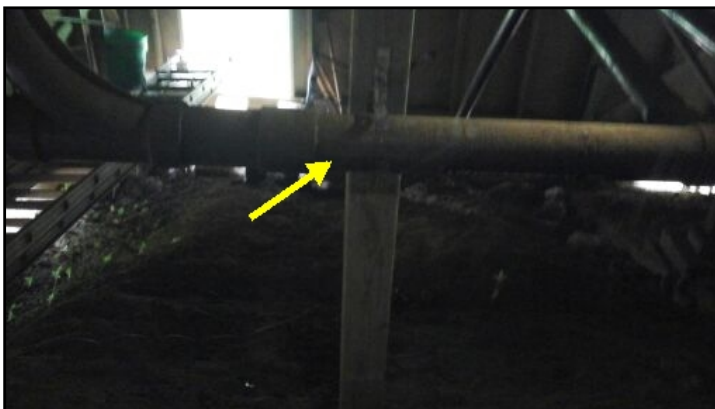
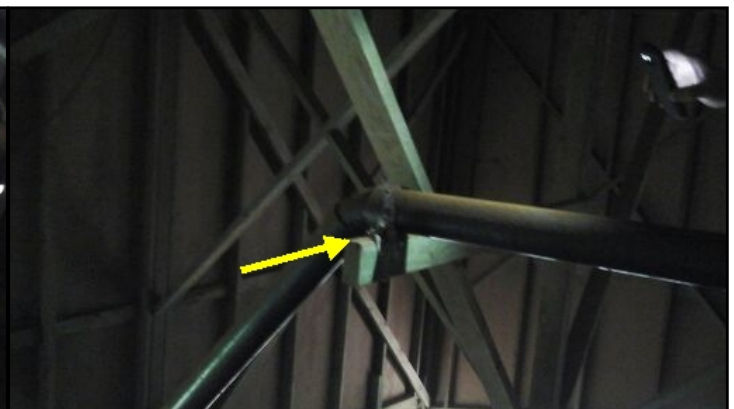
Drain pipes missing support straps

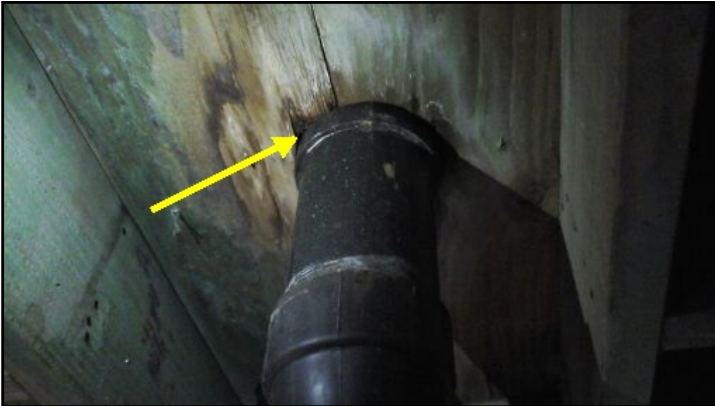
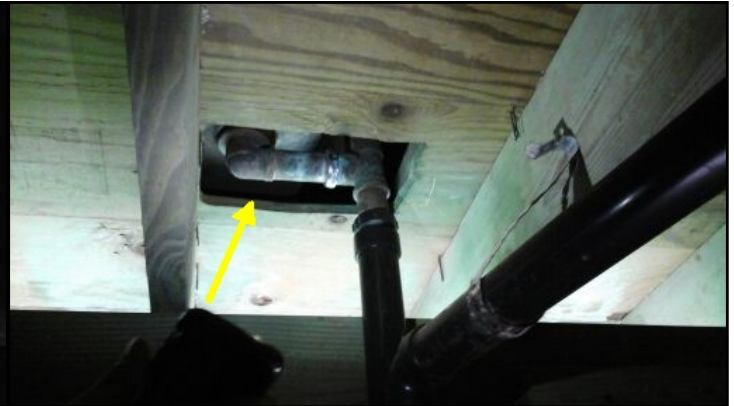
Need caulking to seal pipe penetrations

Need to seal pipe penetrations

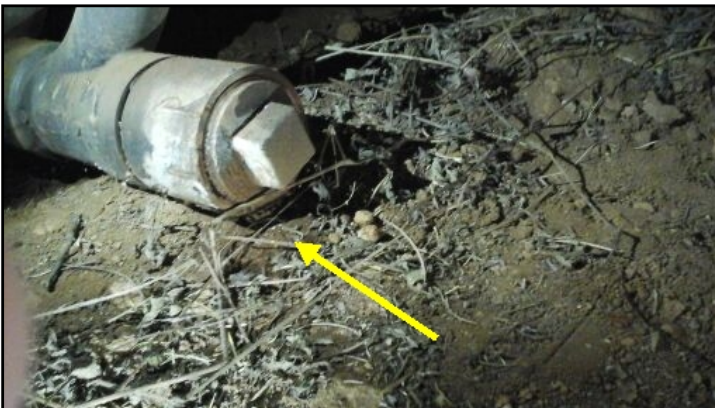
Leaking drain at clean-out cover

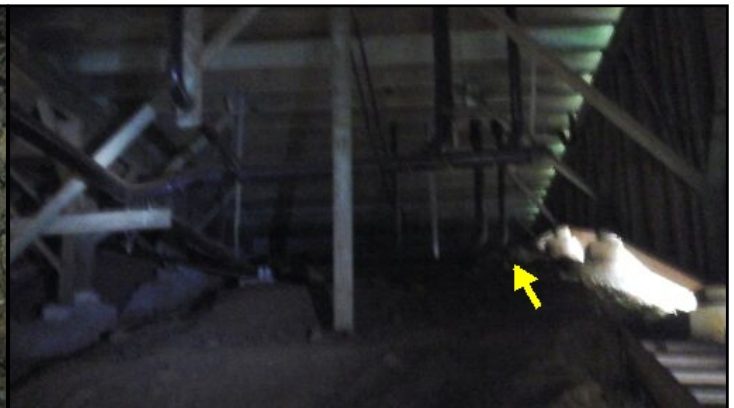
Leaking drain pipe on the ground on the right side.
