**Location of incident:** St Peters Road Underbridge

**Discipline:** B&C Structures

**Event description:** IP and staff were installing a mano flex curtain for encapsulation to carry out a jet wash on the bridge structure VIR 836 St Peters Road (Broadstairs 77m 11ch). To carry out this work, they were using magnets which were attached to the underside of the bridge structure. A magnet then came loose and fell from the structure on to the IP (PPE hard hat), which caused a cut on his head.

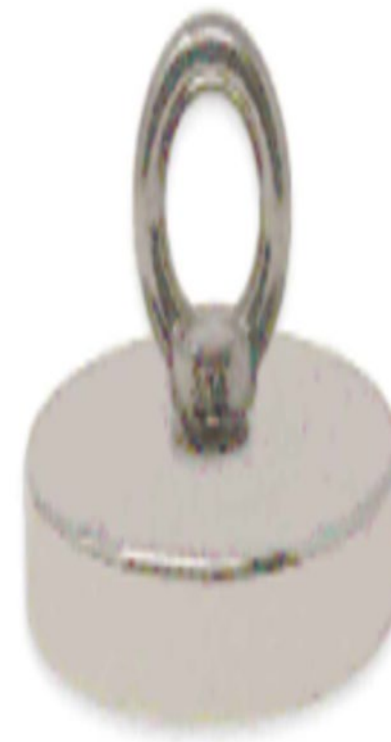
- Magnet fell during installation of Visqueen Curtain.

- Consider the use of mandatory exclusion zones.
- Always ensure you have carried out a temporary works inspection post installation.
- When installing temporary works, always ensure that you have considered the state of asset during installation.

- Works stopped
- Route control advised
- Investigation underway
