## Event details

**Location of incident:** Parks Bridge relay room

**Discipline:** CP6 Tail Signalling

A fuse removed during testing unintentionally cut power to signals outside the possession, triggering a SPAD alarm.

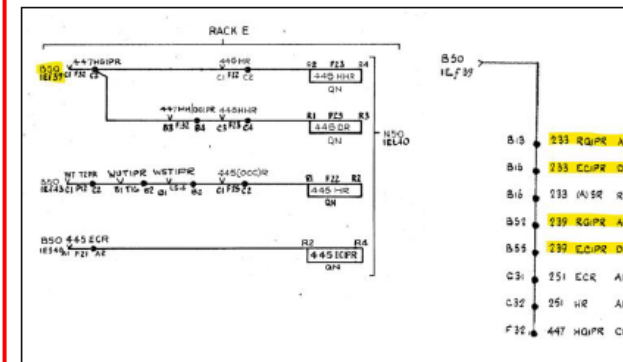
During an enabling stage to commission a new signal disconnection box on TL445 signal, a fuse was removed in Parks Bridge relay room to assist correspondence testing by de-energising some signal aspect control relays. Unknowingly, this fuse also fed several signal circuits in the area outside of the possession footprint via a 50V positive looping circuit. Therefore, removing the fuse also removed the feed to circuits for signals outside of the possession (TL233 and TL239). The timing of the fuse removal resulted in a SPAD alarm at TBROC due to the location of a train in the area.

- Removing the B50 fuse affected looped signals outside of the possession footprint.

Circuits indicating fuse and affected looping

- Before removing any fuses, stop and verify understanding and presentation of signalling design circuits and looping in legacy relay rooms
- If you are unclear on circuit presentation or how to proceed, stop works and report your concerns to the Tester in Charge
