## Event details

**Location of incident:** Hither Green

**Route:** Kent

**Discipline:** Track

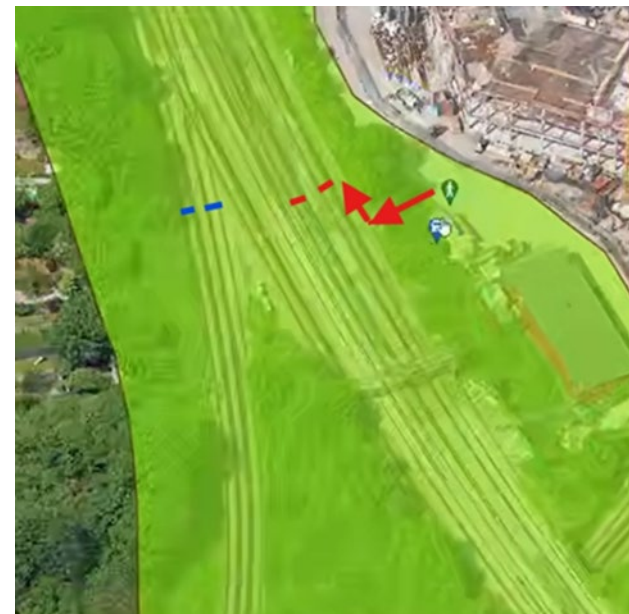
It was discovered that a worksite/isolation operative had placed the worksite protection straps at 6M18CH on the Up and Down Kent Fast instead of the Up and Down Ladywell Loop.

The worksite/isolation operative accessed at the correct location and placed straps on the two lines closest to them. However, the strapping location was incorrect as per the diagram.

**Red** = Where straps & boards were placed

**Blue** = Where they should have been placed

- D&A testing was undertaken
- Witness Statements gathered
- Staff stood down from safety critical duties whilst investigation is undertaken.
