## Event details

**Location of incident:** Brighton 1844 points

**Discipline:** Works Delivery Track

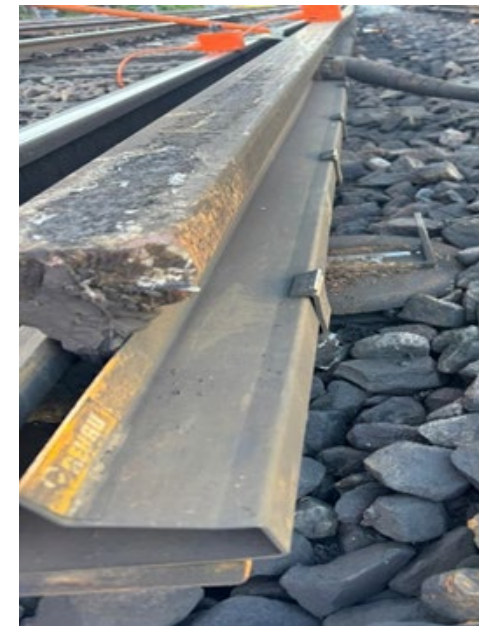
Following planned possession works at Brighton 1844 points (S&C Medium, Item 168), a section of conductor rail (con-rail) on the approach was left incorrectly configured (ungauged).

The con-rail was left positioned proud, sitting incorrectly on the ramp end pot ears. As a result, the first passenger service operating over the section struck the ungauged con-rail. This caused damage whereby the train lost its shoe gear.

- Final hand back check of the con-rail floater rail did not identify that the con-rail was not correctly gauged inside and just outside of work extremities.

- Competencies requested from specialist supplier to review.
- Hand back staff on the last shift have been stood down from their hand back duties effective immediately until investigation completed and findings / corrective measures have been taken.
