# Southern Significant Event Fast Facts – Sussex

## Near Miss at East Croydon | 02 July 2026

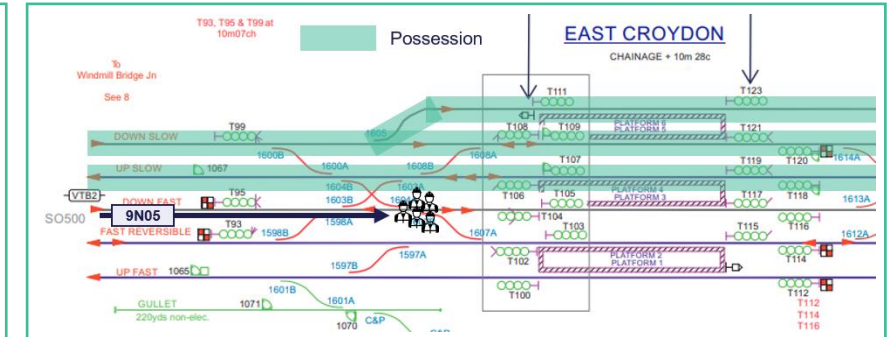
- Over the next two hours, their work led them to the London end of East Croydon station, where one of the blocked lines merges into the Down Slow. At the time of the incident, they were working in the 4ft of the open Down Fast between 1604A and 1607B points.

- As 9N05 approached at approx. 02:57, the train sounded a horn which was not immediately reacted to by the trackworkers. The work group subsequently moved out of the way as the train approached at a slow speed, with the Driver sounding a subsequent warning tone. The Driver did not apply the emergency brake but was slowing to a stop short of the group before they moved clear.

- In the process of moving clear, the work group left small hand tools in the 4ft of the Down Fast, some of which were reportedly struck by the train as it continued into the platform.
