Drainage CCTV Survey

Drainage Services - Pre-Purchase CCTV Drainage Survey & Report

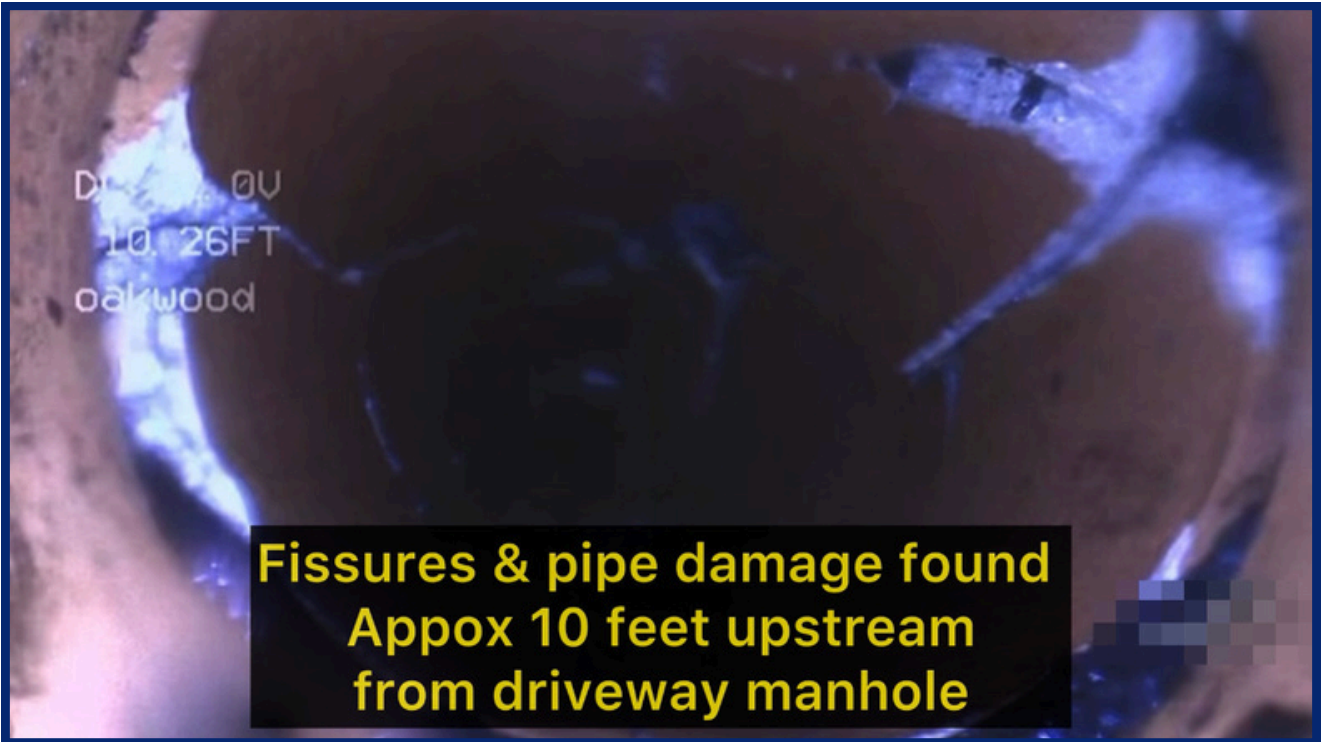
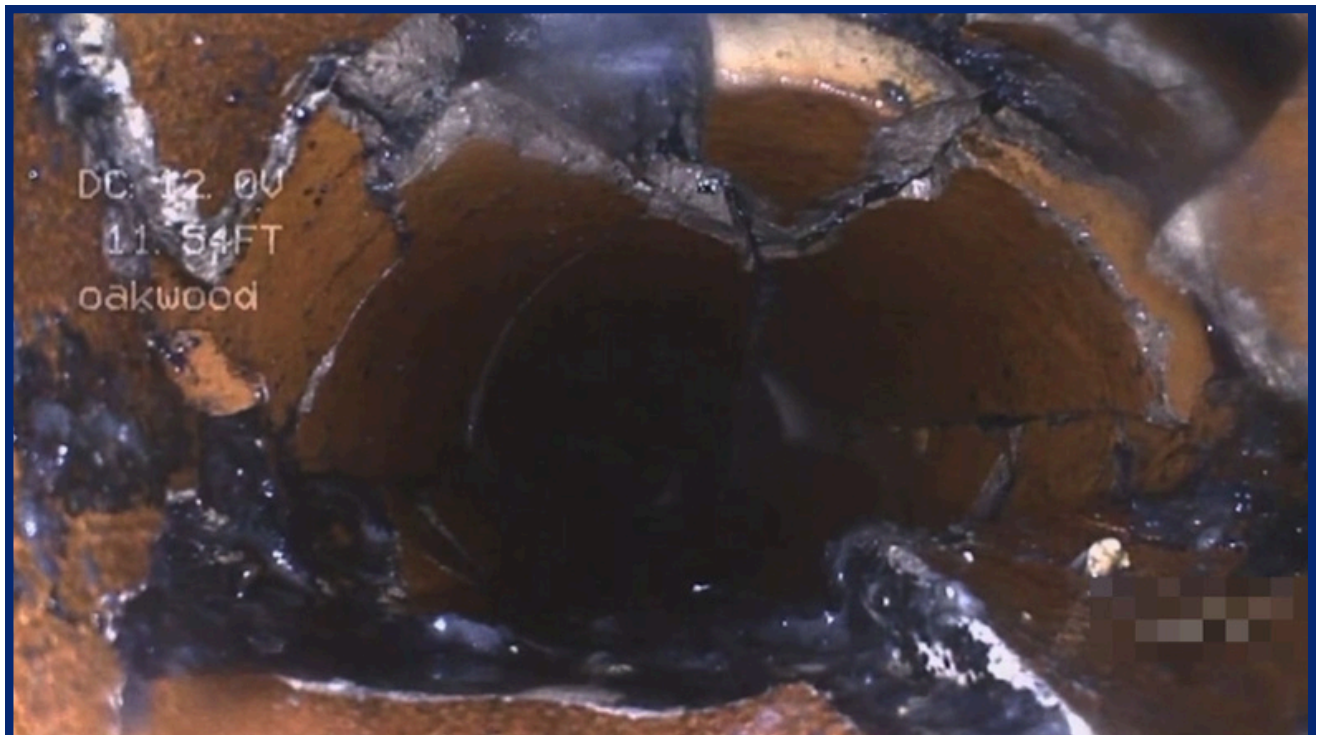
Major pipe damage and pipe fissures found between approx 10-18 feet upstream from driveway manhole towards rear patio manhole. Drain line is currently flowing, however pipe damage will deteriorate further. Drain relining or replacement recommended.

Major pipe damage found between 10-18 feet upstream from driveway manhole. Repair required

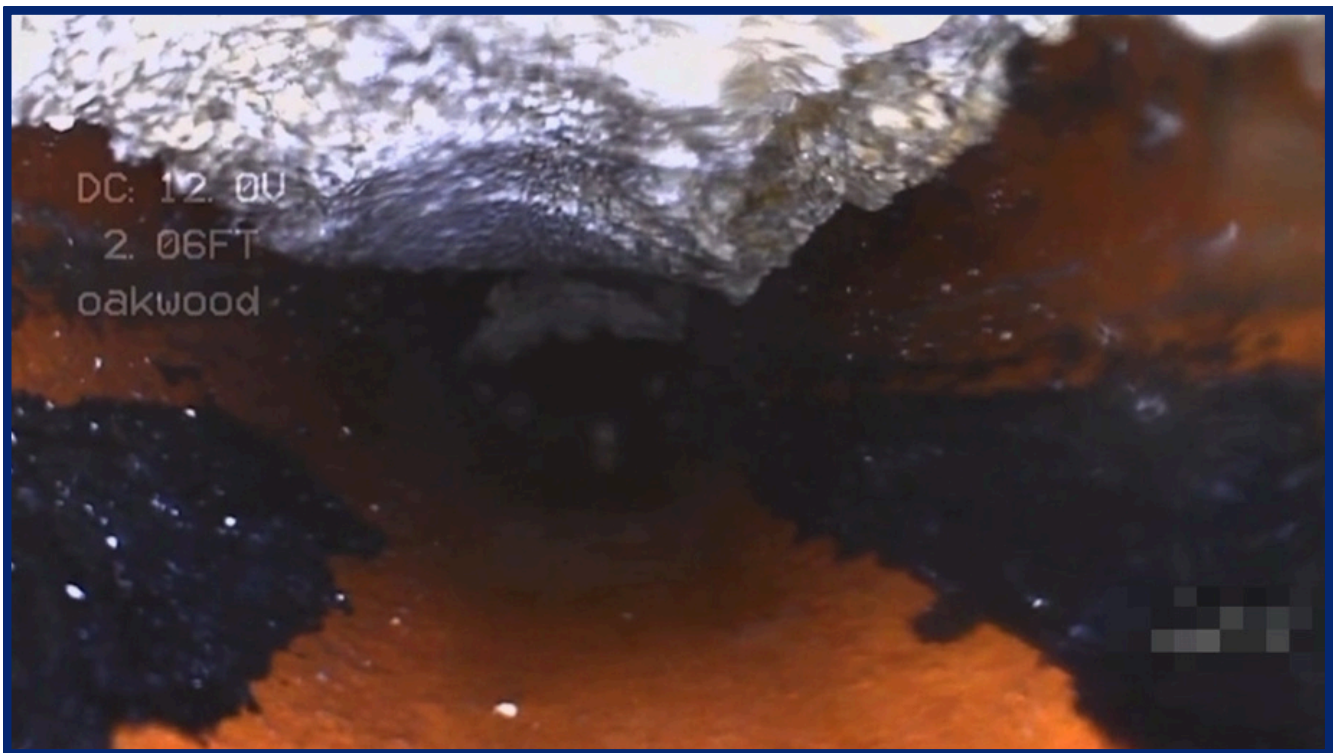
Solidified cooking fat found inside drain line, high pressure jet service clean is recommended.

Settled cooking fat found in drain line. Service clean recommended
