Kempsey - Armidale Road Restoration

Arborist Report

Tree Assessment Report (Part A)

Kempsey to Armidale Road Recovery Program

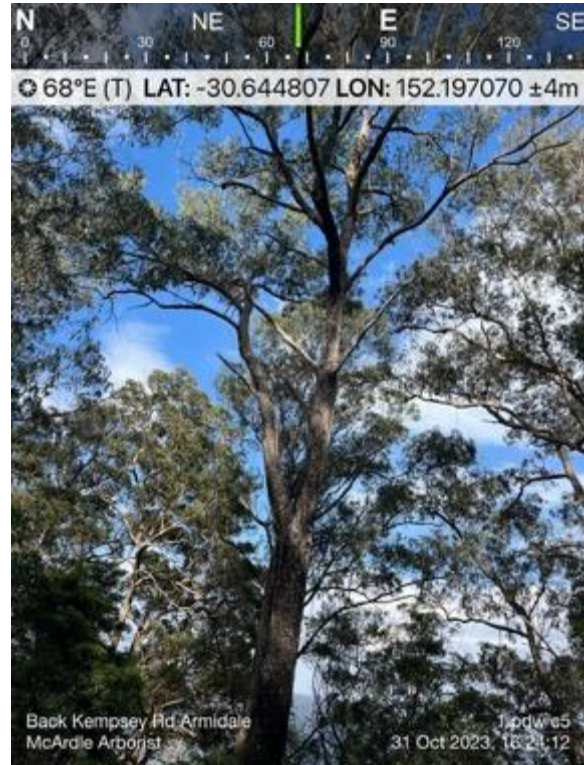
Plate 2: Tree 1a, *Eucalyptus caliginosa* prune dead wood (5 branches) from 15 to 26 meters.

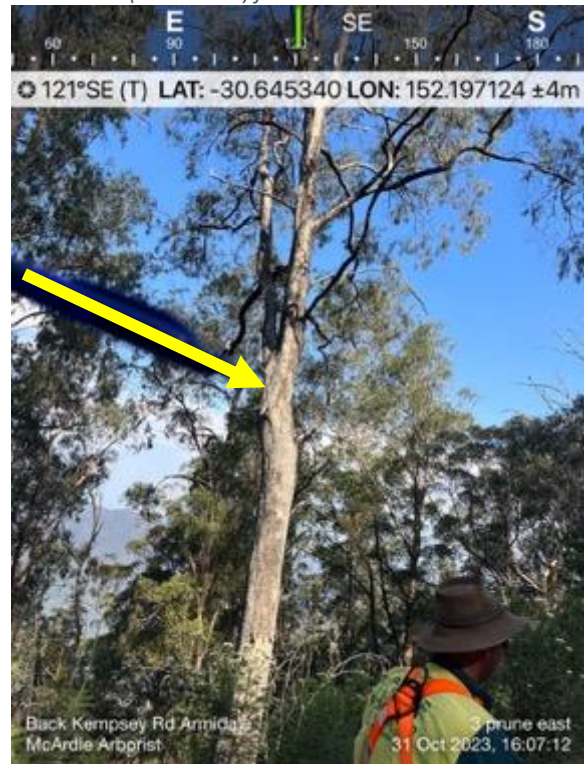
Plate 4: Tree 3, *Eucalyptus netriens* Prune dead wood to the East at 15 meters – heavy dead wood over site. Yellow arrow.

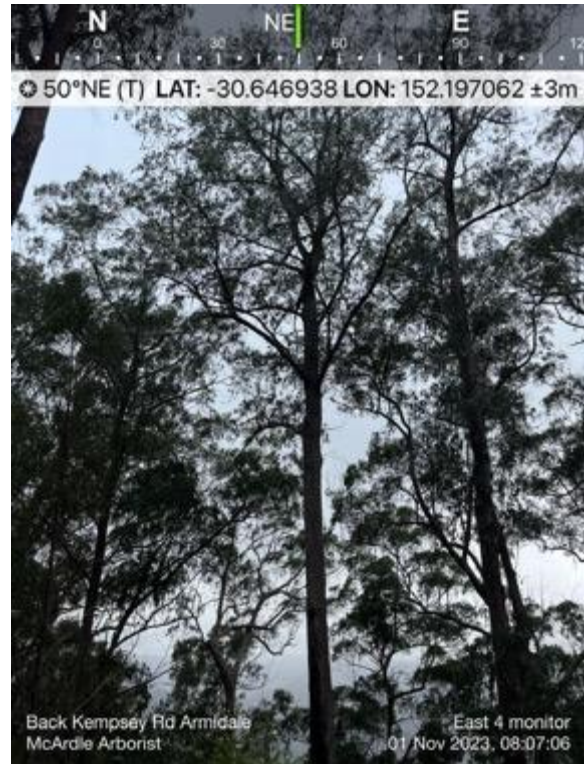
Plate 6: Tree 4, *Eucalyptus netriens* Monitor.

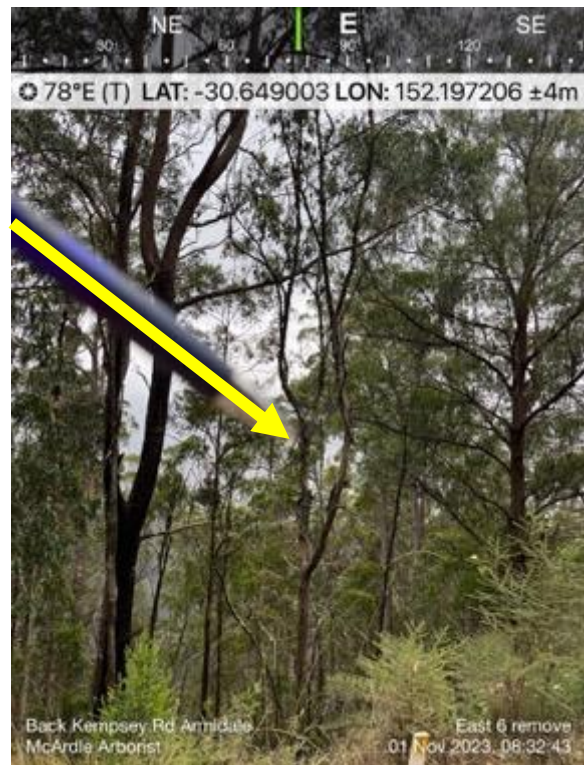
Plate 8: Tree 6, Dead stag, Remove. Yellow arrow.

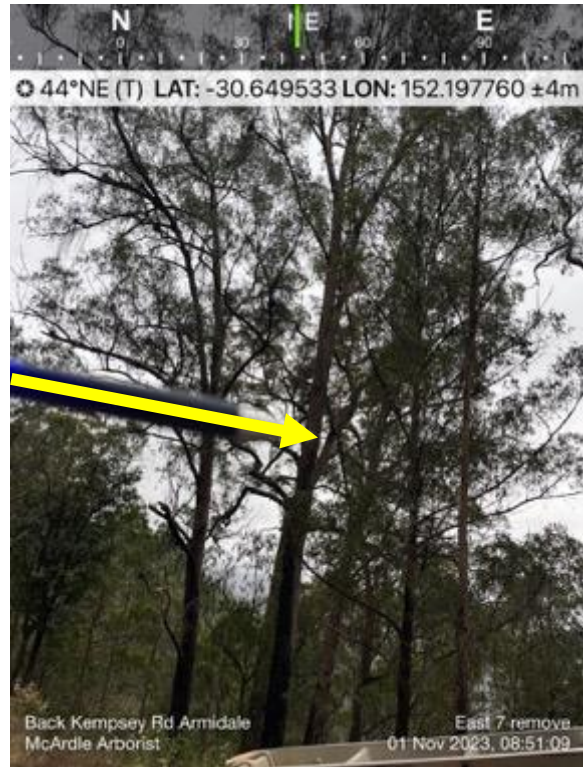
Plate 10: Tree 7, *Eucalyptus caliginosa*. Remove. Yellow arrow.

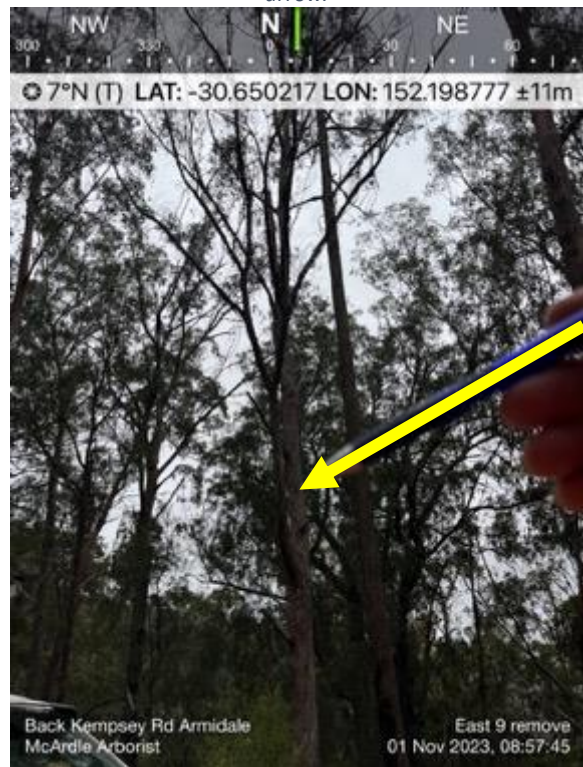
Plate 12: Tree 9, Dead stag, Remove. Yellow arrow.

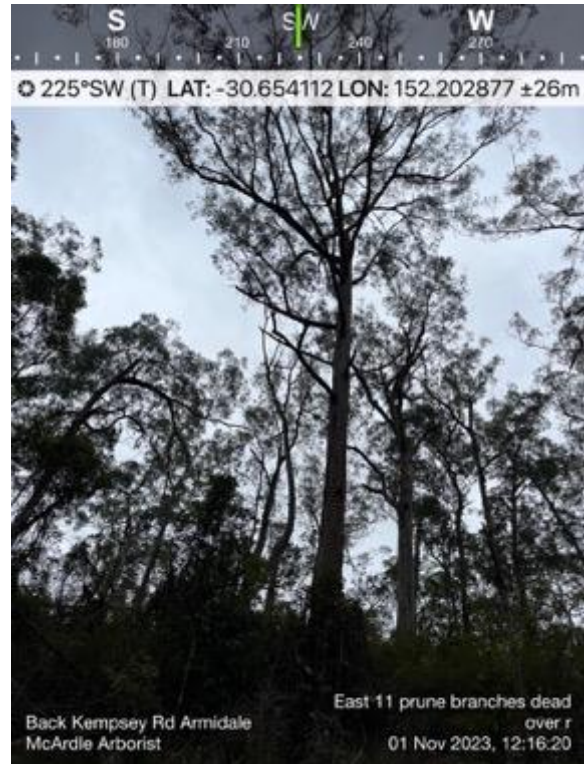
Plate 14: Tree 11, *Eucalyptus caliginosa* Prune dead branches over road.

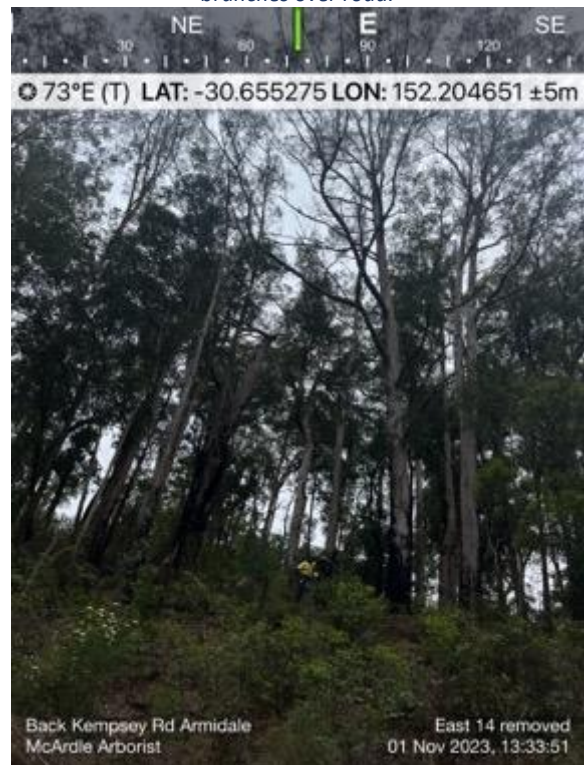
Plate 16: Tree 14, Dead tree, Remove.

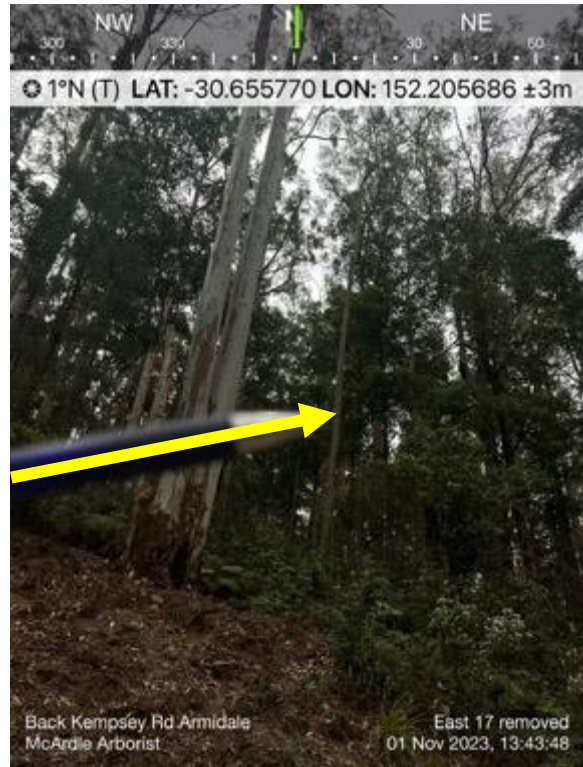
Plate 18: Tree 17, *Eucalyptus saligna*, Remove. Yellow arrow.

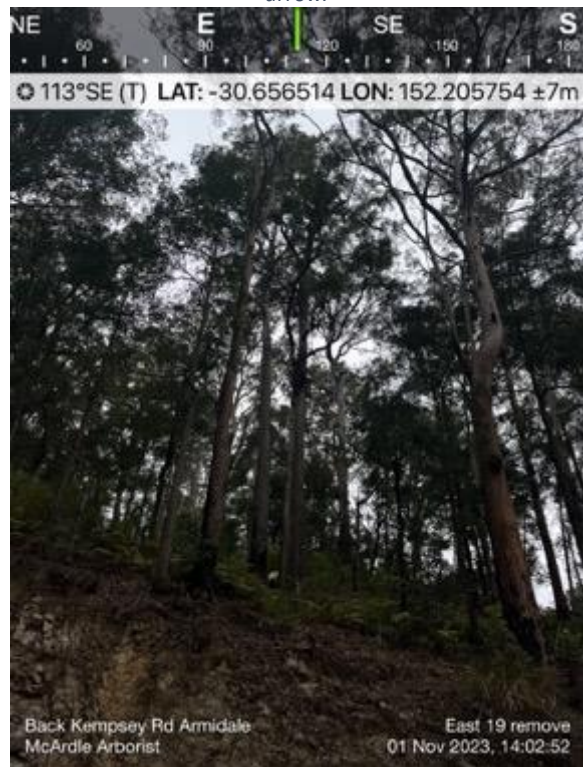
Plate 20: Tree 19, *Syncarpia glomulifera*, Remove.

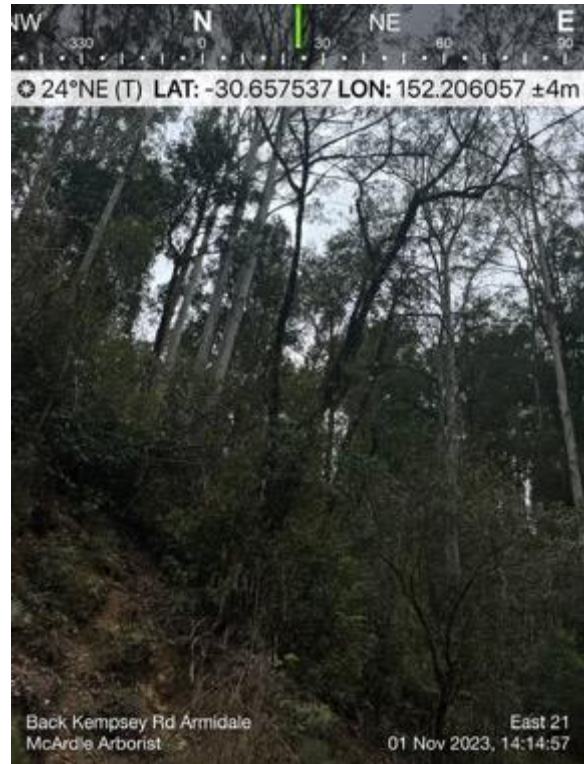
Plate 22: Tree 21, Dead stag, Remove.

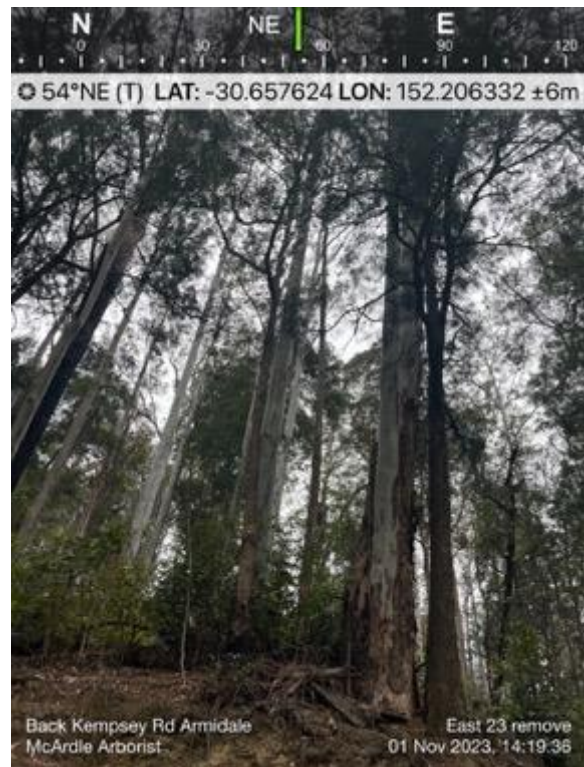
Plate 24: Tree 23, Dead stag, Remove.

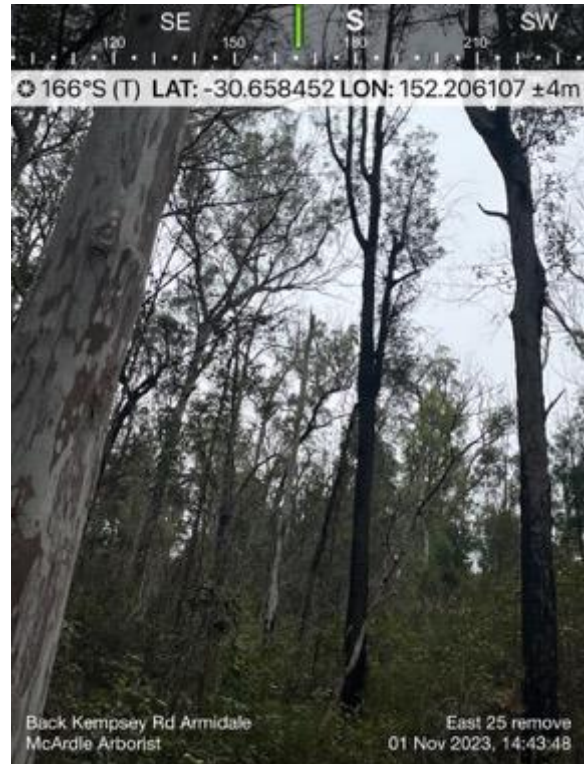
Plate 26: Tree 25, Casuarina species, Remove.

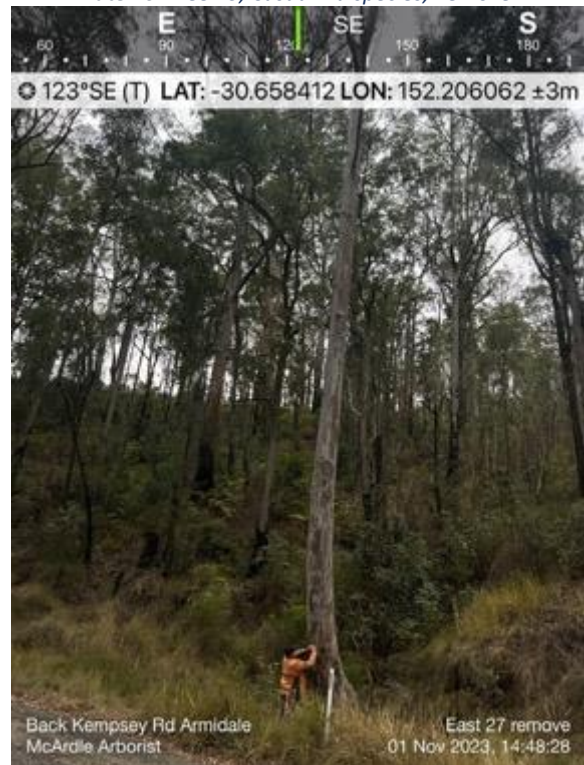
Plate 28: Tree 27, Eucalyptus saligna, Remove.

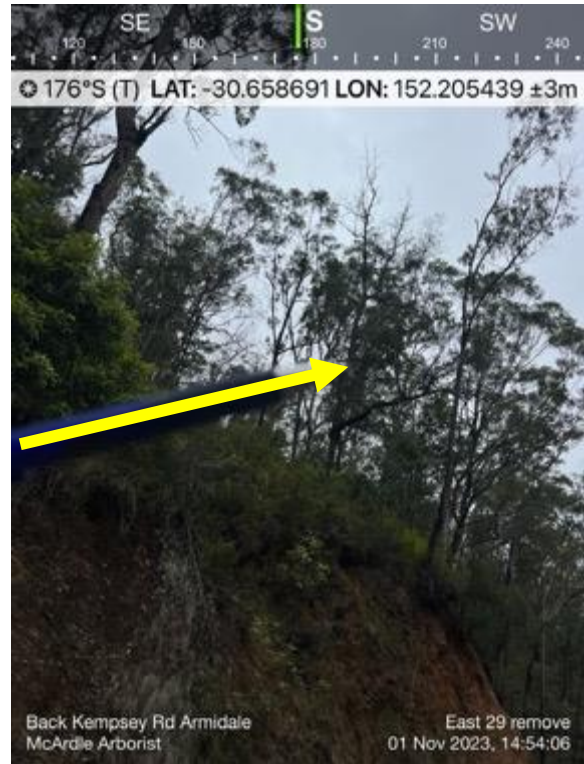
Plate 30: Tree 29, *Casuarina* species, Remove. Yellow arrow.

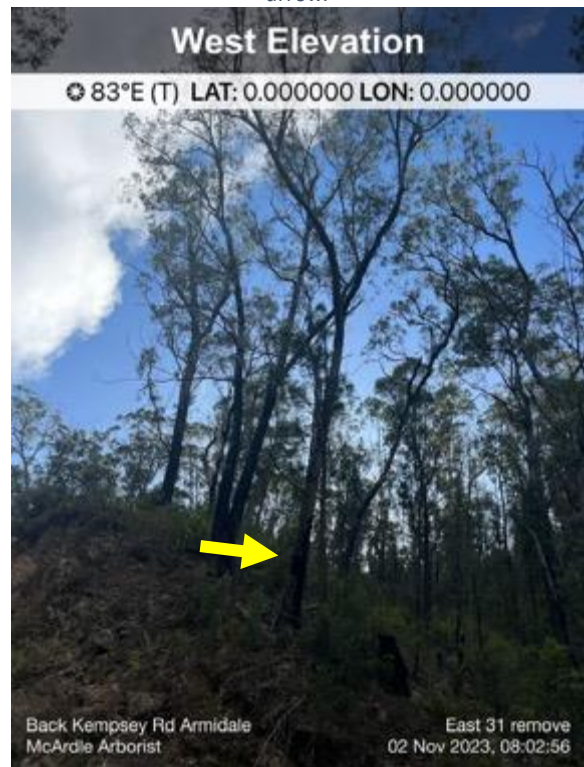
Plate 32: Tree 31, *Eucalyptus caliginosa*. Remove.

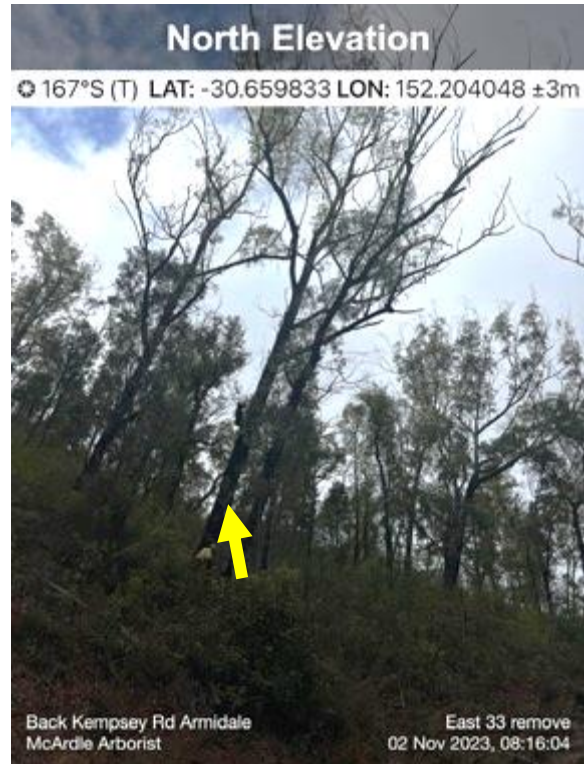
Plate 34: Tree 33, *Eucalyptus caliginosa*. Remove.

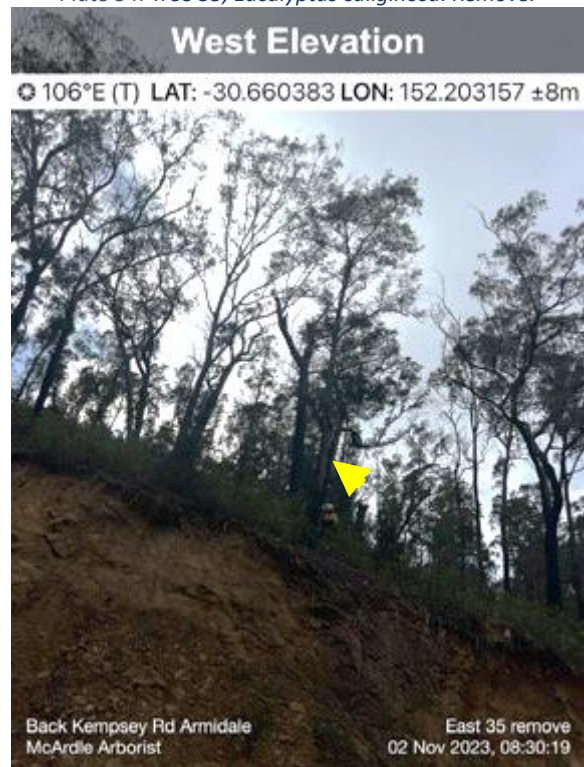
Plate 36: Tree 35, *Syncarpia glomulifera*, Remove.

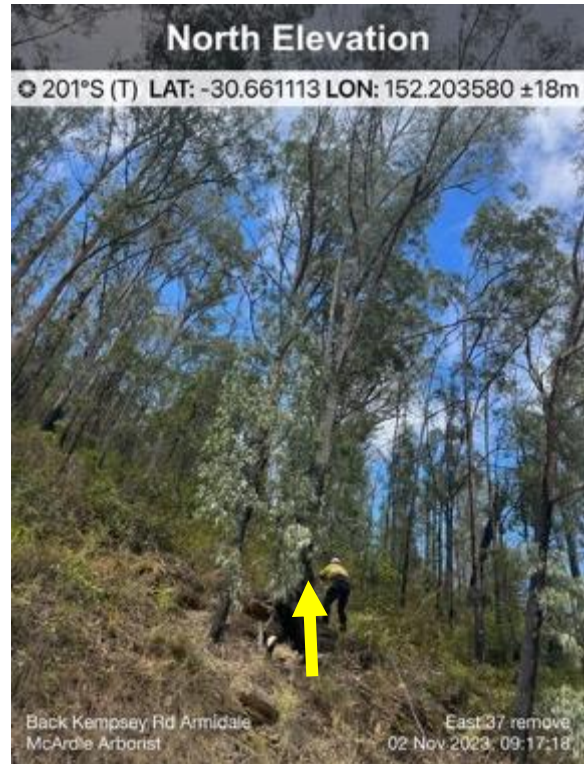
Plate 38: Tree 37, Eucalyptus caliginosa. Remove. On bank.

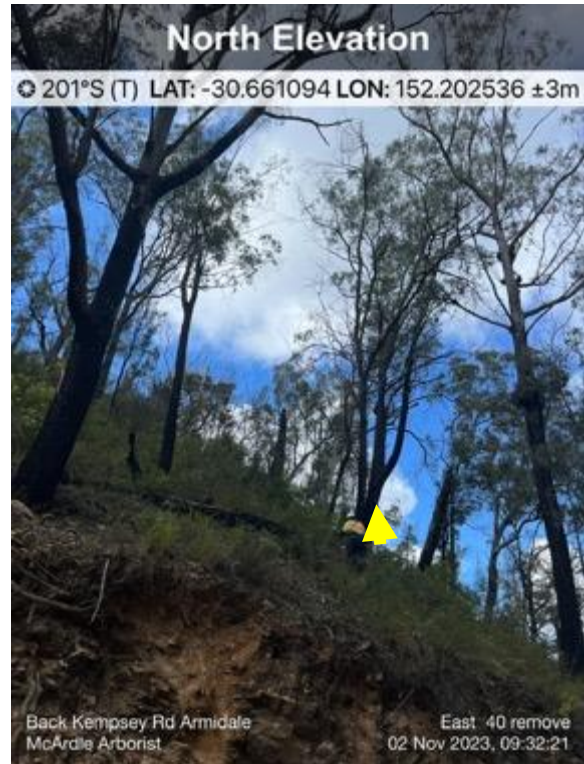
Plate 42: Tree 40, *Casuarina* species, Remove.

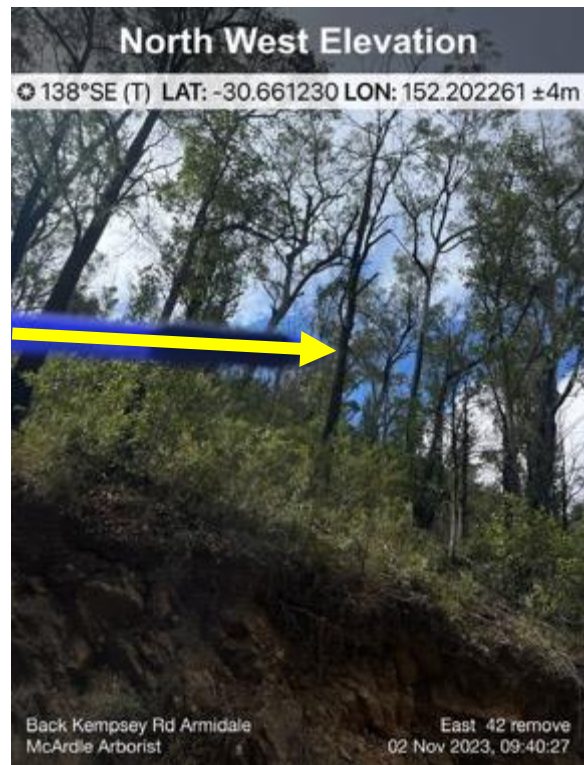
Plate 44: Tree 42, Dead *Casuarina* stag, Remove. Yellow arrow.

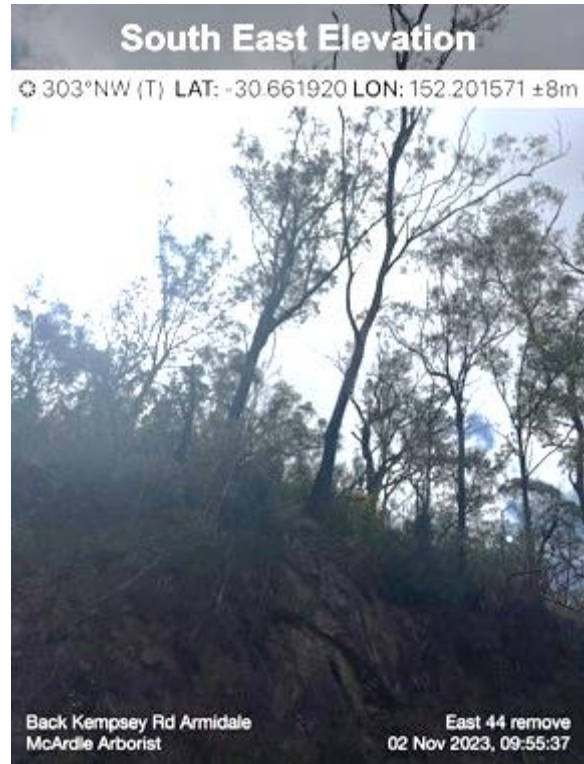
Plate 46: Tree 44, *Eucalyptus caliginosa*. Remove.

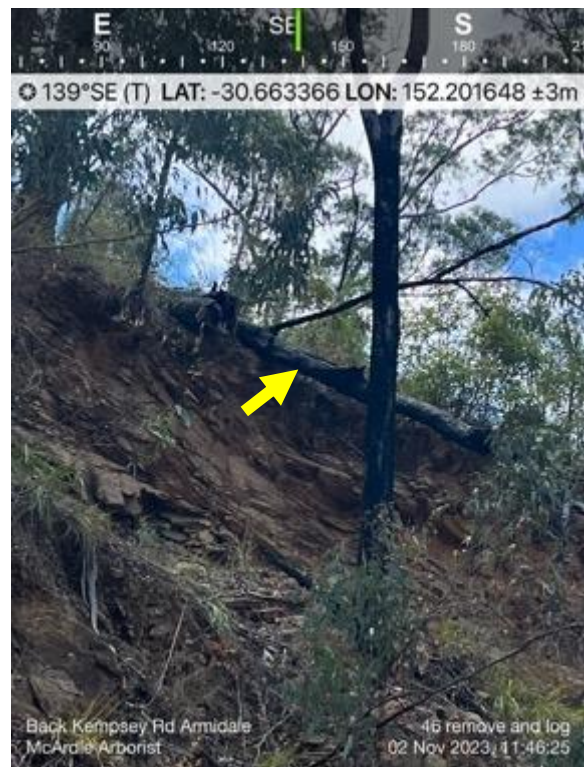
Plate 48: Tree 46, Dead stag, Remove.

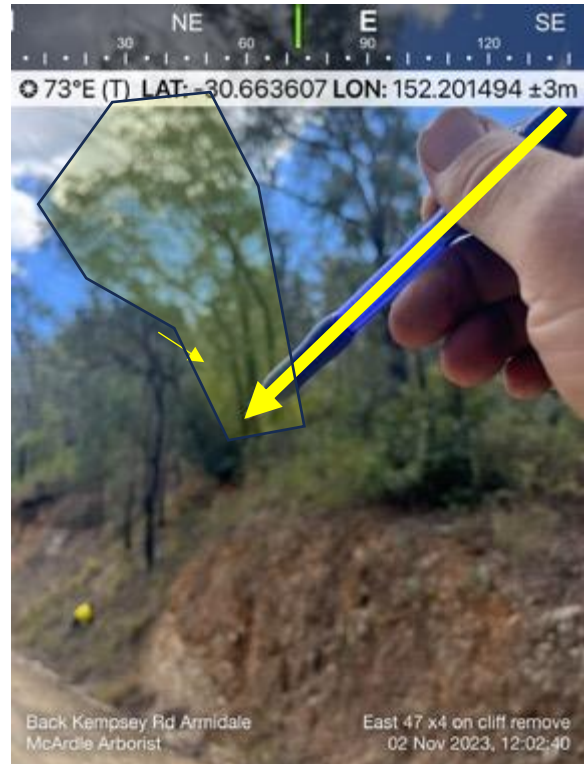
Plate 50: Tree 47, *Eucalyptus caliginosa* Remove. Yellow arrow and yellow hatch.

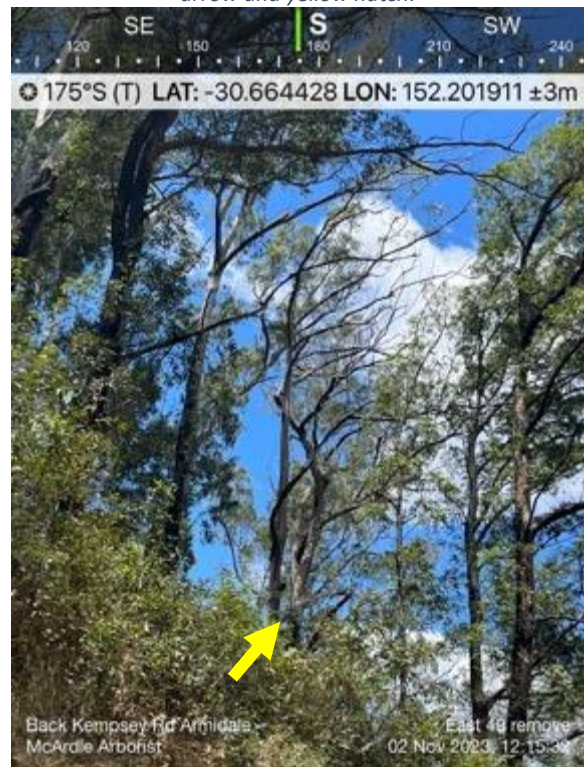
Plate 52: Tree 49, Dead stag, Remove.

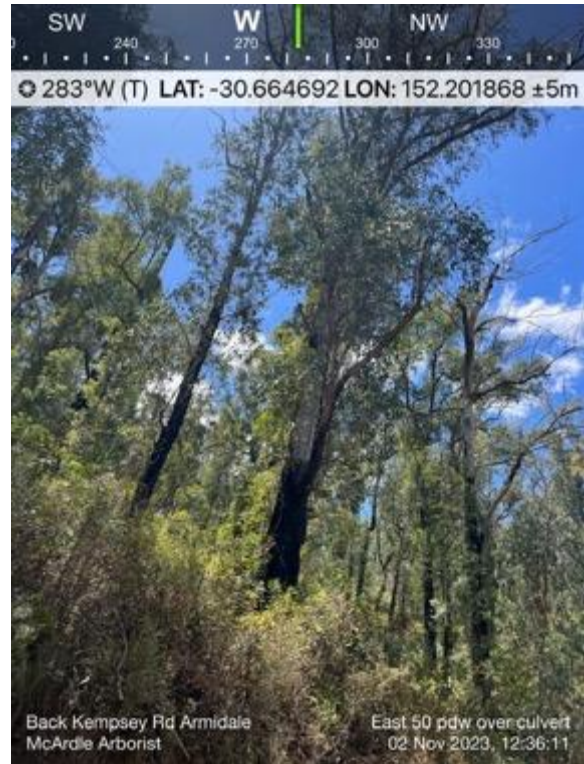
Plate 54: Tree 50, *Eucalyptus caliginosa* Prune dead wood at 10 to 20 meters.

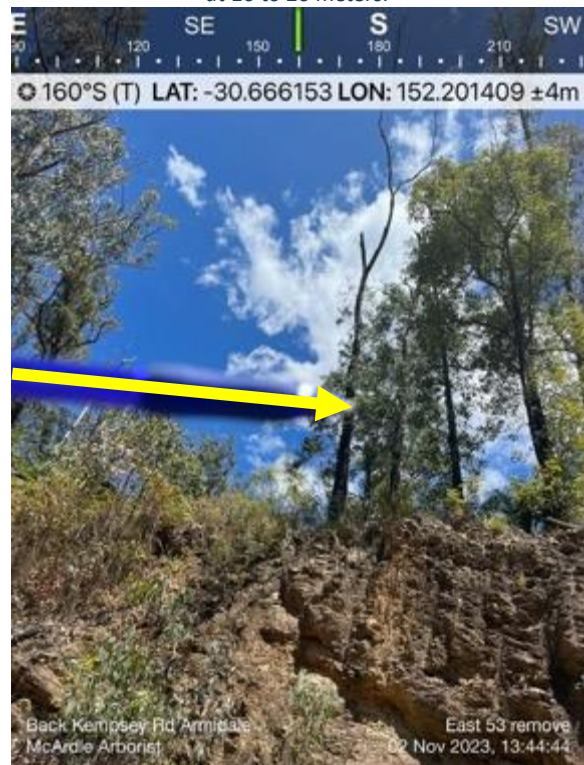
Plate 56: Tree 53, *Eucalyptus caliginosa* Remove. Yellow arrow.

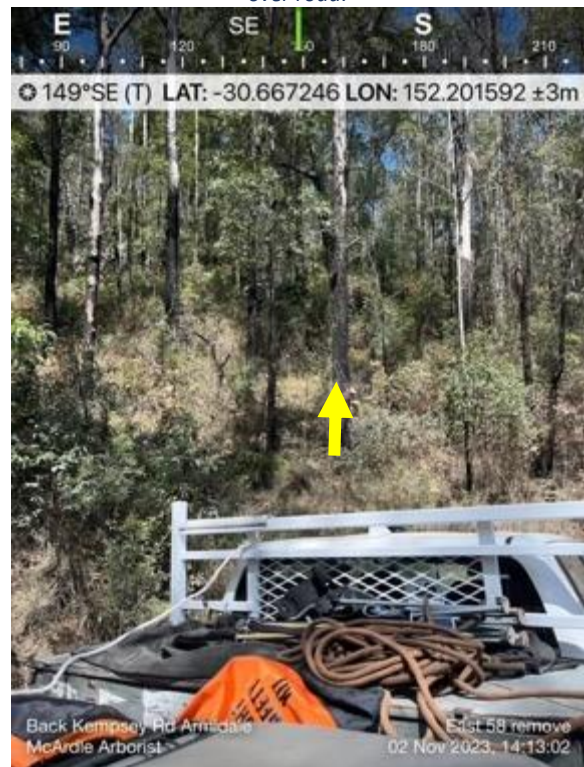
Plate 60: Tree 58, *Eucalyptus caliginosa*, Remove.

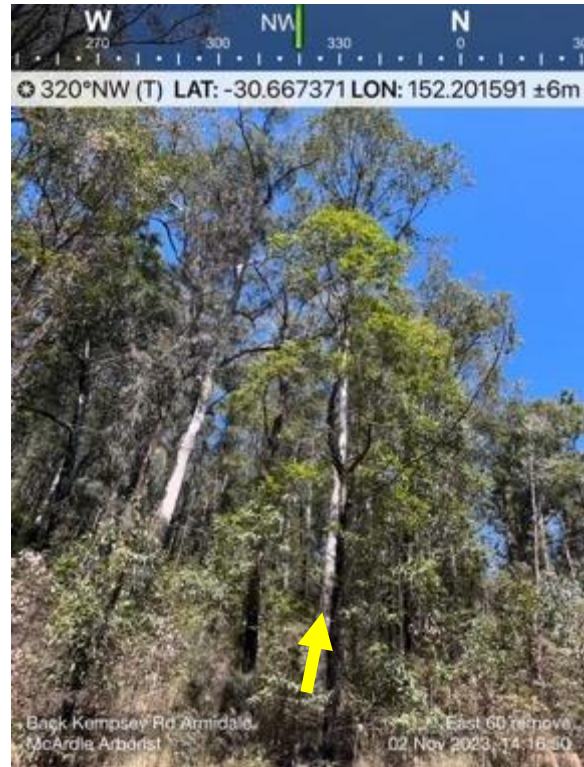
Plate 62: Tree 60, *Eucalyptus saligna*, Remove.

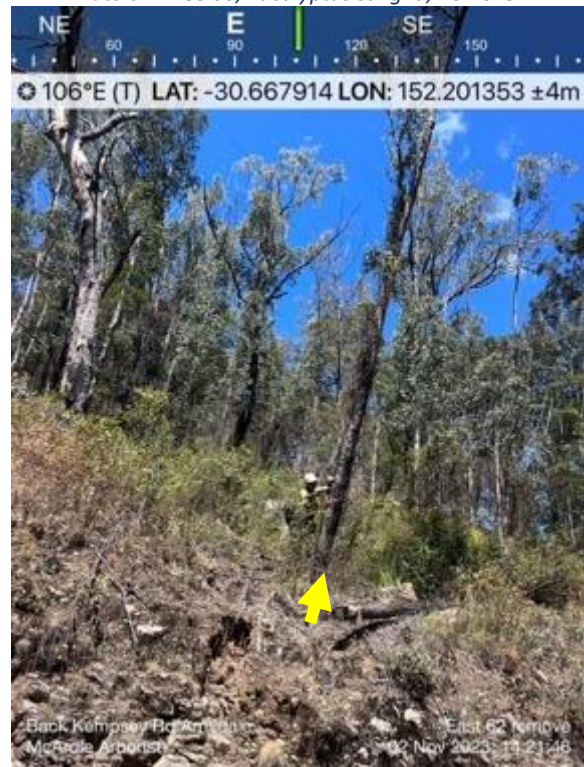
Plate 64: Tree 62, *Eucalyptus caliginosa* Remove.

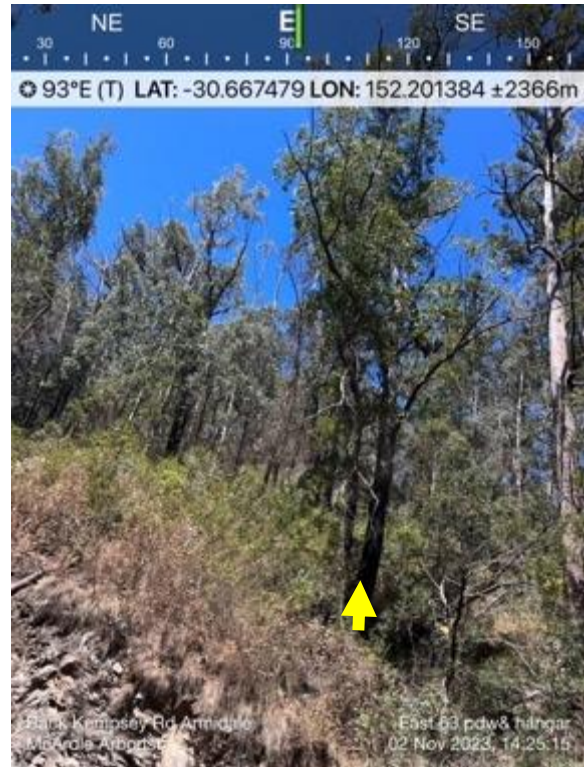
Plate 66: Tree 63, *Eucalyptus caliginosa*, Prune dead wood and hanging branch over target.

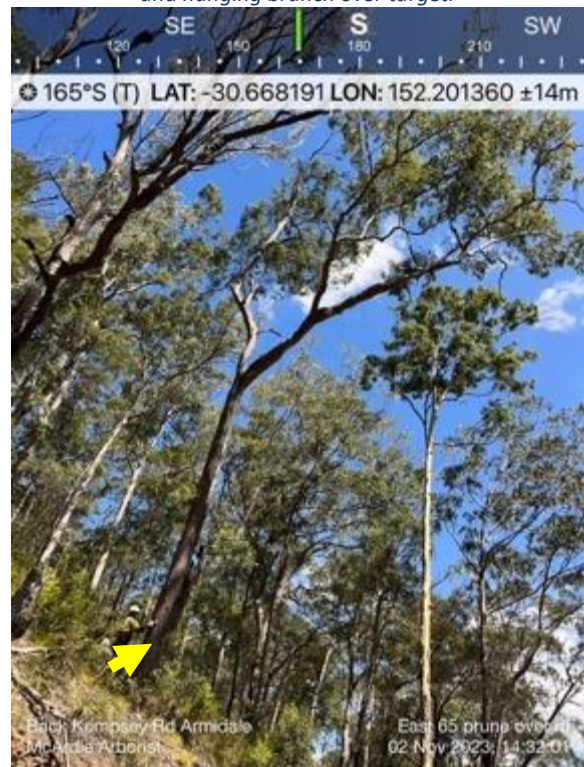
Plate 68: Tree 65, *Angophora costata*, Prune with 300 mm diameter cut at 16 meters.

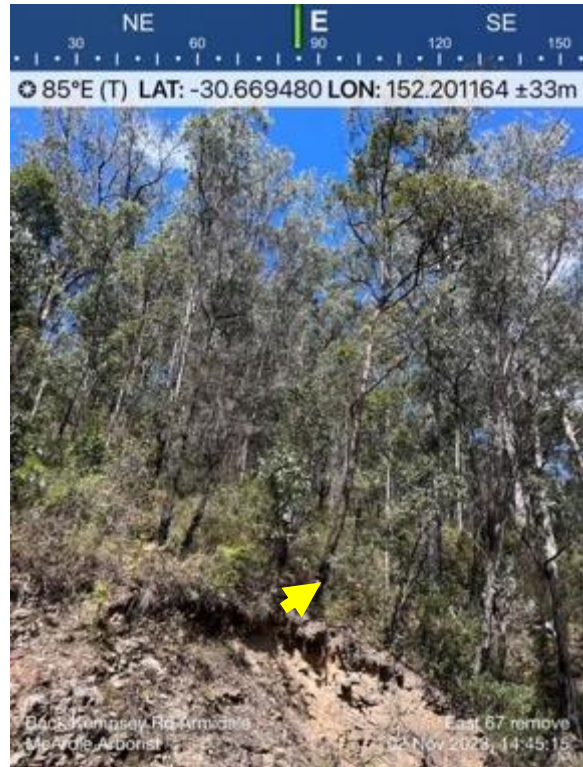
Plate 70: Tree 67, *Eucalyptus caliginosa* , Remove.

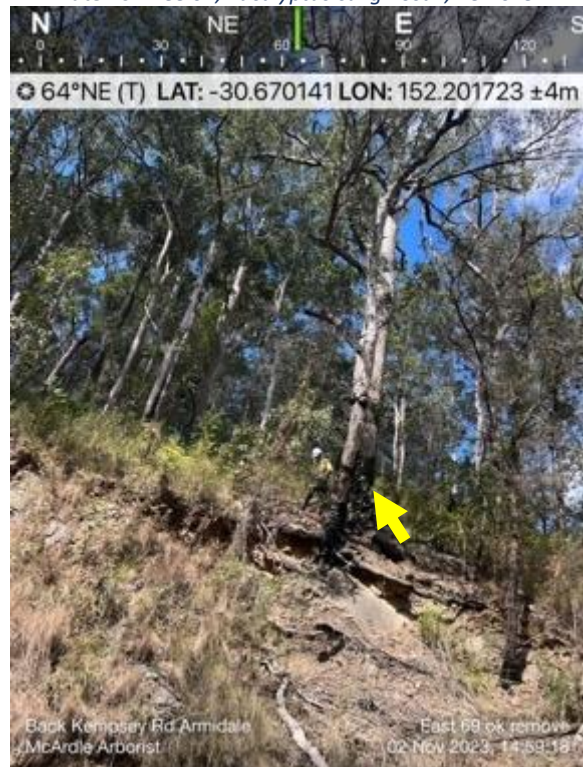
Plate 72: Tree 69, *Eucalyptus caliginosa* , Remove to stump.

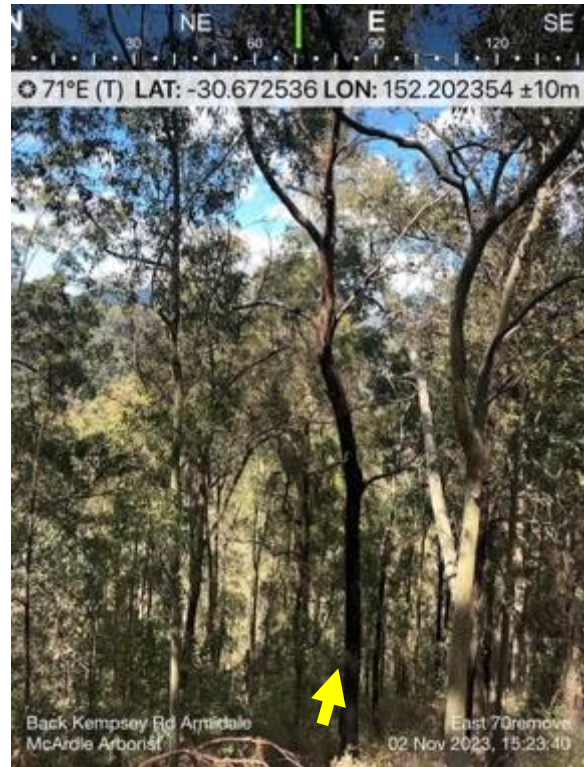
Plate 74: Tree 70, *Eucalyptus microcorys*, Remove.

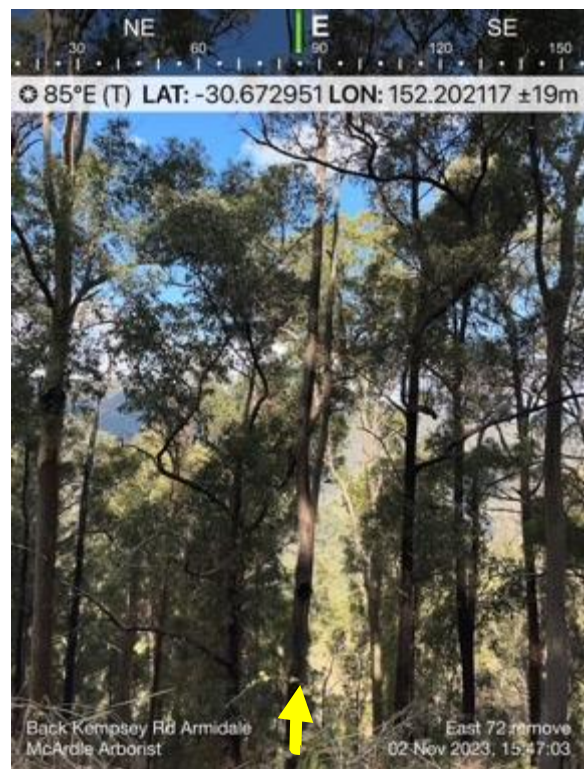
Plate 76: Tree 72, Dead stag, Remove.

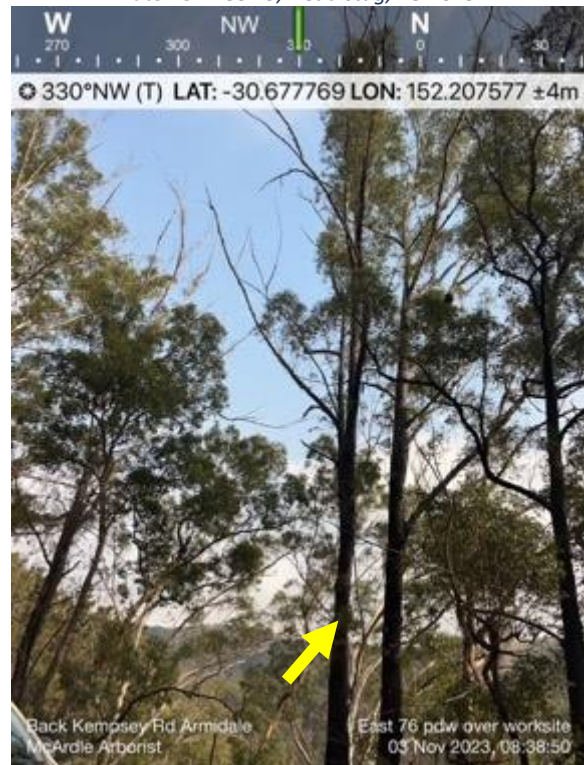
Plate 80: Tree 76, Eucalyptus caliginosa, Prune dead wood over road 12 to 25 meters.

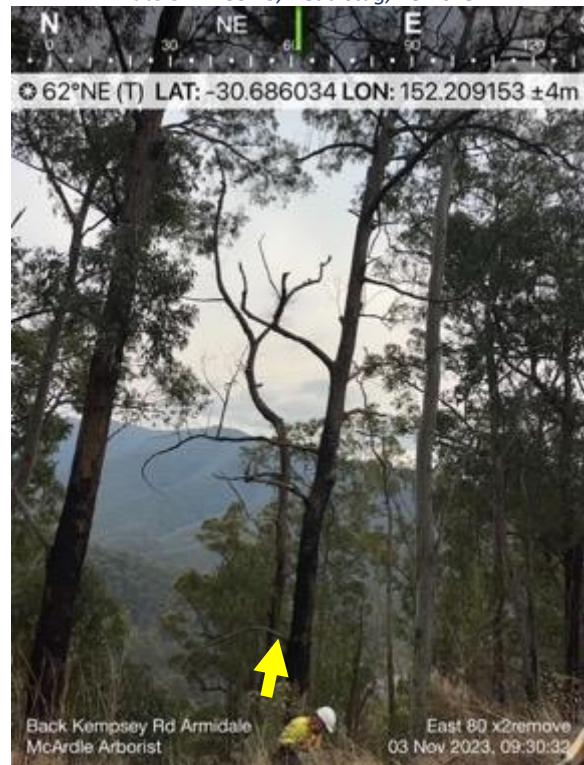
Plate 84: Tree 80, Dead stag, Remove.

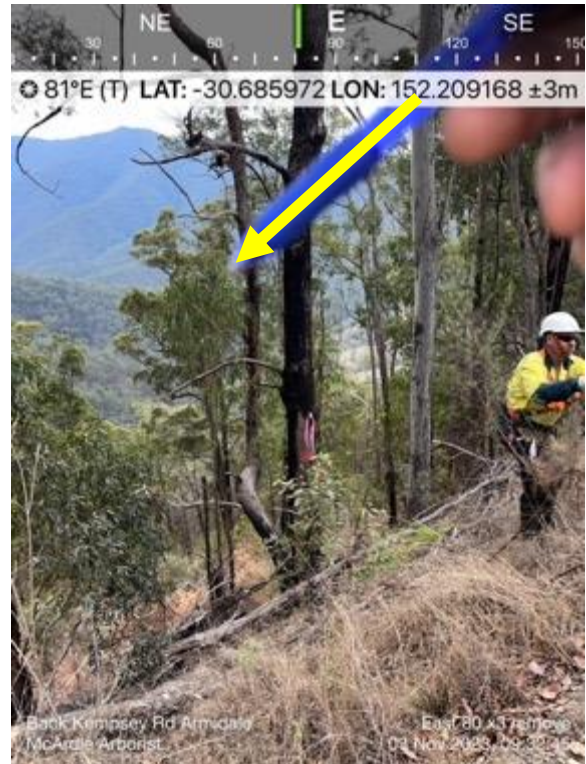
Plate 86: Tree 80, Dead stag, Remove. Yellow arrow.

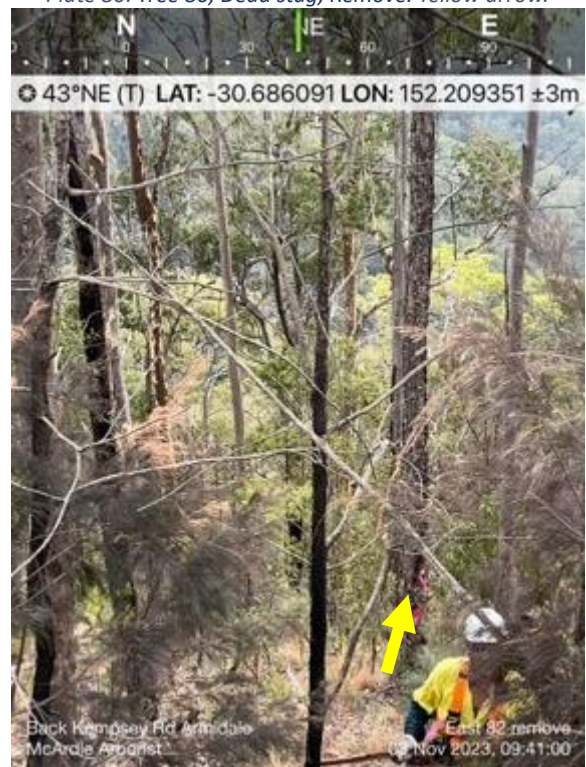
Plate 88: Tree 82, Dead stag, Remove.

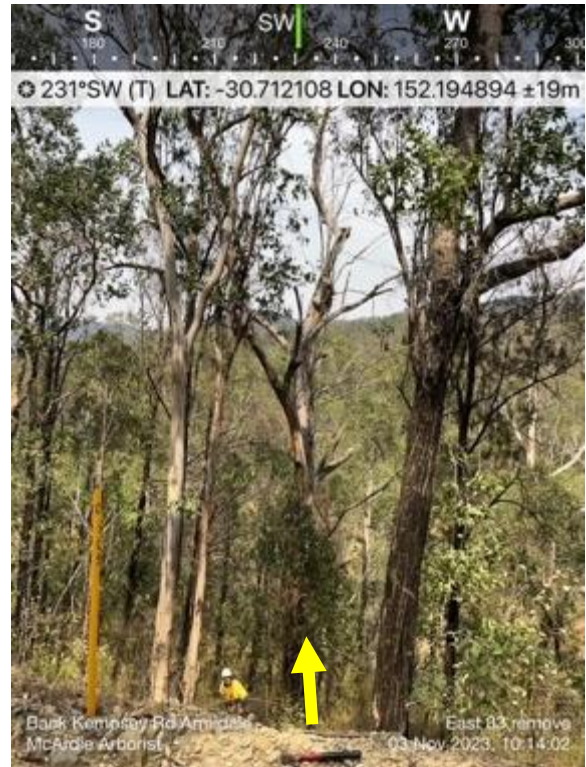
Plate 90: Tree 83, Dead stag, Remove.

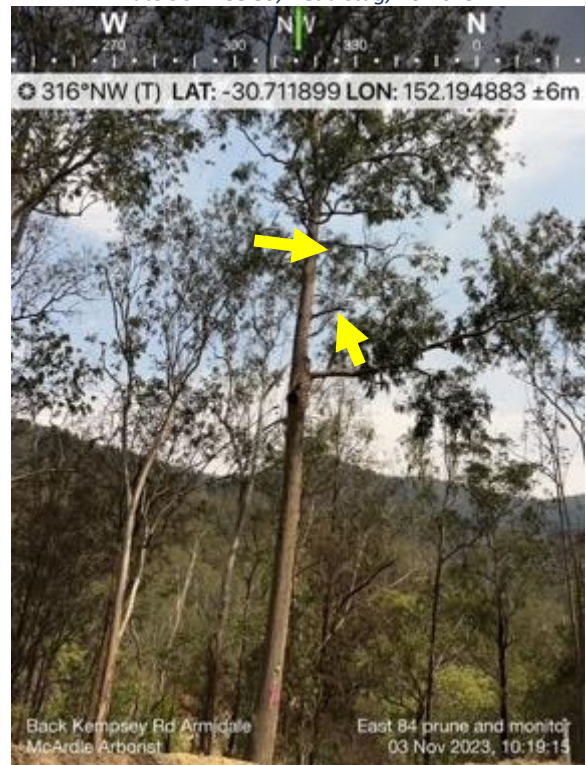
Plate 92: Tree 84, *Corymbia maculata*, Prune (Yellow arrow) and monitor.

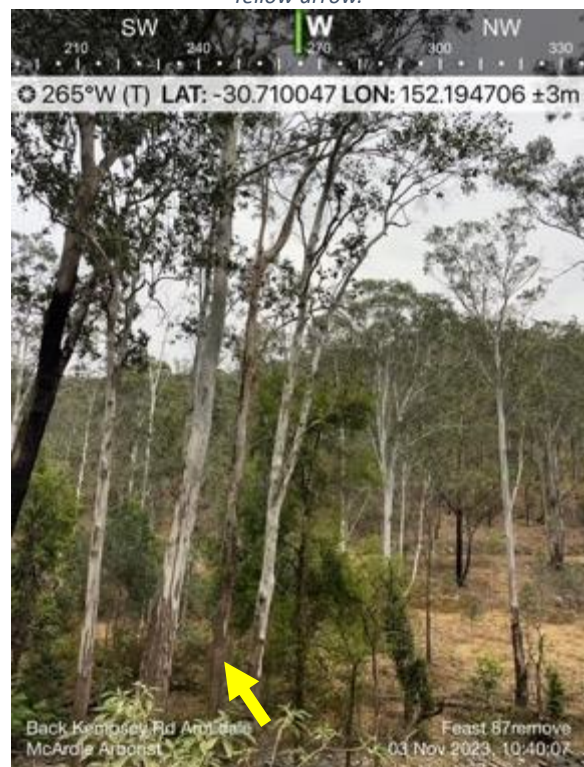
Plate 96: Tree 87, Eucalyptus Remove.

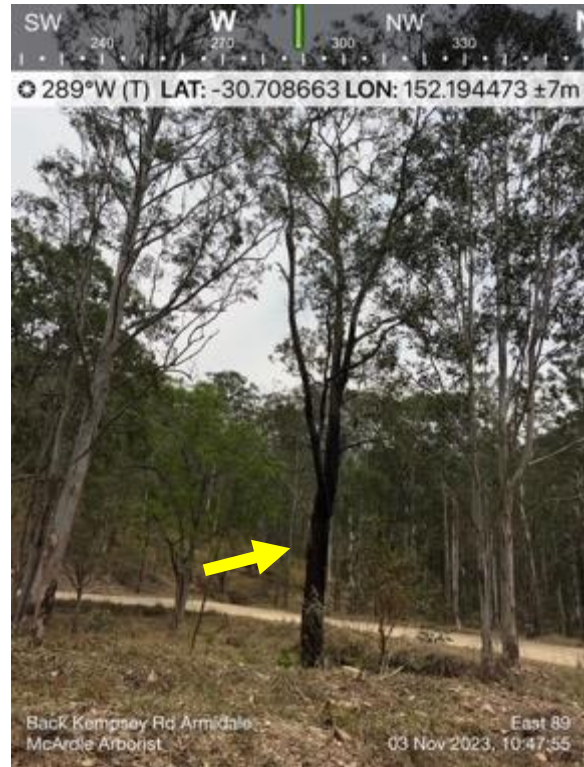
Plate 98: Tree 89, *Angophora floribunda*, Remove tree if working adjacent.

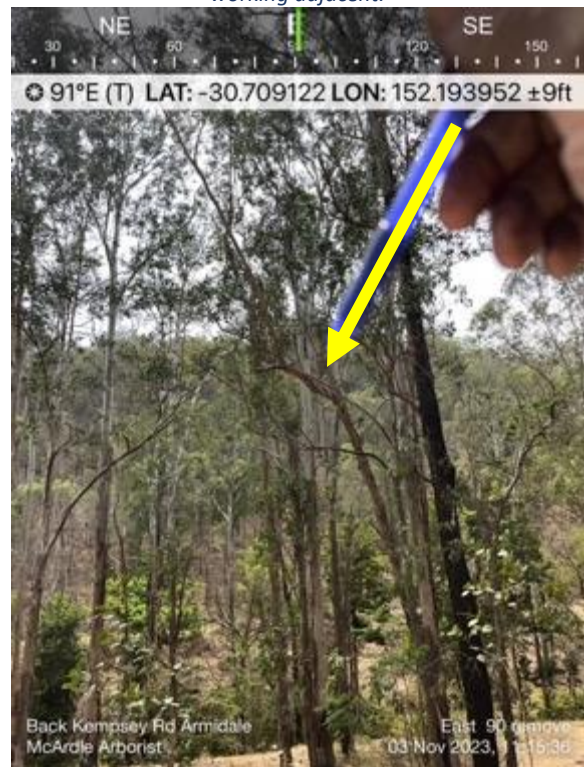
Plate 100: Tree 90, Dead stag, Remove. Yellow arrow.

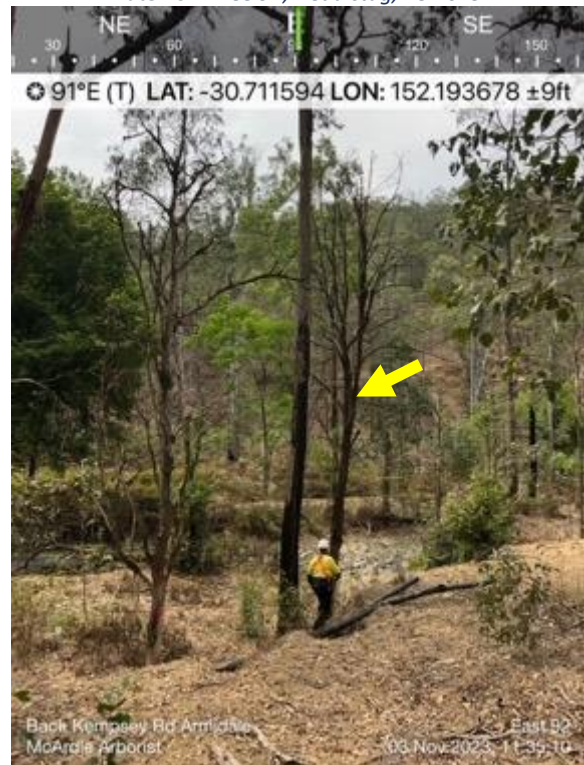
Plate 104: Tree 92, Dead stag, Remove.

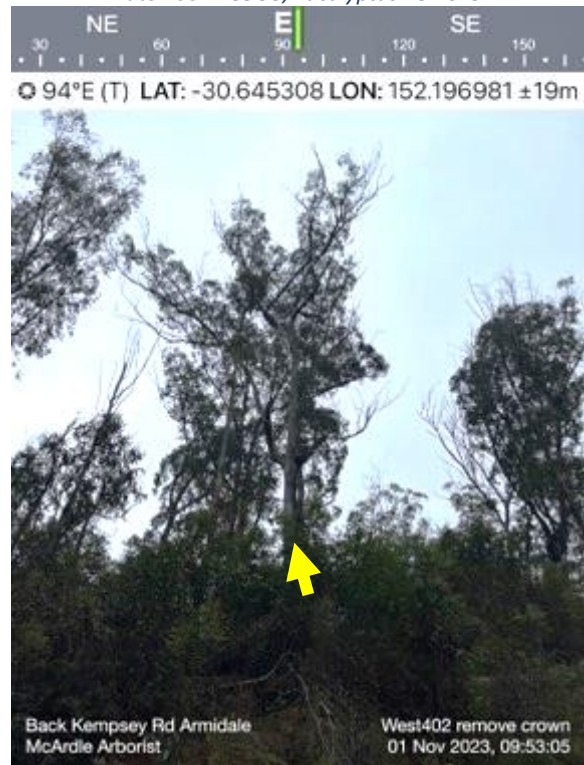
Plate 108: Tree 402, Eucalyptus caliginosa, Prune branches over work area or remove.

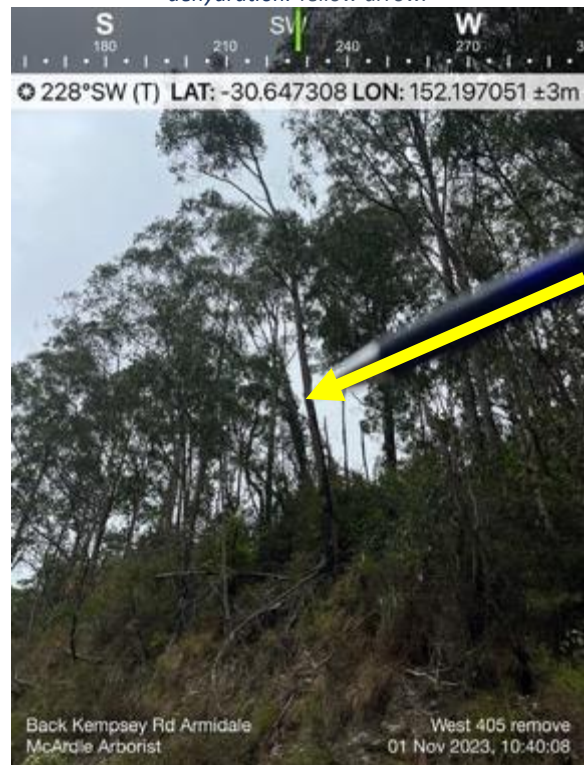
Plate 112: Tree 405, *Eucalyptus caliginosa*, Remove. Yellow arrow.

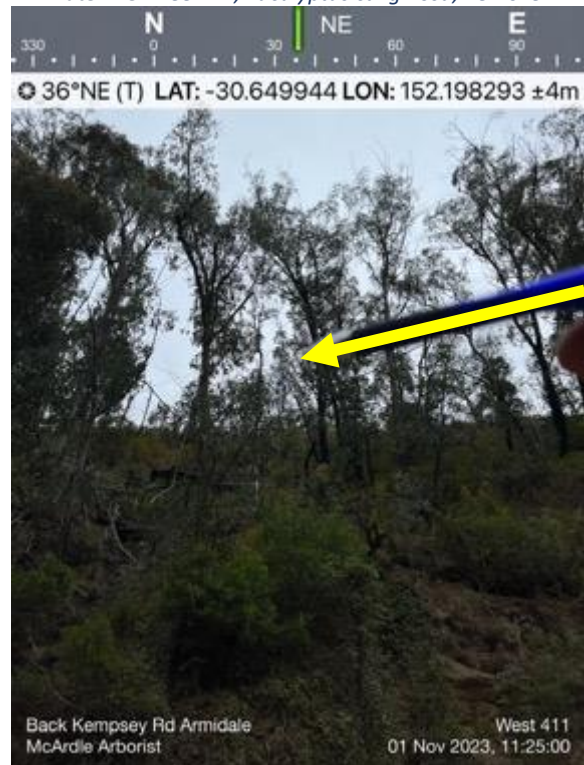
Plate 120: Tree 411, *Eucalyptus caliginosa*, Remove.
Yellow arrow.

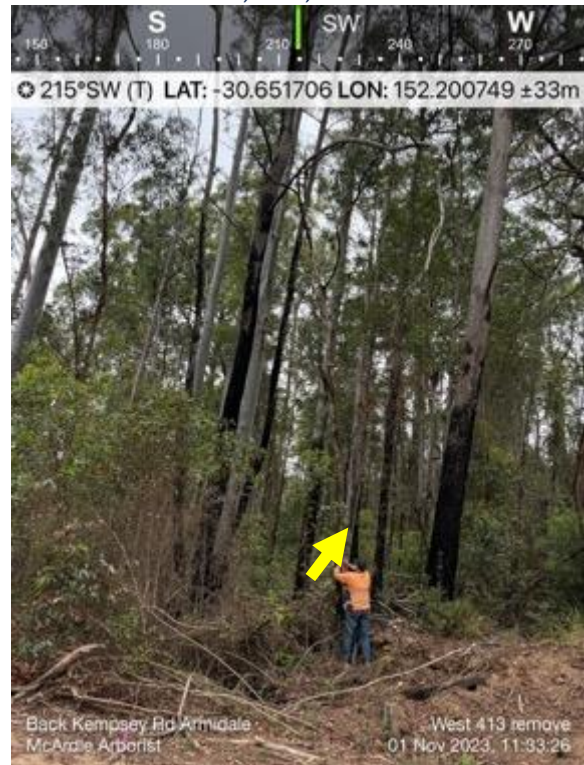
Plate 124: Tree 413, Dead, Remove.
