Kempsey - Armidale Road Restoration

Arborist Report

Tree Assessment Report (Part A)

Kempsey to Armidale Road Recovery Program

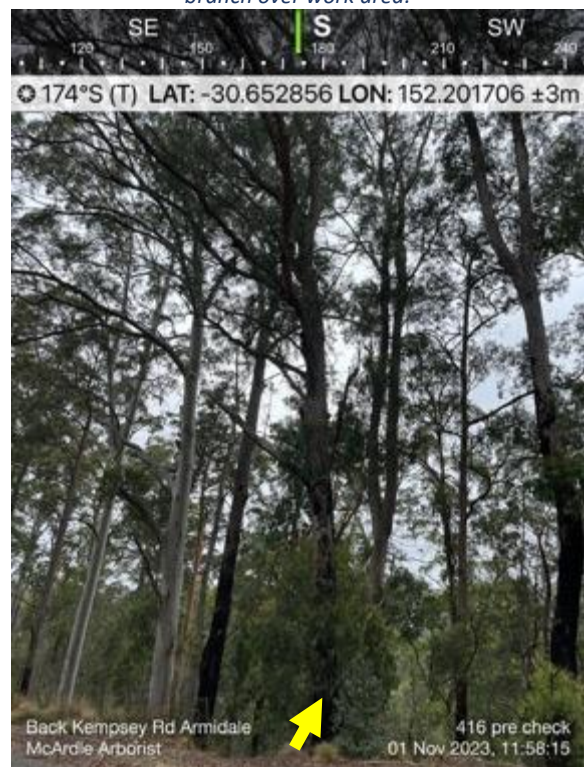
Plate 128: Tree 416, Eucalyptus caliginosa, Prune dead wood over walk area.

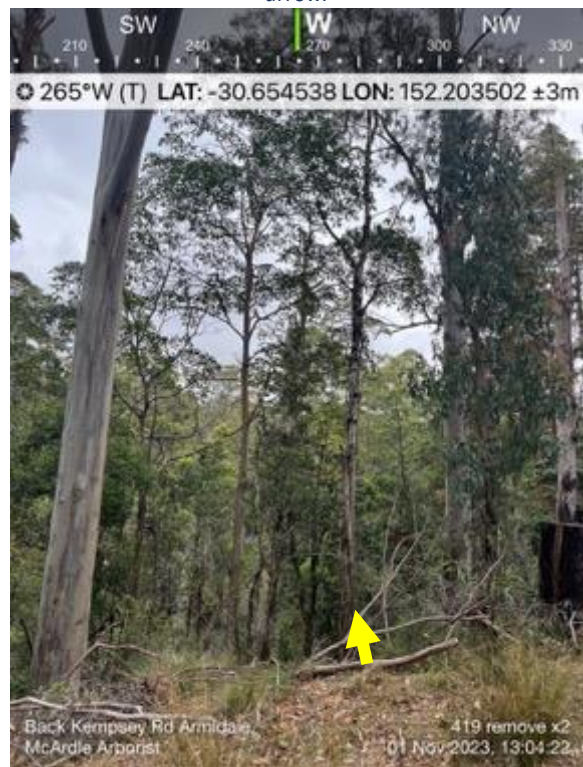
Plate 132: Tree 419, Dead stag, Remove.

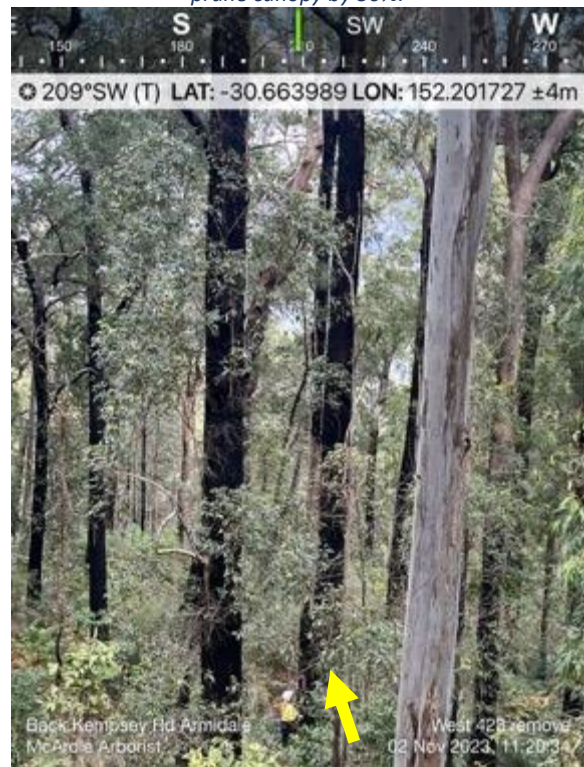
Plate 136: Tree 423, Dead stag, Remove.

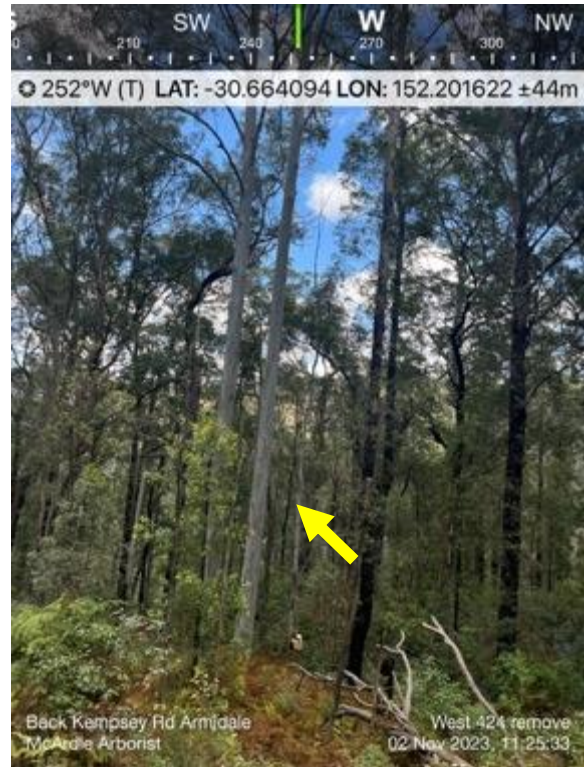
Plate 138: Tree 424, Dead stag, Remove.

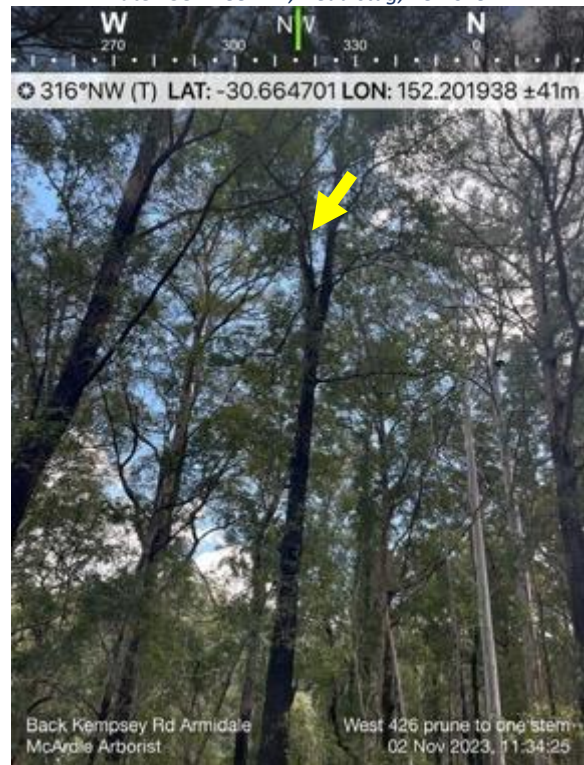
Plate 140: Tree 426, *Syncarpia glomulifera*, Prune to one stem at 18 meters.

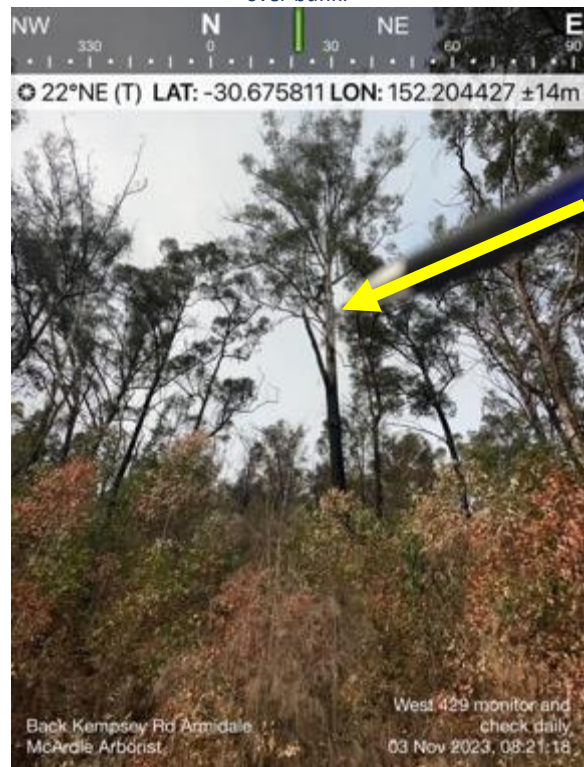
Plate 144: Tree 429, *Eucalyptus pilularis*, Prune failed branch. Yellow arrow.

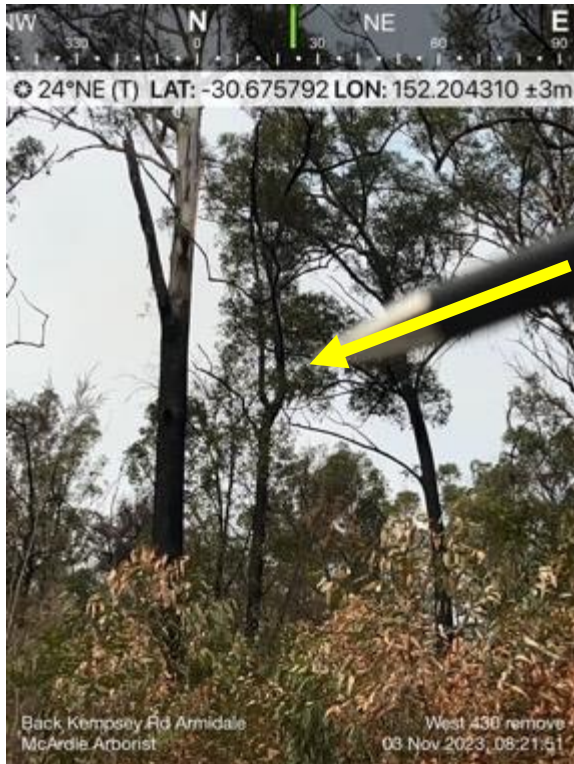
Plate 145: Tree 430, *Eucalyptus caliginosa* Remove. Yellow arrow.

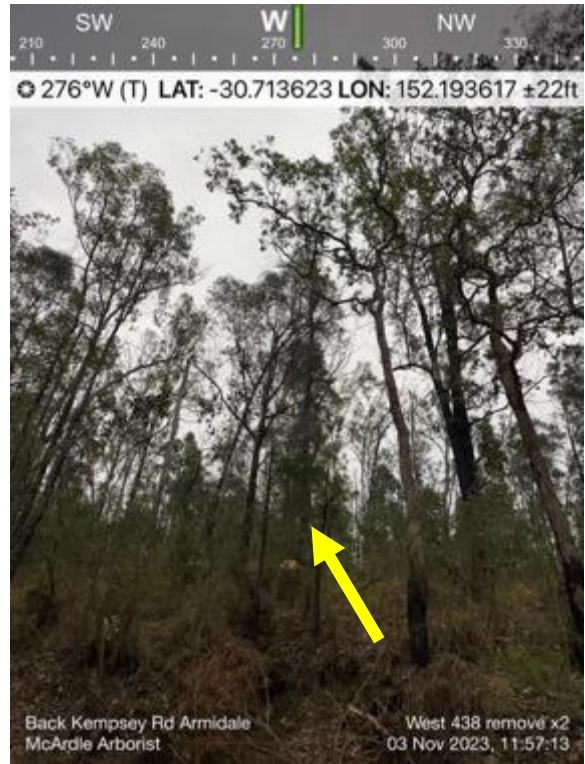
Plate 154: Tree 438, Dead stag, Remove.

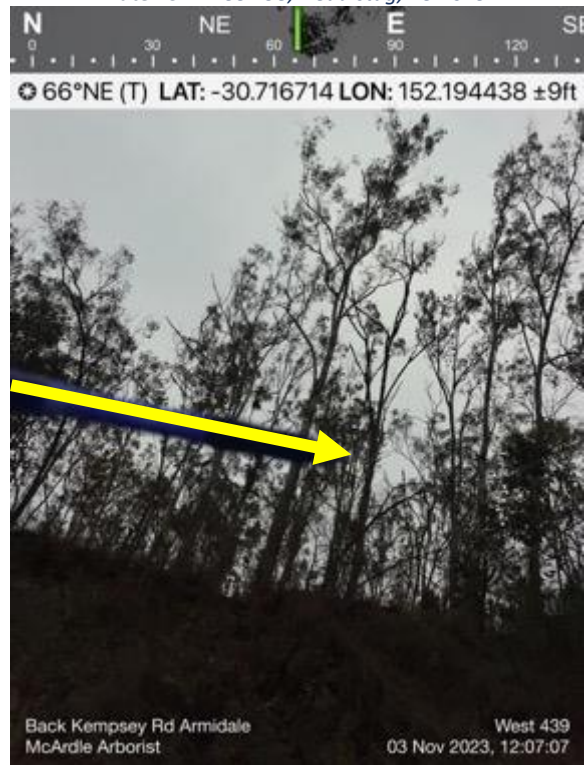
Plate 156: Tree 439, Dead stag, Remove, and remove stumps. Yellow arrow.
