IADD MUD MOTOR FORUM

- Carlos Menendez
- Motor Stalling Within Operational Parameters - Causes, Protocols, Repercussions, Prevention, and Redesigning the Limit of Performance
- January 26th, 2023
- Percussion Petroleum
- Texas A&M, Petroleum Engineering, Class of 2016.

Subject Well – Ward County, TX

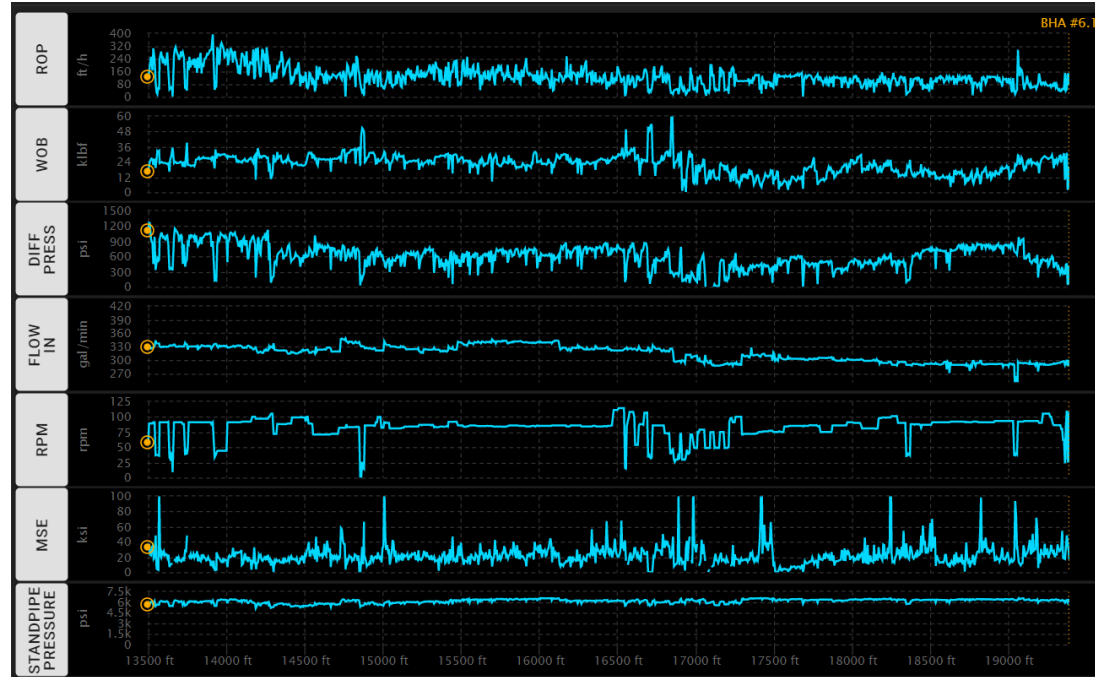
- High initial ROP
 - 1,400' in 12 hrs conventional 6.75" lateral (115 fph), 250-300 fph instantaneous
 - Slowed down to 100 fph by end of run.
- Riding SPP, limiting motor HP
 - 1,200/2,500 max dP (50%)
 - With 325 gpm, 70% of dyno HP and 25% of spec.

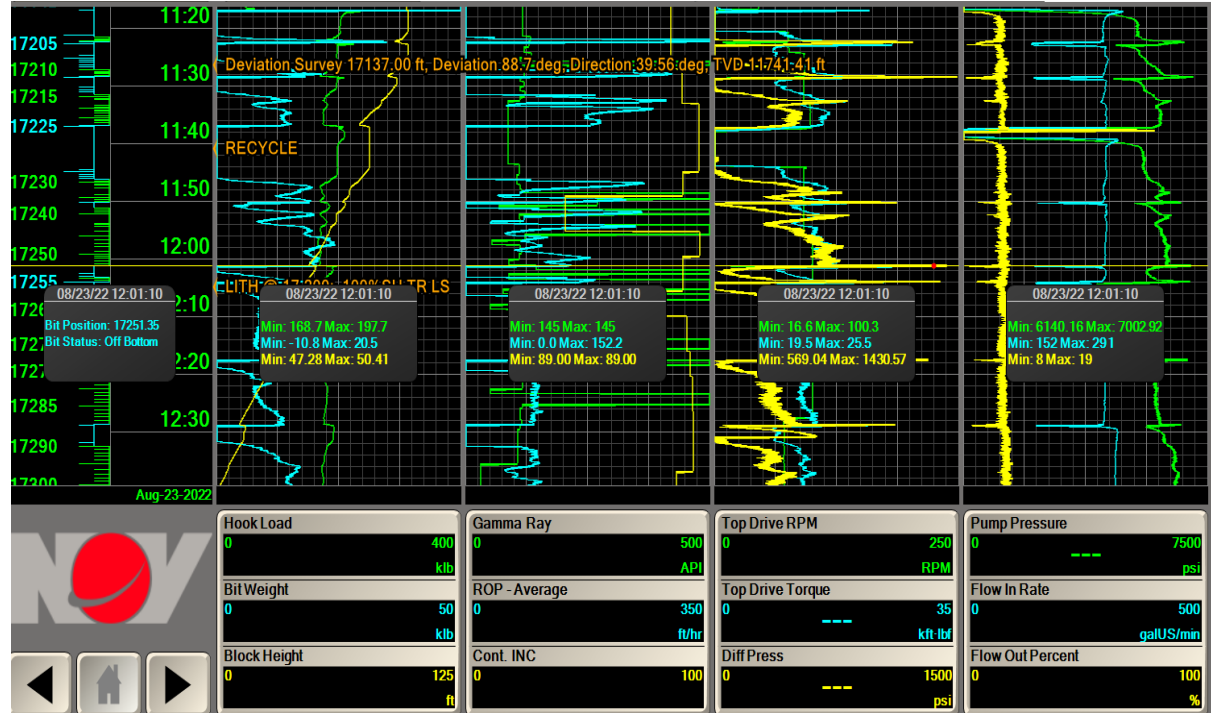
What does it look like?

- Repeated stalls, unable to “push” as hard as we would like. Forced to reduce WOB.

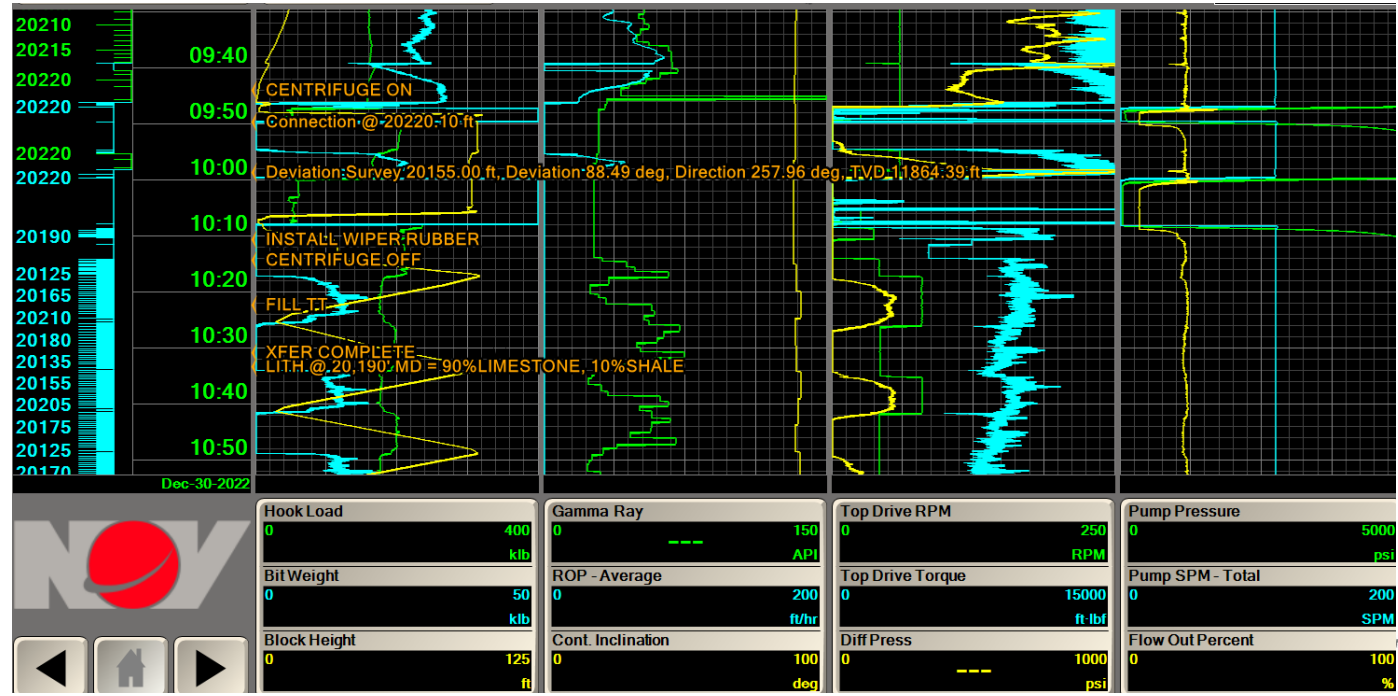
Causes - Formation

- Interbedded shale and lime as shown in gamma and sample.

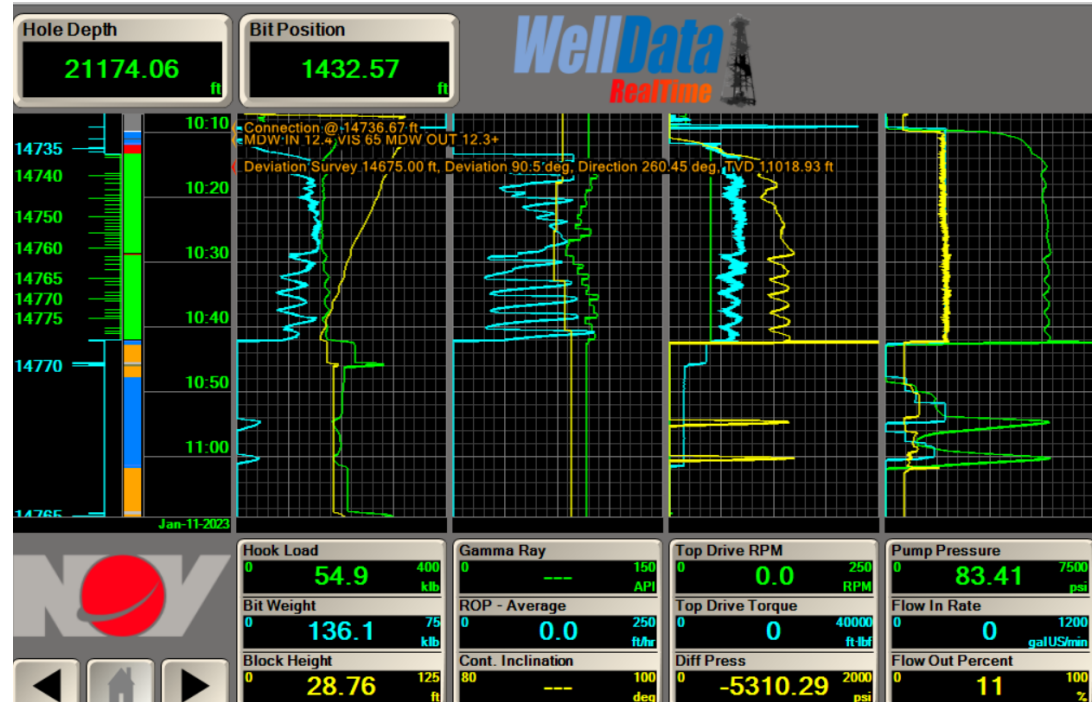
Causes - Improper AD Setpoints

- Right before stall, improper AD settings causing “seesaw” pattern.

- Kill mud pump(s)
- Kill rotary and let torque out.
- Pick all the way up until hookload breaks over.
- Kick in rotary and pump and check off bottom psi and torque.

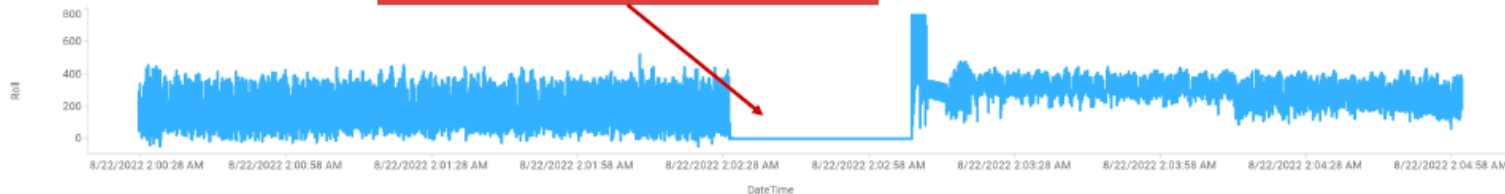
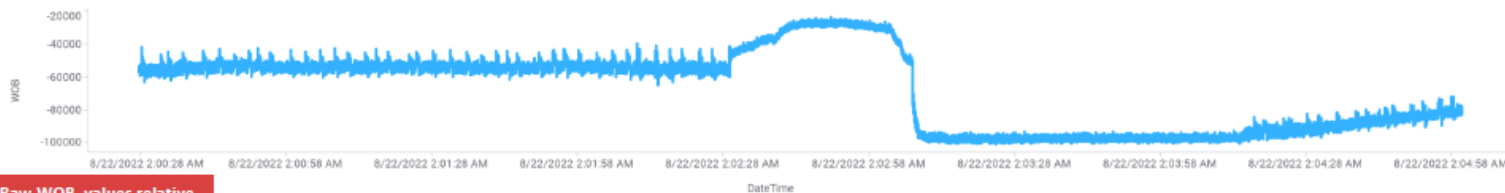
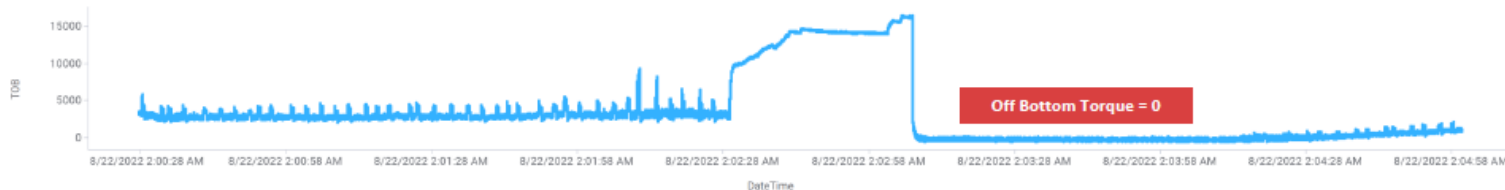
High Frequency Analysis of first stall @ 14,539'

Eventhough Cerebro did not record as Stick Slip HF data tells us it stalled for 40 secs. WOB and TOB spike during the Stall. Also RPMs max out at 764 RPMs after picking up off bottom.

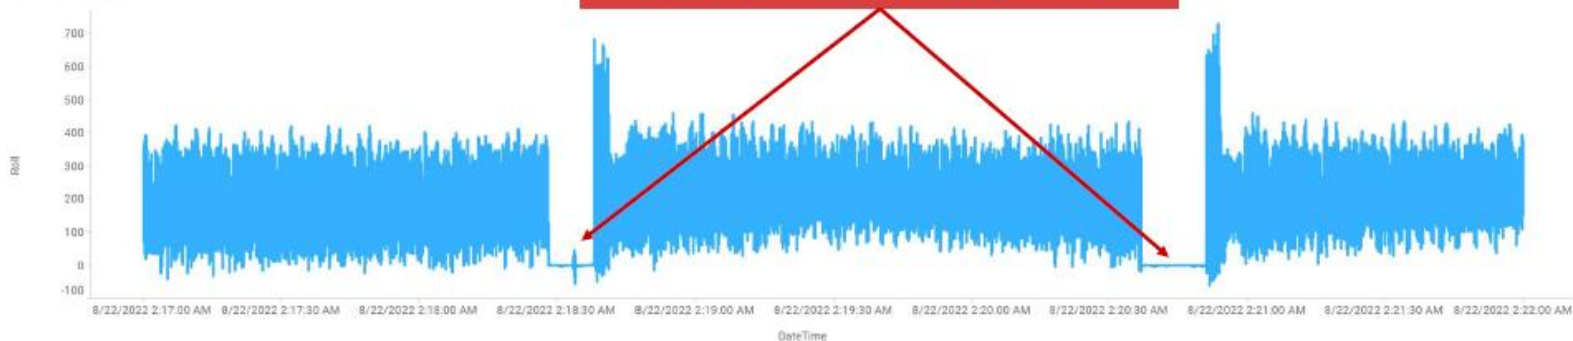
High Frequency Analysis of next two stalls @ 14,559' & 14,563'

In this case Cerebro did record as Stick Slip and HF data tells us it stalled for 12 and 15 secs. WOB and TOB spike during the Stall. Also RPMs max out at 683 and 730 RPMs but did not pick up off bottom.

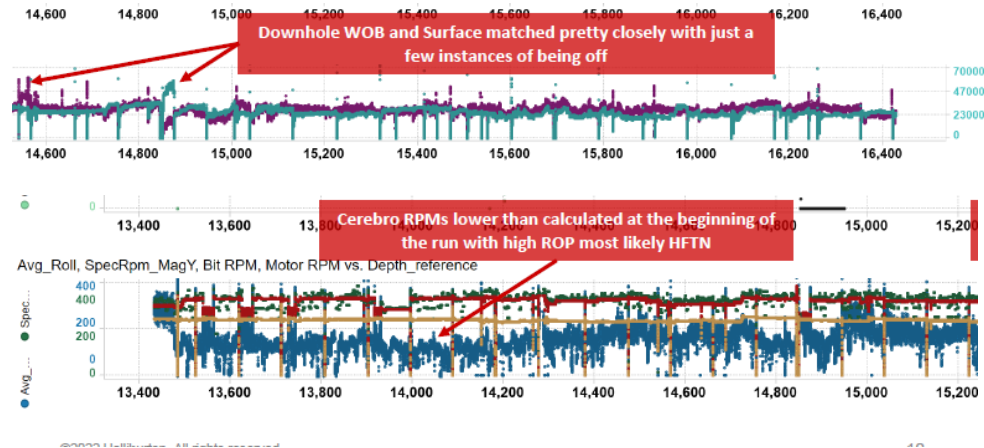
Other Notable Findings and Possible Causes

- High levels of HFTO noted.
 - Although typically thought of as separate issue, could cause premature wear and/or stalls.
 - Other data captured shows delta rpm during HFTO are lower with slower speed motors. (RSS)
- Accurate WOB calibration during run.
 - Typically run less WOB in extended reach, but this sensor can also show when we do not pick all the way up off bottom during connections we may still have trapped weight and/or torque, leading to damage.
