## Building Survey Report

**Property Address:** 25 Anywhere Street  
Anytown  
BH50 1AA

**Chartered Building Surveyors**

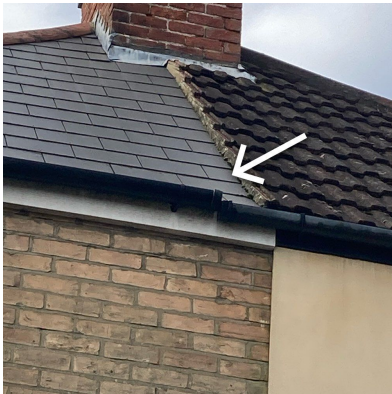
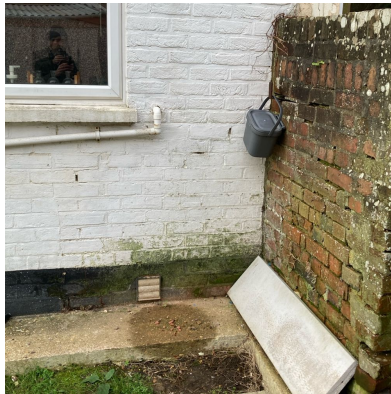
There is a gap between the gutters here, and this is allowing water to drip onto the wall below. You mentioned that it smelled damp in the kitchen cupboard here, and this may be the cause. The gutter design needs to be altered so that there is no gap.

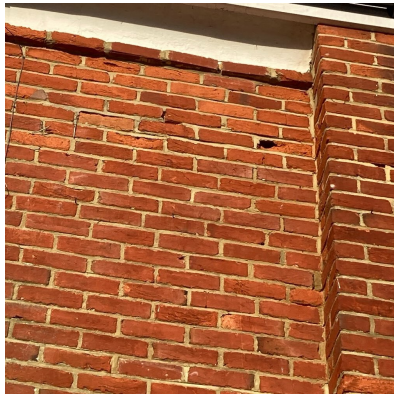
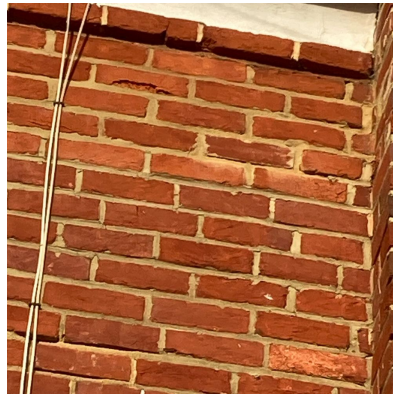
Also, a number of the bricks have deteriorated (called spalling). The action of the weather has caused the surface of the bricks to break down and spall. This can allow dampness to get inside the building. The spalled bricks will need to be cut out and replaced.

The building shows signs of some past structural movement (and you advised that the building has been underpinned), and some minor cracking was found likely due to normal shrinkage and/or thermal movement (the expansion and contraction of building materials due to changes in temperature and humidity). However, these appear to be long-standing and no indication of a significant current structural problem was found. The movement is typical of a property of this type and age. A few minor repairs to brickwork are needed.

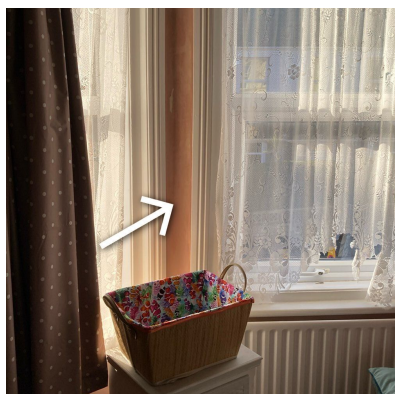
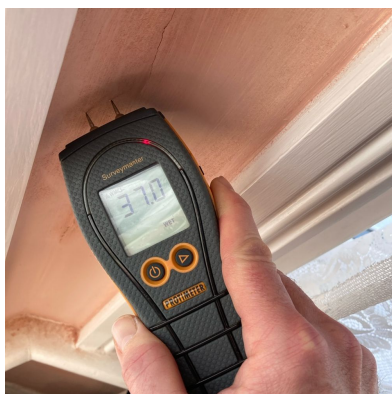
There are slightly elevated damp readings between the windows to this bay, and minor resultant damage to the decorations. You mentioned that you thought that there is a similar problem to the ground floor bay, but I found no elevated readings there.

I was not able to diagnose the cause of the elevated readings, but possible causes are a lack of a cavity tray over the windows and / or a missing vertical damp-proof course to the windows allowing water to bridge the cavity to the inner leaf.

I recommend that the area is inspected more closely from high level and consideration given to the provision of cavity trays over the windows, and the application of a breathable sealant to the brickwork around here. Alternatively/additionally, the internal plaster could be hacked off and replastered with a proprietary water-proof plaster or cavity membrane system (see section 5.5).

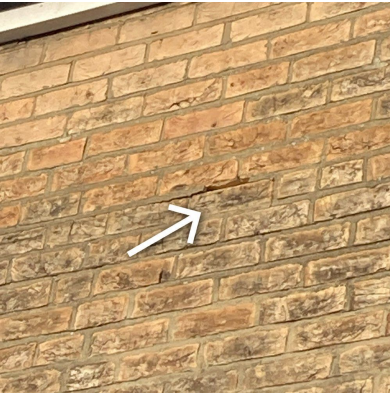
Further example of small area of eroded pointing.

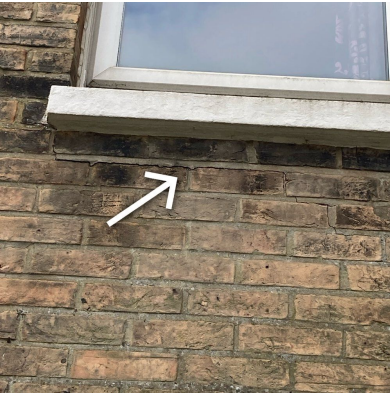
Small area of cracking through mortar joints.

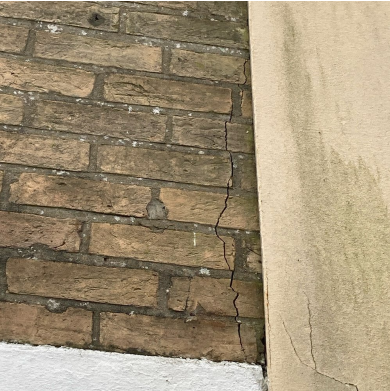
Short length of vertical cracking.

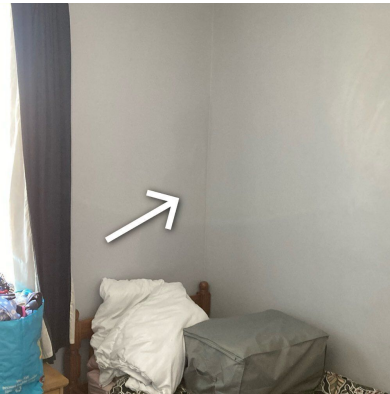
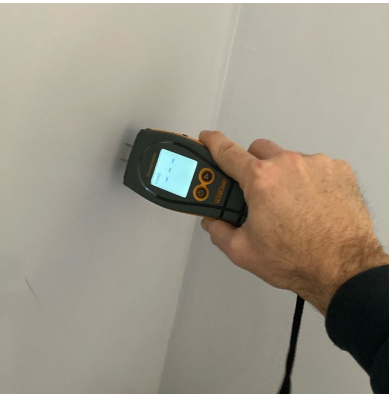
There is some discolouration here, but there were no elevated damp readings. It is possible that there is occasional dampness here. When work is being carried out to the external walls, I recommend that a couple of bricks are removed, and the cavity checked and cleared out as necessary.

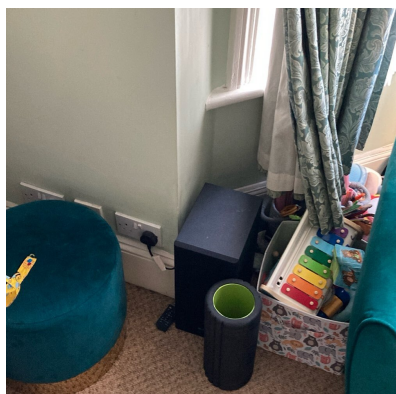
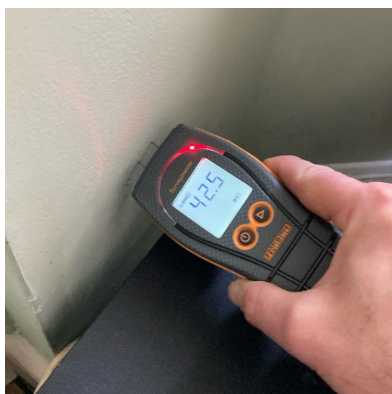
Slightly elevated damp readings were obtained to the inside of external walls here, but there is no damage to the decorations. I was not able to diagnose the cause of the elevated readings, but a possible / likely cause is a bridged cavity (where mortar or detritus fills the cavity and allows moisture to pass into the inner leaf) and / or condensation due to the base of the external walls being colder.

When work is being carried out to the external walls, I recommend that a couple of bricks are removed, and the cavity checked and cleared out as necessary.

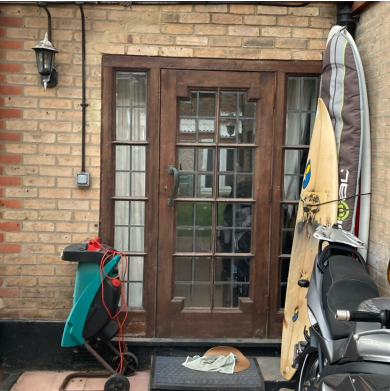
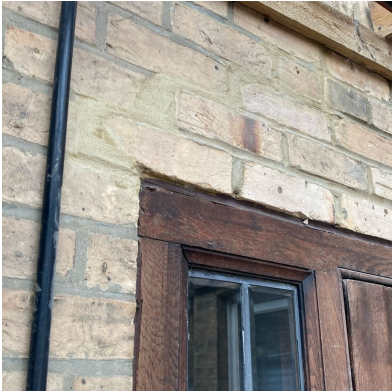
I couldn't see a lintel (to support the brickwork) over this door. The timber frame may be providing the structural support. I saw no movement to the brickwork over to give me concern, but if the door is replaced, the brickwork will need to be supported. If the door is replaced with a PVC frame, a lintel will likely need to be provided.

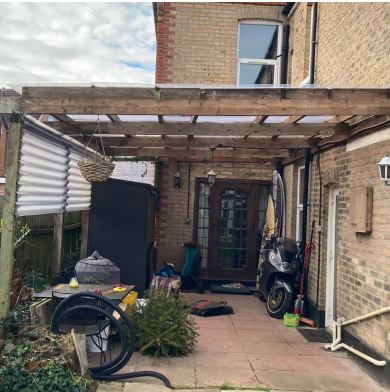
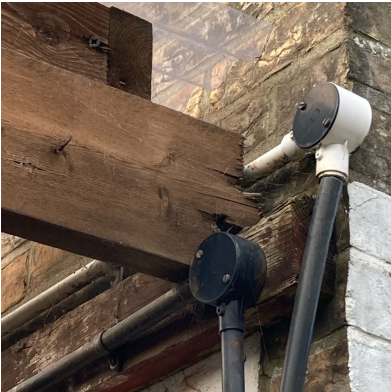
There is a canopy of rudimentary construction. This is in fair condition, but with signs of decay to the timbers. Timber treatment / decoration may extend the life of the structure.

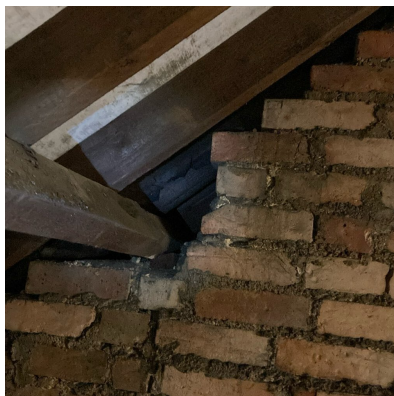
The wall between this and the neighbouring dwelling (called the party wall) is made of brick. There are gaps in this wall which could allow fire to pass from one property to the other. To prevent the spread of fire from one dwelling to the other, you should build up the wall / seal any gaps to the underside of the roof covering.

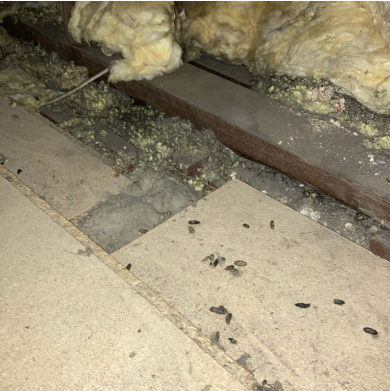
I saw evidence of rats. Rats can cause damage, for example by gnawing wires. You should arrange for a pest control specialist to check the property.

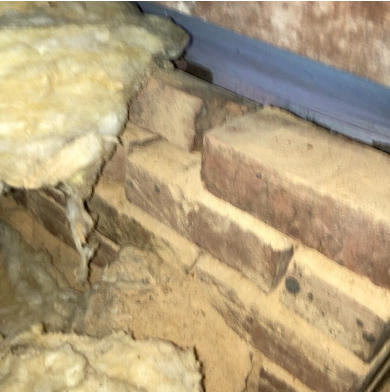
This chimney stack, where it has been removed to below roof level, has loose bricks. I recommend that this is made safe.

5.1 Roof structure: Repair chimney stack in roof space where bricks are loose.

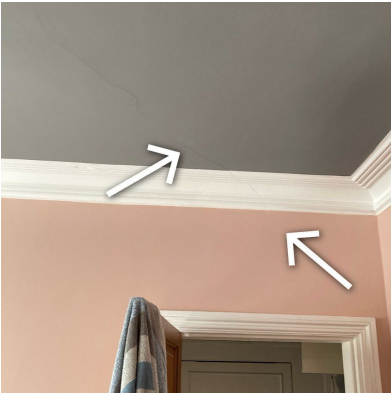
Example of hairline cracking.

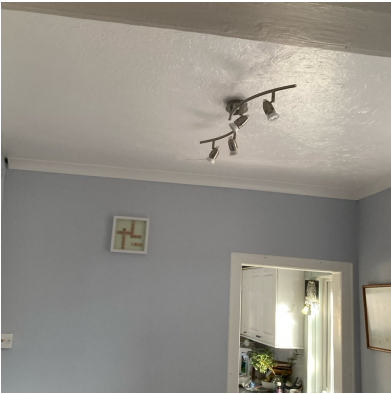
This ceiling has been lowered by a few inches. I couldn't see why, but it is possible that the original ceiling is in poor condition, or that there are services run within the void.

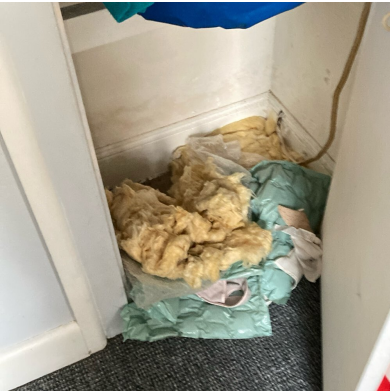
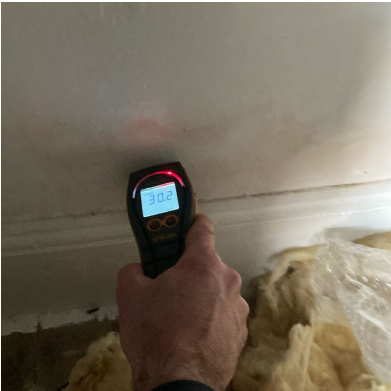
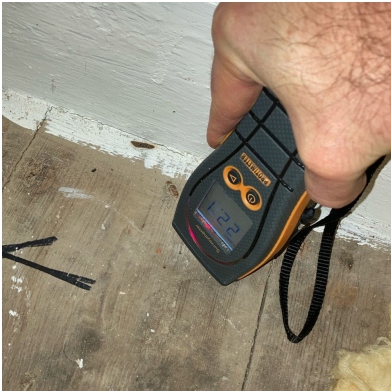
There is slight staining and slightly elevated damp readings here. I was not able to diagnose the cause of the elevated readings, but possible causes are sub-floor dampness or a current / old service leak. I recommend that the floorboards are lifted and the sub-floor timbers inspected, and all of the surrounding pipework is checked for a slight leak.

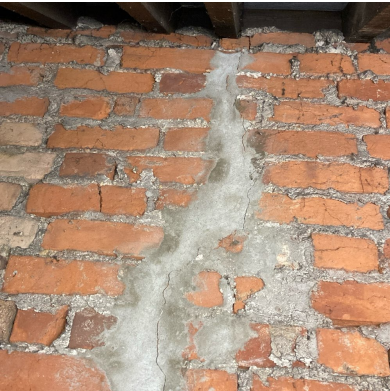
There is an old (repaired) vertical crack to the party wall in the roof space. In my opinion, no action is needed.

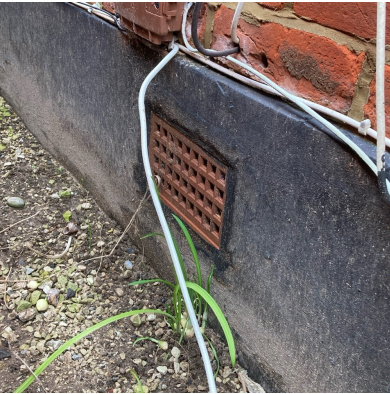
Ground-floor timber floors require sub-floor vents to allow air to circulate beneath the floor. This prevents the build-up of condensation which can lead to timber decay (by way of wood-boring insects, wet rot or dry rot). Sub-floor vents are provided. These should not be obstructed.

If you decide to provide retrospective cavity wall insulation, and / or when work is being carried out to the external brickwork, I recommend that you check that the vents are sleeved through the cavity to the sub-floor.

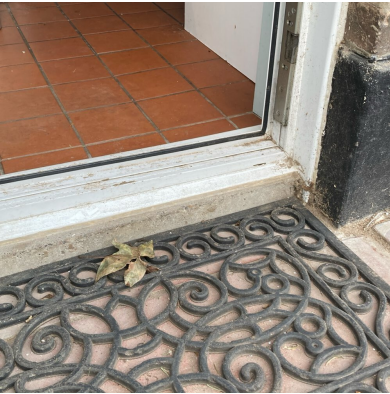
It is good practice for ground levels to be at least 150mm (6") below the internal floor level and damp-proof course (DPC), which helps to avoid dampness to the inside of external walls at low level. External ground levels are above this level outside the kitchen only, but this is common, and I found no evidence of any internal dampness as a result of this. Therefore, in my opinion, no action is needed in this regard, but if work is carried out to external hardlandscaping, I recommend that ground levels are lowered.

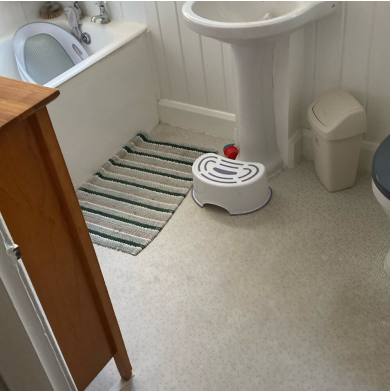
The floor is sloping here, but this is not uncommon in buildings of this age. In my opinion, no action is required, but it should be possible to level the floor if / when the floor covering and bathroom suite is replaced.

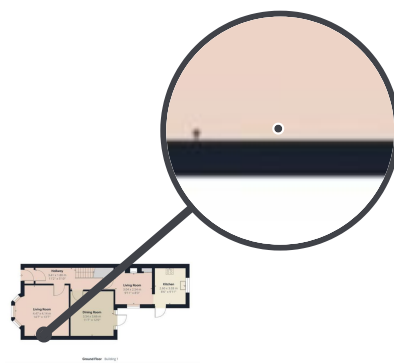
There is a flush chimney breast here, continuing up through the room above. The chimney stack has been removed to below roof level.

There is some slight dampness to the bottom of the chimney breast. This is quite common in older buildings and could be from dampness rising up from the ground through the hearth. It could also be due to a bridged cavity (as described in section 4.4) and / or water entering the cavity at high level (where the brickwork is in poor condition (see below)), and tracking down the cavity.

There is also slight dampness at the top of the chimney breast in the bedroom. In my opinion, this is likely to be caused by hygroscopic salts remaining in the brickwork and plaster originating from flue gases (with hygroscopic salts, moisture is attracted from the air into the plaster). I recommend that you remove the damp plaster and re-plaster with a proprietary salt retardant render/plaster, or apply a cavity membrane before plastering with plasterboard.

1. Carry out repairs to the brickwork as described elsewhere, and when this work is being carried out to the external walls, remove a couple of bricks, and check the cavity and clear out as necessary.
2. If the dampness persists, then the most cost effective solution might be to hack off the plaster and to replaster with a proprietary water-proof plaster or to line with a cavity membrane system.

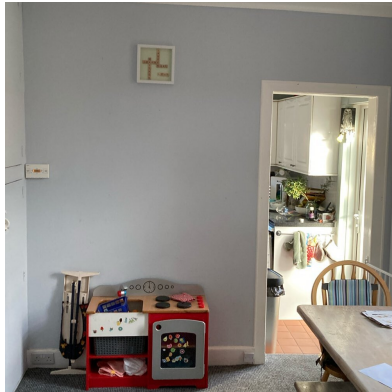
You mentioned that you are considering removing this internal wall to create a larger kitchen breakfast room. This wall is supporting the wall above, and possibly the floor joists above. As such, a beam will need to be provided to provide support. I saw nothing to give me concern about this, but a structural engineer will be needed to design the beam and detail, and building regulations approval will be needed.

It would be beneficial to raise the level of the kitchen floor at the same time, so that the floor level is continuous. I don't have any great concerns about this and it should be relatively straightforward. Note that the external door from the kitchen will need to be replaced and the resultant door height will be slightly lower unless the door head is also raised.

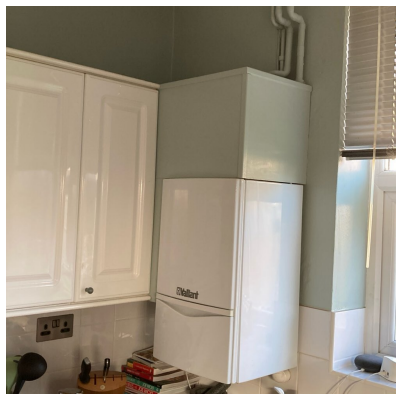
I couldn't see a Carbon Monoxide detector near the gas-fired boiler. I recommend that one is provided.
