Home Inspection Report

New Constrcution Sample

Wake Forest, NC 27587

Inspected on Mon, Aug 18, 2025 at 8:00 AM

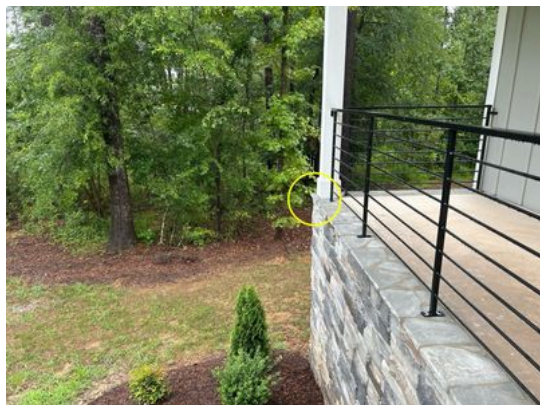
Comment 8

Secure the loose flagstone on the front porch to prevent further detachment.

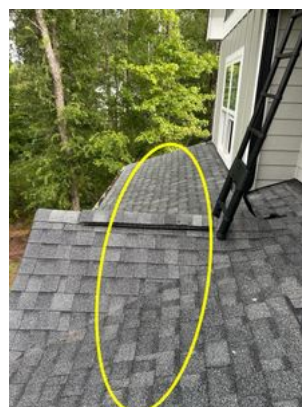
Comment 10

Multiple shingles were found to be damaged. Replacement of the affected shingles is recommended. Damage that compromises the protective granule layer and asphalt composition can lead to premature shingle failure, increasing the risk of water intrusion.

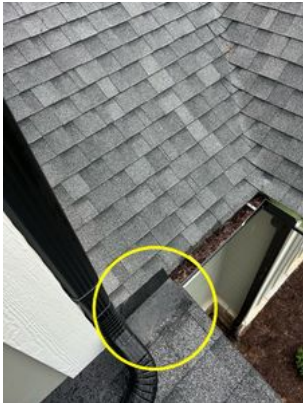
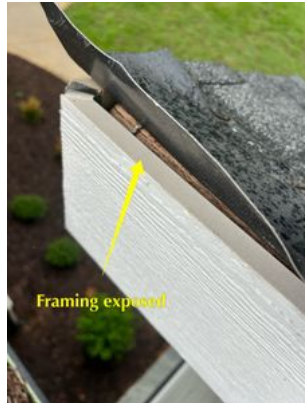
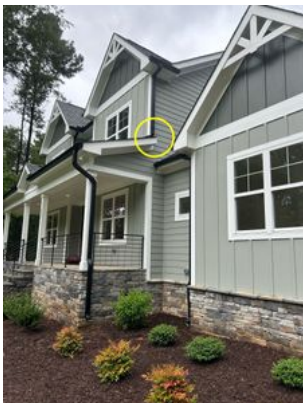
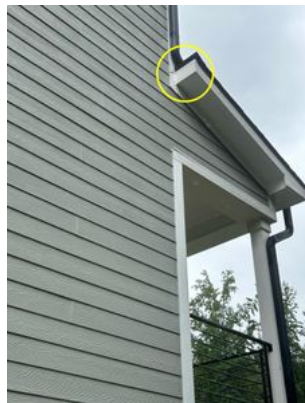
Comment 11

Flashing should be installed (or bent over the fascia) where the roof line extends beyond the main exterior wall of the home. Headwall flashing is installed in this location but water could enter behind the flashing and deteriorate the substrate. (Front porch)

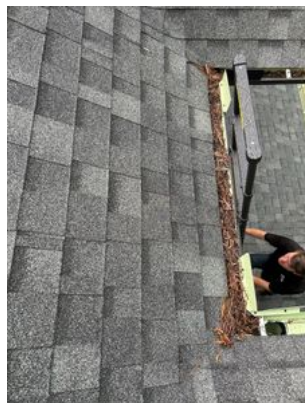
Comment 14

The gutters, in multiple locations, were filled with debris which will prevent water from exiting into the downspouts. This could cause water runoff in areas that could present moisture problems. Cleaning out the gutters and ensuring functional flow out of the downspouts is recommended.

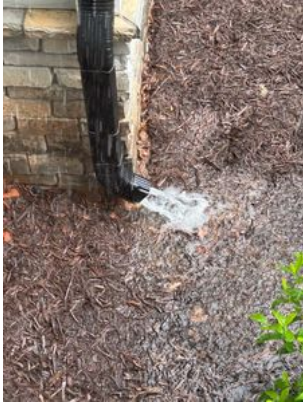
Comment 15

Gutter downspouts should direct water away from the foundation at least 6 feet to reduce the risk of water intrusion, soil erosion or foundation settlement/deterioration.

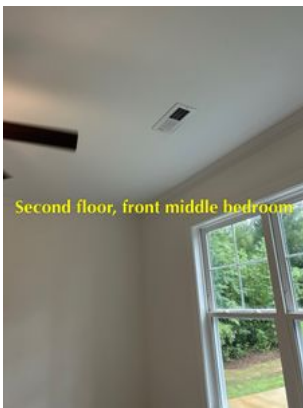
Comment 28

Cosmetic defect at an HVAC supply diffuser. The ceiling paint will need to be touched up.

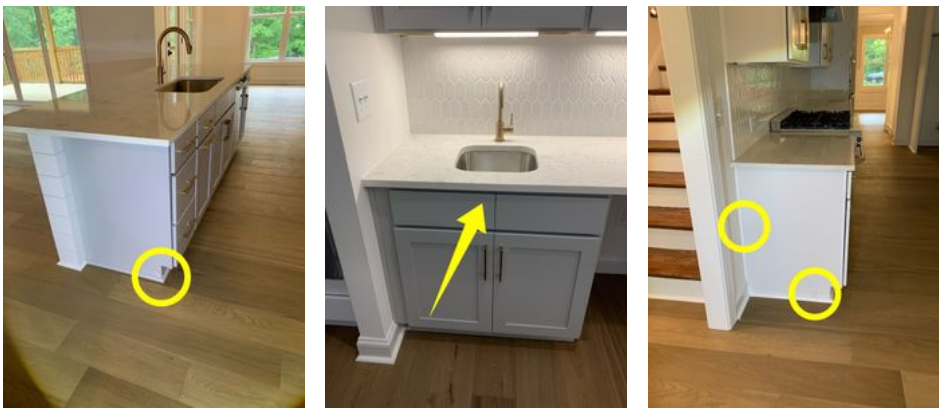
Comment 40

There were several areas of damaged finish on the kitchen cabinets.

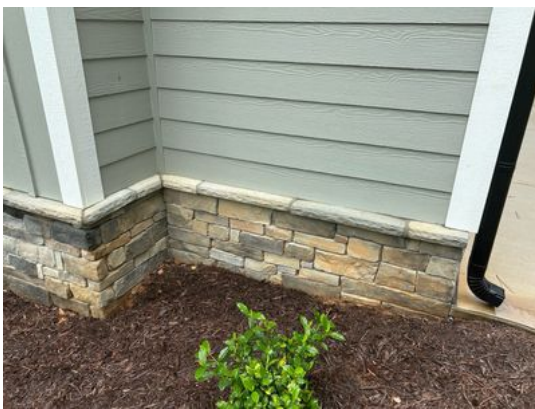
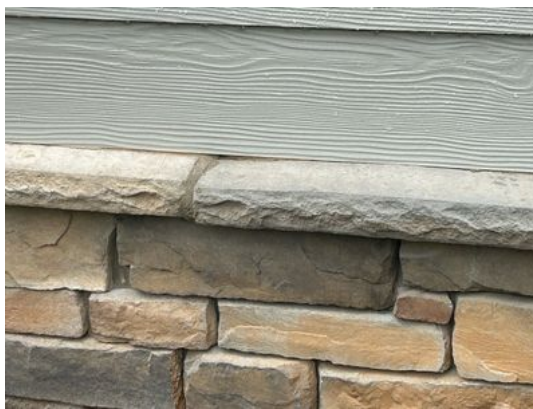
Comment 1

The fiber cement siding was not installed according to manufacturer installation instructions. A 1/4" gap is required at all horizontal transition flashings. This helps prevent premature moisture damage to the siding. There were no signs of damage at the time of inspection. If you have concerns, consult the builder for proper installation.

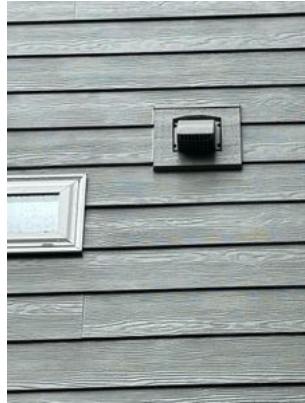
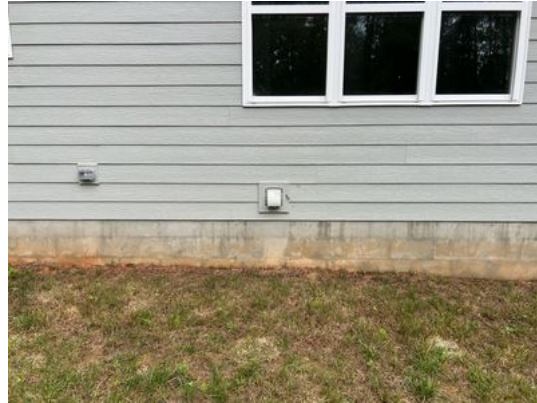
Comment 3

Sealing the gap between the exterior vent cap(s) and siding is recommended to prevent water entry behind the siding.

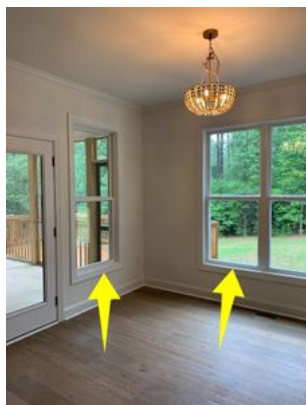
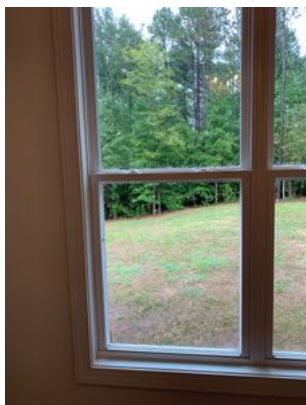
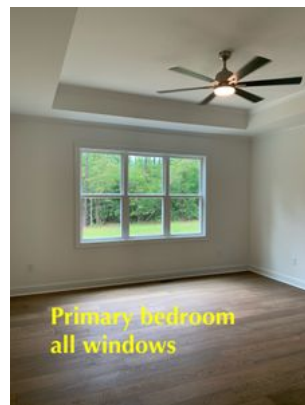
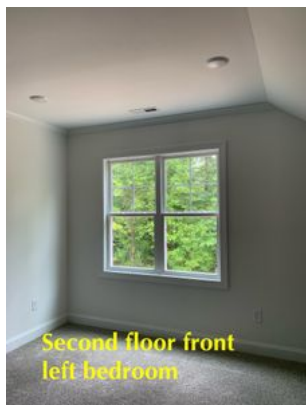
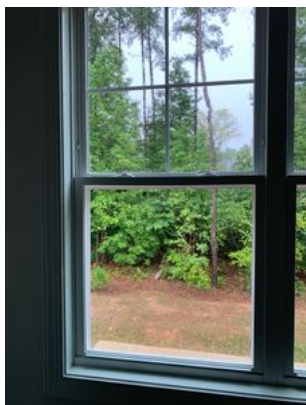
Comment 6

Multiple windows are loud when opened compared to other windows in the home. It is recommended to have a qualified professional make any adjustments needed to allow for easier function. (Photos may not be all inclusive)

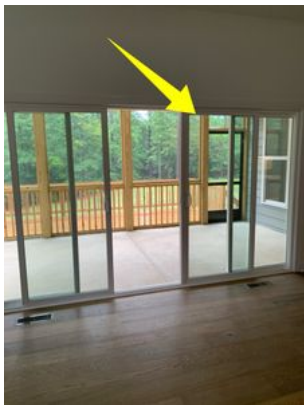
Comment 7

The sliding glass door requires adjustment/repair. The door gets stuck on the track when closing. This could lead to damage of the door over time.

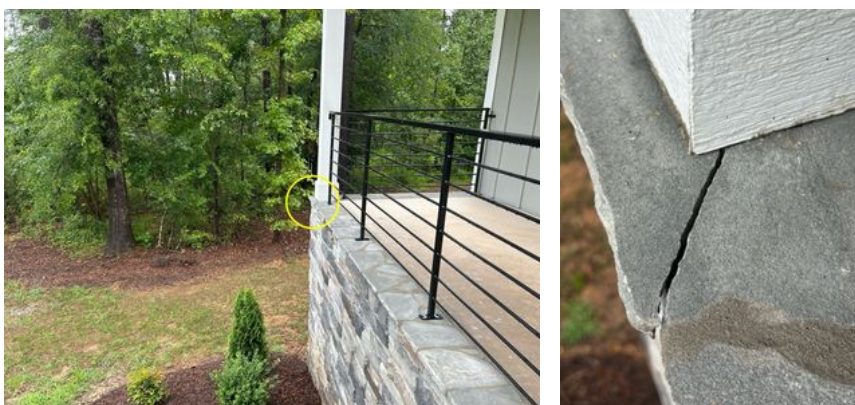
Comment 8

Secure the loose flagstone on the front porch to prevent further detachment.

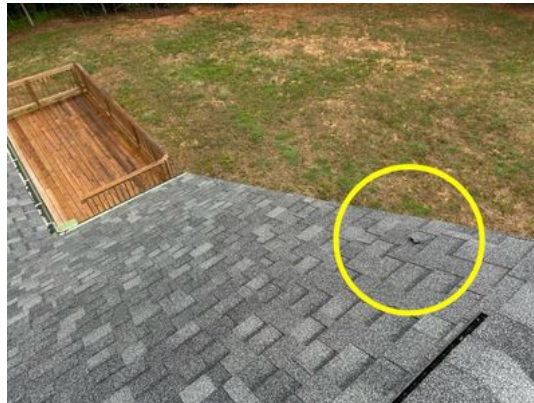
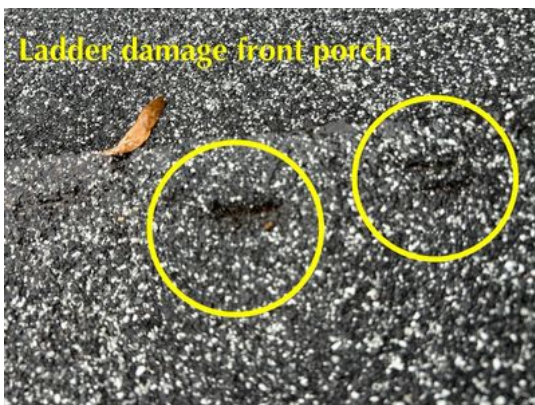
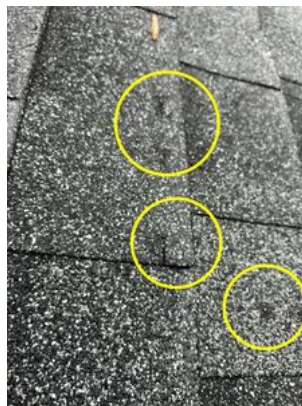
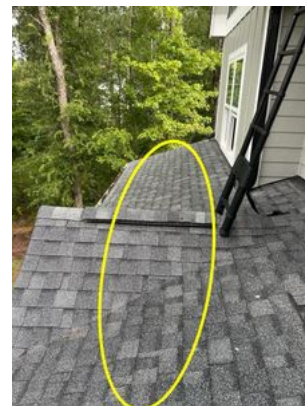
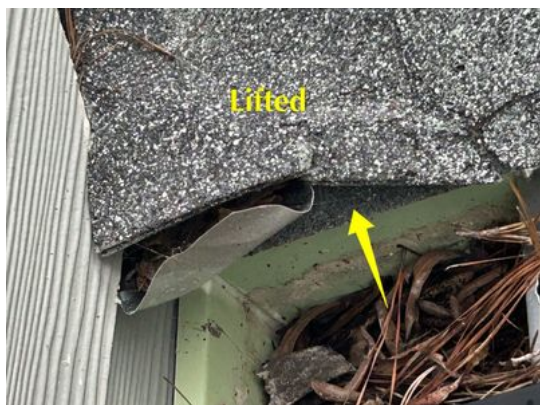
Multiple shingles were found to be damaged. Replacement of the affected shingles is recommended. Damage that compromises the protective granule layer and asphalt composition can lead to premature shingle failure, increasing the risk of water intrusion.

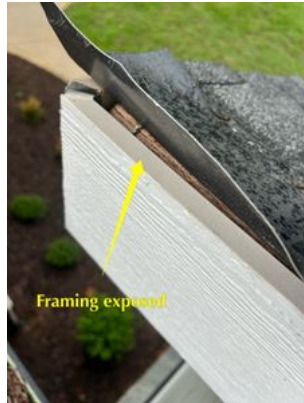
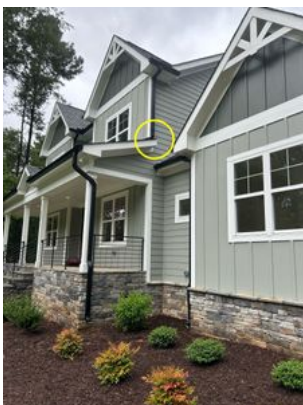
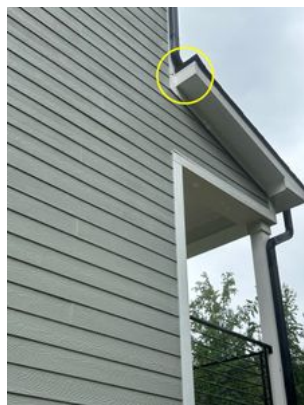
Flashing should be installed (or bent over the fascia) where the roof line extends beyond the main exterior wall of the home. Headwall flashing is installed in this location but water could enter behind the flashing and deteriorate the substrate. (Front porch)

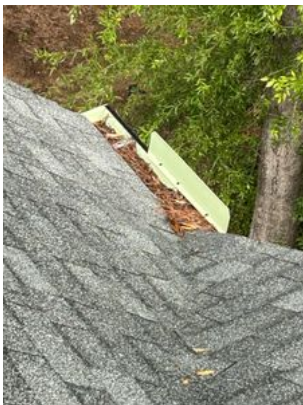
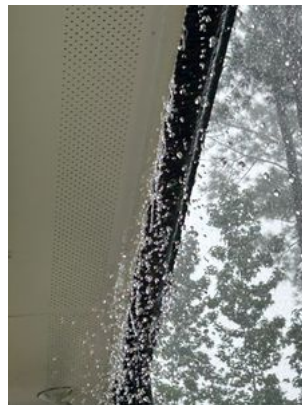
Comment 14 **Deficiency**

The gutters, in multiple locations, were filled with debris which will prevent water from exiting into the downspouts. This could cause water runoff in areas that could present moisture problems. Cleaning out the gutters and ensuring functional flow out of the downspouts is recommended.

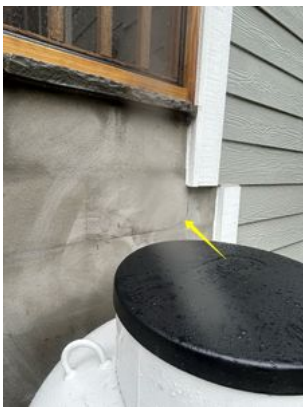
Comment 18 Information

The masonry stemwall has settlement cracks. These type of settlement cracks are common and are not necessarily a sign of any structural issue. A typical rule of thumb is any crack 1/4" or more requires further evaluation/repair. Monitor the stem-wall for excess settlement. If you have concerns, consulting a licensed contractor or structural engineer is recommended. (Photo(s) example(s) may not be inclusive of all areas of settlement cracks.)

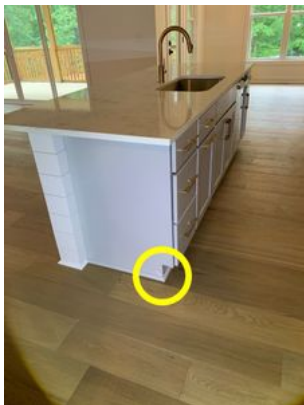
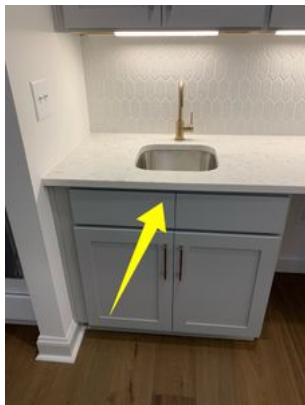
There were several areas of damaged finish on the kitchen cabinets.

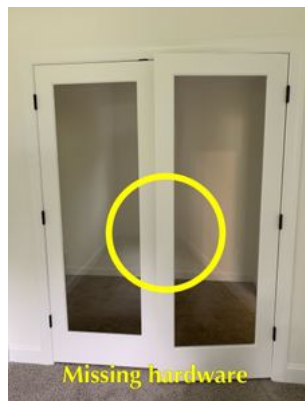
Comment 50 Deficiency

Door handles were not installed on the 2nd floor office doors.
