Home Inspection Report

123 Sample Report Dr
Raleigh, NC 27606

Inspected By: Stephen Pait, CMI- Lic # 4329 &
Septic Lic #72451

Inspected on Thu, Jan 2, 2025 at 8:00 AM

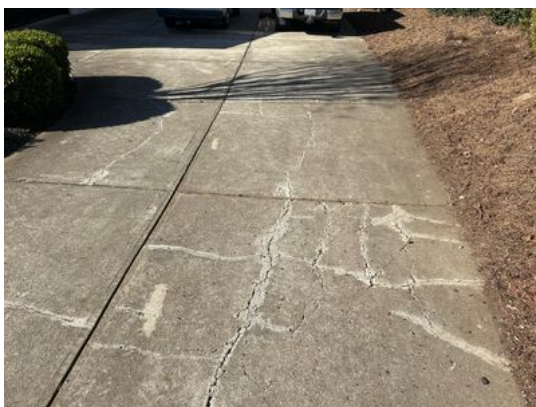
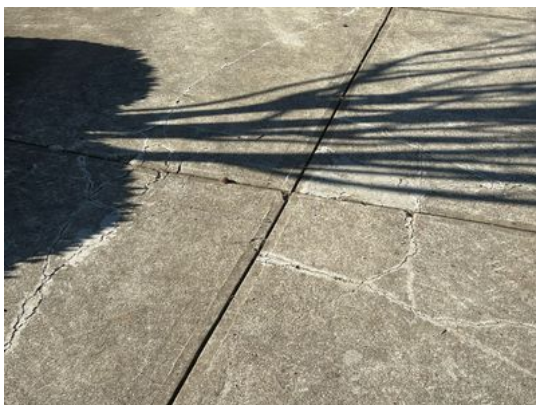
The driveway has a significant number of stress or settlement cracks. Over time these cracks could lead to lifting or settling of the driveway which will create walking hazards and issues with driving. Repairing any damaged areas is recommended by a qualified concrete contractor.

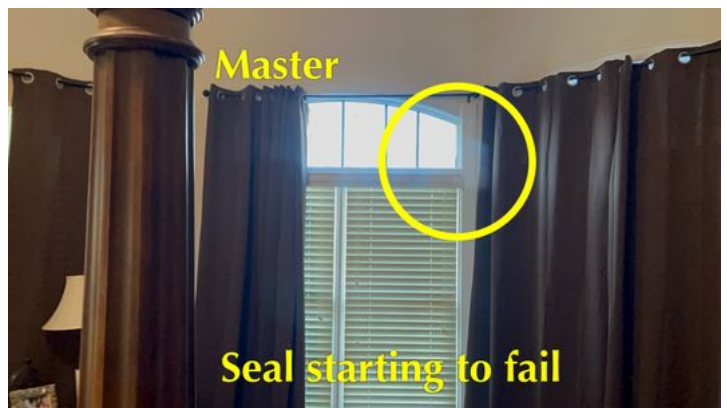
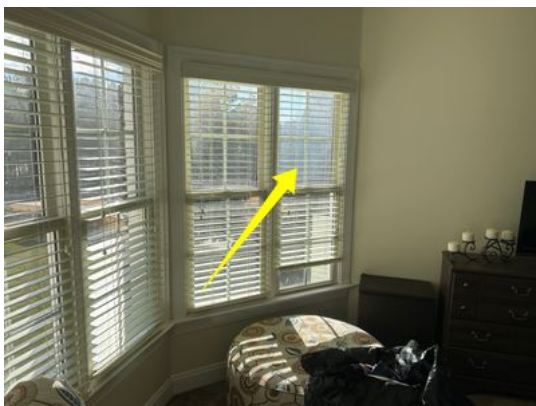
Comment 5 Deficiency

Hazing and moisture was observed in between multiple window panes. This is likely caused by deterioration of the low-e film and hermetic seal in between the window panes. Low-E is a film applied to the windows to help reduce solar heat gain. This condition may result in increased solar heat gain. It is recommended to consult with a qualified window repair professional to evaluate this condition and perform and necessary repairs or replacements.

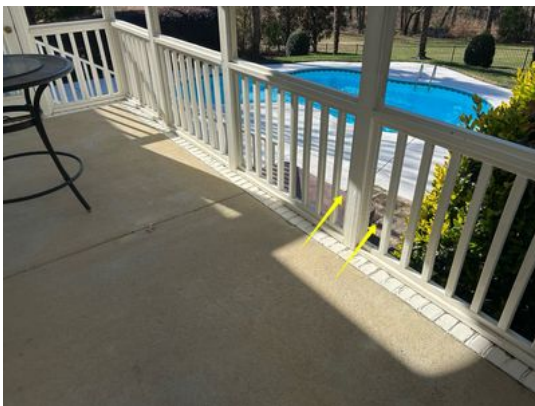
Comment 8
Deficiency

At several areas on the back porch, the spindle spacing does not meet current requirements. A 4" sphere should not pass between two spindles. This is considered a fall safety hazard. A qualified professional is recommended to repair the railing where needed. (Photos are not all inclusive)

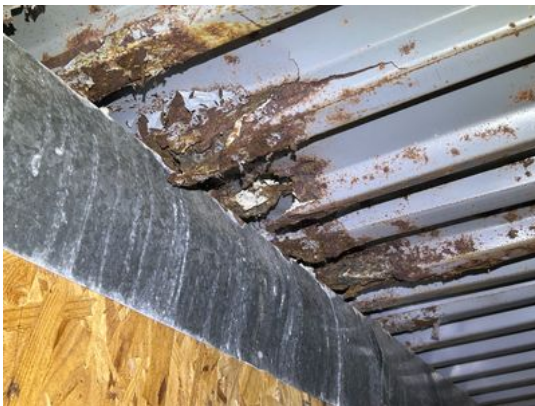
Comment 9
Deficiency

A qualified concrete contractor is recommended to evaluate the back porch concrete slab and corrugated form panels. The slab has settlement at a control joint which appears to promote water entry at the home's rim joist. This has led to deterioration of the metal forms and the concrete was brittle and breaking apart. (See video). Over time, this could lead to possible deterioration of the framing in this location.

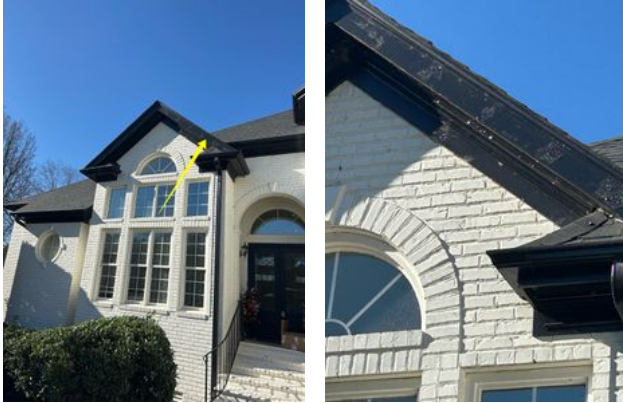
Paint was peeling at several locations on the front fascia. A qualified painting professional is recommended for repair to prevent further peeling and to ensure the material is properly sealed. Improperly sealed composite material can lead to premature deterioration.

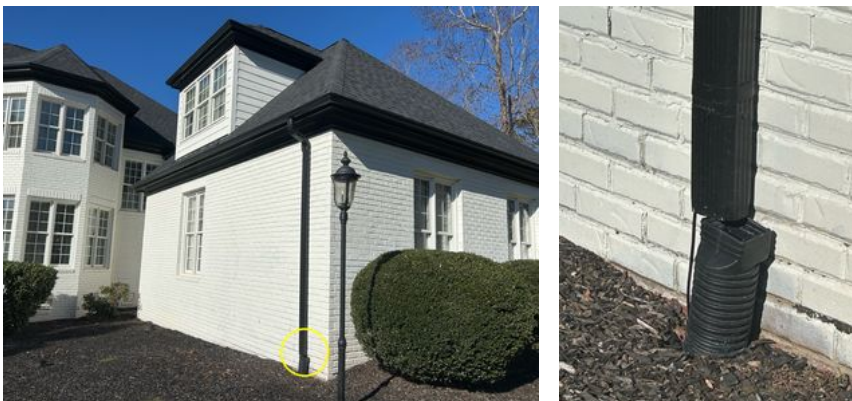
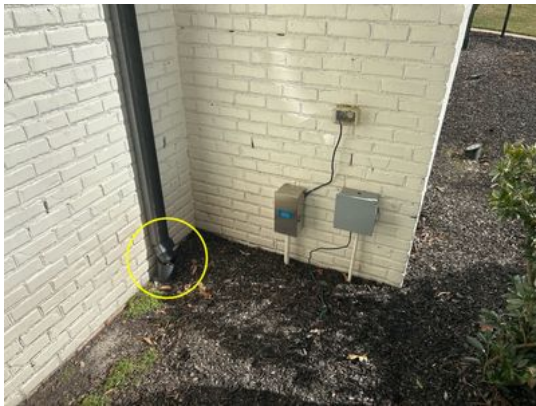
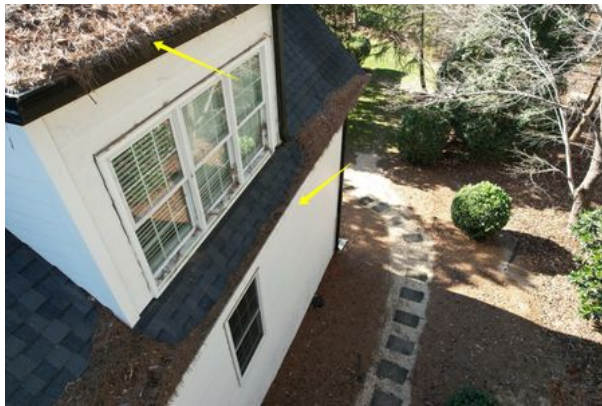
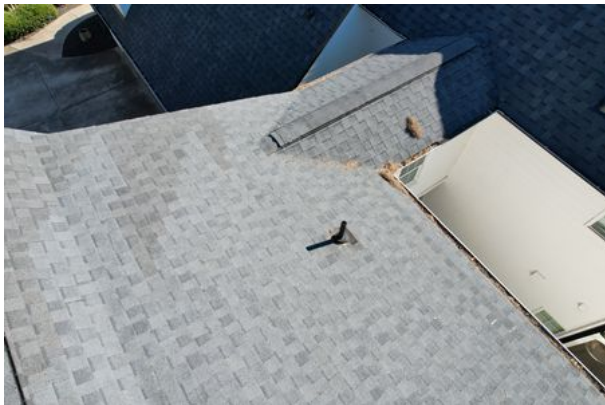
The gutters, in multiple locations, were filled with debris which will prevent water from exiting into the downspouts. This could cause water runoff in areas and present moisture related problems and lead to premature deterioration of the composite fascia. Ensure all gutter downspouts are properly connected to the corrugated drain lines and discharging away from the home. A qualified professional is recommended for repair. (Photos may not be all inclusive)

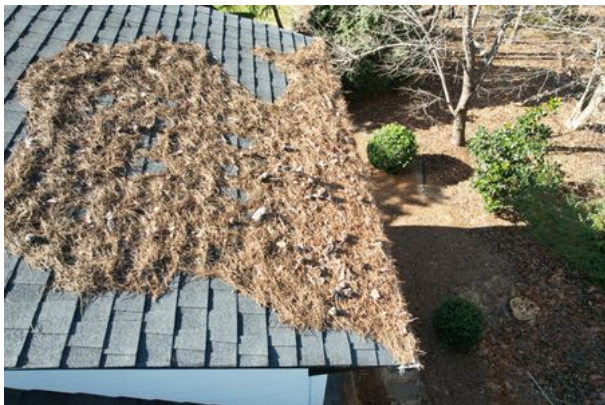
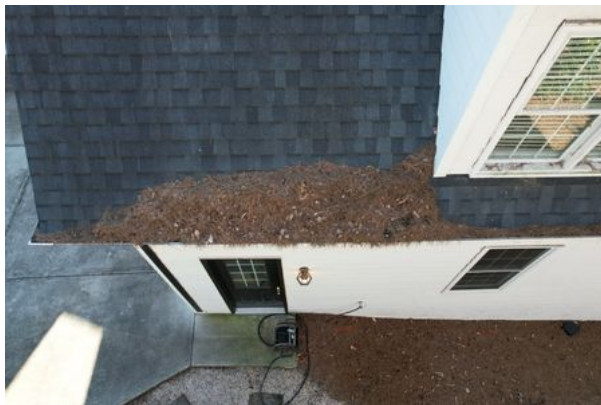
Comment 20

There was debris from trees and surrounding vegetation on the roof. This can allow water to back up under the roofing materials and could lead to water entry and damage to surrounding components. Removal of the debris is recommended.

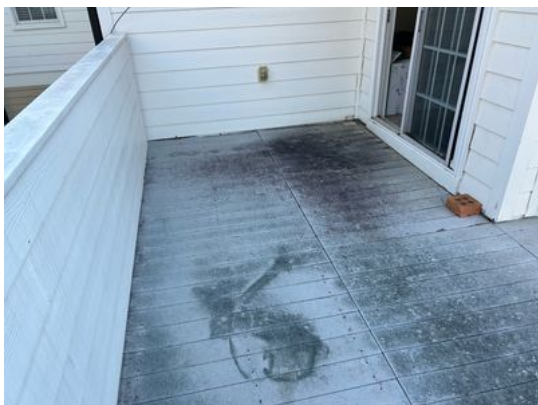
Comment 21

The roof covering below the balcony deck was unable to be inspected.

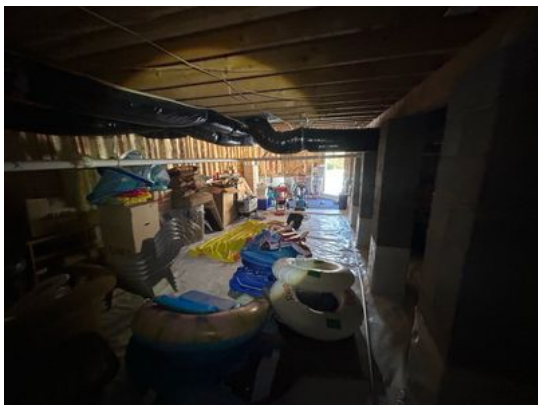
This home has a sealed/encapsulated crawlspace which reduces the visibility of the foundation walls and piers. Additionally, portions of the foundation stem wall were not visible due to items being stored in the crawlspace.

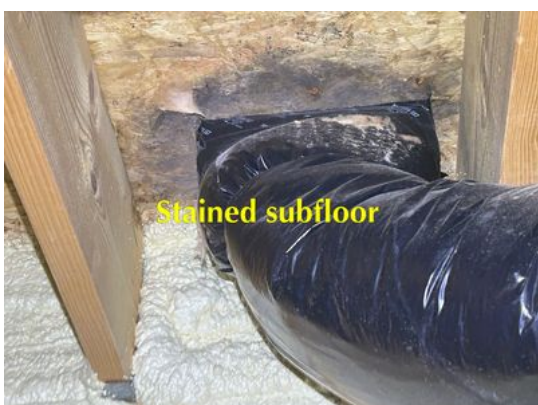
The subfloor at multiple hvac discharge boots was discolored and showed evidence of previous high moisture. Many times the air vents directly under the cabinet and is not in a chase or duct. The cool conditioned air leaves moisture under the cabinet base and this causes staining to the subfloor/base cabinet and sometimes damage to the base cabinet bottom panel. The subfloor was structurally sound in this location and moisture levels were normal at the time of inspection. The kitchen sink base cabinet was damaged and warm air was discharging inside the cabinet. A qualified contractor is recommended to evaluate the air discharge and repair the kitchen base cabinet to prevent further damage.

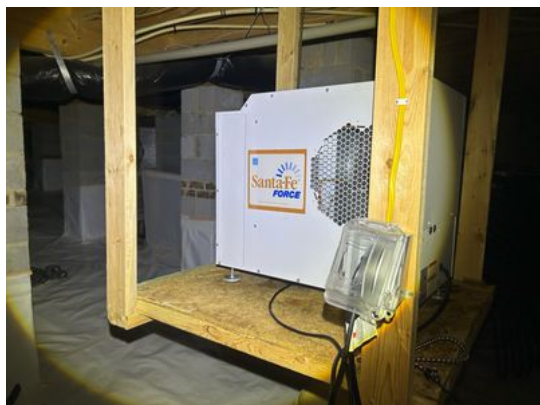
Comment 30 Information

There was a crawlspace dehumidifier. It is beyond the scope of a NC Licensed Home Inspector to determine if a dehumidifier is properly functioning. There was no water/condensation inside the condensate pump at the time of inspection but the system was on and running.

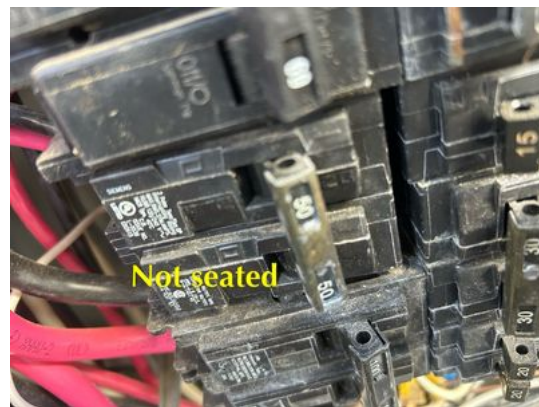
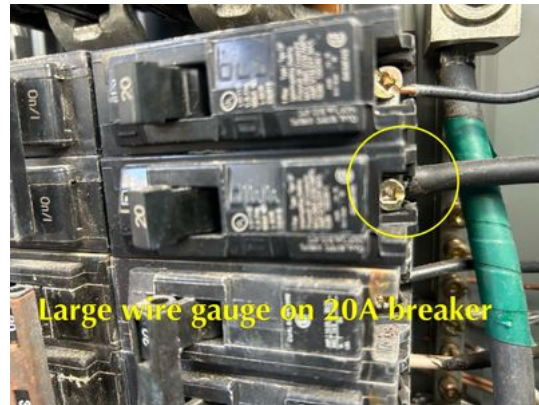
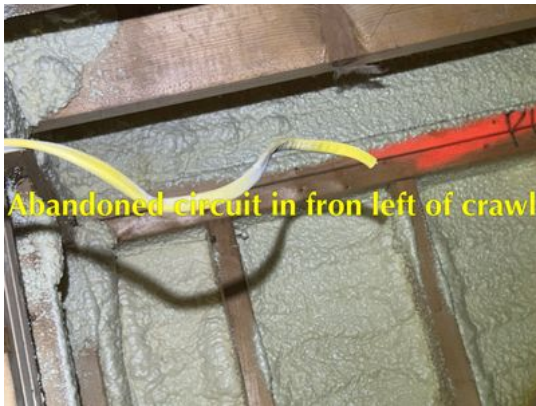
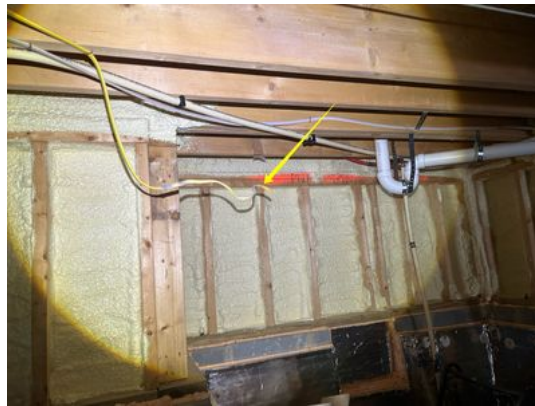
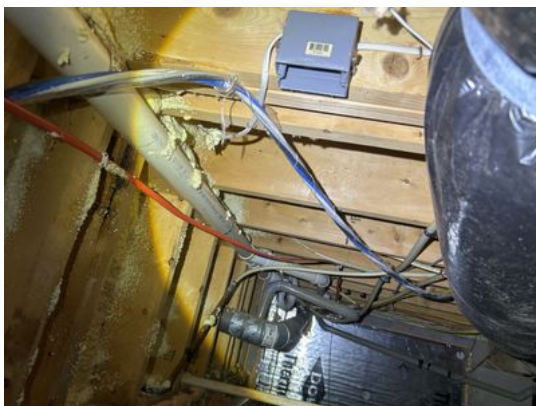
There were multiple deficiencies in the electrical system that should be evaluated/repair by a licensed electrician.

- An AFCI breaker failed to trip when tested in the laundry room sub panel. AFCI helps protect against potential fire hazards.
- A breaker was not properly seated on the bus bar in the exterior sub panel. This is a safety hazard that could lead to potential arcing or fire safety hazard.

- All electrical breakers are required to be properly identified on the legend attached to the panel. There were missing identifications on the exterior sub panel. This is a safety hazard.

- A large gauge conductor was installed in a 20A breaker in the exterior sub panel. A conductor too large to properly fit under a breaker terminal screw could lead to improper fit or needing to be modified to fit. Modified or improperly secured conductors can be a fire safety hazard. The max size wire gauge is typically stated by the manufacturer. The inspector was unable to confirm if the conductor had been modified. Typically a split bolt or wire nut is used in this application to downsize the conductor to fit the breaker.

- The exterior sub panel has a mismatching breaker. All breakers installed are required to be of the same type and manufacturer of the service panel. There are however some breakers that are suitable for replacement of certain breakers in certain panelboards. This information is provided by the breaker manufacturer. Improperly installed breakers can lead to voided warranty, failure or even fires.

- The GFCI receptacle to the right of the cooktop had no power and would not reset. Therefore, all receptacles on this circuit were unable to be tested. (Breakfast nook as well)

- The receptacle to the left of the kitchen sink was loose and should be properly secured to prevent possible loosening of the electrical conductor connections. Improperly/loosely connected wiring could result in arcing which can lead to possible fires. (Cover plate also broken)
- There was an open electrical junction box located in the right side of the crawlspace. All junction boxes should have a blank plate cover installed to prevent access to the electrical conductors.
- Replacing the missing exterior receptacle's weatherproof cover on the back side of the home and damaged cover on the balcony is recommended to prevent possible moisture entry which could lead to nuisance tripping of the GFCI receptacle and premature deterioration of the electrical components.

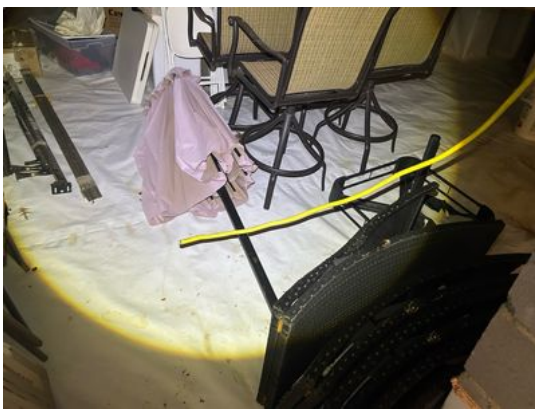
There was a disconnected/abandoned gas supply line in the crawlspace that should be properly capped or removed by a qualified professional. The inspector was unable to confirm if the line was disconnected at both ends. This could lead to possible gas leaks if the line is still active and a valve is opened. (Back left of crawlspace)

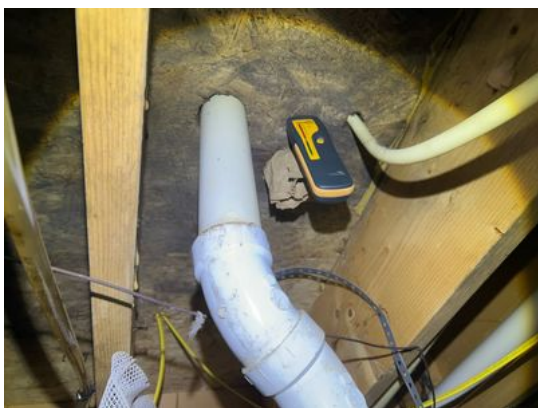
There are signs of previous water stains to the subfloor and floor framing below the kitchen sink. There appears to be no active leak at the time of the inspection as all visible areas tested normal for moisture. If you have concerns, consult a licensed plumbing contractor.

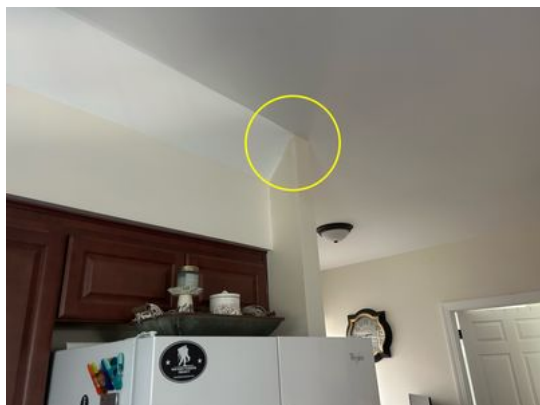
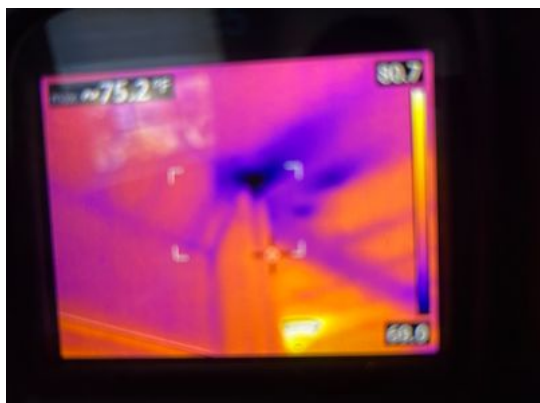
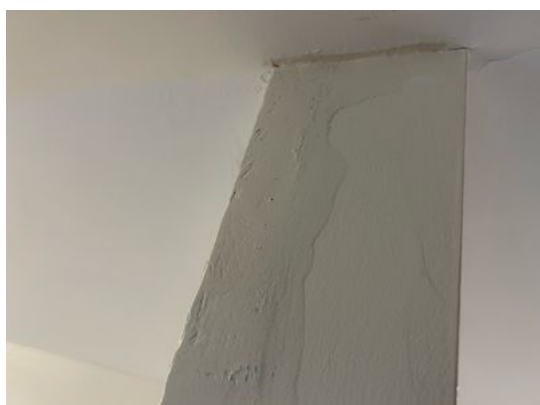
Elevated moisture levels were present on the garage apt walls, above the refrigerator. This appears to be a recent repair. It is recommended to consult the owner on any known repairs or current issues. If no information is available, further evaluation is recommended by a qualified professional.

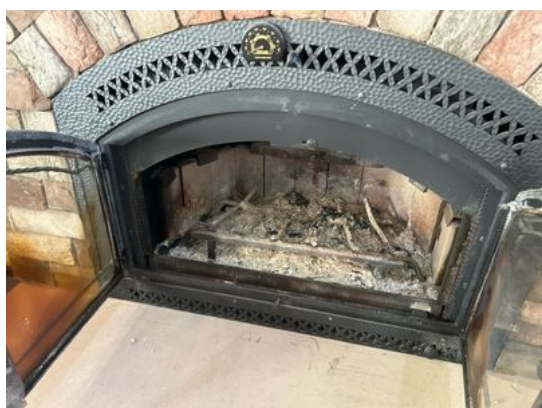
The wood burning stove and associated components should be properly inspected by a qualified professional before its first use to ensure safety and proper function. The system did appear to be in good condition and the damper was functional.

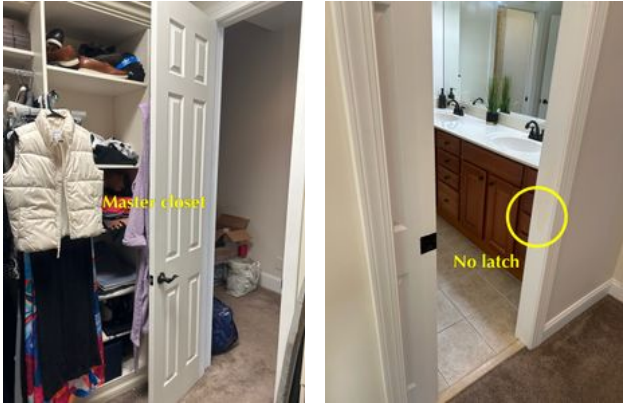
Multiple interior doors need repair/adjustment in order to shut/function properly.

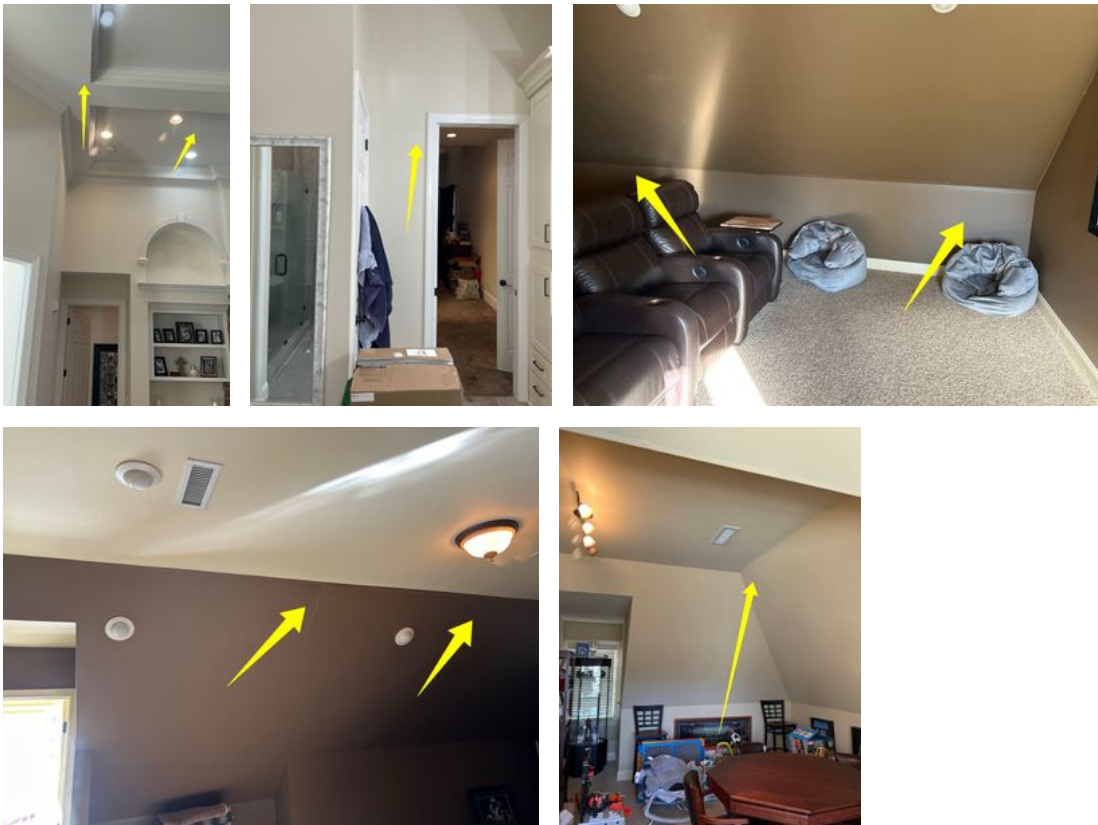
Comment 88

The ceiling/walls in several rooms had nail pops, corner bead and/or tape joint cracks. (cosmetic) (Photos are just examples and may not be all inclusive)

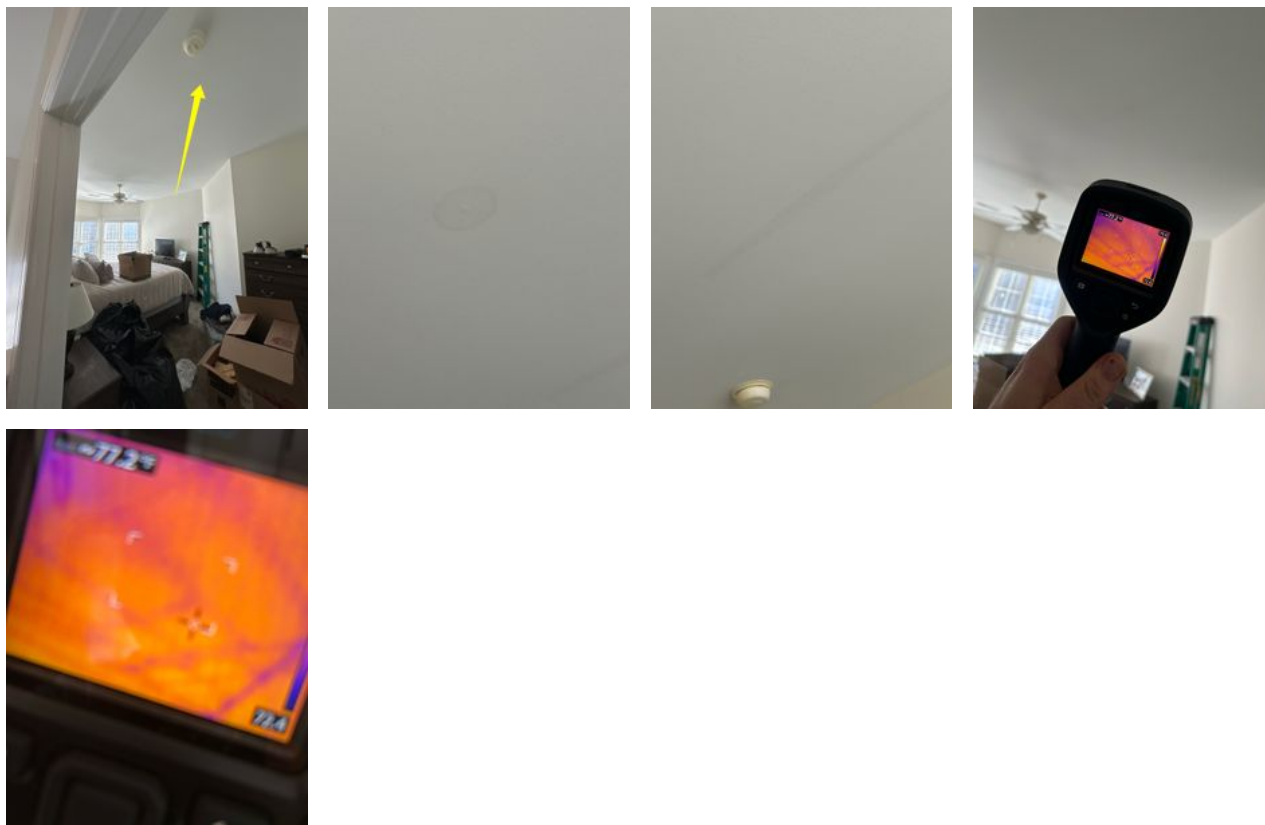
Comment 89
Information

There were water stains on the 2nd floor, front left bedroom ceiling. These appear to be from a previous leak as they were dry at the time of the inspection and there were no signs of active leaks. Moisture levels tested normal at the time of inspection. If you have concerns, a licensed roofing contractor is recommended for further evaluation.

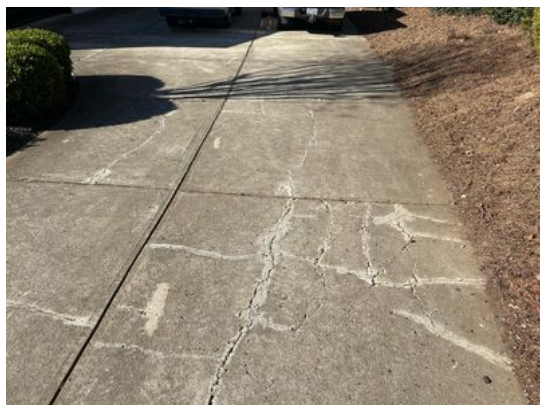
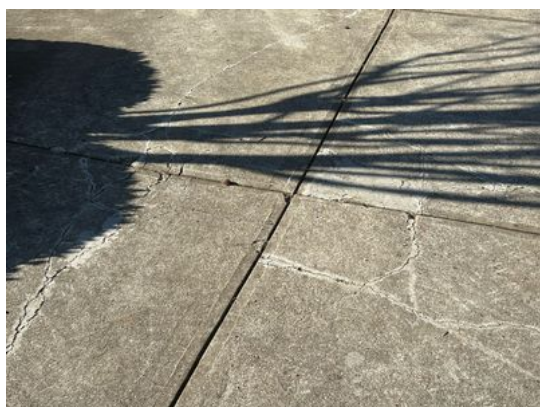
Site: Driveway

The driveway has a significant number of stress or settlement cracks. Over time these cracks could lead to lifting or settling of the driveway which will create walking hazards and issues with driving. Repairing any damaged areas is recommended by a qualified concrete contractor.

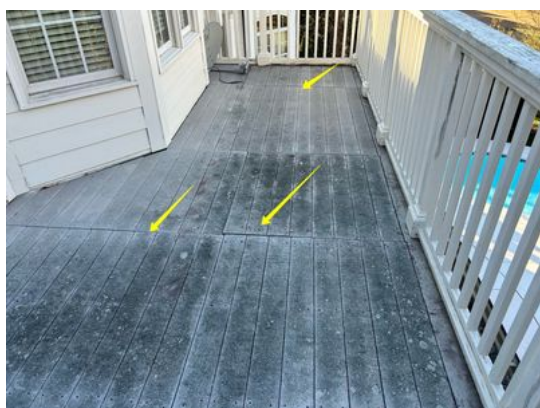
Comment 3

Multiple sections of the floating balcony deck were loose/lifted which creates a trip hazard. Repair is recommended by a qualified professional.

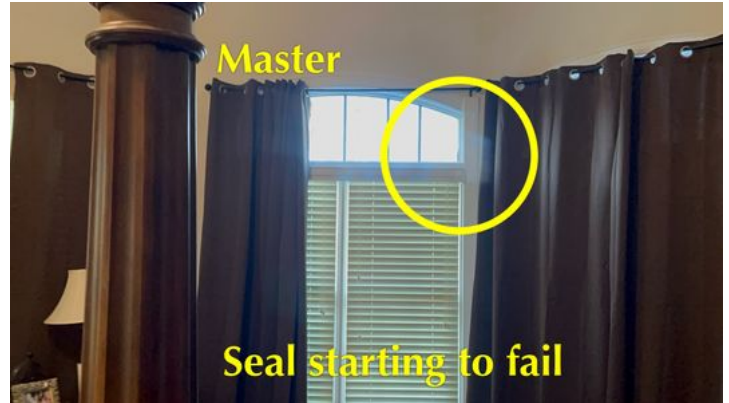
Comment 5

Hazing and moisture was observed in between multiple window panes. This is likely caused by deterioration of the low-e film and hermetic seal in between the window panes. Low-E is a film applied to the windows to help reduce solar heat gain. This condition may result in increased solar heat gain. It is recommended to consult with a qualified window repair professional to evaluate this condition and perform and necessary repairs or replacements.

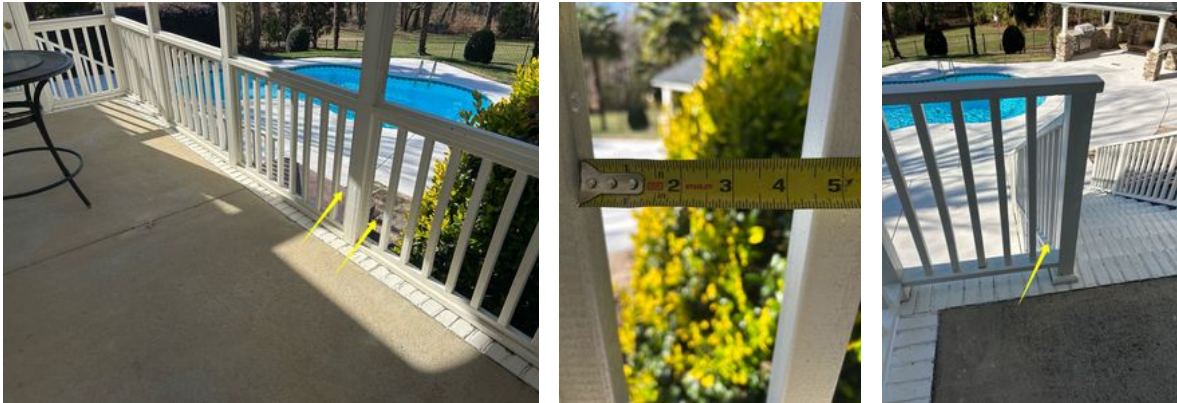
Comment 8

At several areas on the back porch, the spindle spacing does not meet current requirements. A 4" sphere should not pass between two spindles. This is considered a fall safety hazard. A qualified professional is recommended to repair the railing where needed. (Photos are not all inclusive)

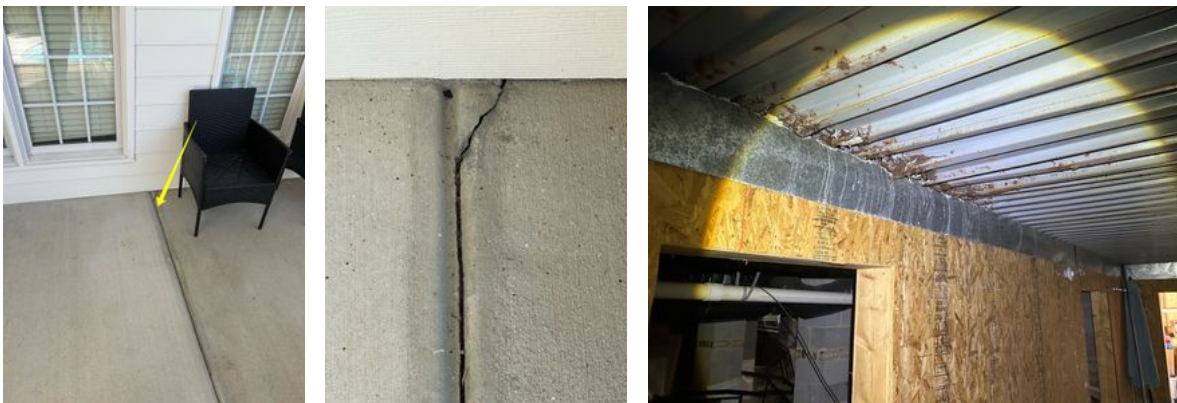
Comment 9

A qualified concrete contractor is recommended to evaluate the back porch concrete slab and corrugated form panels. The slab has settlement at a control joint which appears to promote water entry at the home's rim joist. This has led to deterioration of the metal forms and the concrete was brittle and breaking apart. (See video). Over time, this could lead to possible deterioration of the framing in this location.

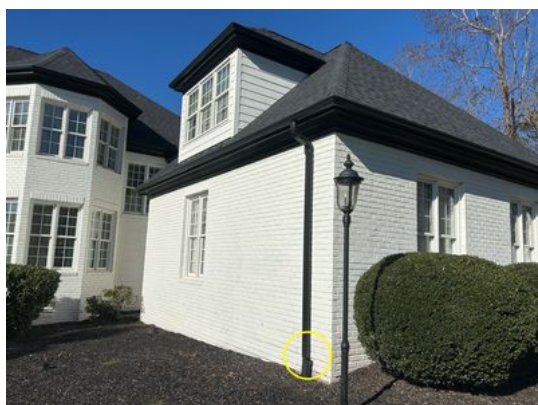
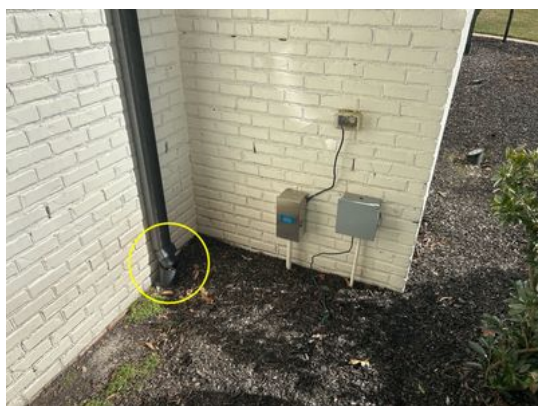
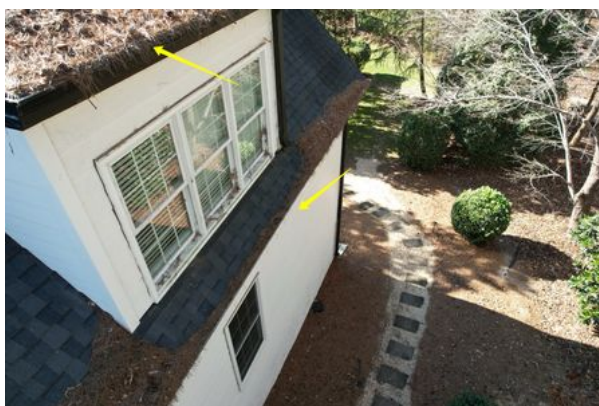
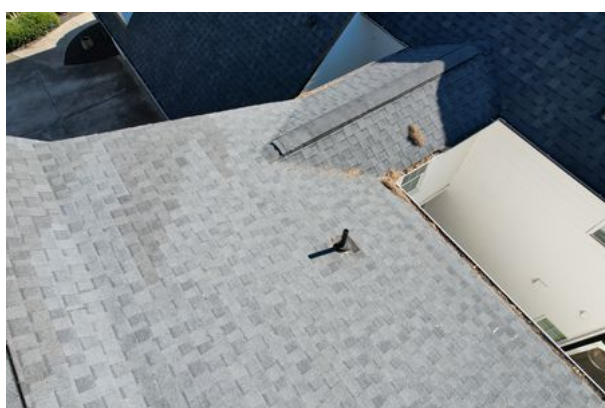
Roofing: Gutters & Downspouts

The gutters, in multiple locations, were filled with debris which will prevent water from exiting into the downspouts. This could cause water runoff in areas and present moisture related problems and lead to premature deterioration of the composite fascia. Ensure all gutter downspouts are properly connected to the corrugated drain lines and discharging away from the home. A qualified professional is recommended for repair. (Photos may not be all inclusive)

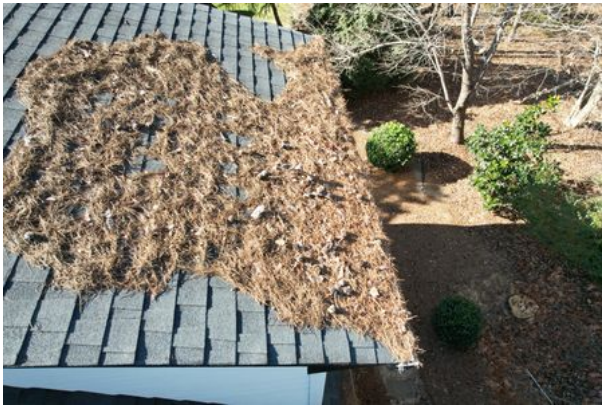
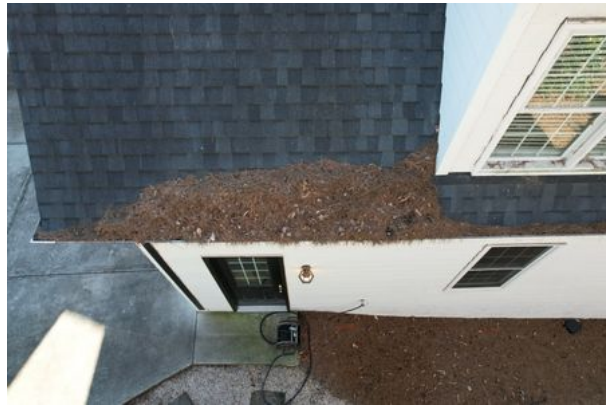
Comment 20

There was debris from trees and surrounding vegetation on the roof. This can allow water to back up under the roofing materials and could lead to water entry and damage to surrounding components. Removal of the debris is recommended.

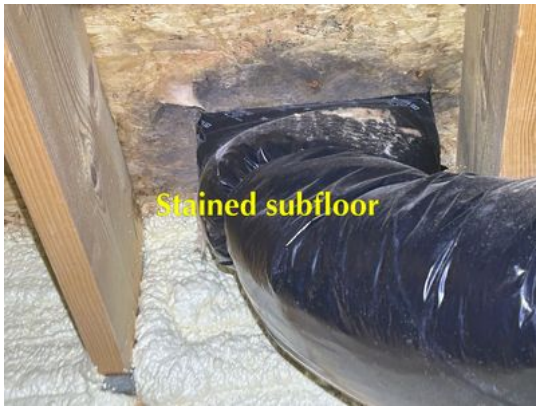
Comment 23

The subfloor at multiple hvac discharge boots was discolored and showed evidence of previous high moisture. Many times the air vents directly under the cabinet and is not in a chase or duct. The cool conditioned air leaves moisture under the cabinet base and this causes staining to the subfloor/base cabinet and sometimes damage to the base cabinet bottom panel. The subfloor was structurally sound in this location and moisture levels were normal at the time of inspection. The kitchen sink base cabinet was damaged and warm air was discharging inside the cabinet. A qualified contractor is recommended to evaluate the air discharge and repair the kitchen base cabinet to prevent further damage.

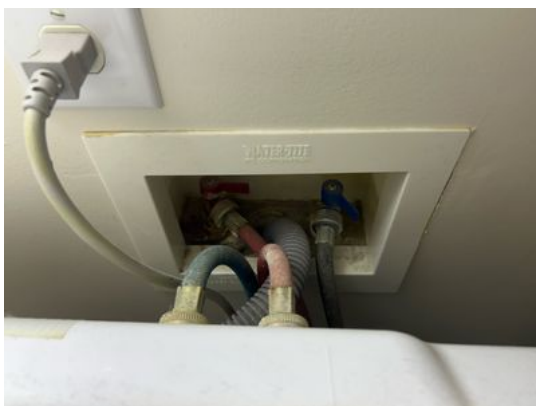
Corrosion and active leaking was observed on the hot water supply angle stop at the main house washer box. Replacement is recommended by qualified professional to prevent further deterioration or damage to surrounding components.

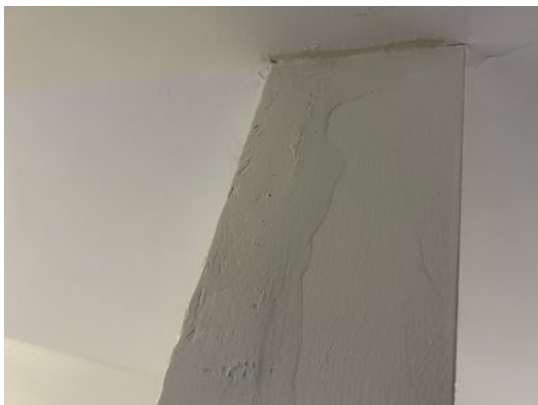
Elevated moisture levels were present on the garage apt walls, above the refrigerator. This appears to be a recent repair. It is recommended to consult the owner on any known repairs or current issues. If no information is available, further evaluation is recommended by a qualified professional.
