## Home Inspection Report

### New Construction Sample

### Wake Forest, NC 27587

Inspected By: Stephen Pait, CMI- Lic # 4329 &  
Septic Lic #72451

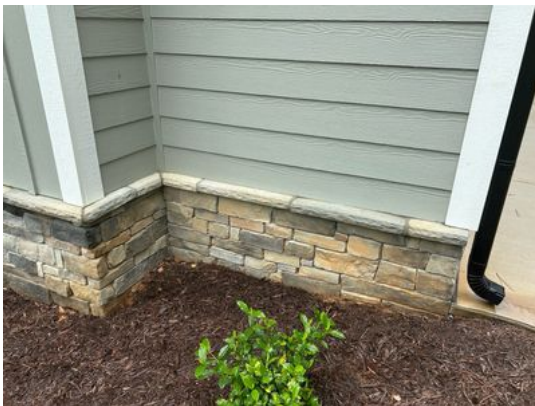
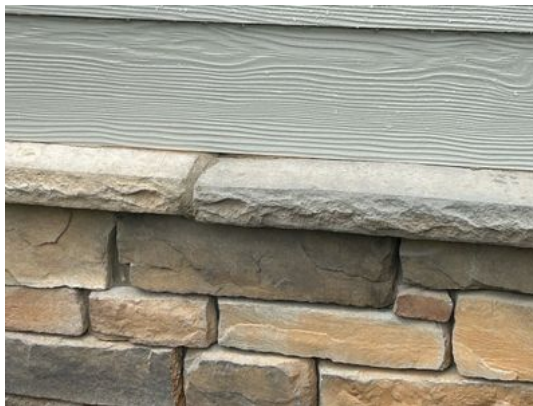
#### Comment 1

The fiber cement siding was not installed according to manufacturer installation instructions. A 1/4" gap is required at all horizontal transition flashings. This helps prevent premature moisture damage to the siding. There were no signs of damage at the time of inspection. If you have concerns, consult the builder for proper installation.

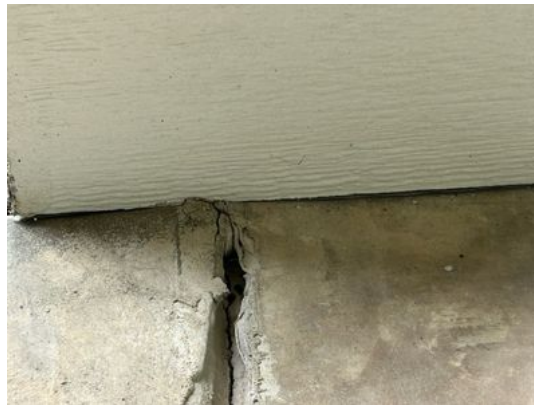
**Comment 2**

A 1/2" gap is required between composite trim material and any concrete surface per manufacturer's installation instructions. Cutting any trim to meet this guideline is recommended to help reduce possible moisture related damage.

Properly flash and space at least 1/2" from any flatwork (such as porches, patios, decks, or driveways) or horizontal brick ledge. Prime and paint bottom edge before installing. Also all miter joints should be glued and caulked.

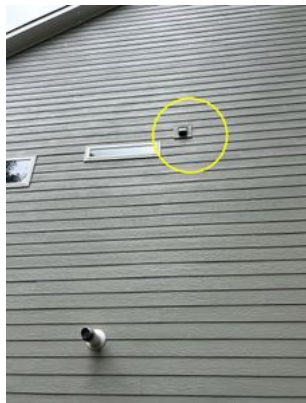
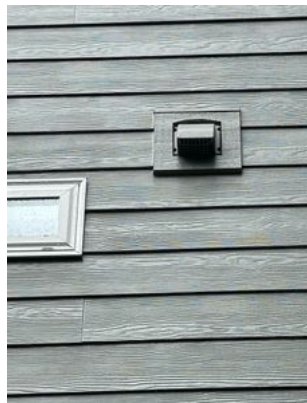
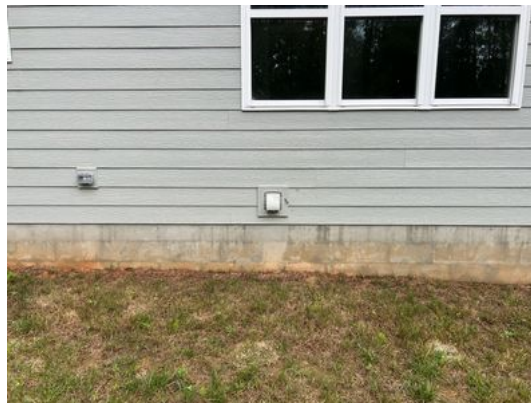
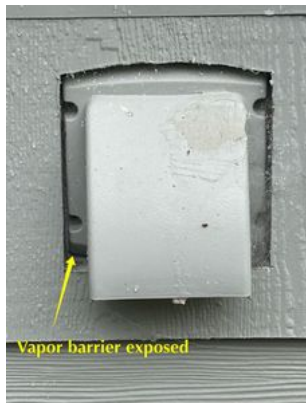
**Comment 3**

Sealing the gap between the exterior vent cap(s) and siding is recommended to prevent water entry behind the siding.

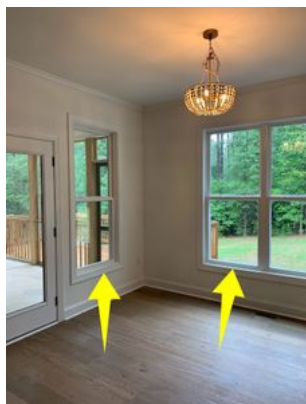
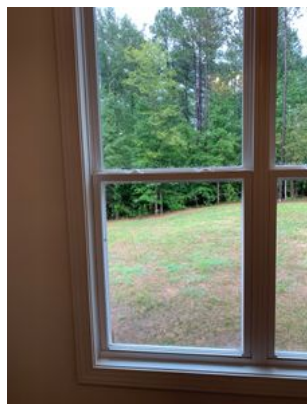
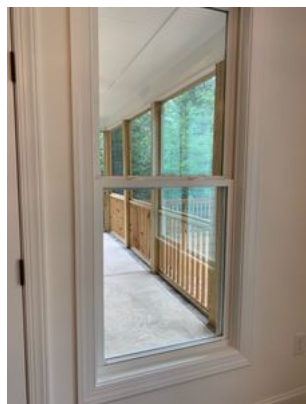
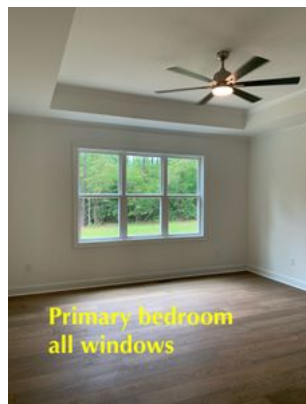
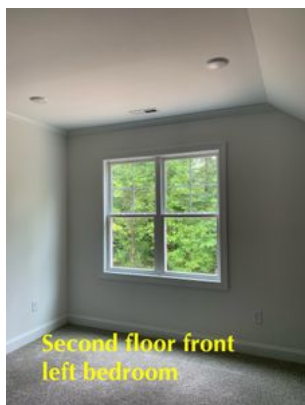
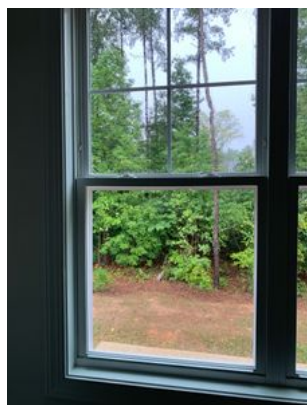
**Comment 6**

Multiple windows are loud when opened compared to other windows in the home. It is recommended to have a qualified professional make any adjustments needed to allow for easier function. (Photos may not be all inclusive)

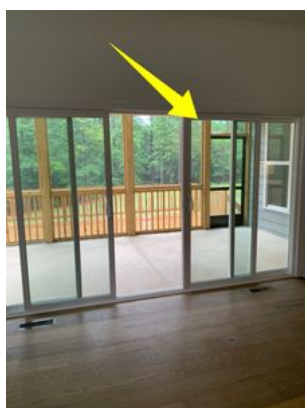
**Comment 7**

The sliding glass door requires adjustment/repair. The door gets stuck on the track when closing. This could lead to damage of the door over time.

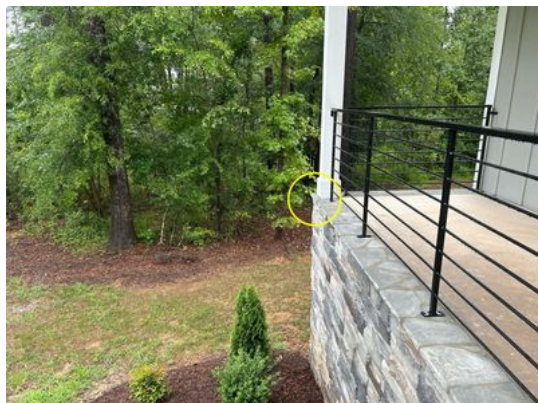
**Comment 8**

Secure the loose flagstone on the front porch to prevent further detachment.

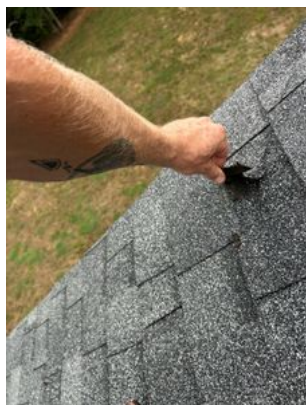
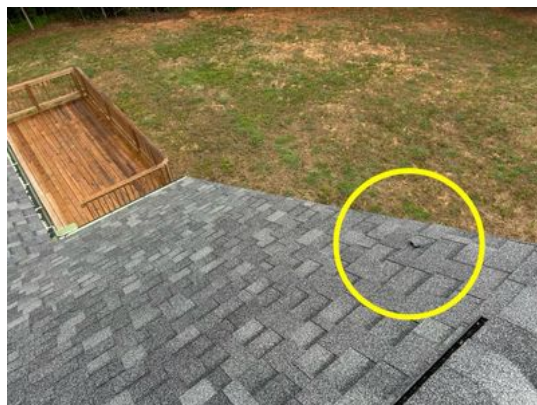
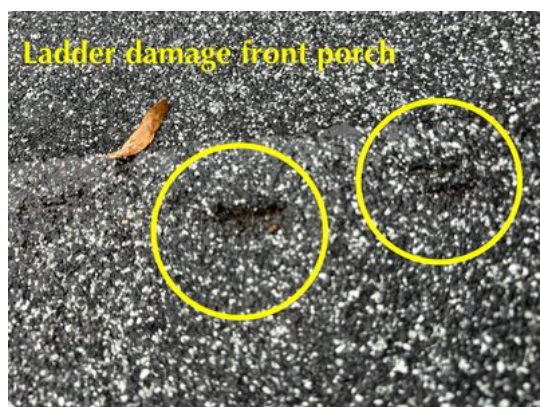
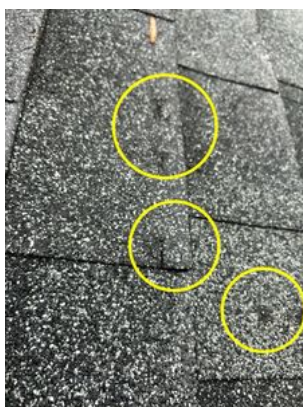
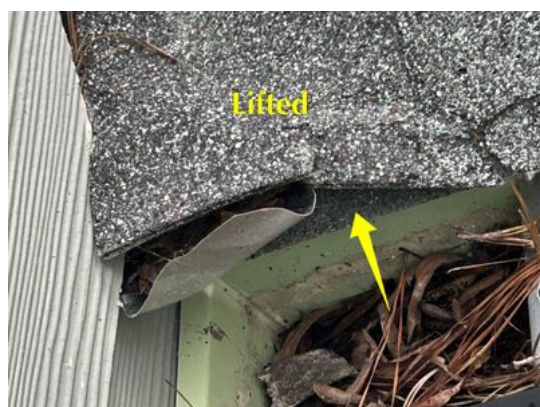
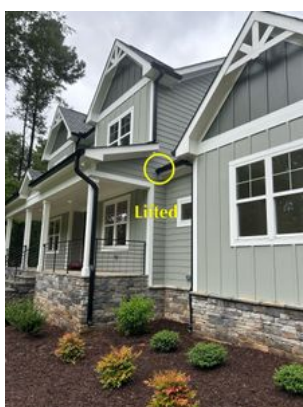
**Comment 10**

Multiple shingles were found to be damaged. Replacement of the affected shingles is recommended. Damage that compromises the protective granule layer and asphalt composition can lead to premature shingle failure, increasing the risk of water intrusion.

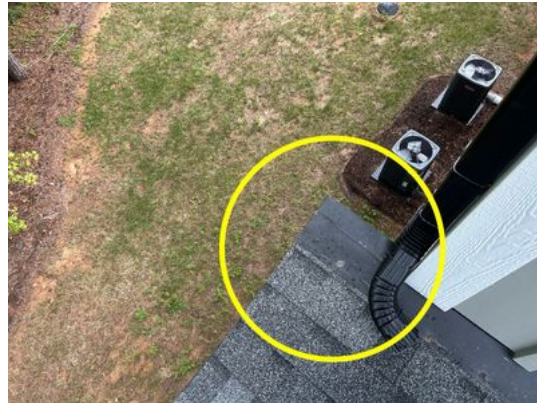
**Comment 11**

Flashing should be installed (or bent over the fascia) where the roof line extends beyond the main exterior wall of the home. Headwall flashing is installed in this location but water could enter behind the flashing and deteriorate the substrate. (Front porch)

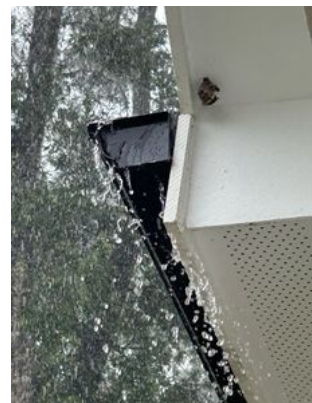
**Comment 14**

The gutters, in multiple locations, were filled with debris which will prevent water from exiting into the downspouts. This could cause water runoff in areas that could present moisture problems. Cleaning out the gutters and ensuring functional flow out of the downspouts is recommended.

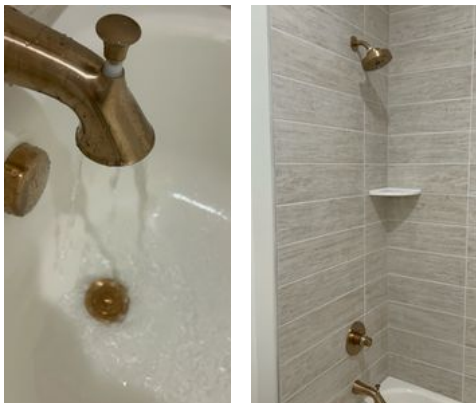
### Comment 34

The 2nd floor tub diverter did not properly divert all of the water to the shower head. This leads to low water pressure in the shower. Repair/replacement of the tub spout is recommended for proper function.

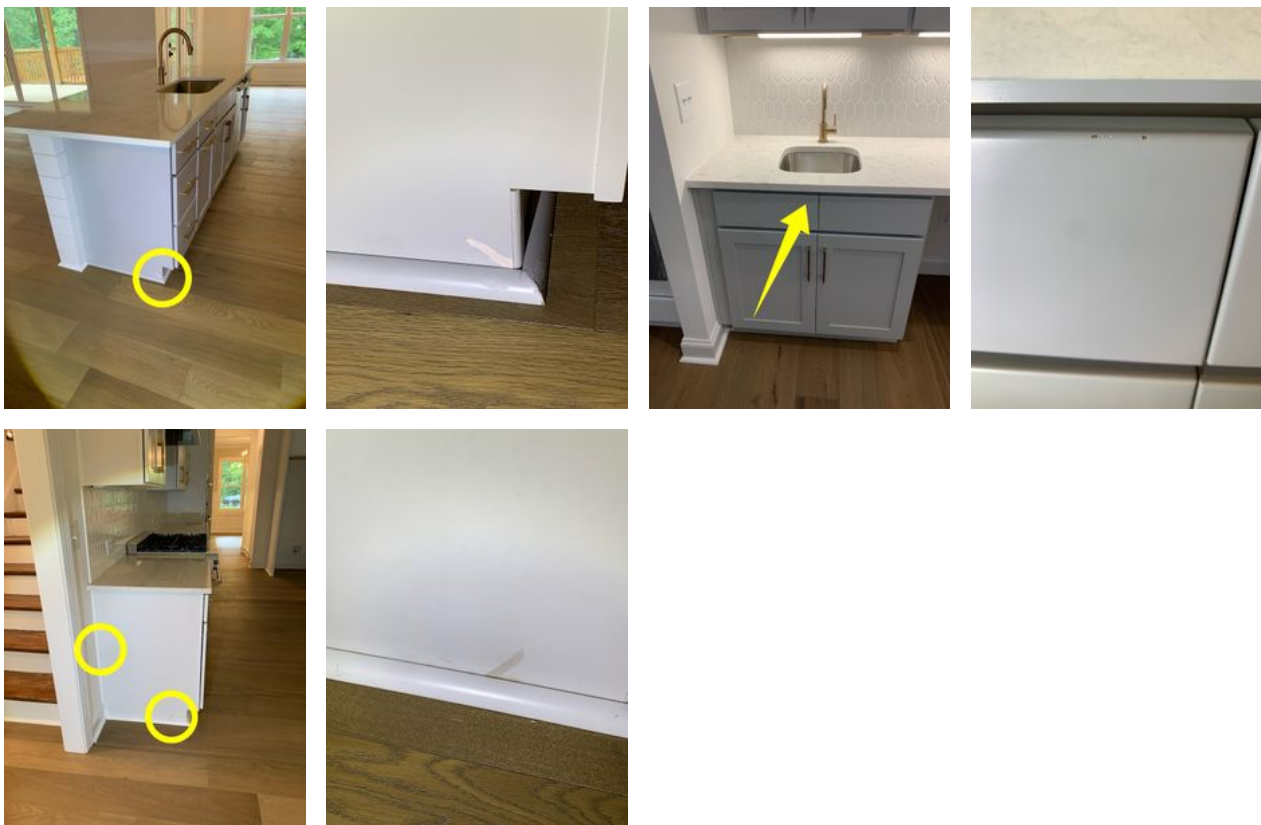
**Comment 40**

There were several areas of damaged finish on the kitchen cabinets.

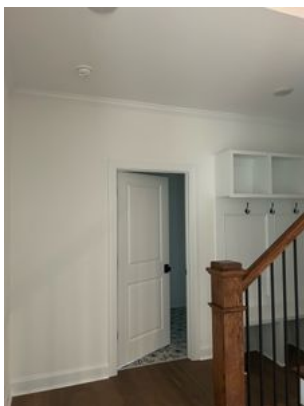
### Comment 45

There was no opening observed for make up air in the laundry room. Where a closet/room is designed for the installation of a clothes dryer, an opening having an area of not less than 100 square inches shall be provided in the closet enclosure or makeup air shall be provided by other approved means. Consult the builder to determine if a transfer grill or jump duct should be installed for this application.

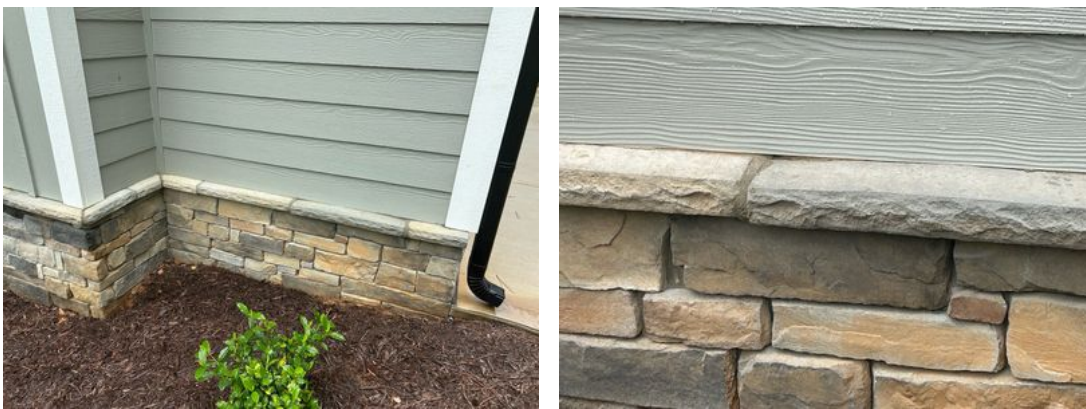
The fiber cement siding was not installed according to manufacturer installation instructions. A 1/4" gap is required at all horizontal transition flashings. This helps prevent premature moisture damage to the siding. There were no signs of damage at the time of inspection. If you have concerns, consult the builder for proper installation.

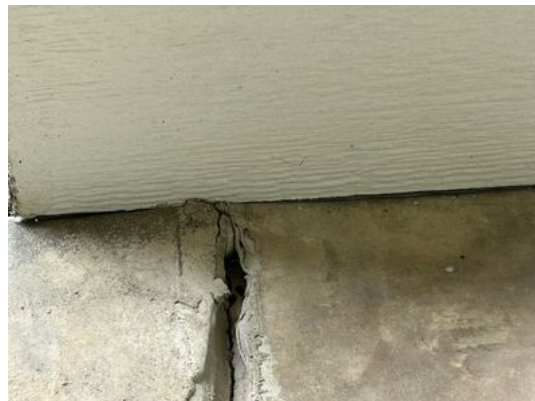
A 1/2" gap is required between composite trim material and any concrete surface per manufacturer's installation instructions. Cutting any trim to meet this guideline is recommended to help reduce possible moisture related damage.

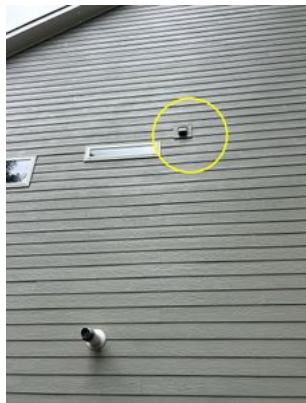
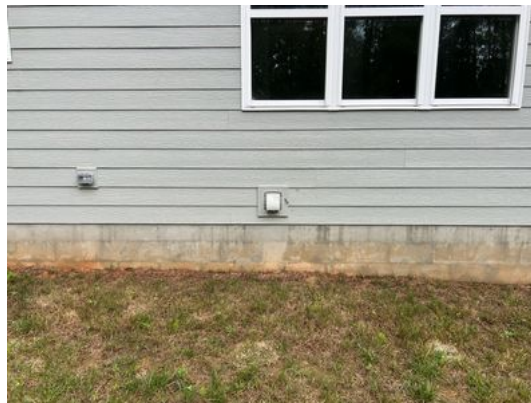
**Comment 3**

Sealing the gap between the exterior vent cap(s) and siding is recommended to prevent water entry behind the siding.

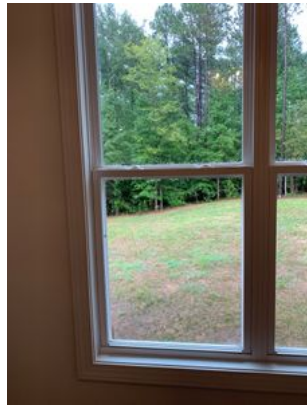
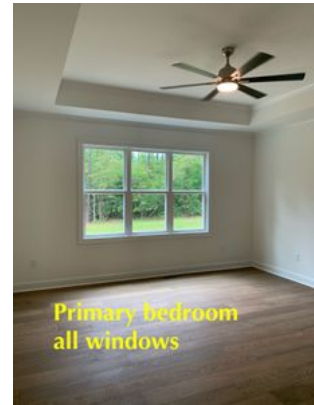
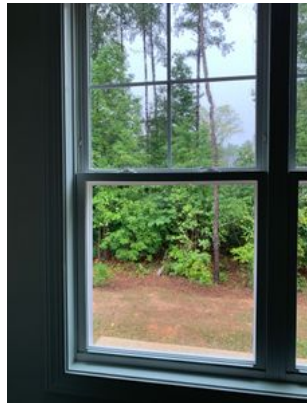
Multiple windows are loud when opened compared to other windows in the home. It is recommended to have a qualified professional make any adjustments needed to allow for easier function. (Photos may not be all inclusive)

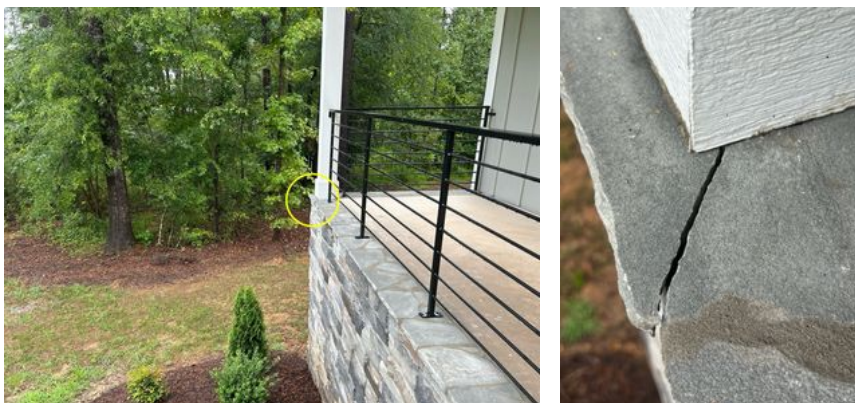
Secure the loose flagstone on the front porch to prevent further detachment.

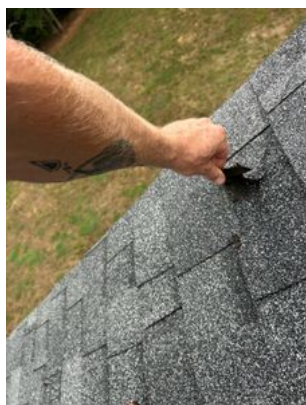
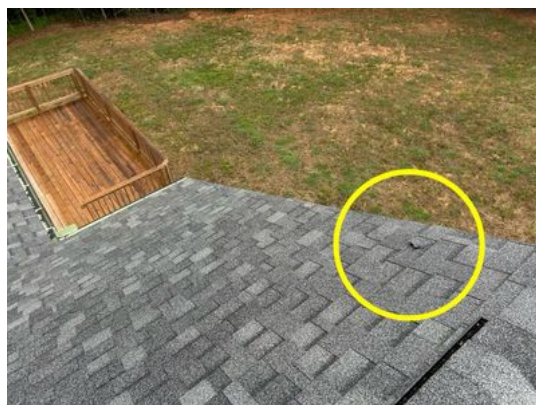
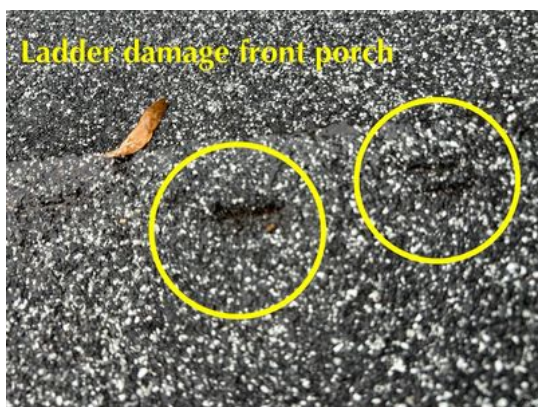
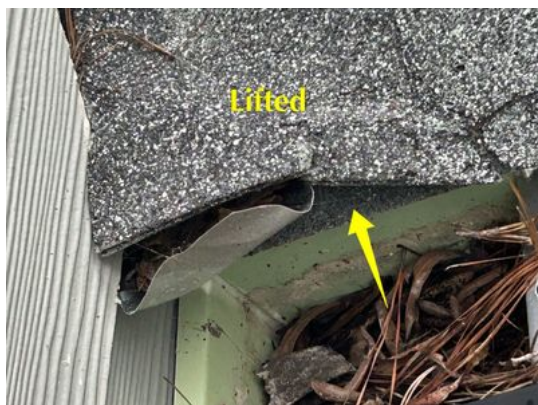
Multiple shingles were found to be damaged. Replacement of the affected shingles is recommended. Damage that compromises the protective granule layer and asphalt composition can lead to premature shingle failure, increasing the risk of water intrusion.

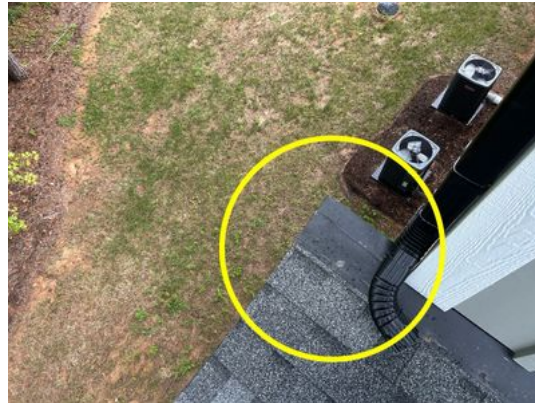
Flashing should be installed (or bent over the fascia) where the roof line extends beyond the main exterior wall of the home. Headwall flashing is installed in this location but water could enter behind the flashing and deteriorate the substrate. (Front porch)

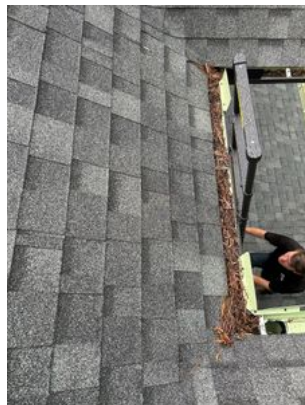
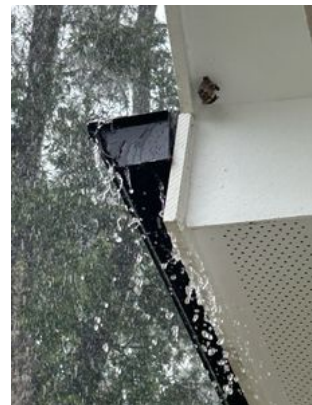
### **Comment 14** **Deficiency**

The gutters, in multiple locations, were filled with debris which will prevent water from exiting into the downspouts. This could cause water runoff in areas that could present moisture problems. Cleaning out the gutters and ensuring functional flow out of the downspouts is recommended.

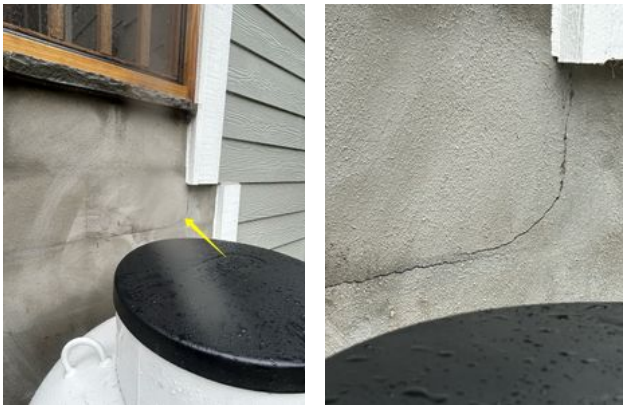
#### Comment 18 Information

The masonry stemwall has settlement cracks. These type of settlement cracks are common and are not necessarily a sign of any structural issue. A typical rule of thumb is any crack 1/4" or more requires further evaluation/repair. Monitor the stem-wall for excess settlement. If you have concerns, consulting a licensed contractor or structural engineer is recommended. (Photo(s) example(s) may not be inclusive of all areas of settlement cracks.)

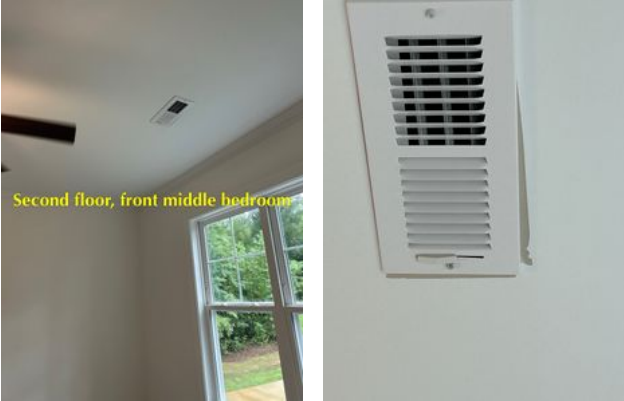
<b>Comment 28</b>	
<b>Deficiency</b>	
Cosmetic defect at an HVAC supply diffuser. The ceiling paint will need to be touched up.

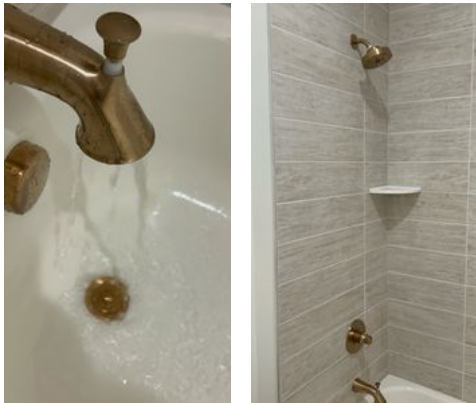
The 2nd floor tub diverter did not properly divert all of the water to the shower head. This leads to low water pressure in the shower. Repair/replacement of the tub spout is recommended for proper function.

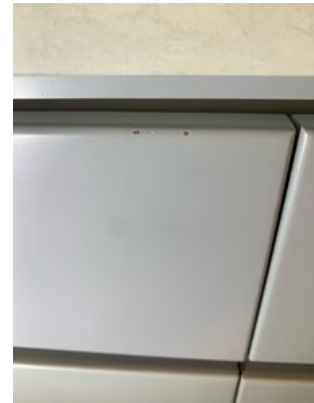
There were several areas of damaged finish on the kitchen cabinets.

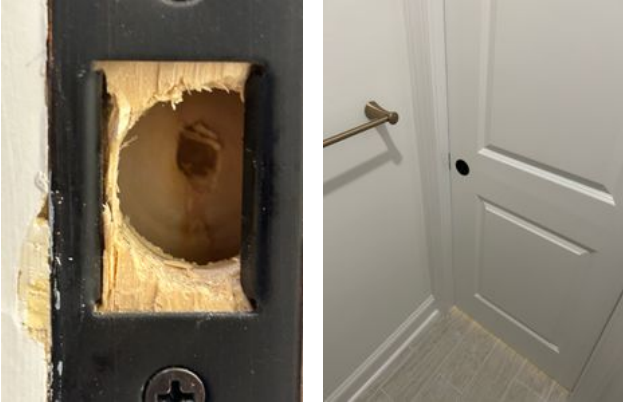
An interior door needs adjustment in order to function/latch properly. (2nd floor bathroom pocket door. Mortise incomplete, latch gets stuck)
