**REPORT ON FAA'S ACTIONS TO ADDRESS
MOLD AT THE DETROIT METROPOLITAN AIR
TRAFFIC CONTROL TOWER FACILITY**

Report Number: AV-2006-055

Date Issued: July 11, 2006

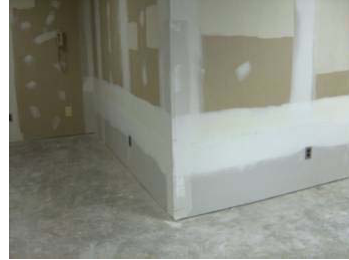
- January 2006 – Remediation was conducted on the third floor in response to mold identified during the November monthly moisture inspection. The photo at right depicts this completed remediation that replaced the lower two feet of gypsum wallboard from the wall bordering the elevator shaft.

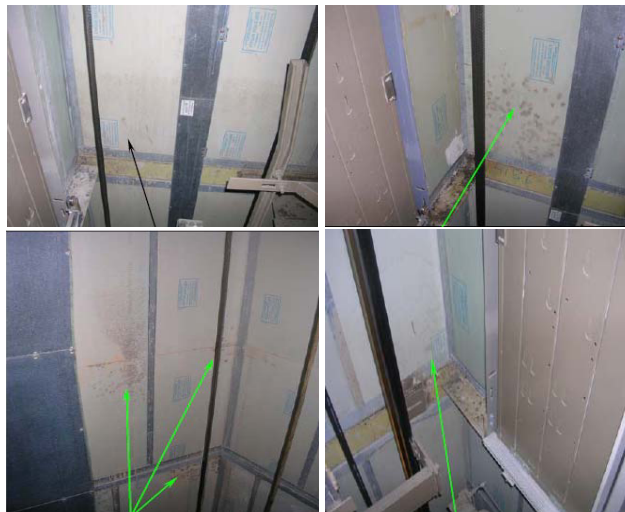
What did the mold in the elevator shaft look like?

- **Top Left:** Spots of visible mold growth on east wall of shaft of the third floor.
- **Top Right:** Visible mold growth on shaft on west wall of seventh floor.
- **Bottom Left:** Visible mold growth on shaft on west wall of eighth floor.
- **Bottom Right:** Visible mold growth on east wall of shaft of sixth floor.

- May 2006 – Mold in the elevator shaft was remediated by HEPA vacuuming and damp wipe-down with detergent and water. FAA continues to conduct monthly moisture inspections of the facility (including the elevator shaft) to identify mold or moisture issues.
