**Housing Authority of the City of Aurora  
REQUEST FOR QUALIFICATIONS NO. RFQ20261008  
ARCHITECTURAL DESIGN SERVICES**

**PROPERTY CONDITION REPORT  
TROLLEY PARK  
1445 DALLAS STREET  
AURORA, COLORADO 80010**

**D3G PROJECT NUMBER:  
2023-1793**

Property: Trolley Park  
1445 Dallas Street  
Aurora, Colorado 80010

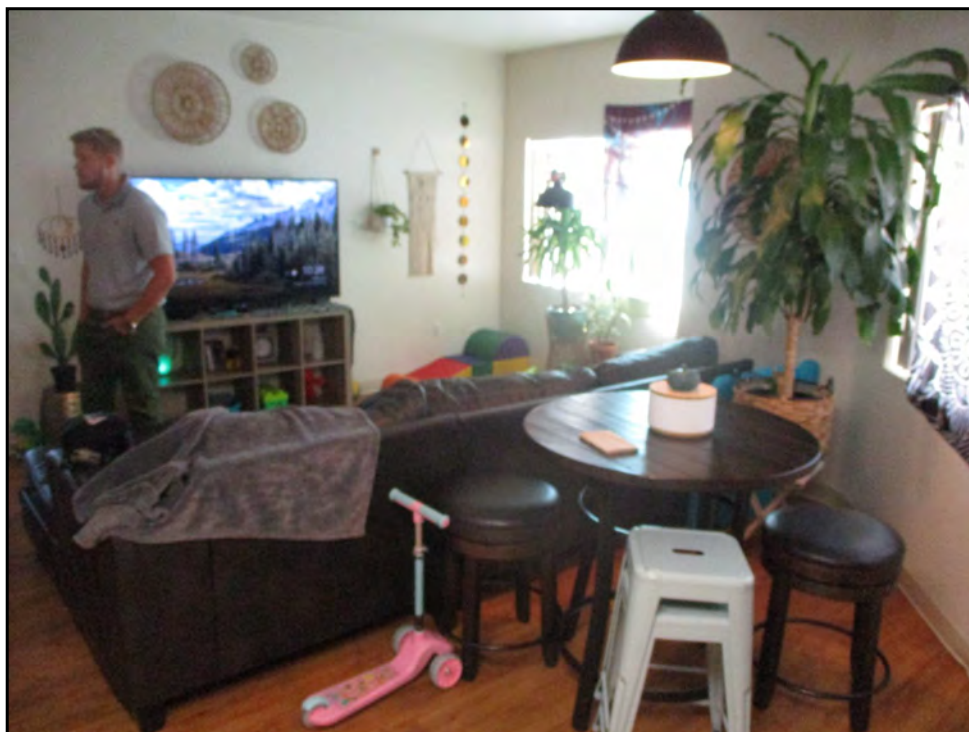
89: Interior dwelling unit. 3 Bed/ 2 Bath Type F unit without 48-inches at the base of the U (Immediate Repair).

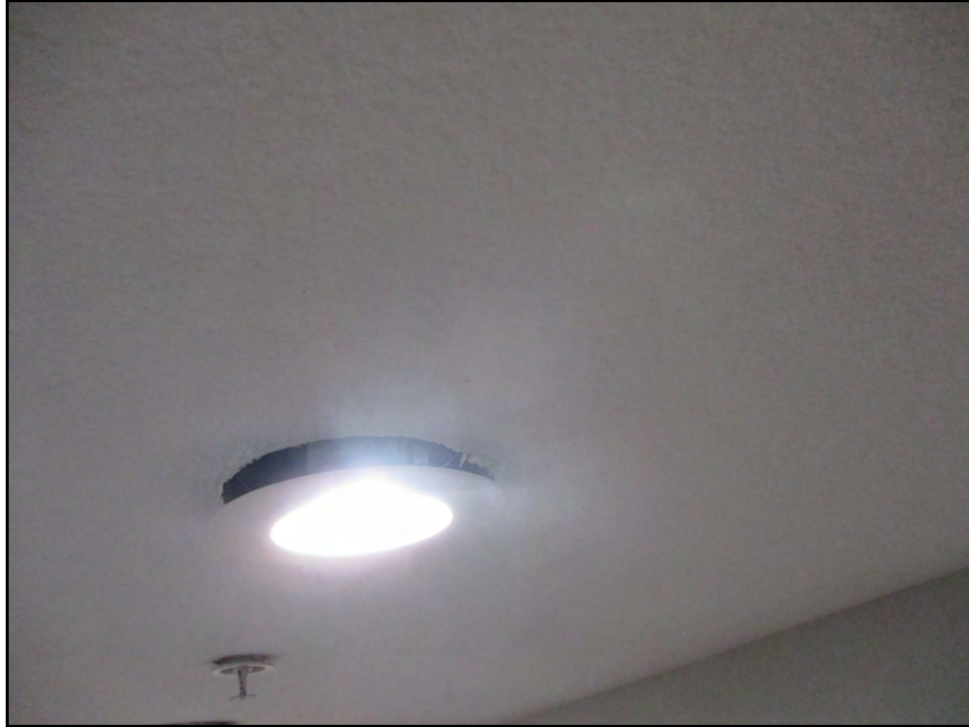
Interior lighting throughout the property is provided via wall mounted and ceiling mounted incandescent, fluorescent, and LED lighting fixtures. It could not be determined if lighting was adequate as the survey was performed during the day; however, based upon the number of interior lighting fixtures, the lighting is assumed to be sufficient for the needs of the property. Numerous light fixtures were observed damaged or broken. Therefore, repair of the interior light fixtures throughout the building is recommended (Immediate Repair).

124: Repair common area lighting (Immediate Repair)

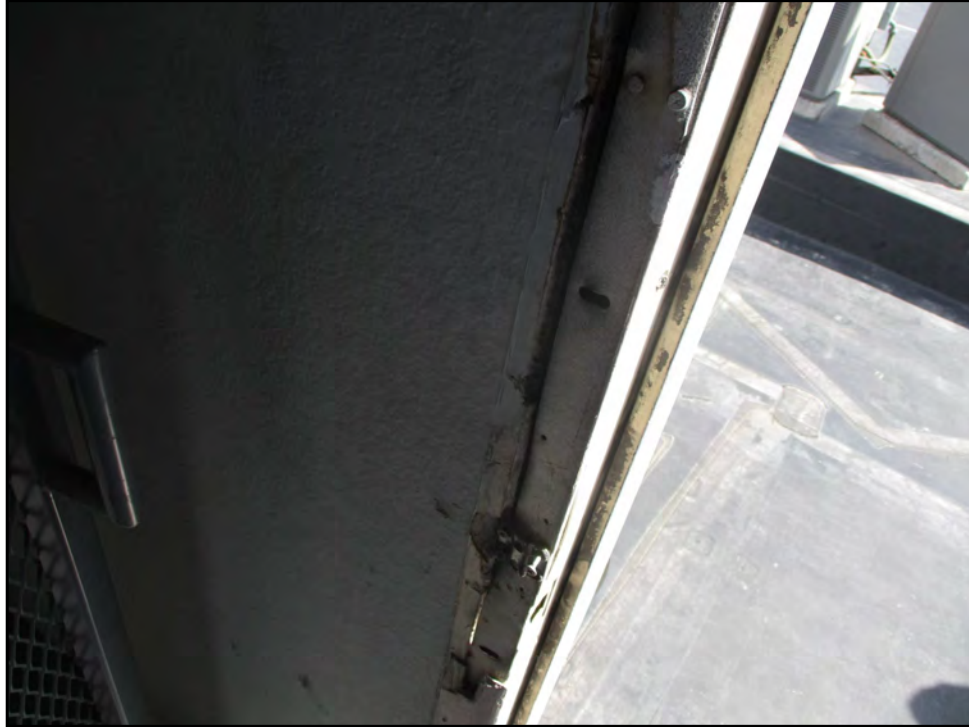
126: Repair damaged roof access door and frame (Immediate Repair)

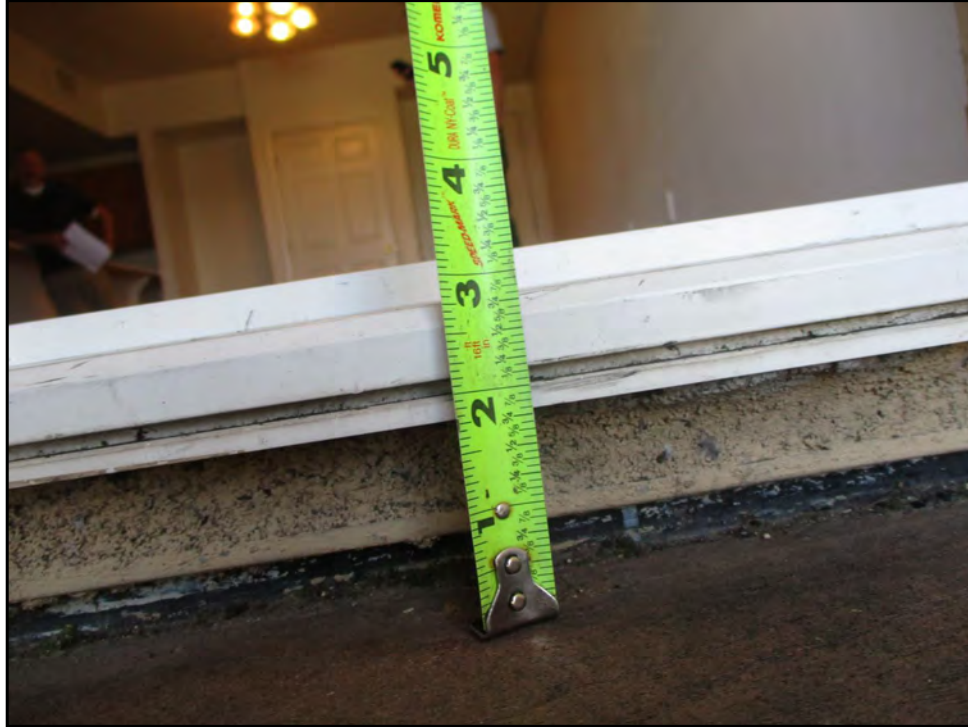
142: Reconfigure thresholds at patio sliding glass doors (Immediate Repair)

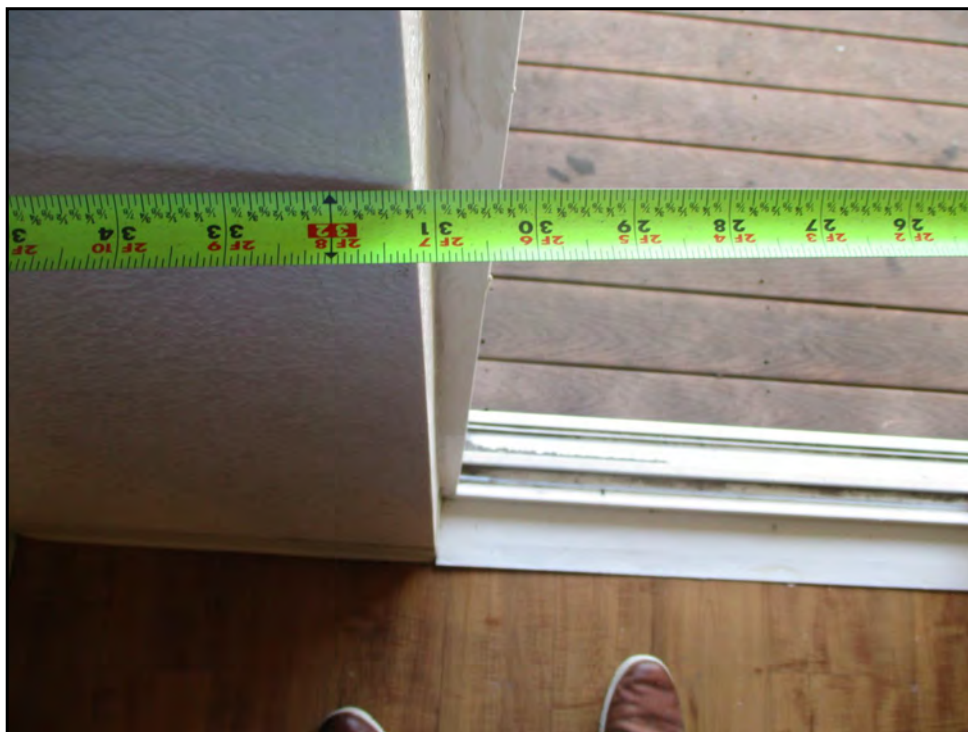
143: Reconfigure thresholds at patio sliding glass doors (Immediate Repair)

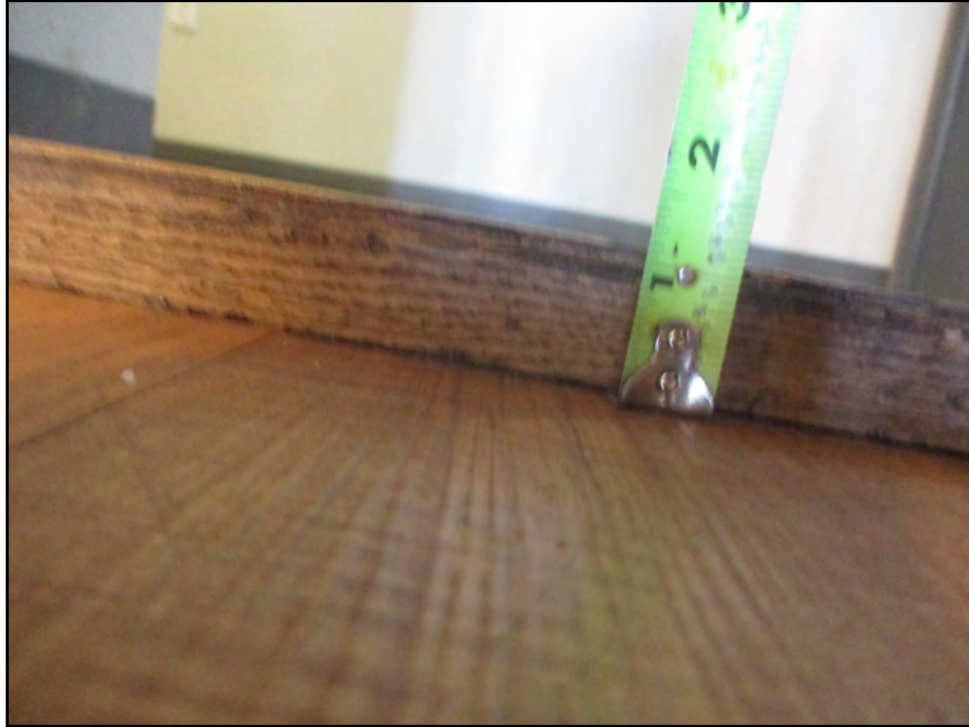
144: Sliding glass door opening less than 32-inches (Immediate Repair)

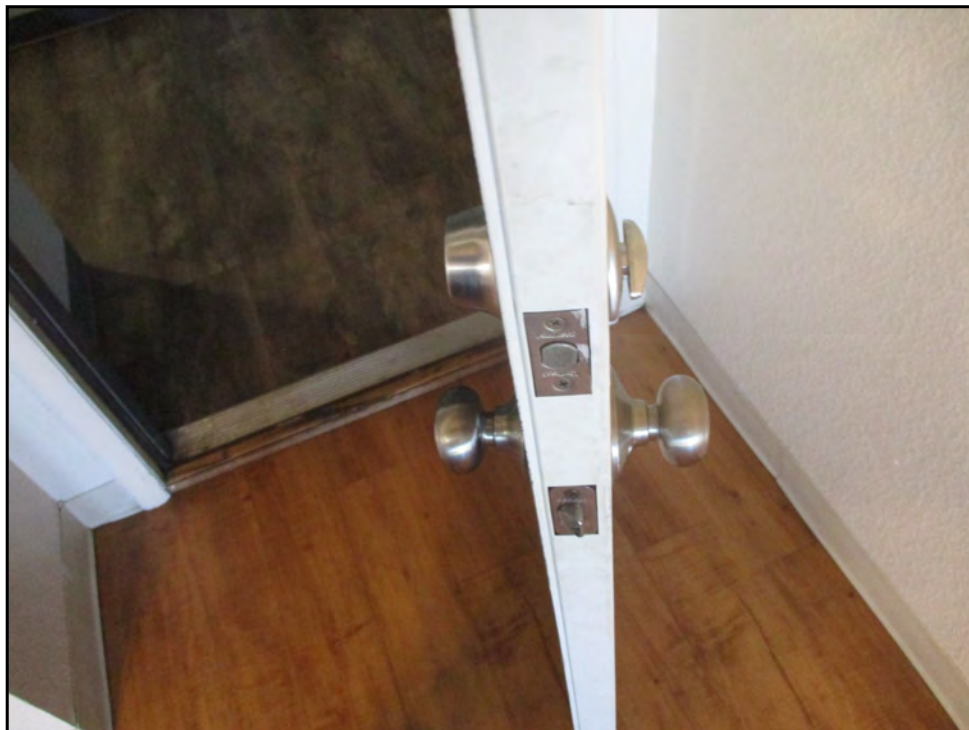
145: Non-compliant primary door threshold at dwelling units (Immediate Repair)

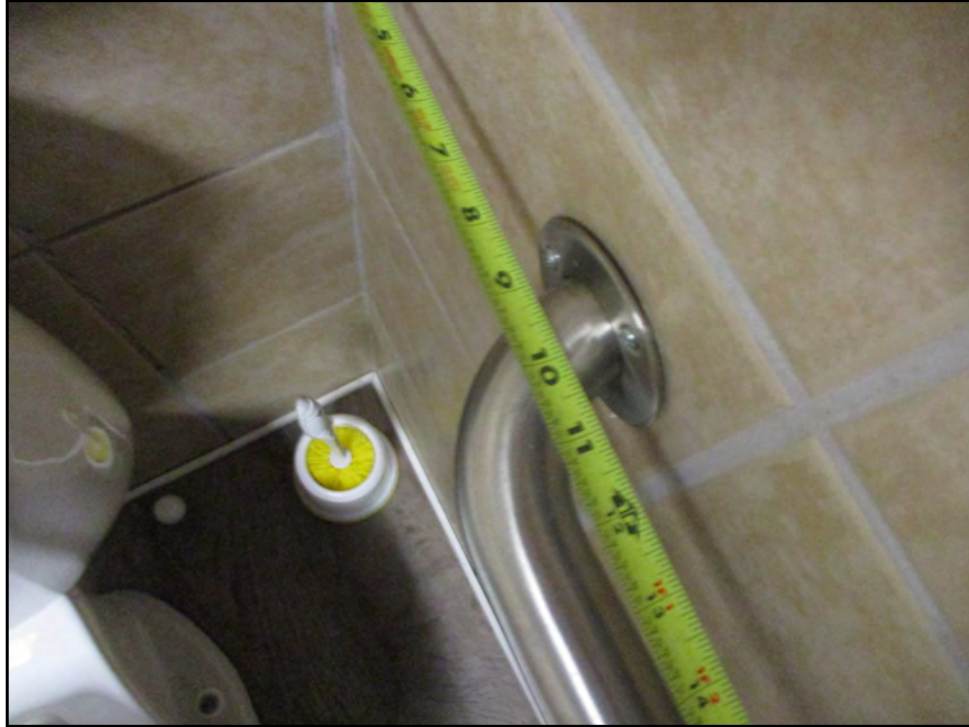
150: Non-compliant toilet grab bar at common restroom (Immediate Repair)

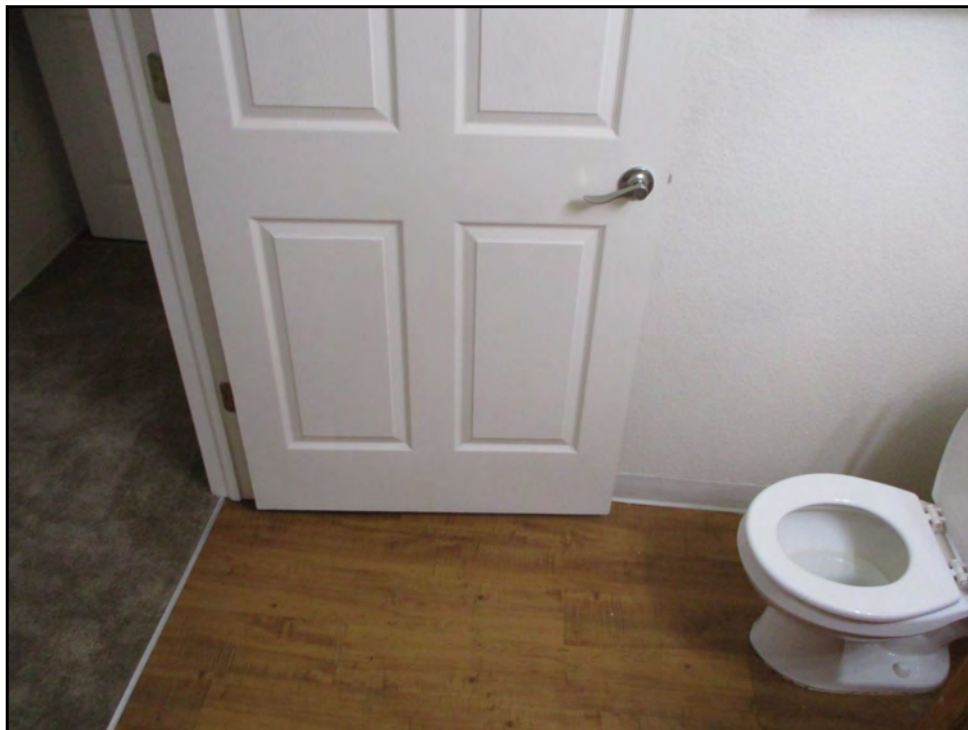
153: Reverse door swing in master bath unit type G (Immediate Repair)

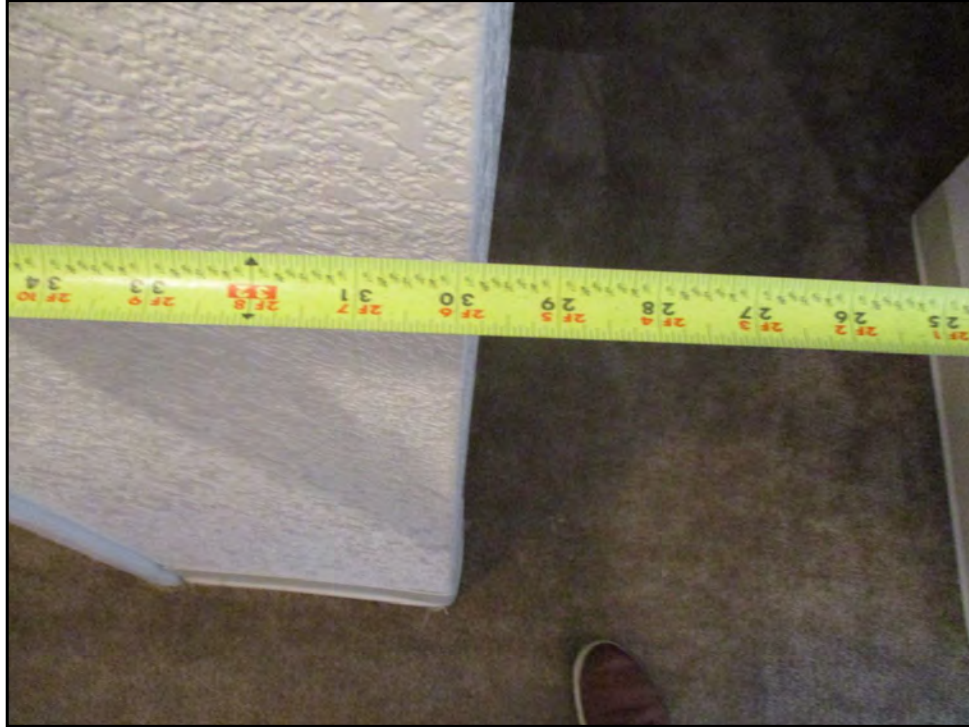
154: Reverse door swing in master bath unit type G (Immediate Repair)

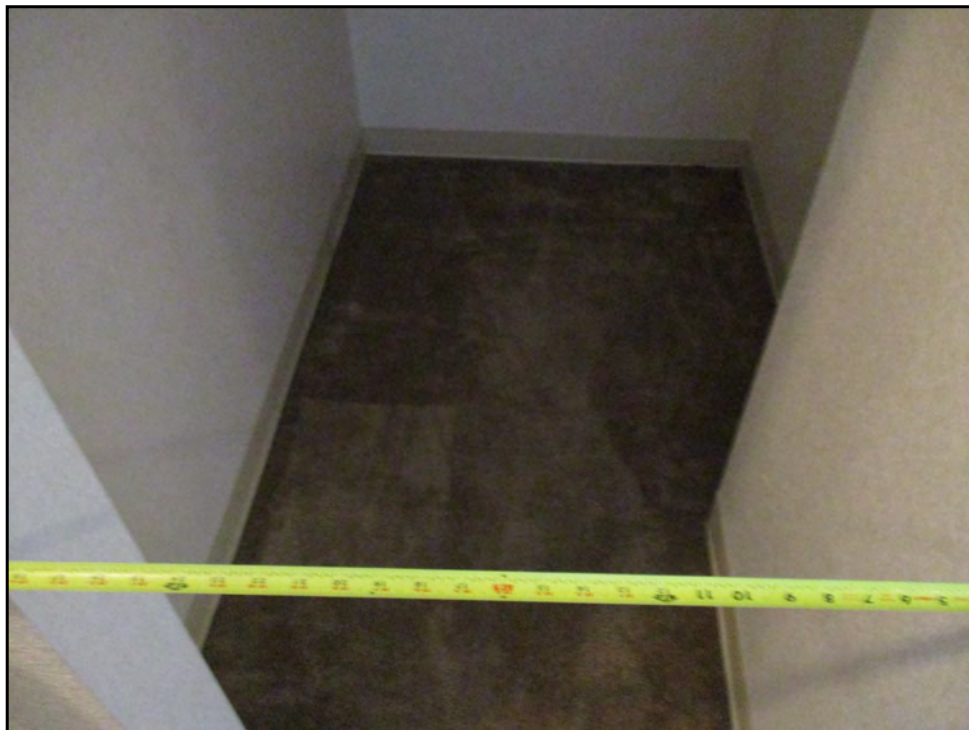
155: Master closet in Type J less than 32-inch wide openings (Immediate Repair)

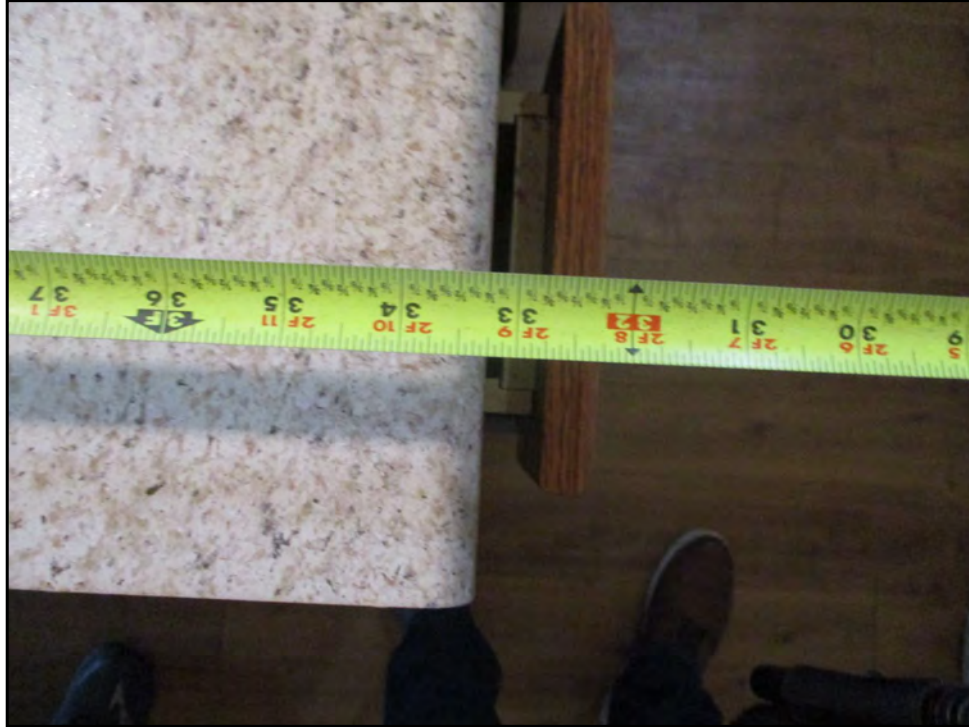
158: Install wall hung sinks at Type G master bathrooms (Immediate Repair)

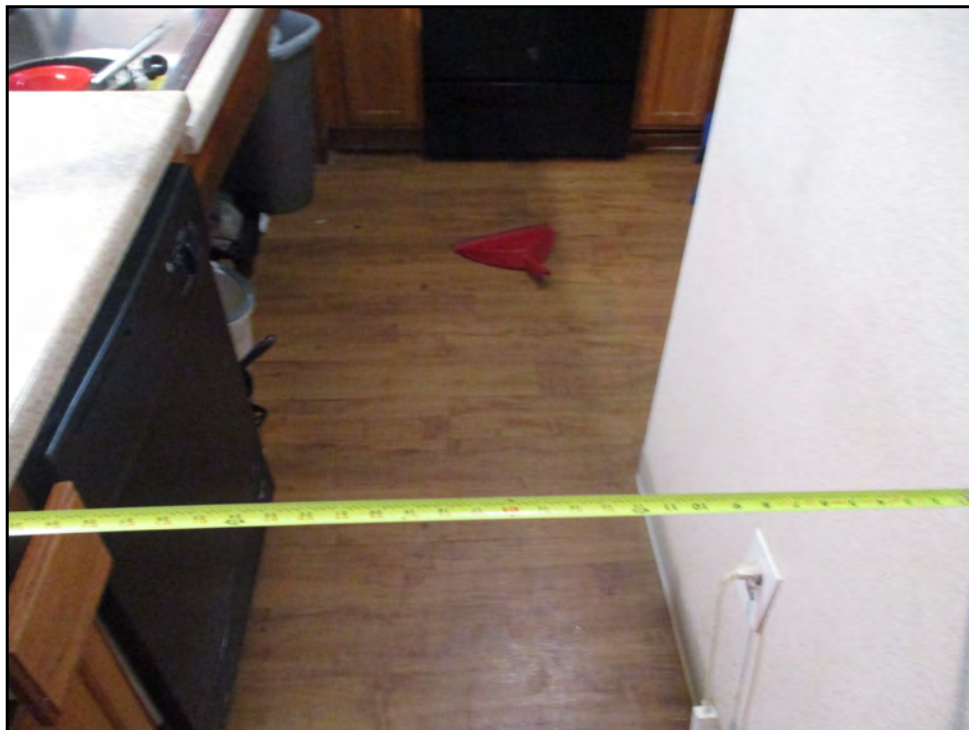
159: Missing compliant maneuvering space within galley kitchens in Type J floorplans (Immediate Repair)

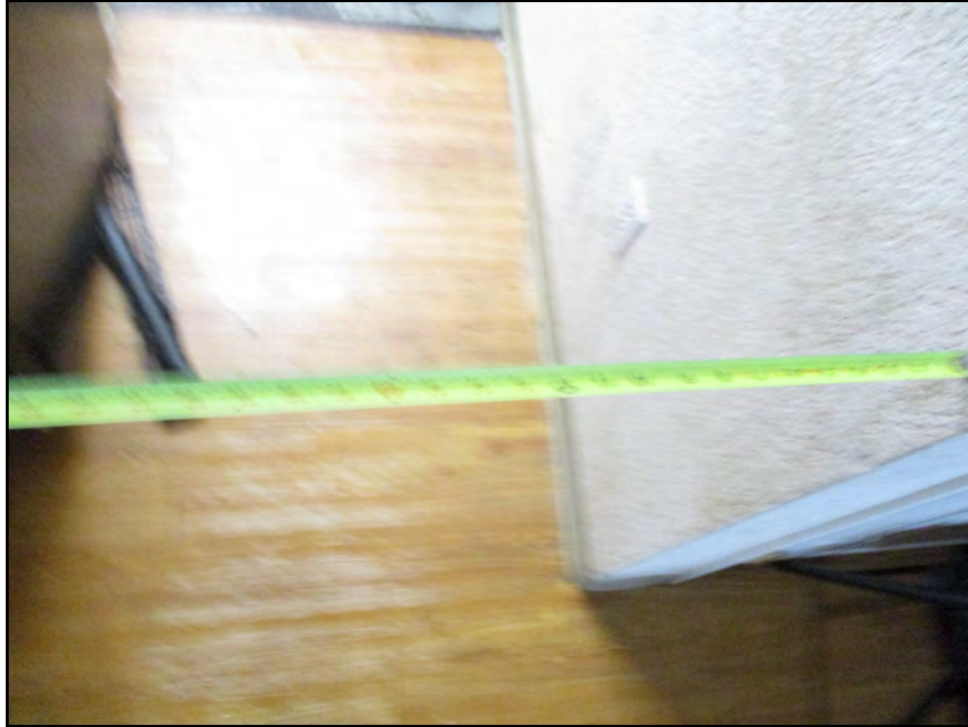
164: Missing compliant maneuvering space within galley kitchens in Type K units (Immediate Repair)

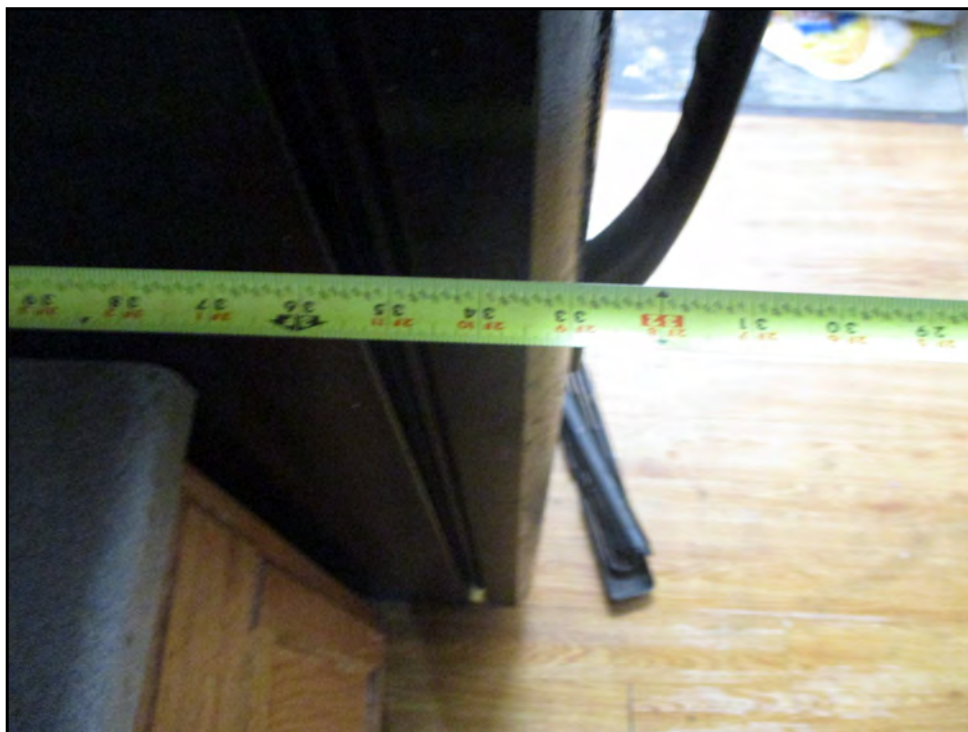
165: Missing compliant maneuvering space within galley kitchens in Type K units (Immediate Repair)

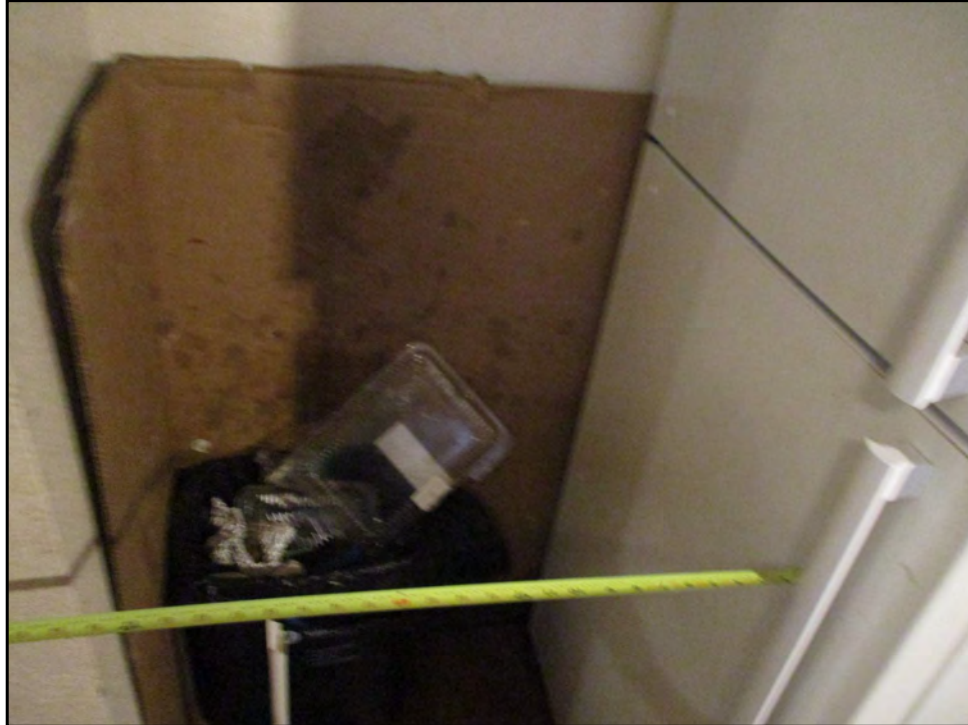
166: Missing compliant maneuvering space within galley kitchens in Type K units (Immediate Repair)

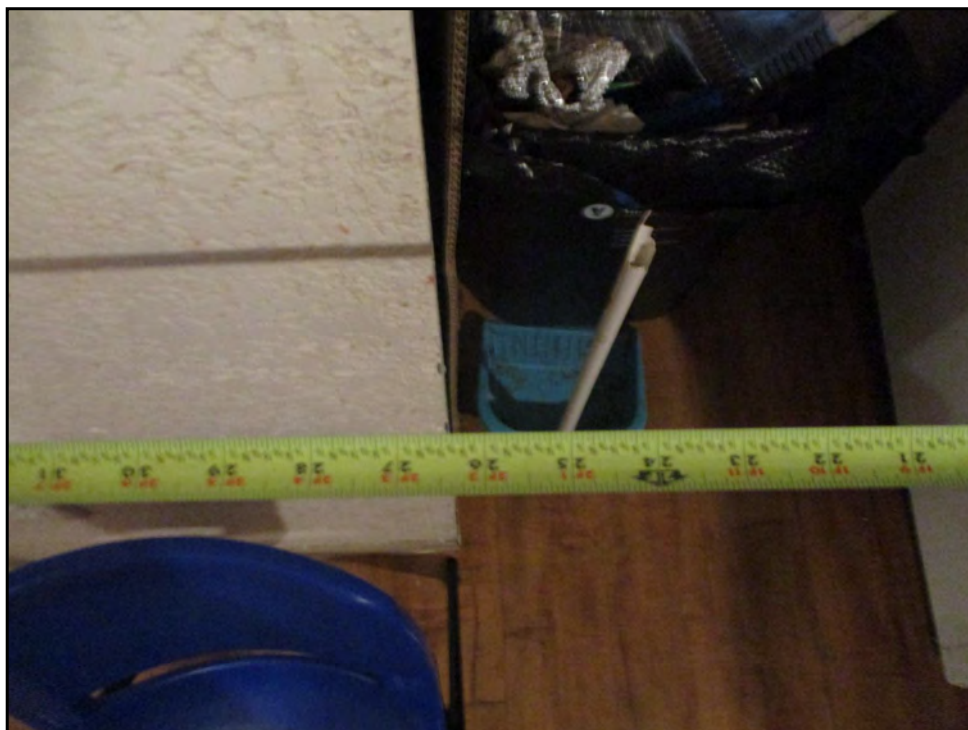
167: Missing compliant approach to refrigerator within Type C units (Immediate Repair)

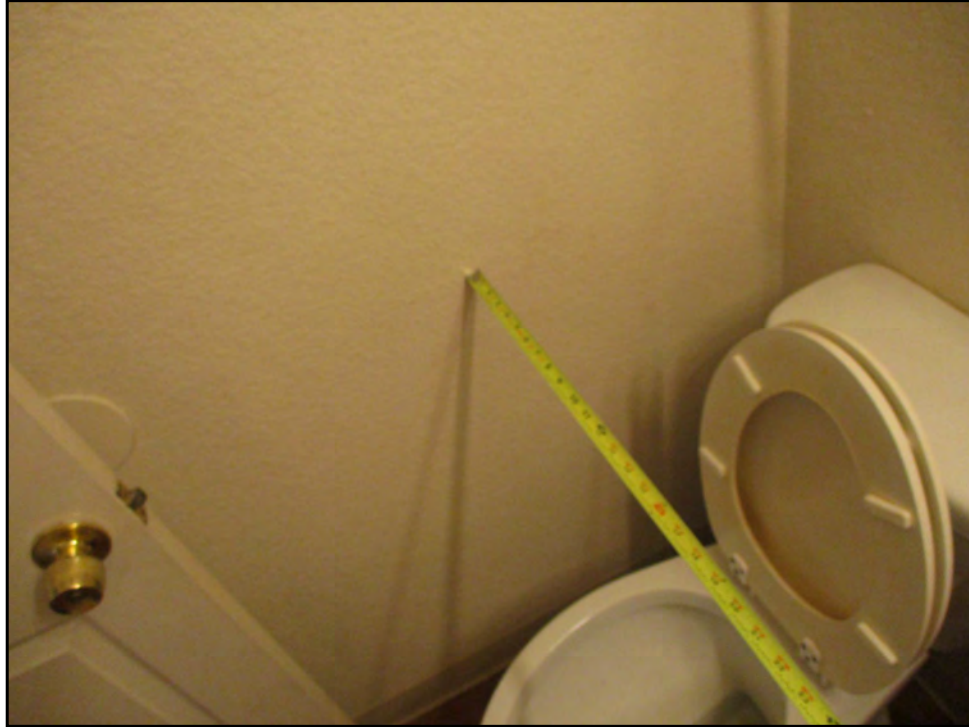
170: Less than 33-inches between wall and vanity at toilet in select floorplan types (Immediate Repair)

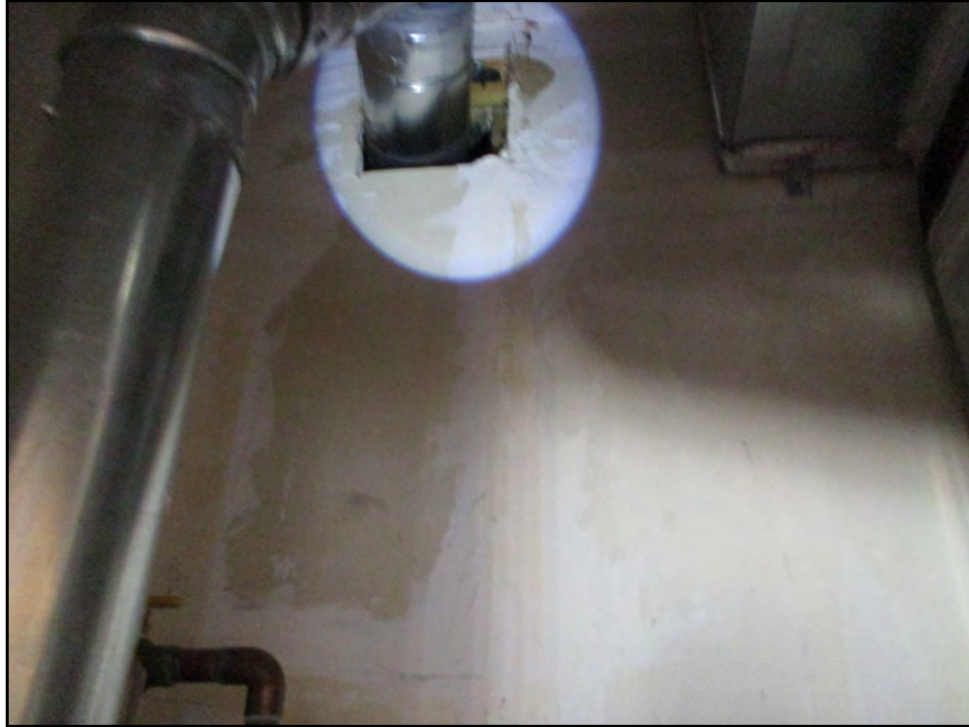
172: Unsealed thru-wall penetrations at unit mechanical closets (Immediate Repair)
