Level 2, Premium Reserve Analysis

Aspen Mountain Condominium Association 731 S. Mill St. Aspen, CO. 81611

FINAL VERSION

Date of Property Observation – August 12, 2025

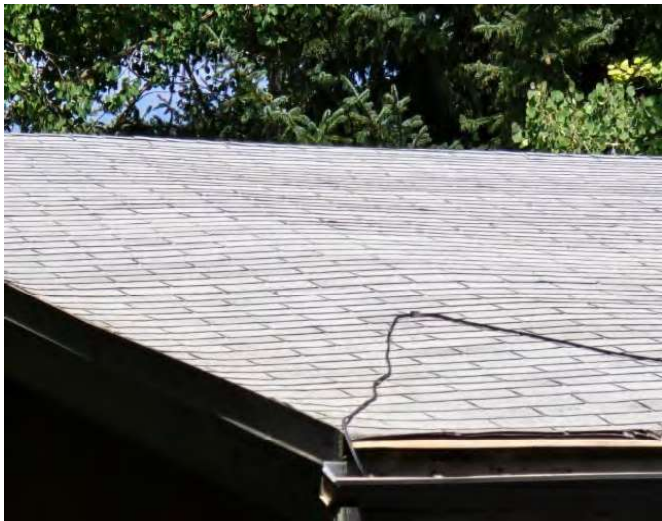
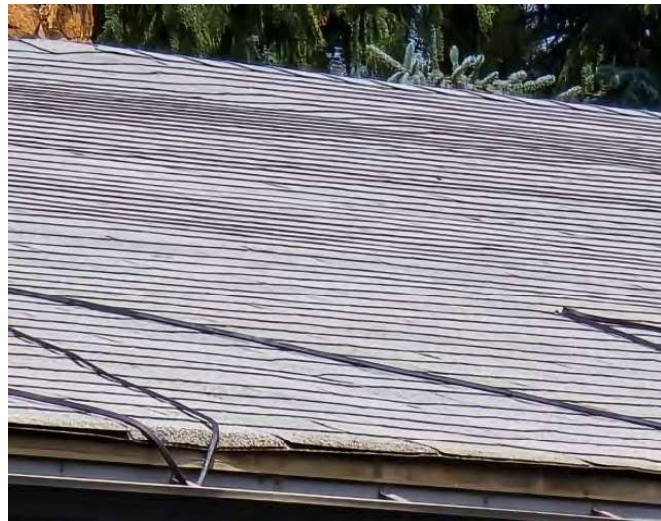
Comp #: 105 Comp Shingle Roof - Replace

- Roof is at least 35 years old and has far exceeded the normal life expectancy for this quality of roof in this climate.
- Due to the harsh winters, extensive freeze/thaw cycle, and high UV levels over the useful life of the roof, we typically see associations replacing roofs sooner than the manufacturer's suggested useful life.
- Reserve to replace future roofs every 20-25 years as that is the typical life expectancy for properly installed roofs in this climate

Best Cost: **\$84,500**
Estimate to remove and replace

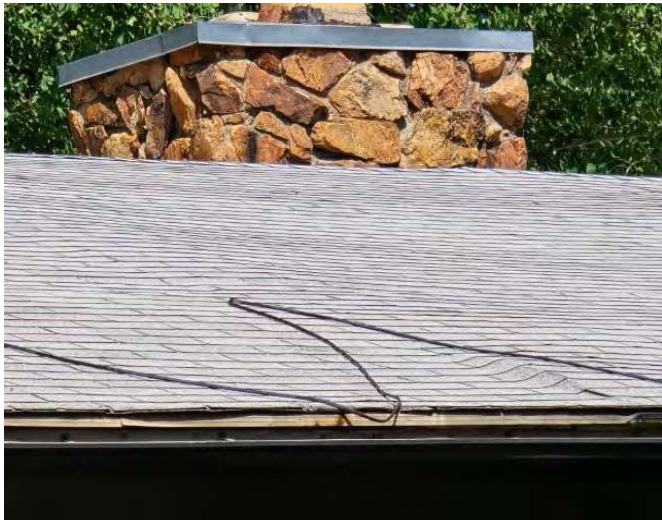
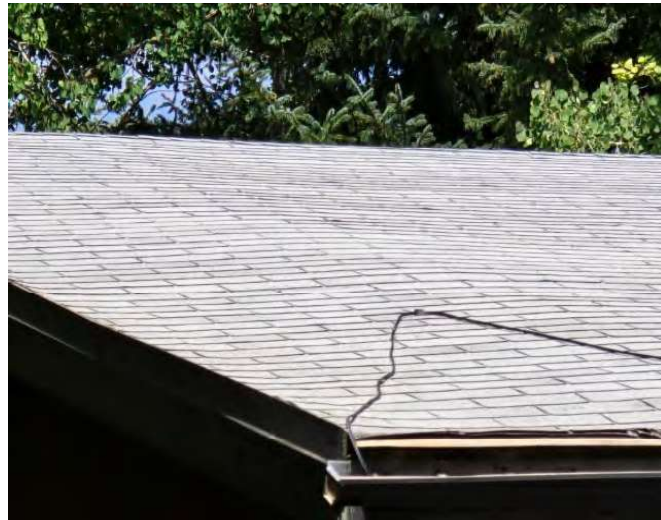
Comp #: 121 Heat Tape - Replace

- The useful life of heat tape varies based on working time, exposure, damage, etc.
- High use/exposure areas may require replacement every 10-15 years
- In between replacement cycles, repairs should be handled as needed with operating funds.

\$25/LF: Estimate to replace

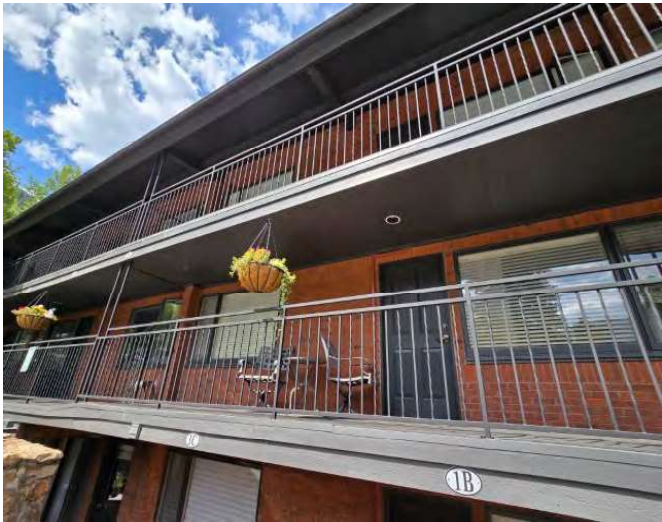
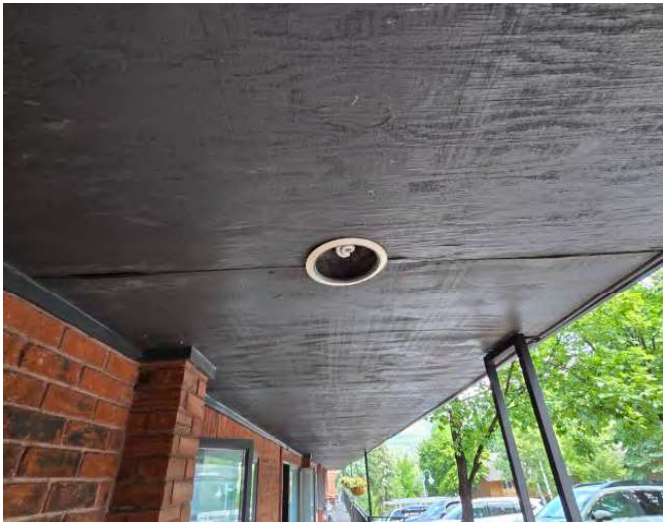
Comp #: 202 Building Exterior Surfaces - Repaint

- Repaint these surfaces approximately every 4 to 6 years to maintain appearance and protect wood materials
- Remaining life based on current age and condition.

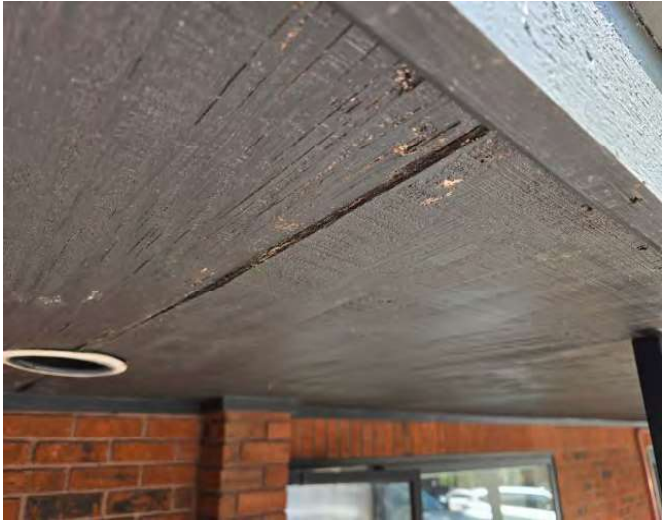
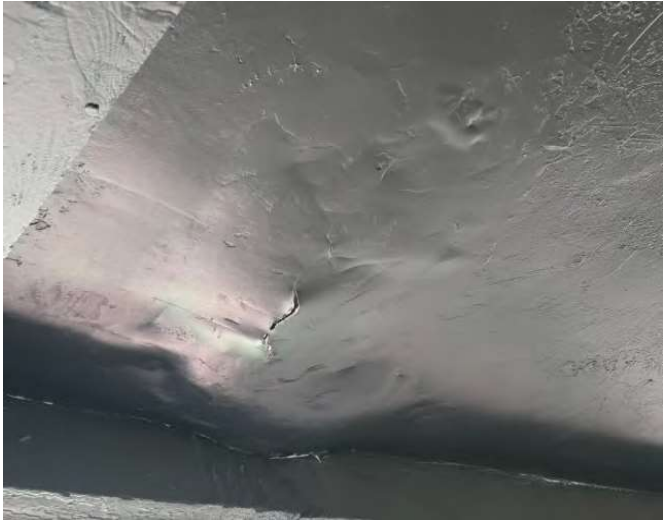
Comp #: 305 Wood Ceiling - Major Repairs

- Observations:*
- At the time of observation, the 3rd floor has a lot of leaks, possibly from the roof
 - With limited exposure to elements, and by following our recommended staining/sealing cycles, the life expectancy of this material should be indefinite.
 - However, based on the observed conditions and the age of the building, we recommend establishing some funding for periodic repairs to the ceilings and trim work
 - Coordinate with painting cycle for best results

Best Cost: **\$5,000**
Allowance for repairs

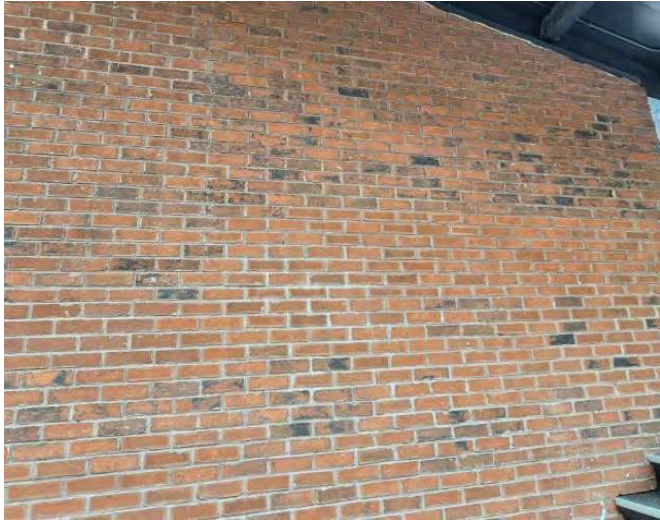
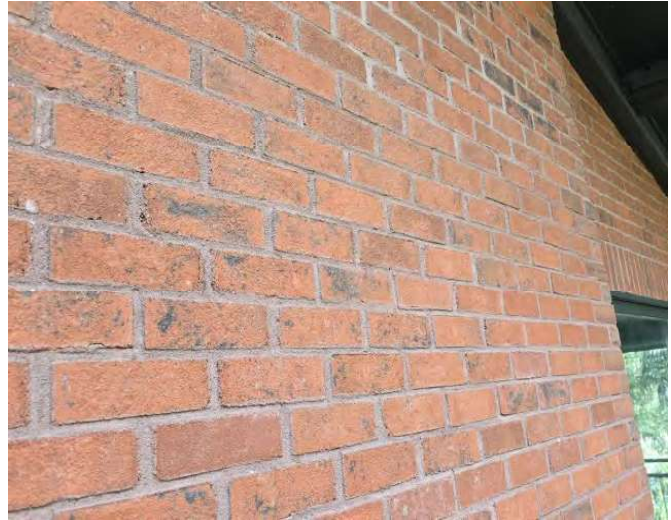
Comp #: 306 Brick - Inspect/Major Repairs

- Typically, this material has an extended life expectancy and complete replacement is unlikely.
- No unusual conditions noted during recent site visit.
- There are times where minor repairs may become necessary, but this is unpredictable when and how much would occur.
- Based on the age of the buildings and the observed conditions, we recommend establishing a line item for periodic major repairs and tuck pointing every 10 years.

Allowance for periodic inspections and repairs

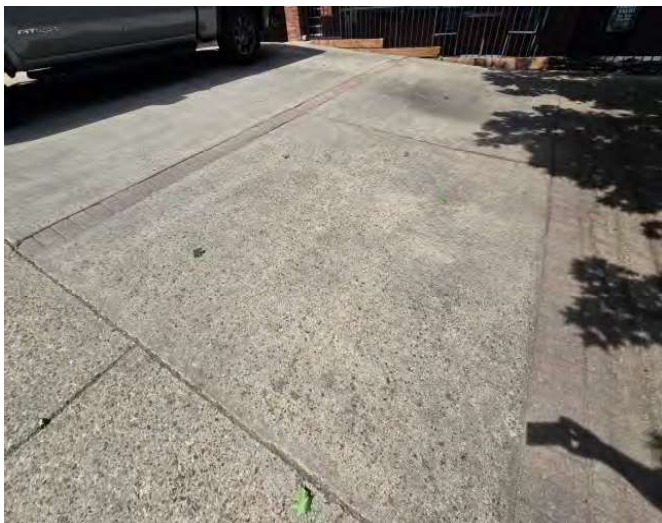
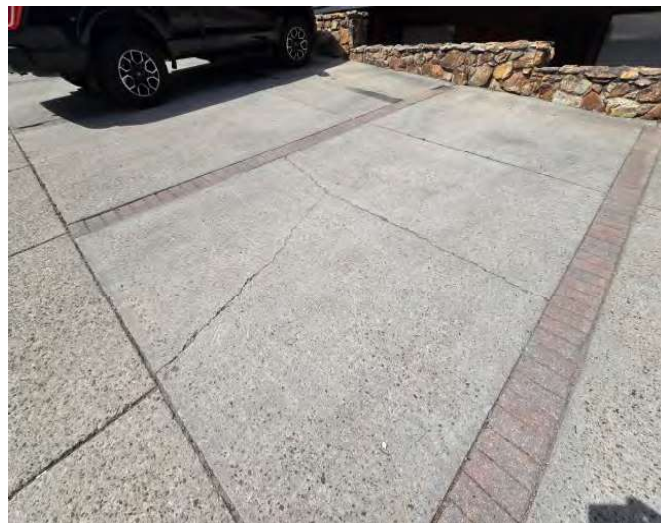
Comp #: 403 Concrete Parking - Repair/Replace

- Concrete is in good condition, considering age, with no major signs of cracking or deterioration. Over a period of time, concrete will crack and deteriorate due to the climate and the wintery conditions.
- Since it is unlikely all concrete surfaces will fail at the same time, we suggest establishing a Reserve fund for periodic repairs and replacement to approximately 20% of the total area (460 GSF) every 6 years.
- Repairs should be coordinated with other concrete surfaces for best cost estimate

Estimate to replace 20% of area every 6 years

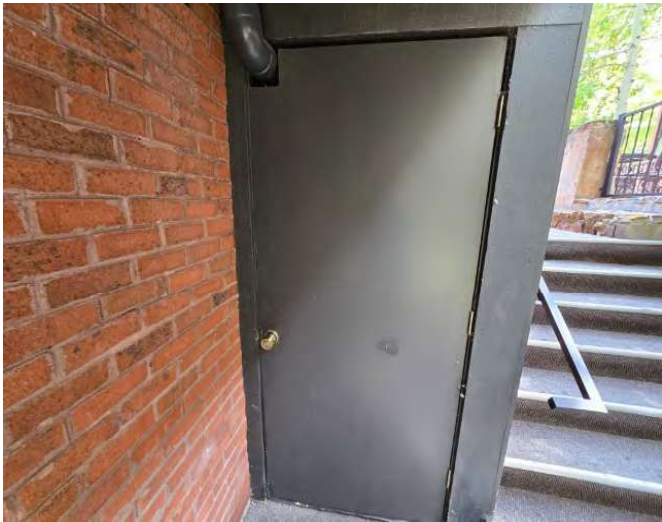
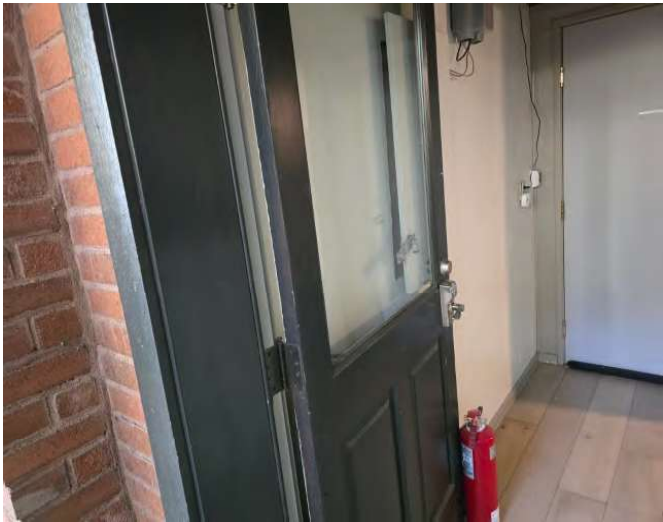
Comp #: 503 Doors - Replace

- According to the associations declarations, the unit owner is responsible for doors, doorways, door frames, and hardware that are part of the entry system. We assume this includes the storage doors that are for unit owner use only. Therefore, Reserve funding is not required for the entry doors.
- Common area doors that are exposed to the elements typically have a life expectancy of 25 - 30 years, depending on the quality of the door and the level of maintenance.
- To maintain a consistent appearance, we recommend establishing funds to replace common area doors every 30 years
- While doors are older than the useful life, we suggest replacing during the next paint cycle to enhance the appearance of the building

Allowance to replace 12 doors every 10 years

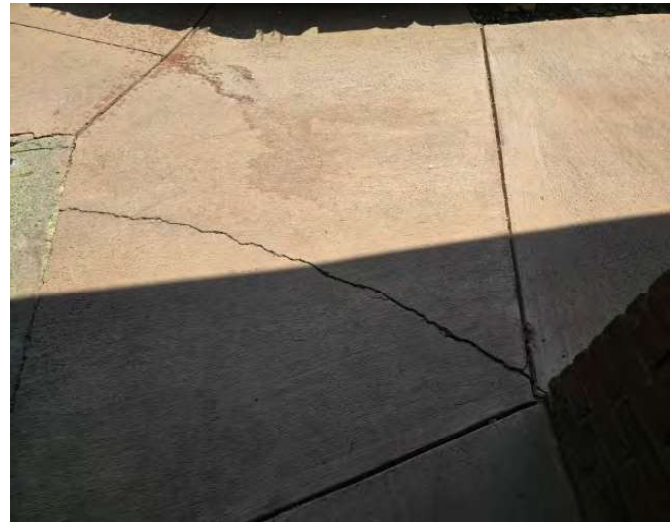
- This line item is for periodic major repairs and should not be misinterpreted as complete replacement.

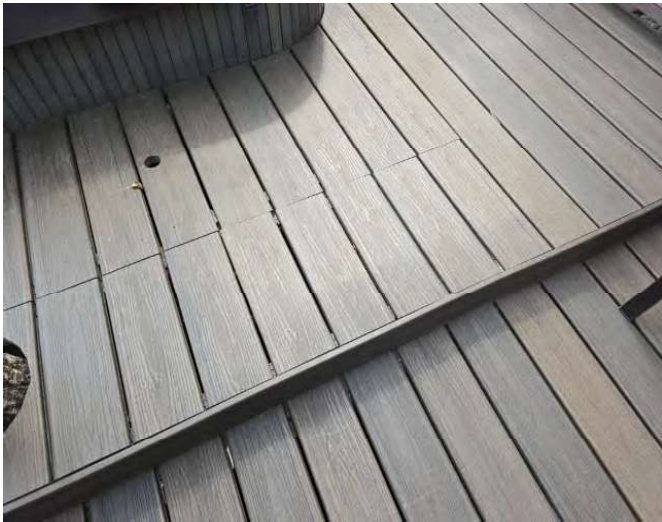
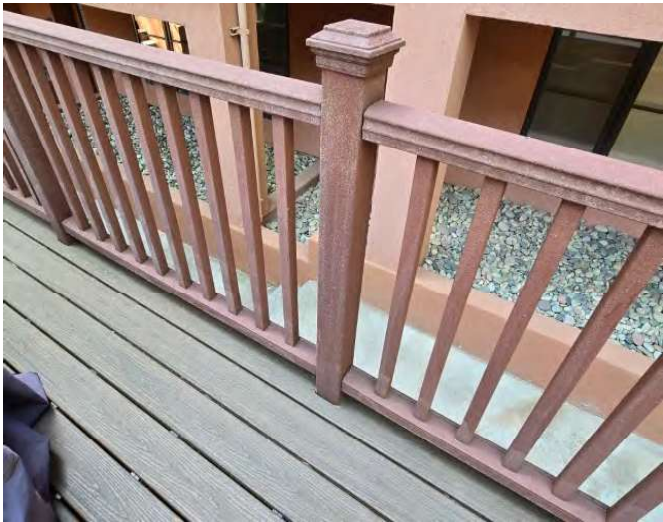
Comp #: 609 Composite Deck - Replace

- At the time of observation, it appears the decking is new but the rails are older
- Even though composite materials are considered "lifetime", this material is also subject to scratching and deterioration that could warrant replacement within 20 - 25 years of installation.
- With periodic inspections and repairs, we can extend the replacement cycle to occur every 25 years.
- If it later turns out that the deterioration rate is not as we expected, then the life and remaining life can be adjusted in future Reserve Study updates.

Best Cost: **\$29,250**
\$65/GSF; Estimate to replace

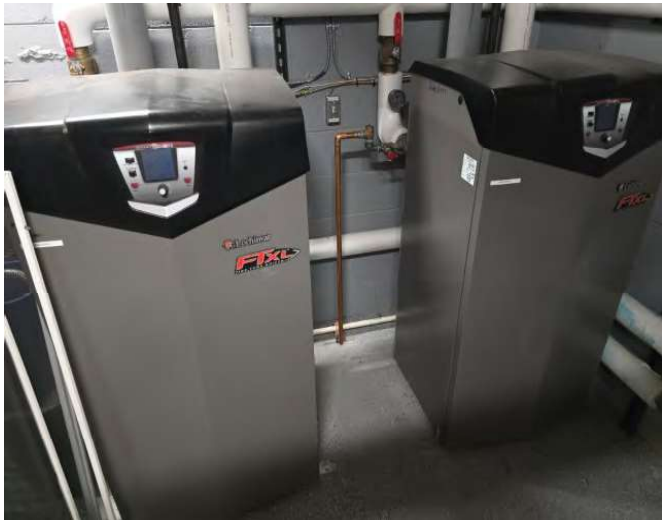
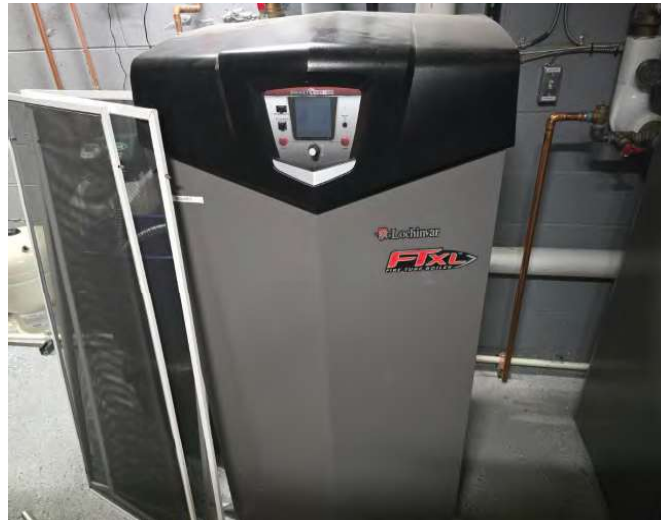
Comp #: 702 Boilers - Replace

- It was reported the boilers were replaced 2 - 3 years ago
- The average life expectancy for these boilers ranges from 20 - 25 years with proper maintenance under normal conditions.
- Remaining life is based on age of unit

Estimate to replace and install

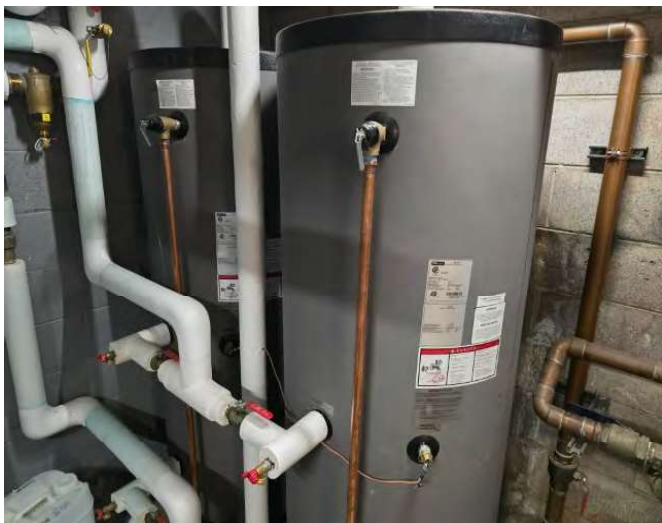
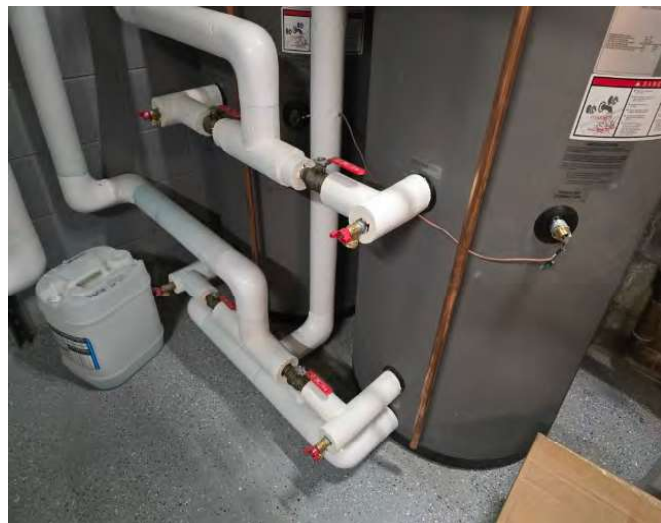
Comp #: 703 Hot Water Storage Tanks - Replace

- The average life expectancy for these storage tanks range from 10-15 years with proper maintenance under normal conditions.
- Remaining life is based on age of units

Best Cost: **\$13,500**
\$6750/tank; Estimate to replace

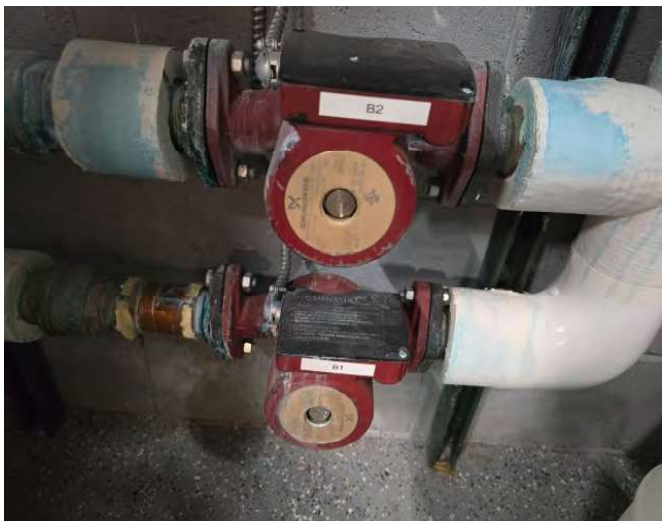
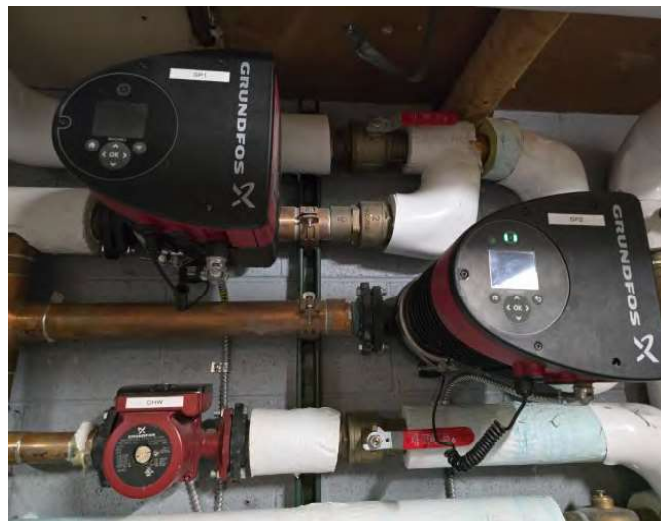
Comp #: 715 Pumps - Replace

- Due to varying ages, sizes, and levels of use, we recommend establishing an allowance for periodic major repairs or partial replacement.
- This line item is not intended to be represent complete replacement of all pumps/motors at the same time.

Allowance for partial replacement every 6 years

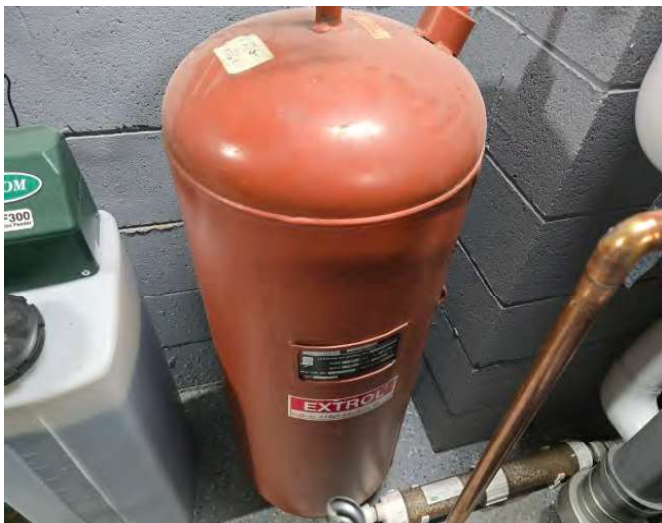
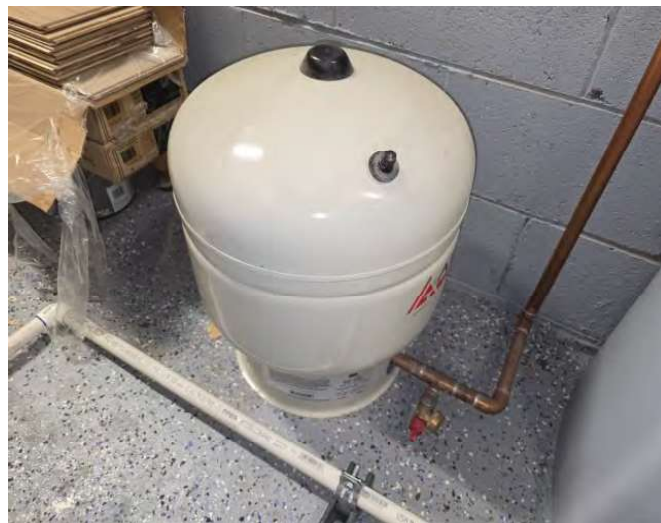
Comp #: 721 Expansion Tanks - Replace

- Under normal conditions and without sudden pressurization, these tanks typically have an indefinite life expectancy.
- Due to the low replacement cost of these tanks and an unpredictable life, we recommend replacing these tanks as needed with general operating funds.

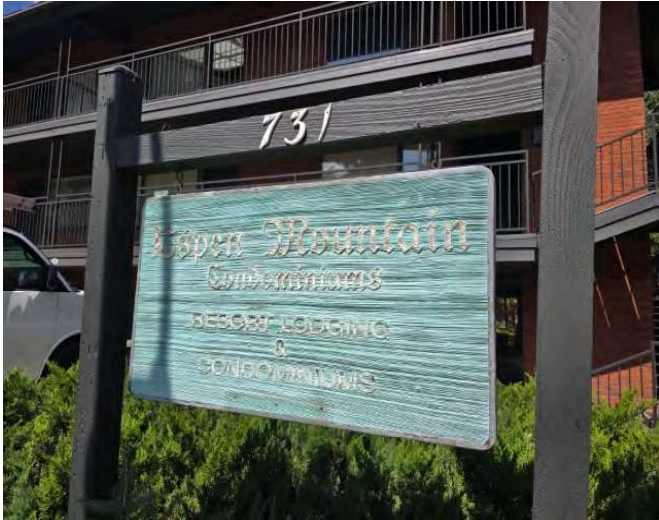
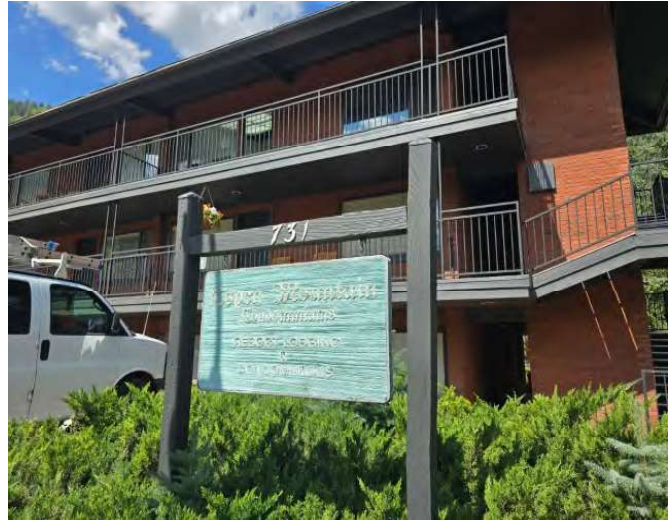
Comp #: 801 Identification Sign - Replace

- Extensive wood rot on the posts as they are unstable. There is wear and tear on the sign as well and in our opinion, the entire sign needs to be replaced
- Materials used to construct this sign typically has a replacement cycle of 15 - 20 years under normal conditions.
- Most associations decide to replace and upgrade monuments to maintain current trends and an appropriate appearance for the community.
- Based on observed conditions, we recommend the association be prepared to replace this sign anytime in the near future
- Exact cost will depend on the design of the new sign and whatever materials are selected for the new sign.

Estimate to replace

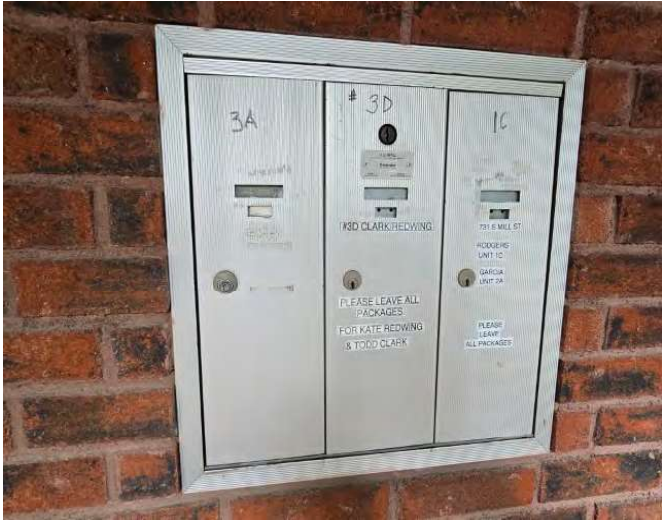
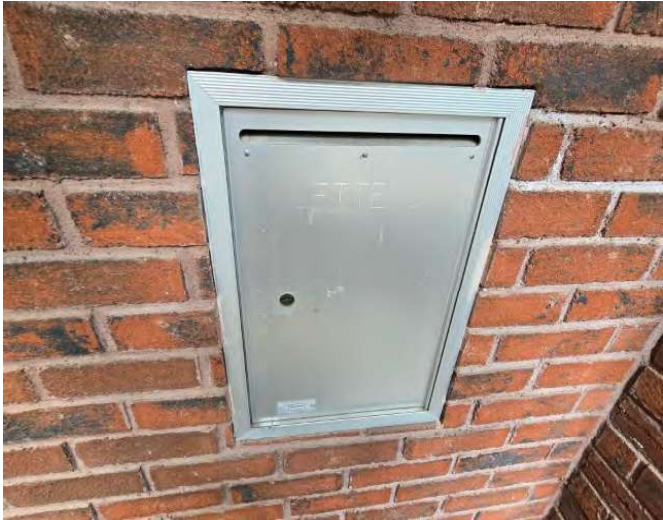
Comp #: 803 Mailboxes - Replace

Observations:
- Due to the low quantity, Reserve funding is not required for this component

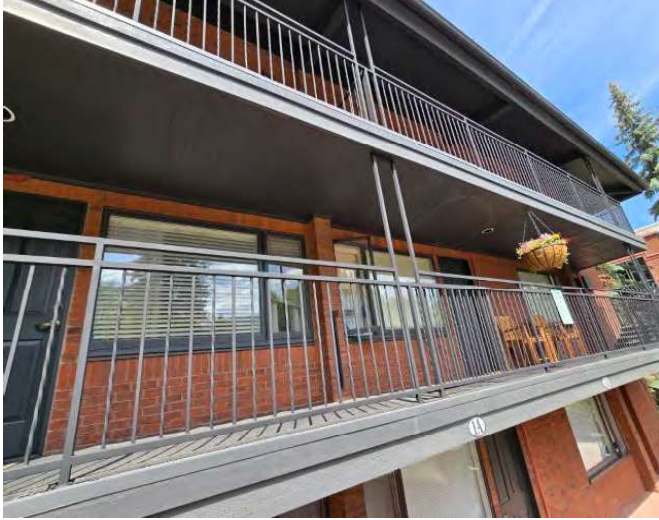
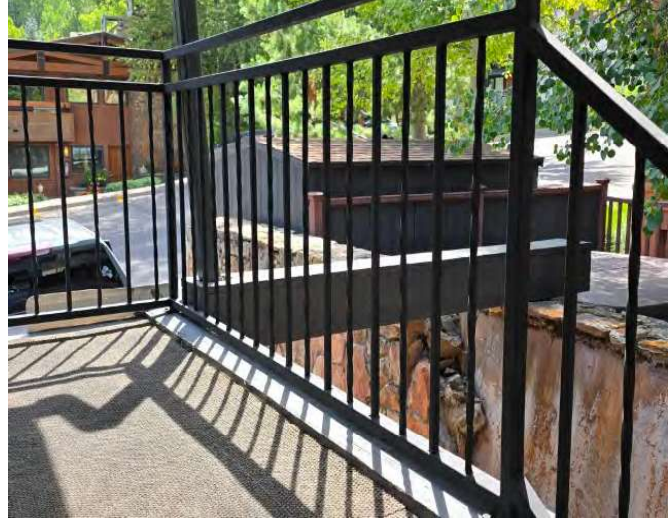
Comp #: 1002 Metal Handrails - Replace

- Rails need to be painted on an as needed basis with general operating funds to preserve and protect the metal from rusting.
- The average life expectancy for metal rails ranges between 25 - 30 years, depending on maintenance levels and exposure to elements.
- There is minimal exposure to the elements since the rails are on balconies and not exposed to elements which can cause major deterioration which will result in eventual replacement
- In order to maintain a safe environment, we recommend establishing funds to replace rails every 50 years
- While railings may still be stable at the 50-year mark, it is important to ensure funds are available in case these need to be replaced.
- At this time, since rails are in fact stable, we have extended the remaining life by 10 years at this time.

\$85/LF; Estimate to replace

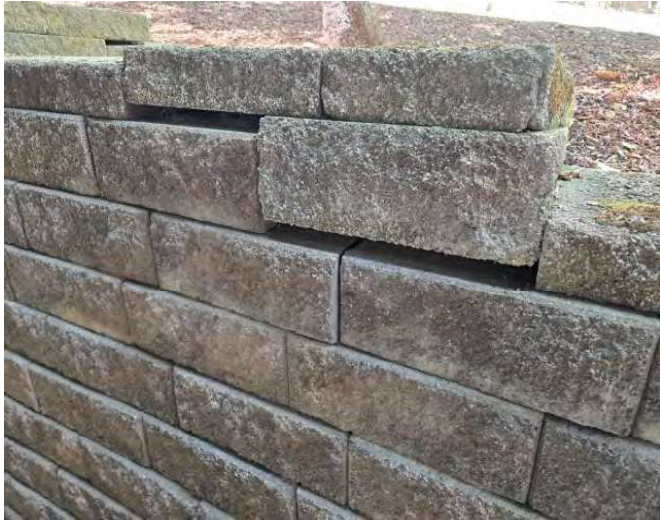
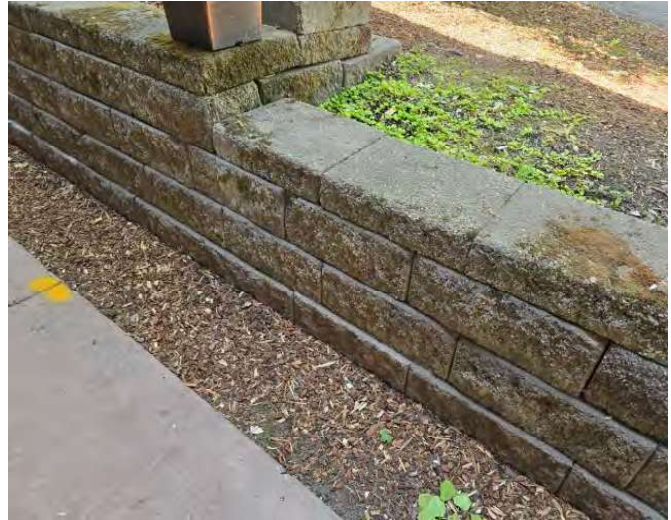
Comp #: 1005 Block Wall - Replace

- As long as block wall was installed conforming to county code requirements, this wall should have an extended useful life.
- This type of material has an indefinite life expectancy and complete replacement is unlikely.
- However, establish some funds for periodic major repairs due to the possibility of shifting and minor deterioration of blocks.

Allowance for periodic inspections and repairs

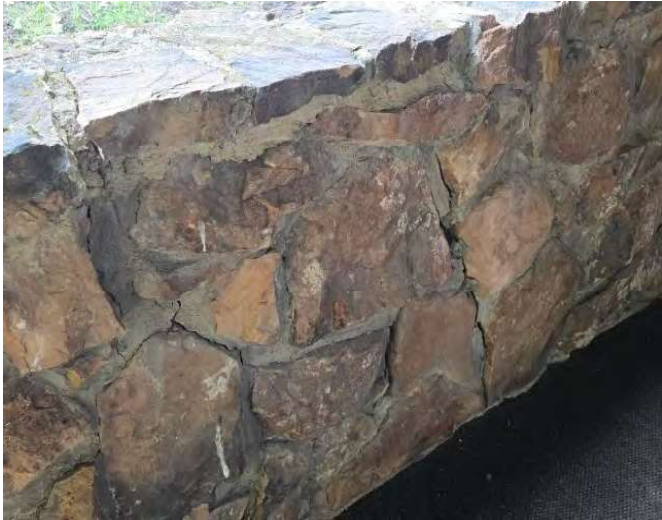
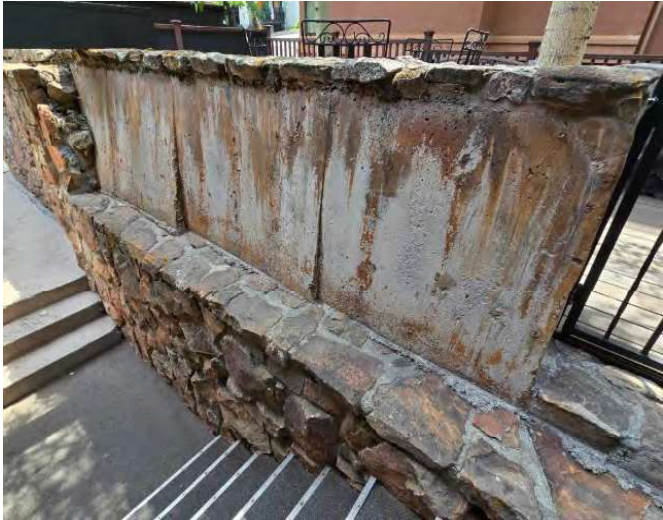
Comp #: 1005 Stone Walls - Major Repairs

- Observations:*
- As these walls typically have an extended useful life, if installed properly and there are no unexpected drainage or soil issues that would cause damage, we do not recommend funding for the replacement of these walls.
 - Based on the age of the walls, we have included a small allowance for periodic inspections and repairs

Best Cost: **\$8,500**
Allowance for major repairs every 10 years

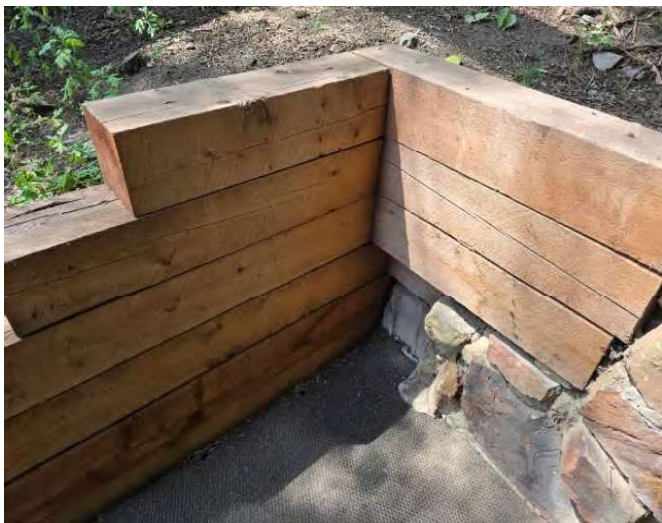
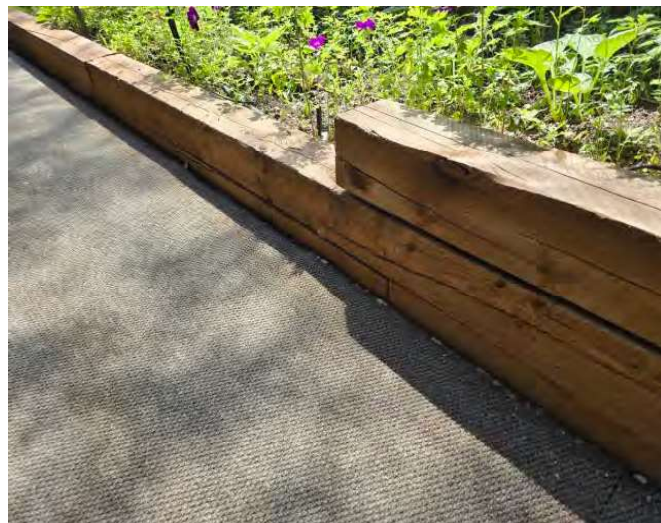
Comp #: 1016 Landscape Timber Walls - Major Repairs

- Timbers are in good condition, with no signs of leaning or deterioration noted.
- The top timber tends to become the first piece to deteriorate and need to be replaced.
- This type of wall also tends to be susceptible to movement and leaning.
- When replacement is necessary, most associations are converting to block wall for longer life expectancy and less maintenance.

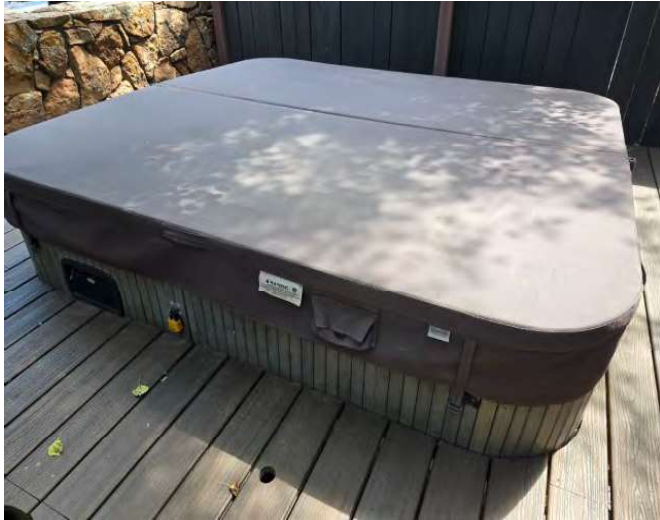
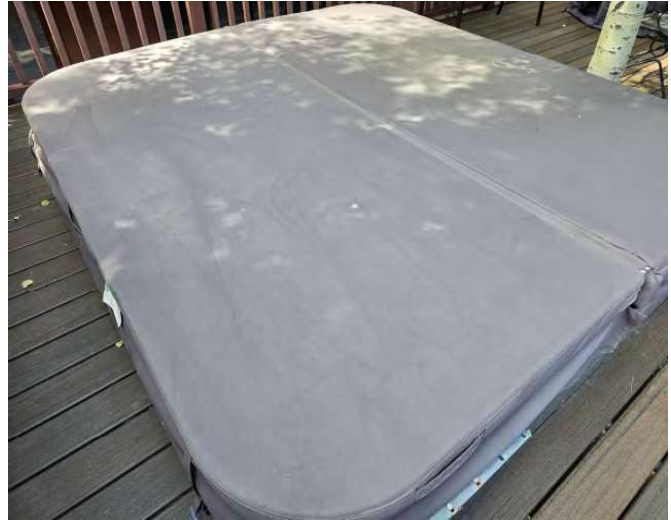
Comp #: 1114 Spa Cover - Replace

- Cover was in good condition at time of inspection.
- Due to low cost of cover replacement, address this expense as an operating issue, not Reserves

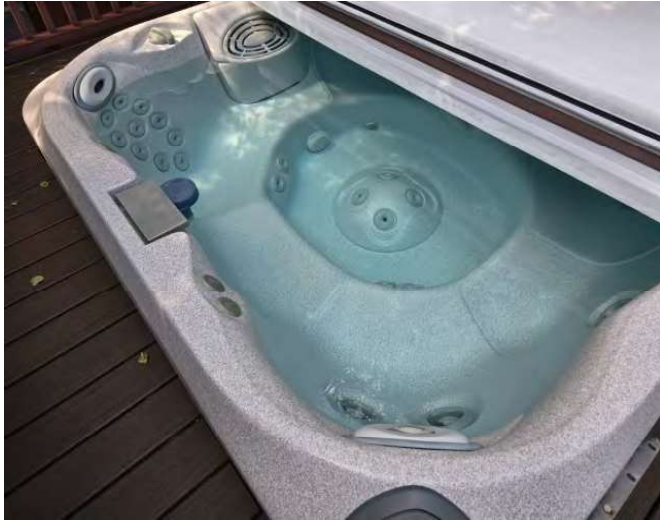
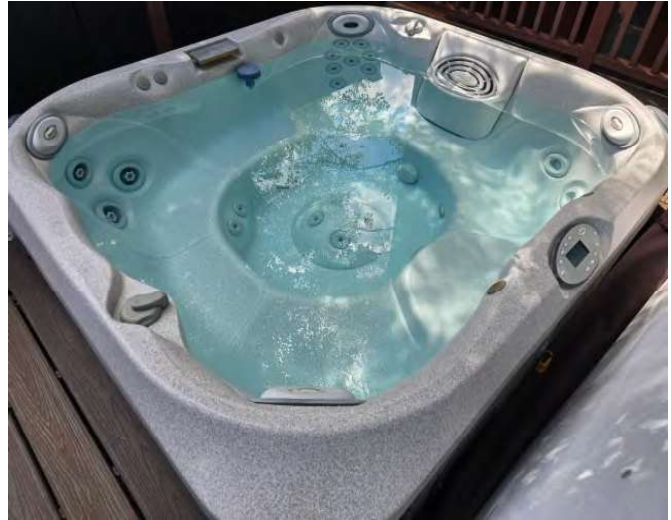
Comp #: 1116 Acrylic Spa - Replace

- Hot tub is older, but functioning well with no unusual conditions observed or reported at time of inspection.
- In normal conditions, the average replacement cycle for acrylic spas range between 15-20 years depending on the level of use and care.
- The remaining life has been extended a few years based on no reported issues.
- New hot tubs has improved features and are more efficient

Best Cost: **\$16,500**
Estimate to replace, deliver and install

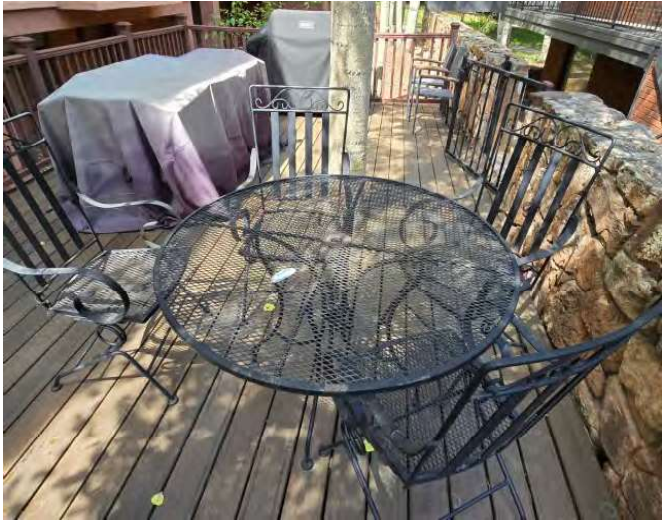
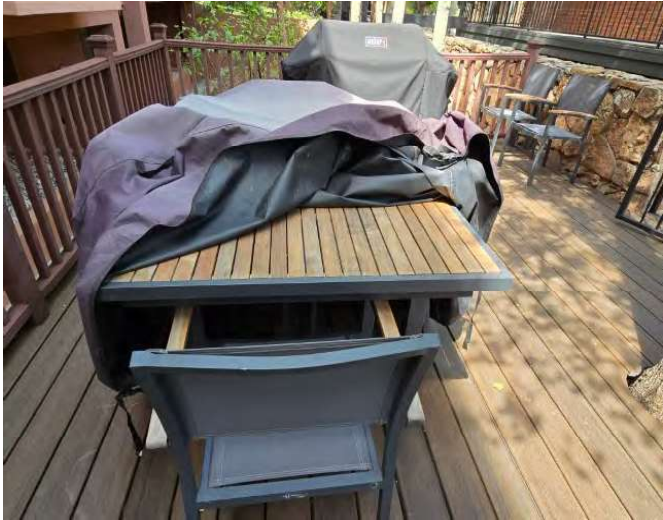
Comp #: 1121 Spa Deck Furniture - Partial Replace

Observations:
- Due to varying types of furniture and different levels of use each piece received, we recommend establishing funds for partial replacement every 5 years.

Best Cost: **\$2,500**
Allowance to replace needed pieces

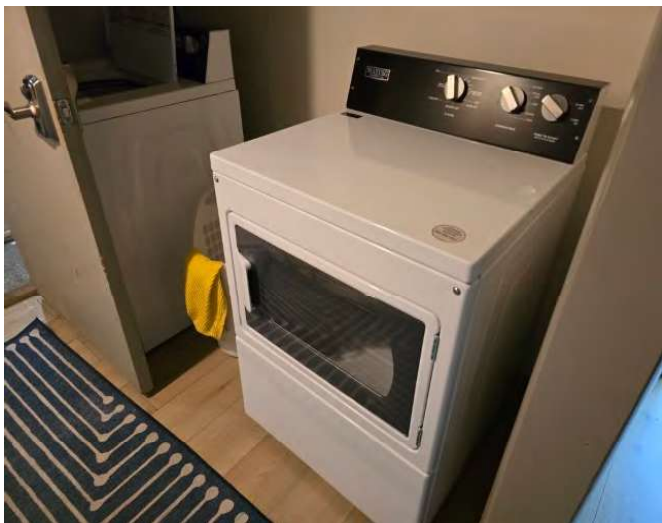
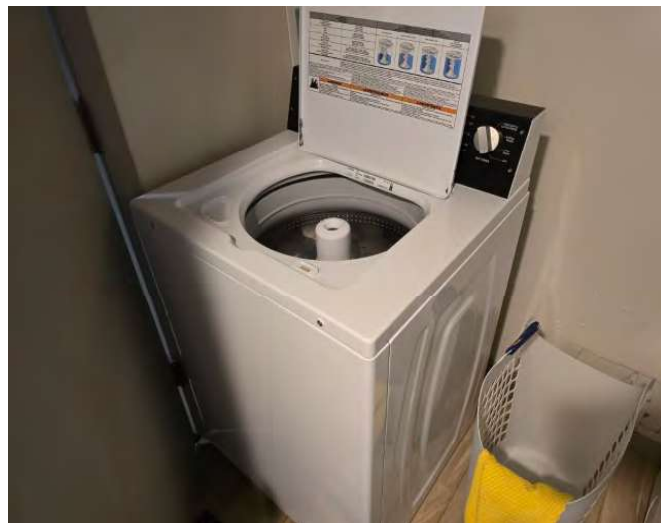
Comp #: 1401 Laundry Equipment - Replace

- Due to low replacement cost of these machines, we recommend replacing on an as needed basis with general operating funds.
- Therefore, at this time, separate Reserve funding is not required for this component

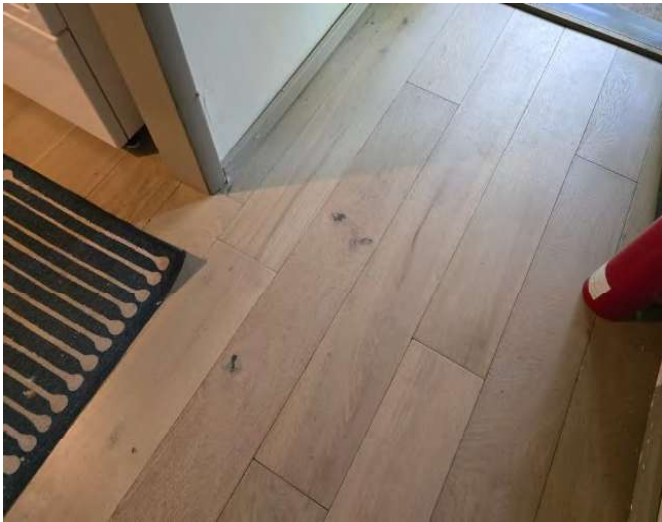
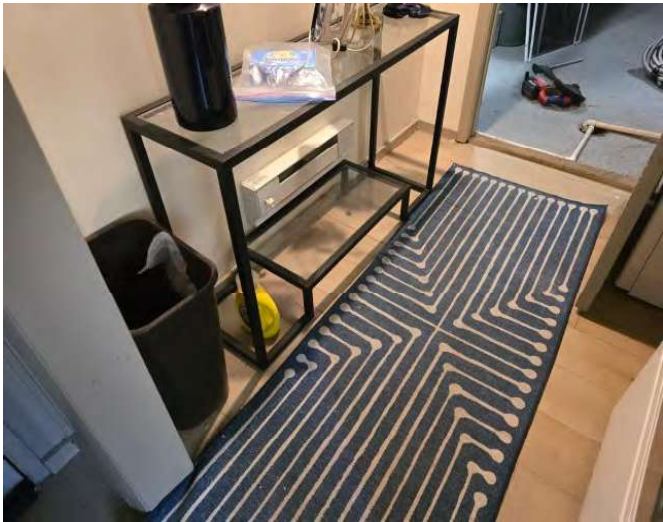
Comp #: 1413 Laundry Room - Remodel

- It appears the laundry area has been remodeled within the past several years and is in very good condition.
- Most associations perform a general remodel of the common interiors every 10 - 15 years to maintain appearance and keep up with current decorative trends.
- The final decision is up to the community members in deciding when to spend the money to perform this project since it is considered cosmetic.

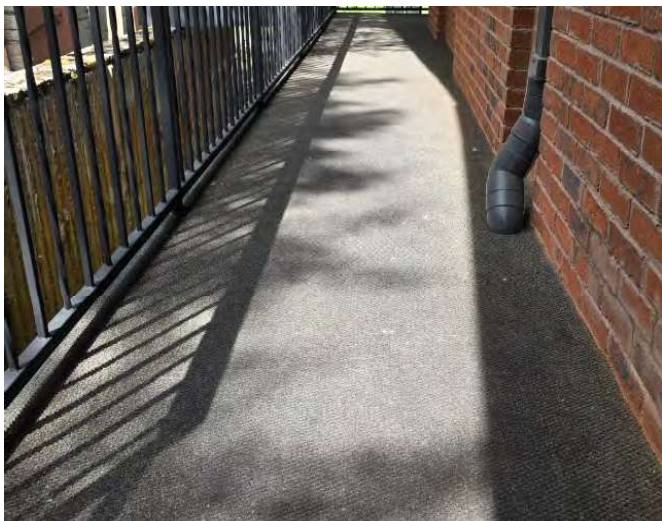
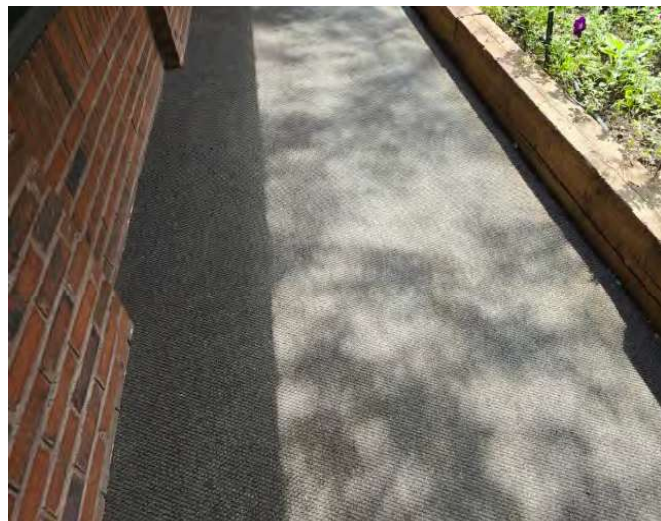
Comp #: 1507 Indoor/Outdoor Carpet - Replace

- Carpet of this quality, installed in these types of areas with current traffic patterns, typically has a useful life of approximately 10 - 12 years before needing to be replaced.

Best Cost: **\$18,225**
\$45/GSY; Estimate to remove and replace

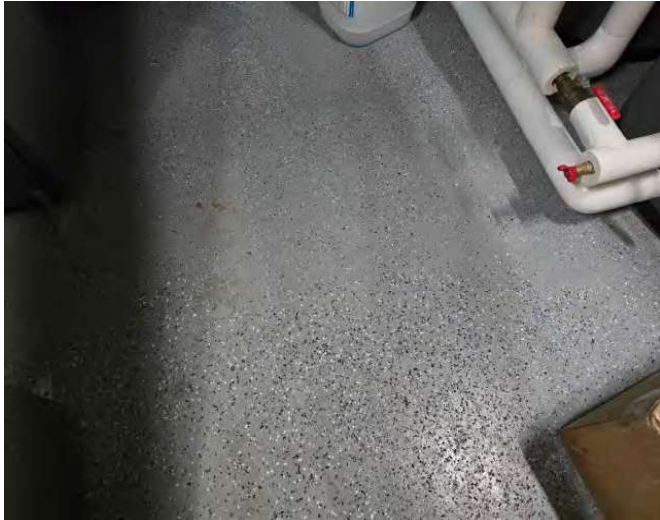
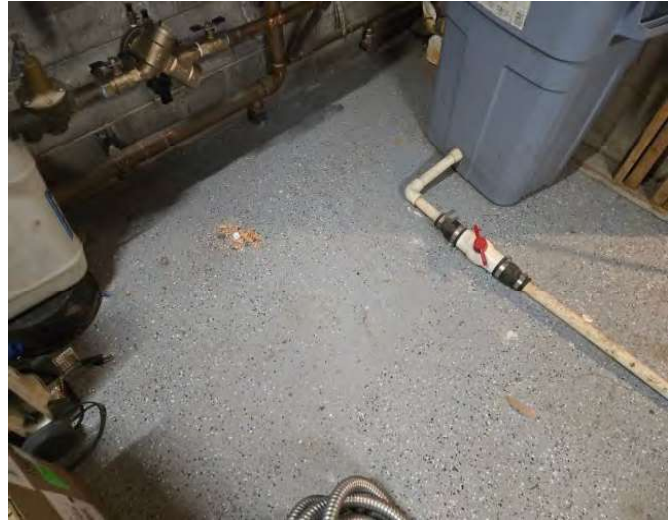
Comp #: 1511 Epoxy Flooring - Replace

- Due to the minimal area, recoat as needed with operating funds

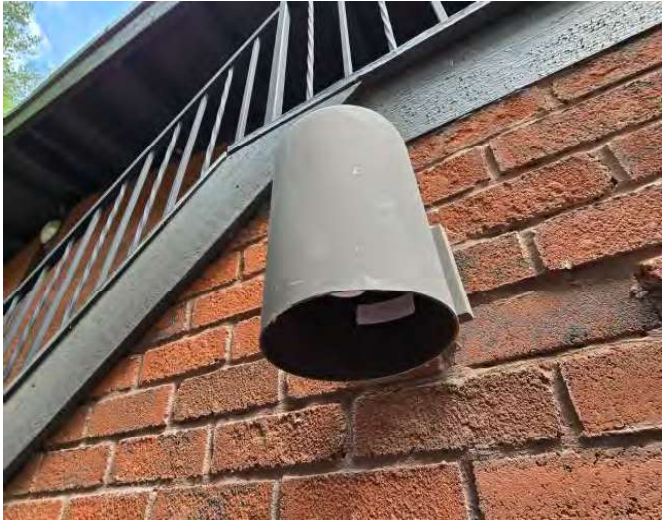
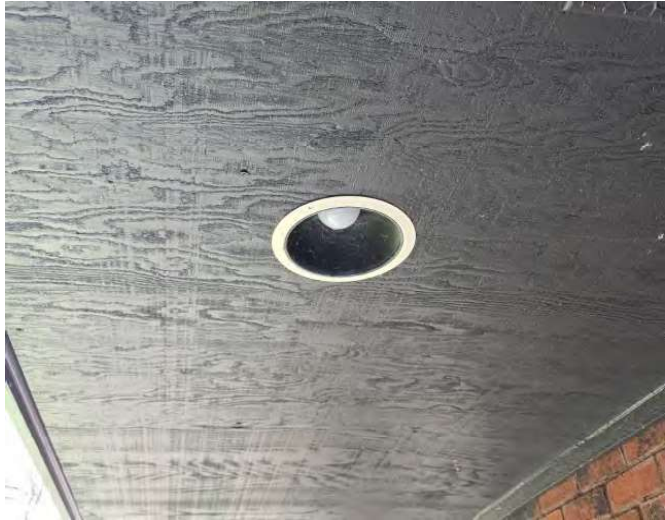
Comp #: 1602 Exterior Lighting - Replace

- While replacement can occur on an as needed basis, it is our opinion and recommendation to replace all lights at the same time every 15 - 20 years to maintain a consistent appearance throughout the property.
- In addition, by replacing multiple fixtures, the association will be able to obtain a quantity discount for the fixtures.
- These can be replaced on an as needed basis with general operating funds.
- At this time, Reserve funding is not required for this component.

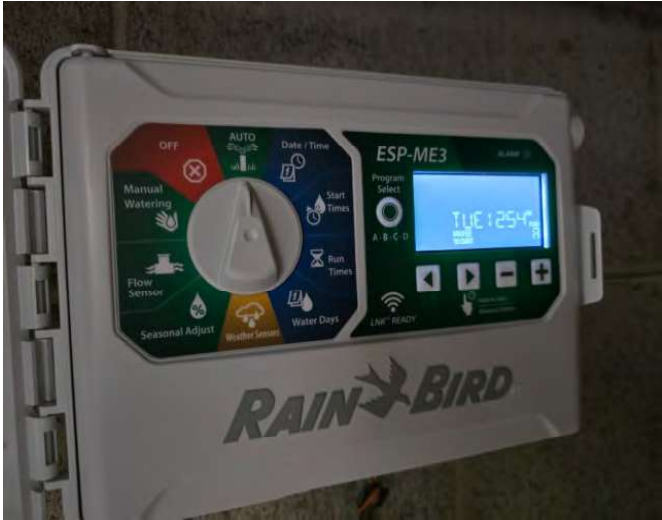
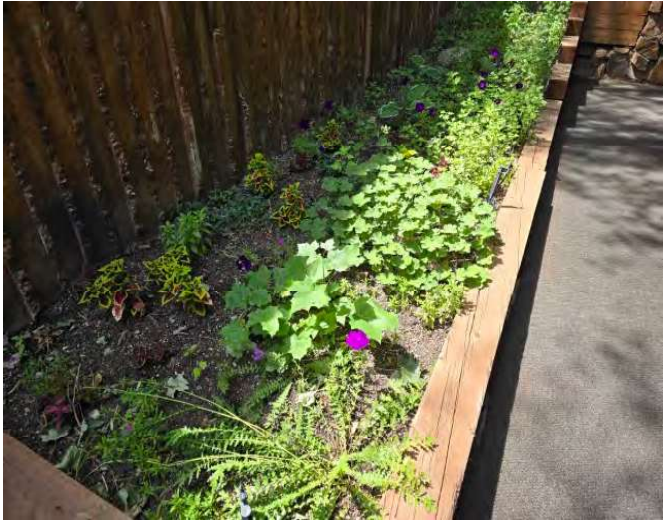
Comp #: 1703 Irrigation Controller/System - Replace

- Observations:
- Due to the minimal replacement cost associated with this small system, Reserve funding is not appropriate.
 - Perform major repairs as necessary as an operating expense

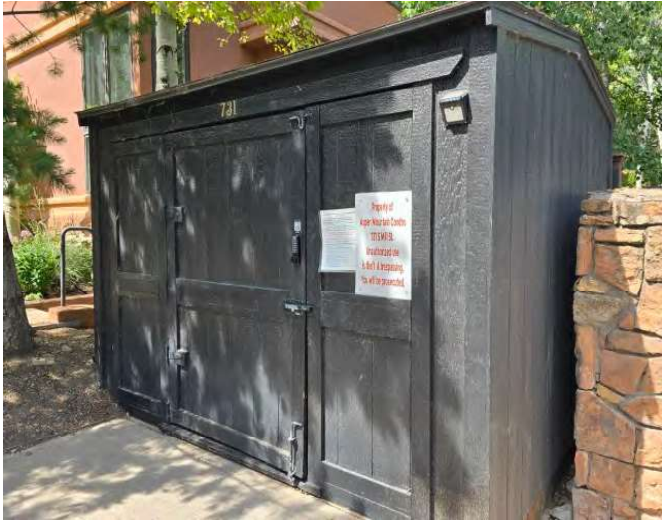
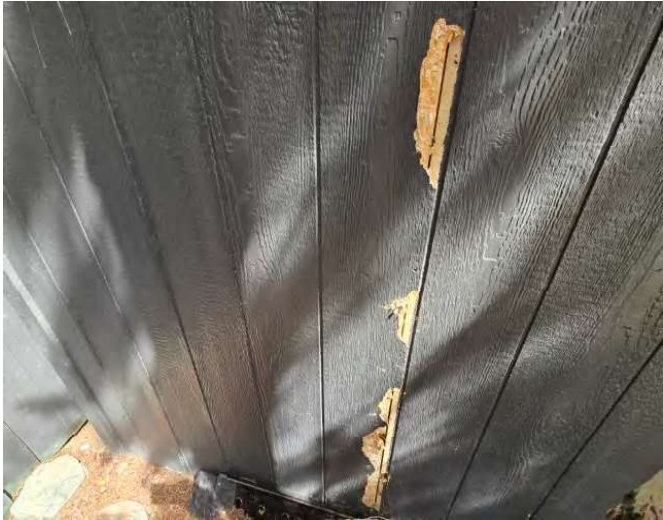
Comp #: 1904 Storage Shed - Replace

- Observations:*
- At the time of observation, there are holes in the side of the unit. Repair holes as a maintenance expense to extend the life of the shed.
 - It was reported this is for trash
 - Plan on replacing the shed every 15-20 years under normal conditions.
 - Remaining life is based on observed condition of the shed

Best Cost: **\$4,250**
Estimate to replace with similar size
