Level 2, Premium Reserve Analysis

Aspen Mountain Condominium Association 731 S. Mill St. Aspen, CO. 81611

FINAL VERSION

Date of Property Observation – August 12, 2025

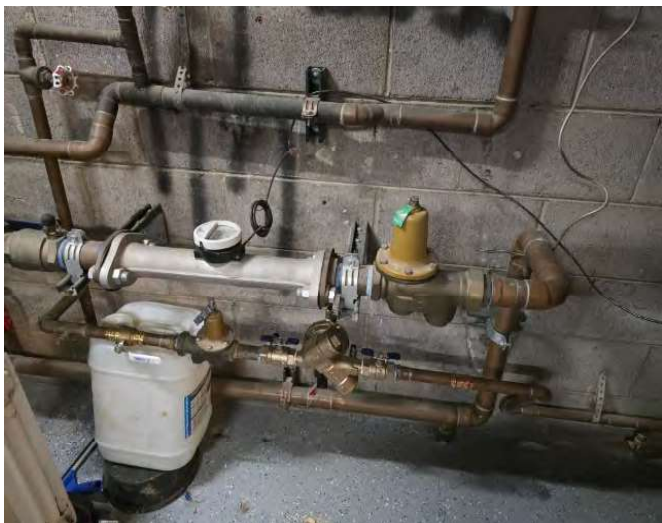
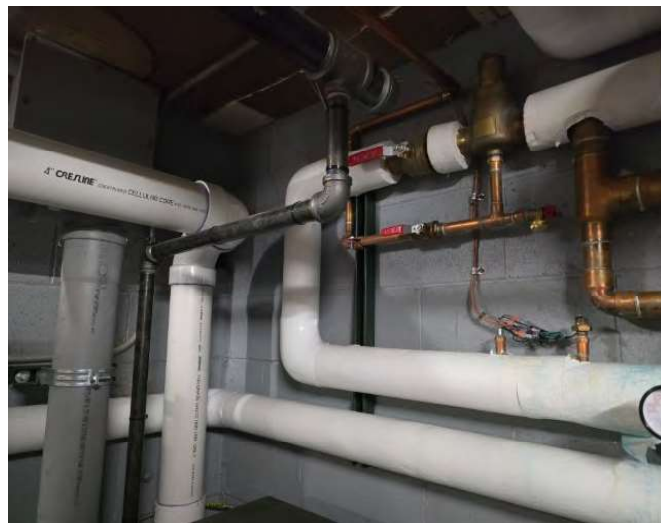
Comp #: 2002 Plumbing/Backflow Preventer - Major Repairs

- Utility lines are not typically included as a Reserve item due to unpredictable nature of this component.
- However, due to the age of the building, we recommend establishing an allowance for major repairs every 4 - 5 years.
- As the association establishes a history of expenses, we can adjust the figures accordingly based on actual costs.

Allowance for major repairs

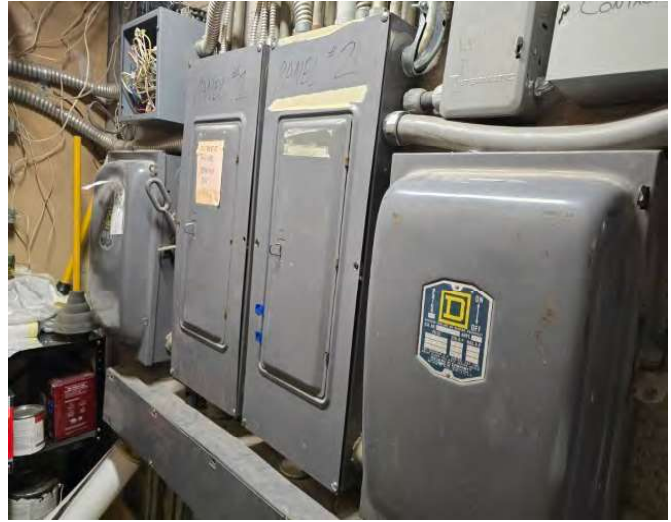
- Since the life of expectancy of electrical systems is unpredictable, Reserve funding is not included for this component.
- If the association establishes a pattern of frequent repairs or inspections, then an allowance could be added to the report at the request of the client.
